CALIFORNIA GEOLOGY

Effects of the Loma Prieta Earthquake October 17, 1989

San Francisco Bay Area

DAVID R. MONTGOMERY

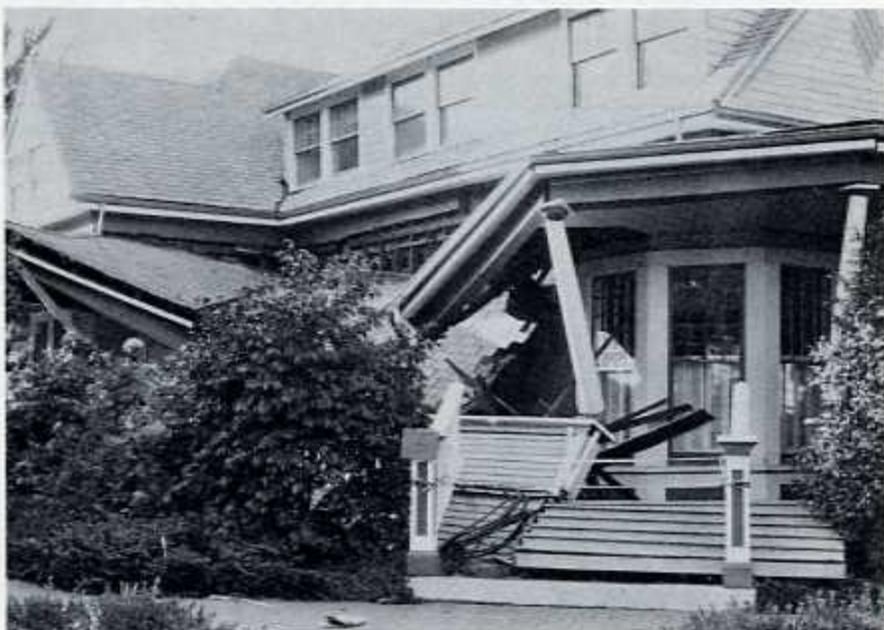
Photo 1. Partially collapsed house, Los Gatos, California.

During the Loma Prieta earthquake severe ground shaking caused a variety of damage to structures. The worst ground shaking appeared to occur in the Santa Cruz Mountains where many buildings were damaged or destroyed by ground cracking and shaking, as well as landsliding. Farther from the epicenter, the damage due to groundshaking was much more selective due to both local geology and type of buildings. For example, many houses not bolted to their foundations partially collapsed and some older houses suffered severe damage from partial failure of their foundations (Photo 1).

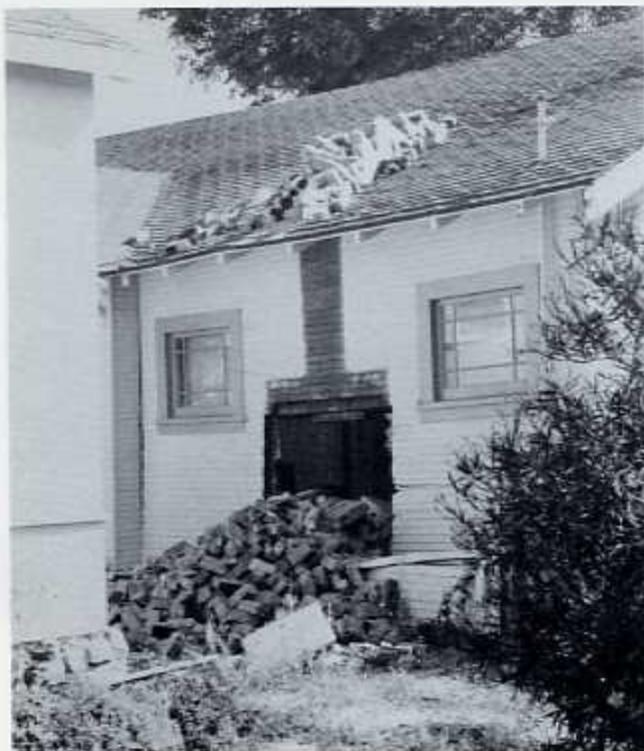
Photo 2. Collapsed chimney and fireplace showing total destruction of masonry but little structural damage to the wood-frame house.

Thousands of chimneys were damaged throughout the Bay Area (Photo 2) and damage to masonry buildings ranged from complete collapse to the partial loss of brick facades (Photo 3). In San Francisco, buildings in the downtown area and south of Market Street sustained severe structural damage. Five fatalities resulted

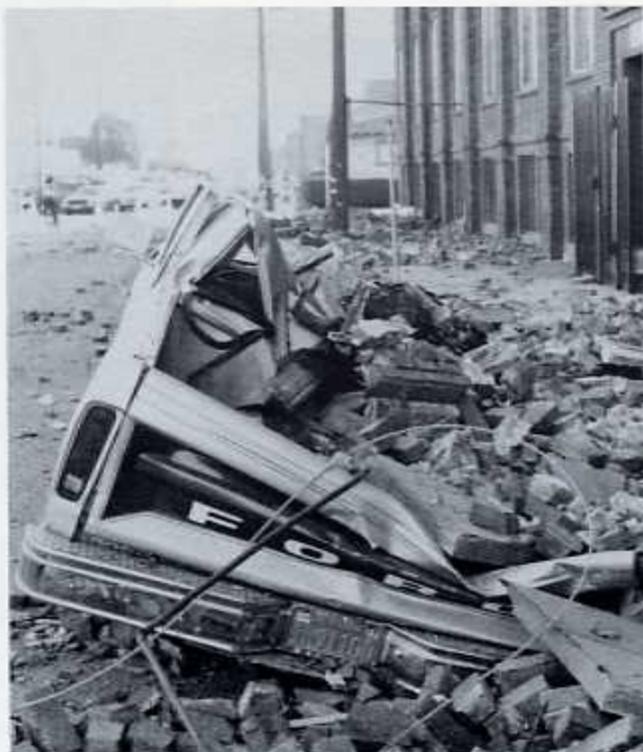
Photo 3. Car crushed by falling bricks from a masonry building.

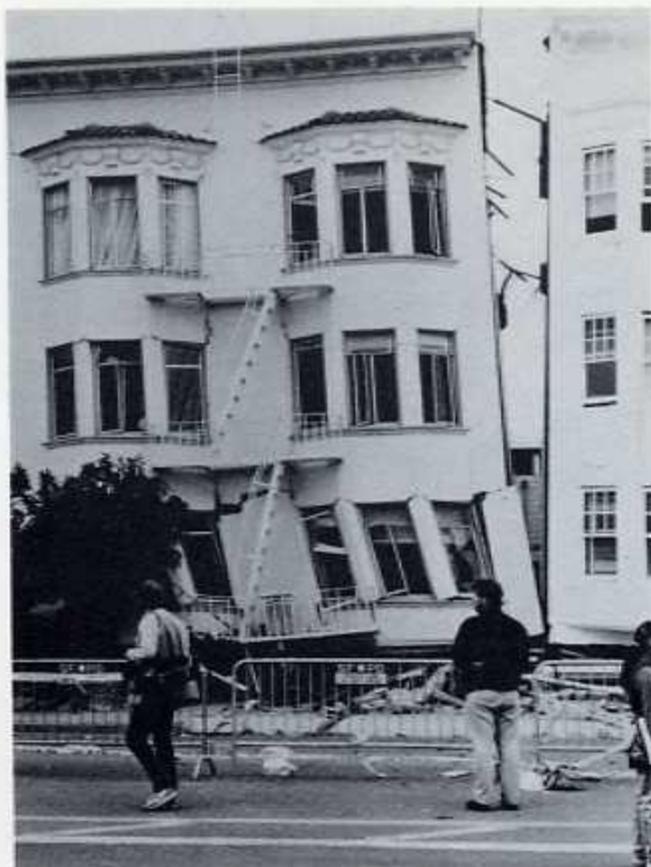
Photo 4. Collapsed apartment building in the Marina district, San Francisco.

when part of the top story of a brick office building collapsed onto cars. Many buildings in the Marina district lost all or pieces of their brick facades and many of the facades that did not fail catastrophically were extensively fractured. Large apartment buildings collapsed into first floor parking garages (Photo 4); some four story units were compacted to two stories tall during the earthquake. Loss of water pressure due to damaged water mains inhibited efforts to fight a conflagration fed by ruptured gas lines. The areas of San Francisco where ground shaking was especially destructive are mostly underlain by fill and unconsolidated deposits.

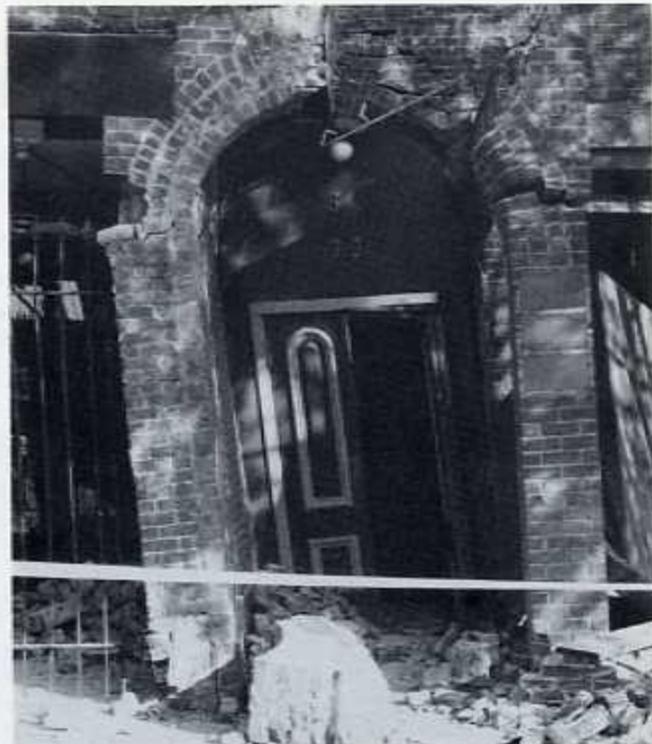
Photo 5. Severely damaged building in downtown Los Gatos. Few of the surrounding buildings showed external signs of severe structural distress, although many windows were shattered throughout the downtown area.

Many old brick buildings in downtown Oakland were severely damaged. Masonry buildings in downtown Los Gatos and Santa Cruz were also completely or partially collapsed (Photos 5 and 6). Some newer concrete buildings were damaged, although the vast majority of structural damage that was observed involved either residences that had detached from their foundations or unreinforced masonry buildings.

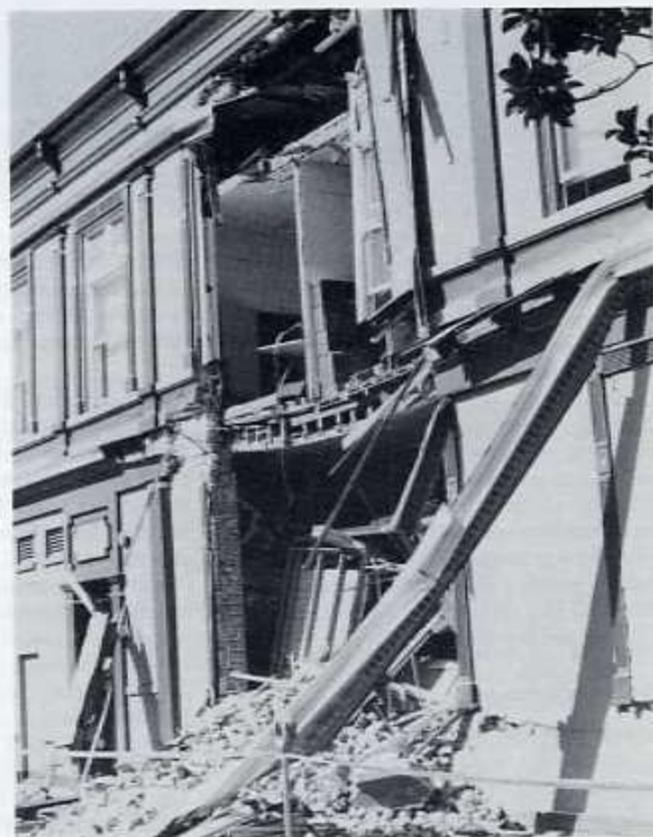
Photo 6. Partially collapsed building in the downtown Santa Cruz mall. Notice how the masonry had been covered by a layer of plaster.

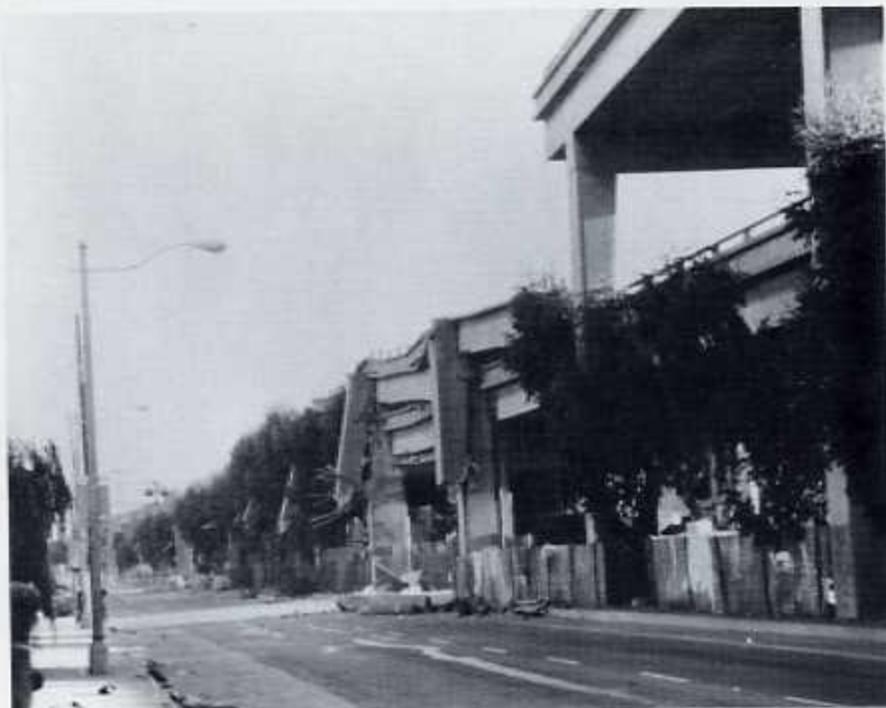
Photo 7. Collapsed double-deck portion of Interstate 880 in west Oakland. Few of the people who were on the lower deck survived when the support columns sheared and the upper deck collapsed.

Damage was quite variable to the freeways throughout the region. The most spectacular example was the collapse of Interstate 880 (Photo 7). The specific causes of this failure are being investigated. Highway 101 also collapsed near Watsonville (Photo 8) and many other freeways sustained structural damage. In Oakland, Highway 980 and the MacArthur Maze developed cracks in the support columns. Across the bay in San Francisco, the Embarcadero Freeway and a portion of Highway 280 were also severely damaged. An illustration of the behavior of one newer design is shown by the performance of the Highway 92/101 interchange in San Mateo. Expansion joints in this structure separated up to several inches during the earthquake (Photo 9), but did not disengage.

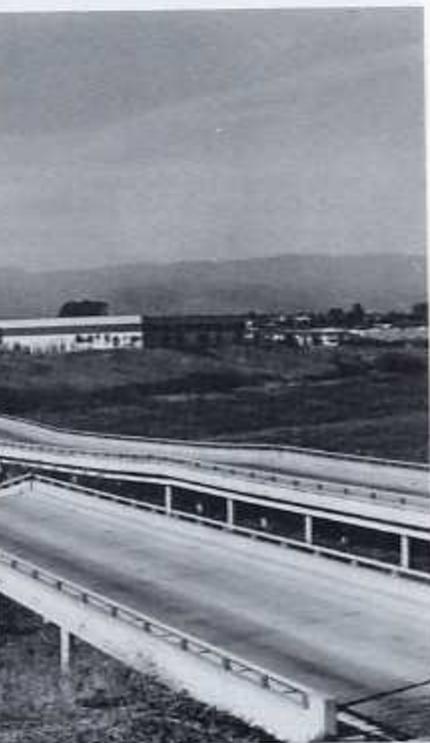
Photo 8. Collapsed portion of Highway 101 over Struve Slough near Watsonville. Note the support columns that punctured the roadway.

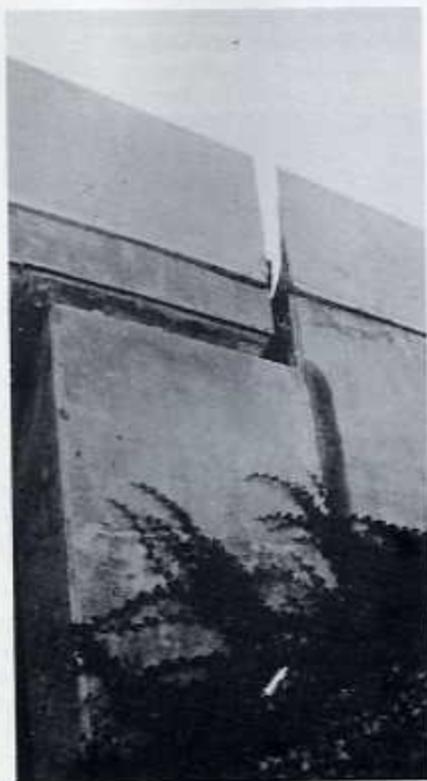
Photo 9. Expansion joint on the Highway 92/101 cloverleaf. The two sections of concrete are separated by styrofoam to allow them to readjust during severe ground shaking. Separation at this particular joint appeared to be on the order of several inches.

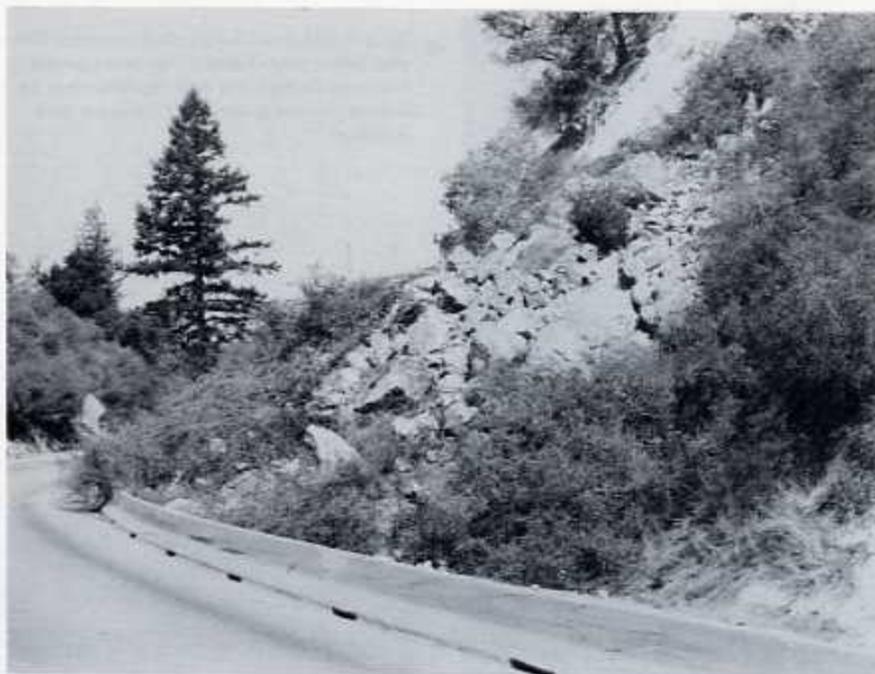
Photo 10. Rock avalanche from a cut slope on Highway 17 west of Summit Road in the Santa Cruz Mountains. The landslide stopped against the center divider and buried the eastbound lanes. Debris was still falling from the scarp two days after the earthquake.

Most of the landsliding clearly attributable to the Loma Prieta earthquake was located in the Santa Cruz Mountains. Many roadcut failures occurred along Highway 17 between San Jose and Santa Cruz and one rock avalanche entirely blocked the eastbound lanes (Photo 10). The ground surface ruptures originally portrayed in media reports as fault offsets were actually due to large-scale landsliding caused, or reactivated, by the earthquake (Photo 11). In the Santa Cruz Mountains many homes have been either destroyed or are threatened by ground

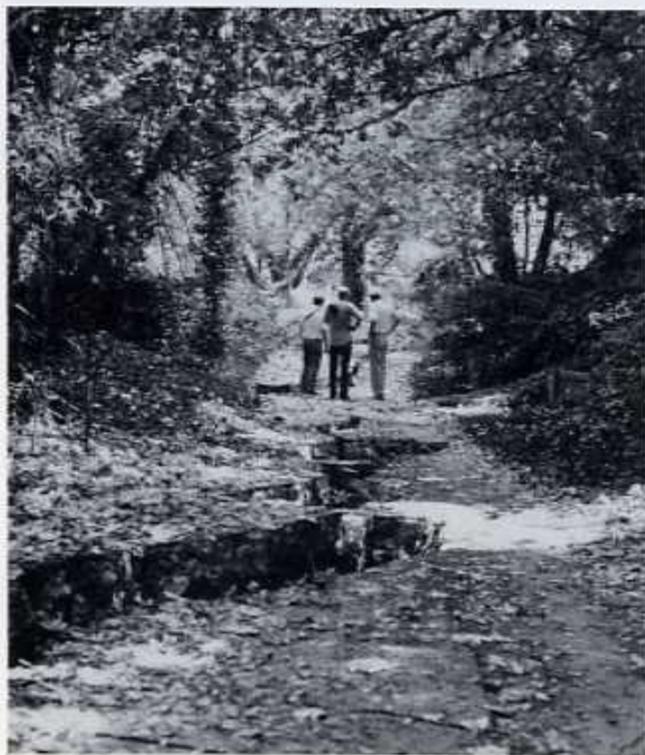
Photo 11. Ground cracks near Summit Road in the Santa Cruz Mountains. Initially interpreted as fault offset, many similar features throughout the area were due to large-scale landsliding initiated by the earthquake.

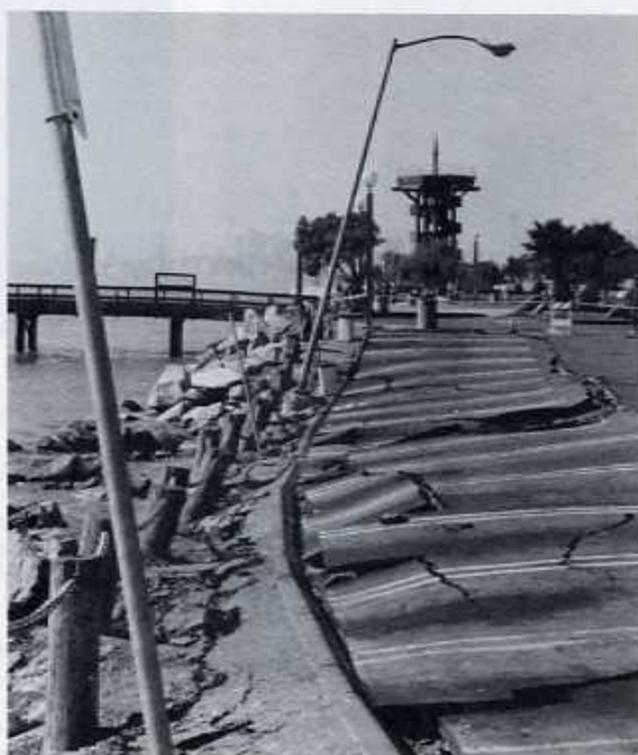
Photo 12. Damage at the Port of Oakland due to liquefaction and slumping of fine-grained, well-sorted sand fill.

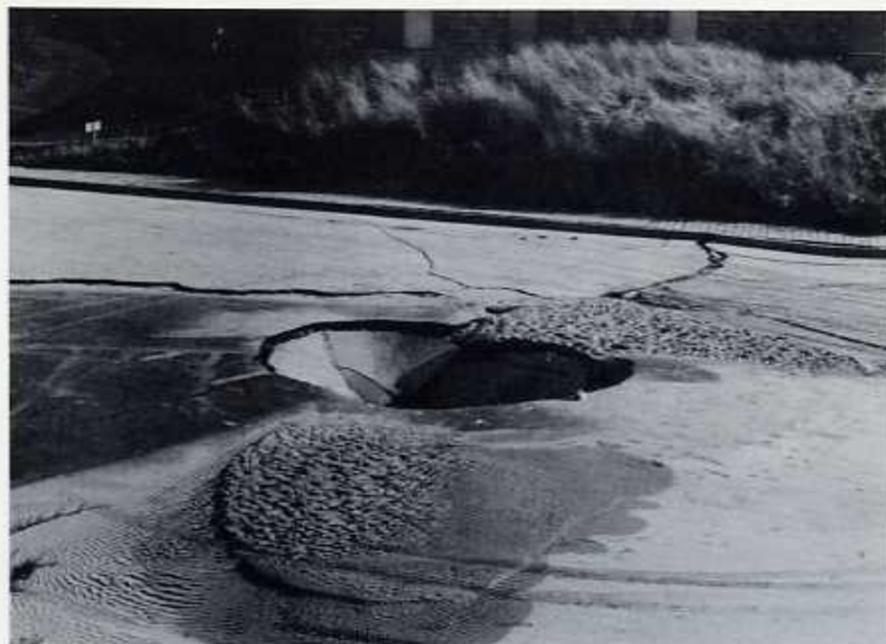
Photo 13. Crater resulting from liquefaction of dune sand underlying a parking lot next to the Watsonville Slough at Pojara Dunes. Ripples still preserved on the surface of the collapsed blacktop indicate that water and sand were flowing out of cracks in the pavement prior to its collapse. After the shaking began to subside, the water pressure supporting the pavement fell and the surface collapsed into the hole left by the evacuated sand.

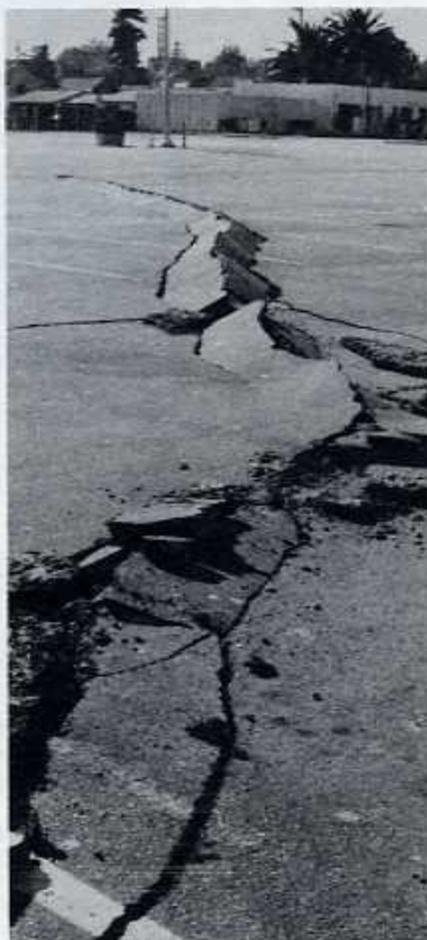
Photo 14. Pressure ridge developed on a parking lot at the Santa Cruz Boardwalk. Sand bails were also observed on the nearby pavement. ☒
