SPECIAL REPORT 188

LANDSLIDES IN THE INTERSTATE 5 CORRIDOR
BETWEEN VALENCIA AND GORMAN,
LOS ANGELES COUNTY, CALIFORNIA

Prepared for
California Department of Transportation
New Technology and Research Program
Office of Infrastructure Research
Project F99TL34

2003

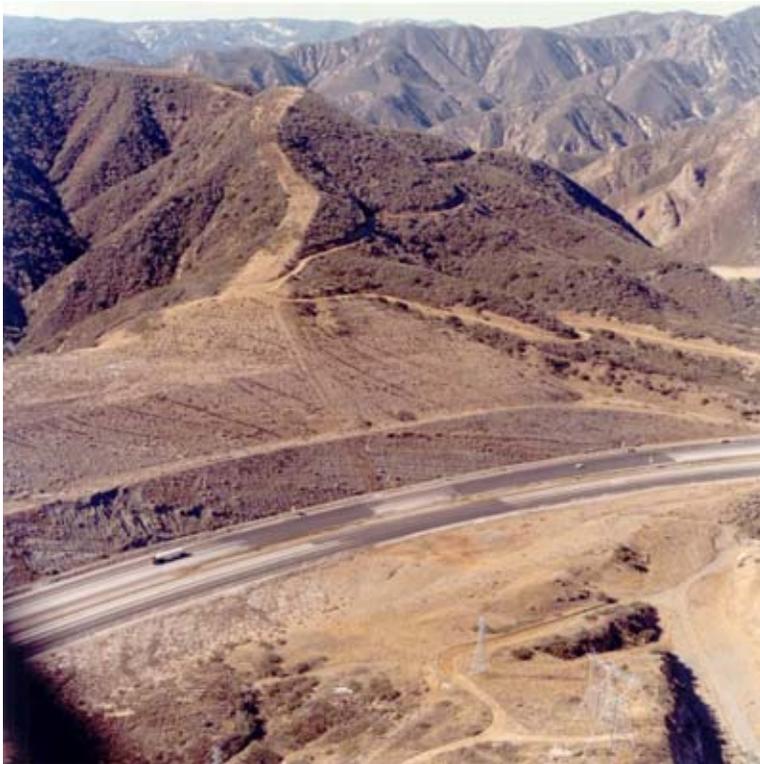
attempt to eliminate the humps and swales at this location. By 1993 slide movement had opened numerous tension cracks, and broken the concrete ditches on both benches. By 2002 it was apparent that a large deep, translational rock slide extends well beyond the boundaries of the cut. The slide is currently active and is delineated by cracks and scarps several feet high. The toe extends beneath the roadway and is causing it to heave. An ongoing investigation of this slide is being conducted by Caltrans.

Figure 3. Aerial view of the Templin Highway slide (P.M. 65.4 to 65.7). View is to the northwest. Photo by Caltrans, 1981.
