**ANALYSES OF STRONG-MOTION RECORDS
FROM A PARKING STRUCTURE
DURING THE 17 JANUARY 1994
NORTHRIDGE EARTHQUAKE**

Said Hilmy, Stuart Werner, Ahmed Nisar and James Beck

Dames and Moore
Santa Ana, California

Data Utilization Report CSMIP/00-04 (OSMS 00-06)

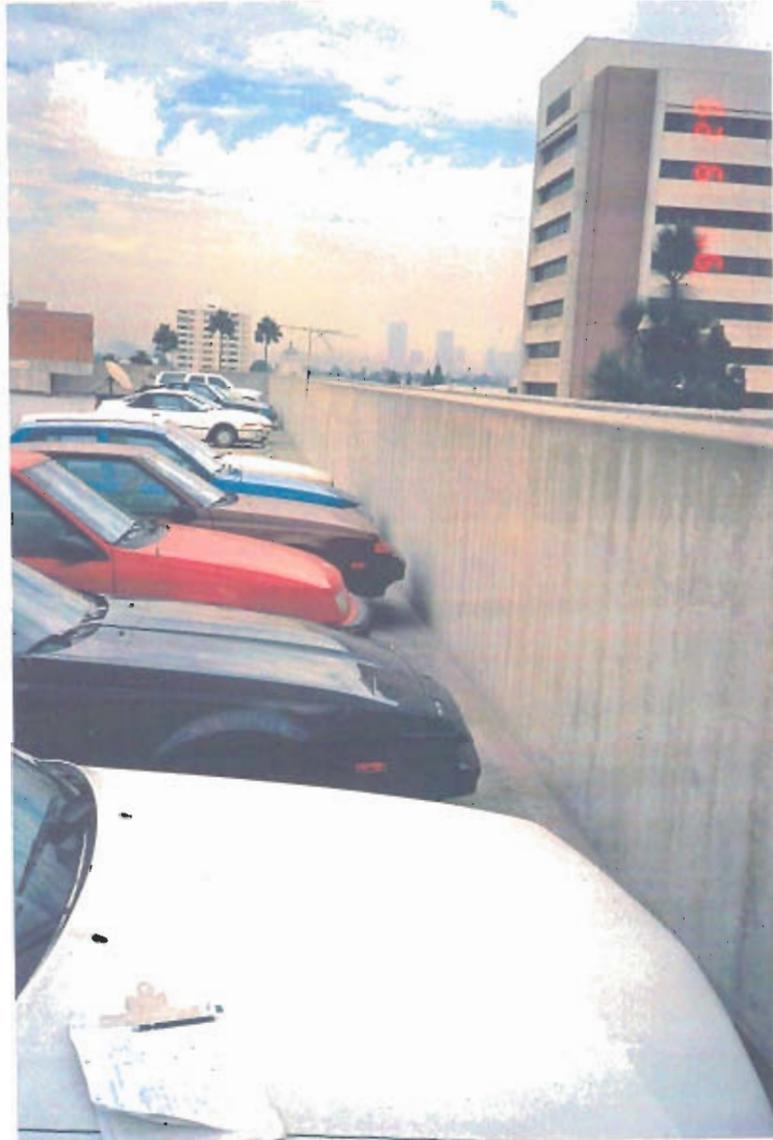
- (a) Diagonal hairline cracking at some beams that interconnect the perimeter shear walls at the east and west sides of the structure.

PHOTO 15: Deep beam at the top of shear walls (east side).

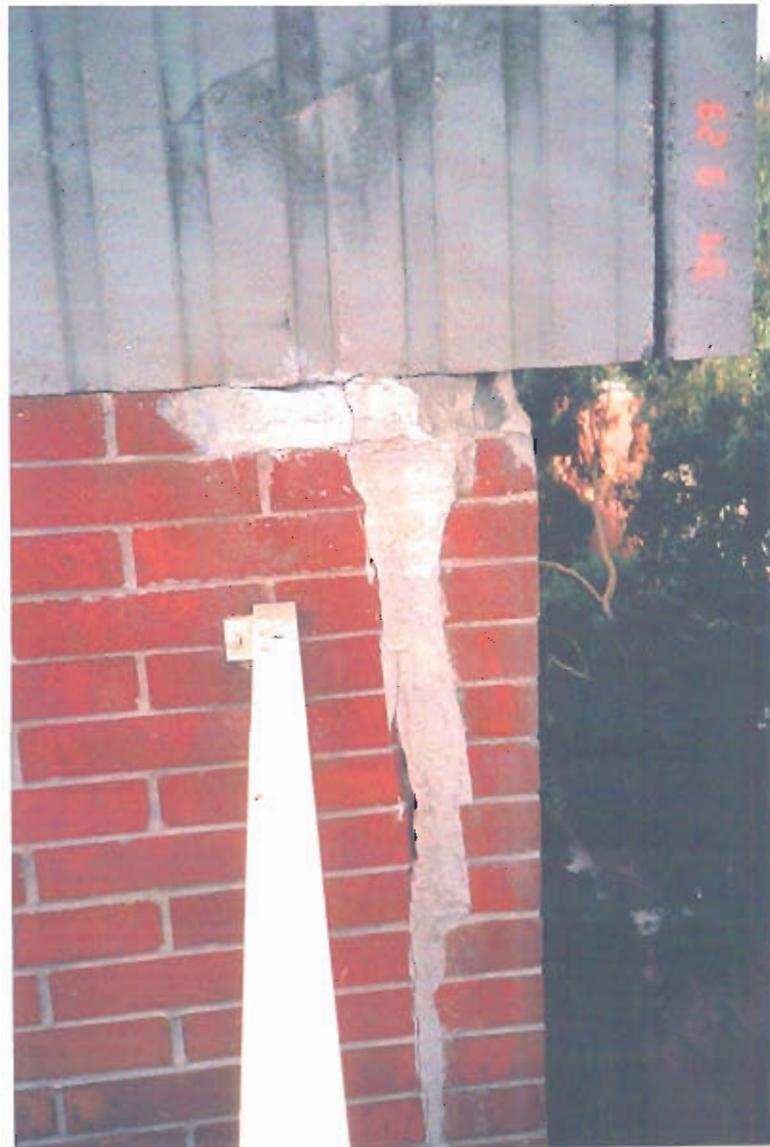
- (b) Some cracking and spalling of brick veneer along the stairwells at the upper levels. However, most of this damage apparently existed prior to the Northridge Earthquake.
- (c) Some movement of precast concrete wheel stops at the roof.

PHOTO 17: Previous spalling at block walls of stair towers.

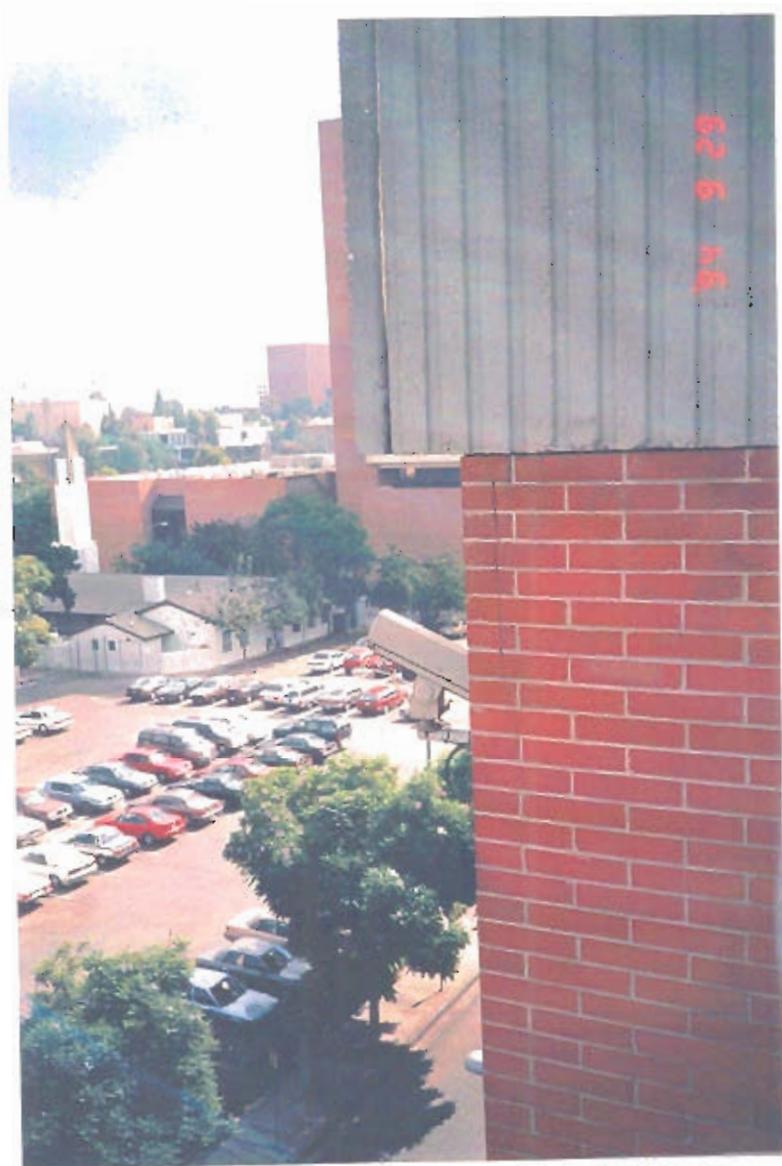
PHOTO 18: Cracks at top of block walls of stair towers.

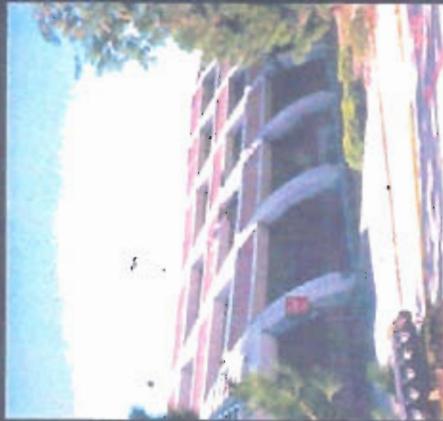
EXTERIOR FRAME OUT-OF-PLANE FAILURE

Photo #7.1 Sequence of Failure of the CSUN Parking Structure.

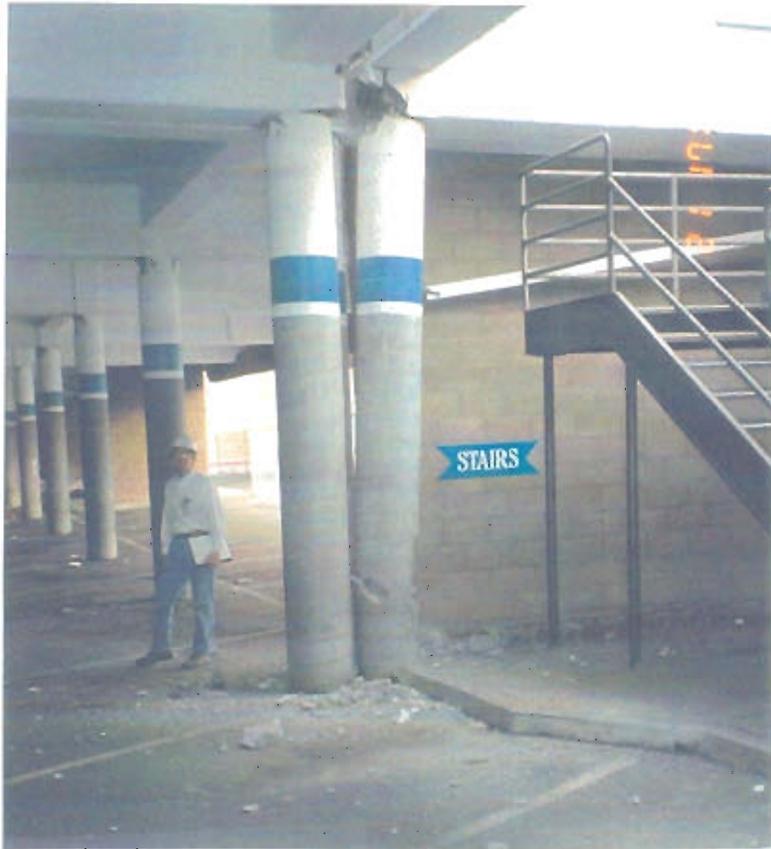
Photo #7.2 Damage to Nonductile Circular Columns at the Northridge Fashion Center East Garage.

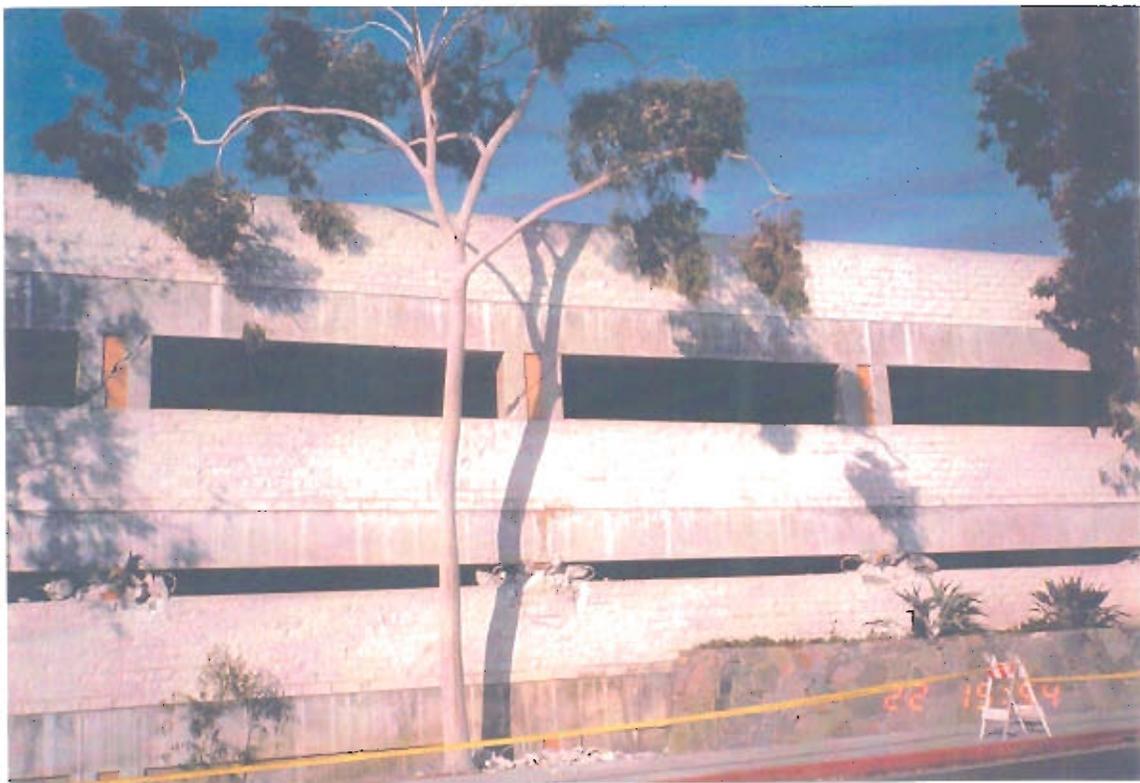
Photo #7.3 Failure of Short Columns at the Glendale Fashion Square Parking Structure.

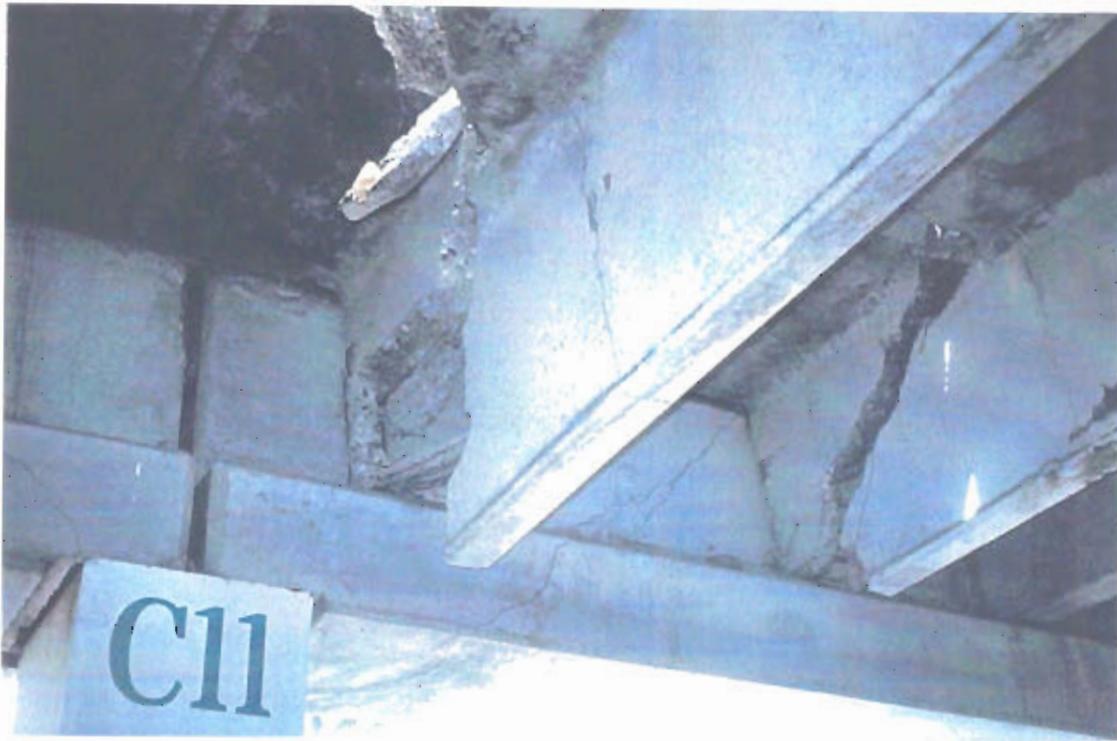
Photo #7.4 Shear cracks at the ends of the post-tensioned double tees beam at the east parking structure in the Northridge Fashion Square.

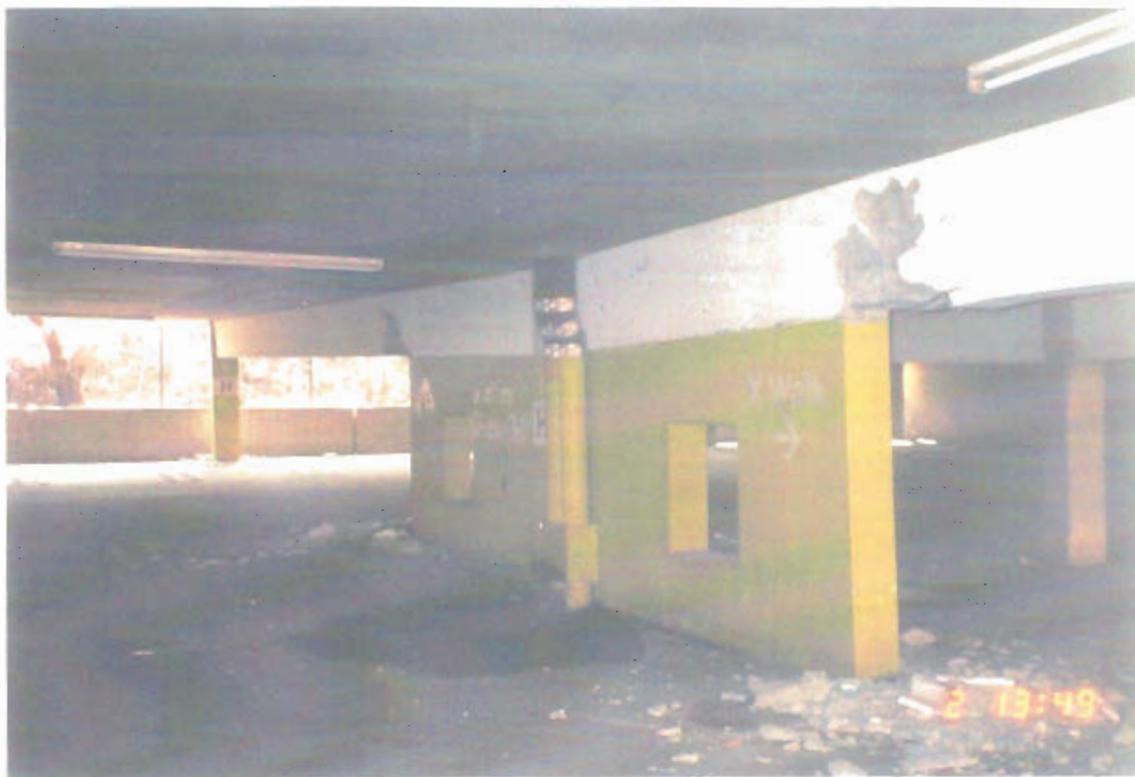
Photo #7.5 Damage due to Rocking of Shear Walls (Sherman Oaks Fashion Center Mall).

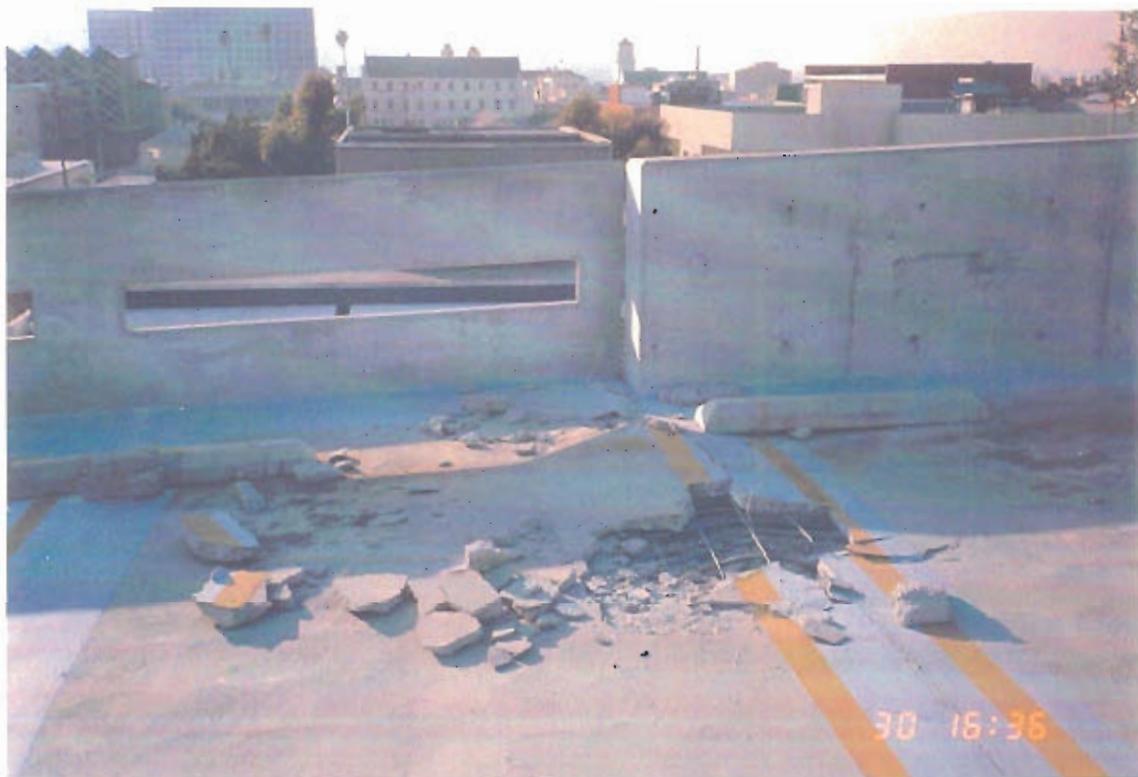
One example of a collector failure is shown at the Glendale Civic Center parking structure (Photo #7.6). For this structure, cast-in-place shear walls provided the primary lateral resisting system. Precast concrete beams were separated from adjacent shear walls and could not transfer the required drag forces. Instead the seismic forces transferred through the chord reinforcements embedded in the slab topping, which first yielded in tension, and then buckled in compression through the topping at the subsequent compressive cycles. This behavior defies the common assumption of rigid diaphragms typically used in design.

Photo #7.6 Damage to Chord Steel Reinforcements (Glendale Civic Center Parking Structure)

The current provisions enforced by the City of Los Angeles after the Northridge earthquake, requires that "for concrete diaphragm chords and collector members, the reinforcement shall be spaced not closer than the $3d_b$ or 1 ½ inches and the concrete cover shall be no less than $2 \frac{1}{2} d_b$ or 2 inches. The shear strength-reduction factor shall be 0.6 instead of 0.9 for the design of chords and collector members for the diaphragms"
