**IMPRESSIONS FROM A FIELD INVESTIGATION OF  
THE WENCHUAN, SICHUAN PROVINCE, EARTHQUAKE  
OF MAY 12, 2008**

Marshall Lew, David A. Friedman and Laurie A. Johnson

Members of the Earthquake Engineering Research Institute (EERI)  
Field Investigation Team

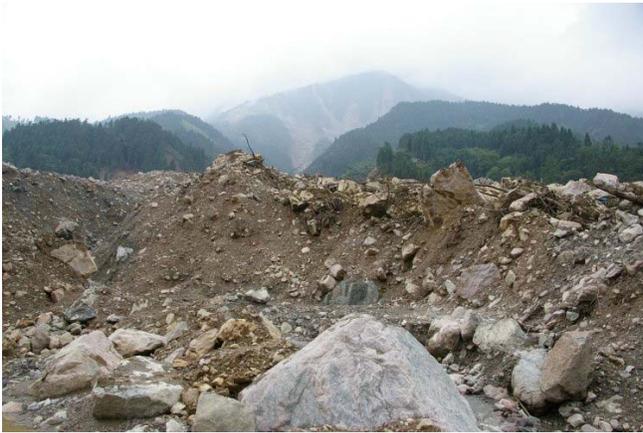
Figure 9 shows the foot of a landslide that originated from the top of the mountains and buried a village of about 70 persons near Yinchanggou. Figure 10 shows massive rockslides near Shenxigou. Figure 11 shows a typical large rock from a rockslide on a road into the Longmenshan Mountains. Figure 12 shows rockslide damage to a resort hotel in Shenxigou.

Fig. 9 Landslide near Yinchanggou

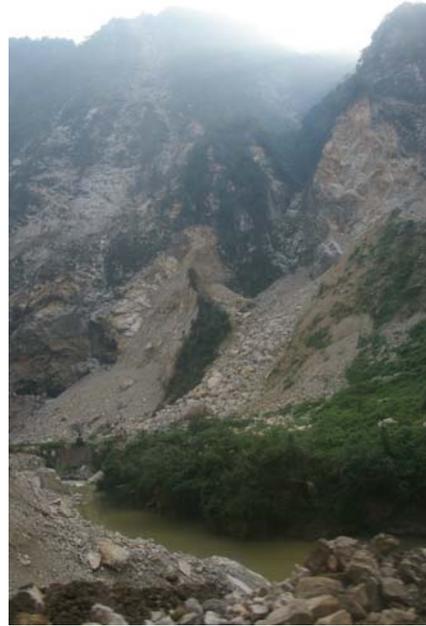
Fig. 10 Massive rockslides near Shenxigou

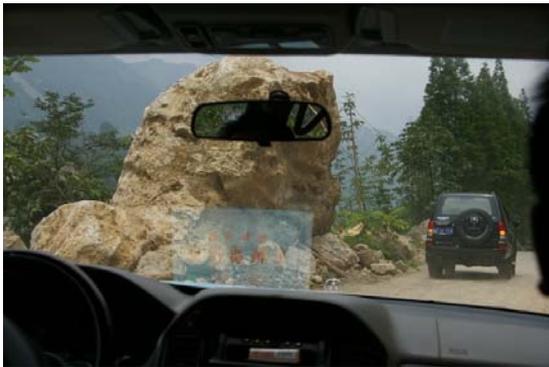
Fig. 11 Large rocks on mountain road from rockslide

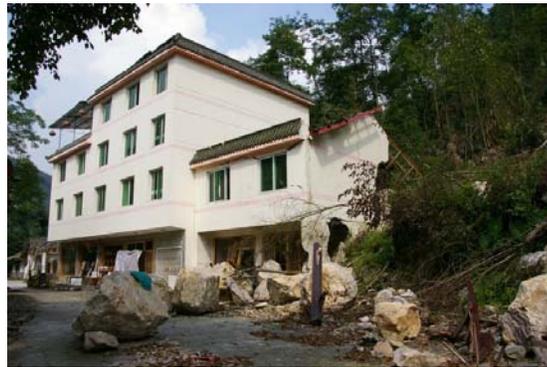
Fig. 12 Resort hotel damaged by rockslide in Shenxigou

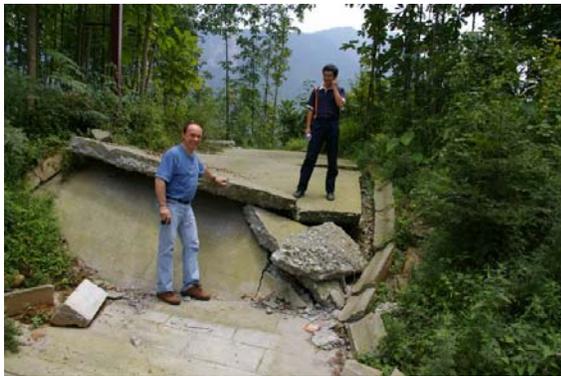
Fault rupture was prominent in the Longmenshan Mountains as the rupture was about 270 km in length. The fault rupture cut through towns, villages, and roads, causing much damage and havoc in the region. The fault movement was predominantly a reverse thrust in southwestern portion of the rupture, becoming more strike-slip towards the northeast. Fault rupture at Gaoyuan Village, north of Dujiangyan, is shown in Figures 13 and 14; Figure 13 shows about 1 meter of vertical displacement as evident in the concrete roadway and Figure 14 shows the effect of the fault rupture on a brick building nearby.

Fig. 13 Surface fault rupture with 2 meter vertical displacement at Gaoyuan Village

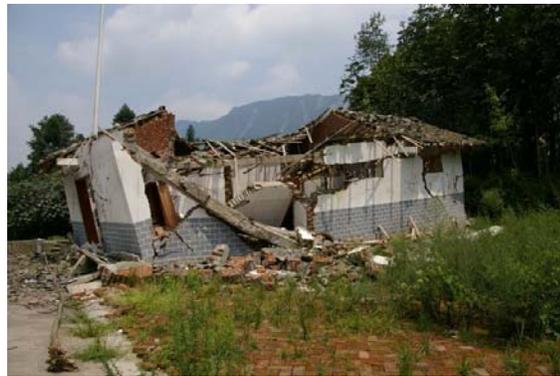
Fig. 14 Surface rupture under brick building at Gaoyuan Village

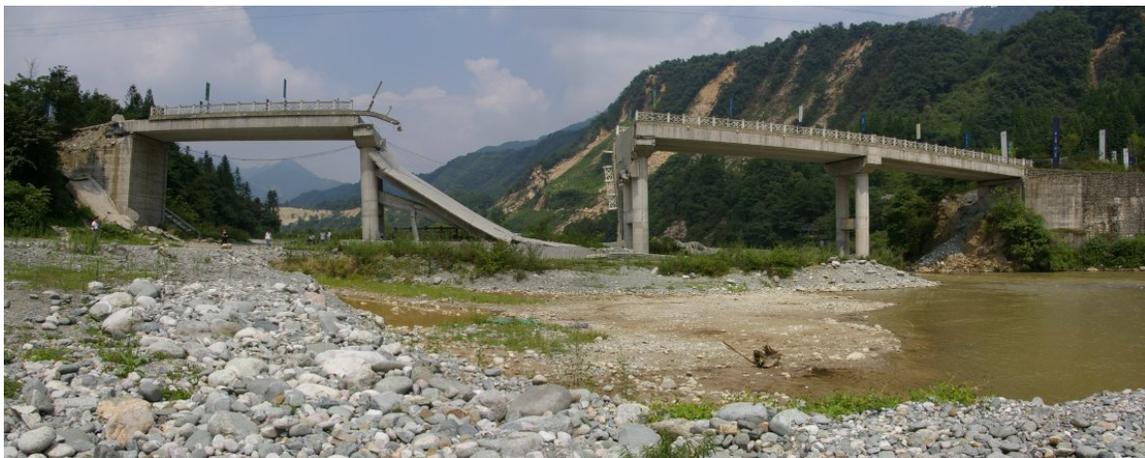
Fig. 15 Surface fault rupture contributed to failure of Gaoyuan Bridge; north abutment is to the left

The Gaoyuan Bridge, near Gaoyuan Village, is a two lane traffic bridge with north and south abutments and three bents over a river (Figure 15). The bridge suffered the collapse of the second simply supported span (from the north). The thrust fault rupture went through the north (left) abutment of the bridge and caused the approach slab to be thrust over the first span of the bridge. In addition, part of the west wing wall of the abutment collapsed along with some of the fill in the abutment. This apparently caused the passive resistance of the north abutment to be reduced. There was also a failure of the south abutment which showed evidence of yield of the abutment and movement inwards towards the north (as the passive resistance at the north abutment was reduced). This movement of the abutment appears to have caused the spans of the bridge to be pushed northward. The movement was large enough that the second span became unseated at the center bent and fell to the ground below. The other side of the span hit the first bent and caused some bending of the piers.

It appeared that many of the bridges in the Longmenshan region have bridge spans that are simply supported at the ends, such as the Gaoyuan Bridge shown in Figure 15. A single span of one of the approaches to the tall Minjiang Bridge over the Zipingpu Reservoir became unseated and fell into the lake as shown in Figure 26. There were numerous other reports of bridges having simply supported spans becoming unseated and collapsing. New replacement bridges will need to consider higher seismic input as well as larger displacements. Existing bridges will need to be retrofitted to prevent unseating in future earthquakes and retrofit strategies used in California and the United States may be needed to prevent unseating.

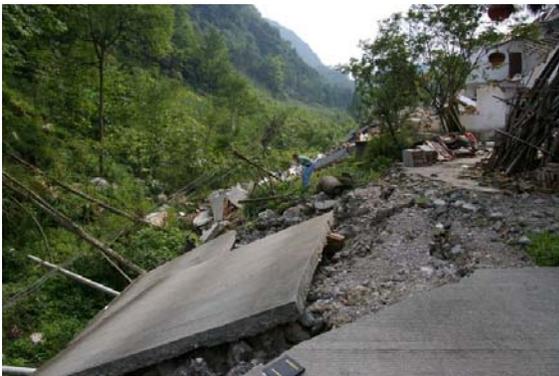
The fault rupture was reported by CEA to be as much as 5 meters of vertical fault displacement with about 4.5 meters of horizontal fault displacement (Fig. 16). Fault rupture caused collapse of many structures that were constructed over the fault traces; as many of the buildings were of brick construction, total collapse was very common (Fig. 17).

Fig. 16 Surface fault rupture with 5 meter vertical displacement at Shenxigou

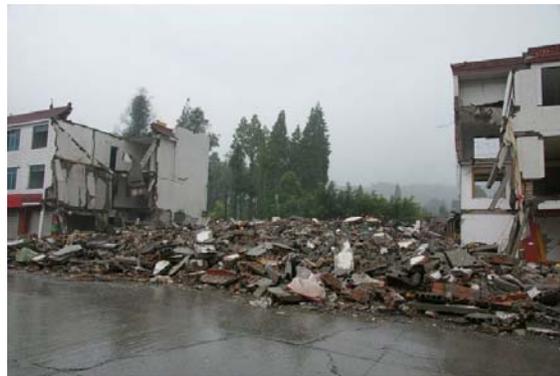
Fig. 17 Surface rupture causing total collapse of buildings at Xiaoyudong

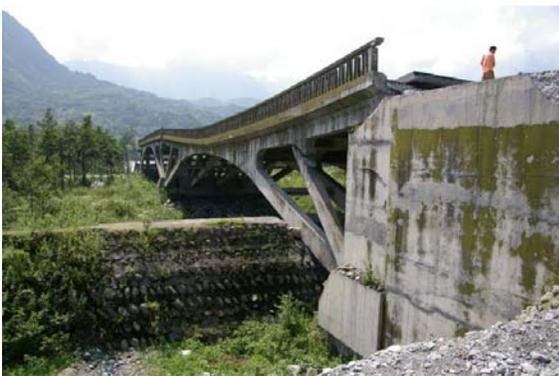
Fault rupture also caused damage and collapse of several bridges, including the Xiaoyudong Bridge as shown in Figure 18 and the Baihua Bridge near Yingxiu as shown in Figure 19.

Fig. 18 Surface fault rupture caused damage and collapse of Xiaoyudong Bridge

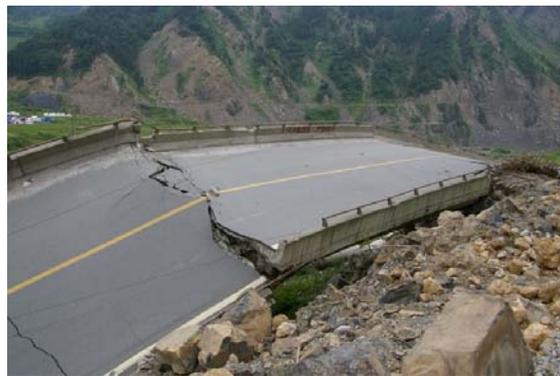
Fig. 19 Collapse and severe damage of Baihua Bridge at Yingxiu caused by fault rupture

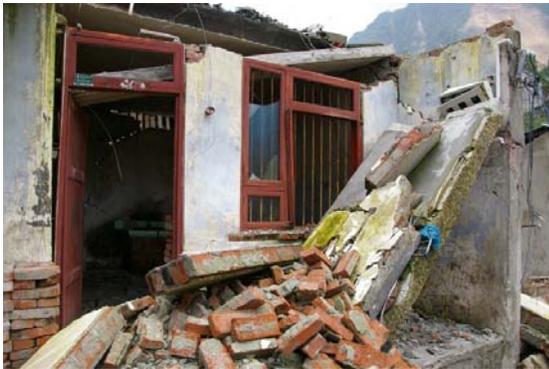
The unreinforced brick bearing wall buildings were typically some two to four stories in height with precast hollow core plank floors and roofs which bear on transverse brick walls and longitudinal perimeter walls which may have many openings. As would be expected, this type of building did not perform well in the earthquake as there were many catastrophic collapses as shown in Figure 20.

Fig. 20 Unreinforced brick bearing wall building

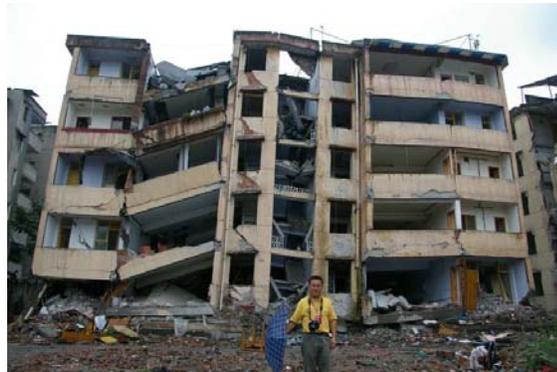
Fig. 21 Restrained brick bearing wall building

Restrained brick bearing wall buildings were typically long rectangular buildings with heights from three to seven stories with precast hollow core plank floors and roofs which bear on reinforced concrete beams spanning to reinforced concrete columns (see Figure 21); there is also a reinforced concrete perimeter ring beam. It was observed that beam stirrups and column ties were typically No. 3 undeformed bars with a fairly wide spacing of 12 inches or greater (Figures 22 and 23). There was no positive connection of floor planks to the bearing beams or perimeter ring beam except by bearing and friction contact. These buildings typically appeared to be stronger in the longitudinal direction than in the transverse direction because the ground floors typically had open storefronts. This type of building had performance that varied from what could be considered “life safe” performance (although there was significant and perhaps unreparable damage) to partial and total collapse. Issues that may have contributed to poor performance include: poor ductile detailing, insufficient concrete cover over reinforcing steel, improper size and shape of aggregate in concrete, quality of cement, and poor quality of brick.

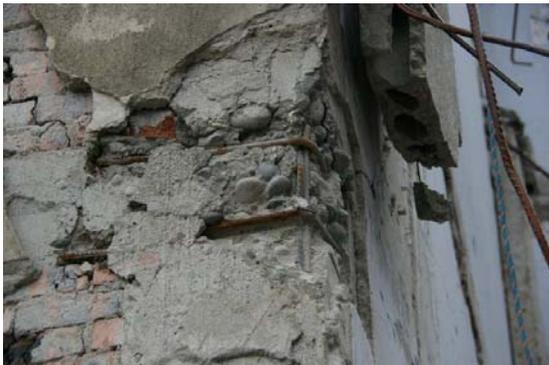
Fig. 22 Steel reinforcing in brick bearing wall building

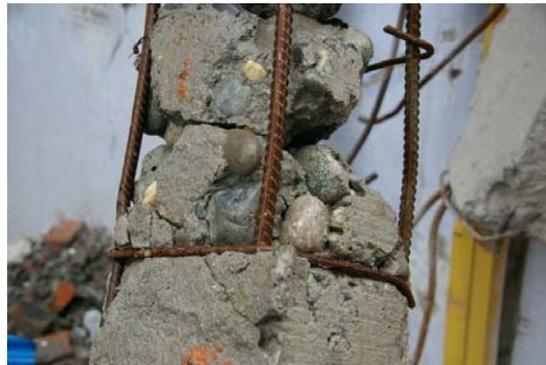
Fig. 23 Steel reinforcing and pebble aggregate used in column of brick bearing wall building

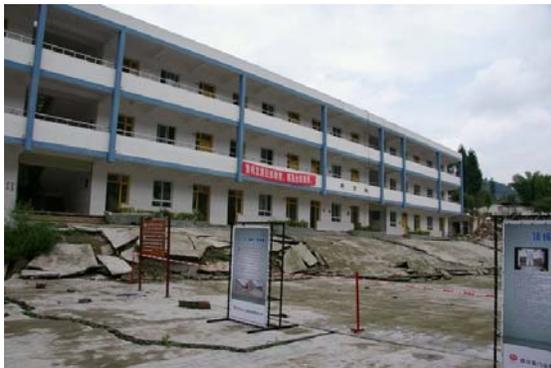
Although not as common in the Longmenshan Mountain region, concrete moment frame buildings appeared to perform much better than the adjacent brick buildings; however, we did not have the opportunity to observe many of these buildings. Although it was observed that some concrete moment frame buildings suffered from weak column/strong beam behavior, there were some buildings that performed remarkably well, even when in close proximity to the fault rupture, such as the newer building constructed in 2007 at the Bailu Middle School and another school building at the middle school in Tongji (see Figures 24 and 25).

Figure 24 Xuankou Middle School building in Bailu with fault rupture in foreground

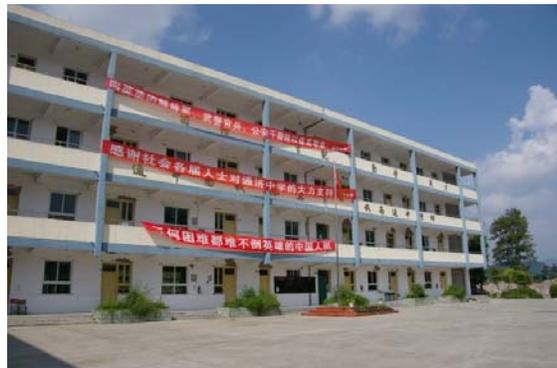
Figure 25 Tongji Middle School building

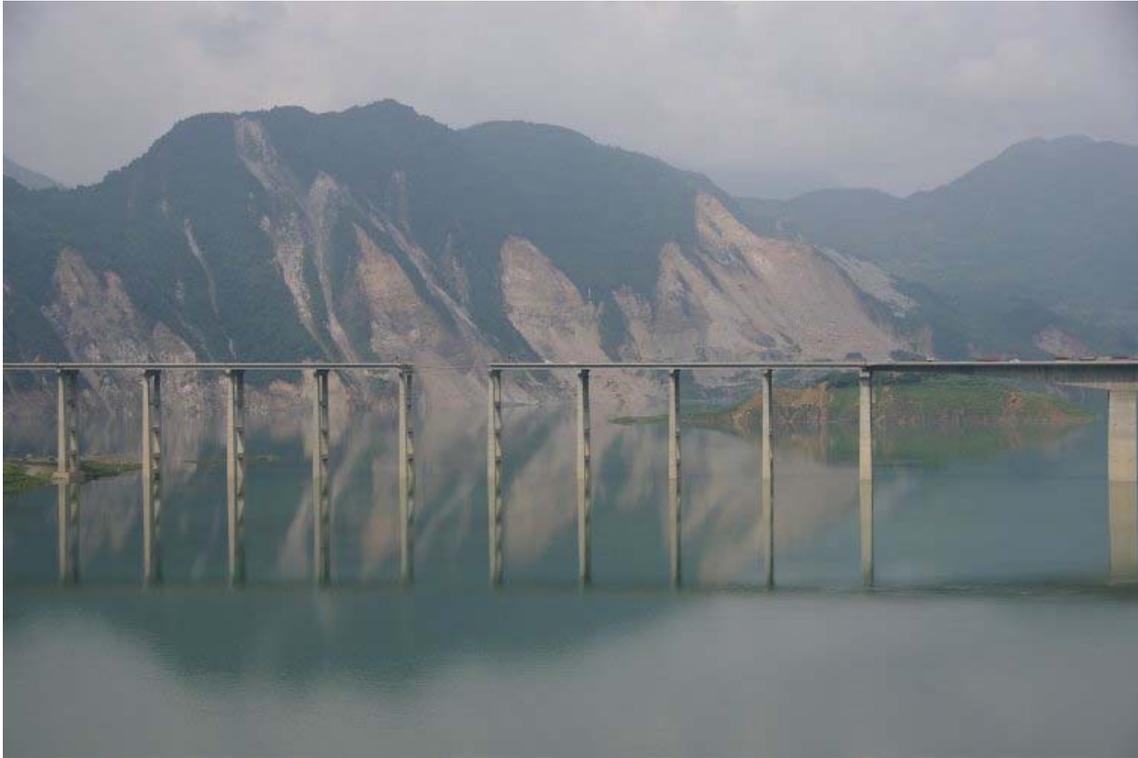
Reports of damage at several bridges indicate that the lateral design for earthquake forces of bridges may not be sufficient given the ground motions of this earthquake. Some bridges had damaged shear keys at the abutments and bent caps when the strongest ground motions were in the transverse direction. Also, the Baihua Bridge had damage to the transverse beams between the piers as well as flexural distress near the base of some of the bent piers.

Fig. 26 Minjiang Bridge crossing over Zipingpu reservoir with one missing span
