**FINAL REPORT:
MORRO BAY WATERSHED STREAM CROSSING INVENTORY AND FISH
PASSAGE EVALUATION**

**Prepared for the
Coastal San Luis Resource Conservation District**

**By
Ross Taylor and Associates**

February 7, 2003

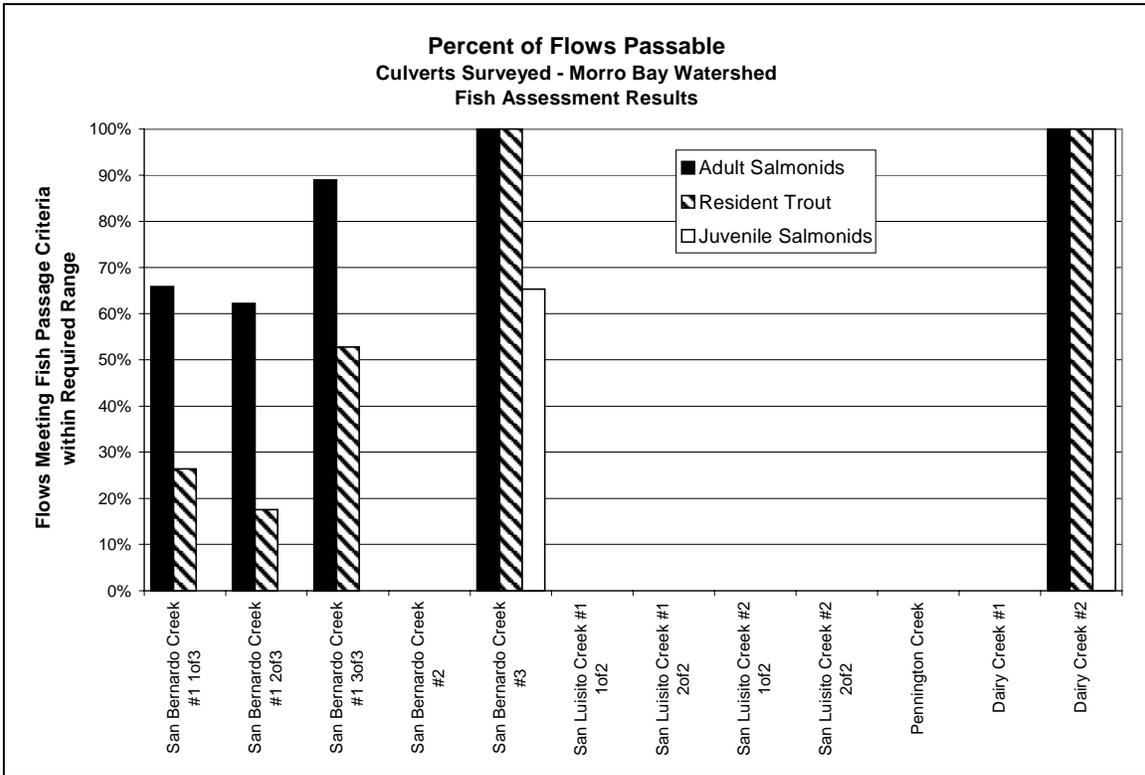
Passage results generated by FishXing are displayed as "percent passable" for the range of migration flows calculated for each barrel or bay of 12 culverts at eight stream crossing locations (Figures 7). The three dams and the natural waterfall on Chorro Creek were evaluated for passage based primarily on the drop height and pool depth below each structure/feature (Figure 8). For each **GRAY** site, by species and life-stage, FishXing evaluation results are provided in Appendix C.

Figure 7. Percent passable estimated by the Green-Gray-Red evaluation filter and FishXing for 12 culvert barrels and bays at eight stream crossings within the Chorro Creek (Morro Bay watershed), by life stages.

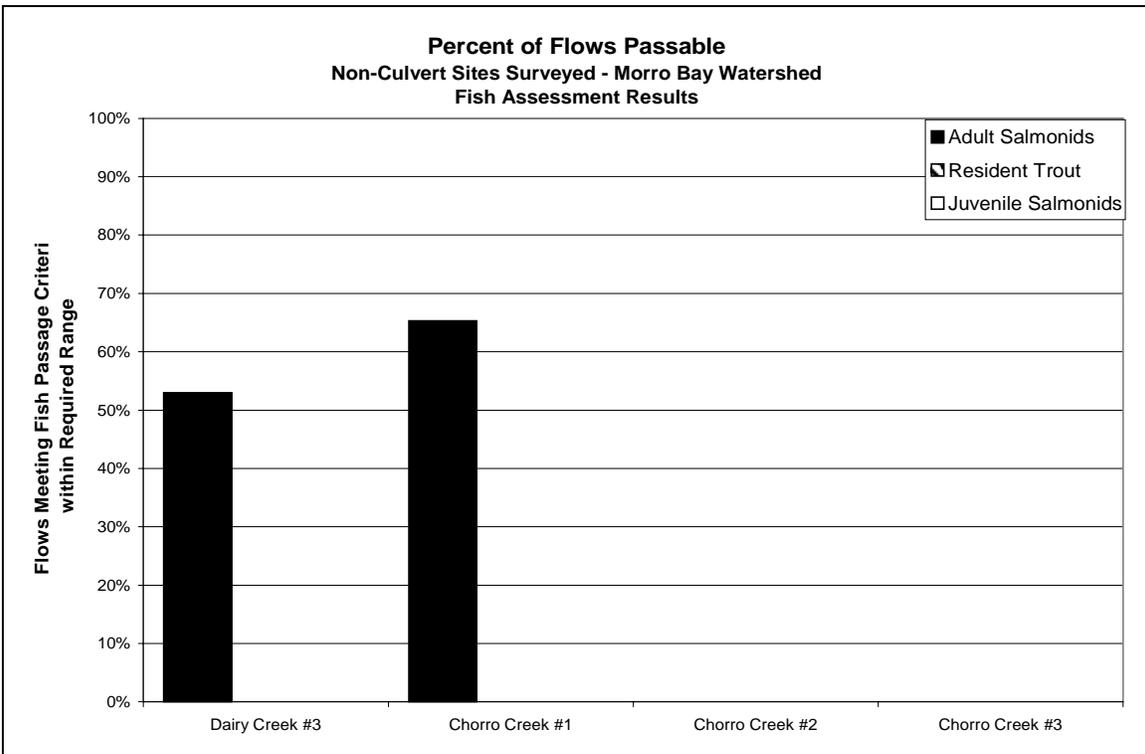
Figure 8. Percent passable as estimated by the Green-Gray-Red evaluation filter and FishXing for three dams and a natural waterfall (Chorro Creek #2) within Chorro Creek (Morro Bay watershed), by life stages.
