Robinson Mine and Mill Site Assessment

Robinson Mine and Mill Site is an underground gold mine and mill located in Plumas County on the Plumas National Forest, south-west of Quincy, CA.

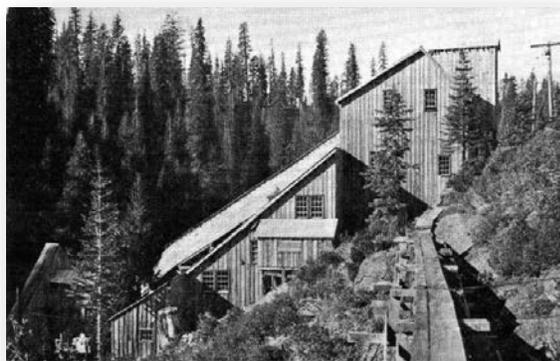
Historic view of the Robinson Mill building, now collapsed. Photo: *California Journal of Mines and Geology* (1937).

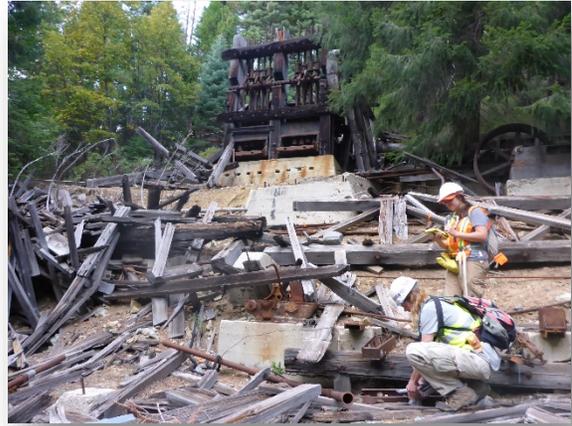
The Robinson mine and mill site is located in a steep canyon, immediately adjacent to Frazier Creek, which flows to the Middle Fork of the Feather River. The stamp mill building has collapsed completely, though the stamp batteries themselves remain standing. Tailings were apparently freely discharged below the mill and into the creek, and a large amount of waste rock from the main shaft runs along the creek. Additionally, a diesel fuel spill occurred at the old powerhouse for the mill in the 1980s. The topography, collapsed mill building, and indistinct remnant mill tailings make proper assessment of the site a challenge.

Sampling for contamination with XRF equipment at the collapsed stamp mill and still-standing stamp battery at Robinson Mill. Photo: David Tibor, DOC (2015).

To best assess the site for potential contamination, a number of steps were followed. DOC reviewed historical literature and previous work onsite, as well as performed a full site inventory of the mine features present (in collaboration with USFS cultural resources staff). A field sampling plan was developed with assistance from the Chico State Research Foundation. Field sampling occurred in October 2015, including X-ray fluorescence, or XRF, screening, diesel soil sampling, and soil, sediment, and water sampling. Laboratory analysis of samples followed, and a report of findings is being prepared for USFS. If the findings demonstrate significant contamination issues, USFS may determine that an Engineering Assessment / Cost Analysis is required, and DOC will continue the partnership with SNC and USFS to develop this analysis.
