Reconnaissance Engineering Geology of the Mill Creek Landslide of January 24, 1997

U.S. Highway 50, El Dorado County, California

ROBERT H. SYDNOR, Senior Engineering Geologist
California Department of Conservation, Division of Mines and Geology

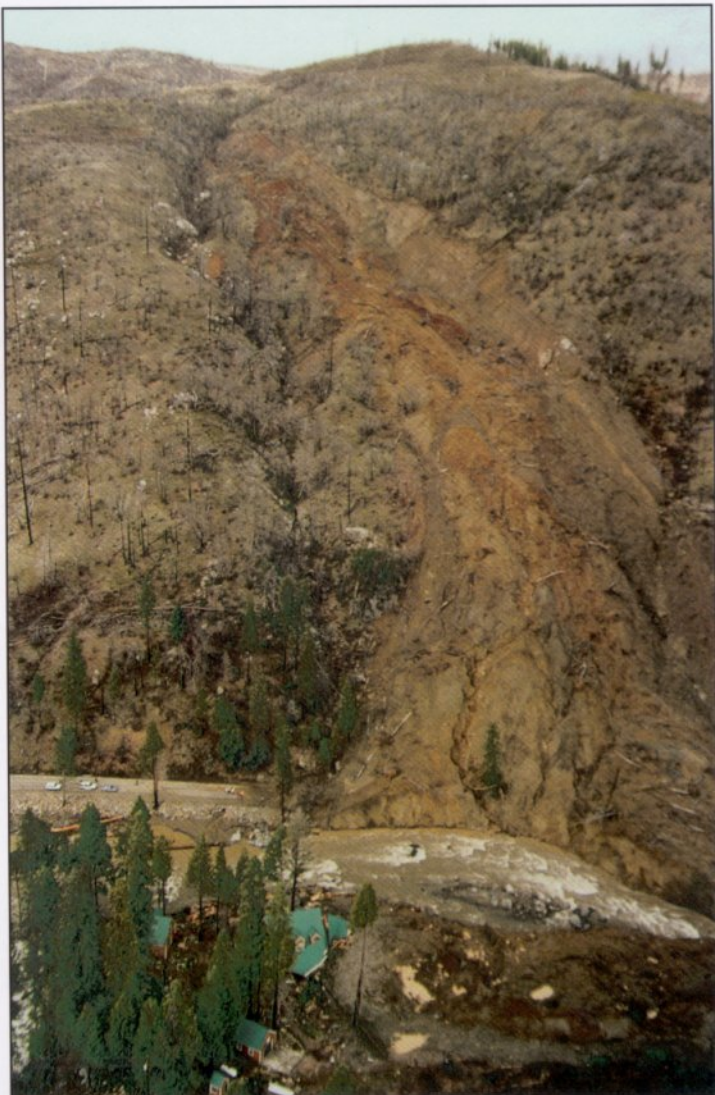
Photo 1. January 27, 1997 view northward of entire Mill Creek landslide, 1,120 feet (340 m) high and 3,100 (945 m) long. Photo by Robert H. Sydnor.

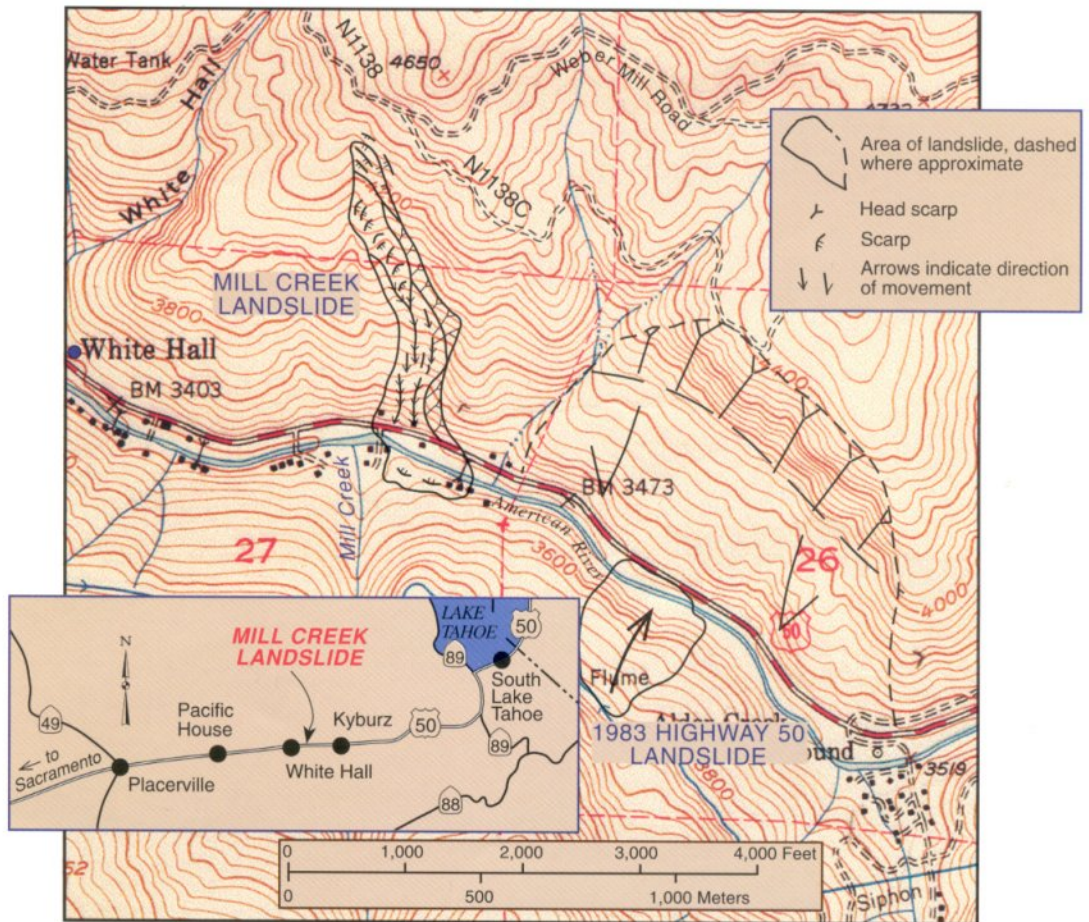
DMG has done both regional geologic mapping for the Sacramento 1:250,000 quadrangle (Wagner and others, 1981), and specific engineering geologic mapping of the 1983 Highway 50 landslide in the White Hall area in cooperation with USFS (Kuehn and Bedrossian, 1987). The 1983 Highway 50 landslide is about 0.6 miles (965 m) east of the 1997 Mill Creek landslide (Figure 1).

Figure 1. Map of landslides in the White Hall area along U.S. Highway 50 corridor in El Dorado County. Base map enlarged from USGS 1950 Riverton Quadrangle.

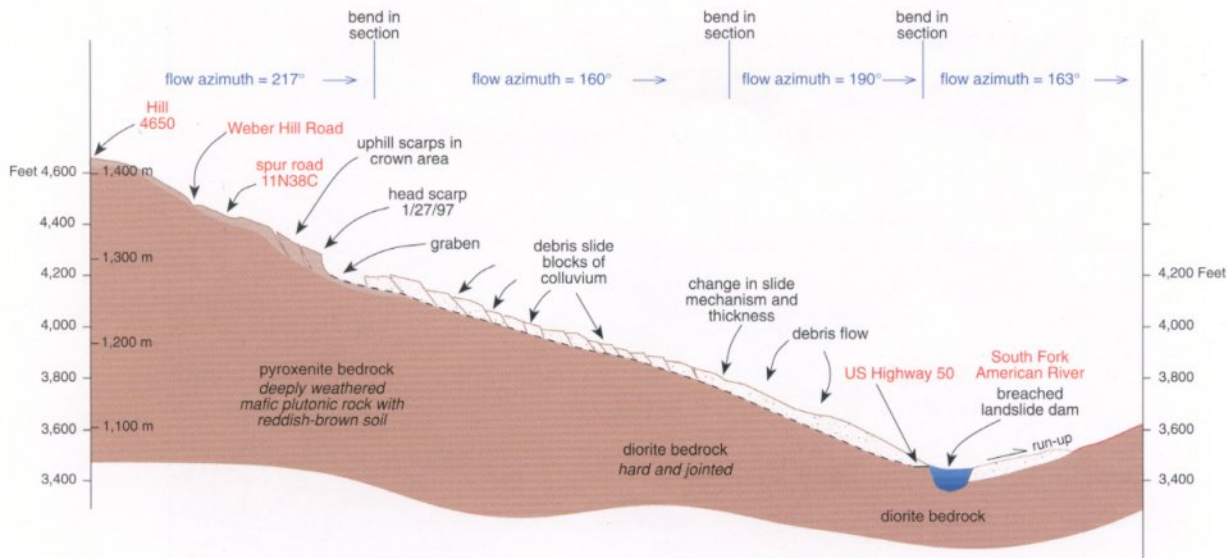
The landslide is 800 to 900 feet (245-275 m) wide where it blocked Highway 50. The main body of the landslide is about 400 feet (120 m) wide and the length from the head scarp to the toe on the opposite canyon wall is about 3,400 feet (1,036 m) (Figure 2). The head scarp is about 1,100 vertical feet (335 m) above the river (elevation $\pm 3,420$ feet [980 m]).

Figure 2. Schematic geologic cross section of the Mill Creek landslide, approximately down the center of the debris slide and parallel to the direction of flow (note three bends in the section).

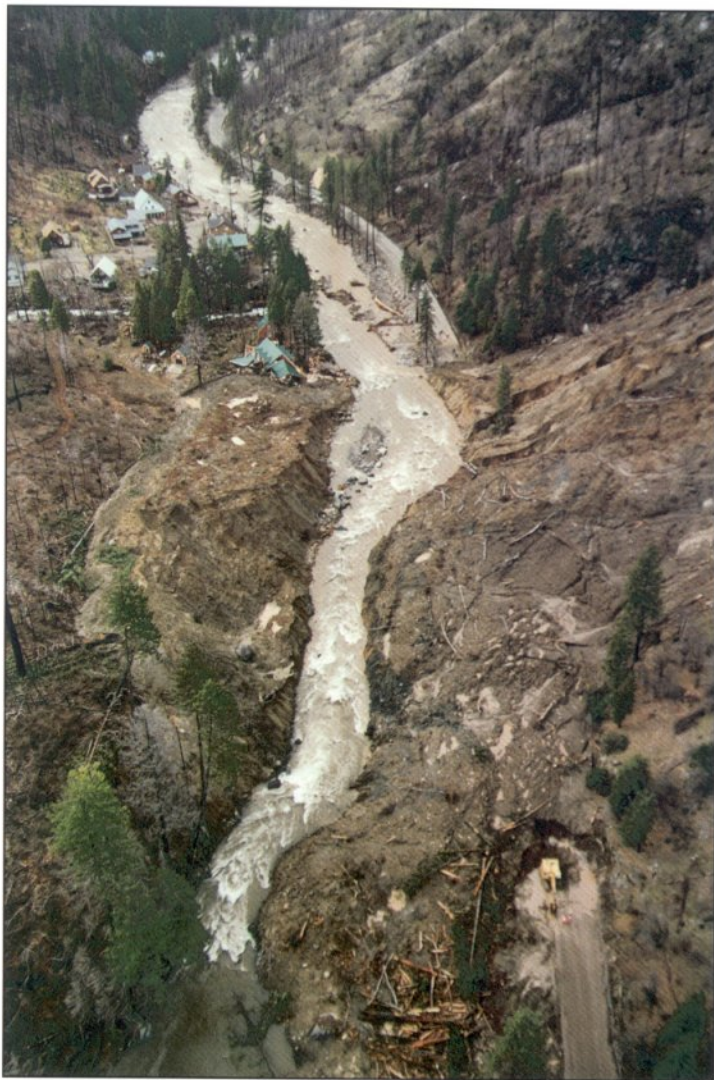
The highly fluid toe of the landslide crossed the river, flowed up the south slope about 50 vertical feet (15 m), and veered westward (Photo 2). The toe of the landslide on the south bank of the river is 600 to 700 feet (180-215 m) wide at the highest elevation of run-up.

Photo 2. View westward down the South Fork American River showing the breached landslide toe and about 800 lineal feet (245 m) of U.S. Highway 50 buried. *Photo by Robert H. Sydnor.*

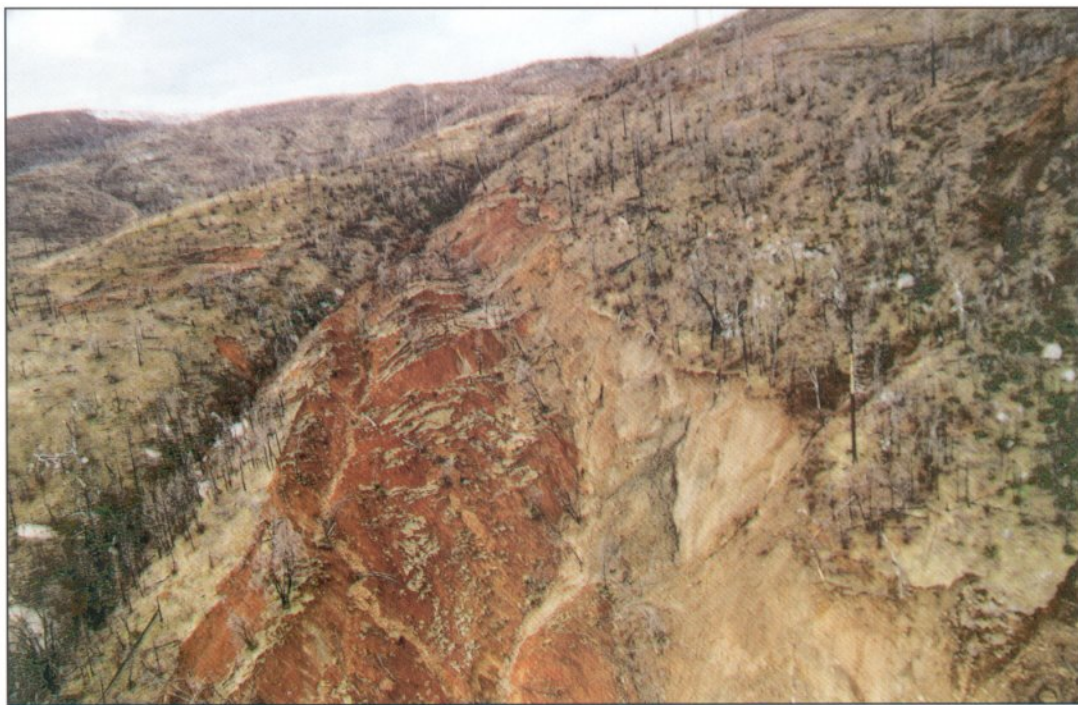
The pyroxenite is coarse-grained and contains mostly pyroxene, with minor hornblende. It weathers easily and is notable in the field for the distinctive reddish-brown residual and colluvial soil caused by a typically high iron oxide content (Photo 3). The pyroxenite is exposed along road cuts in Weber Mill Road near the fork of USFS roads N1138 and N1138C. A few small boulders of reddish-brown pyroxenite were observed as float within intact landslide blocks in the upper third of the debris slide. Otherwise this unit is seldom exposed in natural outcrop and is characterized by subdued topographic form with reddish brown soils on the order of 6 to 10 feet (2-3 m) thick. The pyroxenite appears to be the uphill parent material for the large quantity of sandy colluvial soil forming this landslide.

Photo 3. Axial view N20°W of the upper half of Mill Creek landslide showing debris slide blocks and translational movement. Note structural control of west side of landslide (at left) and asymmetric tilt of slide mass. Prominent joint-controlled bedrock gully at left. Reddish-brown colluvium (derived from pyroxenite) within the debris slide contrasts in color with gray colluvium derived from diorite and schist at right side. Photo by Robert H. Sydnor.

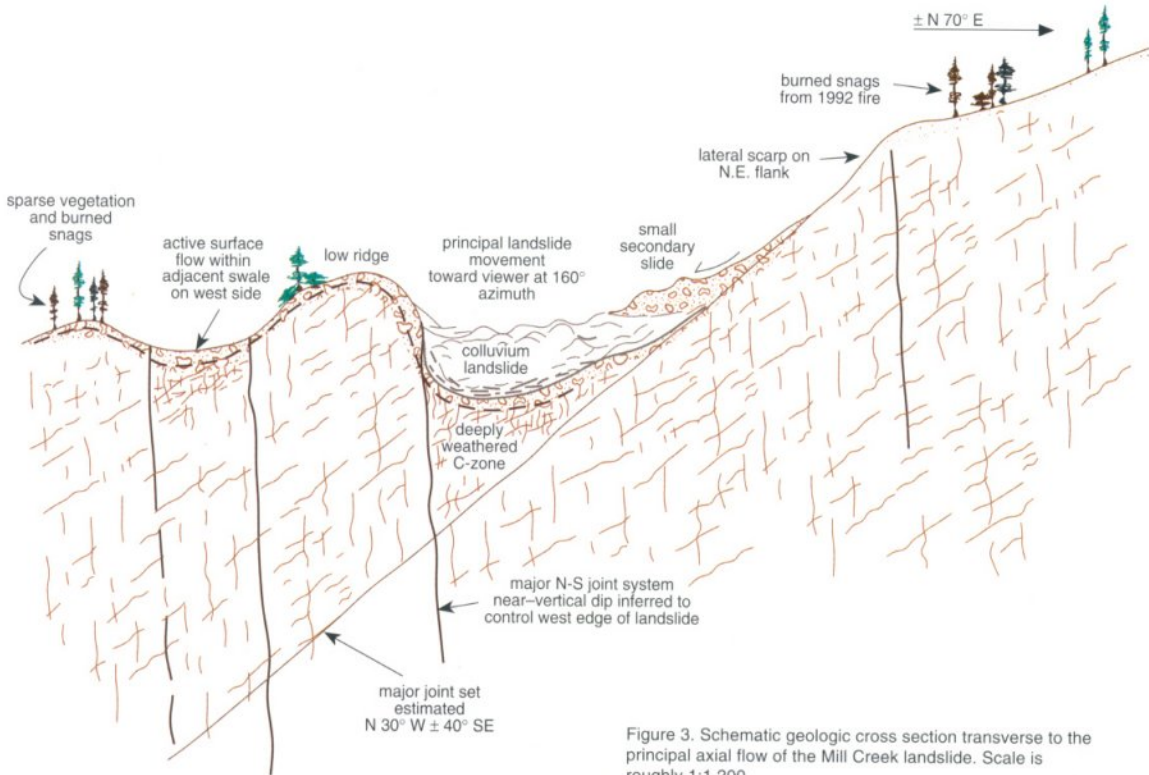
The morphology of the Mill Creek landslide appears to be significantly controlled by the geologic structure of the bedrock. Preliminary geomorphic analysis indicates a near-vertical joint system trending north-south (Figure 3). On the south side of the South Fork American River, this joint set evidently controls the course of Mill Creek, which runs nearly straight for about 1.2 miles (1.9 km). Mill Creek intersects the river at nearly 90 degrees, rather than a more typical 60- to 70-degree angle. This near-vertical joint set is exposed in hard diorite on the north bank of the river at Caltrans milepost 42+88, and continues northward for at least 0.5 mile (800 m), forming a straight

gully. This joint set appears to control the west edge of the upper half of the Mill Creek landslide.

The second joint set is estimated to be about N30°W, 40°SW, and is inferred from the smooth bedrock surface exposed in the northeast flank of the upper half of the landslide. The two intersecting joint sets appear to form an asymmetric trough as shown in Figure 3. The western edge of the landslide is apparently steep and the landslide is inferred to be thickest (roughly estimated 40 to 50 feet [12-15 m]) at the western edge of the upper half of the landslide.

Figure 3. Schematic geologic cross section transverse to the principal axial flow of the Mill Creek landslide. Scale is roughly 1:1,200.

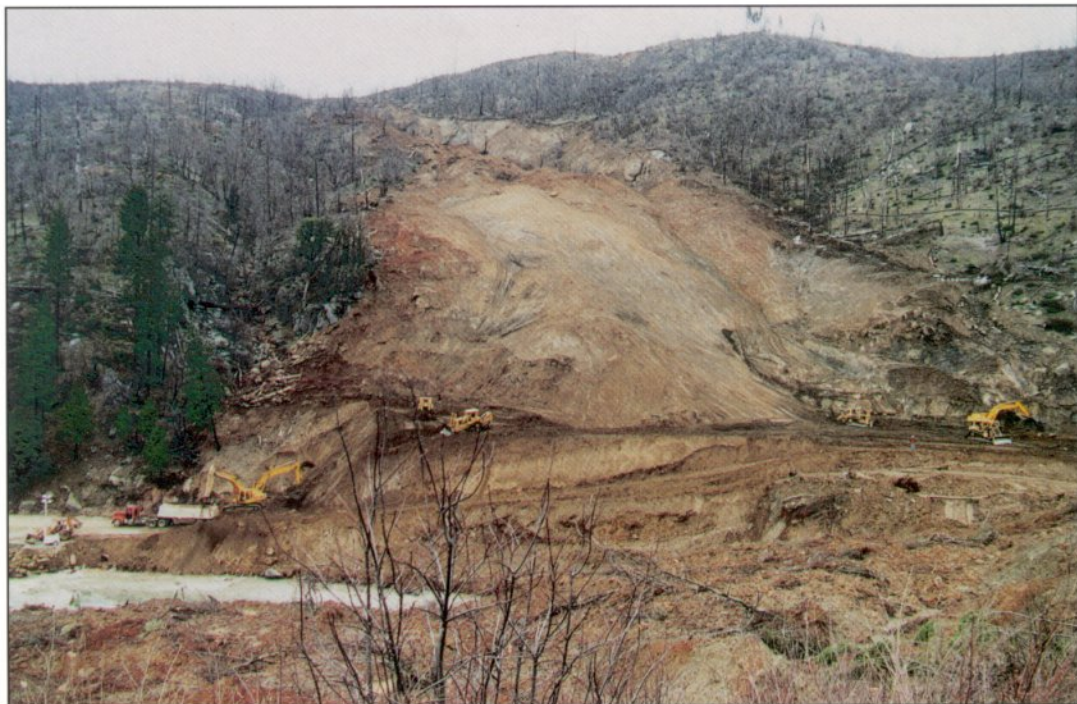
Photo 4. Heavy equipment removing an estimated 250,000 to 300,000 cubic yards (190,000-230,000 m³).
Photo by Robert H. Sydnor.

Highway 50 was closed for 27 days during landslide removal and remedial grading operations (Photos 4 and 5). Remedial landslide repair options were developed by a team of engineering geologists and geotechnical engineers from Caltrans. The repair schedule was of keen interest because it had a salient impact on the economic recovery of El Dorado County and South Lake Tahoe (California and Nevada sides). Many agencies in the public and the private sectors were dependent upon the reopening of Highway 50. Foremost among these were Pacific Bell

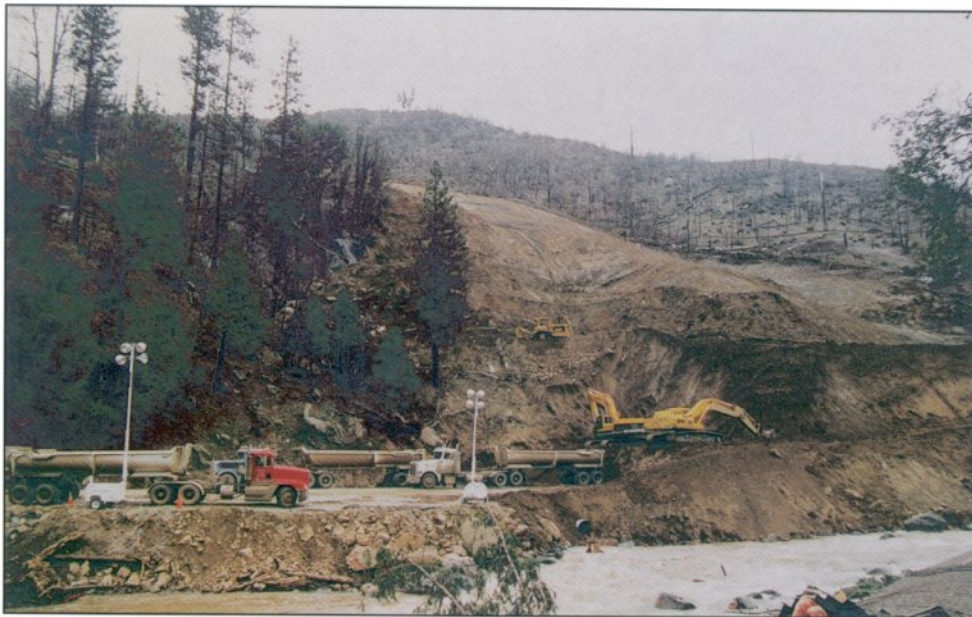
Photo 5. Caterpillar tractors push landslide debris downslope toward two sets of track-mounted loaders at the toe of Mill Creek landslide. The roadbed was found to be intact after 27 days of excavation. *Photo by Robert H. Sydnor.*

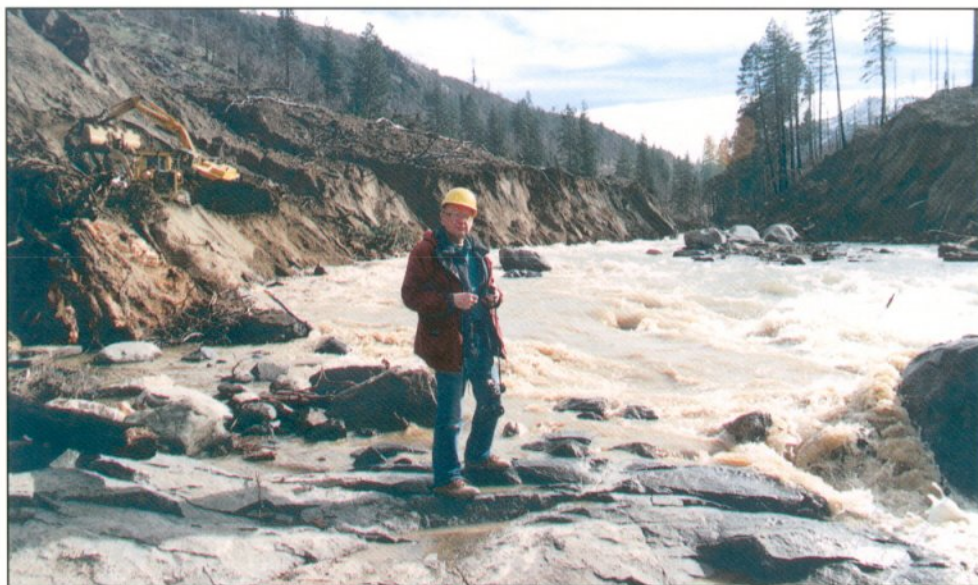
The 11:20 PM landslide dammed the South Fork American River. Floating logs accumulated at the southeast corner of the landslide toe. The river slowly eroded the soft sandy material composing the debris slide, breaching the dam by 4:30 the next morning (Lakey, 1997). The river channel is in hard diorite bedrock, although the thalweg (deepest line of stream channel) was temporarily deflected southward.

Photo 6. The breached landslide dam along the South Fork American River is inspected on January 30, 1997 by Robert L. Schuster, engineering geologist, USGS, Denver. Within about 5 hours the river quickly cut the sandy colluvium to its original base level in hard diorite shown in the foreground. *Photo by Robert H. Sydner.*
