SPECIAL REPORT 187

LANDSLIDES IN THE HIGHWAY 101 CORRIDOR
BETWEEN LEGGETT AND PIERCY,
MENDOCINO COUNTY, CALIFORNIA

Prepared for
California Department of Transportation
New Technology and Research Program
Office of Infrastructure Research
Project F99TL34

2003

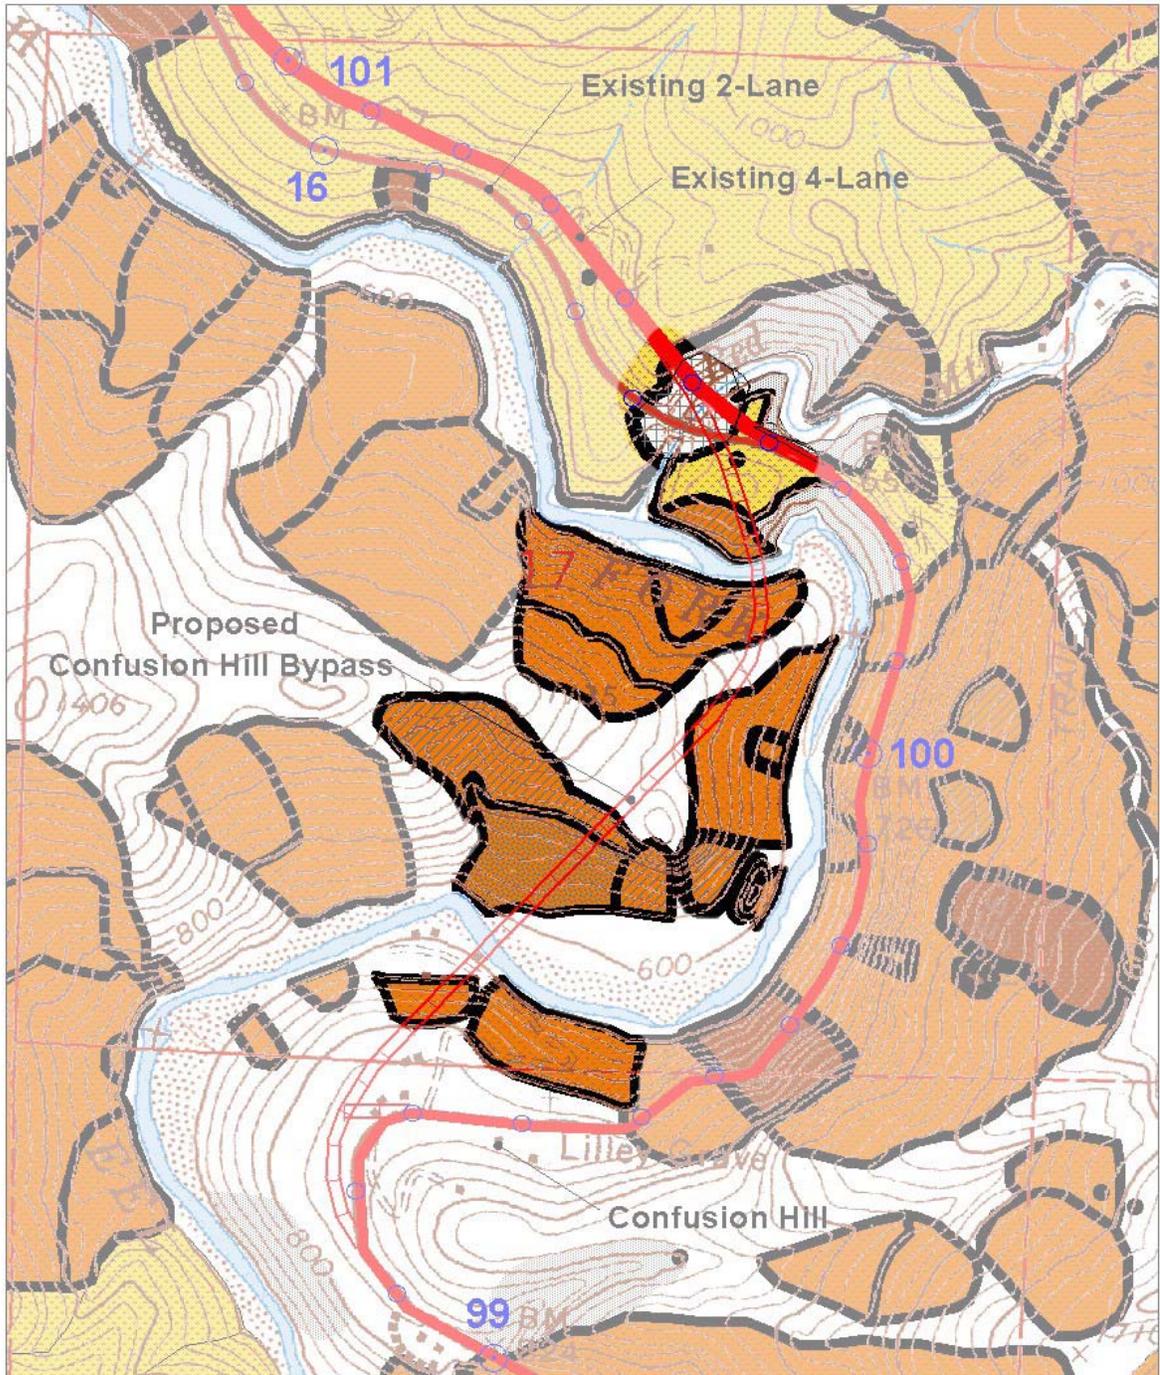
Figure 5a. The proposed bypass would cross the South Fork Eel River twice. The southern end is situated on a river terrace. The southern crossing would be anchored at its south end on a small landslide that could easily be removed or stabilized. The north end crosses a young debris fan and debris slide slope. The mid section of the bypass crosses the upper portions of two landslides. The northern crossing is anchored at its northern end in the toe of a massive landslide, as mentioned below in Figure 5C.

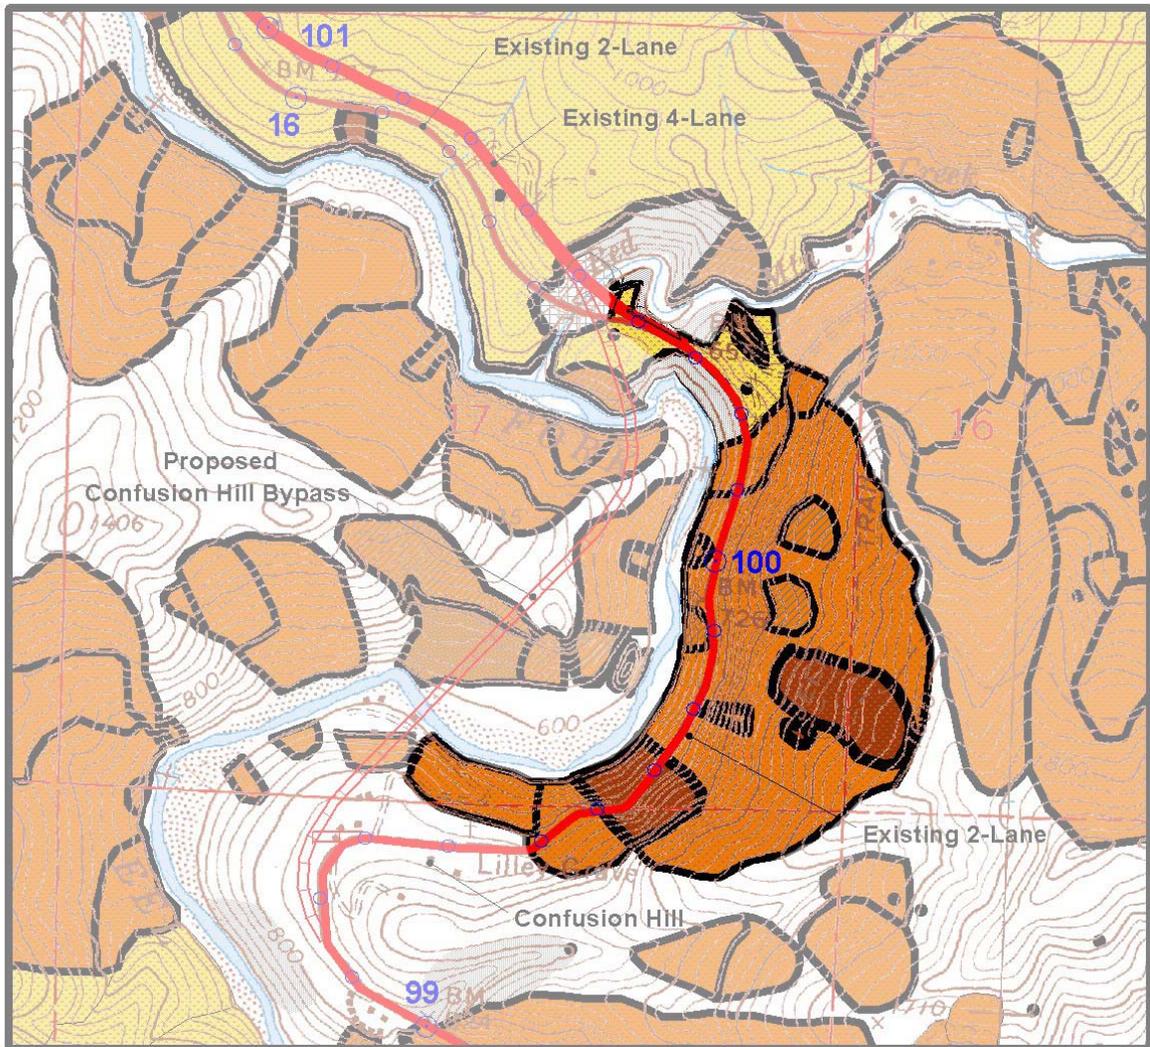
Figure 5b. The existing highway near Confusion Hill is subject to landslides and debris flows, especially at PM 99.8. Recently active slides have resulted in repeated lane closures and traffic control. The proposed bypass would eliminate this segment of Highway 101,

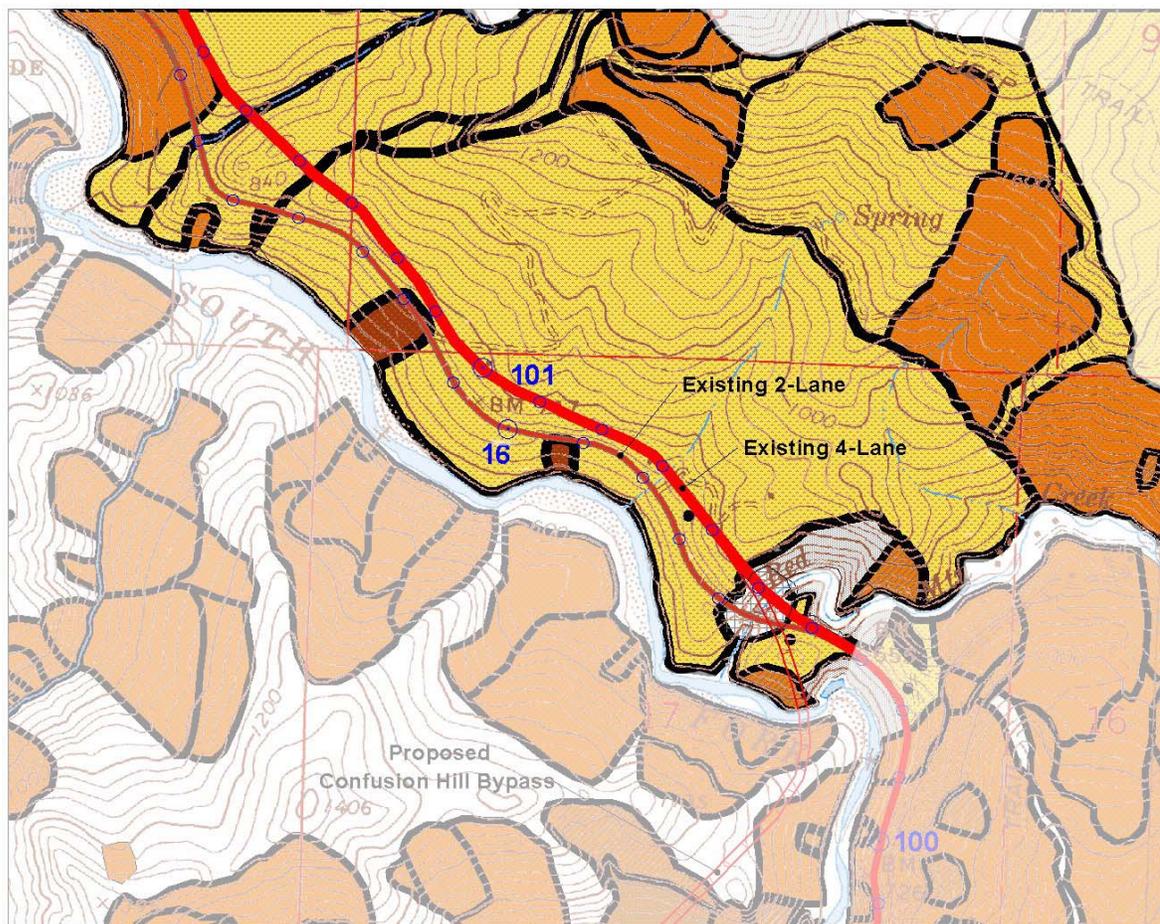
Figure 5c. North of Red Mountain Creek both the old and new highways cross a recently identified massive landslide on the right side of South Fork Eel River. The north end of the proposed bypass would start near the upstream toe of the old landslide. A small landslide exists on the old highway just south of PM 16; this small landslide has distressed the road pavement on the old highway. Another small landslide is distressing the old road at PM 16.15. This small slide has been instrumented by Caltrans to keep track of its movements. If either slide were to reactivate and enlarge, the new highway could be affected

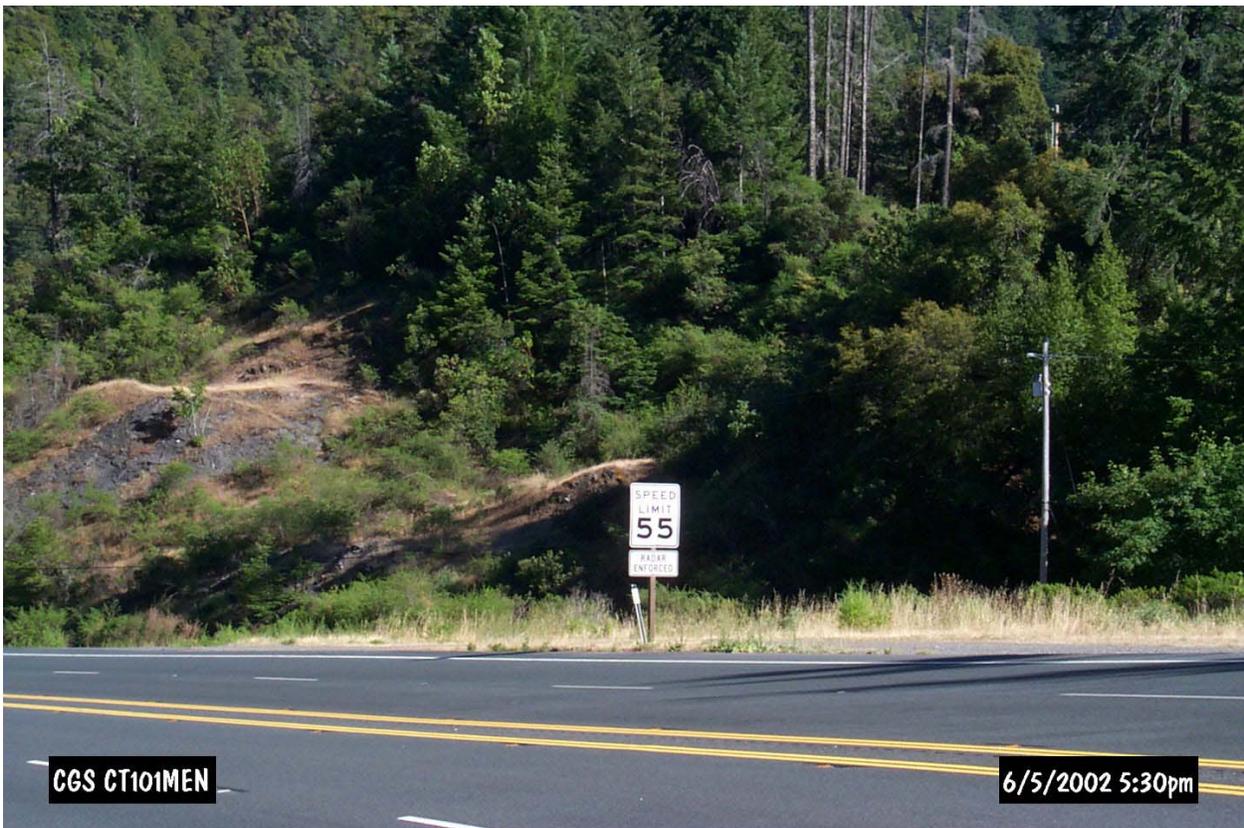
Photo E shows the north end of the proposed bypass, at PM 100.5.
