SPECIAL REPORT 188

LANDSLIDES IN THE INTERSTATE 5 CORRIDOR
BETWEEN VALENCIA AND GORMAN,
LOS ANGELES COUNTY, CALIFORNIA

Prepared for
California Department of Transportation
New Technology and Research Program
Office of Infrastructure Research
Project F99TL34

2003

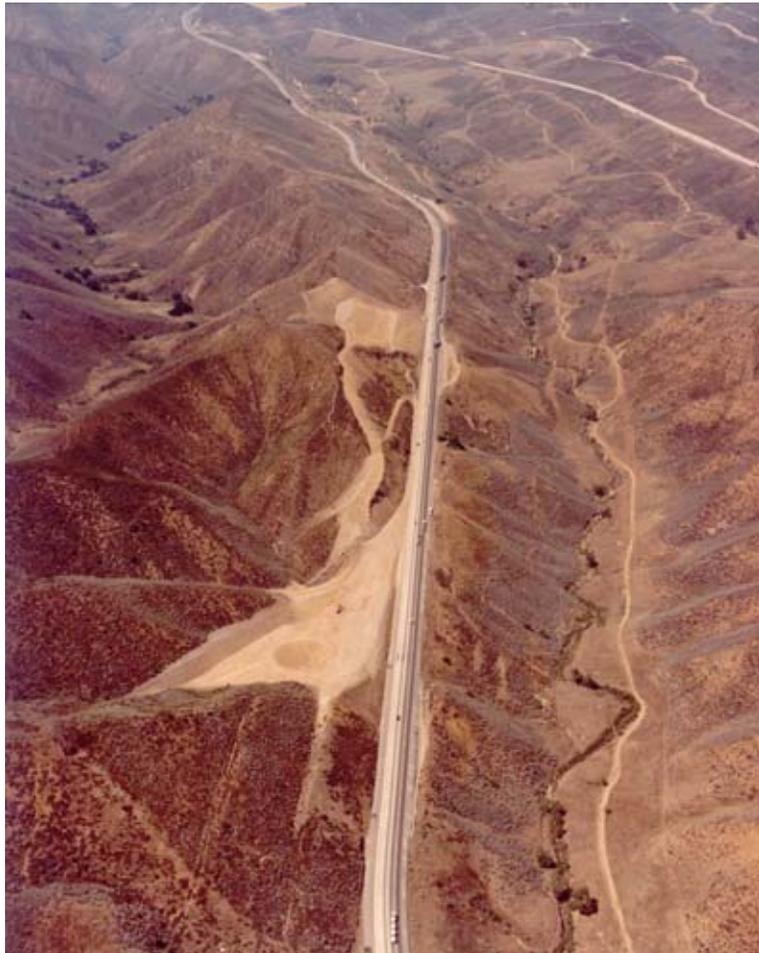
Figure 1. Oblique aerial view of the Interstate 5 corridor, looking north, over the 5-mile grade section.

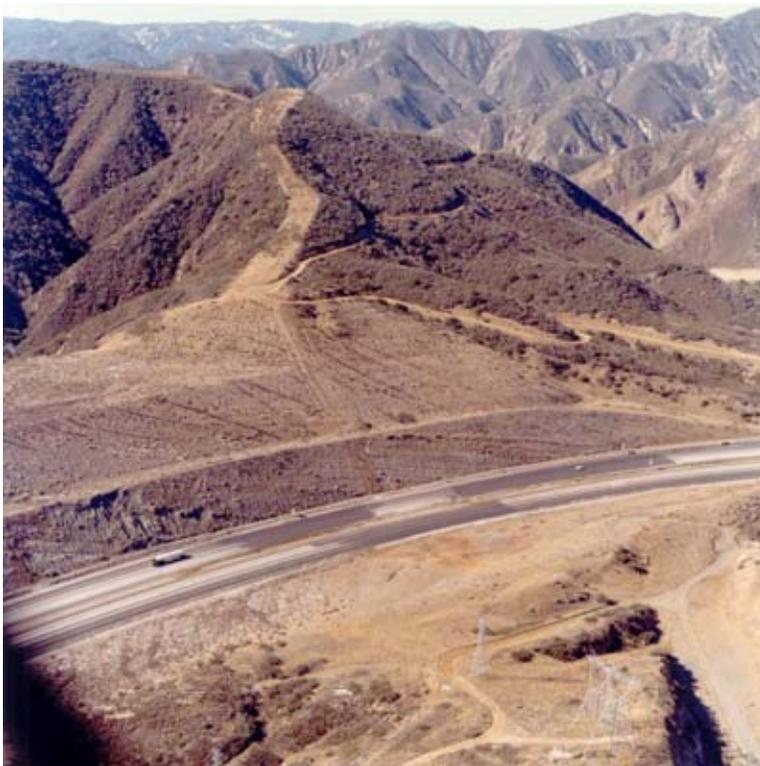
attempt to eliminate the humps and swales at this location. By 1993 slide movement had opened numerous tension cracks, and broken the concrete ditches on both benches. By 2002 it was apparent that a large deep, translational rock slide extends well beyond the boundaries of the cut. The slide is currently active and is delineated by cracks and scarps several feet high. The toe extends beneath the roadway and is causing it to heave. An ongoing investigation of this slide is being conducted by Caltrans.

Figure 3. Aerial view of the Templin Highway slide (P.M. 65.4 to 65.7). View is to the northwest. Photo by Caltrans, 1981.
