**RECORDED RESPONSE AND OBSERVED PERFORMANCE OF  
A WOOD-FRAME HOSPITAL BUILDING  
DURING THE 2003 SAN SIMEON EARTHQUAKE**

Moh Huang

**Abstract**

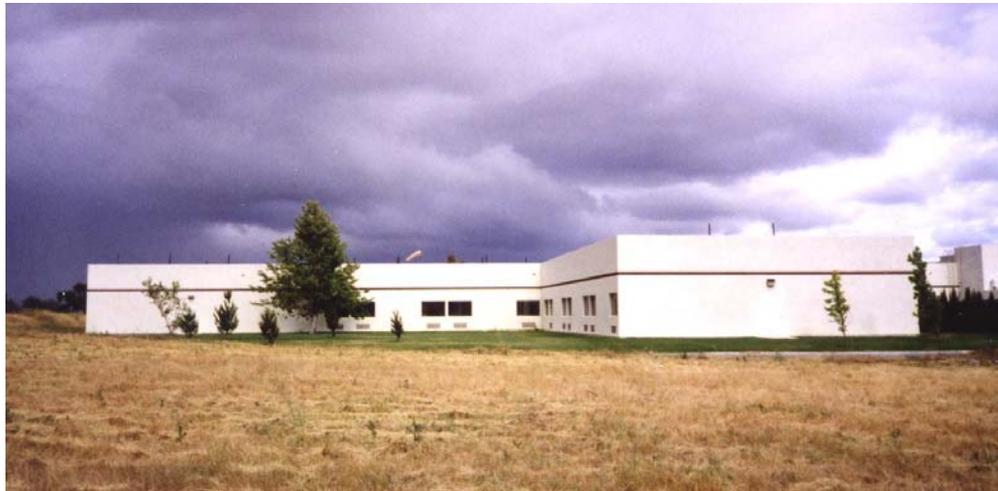
Figure 1. View of the 1-story Hospital in Templeton. The North Wing is on the left side of the photo, while the West Wing is on the right side.

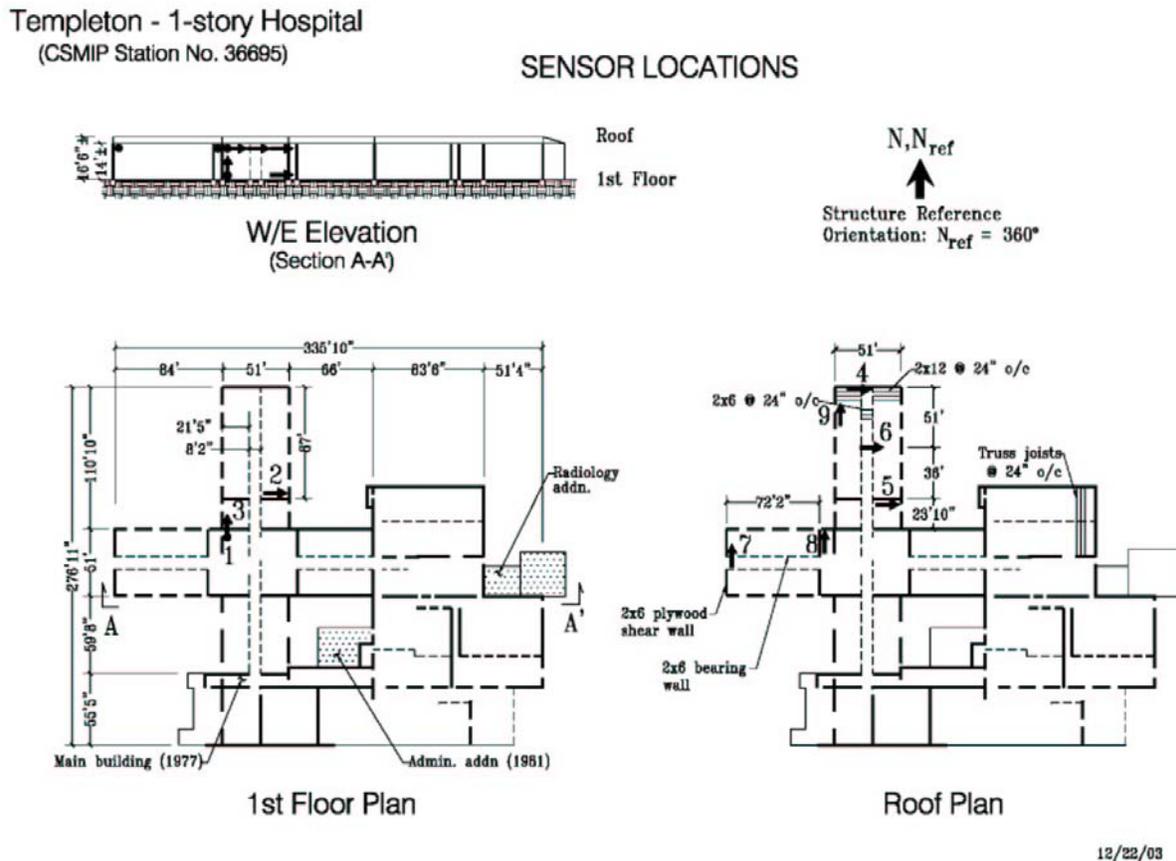
The final instrumentation plan includes 9 accelerometers in the building and three at a reference free-field site. The locations of these 9 sensors are shown in Figure 2. Each of these 9 sensors is connected via cabling to a central recorder located outside the building. The digital recorder coupled with a communication system allows the recording system to immediately send the data to the CSMIP office in Sacramento after the system is triggered by an earthquake. The ground response station was installed in the parking lot, about 200 feet northwest of the building, to measure the referenced ground motion for the building. Unfortunately, this station was removed due to hospital expansion construction before the 2003 San Simeon Earthquake. A new station was installed on January 27, 2004 at a location about 500 feet from the building.

Figure 2. General plans of the 1-story Hospital in Templeton and locations of 9 sensors in the North and West Wings of the hospital.

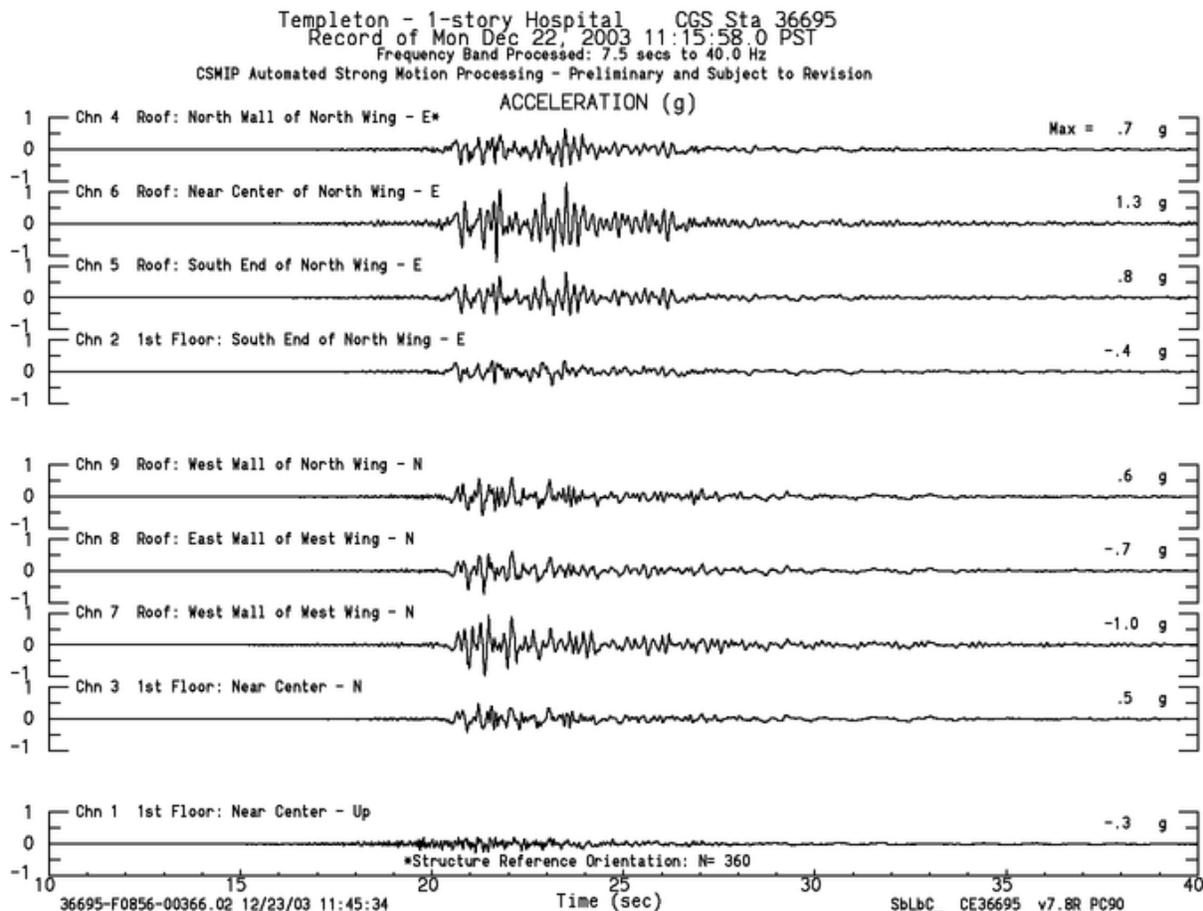
right after the earthquake at the CISN Engineering Strong Motion Data Center (<http://www.cisn-edc.org>). The recorded maximum accelerations were 0.5 g at the ground level, 1.0 g on the top of the wall at roof level and 1.3 g on the roof diaphragm. This is the strongest record ever recorded in a wood frame building.

Figure 4. Recorded accelerations from the 1-story Hospital in Templeton during the San Simeon earthquake of December 22, 2003. (The usable data bandwidth for the processed data is from 40 Hz to 7.5 seconds.)

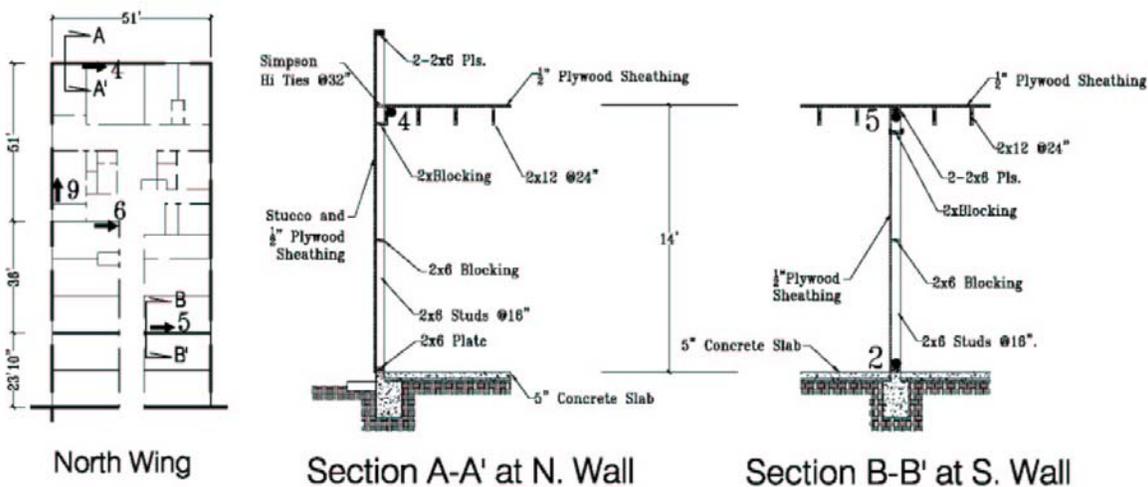
Figure 6. Structural details and sensor locations at the North Wing of the Templeton hospital.

Because the hospital building is a stiff structure and the San Simeon earthquake was close and relatively large, the building is expected to attract a high level of seismic forces. To examine this in more detail, the records from the North Wing are discussed here. The structural details of the North Wing and the sensor locations are shown in Figure 6.

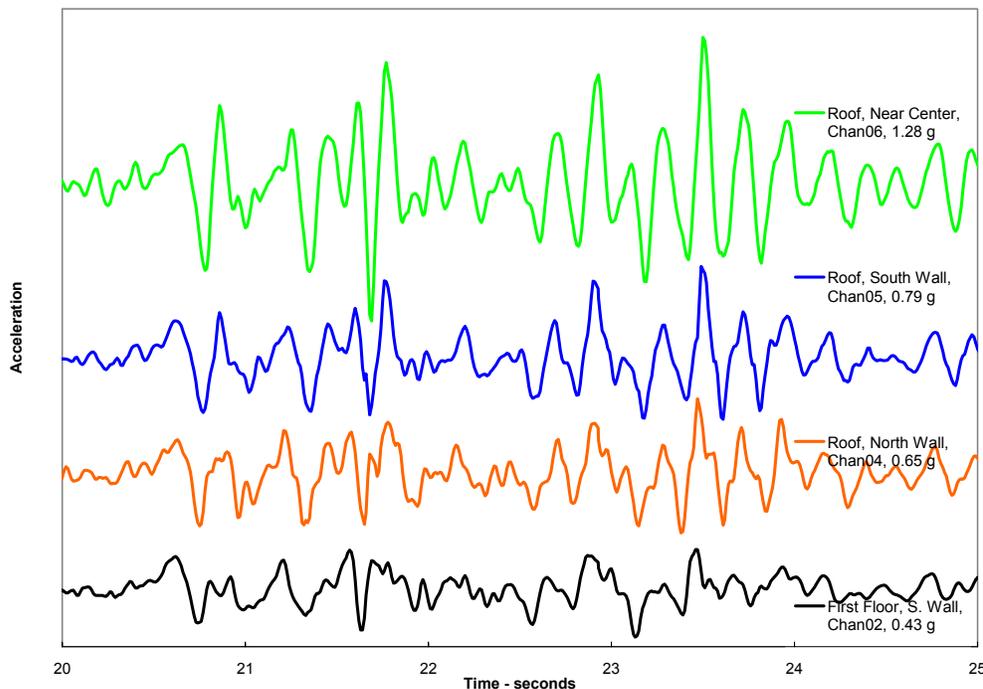
Figure 7 shows a 5-second window of the accelerations recorded by Sensor 2 on the first floor (base) and three sensors on the roof, in the east-west direction. The maximum acceleration at the base is 0.43g. The maximum acceleration reached 0.65g on the top of north shear wall, 0.79g on the top of south shear wall, and 1.28 g near the center of the roof. The roof diaphragm motion is prominent in the acceleration records. One can estimate the period of vibration from the acceleration record or the corresponding response spectra shown in Figure 8. It can be seen from the spectra that both shear walls and the roof diaphragm have a period of about 0.2 second. In the other direction, the period of vibration is also at 0.2 second.

Figure 7. A strongest 5-second window of the east-west acceleration records obtained on the first floor and the roof of the North Wing of the hospital in Templeton during the San Simeon earthquake of December 22, 2003.

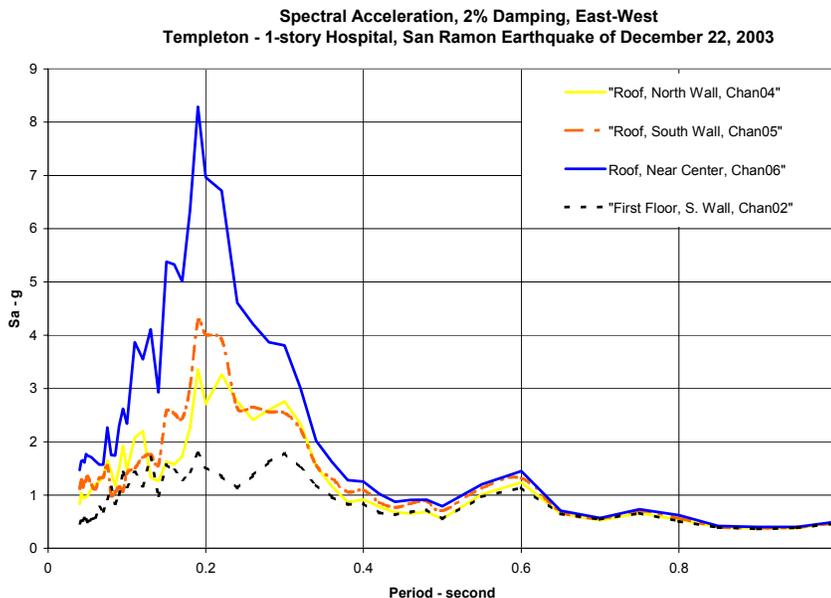
Figure 8. Acceleration response spectra (2% damping) of the acceleration records (shown in Figure 7) in the east-west direction from the North Wing of the hospital in Templeton during the San Simeon earthquake of December 22, 2003.

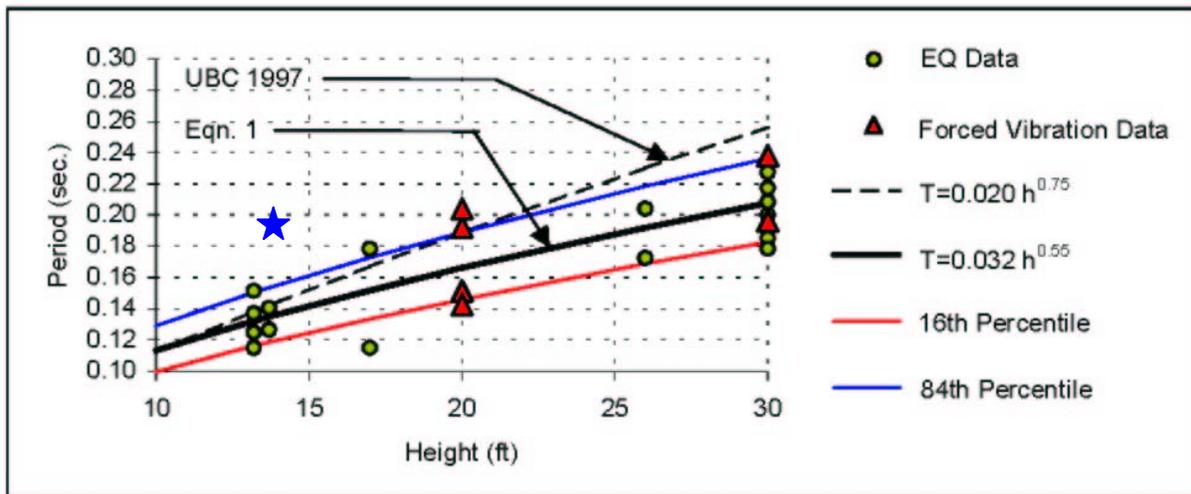
It is interesting to compare the period of this hospital building with those computed from the empirical formula given in the Uniform Building Code. In Figure 9, Camelo, Beck and Hall (2002) compare the building periods derived from the low-amplitude strong-motion data recorded at five CSMIP-instrumented wood frame buildings, forced vibration data from one building, and the period formula given in the 1997 Uniform Building Code. The Templeton

hospital has a story height of 14 feet. It is clear that its period is longer than what the UBC formula would predict.

Figure 9. The period of the 1-story hospital in Templeton derived from the records of the 2003 San Simeon earthquake (shown as a star) is compared with periods of other wood frame buildings and the periods derived from the formula in the 1997 UBC. (Camelo, Beck and Hall, 2002)

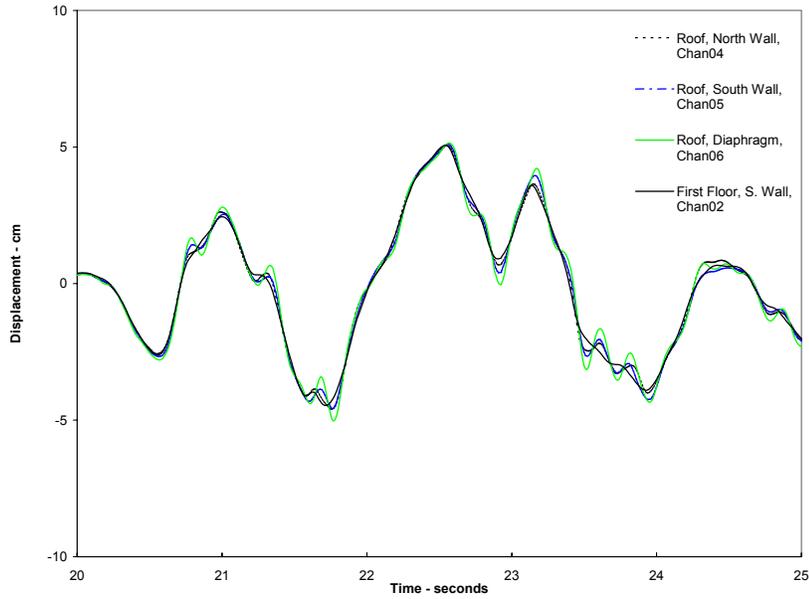
ground displacement. The response of the wall and the roof diaphragm are not obvious from the absolute displacement plots in Figure 10. The deformation of the walls and the roof diaphragm can be calculated by differencing the roof displacement records from the first floor record. They are plotted in Figure 11.

Figure 10. East-west displacements (absolute, integrated from the accelerations) corresponding to the acceleration records shown in Figure 7.

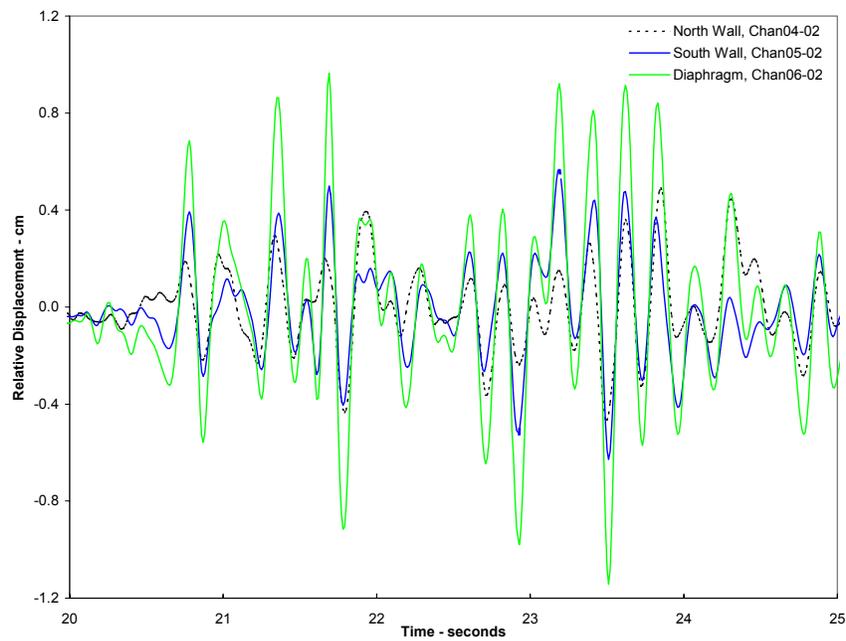
Figure 11. Deformation of the walls and the roof diaphragm, in a 5-second window corresponding to the strongest ground shaking, obtained by computing the relative displacement (east-west) between the roof and the first floor of the North Wing of the Templeton hospital during the San Simeon earthquake of December 22, 2003.

It can be seen from Figure 11 that the roof diaphragm and the wall deformations are in phase and have a period of 0.2 second. The maximum deformation of the walls is about 0.5 cm which corresponds to an inter-story drift ratio of 0.12%. The roof diaphragm had about 0.5 cm deformation relative to the top of the wall. These relative displacements are much smaller than the maximum ground displacement, which is larger than 6 cm.
