MINERAL INFORMATION SERVICE

MARCH 1970

SANTA ROSA EARTHQUAKES

THE SANTA ROSA EARTHQUAKES OF OCTOBER, 1969

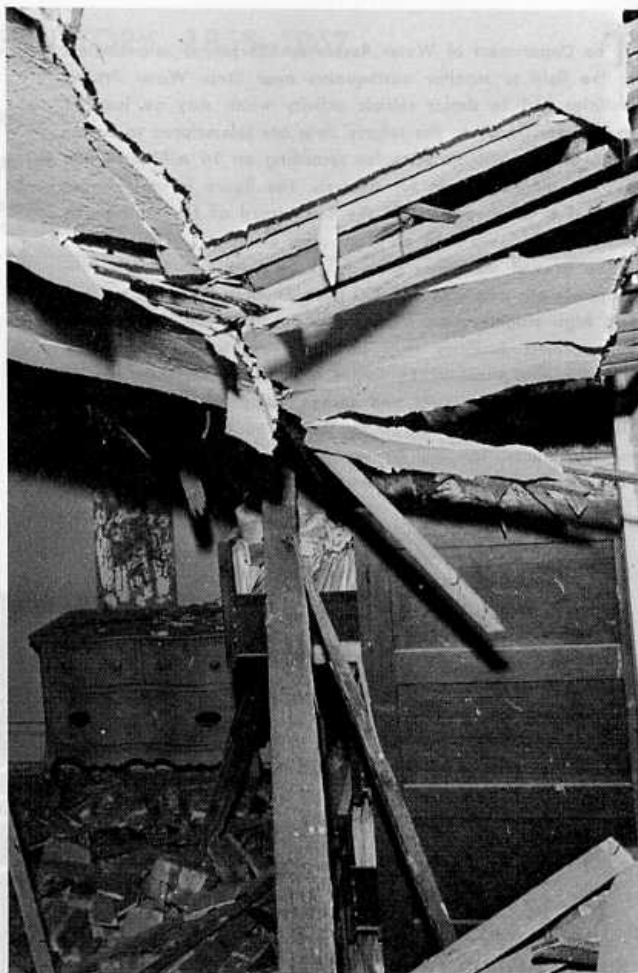
Severe interior damage including collapsed ceiling in office building on College Avenue. Photo by Santa Rosa Press Democrat.

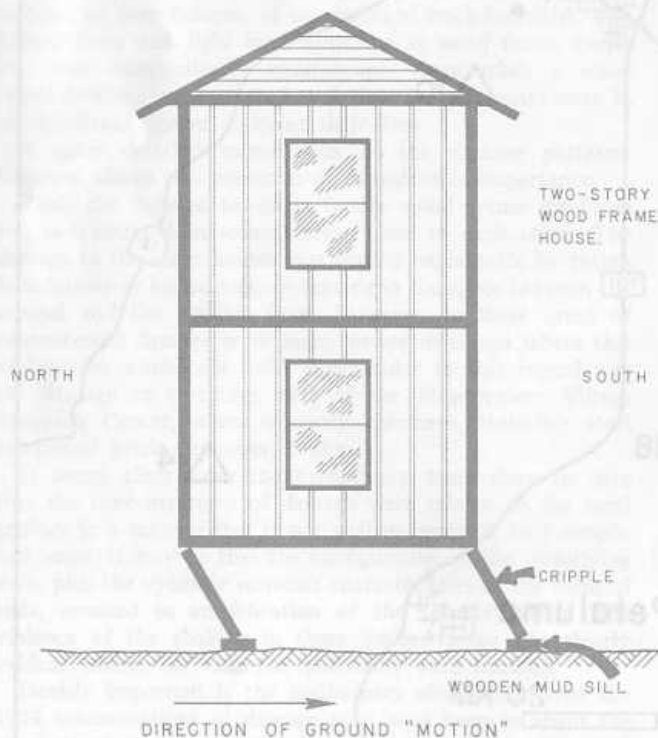
Diagram showing how some of the older dwellings, built before the Uniform Building Code, must have toppled off their foundations as a result of sudden lateral ground motion.

Older buildings in the downtown section showed the most damage. Several old two-story wood-frame buildings, constructed before the provisions of the Uniform Building Code became effective, displayed a spectacular type of severe damage. These buildings were shaken off their wood foundations, leaving them shattered and leaning (prevalently in the northward direction).

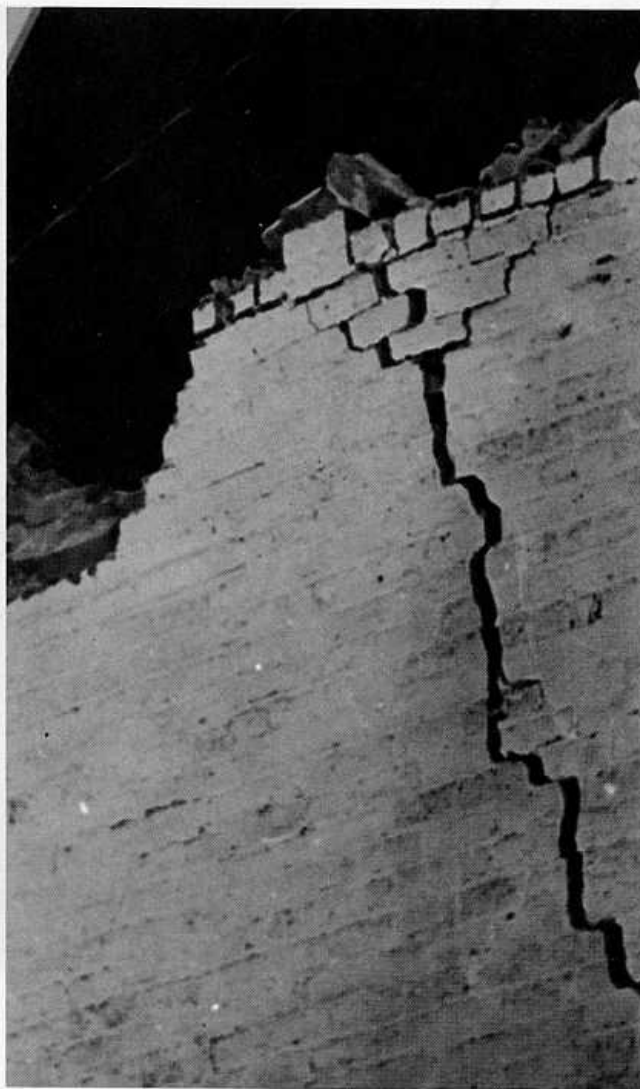
The Beaver House, historic Santa Rosa home, was severely damaged. Constructed in 1850s, the structure was condemned by building inspectors. Photo by Santa Rosa Press Democrat.

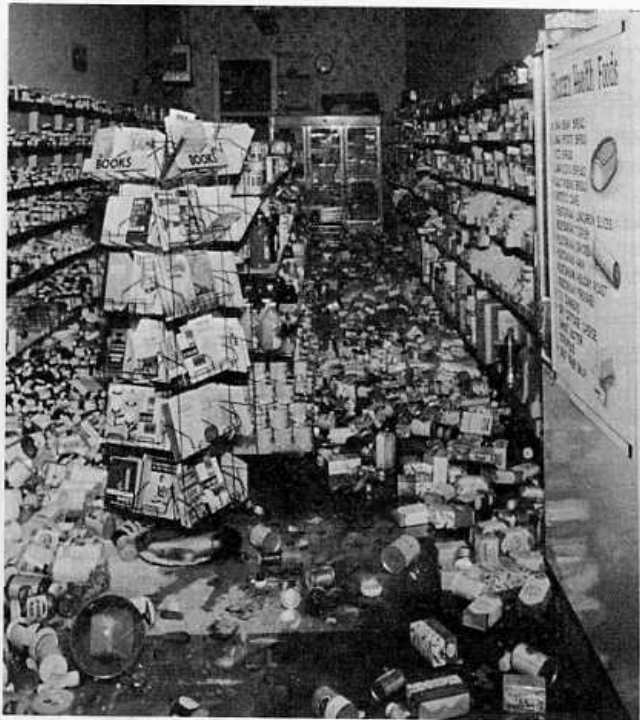
Canned and bottled goods toppled off shelves in many stores in the Santa Rosa area. This is the health food store on Fourth St. Between shocks the merchandise was reshelfed, only to be toppled again. Photo by Santa Rosa Press Democrat.

Toppled and/or broken light objects were the most widespread and numerically most common type of damage; few homes, stores or public facilities in the Santa Rosa area escaped this type of damage. The prevalent orientation of fall appeared to be north or south. Often, on shelves facing these directions, contents were hurled off; whereas, in the same room, shelves facing east or west showed only minor disturbance.

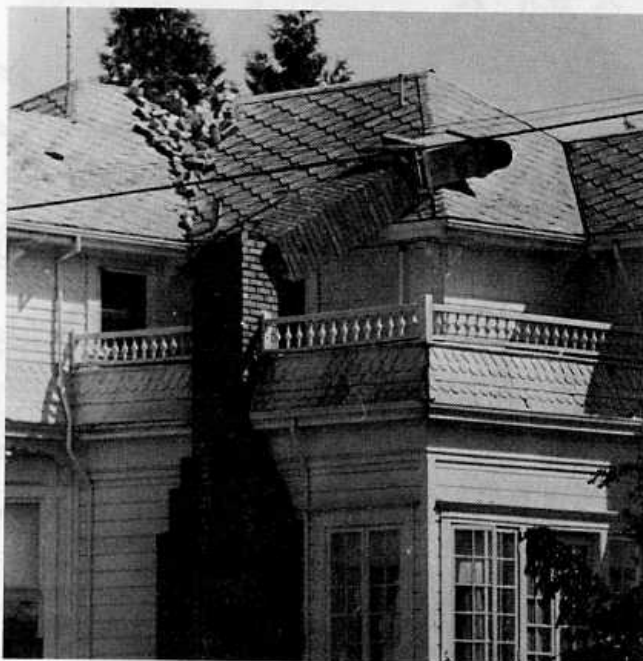
Collapsed chimneys were another common effect of the shock. Older, unreinforced units proved to be most susceptible to this sort of damage.

Toppled brick chimneys were a common sight in Santa Rosa. Photo by Santa Rosa Press Democrat.

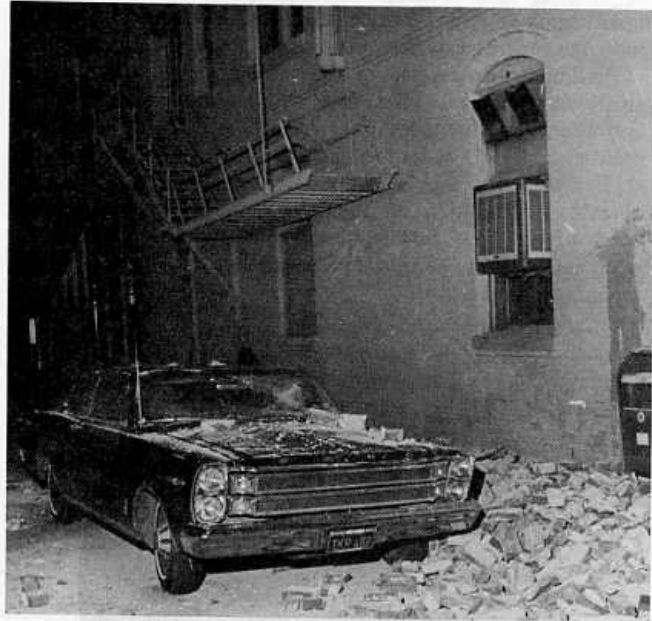
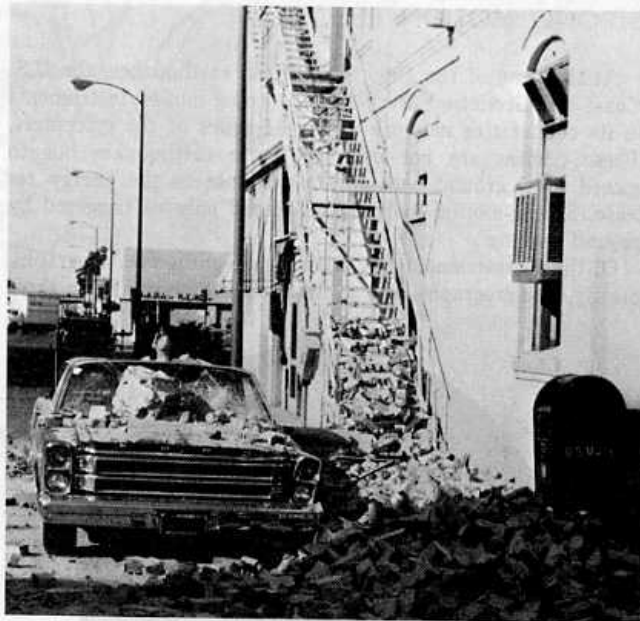
Bricks tumbled from many buildings as a result of the quake. These views of rubble derived from the top of the three-story Galeazzi Building, show successive damage caused by the repeated tremors. The photo in the upper left, taken on the night of October 1, shows damage as a result of the first shock.

The photo on the upper right, taken the following morning, shows further damage to automobile by falling debris after second strong tremor. The fire escape also dropped, weighted down by added brick. Photo to left by Santa Rosa Press Democrat; to right by Robert D. Nason.

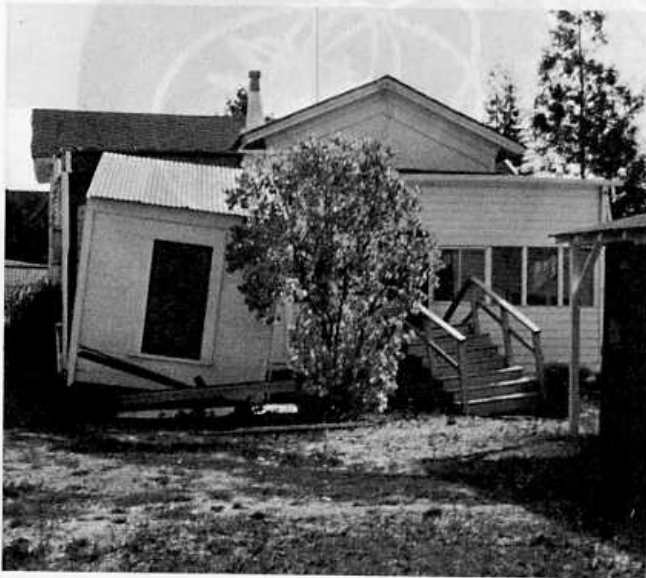
House on Wright Street toppled off foundation. Photo by Robert D. Nason.

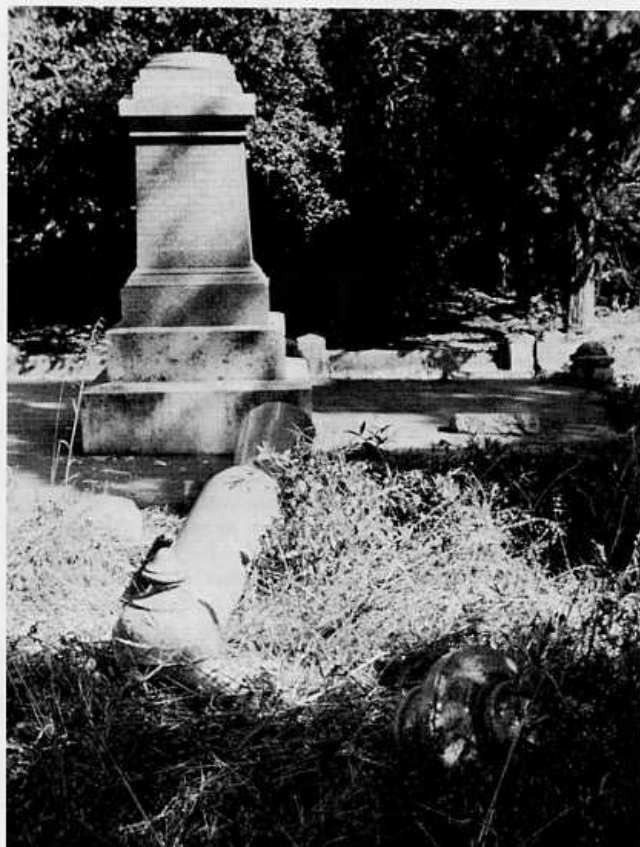
In addition to cracking the earth in cemeteries, the earthquake toppled, rotated or moved many tombstones in both the IOOF and Rural Cemeteries. A total of 45 "topples" were noted and mapped. Sixteen monuments moved laterally. Thirty-six rotated, clockwise or counter clockwise—in nine cases, in a direction opposite to the rotation caused by the earthquake of April 25, 1968.

One of forty-five monuments known to have toppled in Santa Rosa's Rural and IOOF Cemeteries. Fifty-two other monuments shifted or rotated on their bases. Photo by Robert D. Nason.
