# **Liquefaction and Other Ground Failures in Imperial County, California, from the April 4, 2010, El Mayor-Cucapah Earthquake**

By Timothy P. McCrink, Cynthia L. Pridmore, John C. Tinsley, Robert R. Sickler,  
Scott J. Brandenburg, and Jonathan P. Stewart

**CGS Special Report 220**  
**USGS Open File Report 2011-1071**  
**Version 1.0**

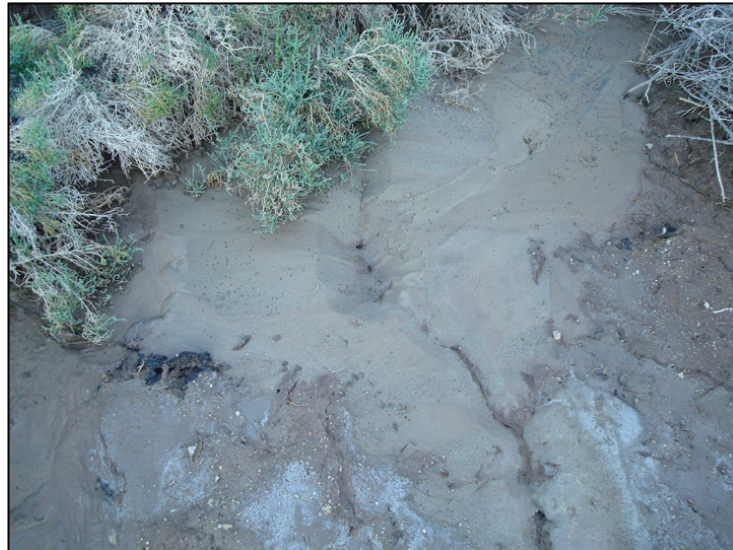
**Figure 13.** Vented sand in the marshy area east of the north approach fill to the Drew Road Bridge (R07). Lateral spreading damage to the road occurred immediately west. Photo by T. McCrink, 4/8/10.

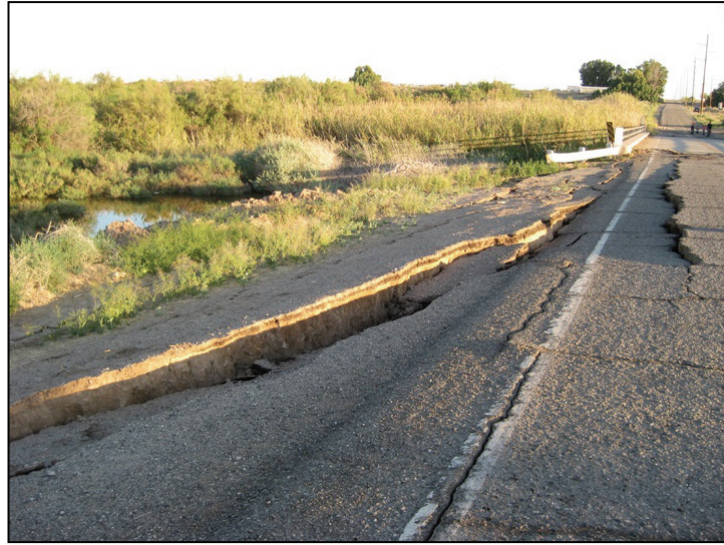
**Figure 14.** Lateral spreading of the north approach fill to the Drew Road Bridge (R07). Vented sand shown in figure 13 is immediately left of this photo. View to the south. Photo by T. McCrink, 4/8/10.

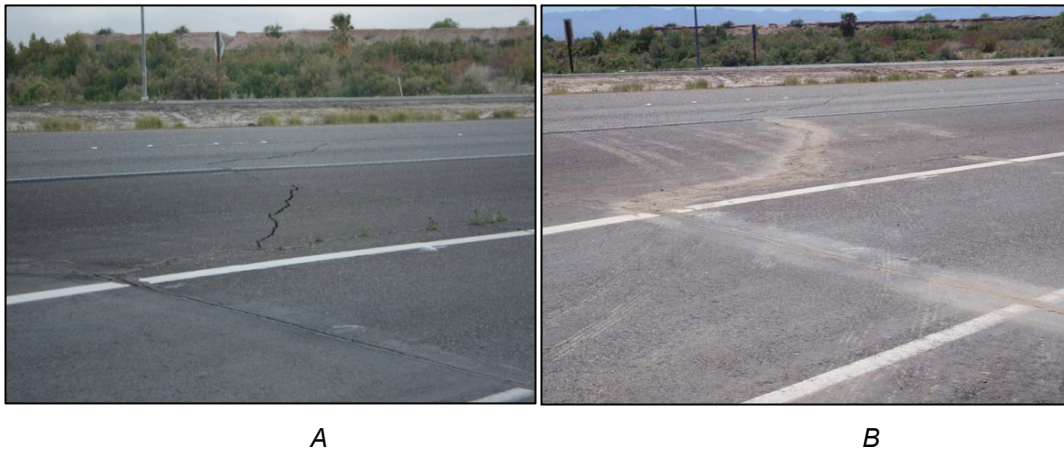
**Figure 17.** Extensional fractures across the westbound lanes of Interstate 8 and the Drew Road onramp (R08). A, Fractures as they appeared on 4/5/10. Photo by D. Y. Kwak. B, Fractures after being patched and sanded on 4/7/10. Photo by J. Tinsley.

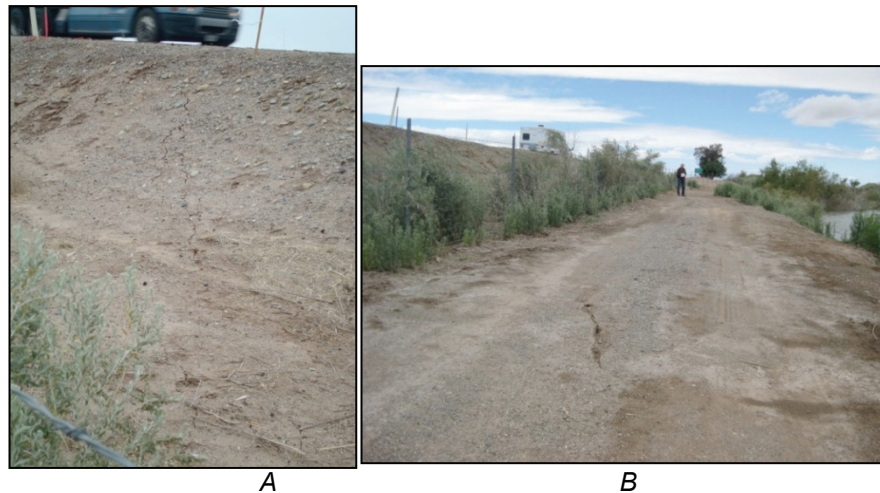
**Figure 20.** Minor cracks in fill at Interstate Highway 8 at the southern end of Sunbeam Lake (R10). *A*, Southeast-trending crack running obliquely through the Interstate Highway embankment. Photo by T. McCrink, 4/12/10. *B*, View to the west of a southwest-trending crack in access road fill. Person in the background is at the matching southeast-trending crack that forms the V-shaped pattern of cracks that open toward the lake on right. Photo by C. Pridmore, 4/12/10.

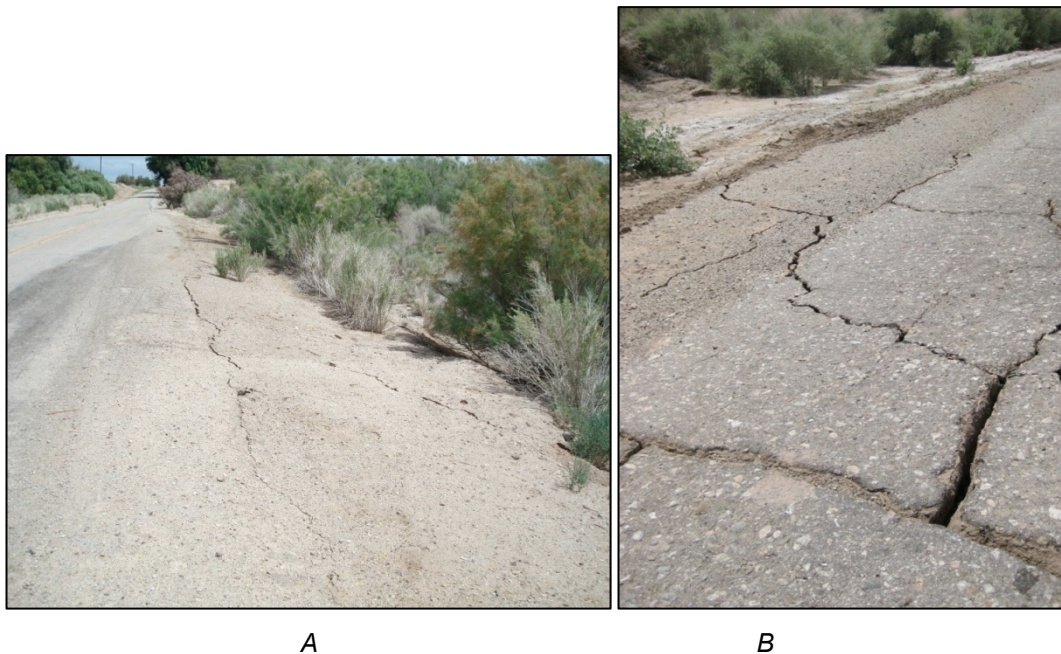
**Figure 21.** Typical shaking effects at Hetzel Road Bridge over Salt Creek Drain (R16). *A*, Incipient lateral spread cracks in the north side of the approach fill west of the drain (Photo by T. McCrink, 4/12/10). *B*, Pre-existing pavement cracks enlarged by shaking, and new cracks that continue into approach fill (Photo by C. Pridmore, 4/12/10).

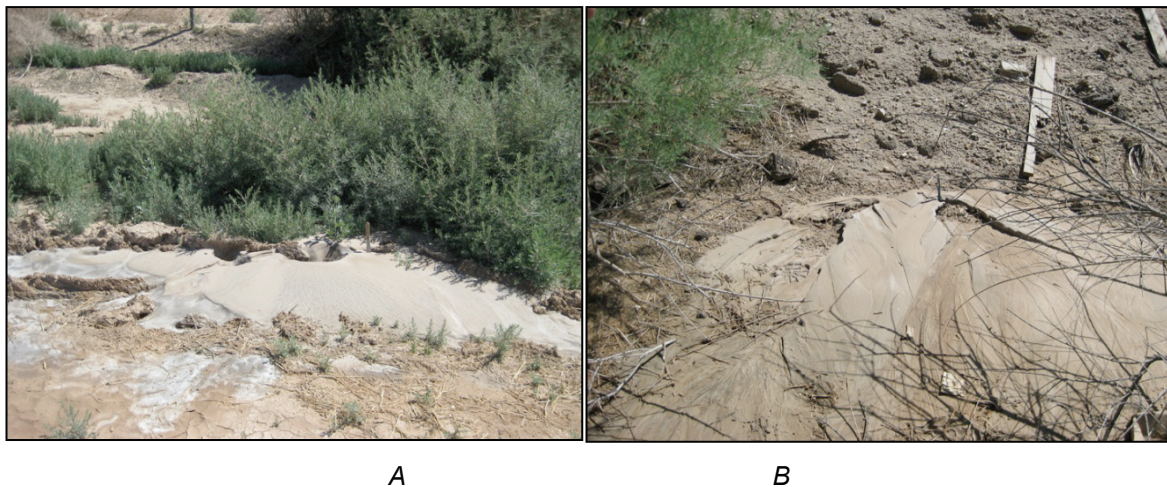
**Figure 22.** Sand vented on approach fill on the east side of the Worthington Road Bridge over the New River (R18). *A*, Light gray sand vented on the south side of the east approach fill indicates river sediments beneath the approach fill liquefied, whereas *B*, brown sand vented at the base of the fill on the north side indicates that fill materials liquefied also. Photos by C. Pridmore, 4/8/10.

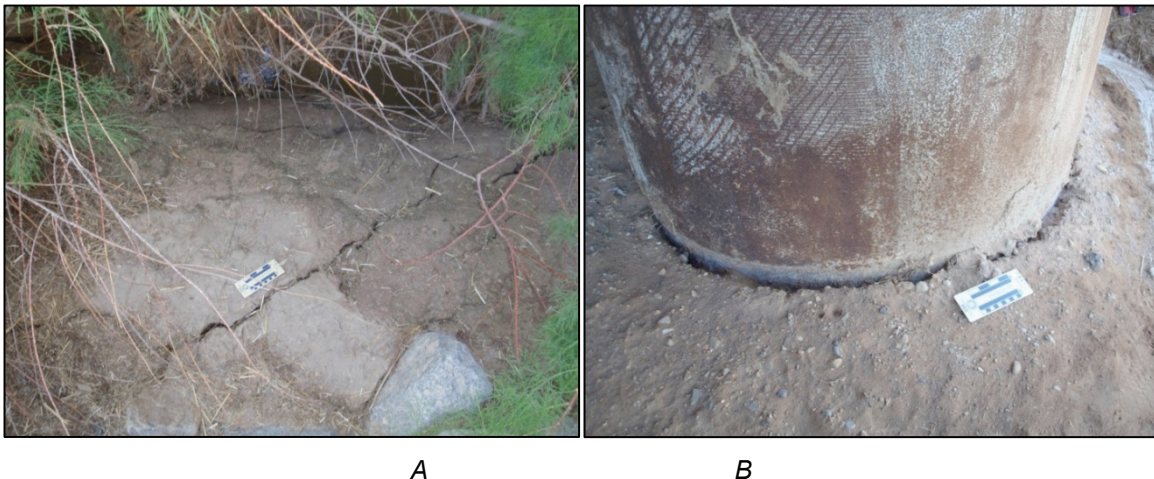
**Figure 28.** Indications of earthquake shaking at the State Highway 86 Bridge over the New River (R36). *A*, Minor soil cracks on the west bank of the New River beneath the bridge. Photo by J. Tinsley, 4/8/10. *B*, Soil apparently pushed 1 to 2 cm away from bridge pier on the west bank. Photo by T. McCrink, 4/8/10.

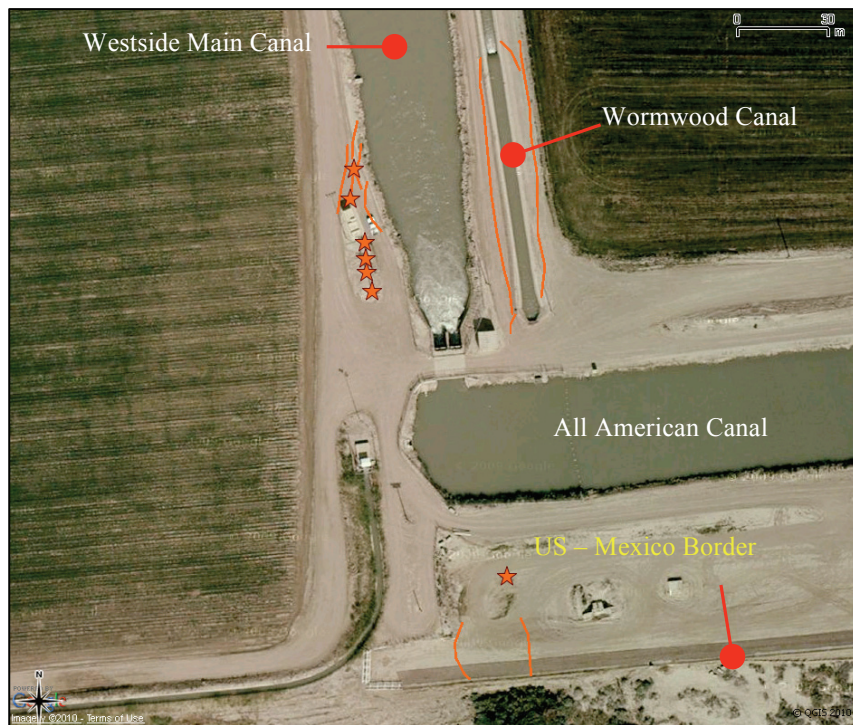
**Figure 30.** Diagrammatic view of the locations of vented sand (red stars) and related cracks and fissures (red lines) for the western end of the All American Canal and the southern end (start) of the Westside Main Canal (C01). Cracks south of the All American Canal coincide with the old alignment of the Westside Main Canal, and settlement of fill in this old canal appears to have displaced the International Border fence. Base Image is from Google Maps.

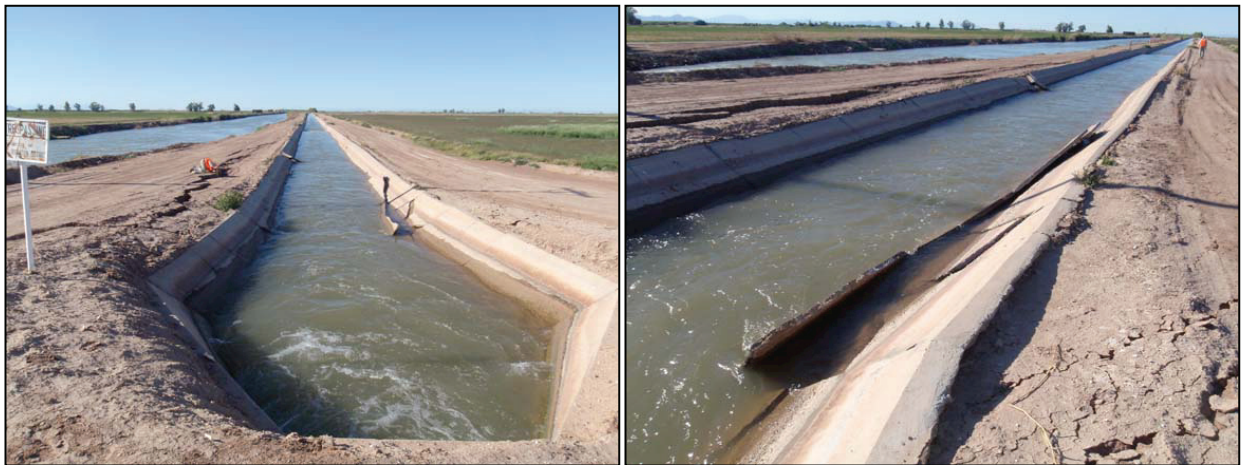
**Figure 31.** Images of Wormwood Canal flowing north from diversion from the All American Canal adjacent to Westside Main Canal (C01). The Westside Main Canal is visible to the west of Wormwood Canal. Lateral spreads on both sides of Wormwood Canal locally deformed the concrete liner, although the canal continued to function. Scarp height indicates about 14 cm of differential settlement. Photos by J. Tinsley, 4/6/10.

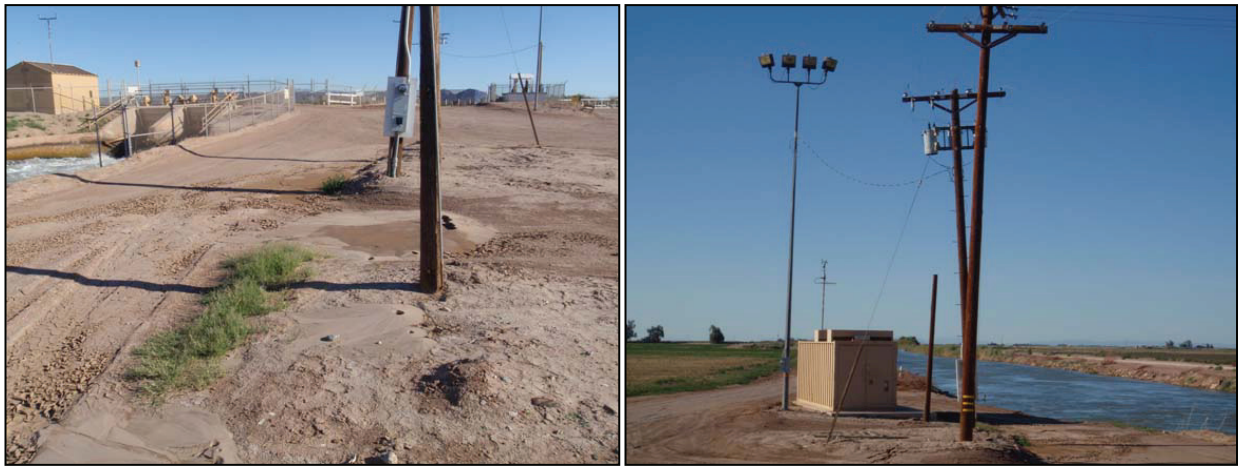
**Figure 32.** View north along west bank of Westside Main Canal, showing utility poles tilted from plumb due to lateral spreading ground failure (C01). Area around base of poles shows light-toned vented sand. Venting of sand in proximity to the poles probably reflects soil-structure interaction that enhanced liquefaction. Photos by J. Tinsley, 4/6/10.

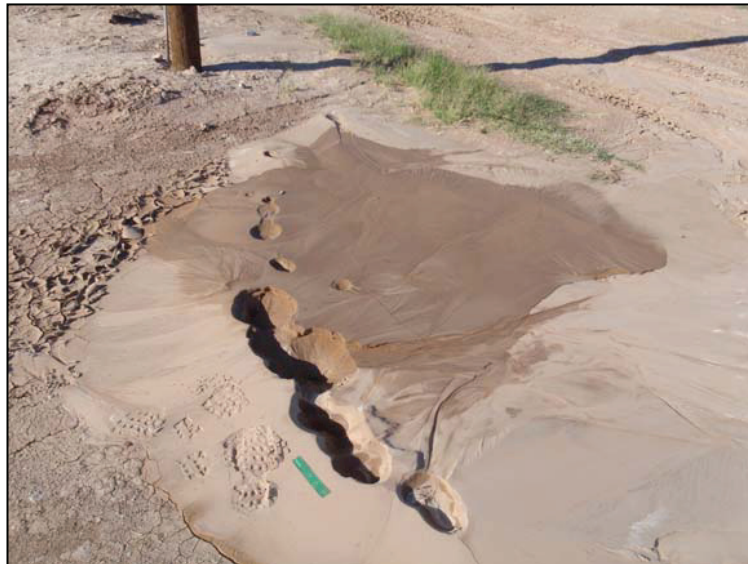
**Figure 33.** Principal fracture linking two tilted utility poles, showing vented sand with some water still seeping from pressurized strata in subsurface three days after the earthquake (C01). The role of large aftershocks in maintaining elevated pore-fluid pressures is suspected but uncertain. Green plastic scale is 15 cm long. Photo by J. Tinsley, 4/6/10.

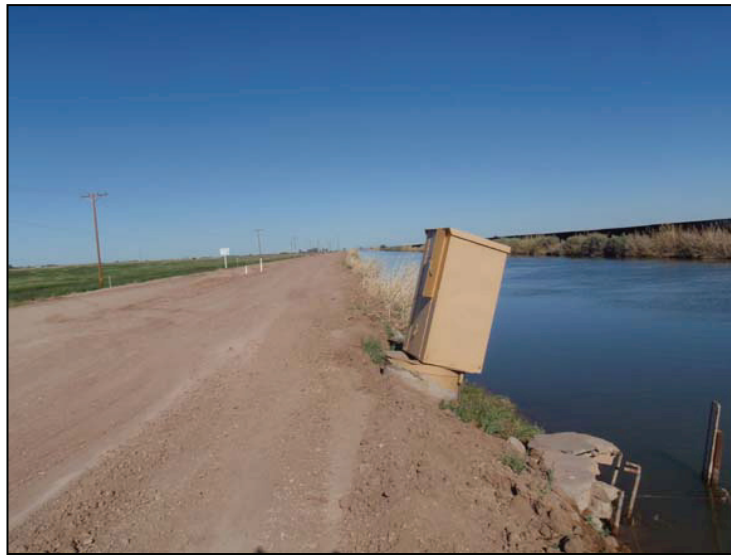
**Figure 34.** Former stage gauge stilling tower tilted from vertical at the Westside Main Canal; associated structures visible to the right of the tower were also tilted from plumb and damaged (C01). No vented materials visible locally. Photo by J. Tinsley, 4/6/10.

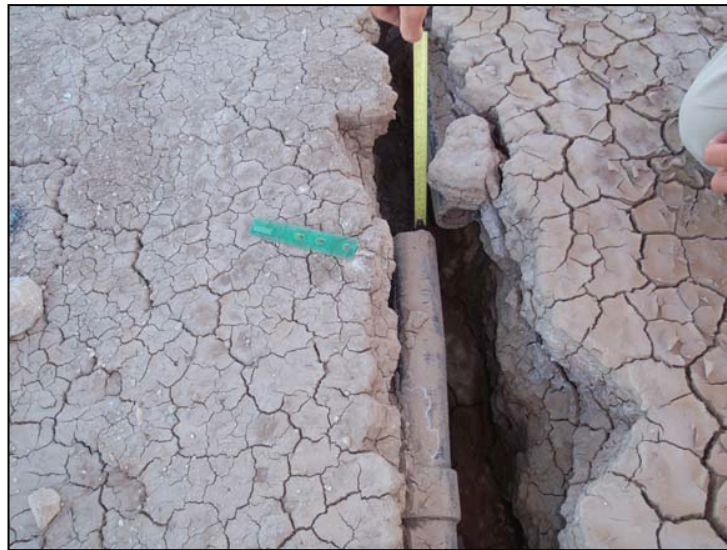
**Figure 35.** Liquefaction-induced extensional fracture near the junction of the Westside Main and All American canals (C01). Exposed pipe or conduit offset 70 mm. Vented sand partly fills fracture underneath the offset pipe. Spreading vector was towards the Westside Main Canal. Photo by J. Tinsley, 4/6/10.

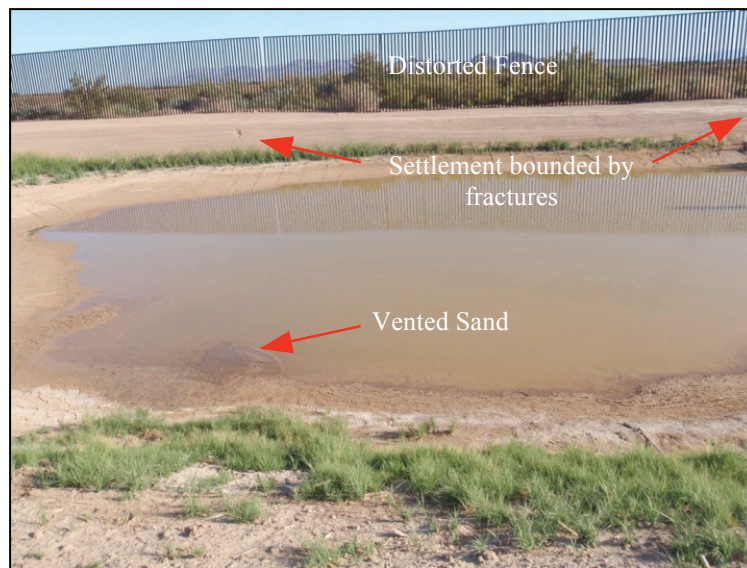
**Figure 36.** View to south, showing small subaqueous deposit of vented sediment in a puddle of water and, in background, fracture in border fence service road where ground deformation caused a distortion in the border fence (C01). Zone of settlement, as well as the depression forming the puddle, matches the old route of the Westside Main Canal from Mexico. Photo by J. Tinsley, 4/6/10.

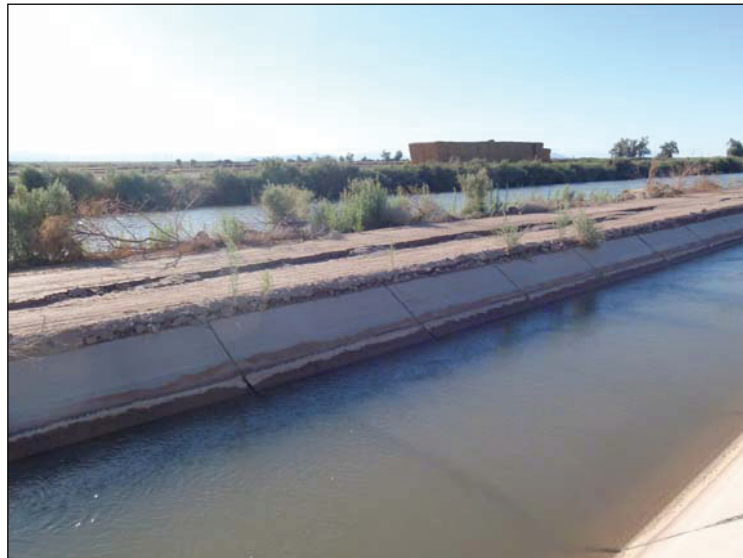
**Figure 37.** Lateral spread ground failure in a strip of fill separating the Westside Main Canal (background) from Wormwood Lateral (foreground) (C03). Photo by J. Tinsley, 4/7/10.

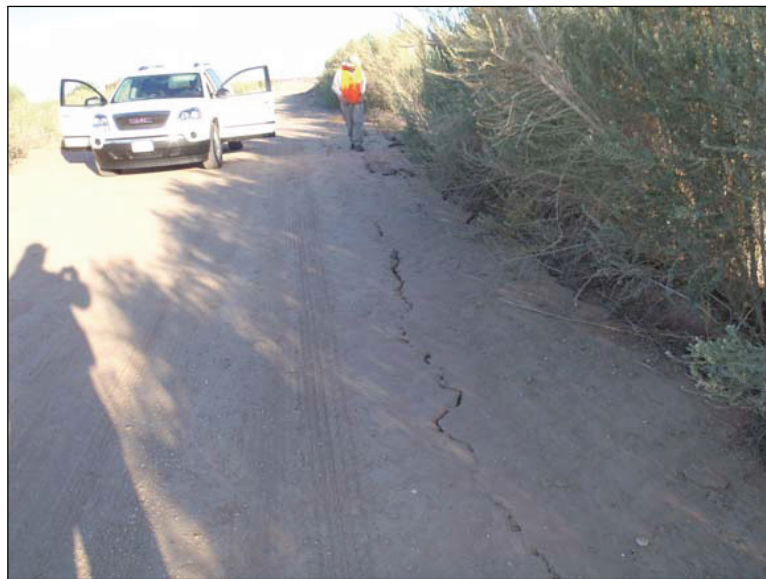
**Figure 40.** Minor extensional fractures parallel to the channel of the Westside Main Canal (C07). No vented materials were observed in association with this ground failure; the failure is likely a result of strong shaking and not liquefaction. Photo by J. Tinsley, 4/7/10.

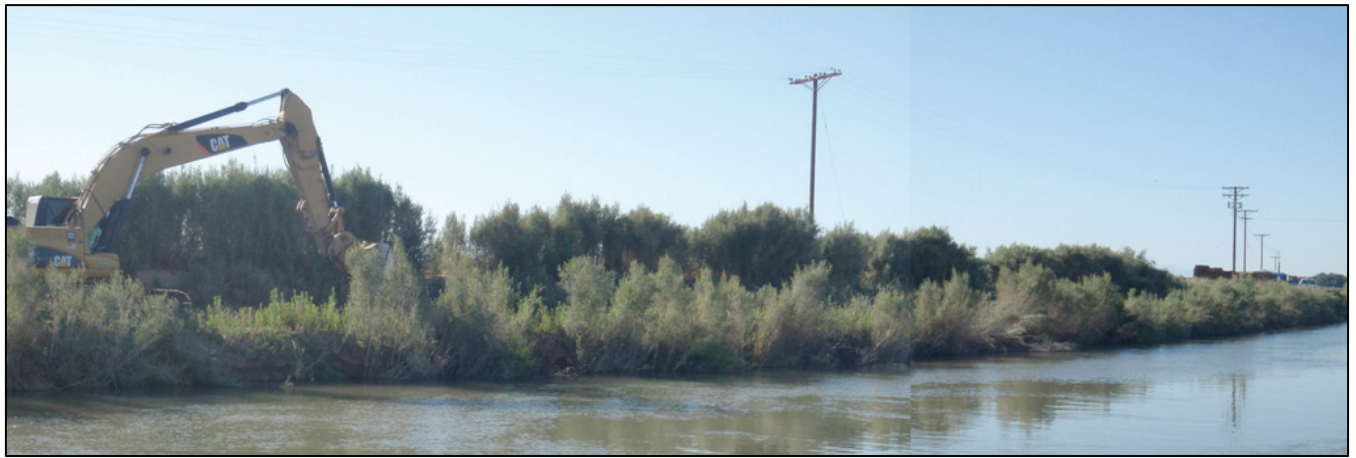
**Figure 43.** Ongoing repairs to the west bank of the Westside Main Canal on 4/7/10 (C15). Tilted and submerged vegetation indicate marked displacement of the levee bank. Photos by J. Tinsley, 4/7/10.

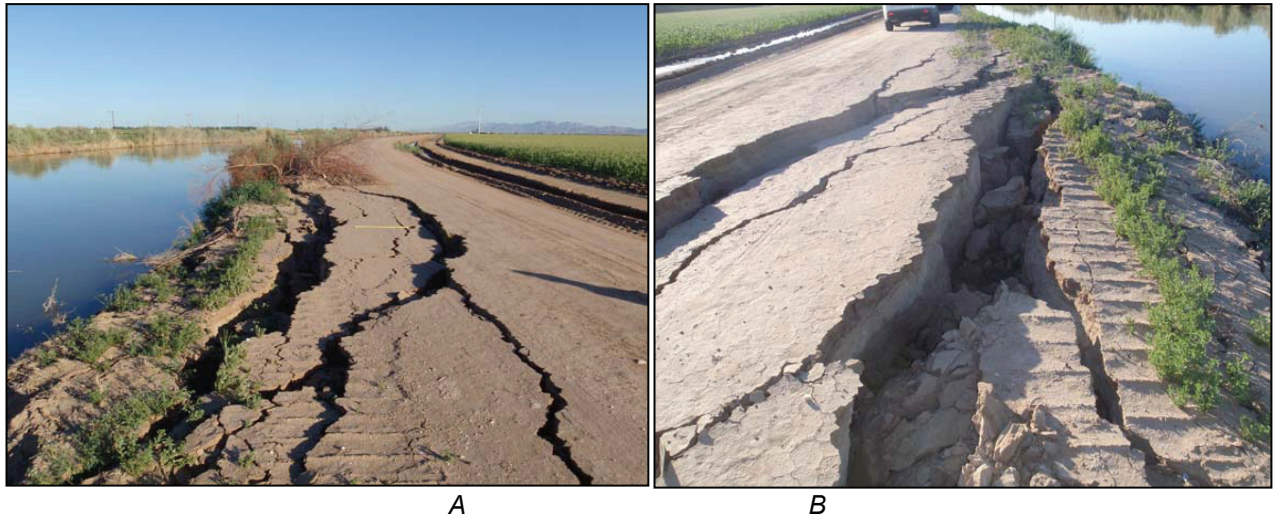
**Figure 44.** Arcuate lateral spread of levee fill on the west bank of the Westside Main Canal (C24). *A*, View to the south showing a portion of the liquefaction ground failure. Tape measure in center of photo is 1 m long. *B*, View north showing graben developed along system of extensional fractures in liquefaction-induced lateral spread ground failure. Photos by J. Tinsley, 4/7/10.

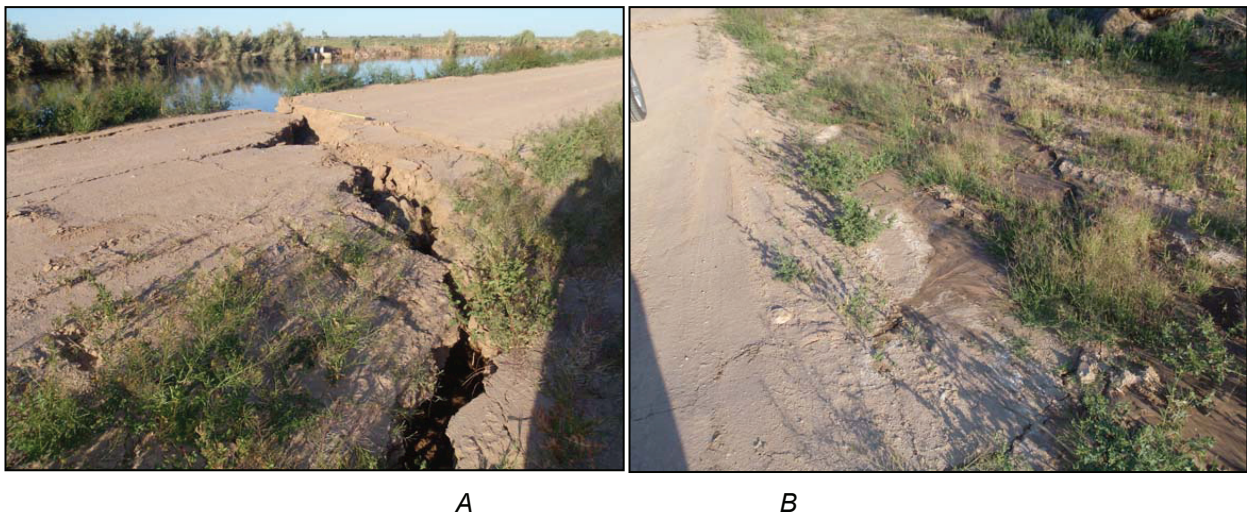
**Figure 46.** Liquefaction lateral spread and settlement of the southwest bank of the Westside Main Canal (C29). *A*, View to northeast along the western levee of the Westside Main Canal showing the large ground failure that spanned the entire width of the levee. *B*, View to the southeast of fractures and vented sand on the outside of the west levee. Photo by J. Tinsley, on 4/7/10.

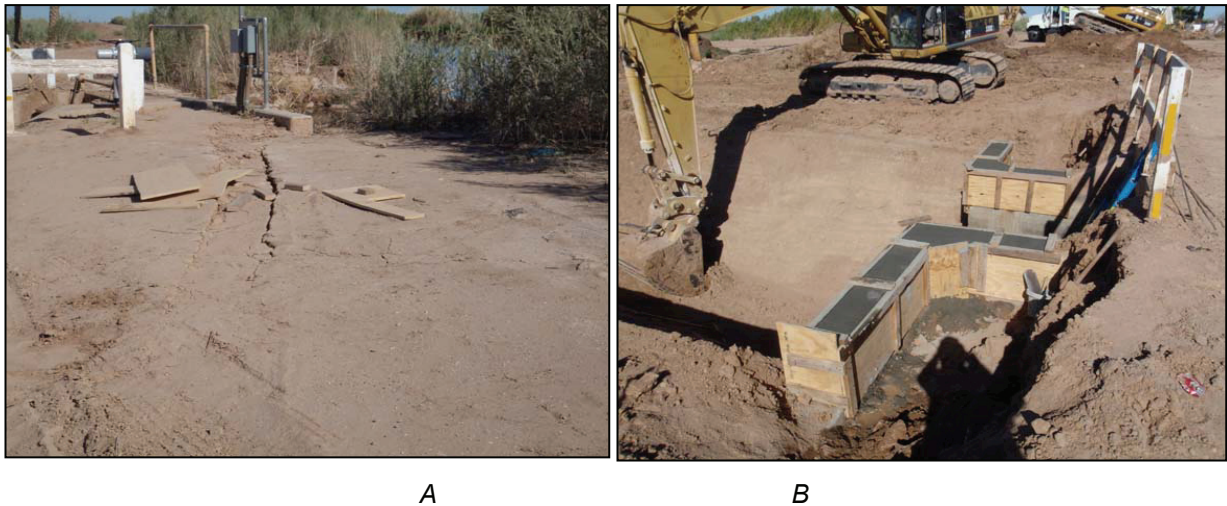
**Figure 47.** Lateral spreading fractures on the east levee of Westside Main Canal (C29). *A*, Diversion structure for the Fern Canal was damaged when ground was displaced eastward, away from Westside Main Canal. *B*, Newly poured foundation and wing wall for the Fern Canal outlet from Westside Main Canal. Photos by J. Tinsley, 4/7/10.

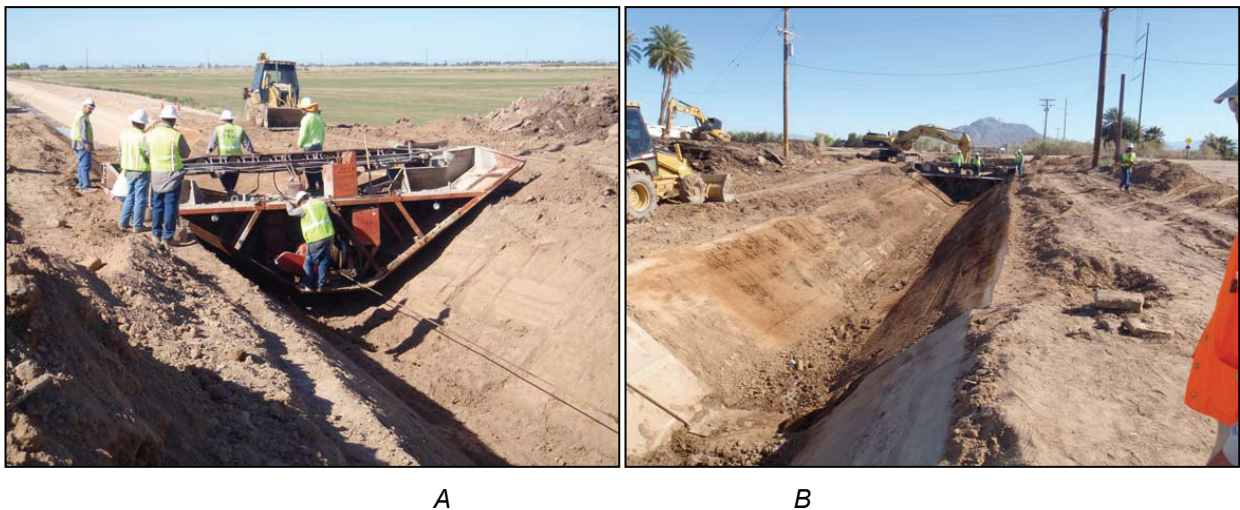
**Figure 48.** Repairs to the liquefaction-damaged Fern Canal (C29). *A*, Repair crew adjusts grading equipment to shape walls of the Fern Canal to repair the effects of lateral spread ground failure. *B*, View to the south with Mount Signal (El Centinela) in the distance, showing reshaped canal prior to pouring new concrete walls and bottom. Photos by J. Tinsley, 4/7/10.

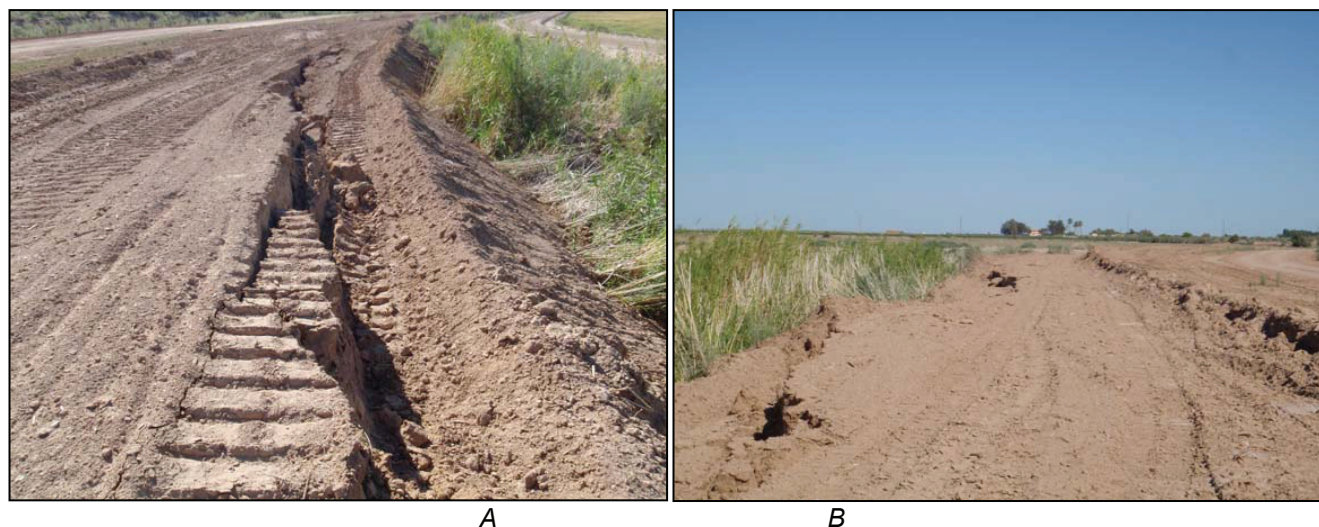
**Figure 49.** Views to the northwest (A, and southeast (B) of a lateral spread ground failure that developed on the east side of the east levee of the Westside Main Canal (D06). Lateral spread fractures extended for about 200 m. The spreading vector was towards the Dixie Drain No. 3B. Grading equipment has made at least one pass prior to these photos, dumping new material into the zone of extensional cracking and lateral spreading, but the major elements of the lateral spread are still visible. Photo by J. Tinsley, 4/7/10.

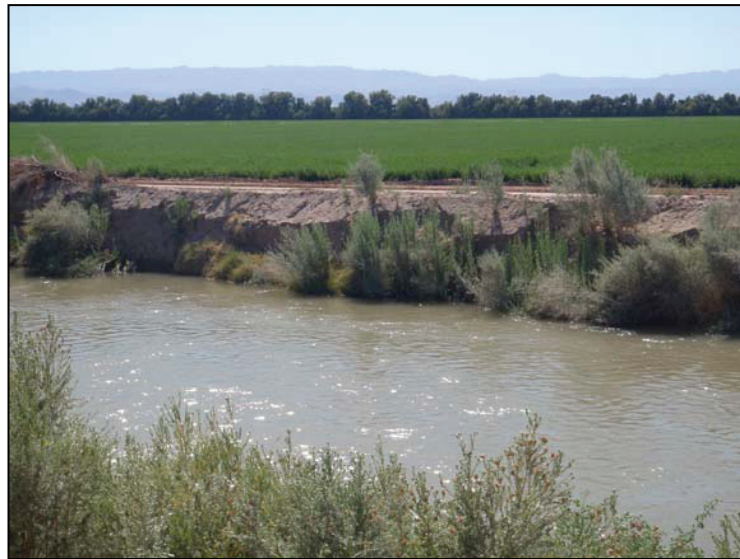
**Figure 51.** View of the west side of Westside Main Canal, showing recent bank failure and slumping of vegetation-bearing soil into the canal (C34). These shallow bank failures were extremely common on both sides of the Westside Main Canal throughout the examined reaches. Photo by J. Tinsley, 4/7/10.

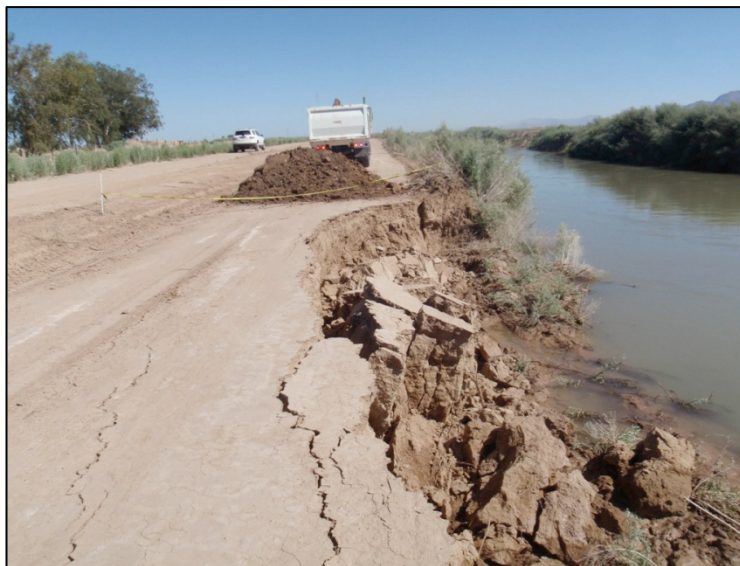
**Figure 52.** Probable liquefaction-related lateral spread slump into the Westside Main Canal (C35). Soil was being imported on 4/7/10 prior to repairs. Photo by J. Tinsley, 4/7/10.

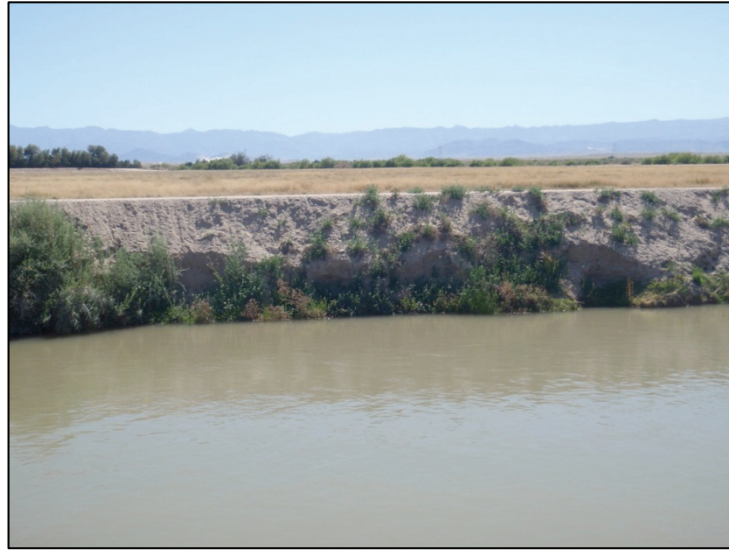
**Figure 53.** View to the west showing shallow slumping of the Westside Main Canal wall that dropped vegetation into the canal and oversteepened the canal-side face of the levee (C36). This stretch of slumping extended for 100 m. Photo by J. Tinsley, 4/7/10.

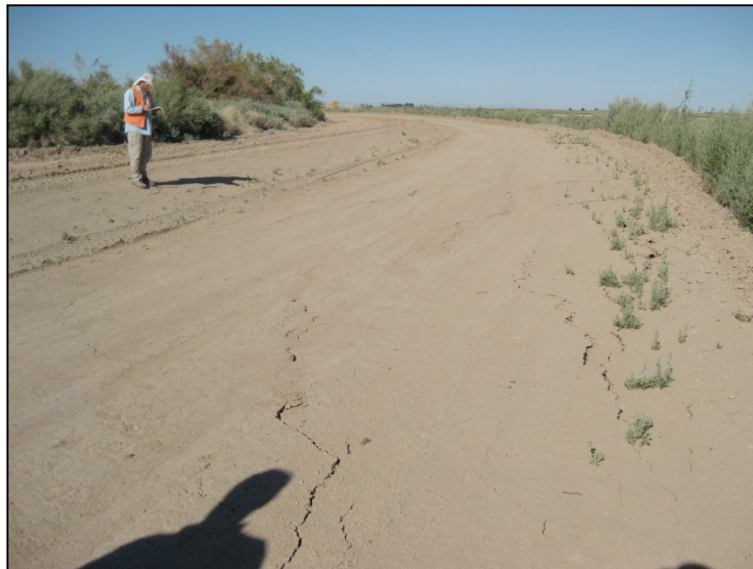
**Figure 54.** Set of three arcuate fractures across the full width of the levee on the west side of the Westside Main Canal (C44). Displacements amounted to a few millimeters, and the fracture set extended about 28 m along the Westside Main Canal. The last set of fractures is at the toes of the geologist on the left. Although no vented materials were observed, the morphology of the failure is consistent with the type of deformation produced by liquefaction. Photo by C. Pridmore, 4/8/10.

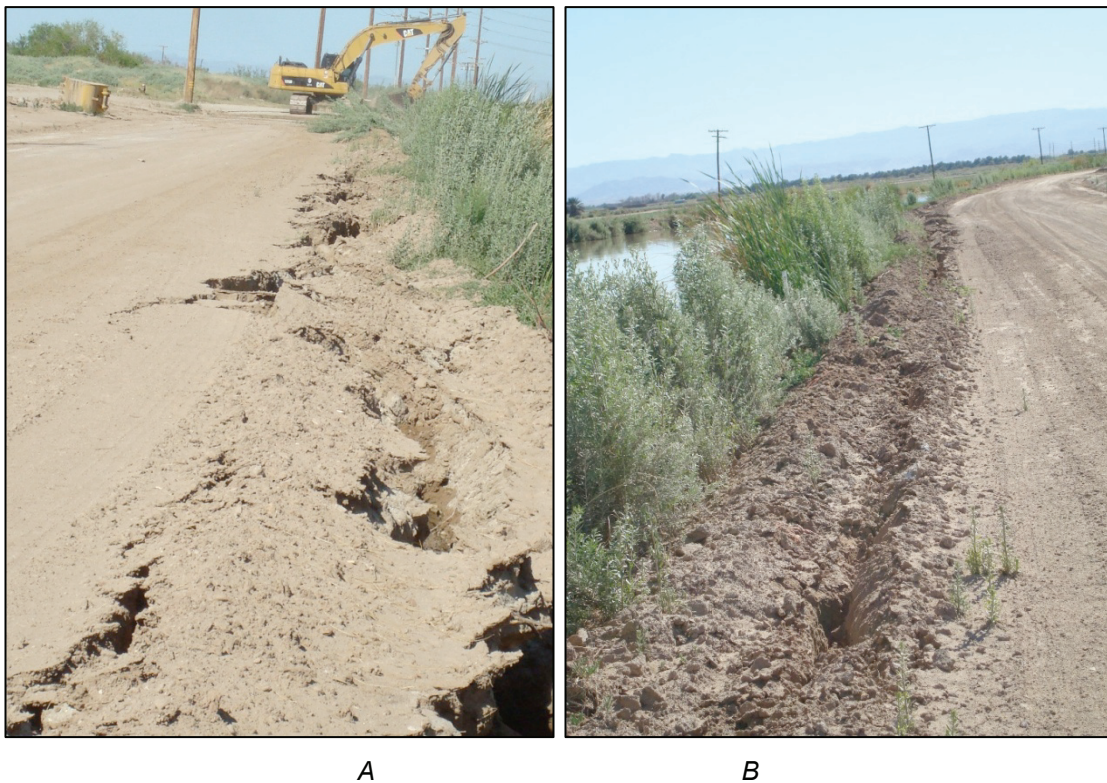
**Figure 55.** Failure of the Westside Main Canal west bank south of the Fillaree diversion structure (C51). *A*, View to northeast; excavator in the background is making repairs. *B*, View to the southwest of the same bank failure. Fractures end where the levee road turns to the right. Vegetation along the canal bank is tilted towards the channel and displaced tens of centimeters. Photos by T. McCrink, 4/8/2010.

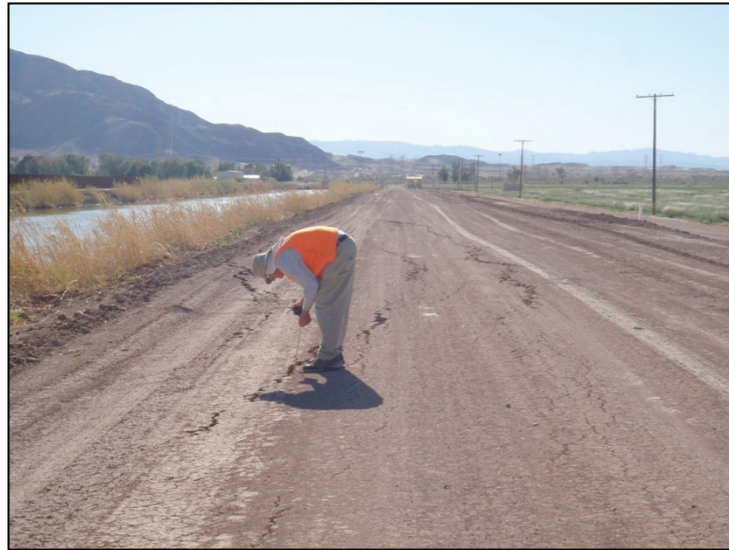
**Figure 57.** View looking west across the westernmost set of arcuate extensional fractures that deformed the north bank of All American Canal near Pullman Road (C02). This failure is 58 m long and open fractures were plumbed to depths of about 135 cm. Differential settlement is about 85 mm and total extension across apparent lateral spread is greater than 12 cm. No vented materials noted. Building in the distance marks the end of the All American Canal and the beginning of the Westside Main Canal. Photo by J. Tinsley, 4/6/10.

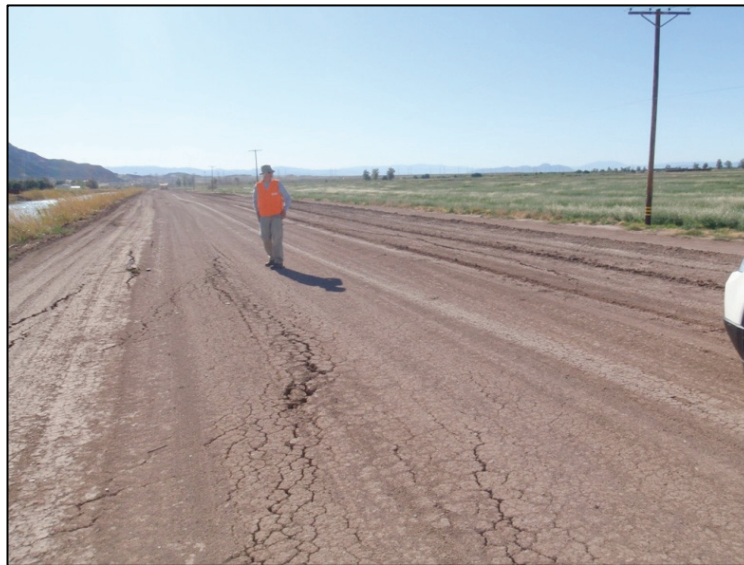
**Figure 58.** Wide-angle perspective image showing an incipient extensional failure that extends nearly across the entire width of the north embankment of the All American Canal near Pullman Road (C02). Total length of southward-extensional deformation exceeds 30 m. Liquefaction unconfirmed as no liquefied materials were vented. In-facing scarps indicate differential settlement involving the highest parts of the earthen levee. This pattern of deformation is consistent with liquefaction. Photo by J. Tinsley, 4/6/10.

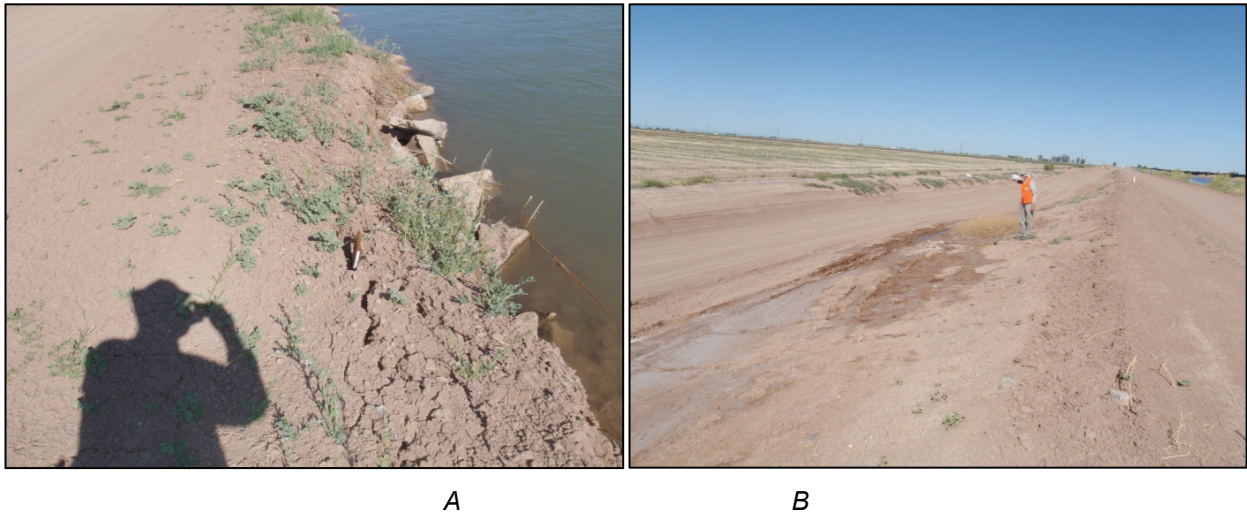
**Figure 59.** A, Extensional cracking and incipient slumping of the north bank of the All American Canal (C09). Slump is 23 m long with 8 to 15 cm extension. B, Active seep on north side of the north embankment, opposite the seemingly minor slump shown in A,. Photos by J. Tinsley, 4/6/10.

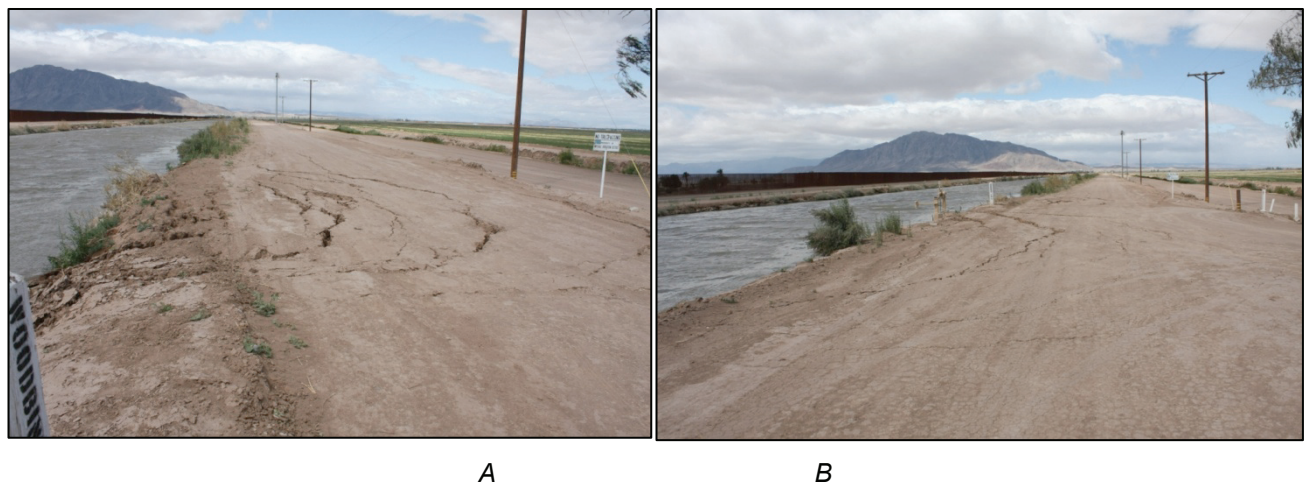
**Figure 60.** View to the west along the All American Canal showing arcuate fractures and incipient slumping on both sides of the Woodbine Lateral 2 diversion structure (C18). A, On the west side, concentric fractures extend through the full width of the levee road. B, Fractures on the east side extend right to the outlet structure and also form a concentric pattern deep into the levee. Photos by D.Y. Kwak, 4/5/10.

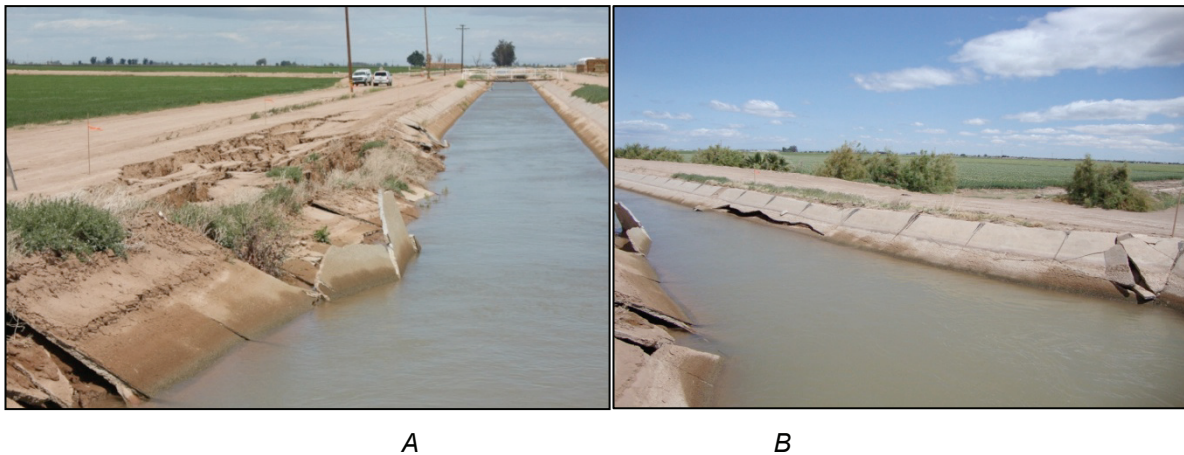
**Figure 63.** Lateral spread of the west bank of the Wistaria Canal near its origin at the All American Canal (C37). *A*, Lateral spread damage to the west bank. Photo by D.Y. Kwak, 4/5/10. *B*, Damage to the east bank liner. Photo by W. Lopez, 4/5/10.

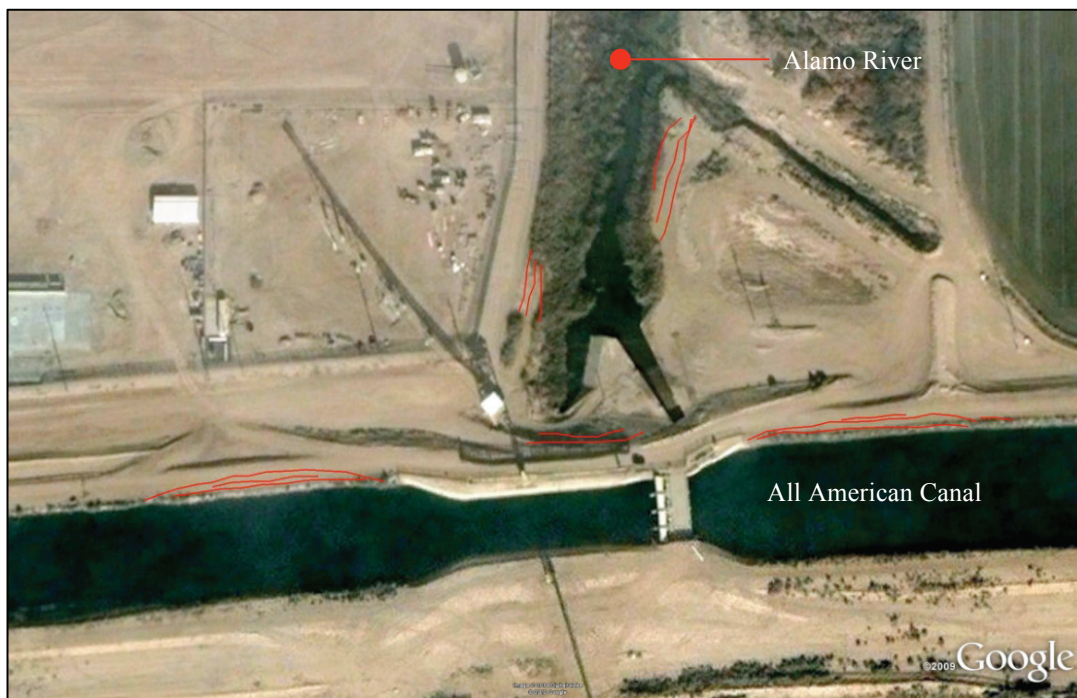
**Figure 64.** Diagrammatic sketch of cracks and fissures observed on the north side of the All American Canal where it crosses the Alamo River (C55). The Alamo River flows to the north beneath the canal. Base Image is from Google Maps.

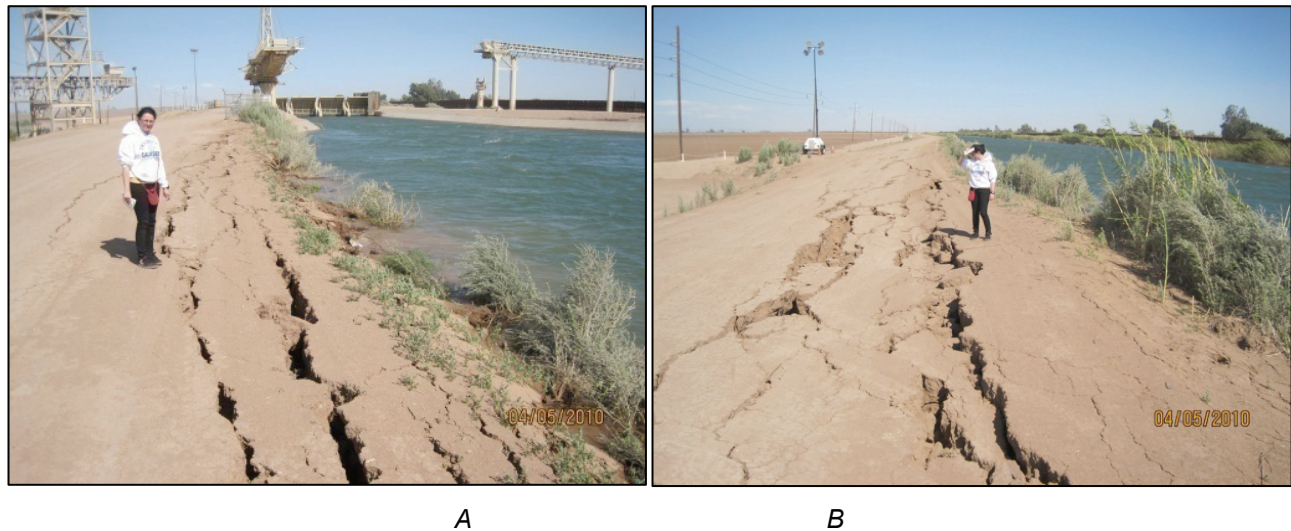
**Figure 65.** Lateral spread cracks on the north side of the All American Canal at the Alamo River crossing (C55). *A*, View to the east of cracks west of the canal crossing; rotating conveyor bridge and flood gates are visible in the background. *B*, Cracks on the east side of the Alamo River; view to the east. Photos by E. Seyhan, 4/5/10.

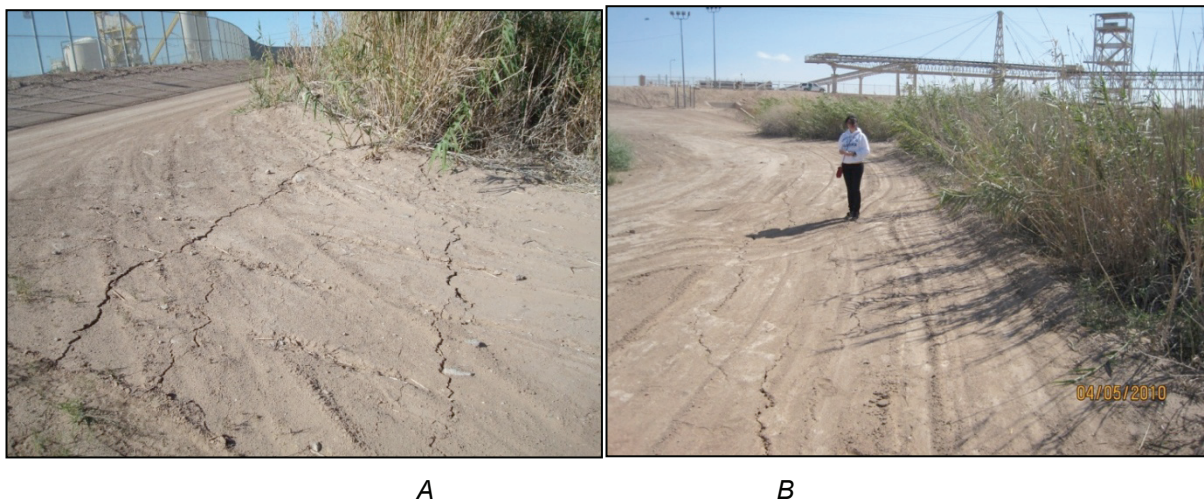
**Figure 66.** Small displacement extensional cracks on the *A*, west side and *B*, east side of the Alamo River immediately north of the All American Canal (D14). Photos by: *A*, T. McCrink, 4/9/10; *B*, E. Seyhan, 4/5/10.
