# **Liquefaction and Other Ground Failures in Imperial County, California, from the April 4, 2010, El Mayor-Cucapah Earthquake**

By Timothy P. McCrink, Cynthia L. Pridmore, John C. Tinsley, Robert R. Sickler,  
Scott J. Brandenburg, and Jonathan P. Stewart

**CGS Special Report 220**  
**USGS Open File Report 2011-1071**  
**Version 1.0**

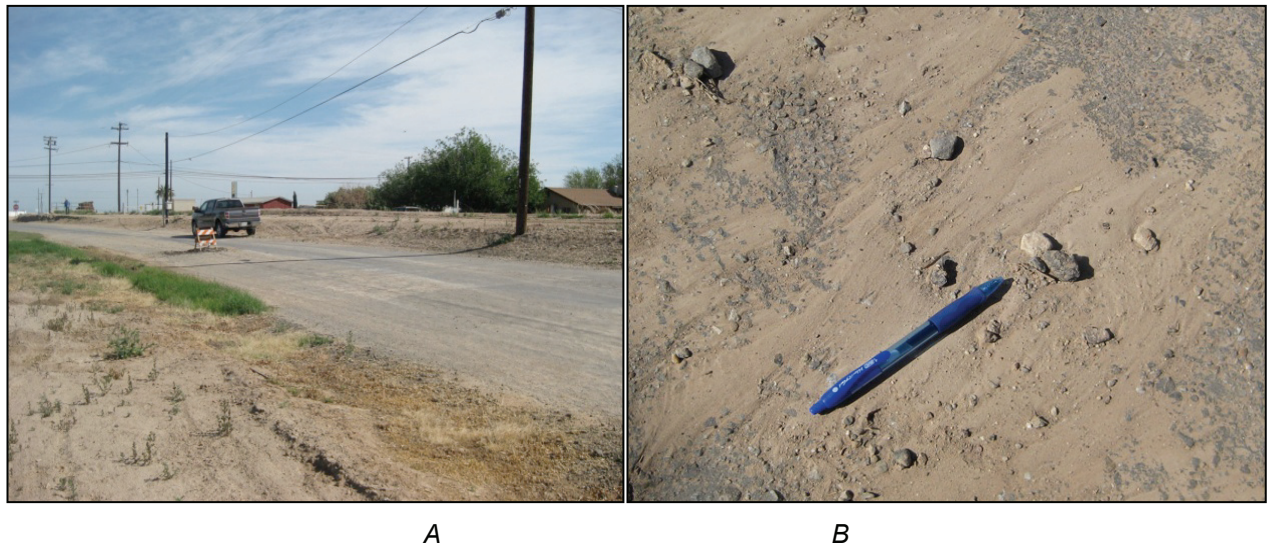
**Figure 68.** Area of seiching from the Eucalyptus Canal along Nichols Road south of Evan Hewes Highway (C48). *A*, View to the north of the Eucalyptus Canal and Nichols Road. Water flowed over the canal levee and across Nichols Road resulting in the temporary closure of the road. *B*, Pen is aligned parallel to water flow direction across Nichols Road pavement. Photos by C. Pridmore, 4/11/10.

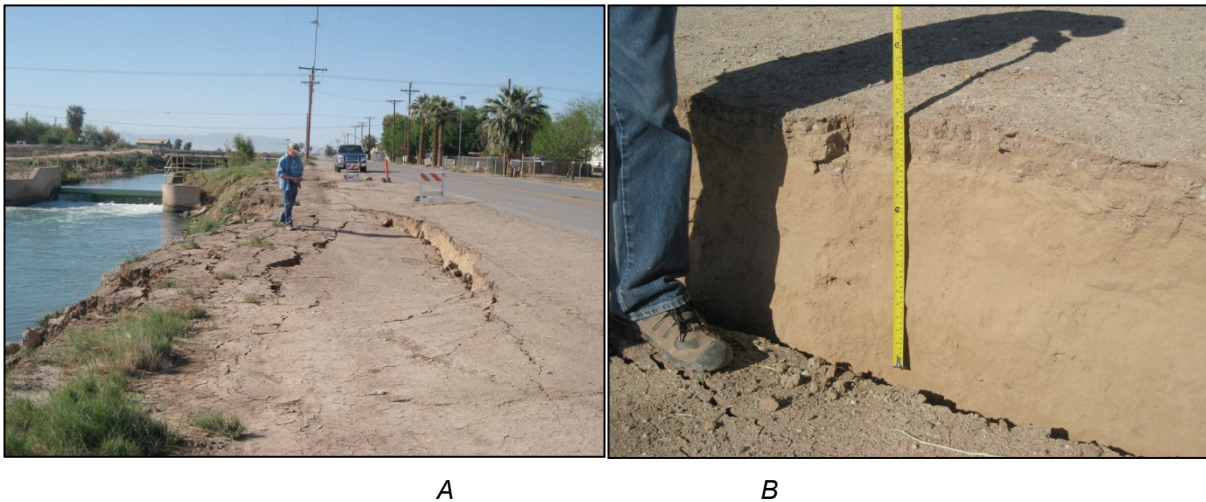
**Figure 69.** Slumping on east side of Austin Road just north of McCabe Road, near McCabe School. *A*, Large crack on shoulder of road that was part of fractured area more than 40 m wide (C42) and extended approximately 15 m back from canal. *B*, The slump had a maximum measured vertical displacement of 75 cm. No surface liquefaction features such as vented sand were observed. Photos by C. Pridmore, 4/11/10.

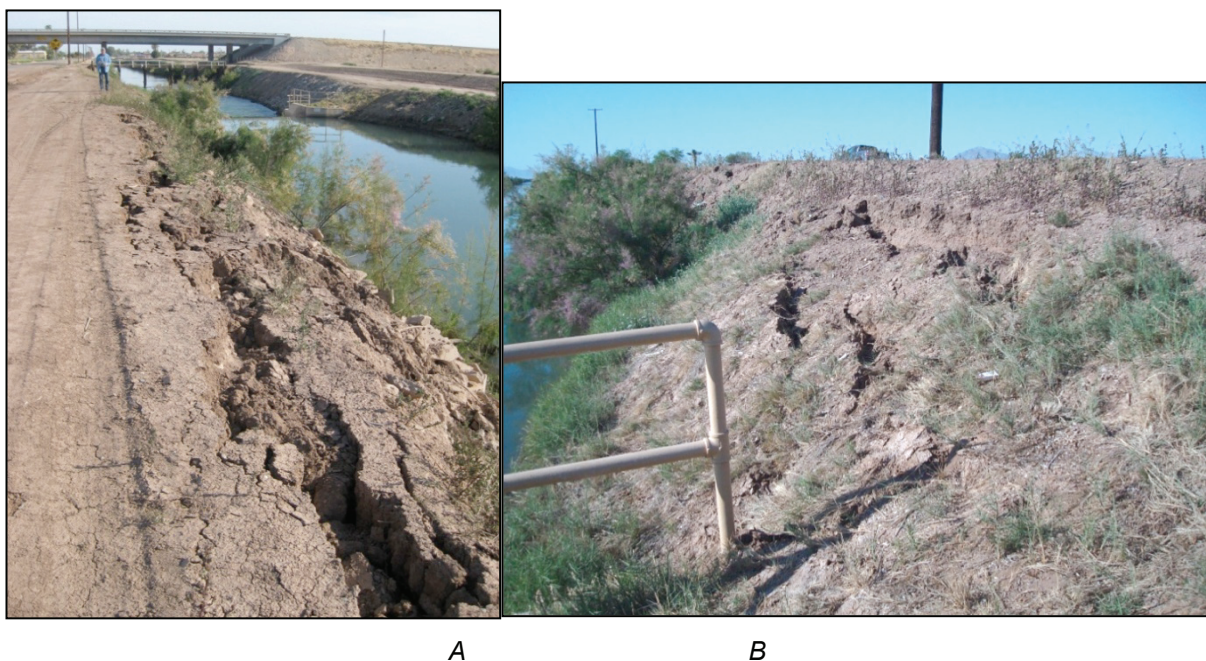
**Figure 70.** Shallow slumping along Austin Road adjacent to the Central Main Canal, just south of Interstate Highway 8 (C46). *A*, View to the north toward the weir and Interstate Highway 8 showing slumping of the outer 2 m of the canal bank. *B*, View to the south at a slump just upstream of the weir showing 30 to 40 cm of vertical displacement. Photos by: *A*, C. Pridmore, 4/11/10; *B*, T. McCrink, 4/11/10.

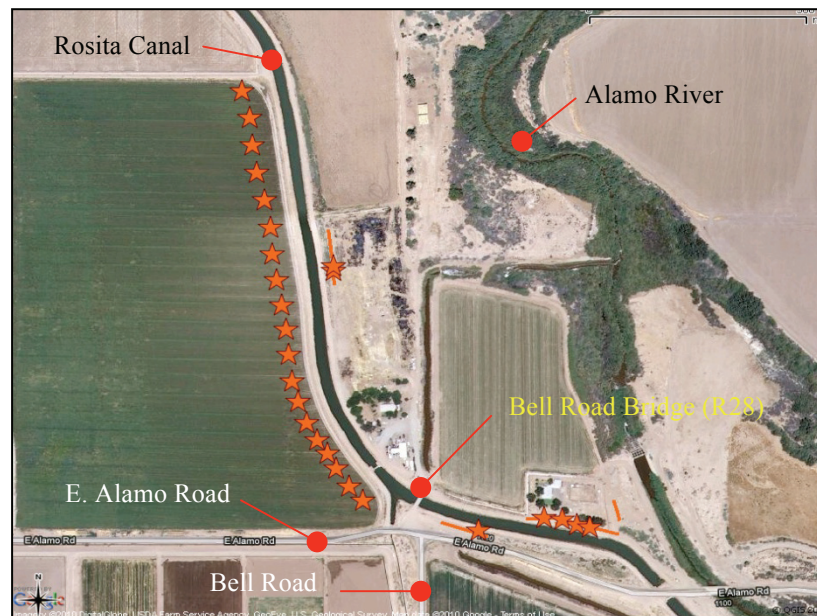
**Figure 71.** Diagrammatic sketch showing liquefaction features along the Rosita Canal west of Holtville. Lines represent approximate locations of cracks and fissures, and star symbols represent approximate sand boil locations (C56, R28). Base image is from Google maps.

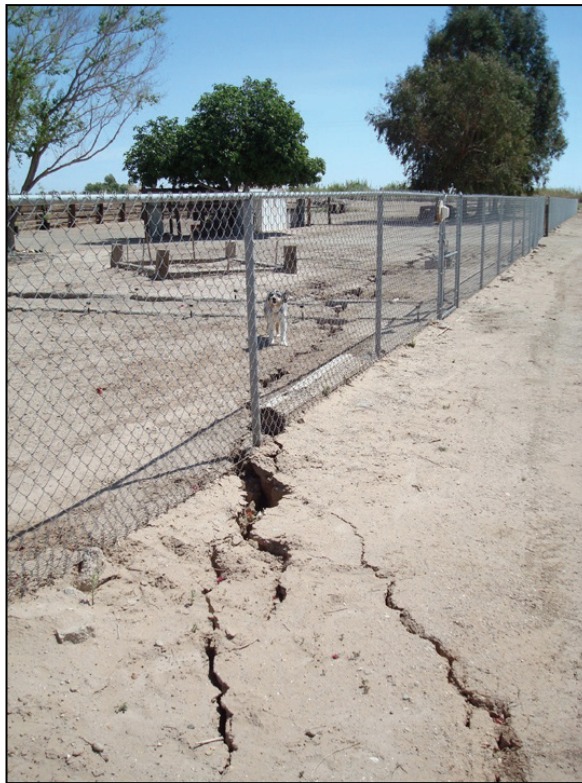
**Figure 72.** An arcuate lateral spreading crack running through a fenced yard on the north side of the Rosita Canal, northeast of the intersection of East Alamo and Bell roads (C56). Vented sand was found in several areas on both sides and filled some parts of the crack. The levee road, just to the right of the picture, had recently been graded, obliterating any liquefaction features that may have existed. View to the east. Photo by T. McCrink, 4/11/10.

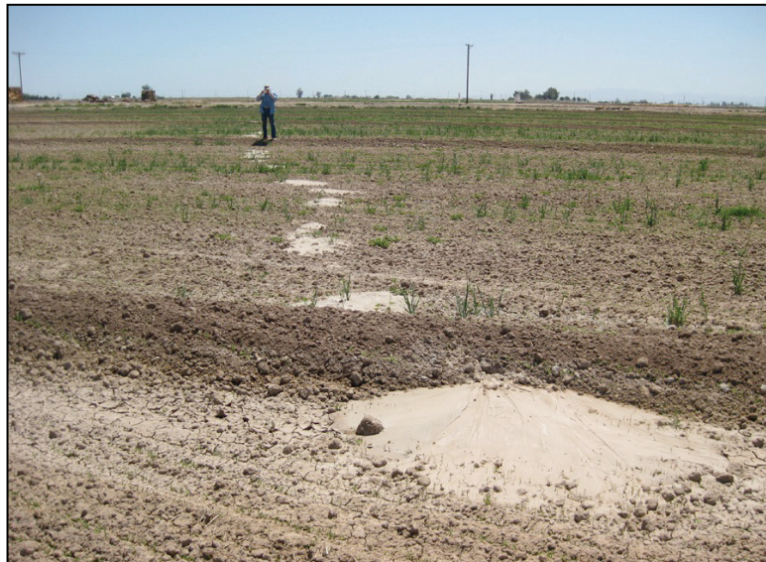
**Figure 73.** Continuous string of sand boils in an agricultural field west of the Rosita Canal (C56). View to the southeast. Photo by C. Pridmore, 4/11/10.

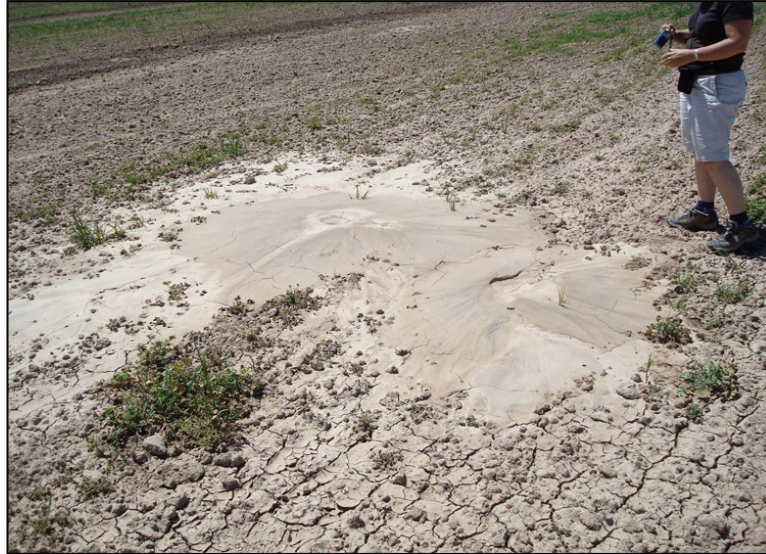
**Figure 74.** A pair of sand boils on the west side of the Rosita Canal that were wet 7 days after the earthquake, suggesting reactivation by aftershocks or subsurface conditions enabling prolonged seepage (C56). Photo by T. McCrink, 4/11/10.

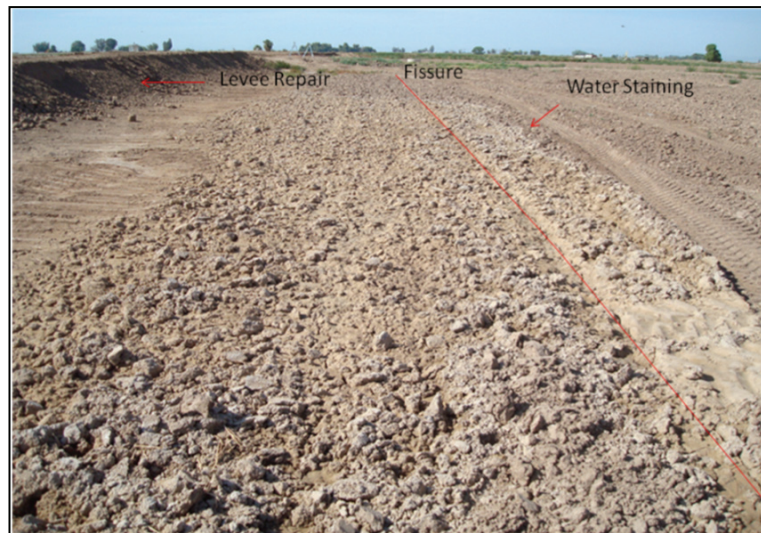
**Figure 76.** Evidence of excessive seepage from the east side of the Rosita Canal (C56). The fissure shown is slightly closer to the levee than the fissure related to the sand boils shown in figure 75. View to the north. Photo by T. McCrink, 4/11/10.

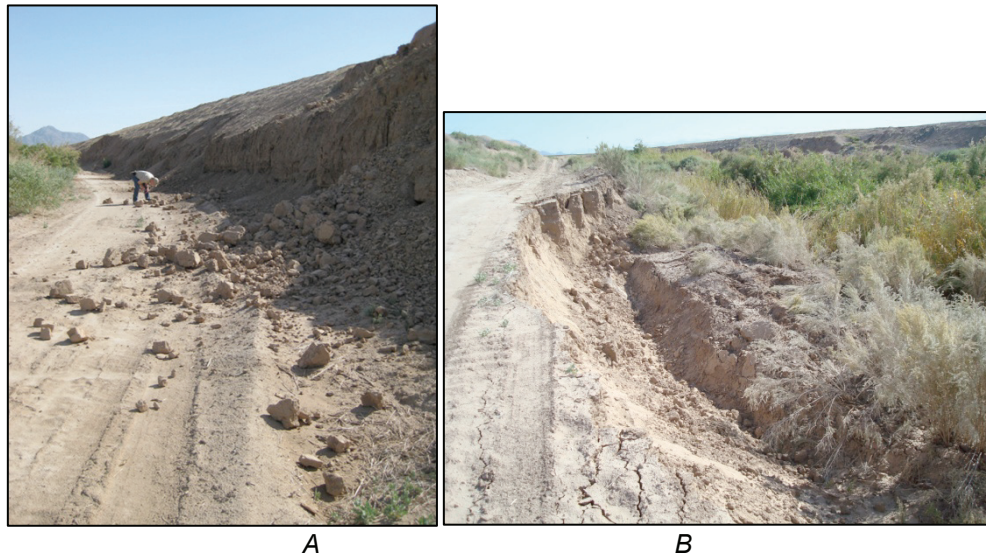
**Figure 79.** Access roads along Fig Drain, south of Fig Lagoon (D07). *A*, Blocky soil topple/fall on the west side of Fig Drain. Several more talus cones of material can be seen in the distance. *B*, Slump of the outer edge of the dirt road on the east side of Fig Drain. Both photos looking south. Photo *A*, by C. Pridmore, and photo *B* by Tim McCrink; 4/10/10.

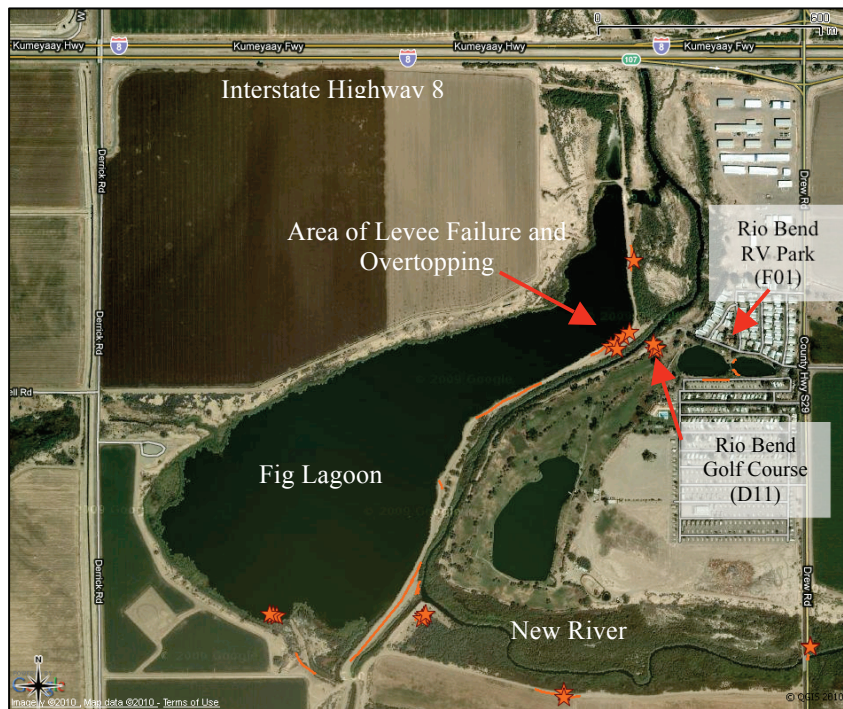
**Figure 80.** Diagrammatic sketch of liquefaction-related features in the vicinity of Fig Lagoon (D10). Red lines represent lateral spread cracks and red stars represent areas of vented sand. Fig Lagoon lies south of Interstate Highway 8, west of Drew Road, and east of Derrick Road. Also shown are the Rio Bend RV Park and Rio Bend Golf Course sites, which will be discussed in under site entries F01 and D11 respectively. Base image is from Google Maps.

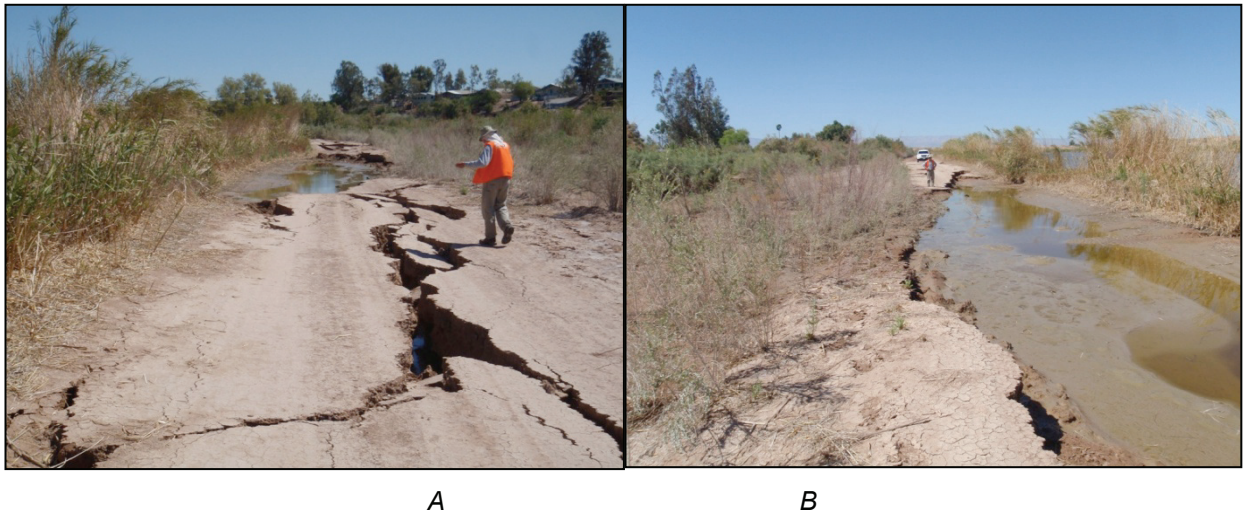
**Figure 81.** Lateral spread–slump failure of the levee between Fig Lagoon and the New River (D10). *A*, View to the northeast along the levee impounding Fig Lagoon, showing liquefaction lateral spread cracks and the large slump that allowed a breach in the levee, overtopped by seiche wave activity. Lake is to the left of riparian vegetation in left foreground of image. *B*, View to the southwest showing the slump and breach in the Fig Lagoon levee. Fig Lake is visible through the vegetation on the right of the image. Standing water is about at the level of Fig Lake. After the earthquake Fig Lake drained near here through an overflow channel that was eroded by escaping lake water. Photos by J. Tinsley, 4/7/10.

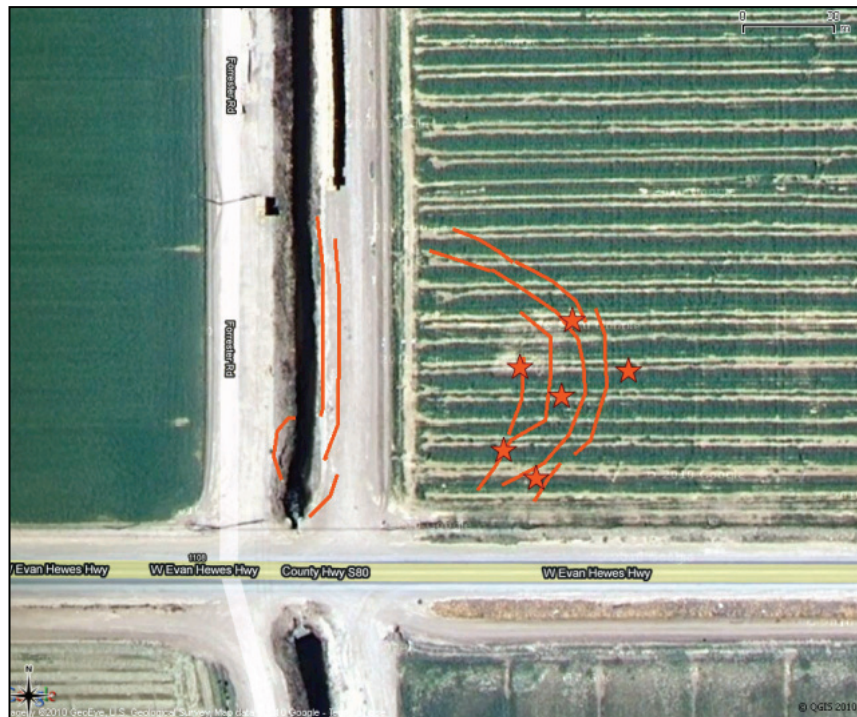
**Figure 88.** Diagrammatic sketch of liquefaction-related features north of Evan Hewes Highway and east of Rice Drain No. 3 (D12). Lines represent approximate location of cracks and fissures, and star symbols indicate approximate location of sand boils. Base image is from Google Maps; Google label for Forrester Road appears to be in error.
