**DEGRADATION OF PLYWOOD ROOF DIAPHRAGMS
UNDER MULTIPLE EARTHQUAKE LOADING**

Data Utilization Report CSMIP/94-02

California Strong Motion Instrumentation Program

February 1994

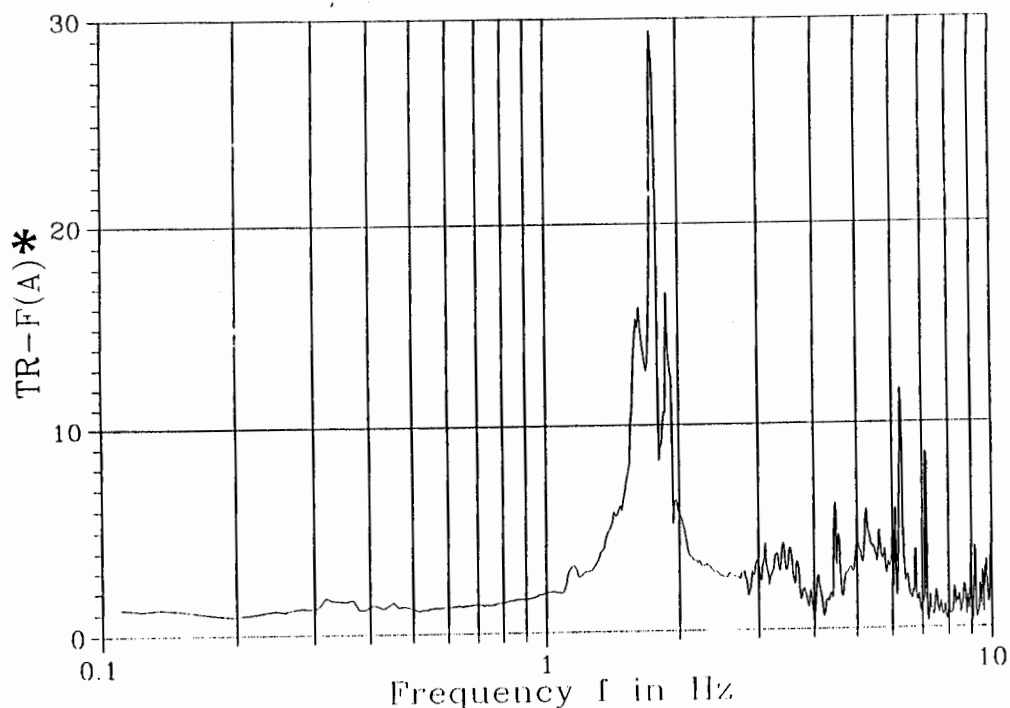
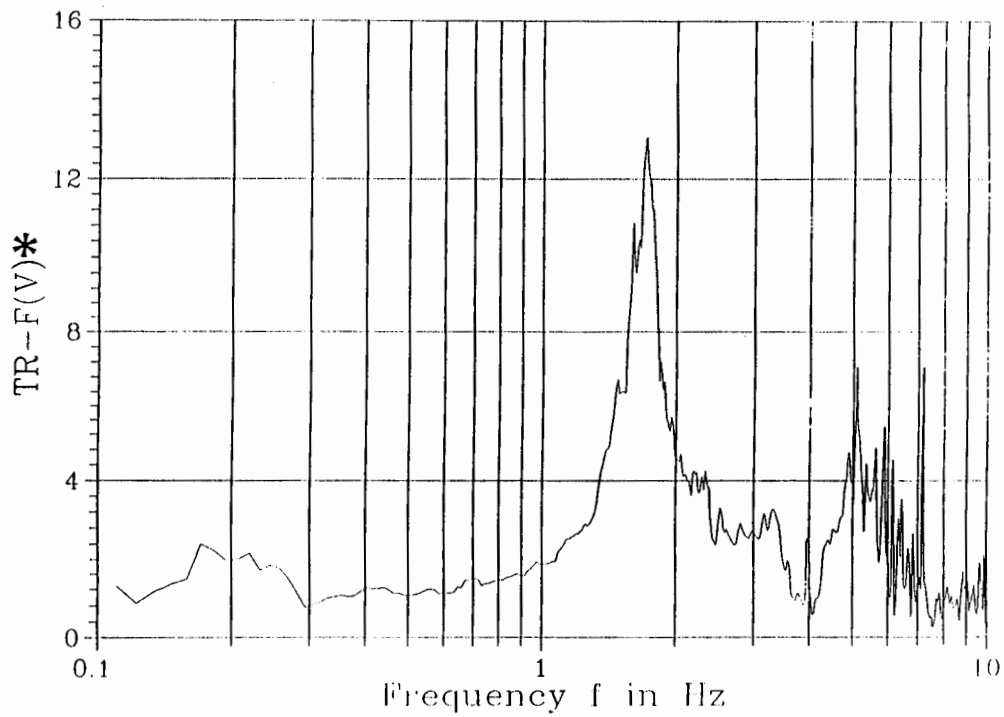
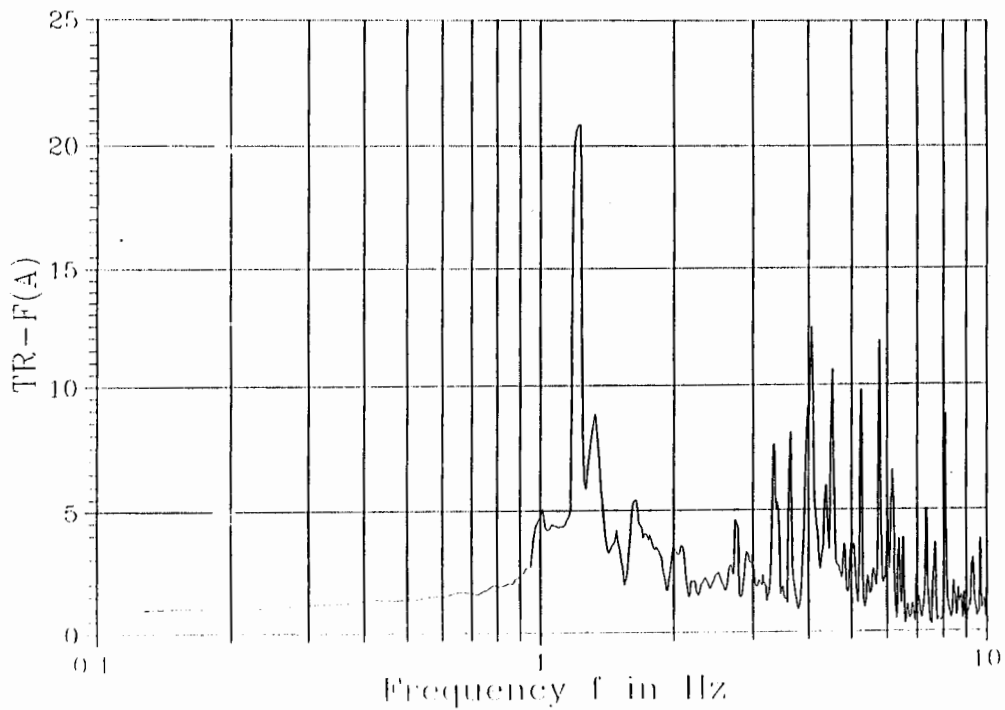
Figure 7. Hollister Warehouse - FFT(A) vs. Frequency
Morgan Hill earthquake, April 24, 1984.
* = Transfer function between roof acceleration
and ground acceleration

Figure 8. Hollister Warehouse - FFT(A) vs. Frequency
 Hollister earthquake, January 26, 1986.
 * = Transfer function between roof velocity
 and ground velocity

Figure 9. Hollister Warehouse - FFT(A) vs. Frequency
 Loma Prieta earthquake, October 17, 1989.

Comparing the plots of the acceleration FFT's for the Morgan Hill and Hollister earthquakes with the plot for the Loma Prieta earthquake, a shift in the predominant frequency of the roof diaphragm is noted. This indicates a softening of the diaphragm stiffness. The magnitude of change in predominant frequency and the associated changes in the relative diaphragm stiffness between the three earthquakes is presented in Table 3. This degradation or softening of plywood diaphragms under high loads has been previously noted in static tests. Non-cyclical tests of plywood diaphragms have shown them to be highly non-linear. A substantial portion of this non-linearity can be attributed to nail slip, a progressive and degenerative process. A representative load-deflection curve of tests on a full size 1/2 inch plywood diaphragm, showing degradation of diaphragm stiffness with increasing load is shown in Figure 10.

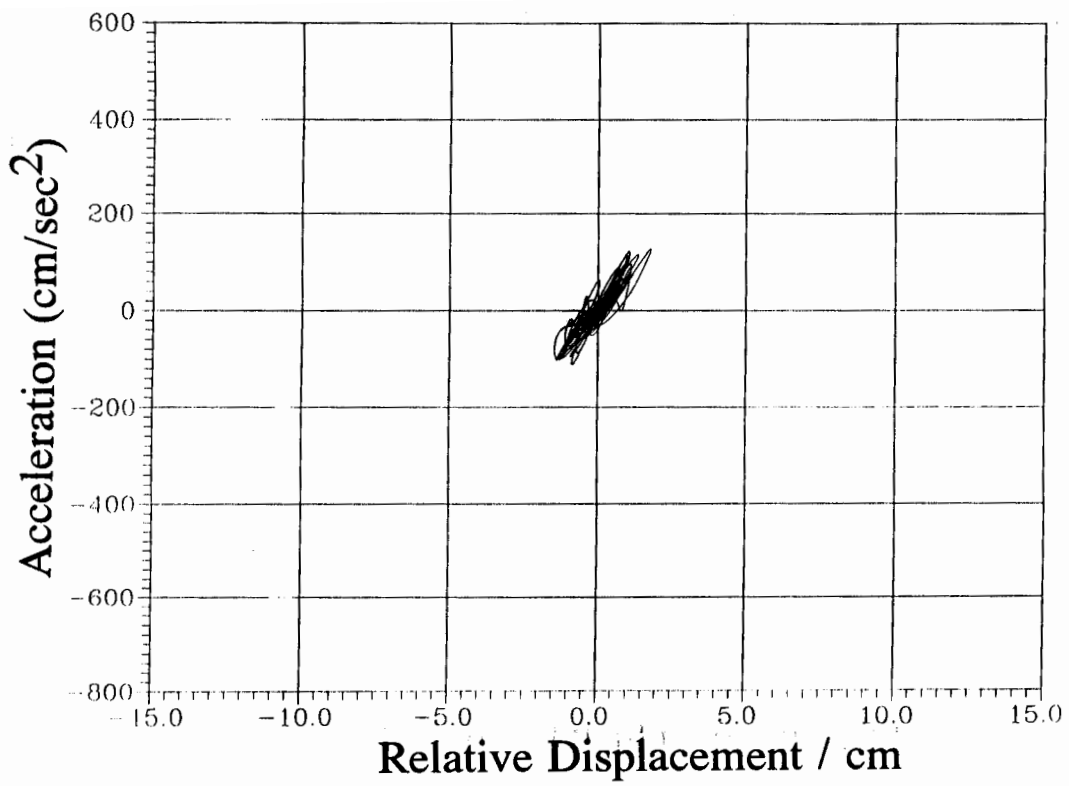
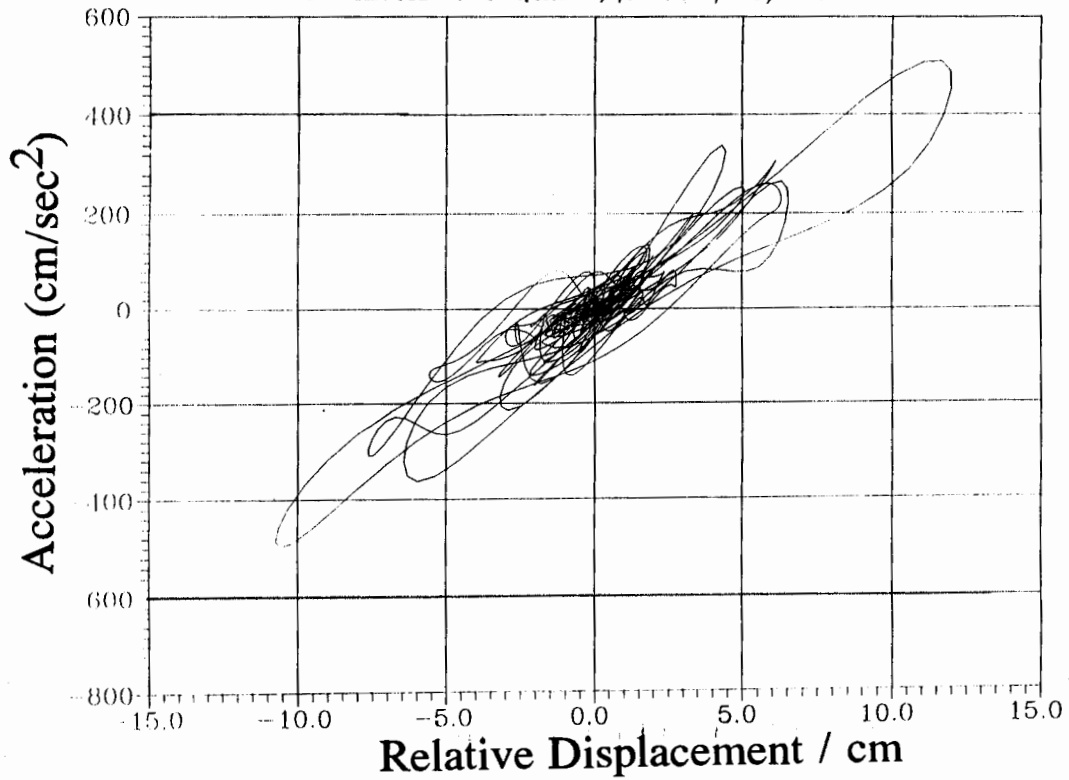
Plots of acceleration versus relative displacement at the center of the roof (channel 4) for the Hollister and Loma Prieta earthquakes are shown in Figures 11 and 12. The acceleration versus displacement plot for the Hollister earthquake (Figure 11) is generally linear, indicating that the diaphragm remained essentially elastic and suffered no apparent degradation in stiffness due to the earthquake. This correlates well with the computed D/C_V of 0.91. The plot for the Loma Prieta earthquake (Figure 12) shows considerable softening of the diaphragm, as evidenced by the trend towards decreasing slope in the acceleration versus displacement plot. The magnitude of the change in diaphragm stiffness is in good agreement with the change in stiffness computed by the period shifts observed using the FFT.

Figure 11. Hollister Warehouse Acceleration vs. Displacement
Hollister earthquake, January 26, 1986.

Figure 12. Hollister Warehouse Acceleration vs. Displacement
Loma Prieta earthquake, October 17, 1989

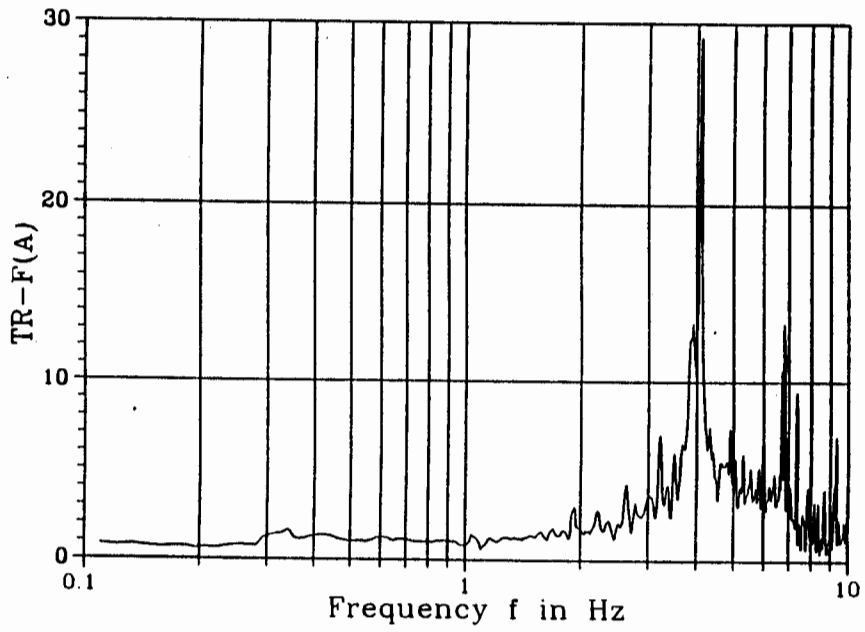
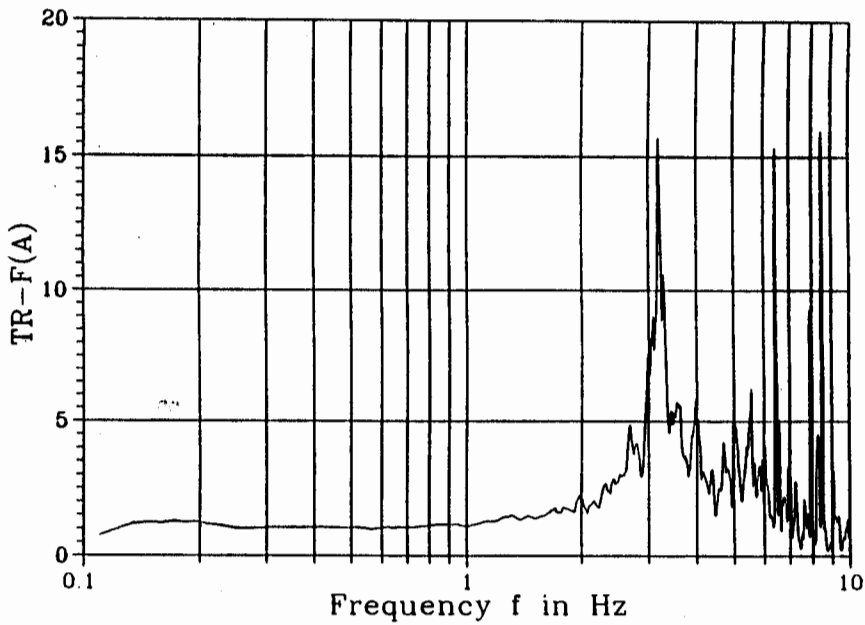
The predominant period of the roof structure was extracted using FFT's on select pairs of instrument records. Figures 13 and 14 are representative plots for the Morgan Hill and Loma Prieta earthquakes in the transverse direction. As with the Hollister

Warehouse, a shift in the predominant frequency of the roof diaphragm was observed, indicating a reduction of stiffness of the diaphragm. This behavior is expected, given the amount of inelastic behavior suggested by the D/C_V ratio of 3.31 observed in the Loma Prieta earthquake. The magnitude of change in the predominate frequency and diaphragm stiffness are summarized in Table 6. Plots of acceleration versus displacement at the center of the roof in the transverse direction for the Morgan Hill and Loma Prieta earthquakes are shown in Figures 15 and 16. The decreasing slope of plot for the Loma Prieta earthquake confirms that softening of the diaphragm is occurring. The magnitude of the change in diaphragm stiffness indicated by the decreasing slope of the acceleration versus displacement plots correlates well with the observed period shifts obtained using the FFT's. The damping ratio for the roof diaphragm in the transverse direction, obtained using the frequencies obtained with the FFT's and the recorded peak roof accelerations, was found to be in the range of 5%. A review of the FFT's and acceleration versus displacement plots indicate no substantial softening of the diaphragm occurred in the longitudinal direction, despite the D/C_V ratio of 2.21 observed in the Loma Prieta event. Damping in the longitudinal direction was estimated at about 5% of critical.

Figure 13. Saratoga Gym - FFT(A) vs. Frequency
Morgan Hill earthquake, April 24, 1984.

Figure 14. Saratoga Gym - FFT(A) vs. Frequency
Loma Prieta earthquake, October 17, 1989.

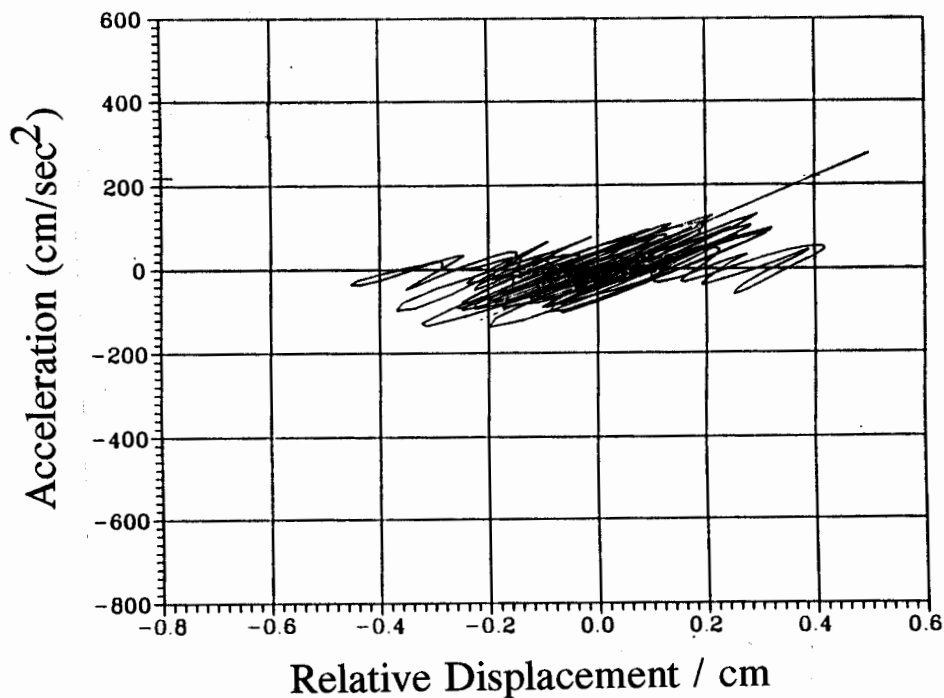
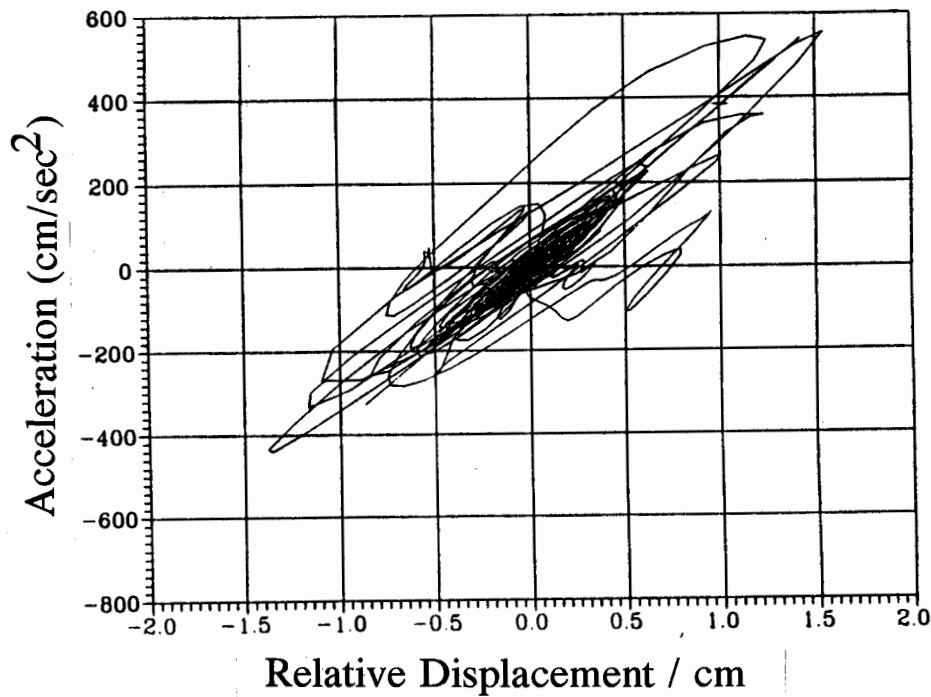
Figure 15. West Valley College Gym Acceleration vs. Displacement Morgan Hill earthquake, April 24, 1984.

Figure 16. West Valley College Gym Acceleration vs. Displacement Loma Prieta earthquake, October 17, 1989
