**STRONG-MOTION RECORDS FROM  
BUILDINGS DAMAGED IN EARTHQUAKES**

M.J. Huang, P.K. Malhotra and A.F. Shakal

California Strong Motion Instrumentation Program  
Division of Mines and Geology  
California Department of Conservation

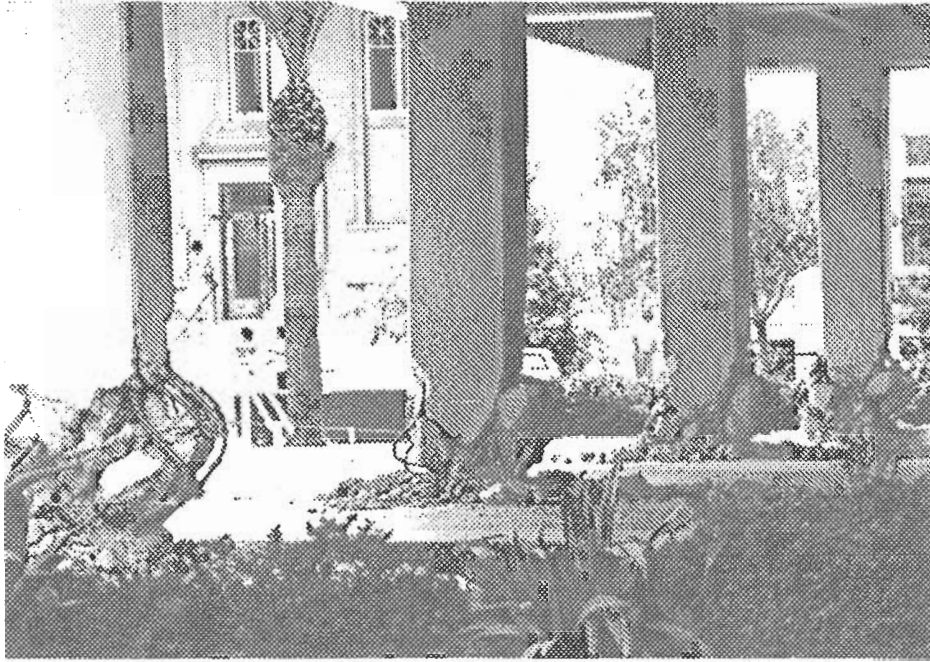
The Imperial County Services Building, a 6-story concrete frame and shear wall building, suffered significant structural damage during the 1979 Imperial Valley earthquake (Figure 1). The building was demolished after the earthquake and replaced with a 2-story steel frame building. At the time of the earthquake, the building was instrumented by CSMIP with 13 sensors in the building and three sensors at a reference free-field site. This is the first case of an instrumented building sustaining significant structural damage.

Figure 2 shows the locations of the sensors in the building (Rojahn and Ragsdale, 1980). The earthquake resistance of the building was provided by shear walls in the transverse (N-S) direction and by moment-resistant frames in the longitudinal (E-W) direction. There were four interior shear walls below the second floor while the only shear walls above the second floor were the exterior walls. During the 1979 earthquake, all the beams and columns on the first story were damaged with the most severe failure occurring in the four columns at the east end of the building, as shown in Figure 1. More detailed description of the damage is given in the ATC-9 report (ATC, 1984)

Fig. 1. Line of columns that failed at east end of the Imperial County Services Building during the 1979 Imperial Valley earthquake.

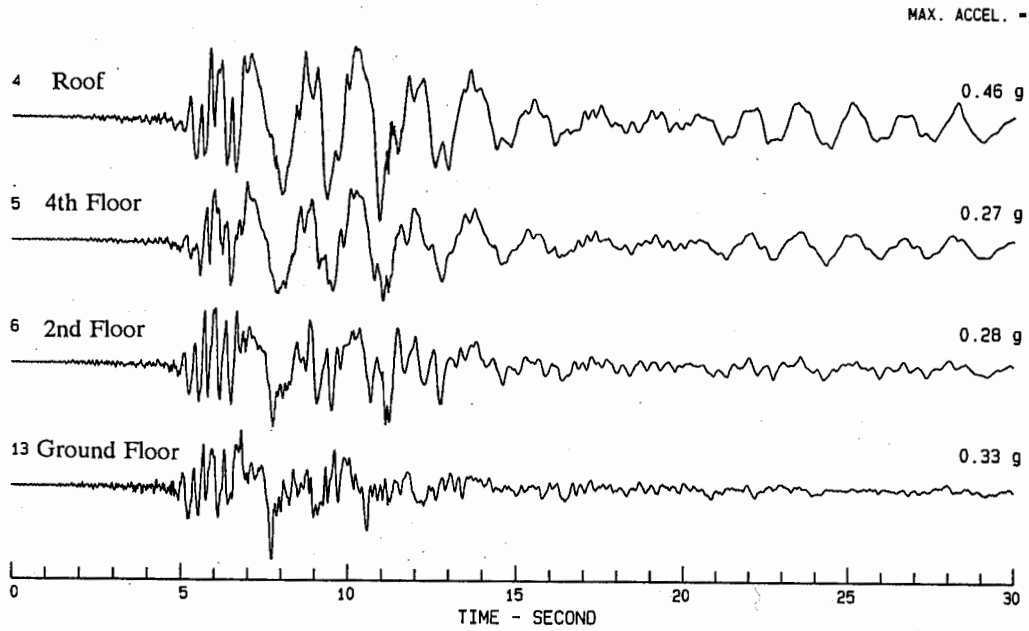
The strong-motion records from this building were studied by numerous investigators (e.g., Housner and Jennings, 1982; Rojahn and Mork, 1982; Kreger and Sozen, 1989; Mau and Revadigar, 1994). The acceleration records in the longitudinal direction are shown in Figure 3. The records show that the response between 5 and 7 seconds is dominated by the second mode with a period of about 0.3 seconds. Between 7 and 11 seconds, the building responded with a period of about 1.6 seconds. In addition, high-frequency spikes appear at near 11 seconds and can be seen in all the upper floor records, in both directions. The time near 11 seconds has been interpreted as the time when the columns failed and the building dropped (Housner and Jennings, 1982; Rojahn and Mork, 1982). After the column failure, the building period was lengthened further to nearly 2 seconds. The building period from pre-1979 ambient measurements was 0.65 seconds (Rojahn and Mork, 1982).

The base shear force, estimated from the acceleration records, has a maximum value of about  $0.24W$  for the east-west direction, which is about 4 times the design base shear ( $0.06W$ ). The absolute displacements, obtained from the accelerations in Figure 3, are shown in Figure 4. These displacements are dominated by the ground motion with periods longer than 3 seconds. The building response is indicated by the relative displacements between the upper floors and the ground floor, which have a period of 1.6 to 2 seconds. The drift can be computed by differencing the displacements at various floors. The maximum drift is about 18 cm, 0.7% of the building height, between the roof

Fig. 3. Accelerations in the longitudinal (E-W) direction recorded at the Imperial County Services Building during the 1979 Imperial Valley earthquake. Failure of columns is inferred to have occurred at about 11 seconds.

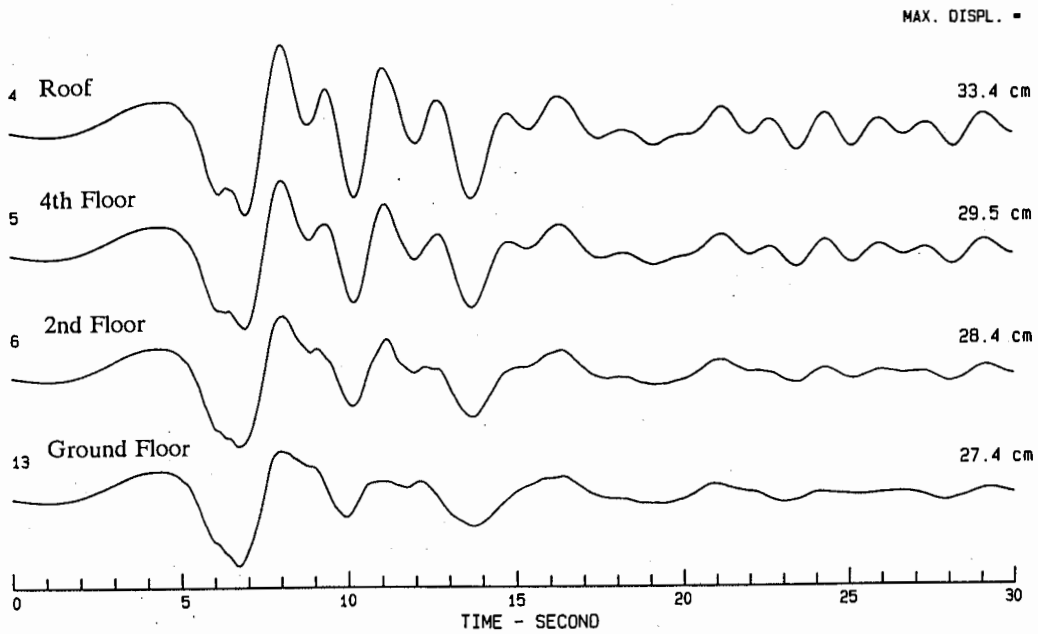
Fig. 4. Displacements corresponding to the accelerations in Fig. 3.

and the ground floor, and is about 8 cm, 1.8% of the story height, between the second and the ground floors. These drifts are larger than the 0.5% code limit

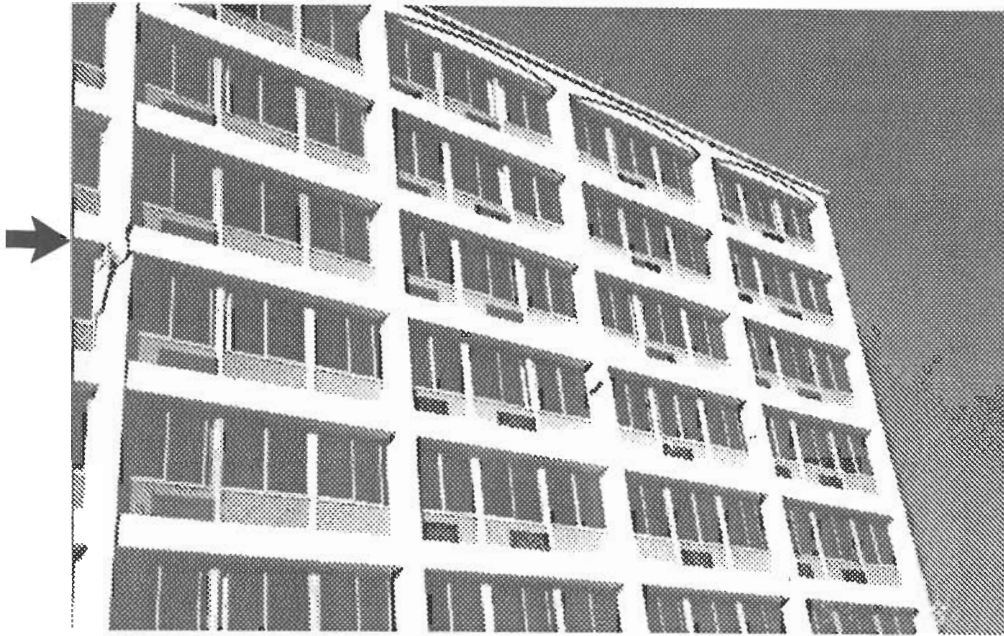
A hotel in Van Nuys, a 7-story concrete frame structure, suffered structural damage during the 1994 Northridge earthquake (Figure 5). The building also suffered minor structural damage in the 1971 San Fernando earthquake. It is the closest instrumented building to the epicenter of the 1971 earthquake and was later instrumented more extensively with 16 sensors by CSMIP. Several distant earthquakes including the 1987 Whittier, the 1992 Landers and the 1992 Big Bear earthquakes were recorded at this building. The recorded peak accelerations in the longitudinal direction from these earthquakes are listed in Table 2. The Northridge shaking is the strongest and had the largest drift, as shown in the table. After the Northridge earthquake the building was repaired and strengthened with new concrete shear walls.

Fig. 5. Partial south elevation of Van Nuys 7-story Hotel showing damage to columns (indicated by an arrow) below fifth floor spandrel beams during the 1994 Northridge earthquake.

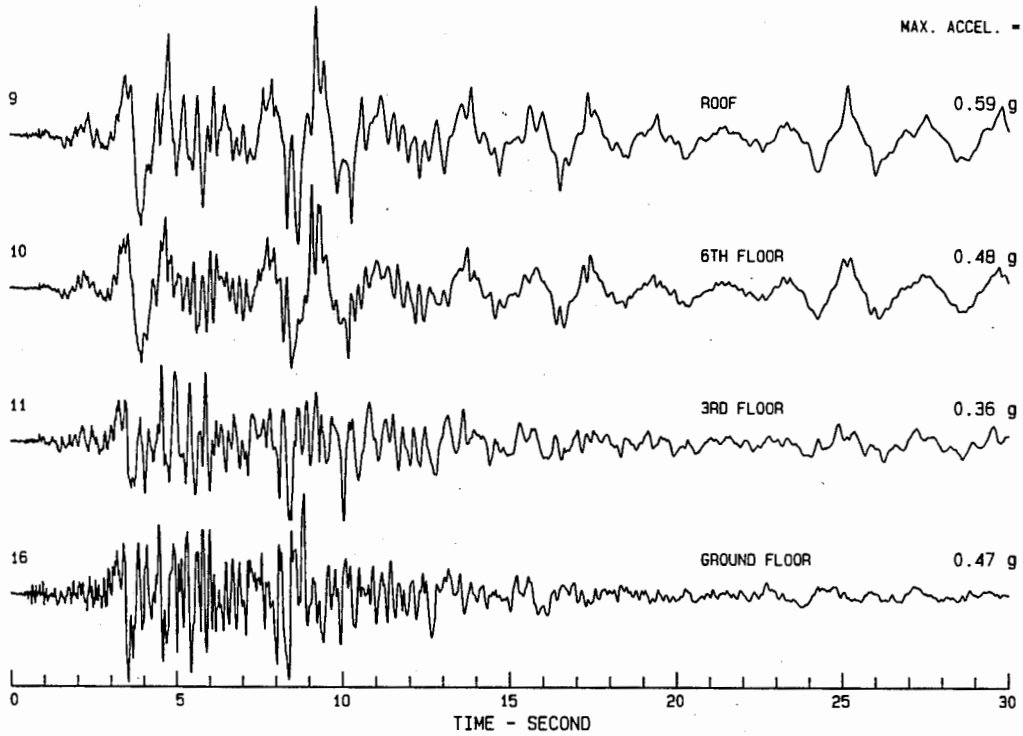
The Northridge records from this building have been used to study analytical techniques by Islam (1996) in the SSC Case Studies project, and by De la Llera and Chopra (1995) in a CSMIP-funded study. The records indicate that the building experienced significant torsional response. Figure 7 shows the accelerations recorded at the roof, the 6th, the 3rd, and the ground floor levels in the longitudinal (E-W) direction. It can be seen from these records that the second mode response with a period of about 0.4 seconds is significant and determined the peak accelerations for all floors. The high-frequency spikes seen in the Imperial County Services building records (Fig. 3) do not appear in these records. This may be due to the fact that the building did not drop vertically and the sensors were not close to the locations of concrete spalling below the fifth floor.

Fig. 7. Accelerations in the longitudinal (E-W) direction recorded at the Van Nuys 7-story Hotel during the 1994 Northridge earthquake. Failure of columns occurred between the 4th and 5th floors.

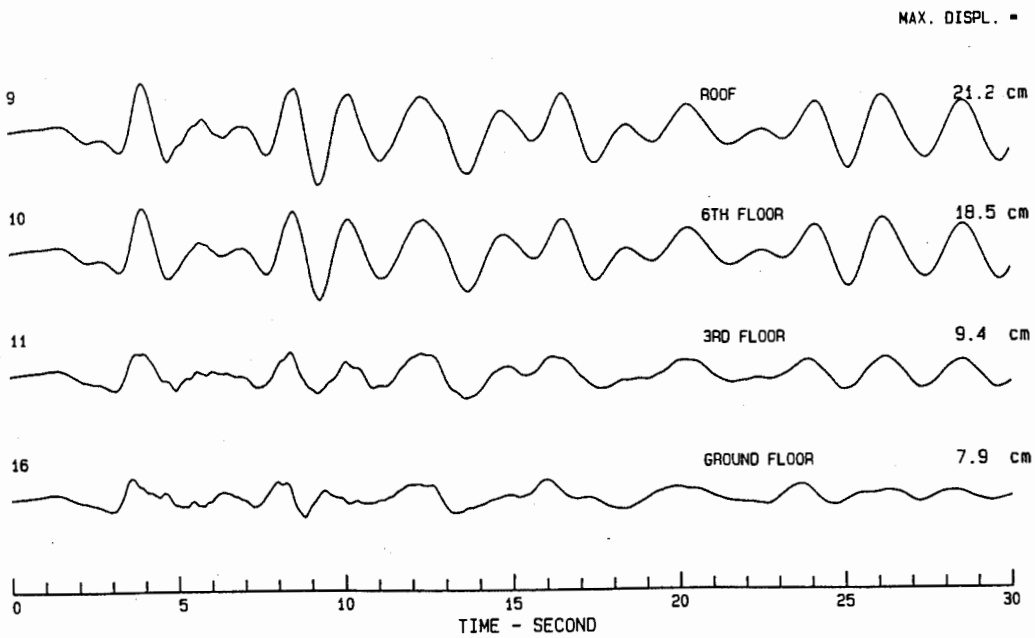
The fundamental mode response is more apparent in the displacement records, as shown in Figure 8. The fundamental period of the building was lengthened from about 1.5 seconds in the first 10 seconds of the record to about 2 seconds later. The inter-story drift ratio is 1% for the first story and 1.9% for the second story. The maximum drift between the roof and the ground floor is about 23 cm, 1.2% of building height, which occurred at 9.34 seconds. It has been interpreted by Islam (1996) that many structural elements may have yielded at approximately 4 to 5 seconds and the most severe damage to the columns may have occurred at about 9 seconds, which corresponds to the time of maximum acceleration. After the columns were damaged, the building period was lengthened to nearly 2 seconds. The maximum base shear from the first mode is about 0.20W which is about 5 times the design base shear (0.04W, according to 1967 UBC).

Fig. 8. Displacements corresponding to the accelerations in Fig. 7.

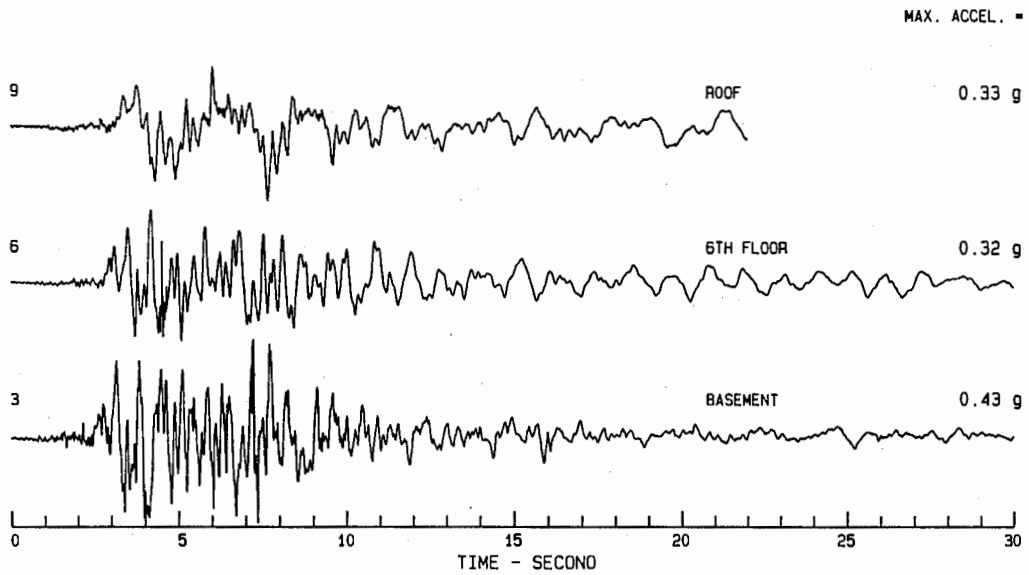
The building was instrumented with three accelerographs by the owner as required by the Los Angeles Building Code. They were located at the basement, the 6th floor and the roof level. Figure 9 shows the acceleration records in the reference N-S direction. The building fundamental period can not be easily determined by a visual inspection of the acceleration records due to prominent higher mode response in the roof record. Only the first 22 seconds of the roof record could be digitized in the initial digitization. The corresponding displacement records are shown in Figure 10. The building's largest response, with a period of about 3 seconds, occurred between 4 and 8 seconds. The ground shaking was so energetic in the beginning that the structural members apparently yielded right at the beginning. From the computer modelling of the structure, Uang et al. (1995) concluded that a significant number of panel zones at the joints yielded and that the panel zones were a major source of energy dissipation during the Northridge earthquake. The total drift between the roof and the basement, computed from the displacement records, has a maximum value of 33 cm in the reference N-S direction, which is about 0.6% of building height. Design of this steel building was probably controlled by the drift limit, 0.5%, rather than by the force. The maximum base shear is about 0.12W which is about 4 times the code-specified force (0.03W).

Fig. 9. Accelerations in the reference north-south direction recorded at the Woodland Hills - Oxnard #4 Building during the 1994 Northridge earthquake. After the earthquake, about 10% of the connections in this 13-story steel frame building were found damaged.

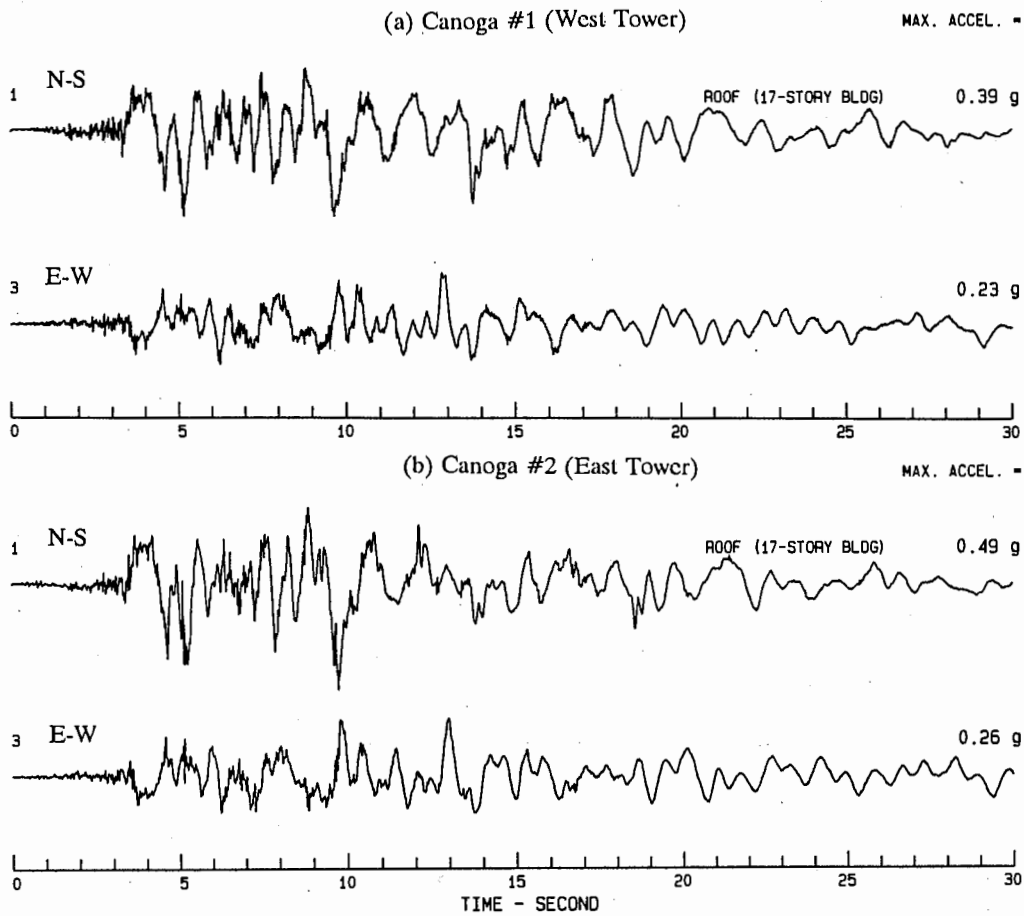
Both buildings were instrumented by the owner with one accelerograph at the roof level by the owner as required by the Los Angeles Building Code. The roof acceleration records for the two buildings are shown in Figure 11. In general, the response of the buildings are quite similar with much stronger response in the N-S direction. The peak acceleration near 9.5 seconds is slightly larger for the East Tower than the West Tower. The building is a long-period structure, so the acceleration records were dominated by the higher mode response. In addition, many high-frequency spikes can be seen in the records. The roof displacements for the first 30 seconds are shown in Figure 12, which indicate that the building period was about 4.6 seconds in the N-S direction and about 4 seconds in the E-W direction. By using the basement record of the Oxnard #4 building, which is across the street from this building, one can estimate the maximum drift between the roof and the base. The maximum drift for the East Tower in the N-S direction is about 47 cm, 0.7% of building height, and about 2.5 times that in the E-W direction. The base shear from the first mode, estimated from the roof record, is about 0.05W. The contribution of higher modes to the base shear is significant as compared to the first mode. The design base shear is about 0.05W. The damping ratio for the N-S direction, estimated from the 60-second long displacement records, is about 4%.

Fig. 11. Horizontal accelerations recorded at the roof level of the Woodland Hills - Canoga #1 (West Tower) and Canoga #2 (East Tower) during the 1994 Northridge earthquake. The East Tower was more severely damaged than the West Tower.

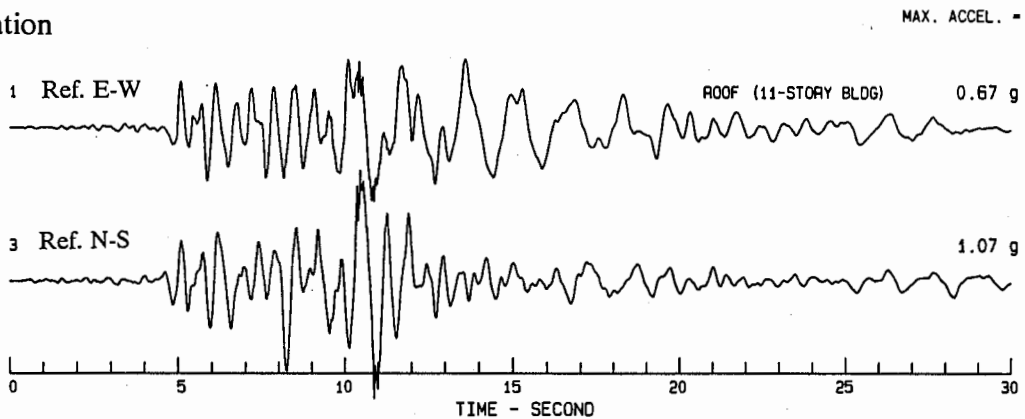
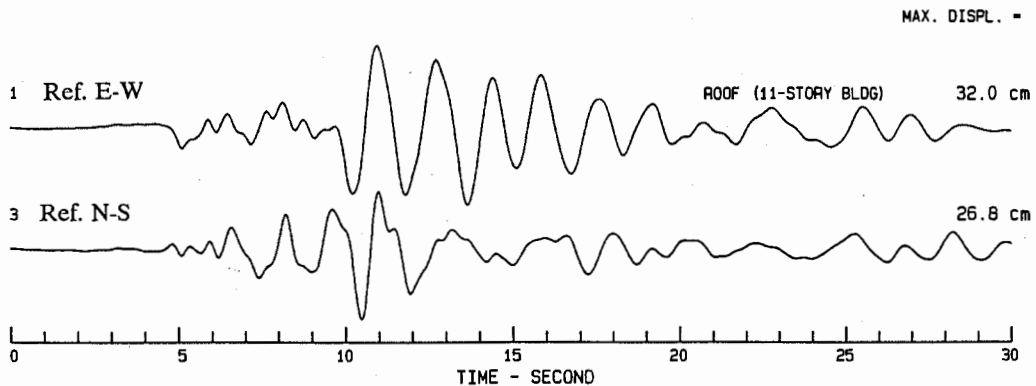
The building was instrumented by the owner with one accelerograph on the roof level as required by the Los Angeles City Building Code. The roof acceleration records and the corresponding displacements are shown in Figure 13. As seen in these records, between 5 and 10 seconds the building responded predominantly in the second mode with a period of about 0.6 seconds. High-frequency spikes appear near 10.5 and 11 seconds and can be seen on the acceleration records in both directions. This corresponds to the time when the maximum displacement occurred. This time may be interpreted as the time when damage of the structural members occurred. After the damage, the building responded mainly in the fundamental mode with a period of about 1.6 seconds, although the second mode response can be seen in the acceleration records. The response in the reference north-south direction was larger than that in the reference east-west direction and does not have a distinct period of vibration. This may imply that the damage in the north-south direction is more severe than that in the east-west

direction, although this has not been confirmed from the inspection. The lack of base records prevents computation of the total roof drift, but the maximum roof drift is estimated to be about 32 cm, 0.8% of building height, in the east-west direction. The maximum base shear from the first mode is about 0.20-0.25W, as compared with the design base shear of about 0.06W.

Horizontal accelerations and displacements recorded at the roof level of the Olympic #2 Building in west Los Angeles during the 1994 Northridge earthquake. After the Northridge earthquake, over 25% of the connections in this steel-frame building were found damaged.
