# Watershed Emergency Response Team (WERT) 2024 Airport Fire

CA-ORC-127883

October 25, 2024

**REPORT TITLE:** Watershed Emergency Response Team (WERT) Evaluation – 2024 Airport Fire

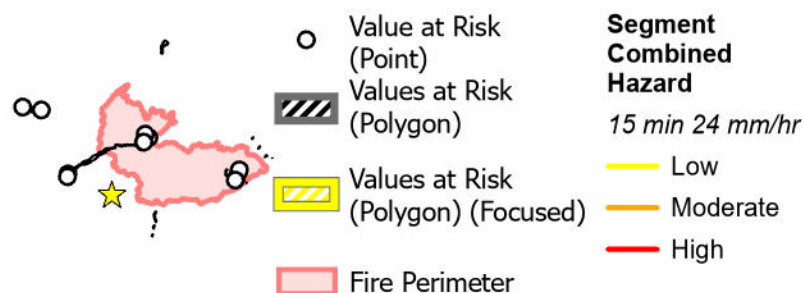
**Description:** The upslope basin burned at mostly moderate soil burn severity. The channel shows signs of high energy flow. Mobilized trees and debris could cause debris jams that force flows out of channel. Downstream bridge may be impacted by debris.

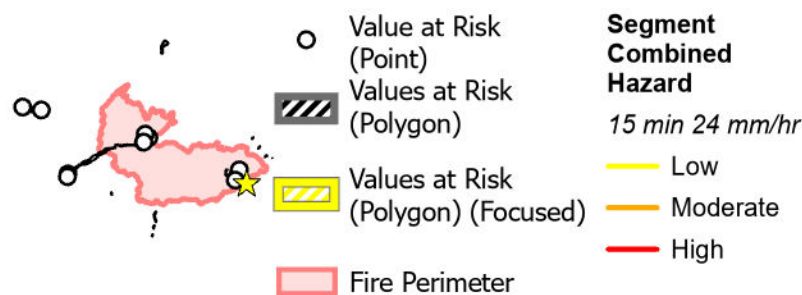
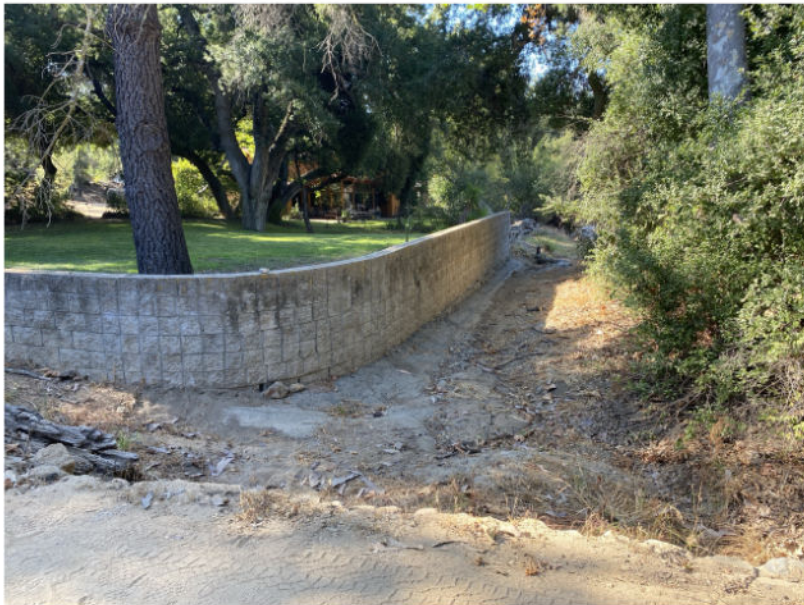
**Description:** Culvert includes a squashed 36" CMP, now 42" x 28", and three ~22" concrete barrels. Barrels up to 60% are plugged with sediment. Upstream channel is choked with brush and vegetation. Block wall adjacent to culvert outlet and downstream made of stacked rock provides some protection to residence. Small pond in residence yard could attenuate potential avulsion away from home. The upstream basin mostly burned at moderate soil burn severity.

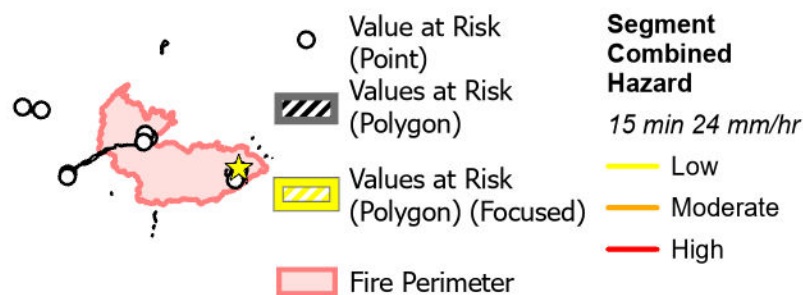
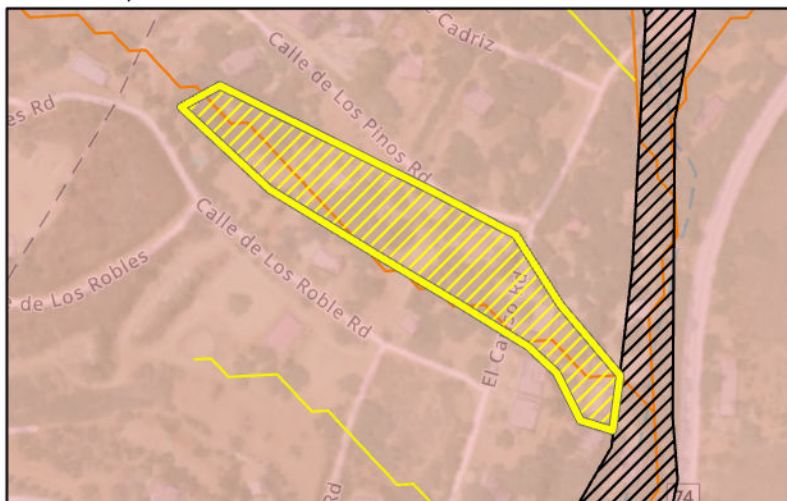
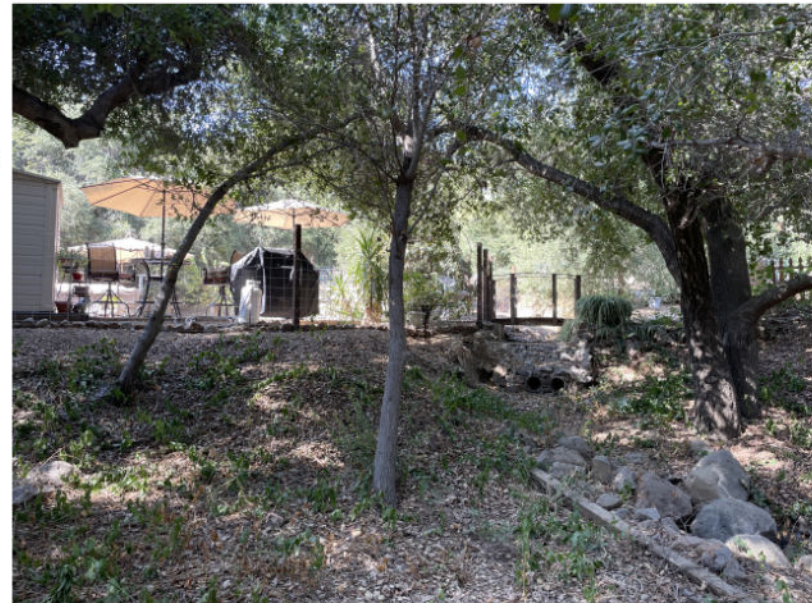
**Description:** Upstream basin burned at moderate soil burn severity. Poor drainage exists along flow paths.

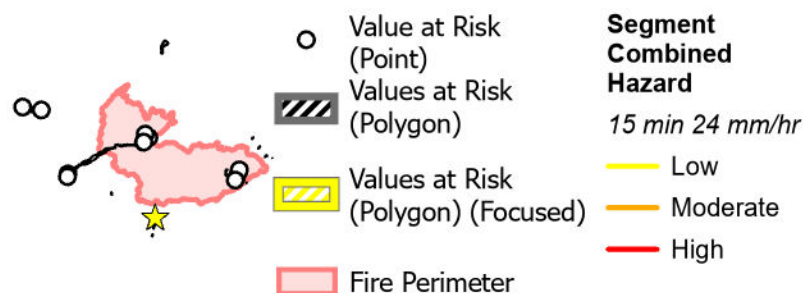
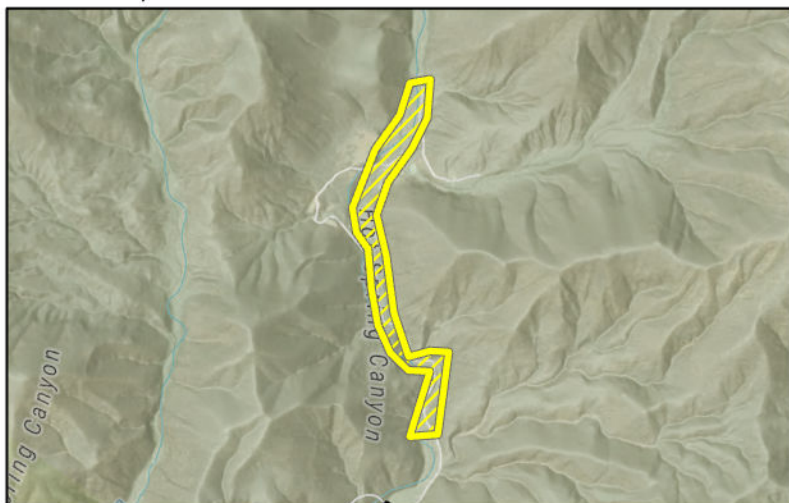
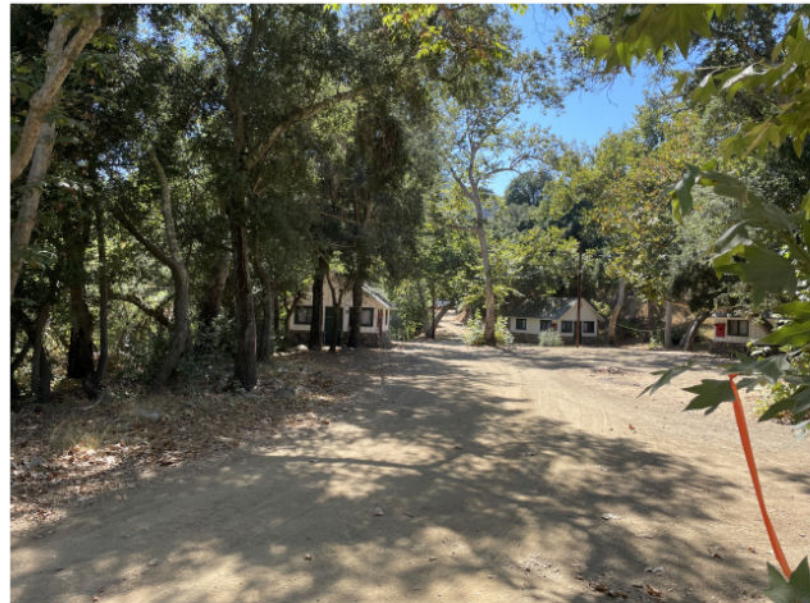
**Description:** The basin upstream burned mostly at moderate soil burn severity with some high. Geomorphic evidence composed of braided channel network, large bedload material featuring large boulders, and steep gradient all suggest a high flow regime capable of flooding and transporting debris. Evidence of past walking bridge failure.

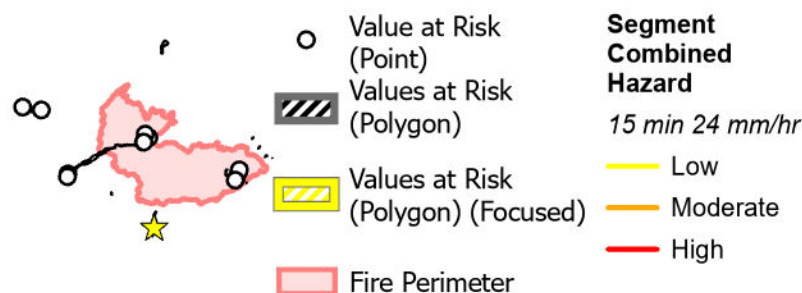
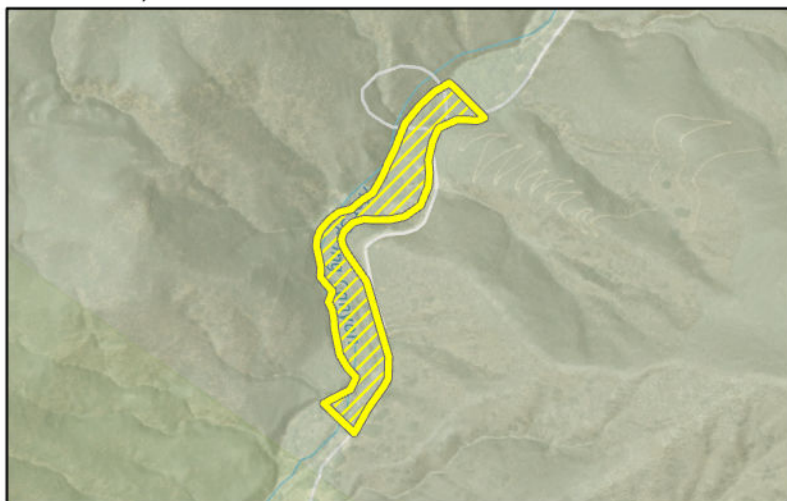
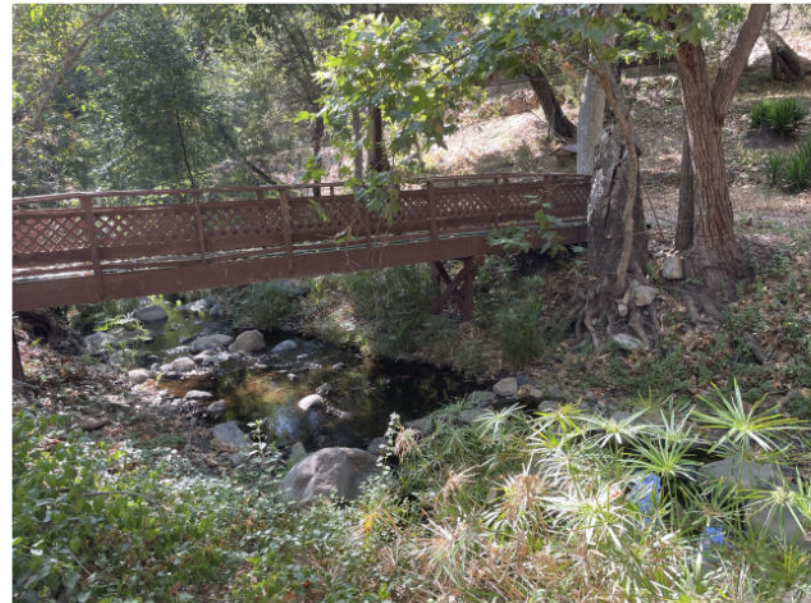
**Description:** Geomorphology of the stream with large boulders in channel indicate potential for high flow power in the stream. The canyon upstream is confined, which will focus flood and debris flows spilling into the local flood terrace. The pedestrian bridge will rack up debris, adding to the flood and debris flow hazard, and block ingress and egress to a house. Some trees upstream may become entrained in flood flows and add to debris clogging the bridge. The presence of constructed rock slope protection adjacent to the watercourse indicate possible prior erosion/flooding issues. Monitor weather and any corresponding stream height changes during stressing rainfall events for situational awareness.

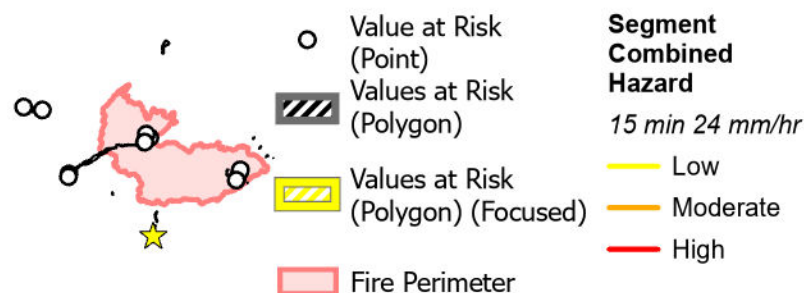
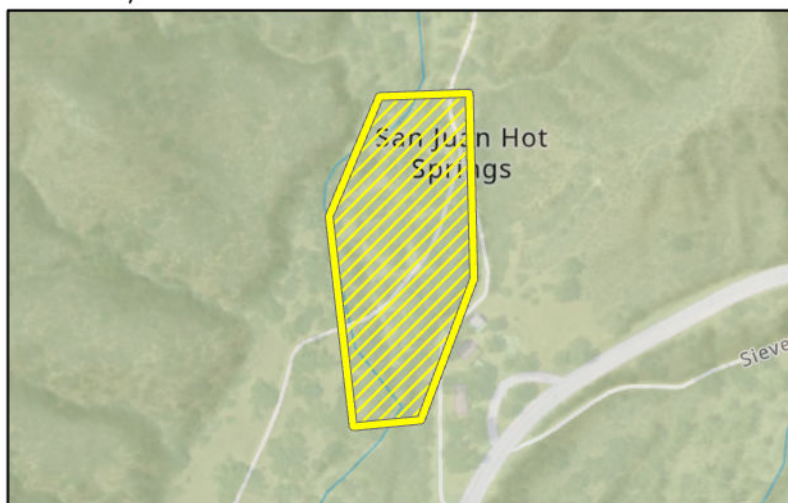
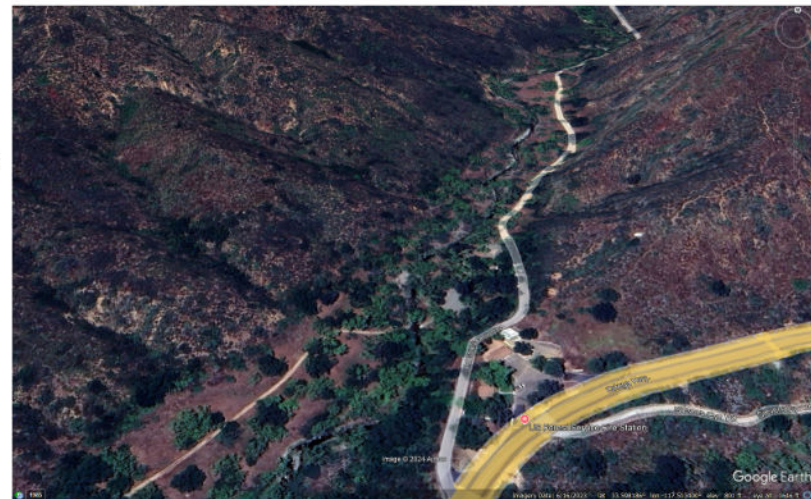
**Description:** The basin upstream is burned mostly at moderate soil burn severity with some high. Geomorphic evidence composed of braided channel network with large bedload material upstream. Shallower gradient and less confined channel at this location may produce flood flows with entrained sediment, woody debris, and some boulders.

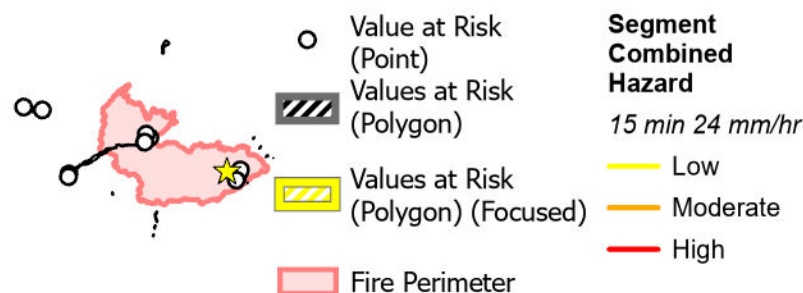
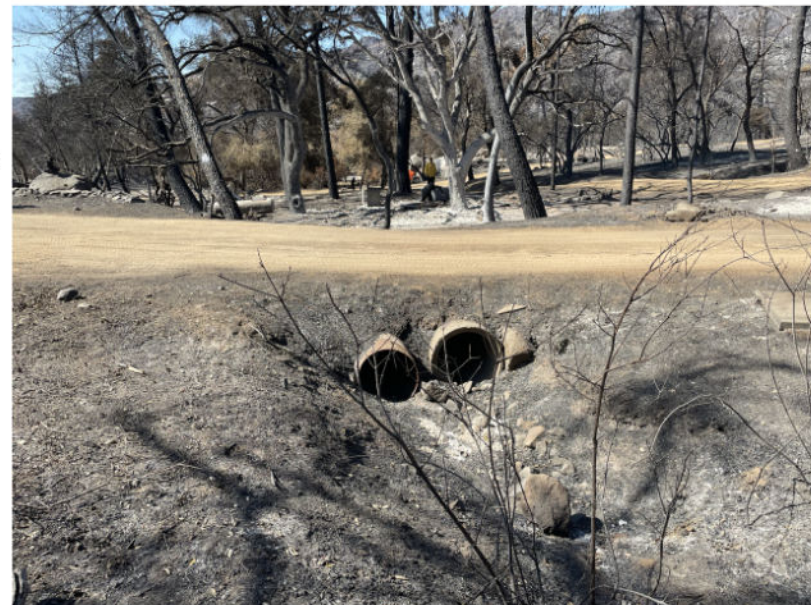
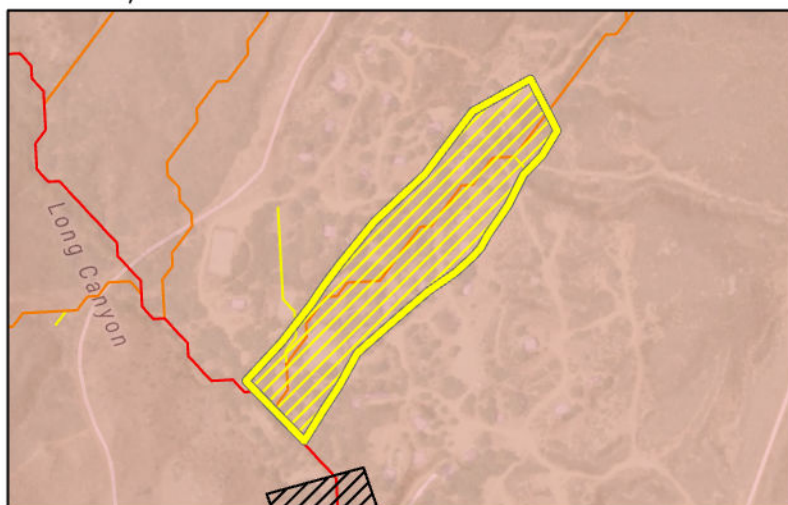
**Description:** Several road crossings and multiple cabins. Swimming pool downstream. Burned structures directly in the water channel. Should clean up burned material before next rain to minimize contaminated water flow. Monitor and maintain the drainage.

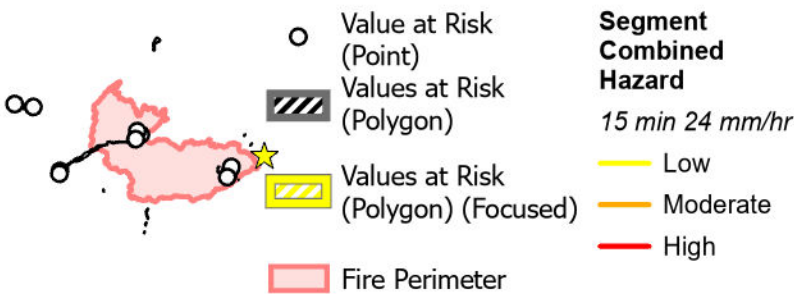
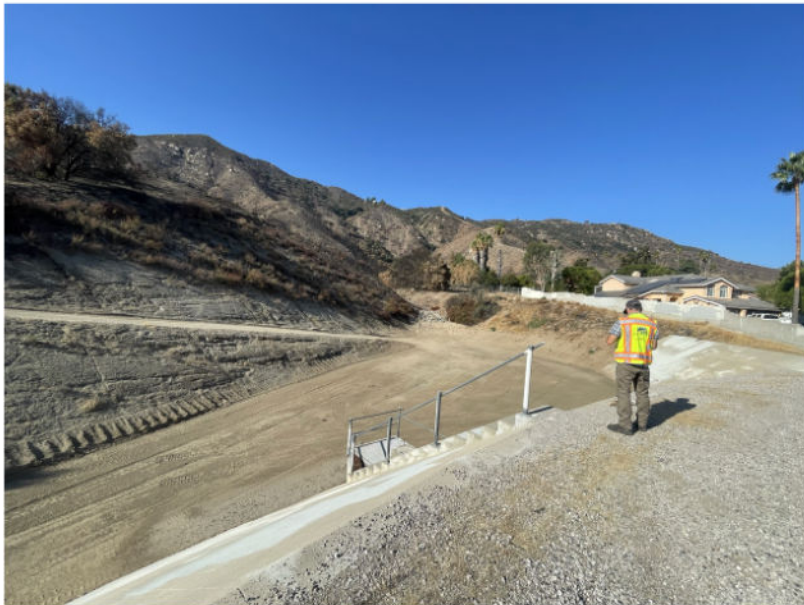
**Description:** Inlet at Ortega Basin Lateral A. Inlet includes 7'x7' box with flared wing walls. Transitions to 60" RCP at 18 feet in. Inlet may clog, making a hazard of flooding and possible debris flowing downstream along Welford Place and toward homes on Lake Ridge Road.
