Los Padres Mine AML Investigation, Remediation, Vandalism

**Los Padres Mine
S36, T4N, R5E, SBBM
Parcel # 191-038
San Bernardino County**

California State Lands Commission

February 17, 2010

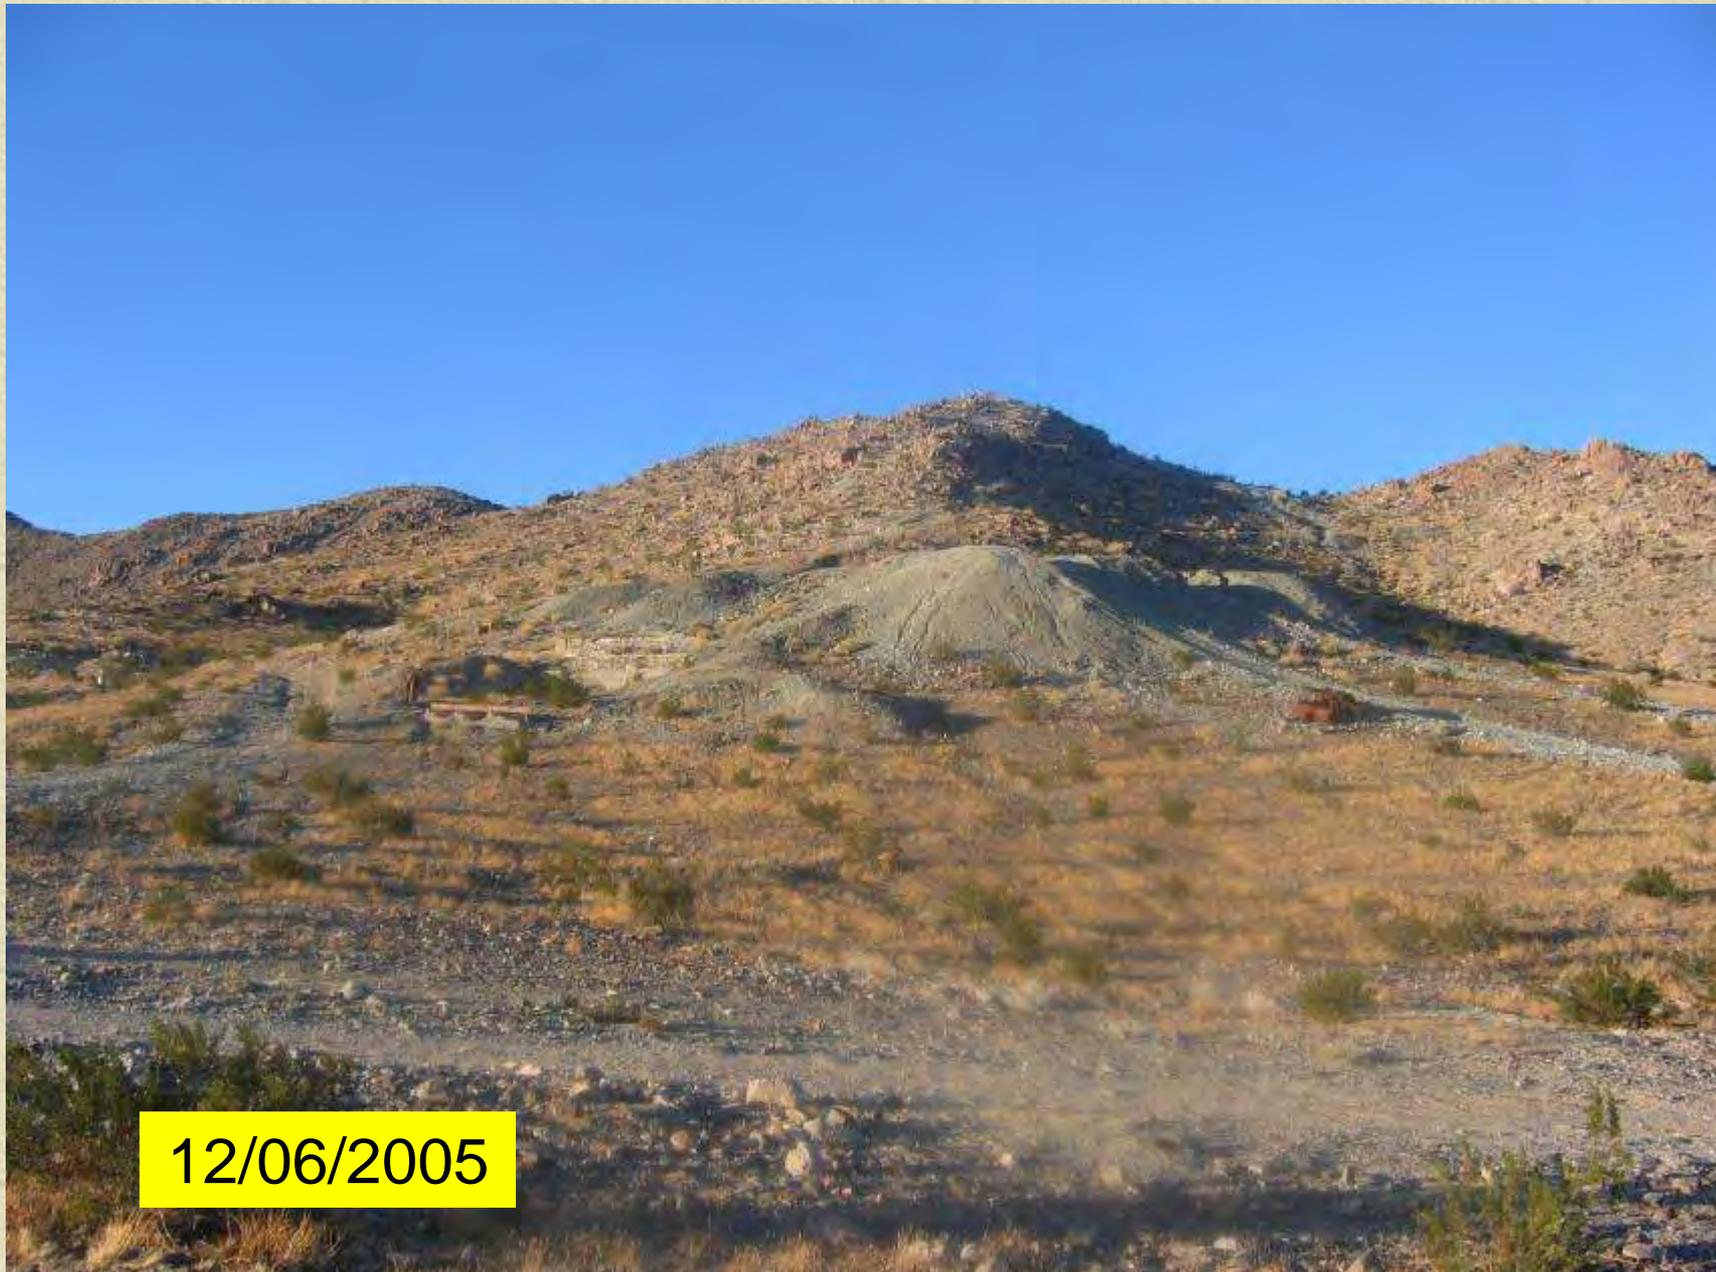
View North at Los Padres Mine With Waste Dump and Mill Site

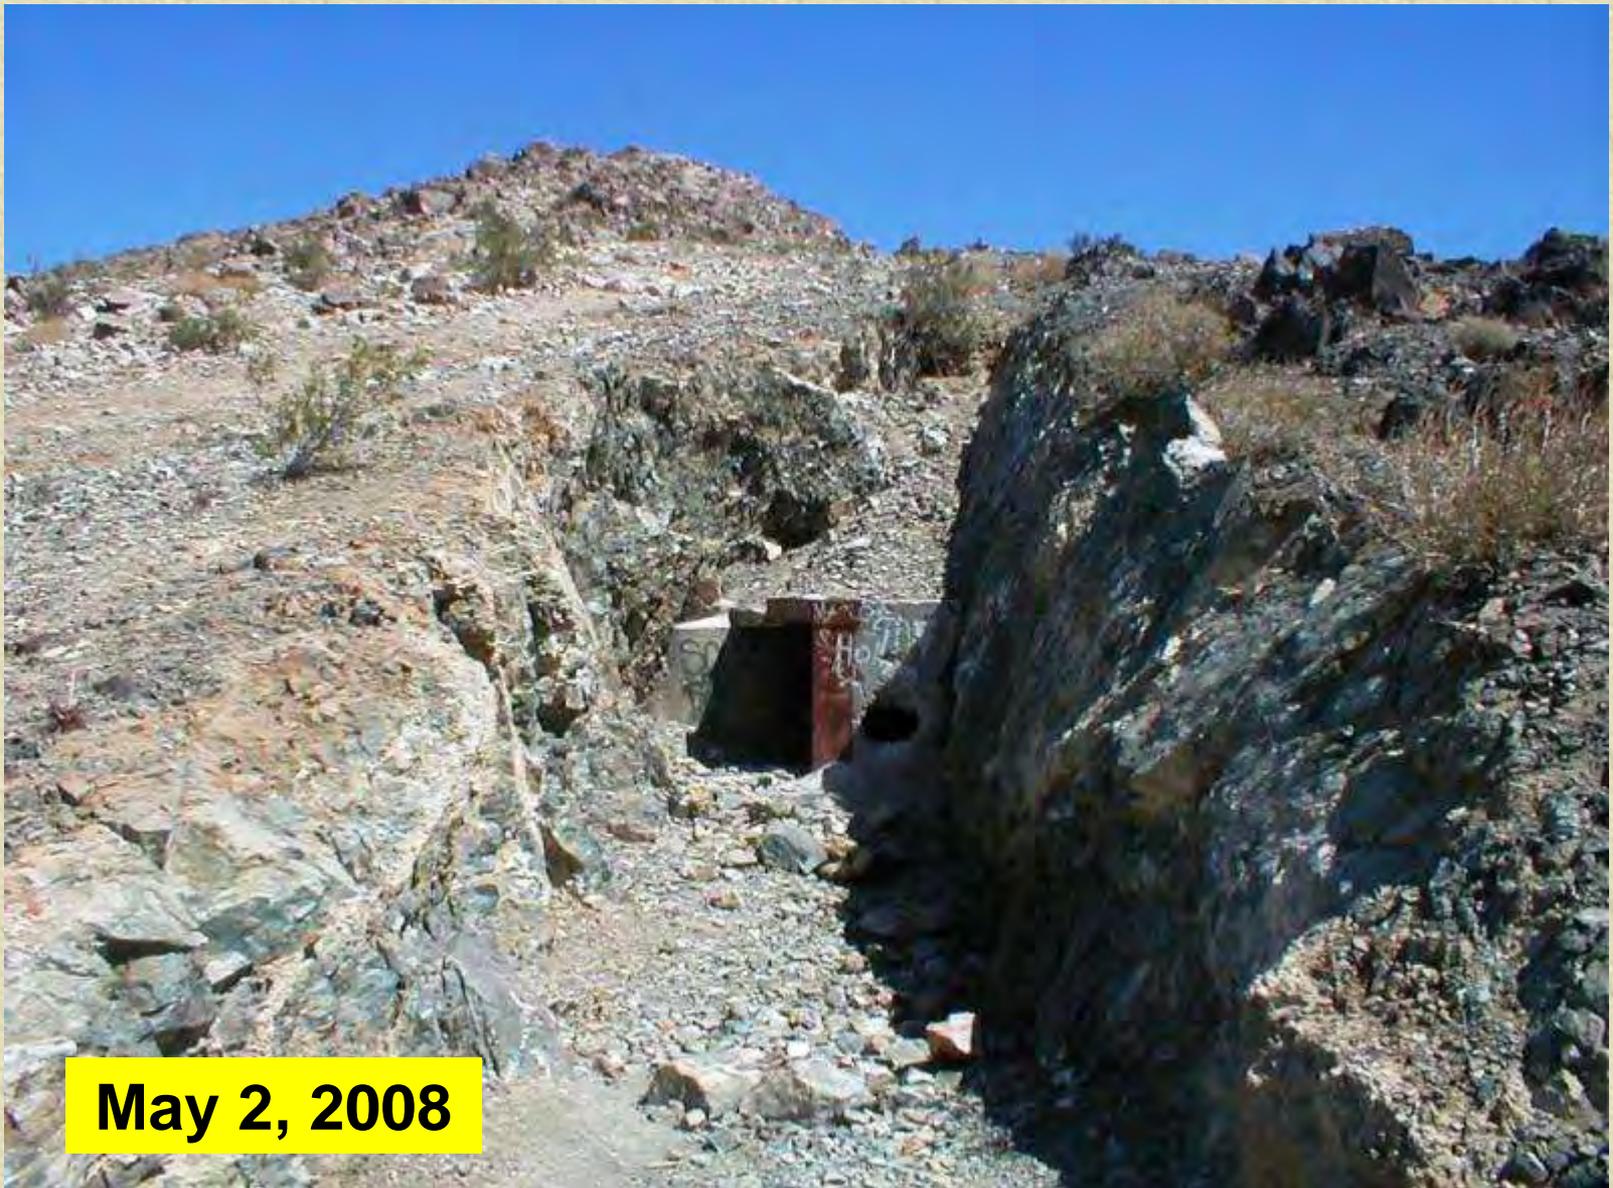
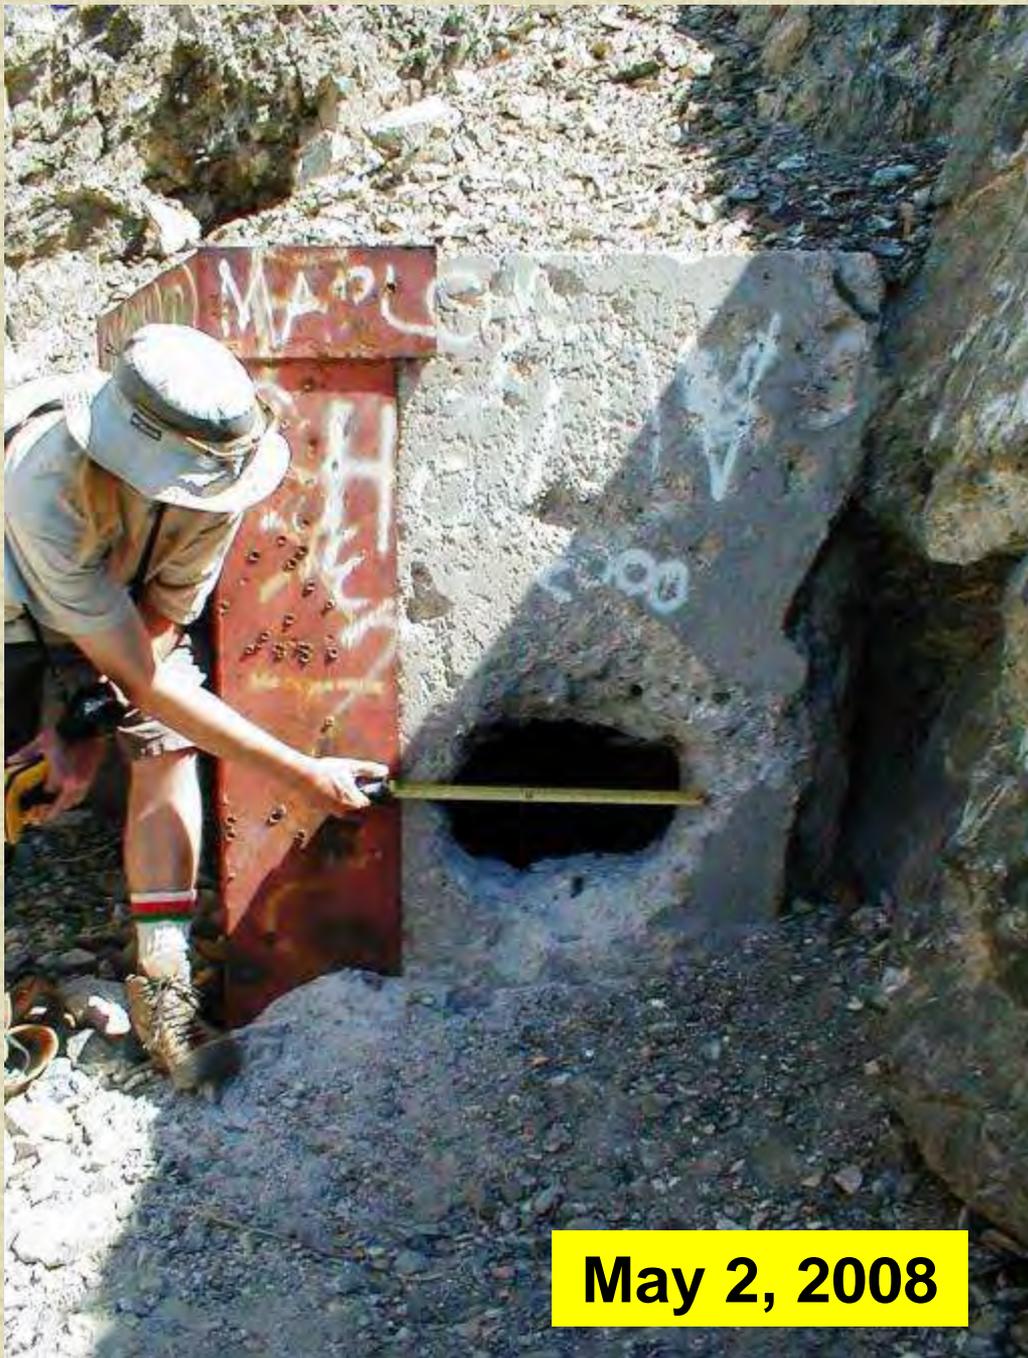
May 2, 2008

Los Padres Mine Crosscut Portal Found Vandalized

**9" Thick Rebar
Reinforced
Concrete Violated**

Secondary Steel Door Appears Intact

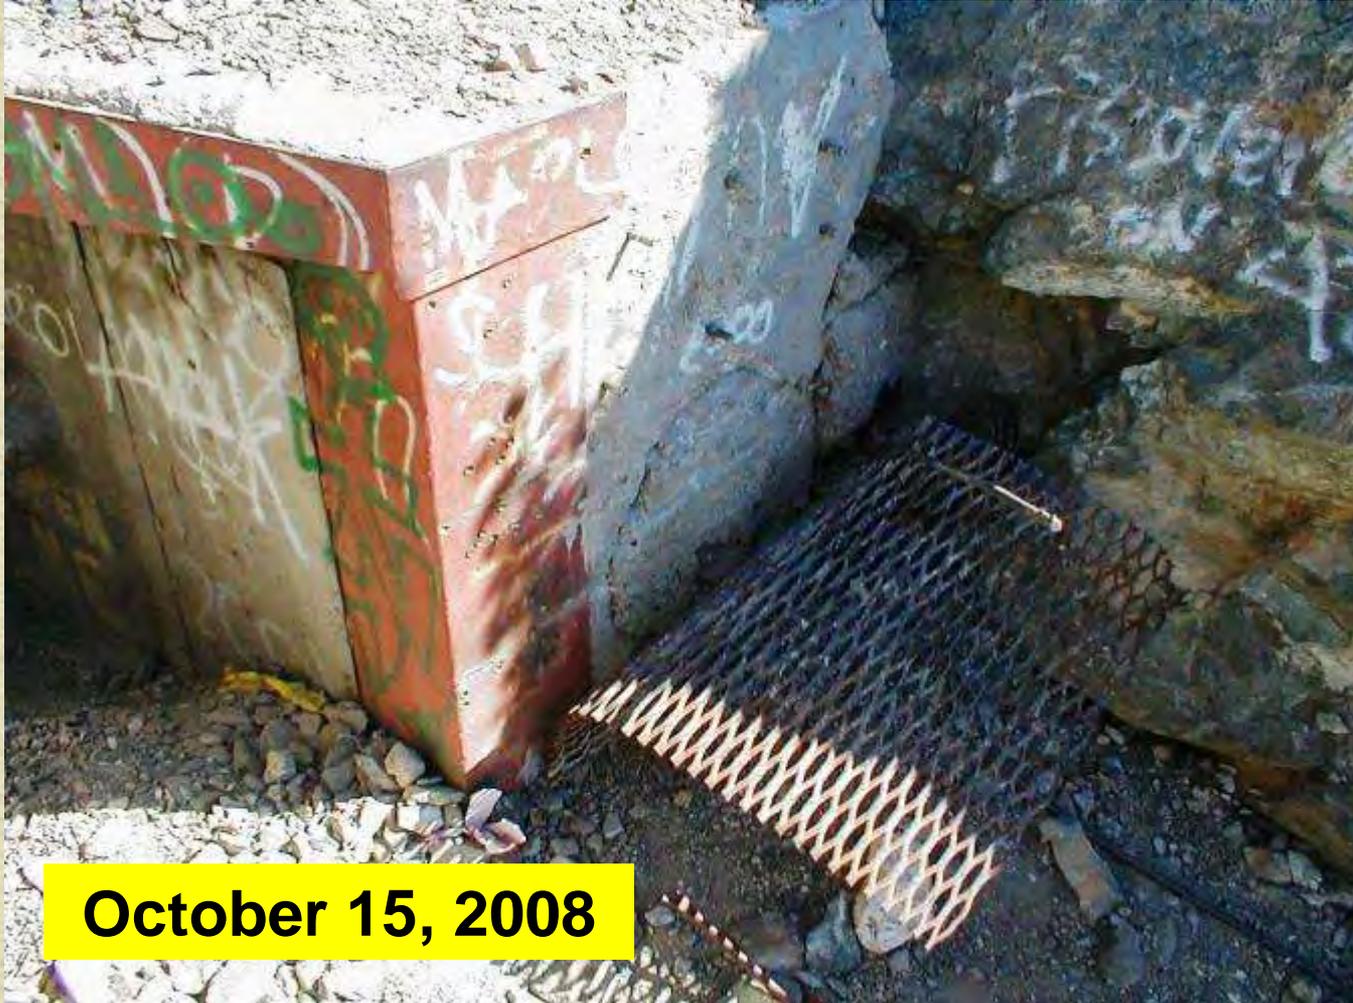
Vandalism Since May 28, 2008 (5 Months)

- **Vandals Break Welds and Pull Screen Down**
- **Concrete Repair Remains Intact**

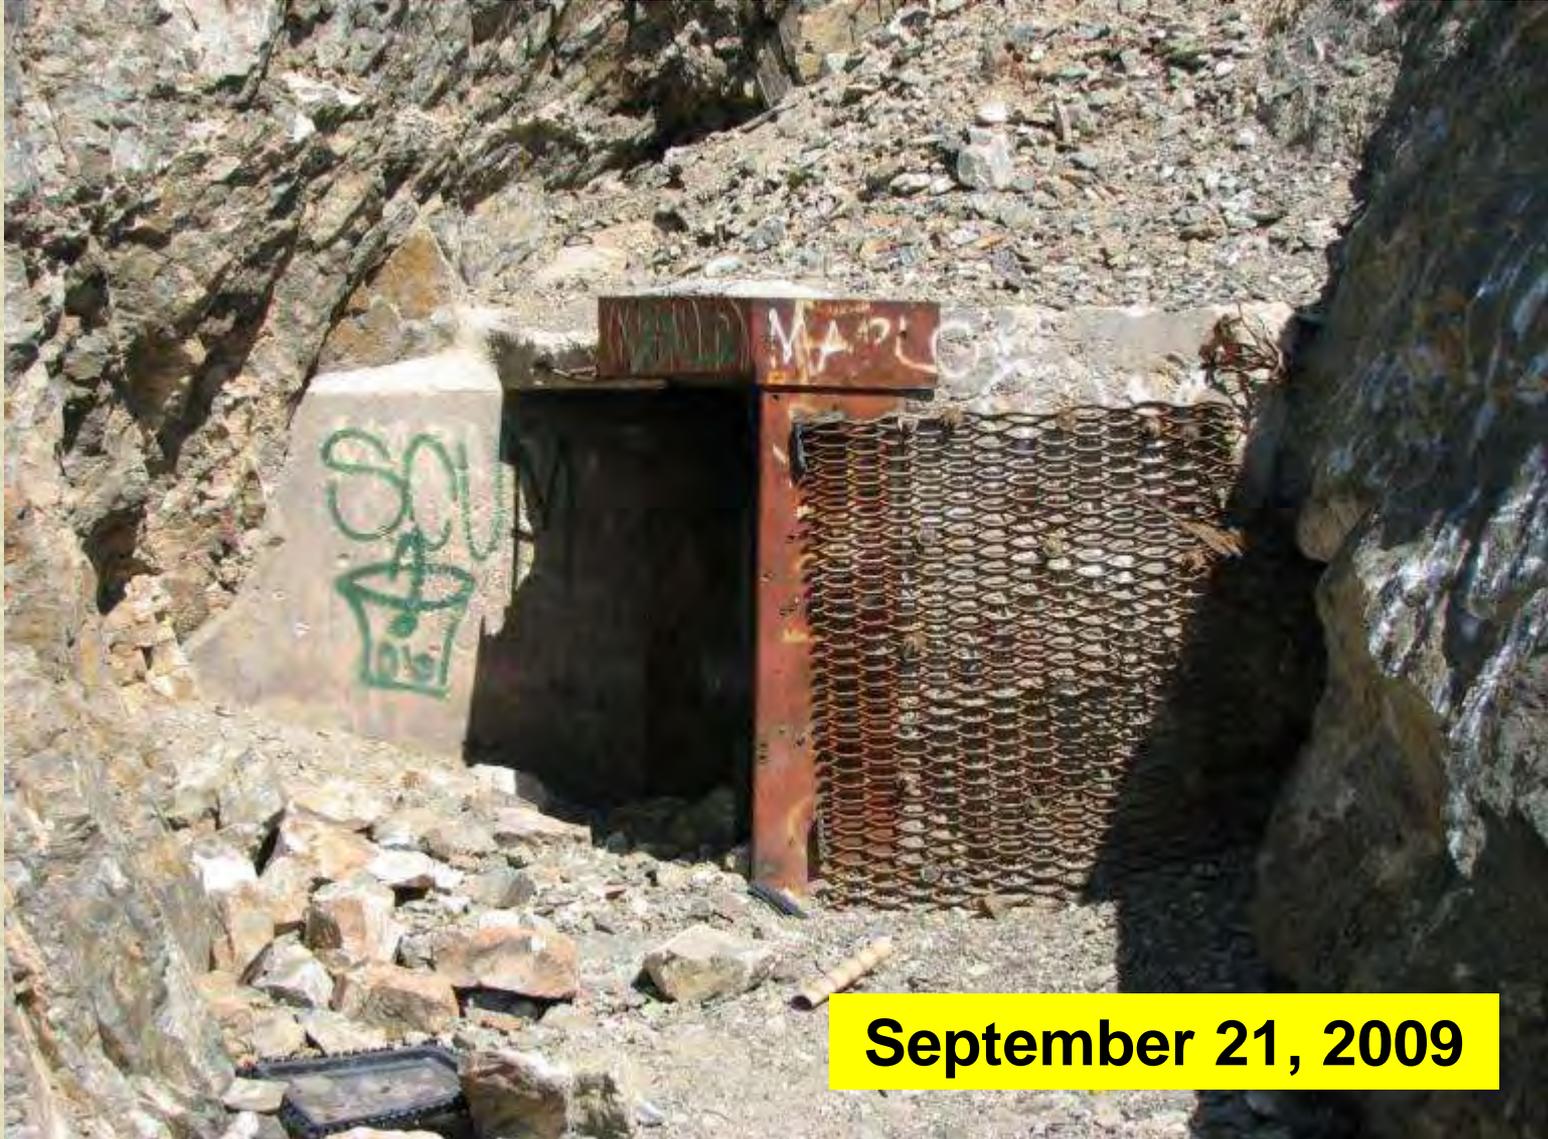
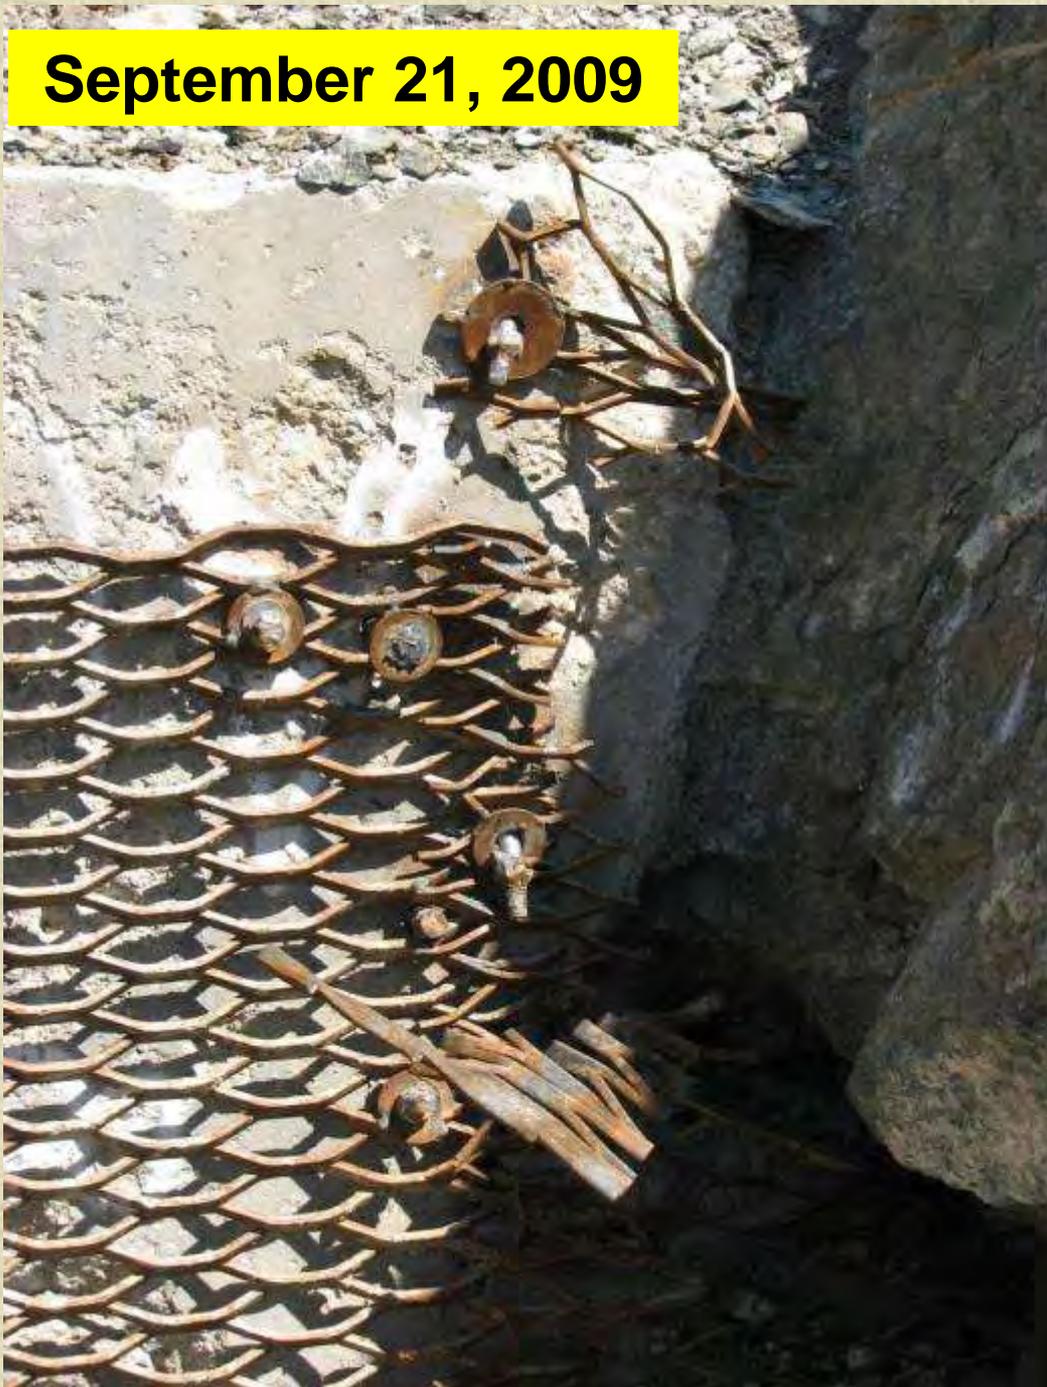
September 21, 2009

Minor Vandalism to Screen and Concrete

**Expandi Metal Cut
and Bent,
Redheads Bent
Welds Holding OK
Vandals Digging at
Interface of
Concrete and
Gneissic Bedrock
to Bypass Concrete
Wall**

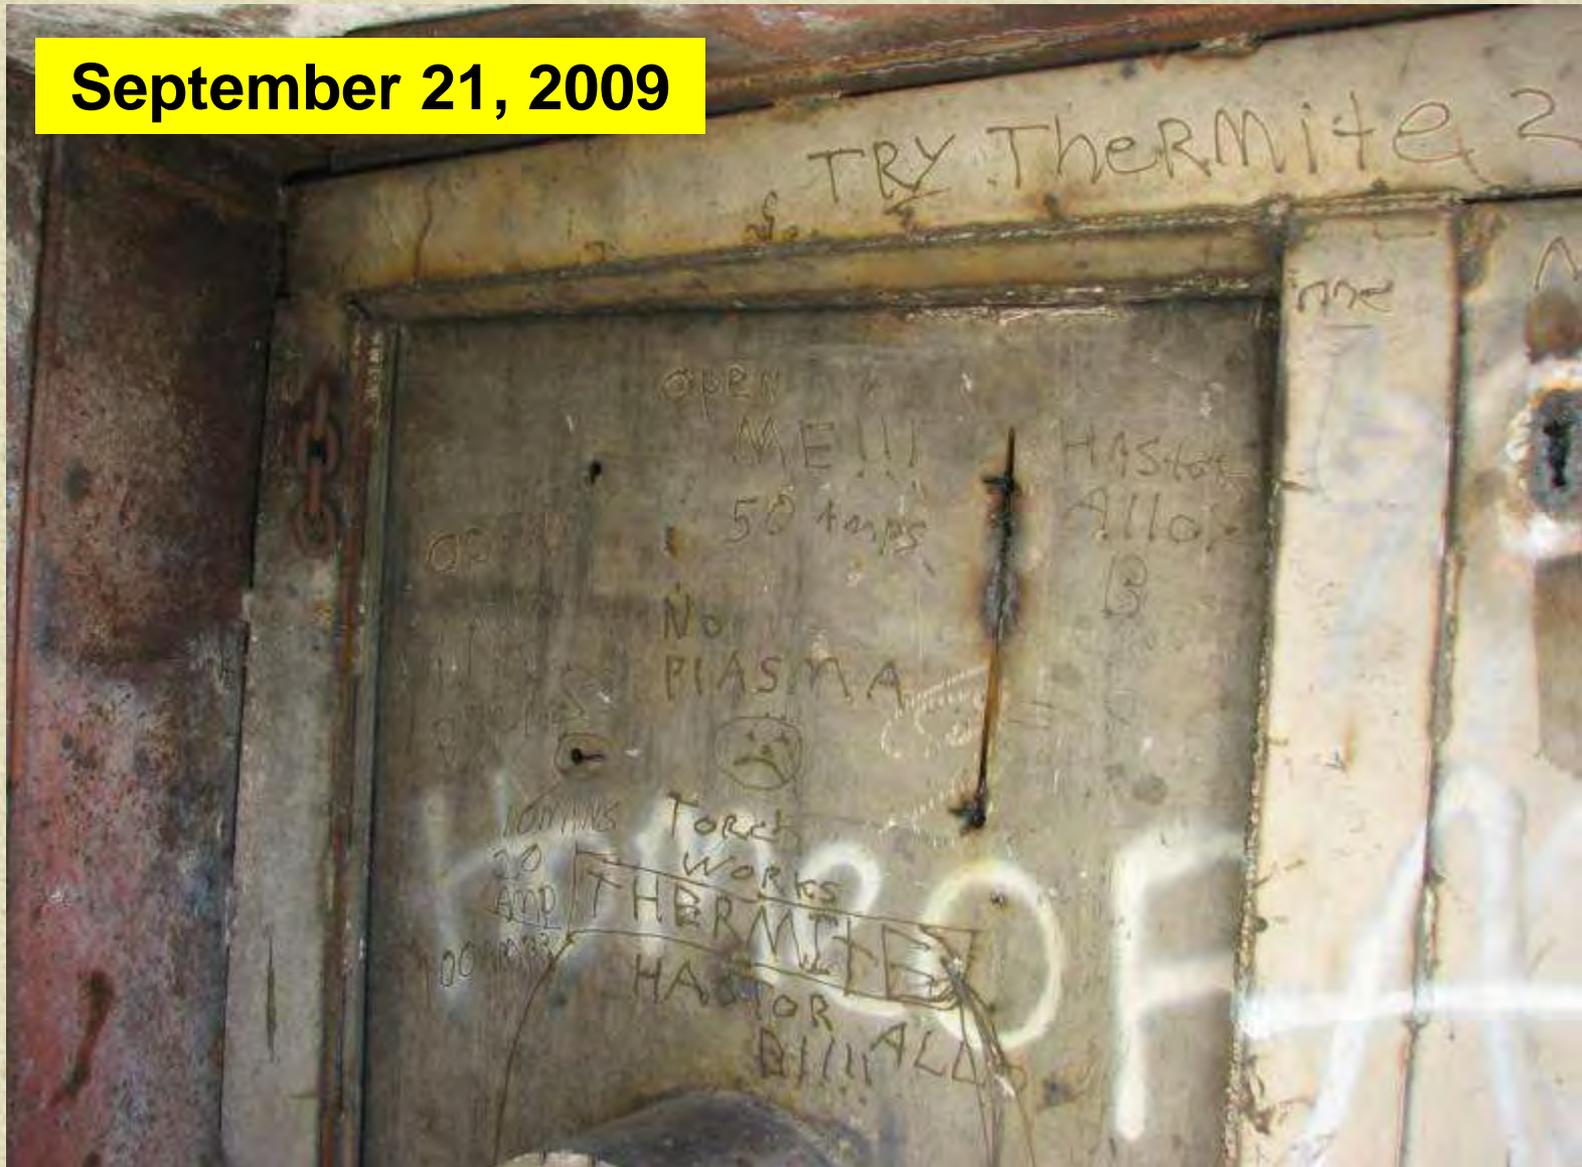
September 21, 2009

Main Steel Door Shows Vandal Scars From Thermite, Plasma Cutter, Torch, Cutoff Wheels, Grinders, Etc.

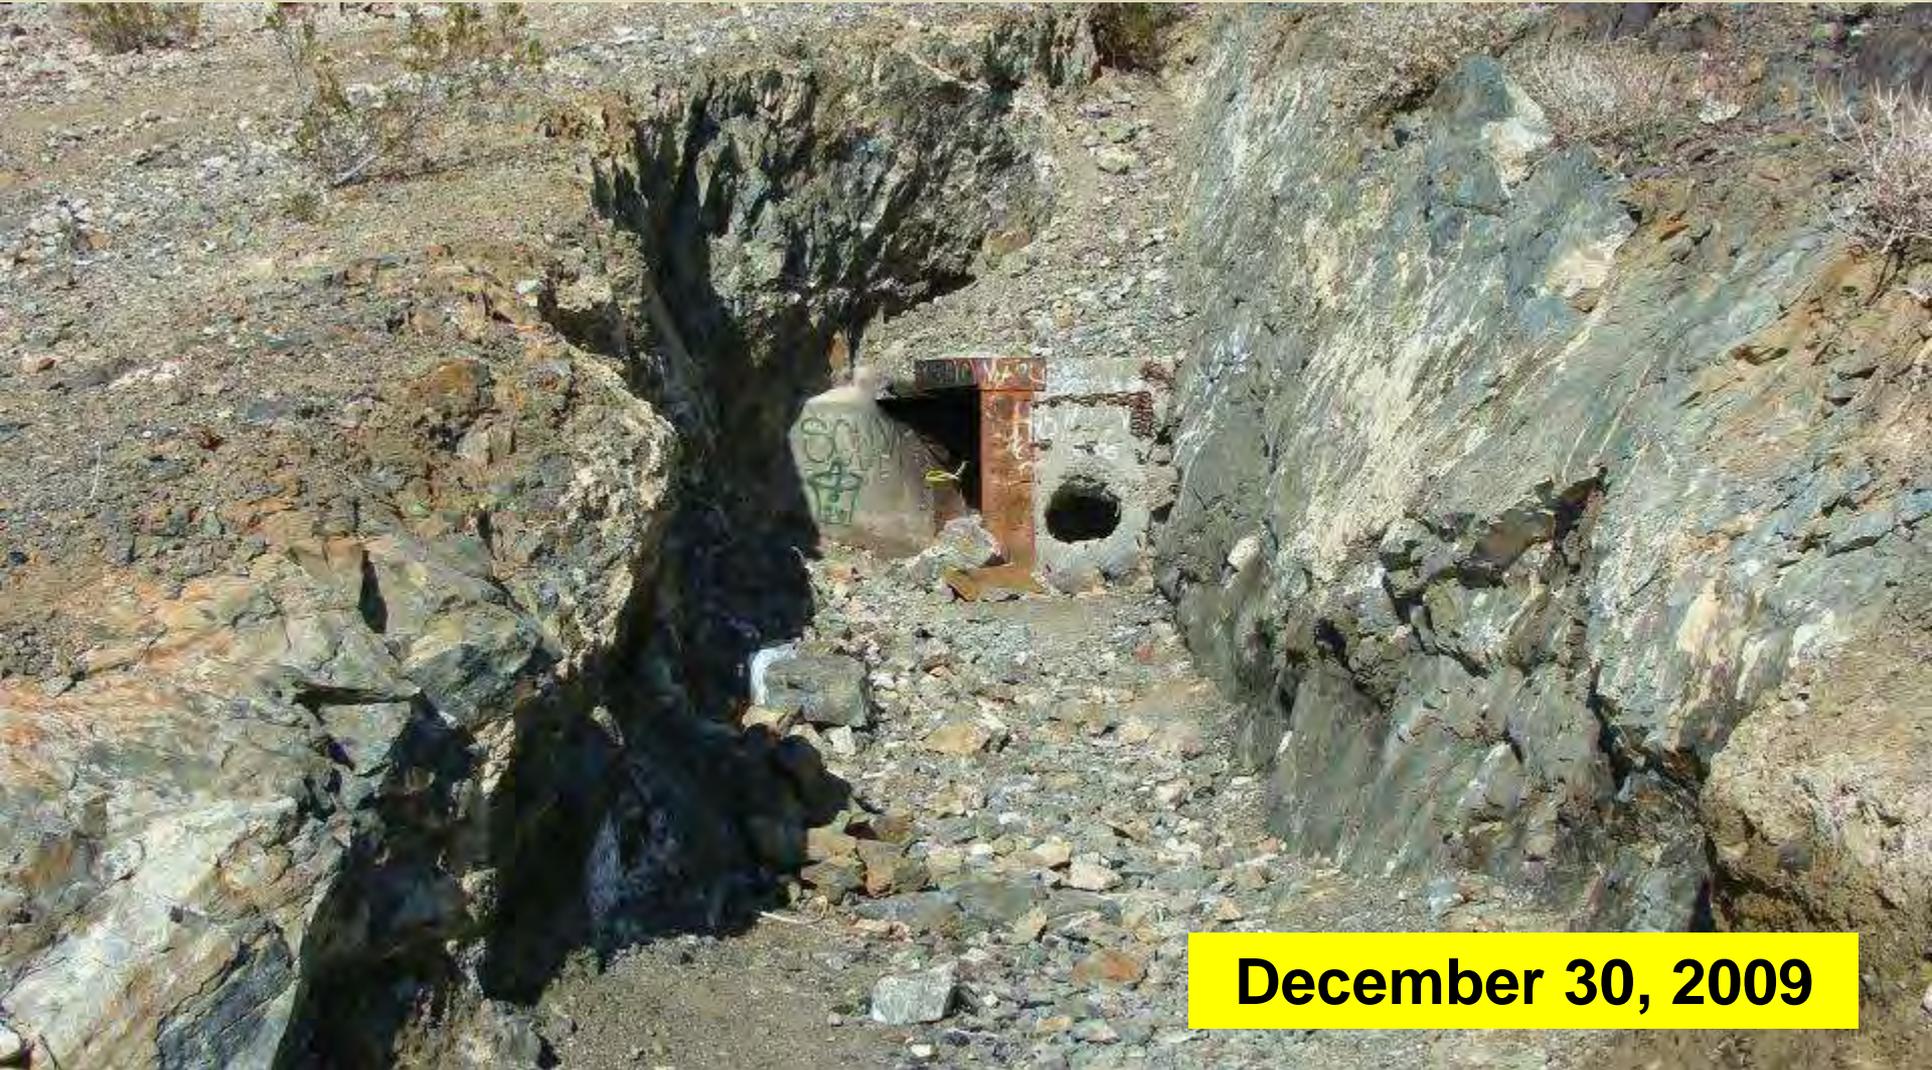
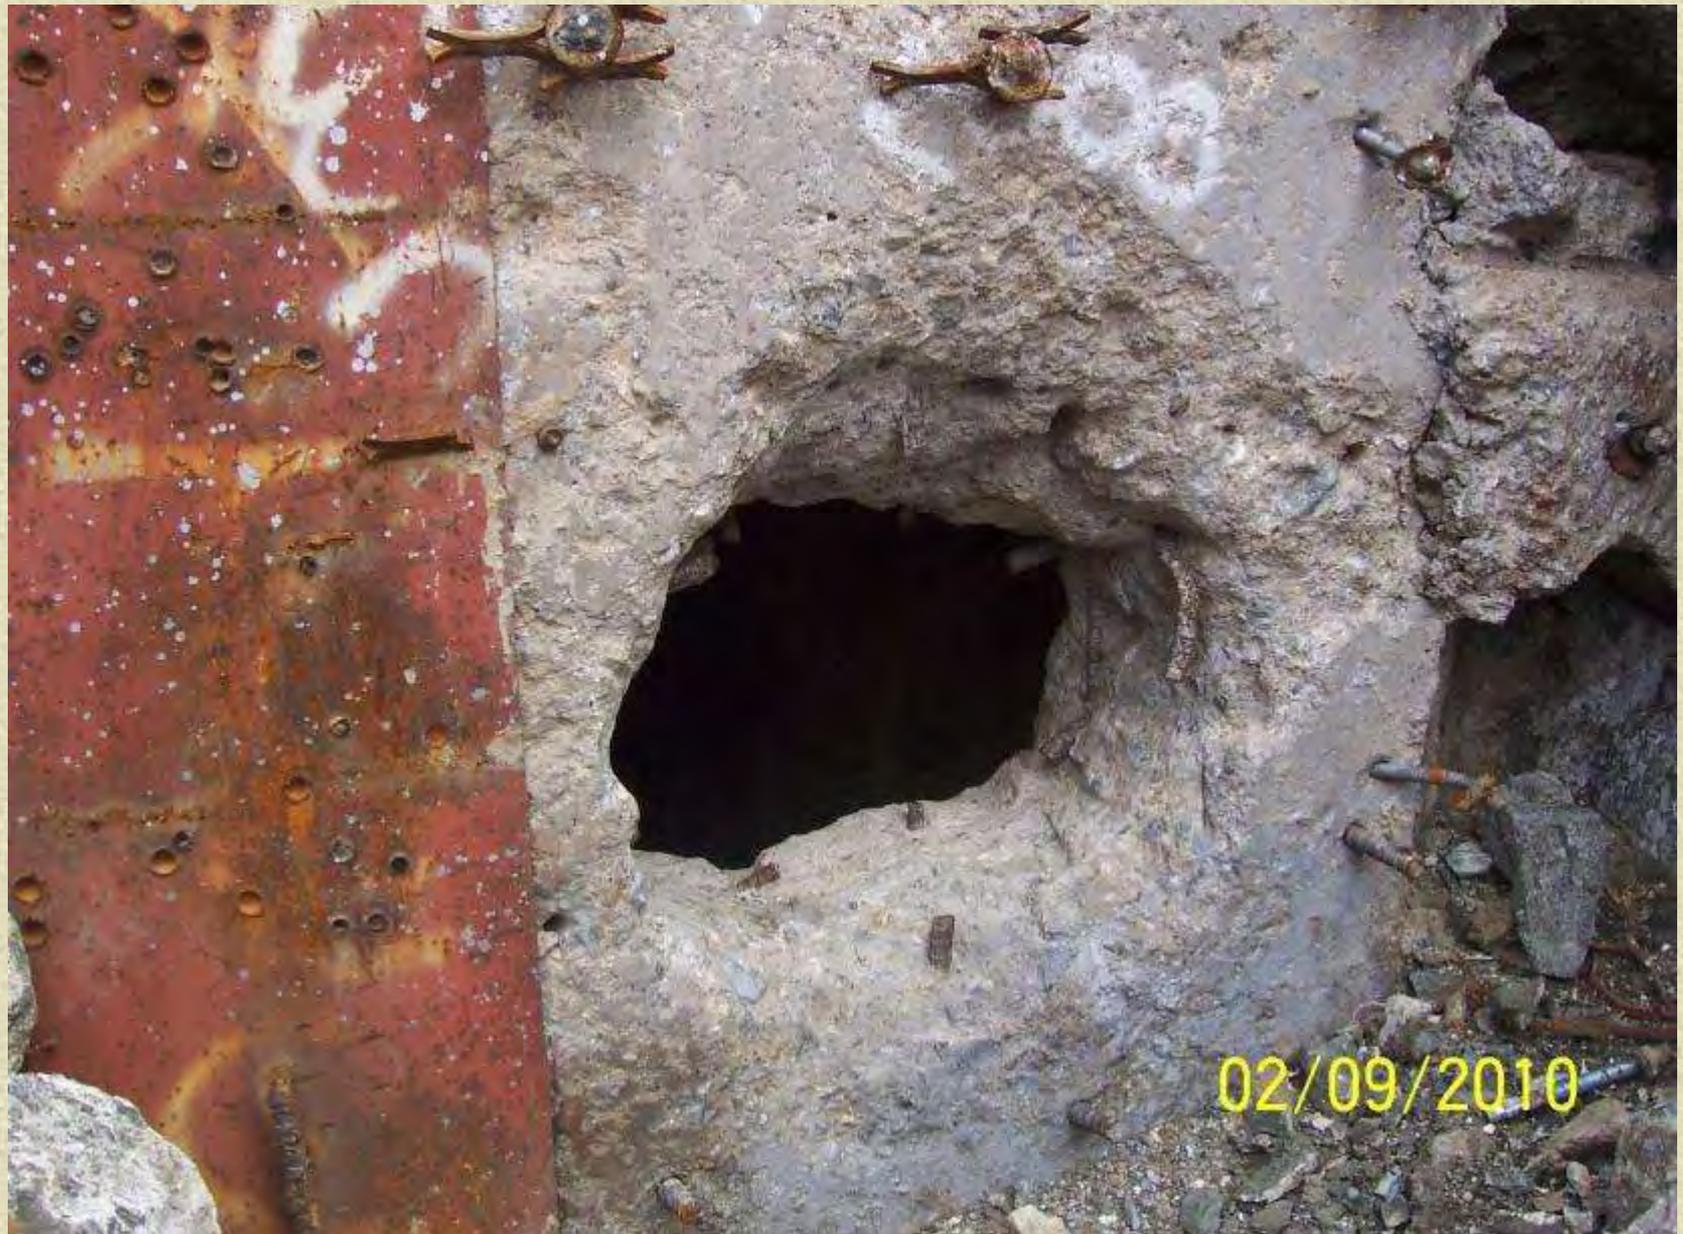
December 30, 2009

Vandals Within 3 Months Succeed, Cut Metal & Concrete, Gain Total Entry Into Mine

Recent Photo of Broken Concrete, Cut Rebar

- **Need Permanent Fix, Needs To Be Vandal Proof**
 1. **Blast Shut, Not Available for Any Future Use, Exploration or Development for State Teachers Retirement System?**
 2. **Cover With 10' Mine Waste Rock, Blend with Hillside?**
 3. **Bat Compatible Closure?**
- **Need to Consider Bats and Other Wildlife Since Open**
- **Internal Survey With Dr. Pat Brown in Next Few Weeks**
- **CSLC To Discuss Options with DOC OMR Along With CDFG, SHPO to Find Best Solution!**
