CALIFORNIA GEOLOGY

January 1979

SOUTHERN CALIFORNIA LANDSLIDES —1978—

BLUEBIRD CANYON LANDSLIDE OF OCTOBER 2, 1978 LAGUNA BEACH, CALIFORNIA

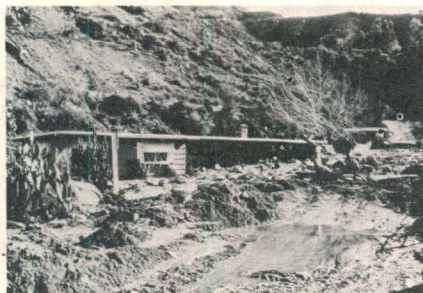
View north shows house in Tujunga at mouth of small canyon on south side of San Gabriel Mountains. House was inundated both by debris from flooding in the canyon and from debris flows from slopes above on the south edge of Verdugo Hills cemetery. The terrain in this area was burned over by a large fire in 1975. Similar damage was widespread in the region.

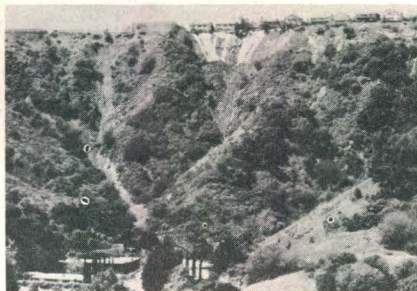
View west across Benedict Canyon, eastern Santa Monica Mountains, City of Los Angeles. Soil slip scars which severely damaged houses are shown at left. Path of debris flows, which followed the existing canyon drainage, can be seen in left center of photo.

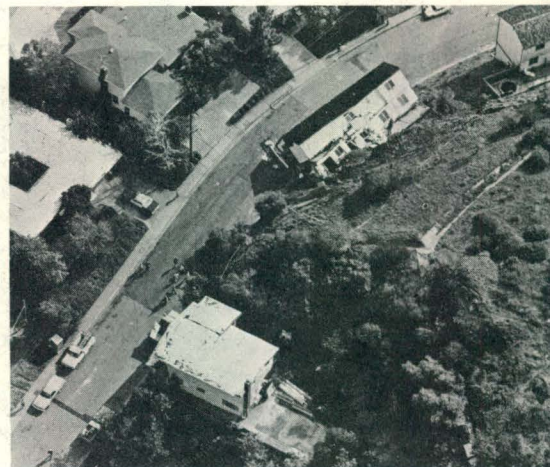
Tarzana area, City of Los Angeles; north flank of Santa Monica Mountains. Bedrock landslide (block glide), moving down slope (south to north) severely damaged houses at toe of slide. Houses out of view at head of slide were also damaged. The house that is pushed off its foundation and the house shown in upper right corner of photo were built within the last few years.
Photo by Mark Malone, KMPC.

Bedrock landslides on the northern side of the Santa Monica Mountains mostly occurred as block glides along gently north-dipping bedding planes in shale of the Modelo Formation. This slide potential has been a long recognized problem. Numerous problems also occurred on slopes of the Santa Monica Slate of Mesozoic age and in the siltstone and sandstone of the Topanga Formation (middle Miocene).

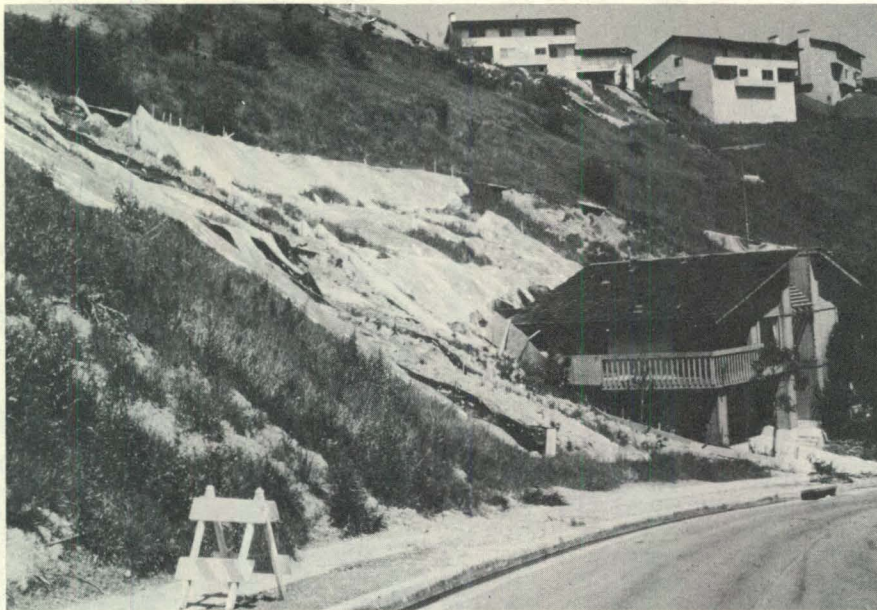
Hacienda Heights, Puente Hills; view southwest. Erosion and supersaturation of slopes beneath bench drains resulted in sloughing and debris flows which seriously damaged house in tract developed during 1970s. This was a widespread problem in this region.

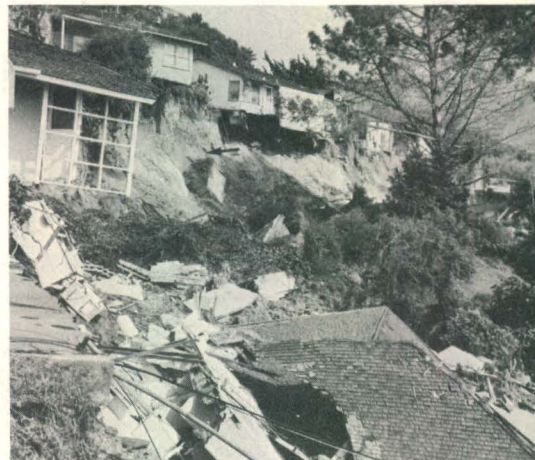
Photo 1. Closeup of headscarp, looking northeast. Arrow pointing to area above concrete slab shows where evidence of older slide plane was found. Exposed bedrock in the headscarp is silty sandstone of the Miocene Topanga Formation. *Photo courtesy City of Laguna Beach.*

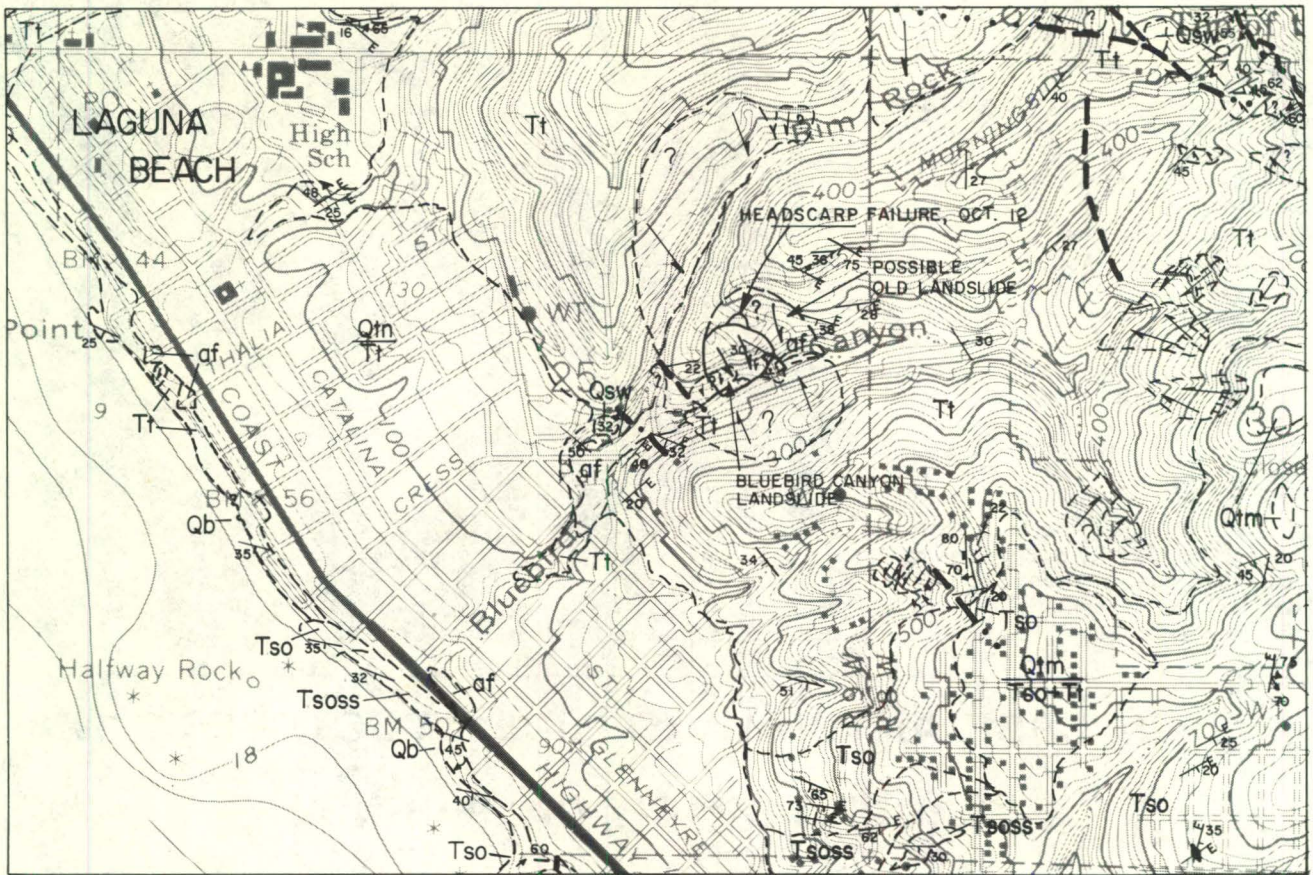
Figure 1. Bluebird Canyon landslide. Map adapted from California Division of Mines and Geology Special Report 127, Plate 1.

Although the Bluebird Canyon landslide covered an area of approximately 3.5 acres, it was suspected by geologists that it was but a portion of a larger, ancient landslide (figure 1). If this was true, the other homes sitting on the unmoved portion of the older slide then were endangered by the possibility of further landslide reactivation. Evidence of the slip surface of this older landslide was found during early examination of the headscarp area of the new slide (photo 1). The landform shown in photo 2 could then be interpreted as possibly the headscarp of this prehistoric slide. In any case the homes immediately uphill from the landslide were in danger from further degrading of the steep headscarp, which is as high as 35 feet.

The basal slip surface of the slide apparently lies along a bedding plane in the underlying bedrock, as the attitude of the surrounding Topanga Formation (Miocene) is close to being parallel with the slope of the hillside. This unstable "dip slope" condition was recorded in previous geological surveys of the area; however, the tract of ill-fated homes was built long before these reports were published and prior to the institution of grading and building codes.

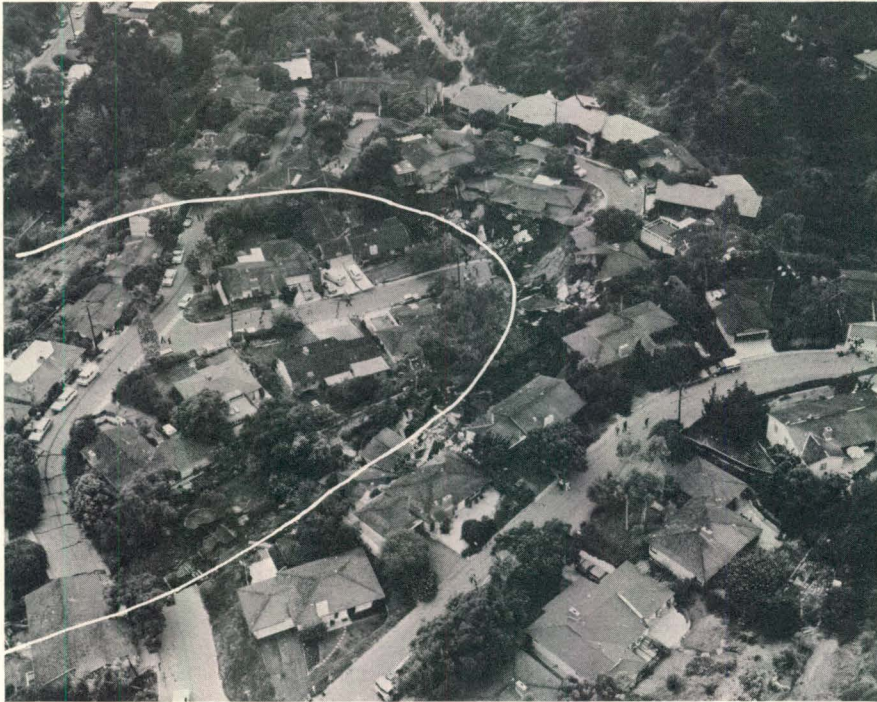
Photo 2. Aerial photo of Bluebird Canyon landslide, looking northeast. *Photo courtesy of City of Laguna Beach.*

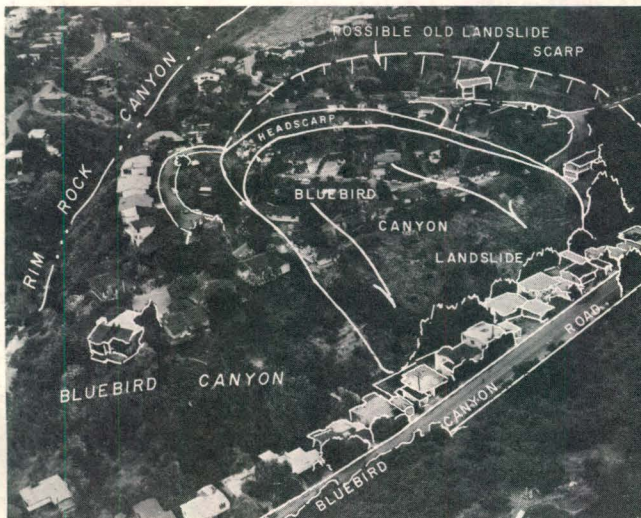
The Bluebird Canyon landslide was determined to be a "block glide" or "rock block" slide — a slide with little or no rotational movement. The slide mass remains fairly intact during its descent (photos 4, 5).

Photo 4. Aerial photo of slide looking southwest with Bluebird Canyon and Bluebird Canyon Road in the upper left corner. Solid line delineates the slide area. Note that the central portion of the slide is intact and the lack of tilting as evidenced by still-vertical telephone poles. *Photo courtesy City of Laguna Beach.*

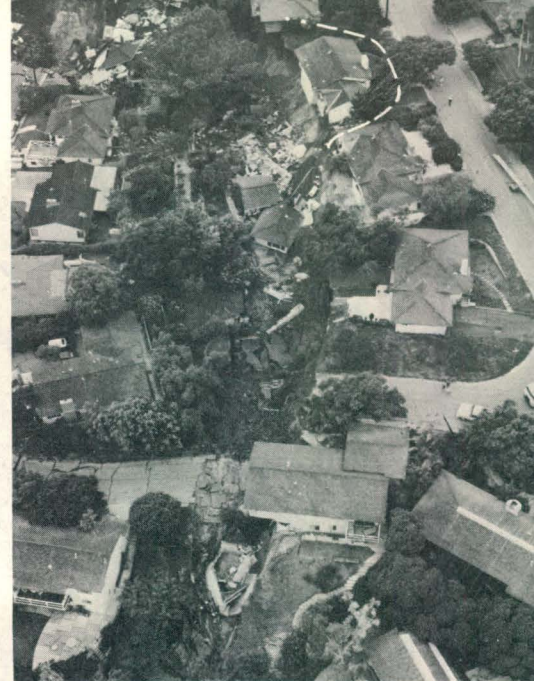
On October 12, ten days after the slide began moving, a small section of ground gave way in the headscarp, taking with it another house (photo 3).

Photo 3. Aerial photo of headscarp area taken the day of the slide (October 2, 1978). Dashed outline is the area which failed 10 days later, illustrating the instability of the ground behind the October 2 headscarp. View looking northeast. *Courtesy of City of Laguna Beach.*

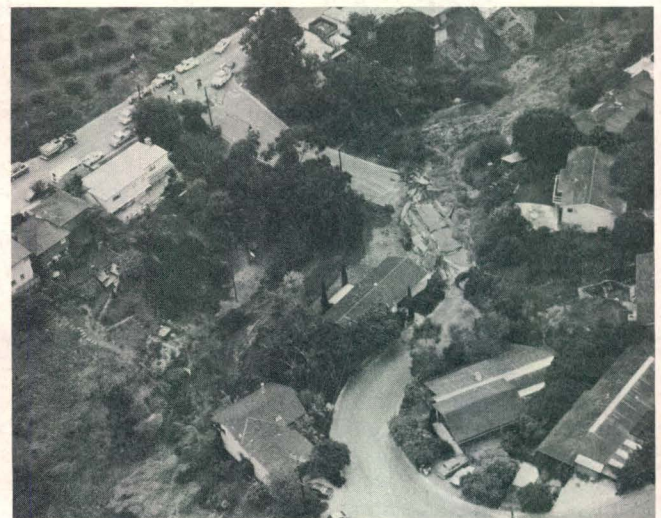
Photo 5. Aerial photo of easternmost toe area of slide. Note butting effect of road fill ("af" on figure 1) where Oriole Drive crosses Bluebird Canyon. View toward the southwest. *Photo courtesy City of Laguna Beach.*

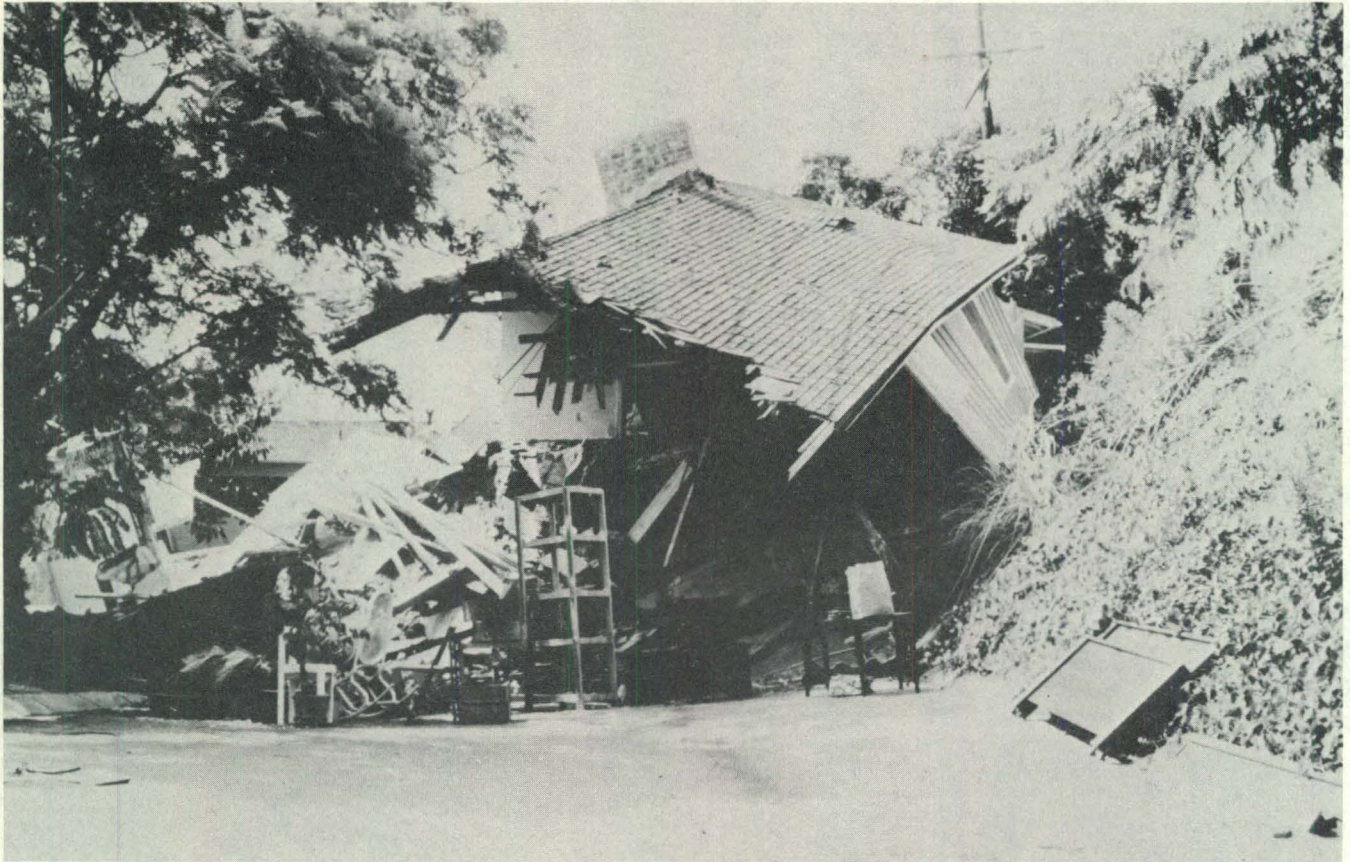
The Bluebird Canyon landslide damaged or destroyed more than 50 homes in a Laguna Beach hillside development. This house was destroyed when landslide movement began on October 2, 1978. For location of house, see upper left quadrant of lower left photo on front cover; see article, p. 5. *Photo courtesy Slosson and Associates.*
