**CORRELATION BETWEEN RECORDED BUILDING
DATA AND NON-STRUCTURAL DAMAGE DURING
THE 1989 LOMA PRIETA EARTHQUAKE**

Data Utilization Report CSMIP/94-04

California Strong Motion Instrumentation Program

April 1994

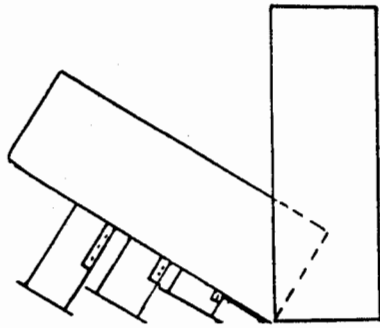
FLOOR 7 - File Cabinets Overturned

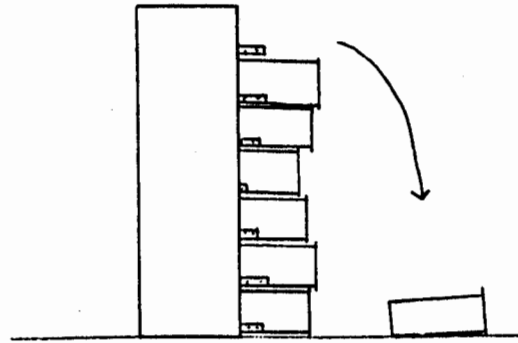
FLOOR 7 - Drawer Thrown From Cabinets

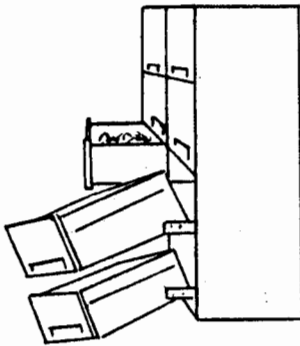
FLOOR 11 - Lower Drawers in the File Cabinets Opened and Twisted off Tracks

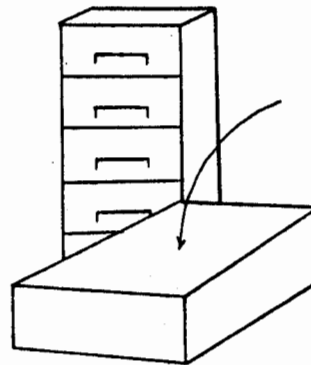
FLOOR 7 - File Cabinets Tipped Forward with Drawers Closed

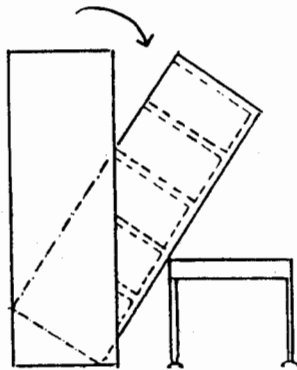
FLOOR 7 - Open Faced Bookshelves Tipped Backward

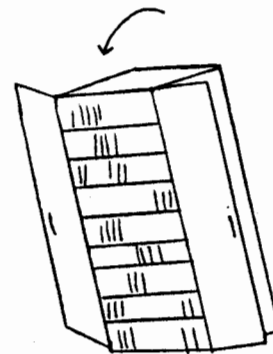
FLOOR 7 - Storage Cabinet Tilted Approx. 30° Doors Opened, Contents Strewn
