**OBSERVATIONS FROM THE APRIL 20, 2013 LUSHAN COUNTY,  
YA'AN CITY, SICHUAN PROVINCE, CHINA EARTHQUAKE**

Marshall Lew

AMEC Environment & Infrastructure, Inc.  
Los Angeles, California

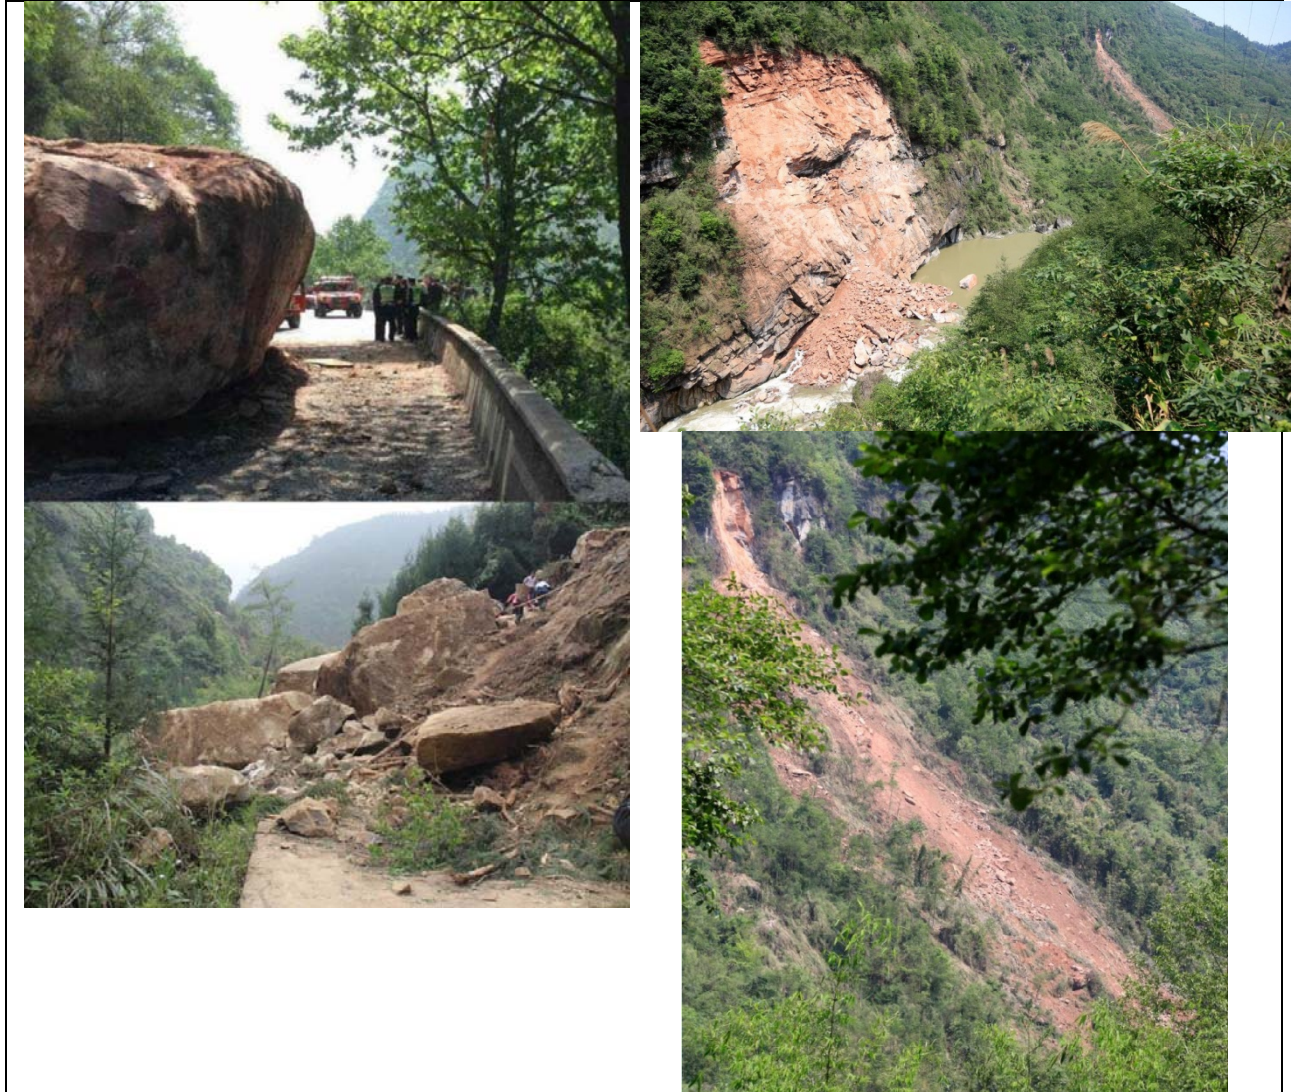
As in the Wenchuan earthquake, there were many landslides and rockslides in the mountainous terrain (see Figure 6). As the terrain in the Longmenshan Mountains is generally very steep, these slides often damaged and blocked roads that were in canyons, along rivers and on the sides of the slopes. Although the earthquake did not occur during the rainy season, precipitation is common in the mountains and landslides and rockslides occur often even in the absence of strong ground shaking. Slides were also observed to have obstructed rivers; there was early concern about a barrier lake formed on the Yuxi River in Mingshan County (IFRC, 2013). It was not uncommon to encounter huge boulders being dislodged from the steep mountainous

Fig. 6. Rock and Landslides in Lushan area. Photographs courtesy of Prof. Liu Aiwen.

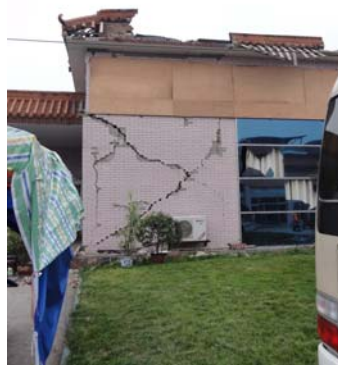
Fig. 8. Damage to Lushan County Government Building.

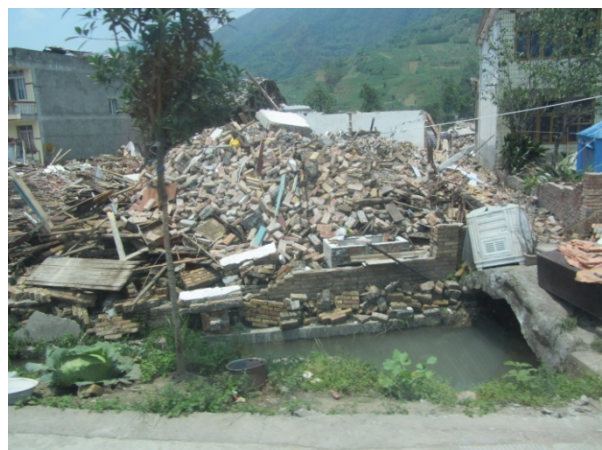
Fig. 9. Debris from collapsed building (Photo by Dr. Craig A. Davis).

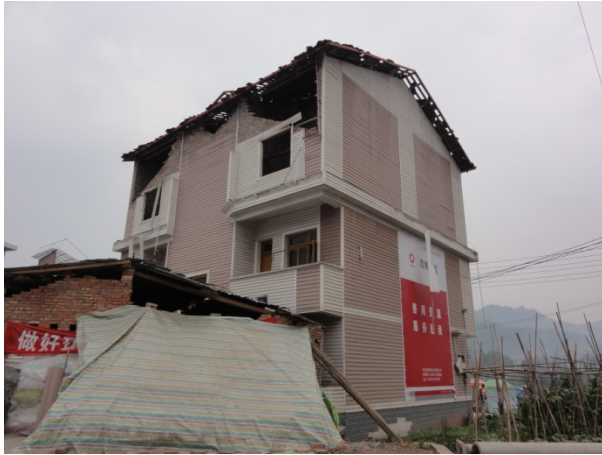
Fig. 10. Damaged residential building of brick construction.

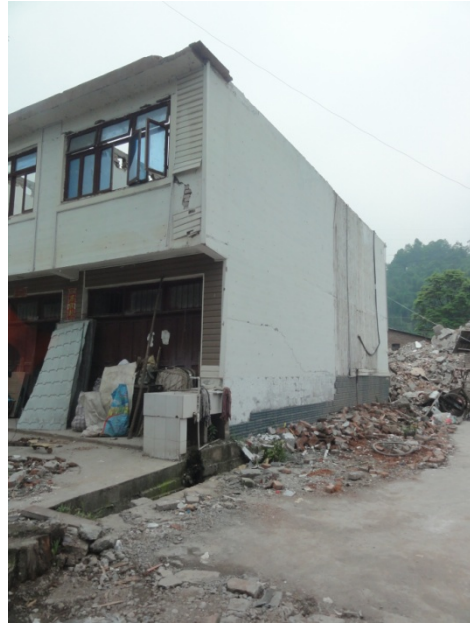
Fig. 11. Damaged building with roof collapse.

Older buildings clearly did not perform well in this earthquake. Under the older Chinese Building Code, buildings in the Chengdu region were designed for a ground acceleration of 0.10g. There is also an obvious lack of attention to detailing of connections, such as roof anchorage as shown in Figure 11. There is also common use of brick and mortar without adequate reinforcement or confinement as seen in Figure 12.

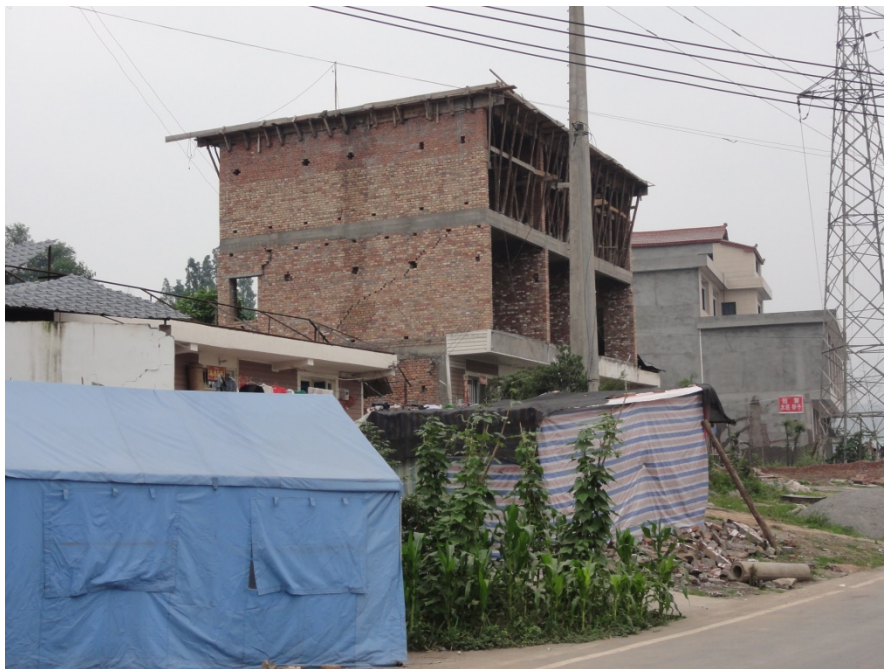
Fig. 12. Predominantly brick building without adequate reinforcement or confinement; note shear failures in wall at the second story.

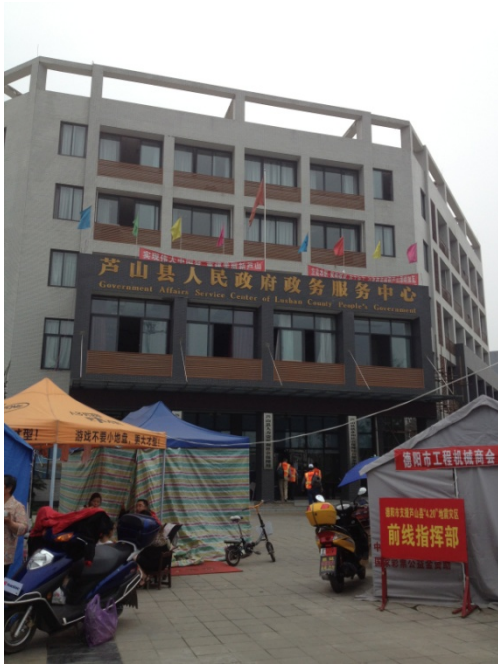
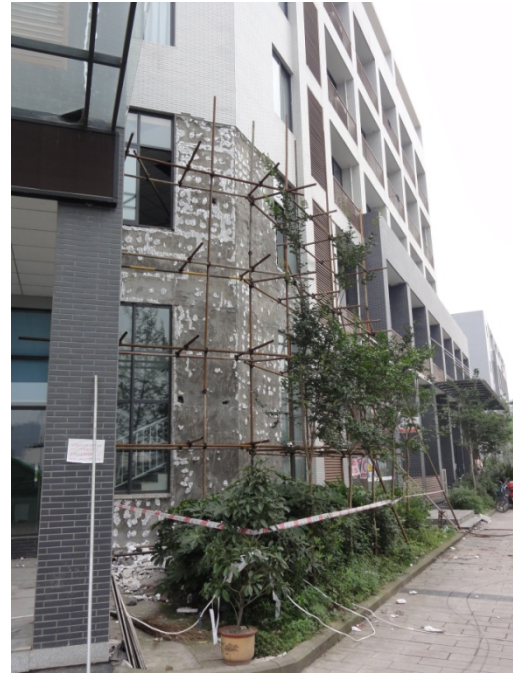
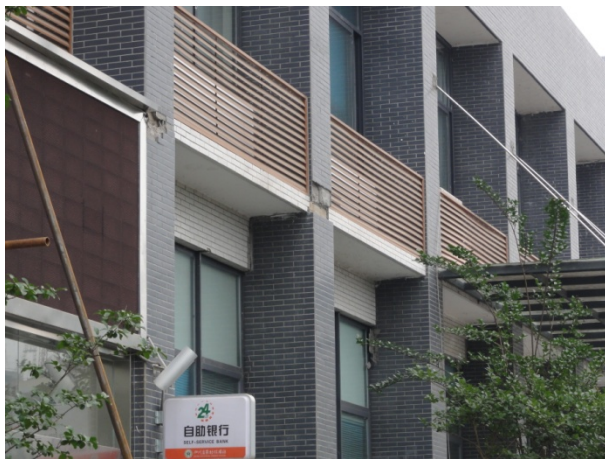
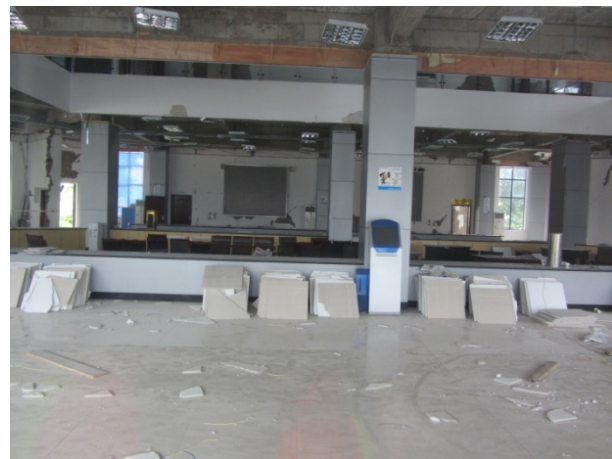
The construction in the New Lushan Town should be governed by the updated seismic design requirements which were increased after the Wenchuan earthquake. It appeared from the exterior that the newer buildings had relatively less damage; however, as seen in Figure 15, the government building was found to be vacated with visible non-structural and minor structural damage. In the interior of the ground floor, ceiling tiles had fallen from a suspended ceiling and non-structural (infilled) walls were observed to be cracked.

(a) Front of Lushan County Building

(b) Damaged exterior tiles removed

(c) Development of hinges at joints

(d) Distress to ceiling tile and light fixtures; damage to non-structural walls. Photo by Dr. Craig A. Davis.

Fig. 15. Vacated Government Affairs Service Center of Lushan County People's Government Building.

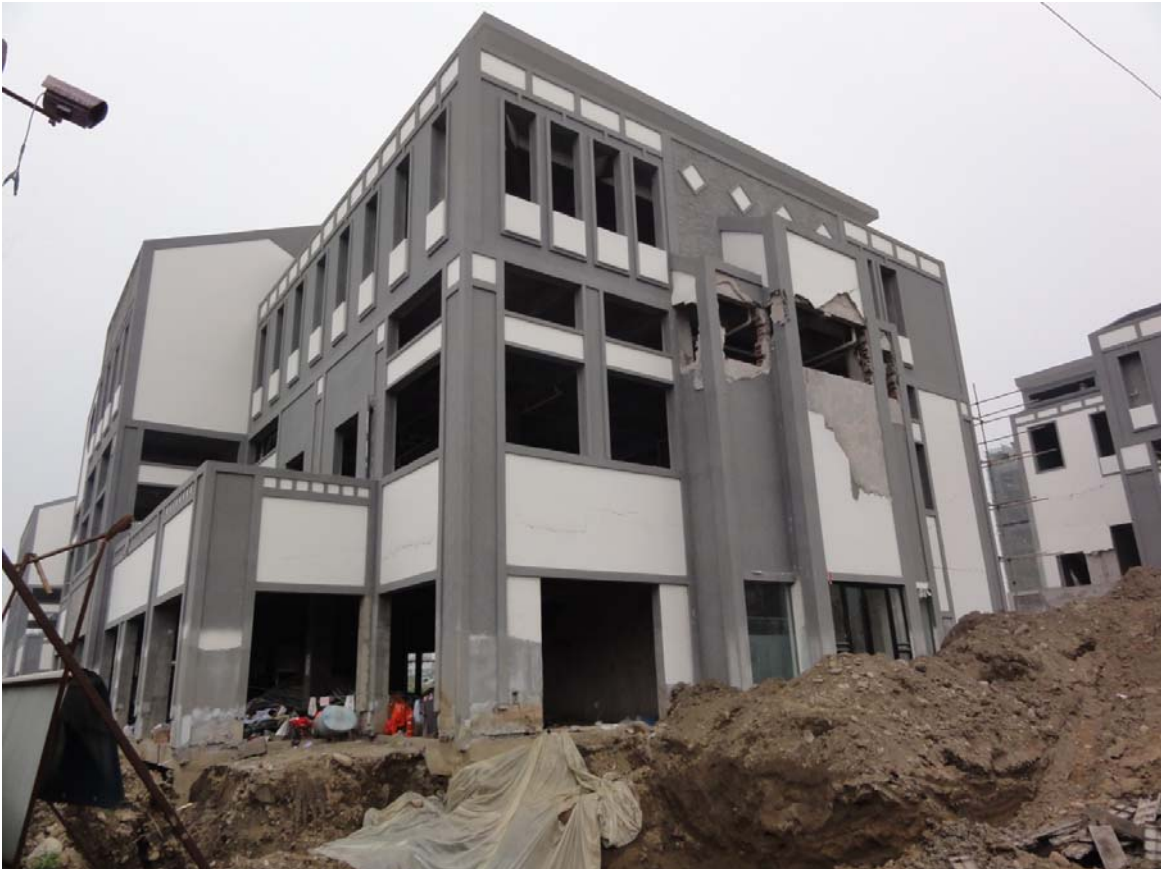
The construction practice of using brick infill between beams and columns is quite prevalent in China. Figure 16 shows a new commercial building under construction which used this system; it can be seen that the infill is subject to out of plane failures as there is lack of reinforcement and inadequate confinement.

Fig. 16. New commercial building under construction with damage to brick infill.

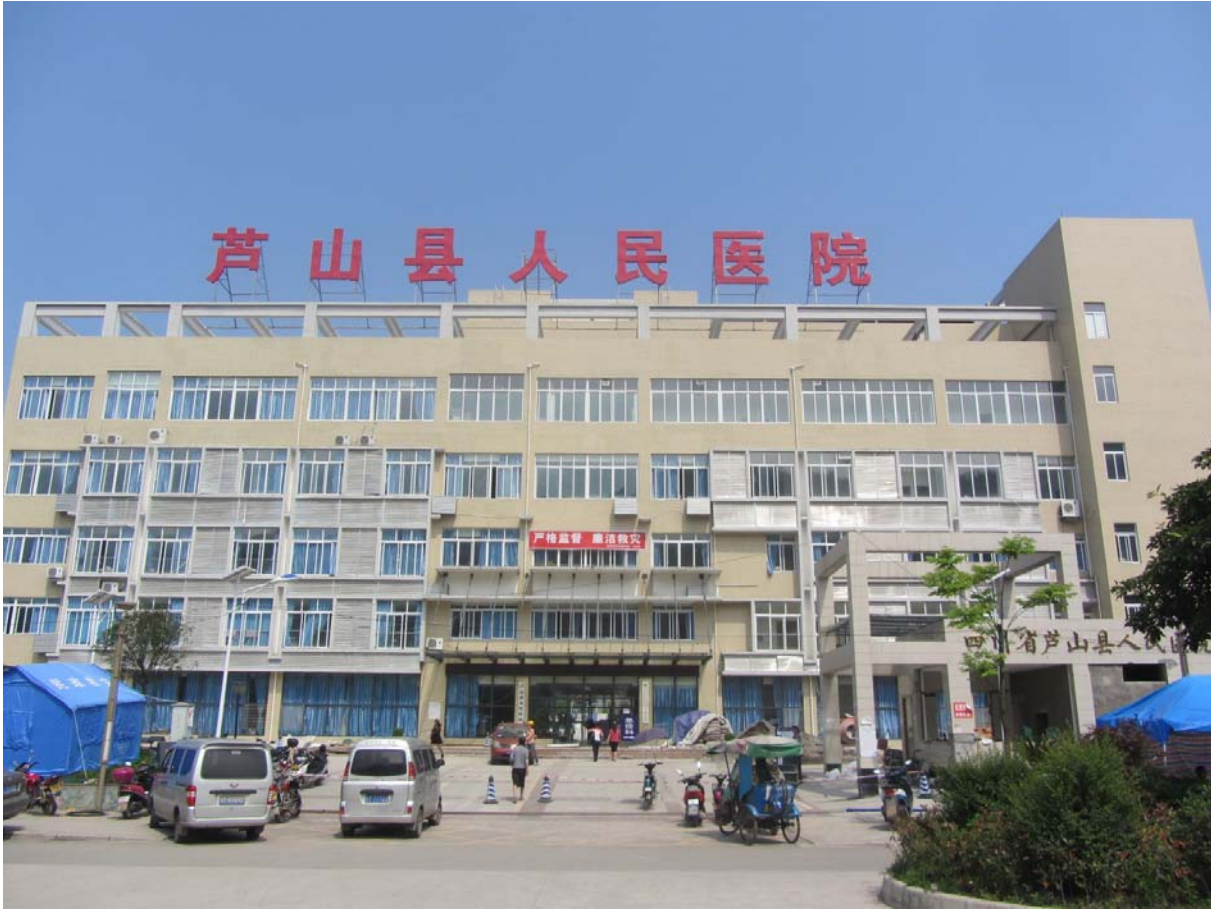
One high point in the observations was the Lushan County People's Hospital Outpatient Building which experienced essentially no structural or non-structural damage during the earthquake; see Figure 17. The building is base isolated on 83 rubber bearings that are 500 to 600 mm in diameter (Best News, 2013a). It is reported that the building was completed in May 2012 and entered service in January 2013; there was no structural damage to the building and minimal impact on non-structural elements, glass or contents (Best News, 2013b). It was reported that some latex paint fell off and a few exterior tiles were shed during the earthquake. It was stated that the building was designed for seismic intensity VII, although it may have experience intensity of up to IX. The design and construction of the outpatient building was funded by the Macau SAR government.

Fig. 17. Base-Isolated Lushan County People's Hospital Outpatient Building. Photograph courtesy of Dr. Craig A. Davis.

Despite the seemingly excellent structural and non-structural behavior of the outpatient building, it was reported by Davis (2013) that water lines servicing the building from the outside were damaged because flexible connections were not provided at the isolation interface; electrical service was reportedly interrupted in the earthquake due to the powergrid going down; however, power cables to the building reportedly had sufficient slack across the isolation interface and did not break. It is unknown if the building had a back-up power system. It is questionable if the repairs to the water service have provided the flexible connections needed for a base isolation system.

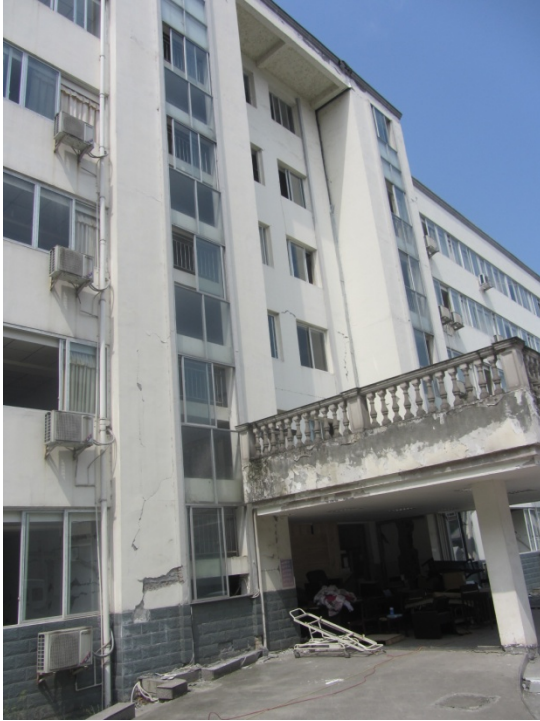
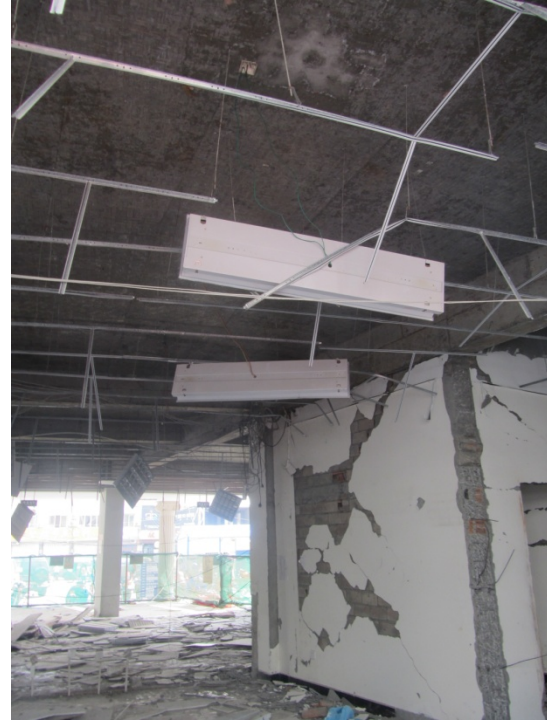
In contrast to the outpatient building, other buildings at the County People's Hospital had substantial damage to structural and non-structural elements which caused the buildings to be vacated as shown in Figure 18. Although the structural frames appeared to be relatively intact, the infill and non-structural walls consisting of masonry elements sustained substantial damage. Suspended ceiling systems did not perform well as T-bars sometimes broke causing ceiling tiles and light fixtures to be displaced and sometimes falling down or left dangling.

(a) Exterior of Lushan County People's Hospital

(b) Interior of Lushan County People's Hospital

Fig. 18. Lushan County People's Hospital, adjacent to Outpatient Building. Photos by Dr. Craig A. Davis.

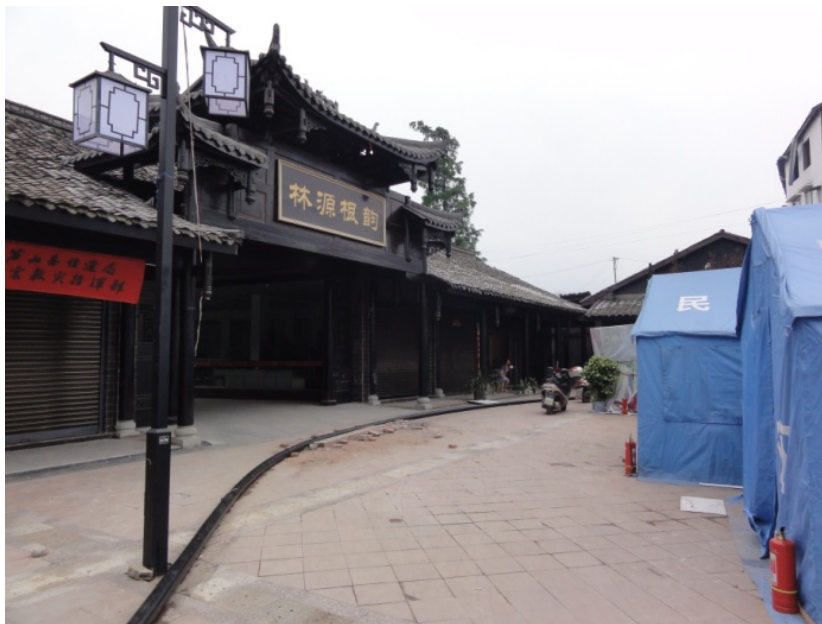
Fig. 19. Temporary above ground water pipe (foreground).

The underground water system was apparently severely damaged and above ground pipes were laid throughout the town providing water service as shown in Figure 19.

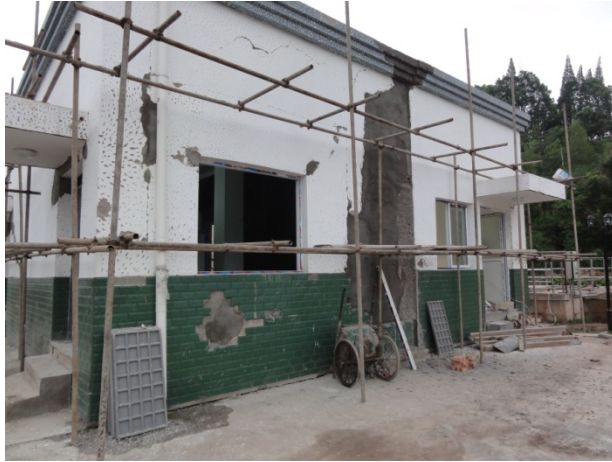
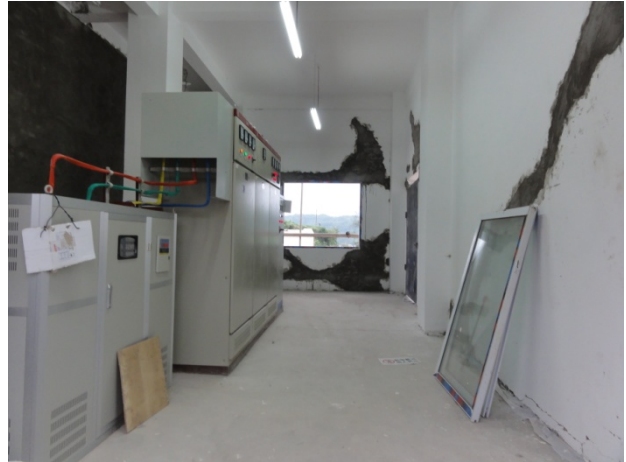
walls, but the treatment tanks did not appear to have any major damage although it appeared that some piping had been replaced. The control buildings were apparently reinforced concrete frame structures with masonry infill. The masonry infill failed in shear and sometimes failed out-of-plane. Repairs to these facilities were being undertaken at the time of visitation about five weeks after the earthquake and appeared to be mostly patching and returning the structures to essentially the pre-earthquake conditions at best; see Figure 20.

(a) Exterior of control building

(b) Interior of control building

Fig. 20. Damaged water treatment plant control building in Lushan undergoing earthquake repairs.

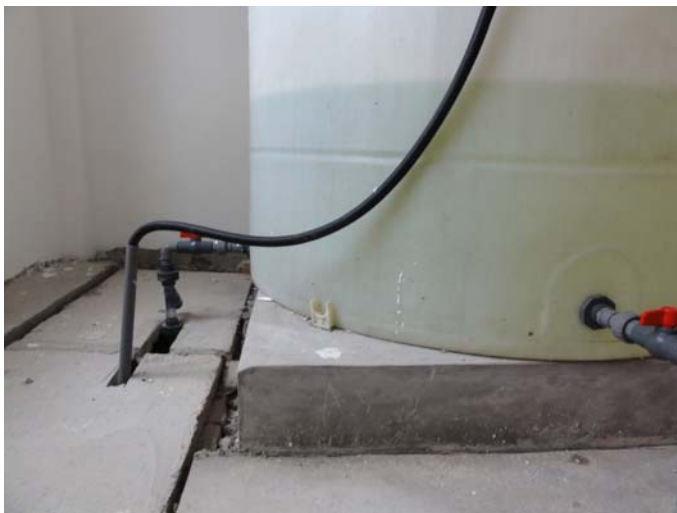
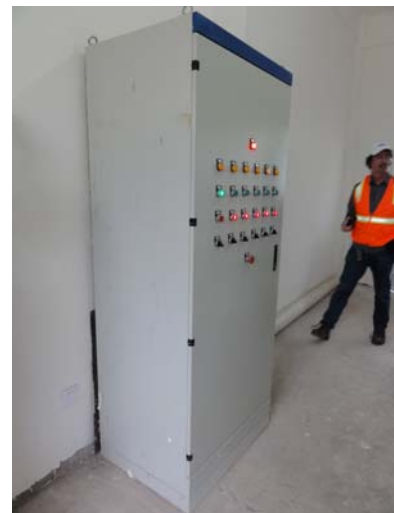
Control equipment, storage tanks, and water treatment mixing equipment did not appear to have adequate bracing and some equipment showed evidence of displacement from their initial locations. There was no evidence that these facilities would be retrofitted to provide adequate bracing; see Figure 21.

(a) Inadequately braced chemical tank

(b) Unbraced control equipment

Fig. 21. Inadequately or unbraced equipment at Water Treatment Plant.

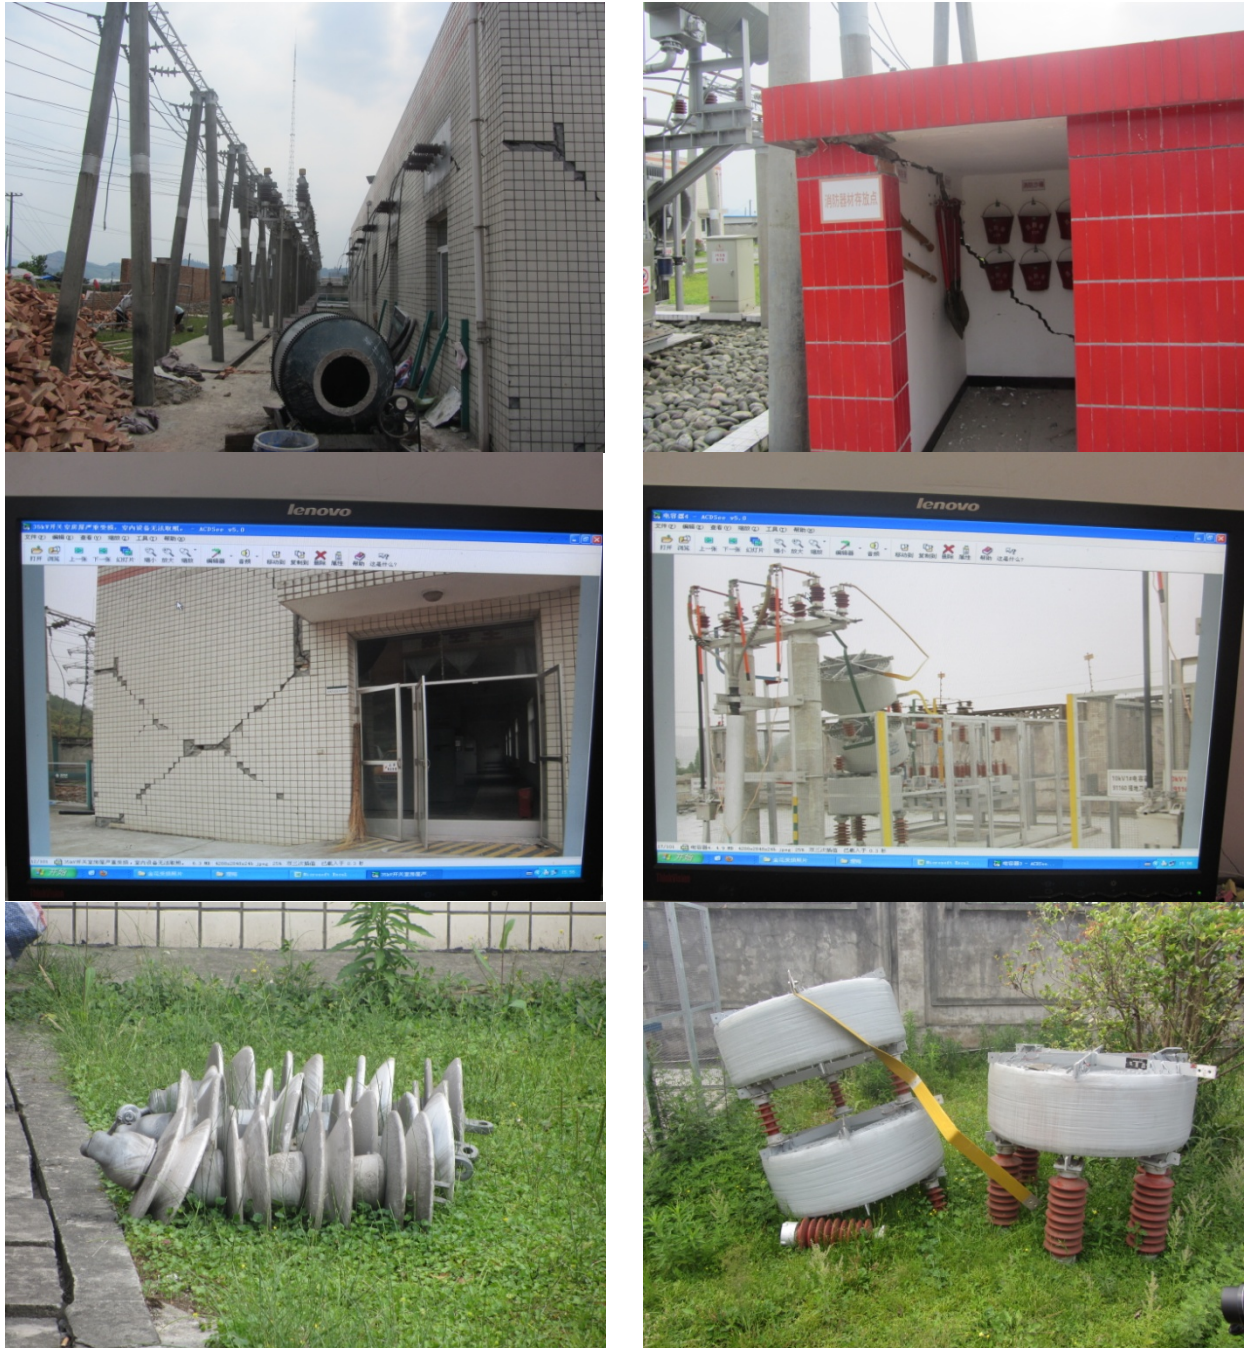
It was reported that electrical power was lost in large parts of the region, including Lushan and Baoxing, as a result of the earthquake. In May 2013, the ASCE TCLEE team visited the State Grid Corporation of China Jinhua 110kV Transformer Substation which is one of several substations which provide power for the Lushan County region. There was severe damage to the structures and transformers at this facility as shown in Figure 22.

Fig. 22. Damage at the Jinhua 110kV Transformer Station. Photographs by Dr. Craig A. Davis.

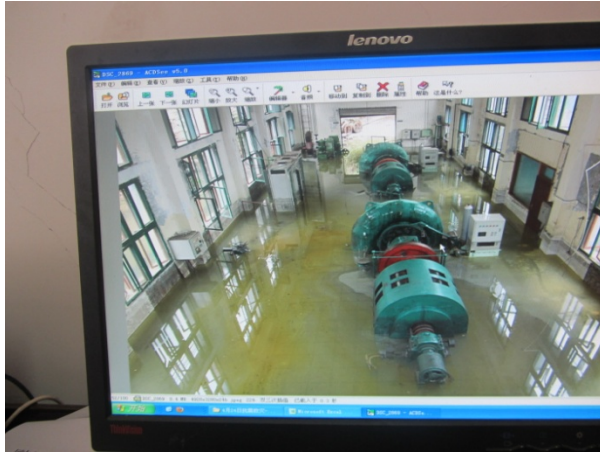
It was also reported that hydropower plants were also affected (Sichuan Provincial People's Government 2013); Figure 23 shows a hydropower plant that was flooded and rendered inoperable at the time of the earthquake. In the mountains, downed power lines were caused by landslides which caused some transmission tower collapses as shown in Figure 24.

Fig. 23. Hydropower plant made inoperable by flooding. (Photograph by Dr. Craig A. Davis)

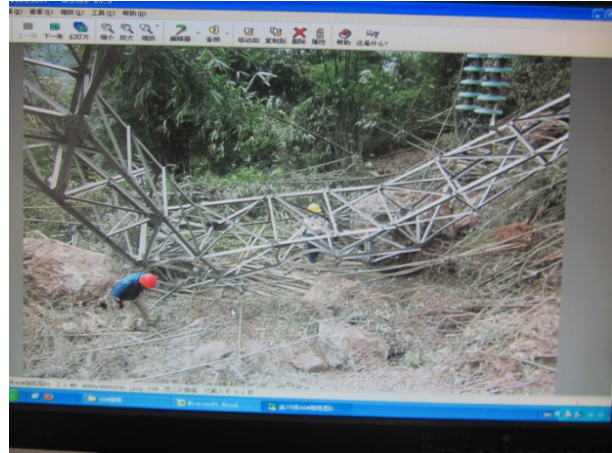
Fig. 24. Transmission tower collapse. (Photograph by Dr. Craig A. Davis)
