CALIFORNIA GEOLOGICAL SURVEY  
FAULT EVALUATION REPORT FER-271

Main Strand of the SAN CAYETANO FAULT  
in the Fillmore Quadrangle  
Ventura County  
California

by  
Brian P.E. Olson  
February 18, 2021

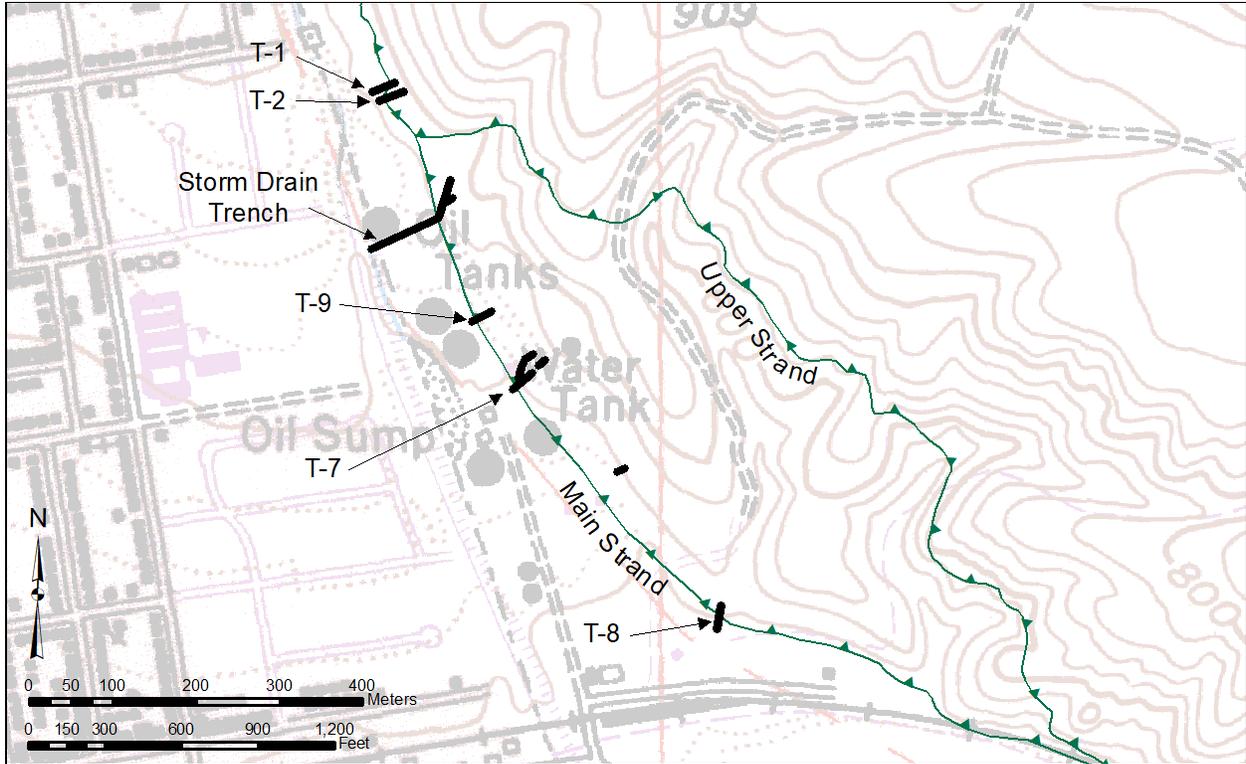
Figure 3. Mapped fault traces and trench locations from the URS (2014) fault investigation. Labeled fault trenches are specifically mentioned in the text.

URS conducted a fault investigation in 2014 as part of their overall geotechnical study of the Fillmore Works site, a former oil refinery and crude oil pumping facility east of Fillmore at the base of the mountains (Locality 1 on Plate 1). A total of 10 trenches were excavated to locate the surface trace of the SCF (Figure 3). They began with two fault trenches (Trenches 1 and 2) excavated across a distinct geomorphic scarp. The trenches ranged from 90 to 95 feet long and were on the order of 10 feet deep. They exposed the SCF, which thrust Modelo Formation bedrock over Holocene alluvium in both trenches. Trench 1 encountered the fault in the extreme northeastern end where it dipped  $20^{\circ}$  northeast at the bottom of the trench and steepened to  $60^{\circ}$  at the surface (Figure 4a). Much more of the fault was observed in Trench 2 where pervasively sheared Modelo bedrock was thrust over alluvium. The fault enters the bottom of the trench dipping  $6^{\circ}$  east, flattens to nearly horizontal, and steepens to about  $36^{\circ}$  as it emerges to the surface. Subsequent to these initial trenches, URS excavated an additional seven fault trenches at the site. URS geologists observed individual strands of the SCF in Trenches 7 through 9, even though there were logged from the surface only due to trench safety concerns (Figures 4b and 5). Each of these trenches exposed the fault wholly within the alluvium. Additionally, the consultants logged an open storm drain trench excavated at the site across the trace of the SCF. This trench exposed the fault where it thrust alluvium over colluvium. Lastly, the URS consultants drilled 16 hollow-stem auger borings along a linear transect perpendicular to the fault. Based on stratigraphic anomalies within the alluvium, URS identified active traces of the SCF at the eastern end of the transect.

URS also inferred an "upper strand" of the San Cayetano Fault zone in the foothills east of the project site based on an exposure of over Modelo Formation bedrock over older alluvium in a railroad right-of-way cut slope (Plate 1). Because this older alluvial deposit is above the Q3 terrace surface it is necessarily older, and the consultants note the older alluvium is most likely late Pleistocene with a maximum age of about 126ka. Therefore, at the latest, this fault initiated in the late Pleistocene, and requires numerous rupture events over that time to bring Miocene bedrock up and over older alluvium. URS did not trench this fault in their investigation, and therefore, conclude "[w]hether or not it is Holocene active is unknown."

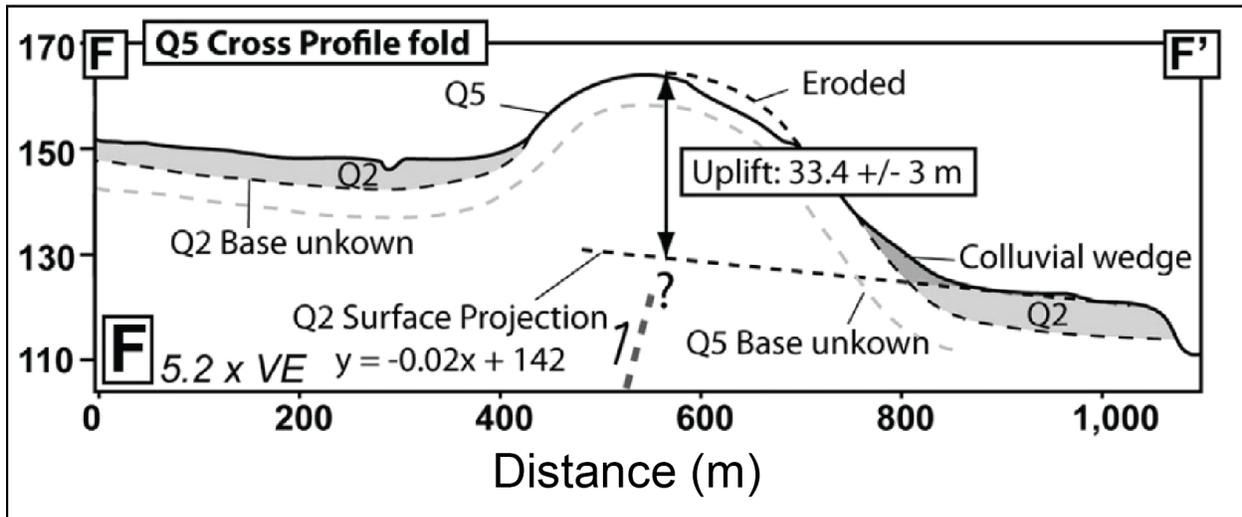
Subsurface data suggested the SSCF dips north between  $50^\circ$  and  $90^\circ$  to a depth of about 100 m where it flattens to approximately  $20^\circ$ . The SSCF would then connect with the main SCF at about 3 km depth. Based on their new alluvial surface dates and fault geometry model, Hughes *et al.* conclude the SSCF initiated about 58 ka at the earliest with an average slip rate over that time of 1.3-1.9 mm/year. Uplift rates calculated for the warped surfaces at the mouth of Santa Paula Creek and Orcutt Canyon range from 0.9-1.6 mm/year. Just west of Timber Canyon the uplift rate is noticeably lower at 0.4 mm/year; however, the folded terrace surface at Locality 2 is uplifting at minimum of 1.9 mm/year. As a result, the authors suggest the SSCF is an active near-surface blind fault along the mountain-front from Adams Canyon to Timber Canyon, where it then steps to the south onto a blind *en echelon* splay beneath the Q5 folded surface in the Santa Clara River Valley (Locality 2 on Plate 2; Figure 6).

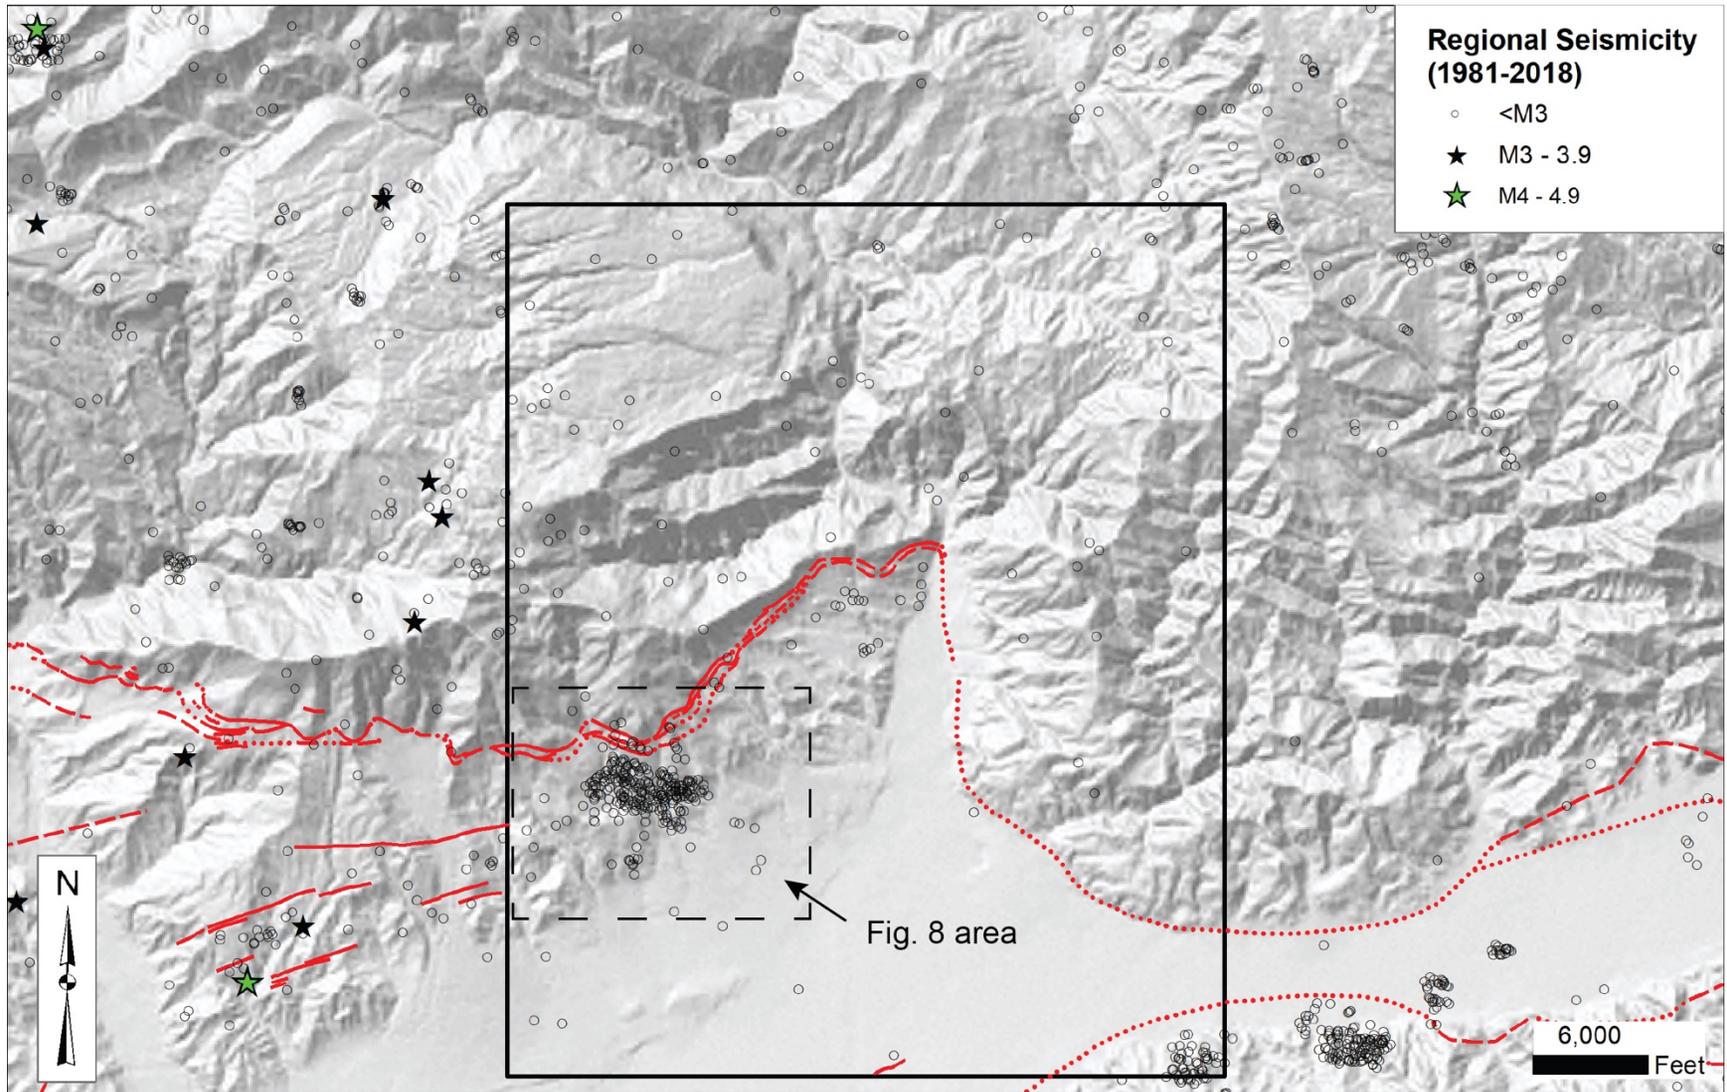
Figure 7. Regional seismicity from 1981-2018 for the Fillmore area. Dashed box highlights epicenters from 2015 earthquake swarm. (epicenter locations from Hauksson et al., 2012)

Regional seismicity data covering the period from 1981 to 2018 (Hauksson *et al.*, 2012) shows a diffuse pattern of low magnitude earthquake activity over the study area with local areas of swarm activity (Figure 7). The most significant of these was the 2015 Fillmore earthquake swarm (Hauksson *et al.*, 2016). This swarm initiated on July 5, peaked on July 9 and 10, and continued with episodic activity until late September. Over 1,400 earthquakes occurred during this time with the largest earthquake being a M2.8 event on July 9. Cross section A-A' through the swarm shows a strikingly planar seismicity zone dipping 26° north (Figure 8). Based on the hypocentral depths, Hauksson and others infer this fault is a westerly extension of the Simi-Santa Rosa fault. However, it is also possible the swarm source is along the low-angle decollement or blind Ventura fault ramp modeled by Hughes *et al.* (2018). Hauksson *et al.* (2016) state the recorded seismicity suggest this swarm was likely caused by metamorphic dehydration, which released fluids that subsequently migrated and increased fluid pressures along the fault zone.

Overall, there is a notable discrepancy between the magnitude of Holocene offsets measured in fault trenches (URS, 2014; Dolan, 2009; Dolan and Rockwell, 2001) and the noted paucity of significant historical earthquakes in the region. Rockwell (1988) points out clearly "the historic seismicity does not represent the long-term activity."

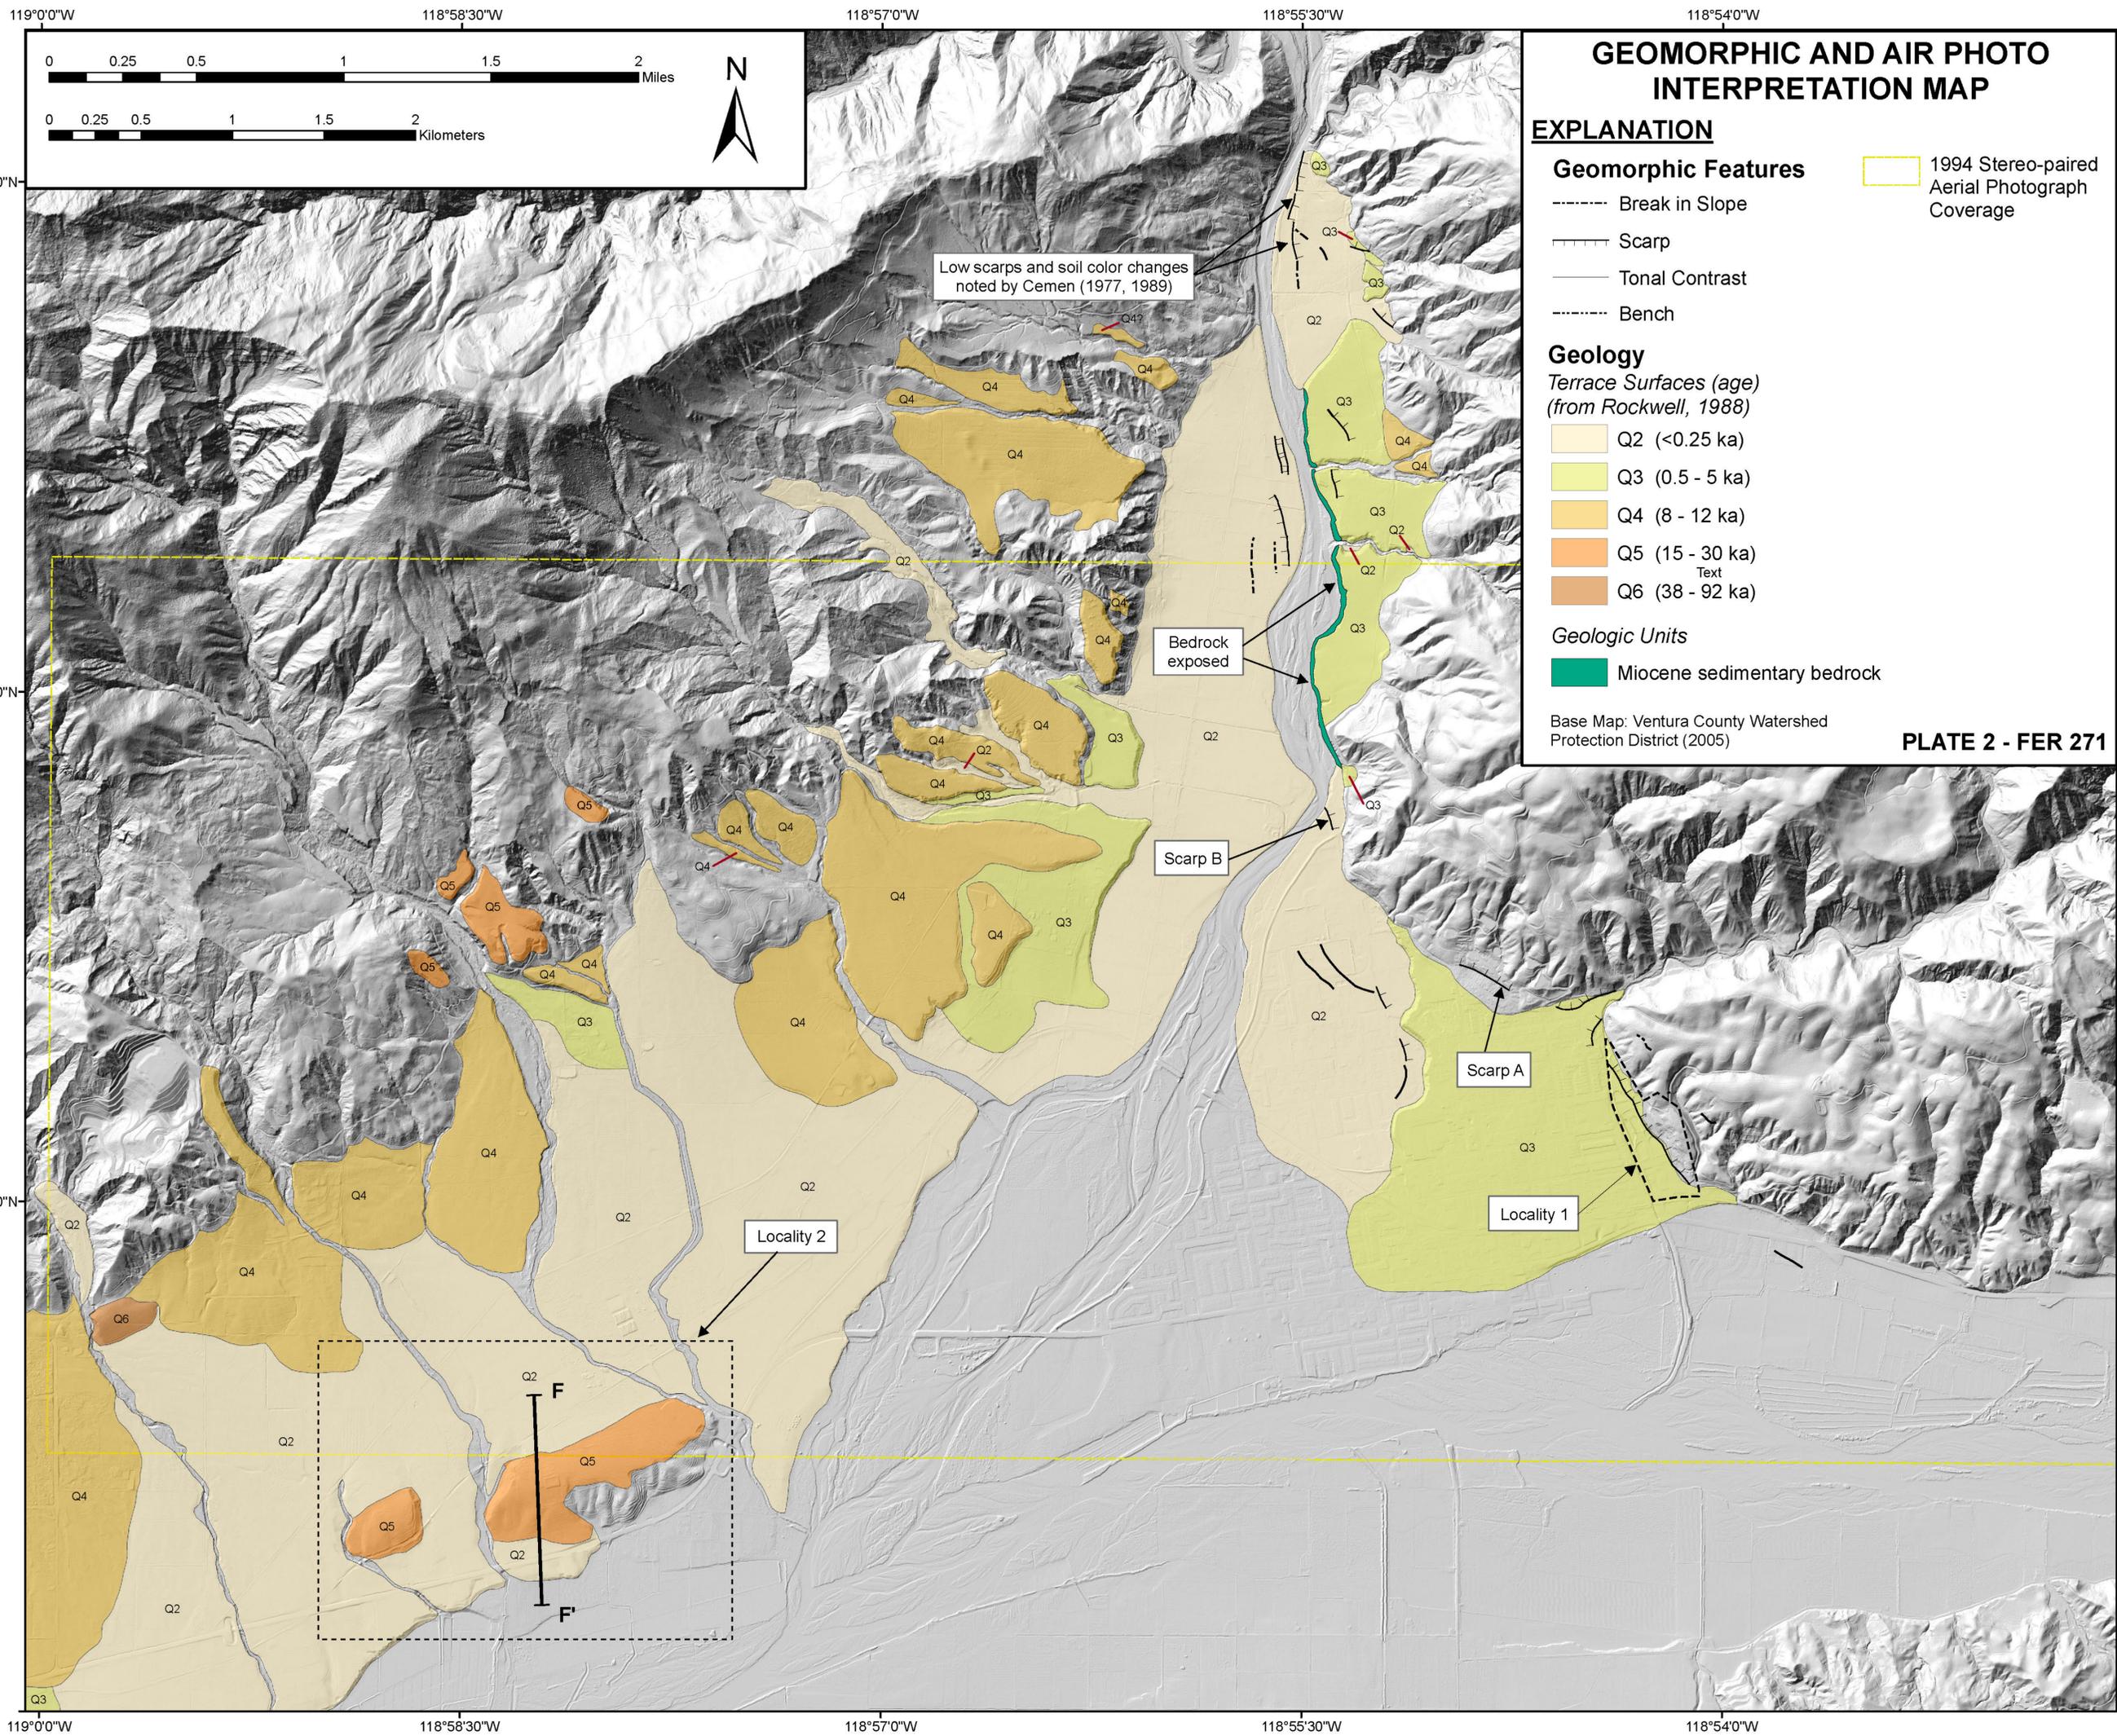
**PLATE 2 - FER 271**

Northwest of the Santa Clara River channel are several Holocene terrace surfaces associated with the alluvial fans emanating from the adjacent mountains and alluvial process related to Sespe Creek. These terraces were mapped and dated by Rockwell (1988) with additional work by Hughes *et al.* (2018). The former Fillmore Works site (Locality 1 on Plate 2) was developed on the Q3 terrace surface in the early 1900s and was continuously operational into the 2000s. As a result, the original topography was extensively modified to create roads, cut slopes, and tank pads. URS (2014) found the fault in various trenches at this site where it displaced Holocene sediments. Additionally, they identified a secondary reverse fault in the foothills above the site to the east with Miocene bedrock thrust over late Pleistocene alluvium. Given its close proximity to the documented active Main Strand at the mountain front and evidence of multiple events since the late Pleistocene, it is reasonable to conclude this strand could rupture along with the Main Strand.

West of this locality the land surface has been largely modified as the city of Fillmore was developed making it difficult to identify geomorphic features or tonal lineaments on aerial photographs. There is a sharp break in slope immediately west of Pole Canyon and a noticeable scarp above it (Scarp A on Plate 2); however, the slope break is within a residential development that was constructed before 1951. For this reason, it is possible this scarp is modified and not natural.

A short scarp preserved in the Q2 terrace north of Fillmore (Scarp B on Plate 2) may be fault-related. It ranges from 1.5 to 2.5 meters high and is subparallel to the mapped trace of the SCF at this location (Plate 1). Additionally, its location at the base of the mountains is consistent with the SCFZ location east of Sespe Creek to Hopper Canyon (Olson, 2012a,b). However, because of the proximity to the Sespe Creek channel and floodplain, the possibility exists that this is an erosional scarp preserved on the abandoned terrace surface.

Farther north, the steep cliffs along the eastern margin of the Sespe Creek channel expose Tertiary sedimentary bedrock (Plate 2). These outcrops are up to 360 m out from the mountain front and underlie the Q3 terrace surface suggesting this section of the alluvial plain is uplifting along with the mountain block to the east. Consequently, the main surface trace is most certainly west of these outcrops. Any previous geomorphic evidence for surface faulting is either buried or was eroded by Sespe Creek; however, the surface trace is most likely immediately adjacent to the eastern channel margin, paralleling Sespe Creek to connect with the easternmost end of the SCF trace mapped by Kahle (1985) near the mouth of Sespe Canyon (Plate 3). This is generally consistent with previously mapped traces of the SCF (Plate 1).
