Watershed Emergency Response Team (WERT) 2024 Lake Fire

CA-LPF-001542 August 15, 2024

REPORT TITLE: Watershed Emergency Response Team (WERT) Evaluation – 2024 Lake Fire

Lake Fire – WERT REPORT EXECUTIVE SUMMARY

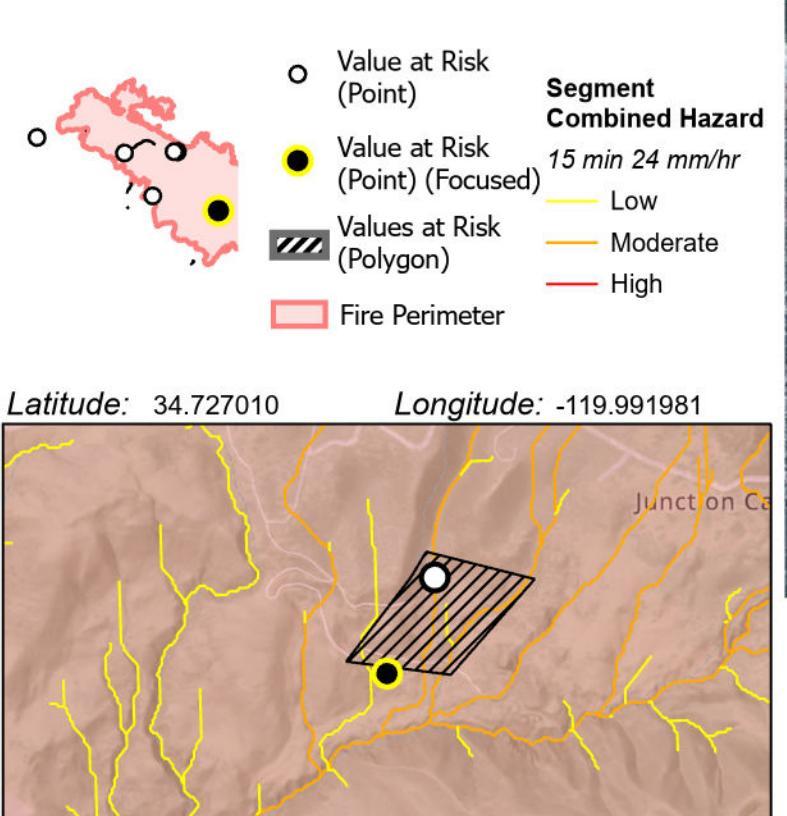
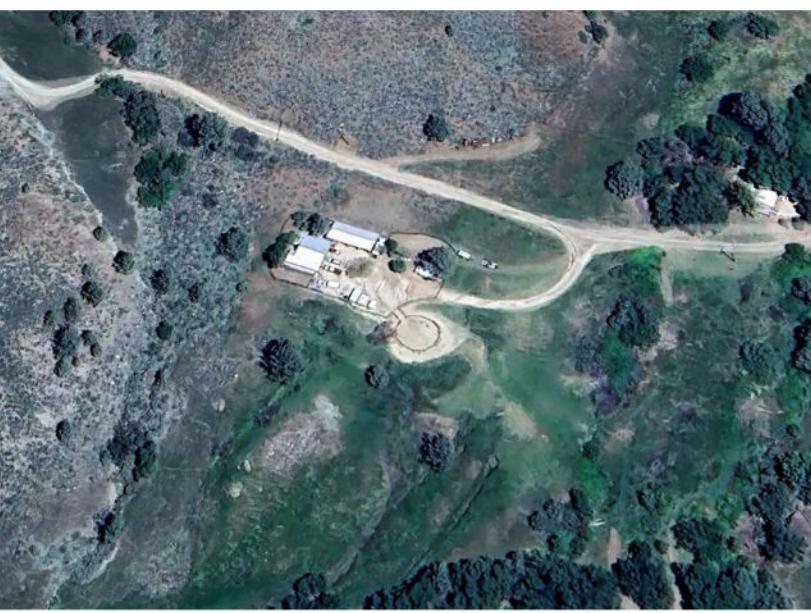
Description: Old landslide deposit that may be reactivated, but is unlikely.

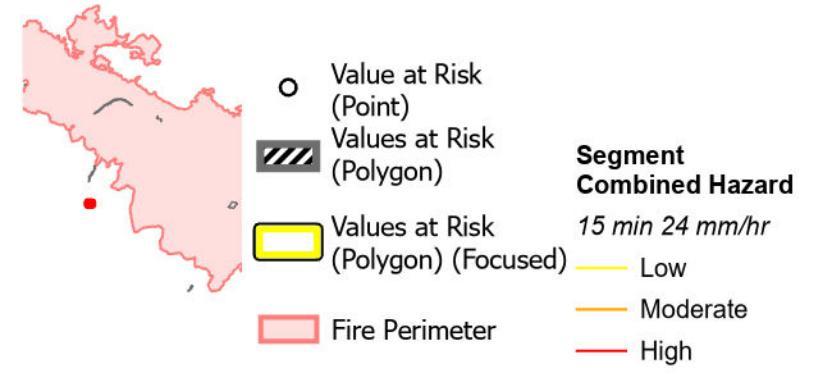
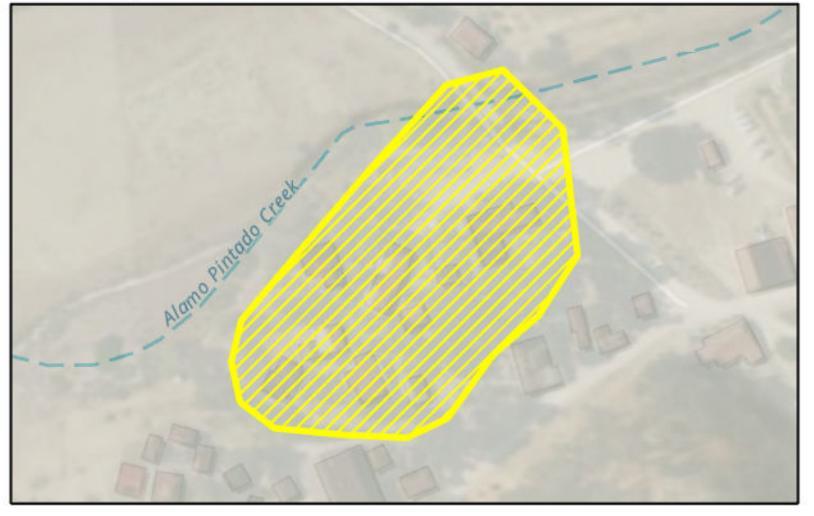
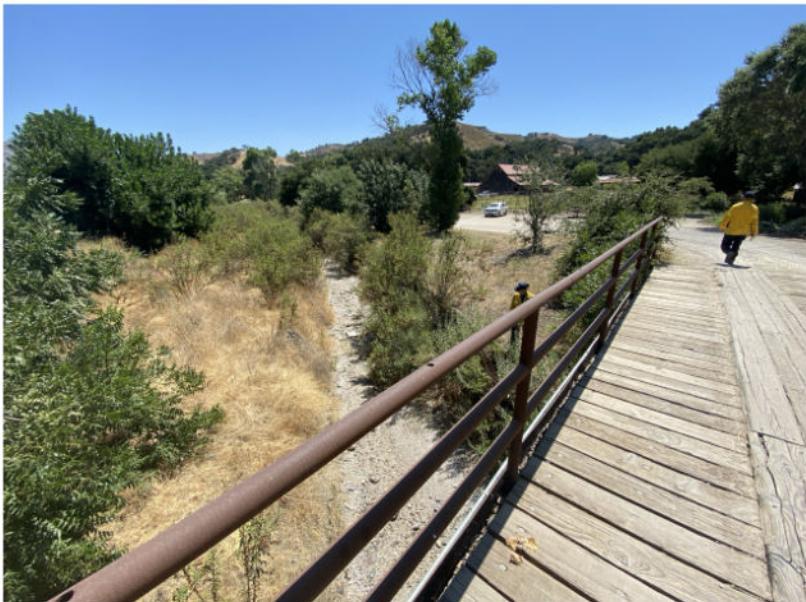
Description: Far distance from burned mountain front, incised channel, low channel slope and depositional reach with sinuous/braided morphology upstream of bridge. At bridge, the active channel is incised and contains two terraces. The lower elevation terrace is vegetated with dense willows. Observed flood flows during 2023 partially inundated structure and solar panels along upper floodplain at inside meander bend downstream of the bridge.

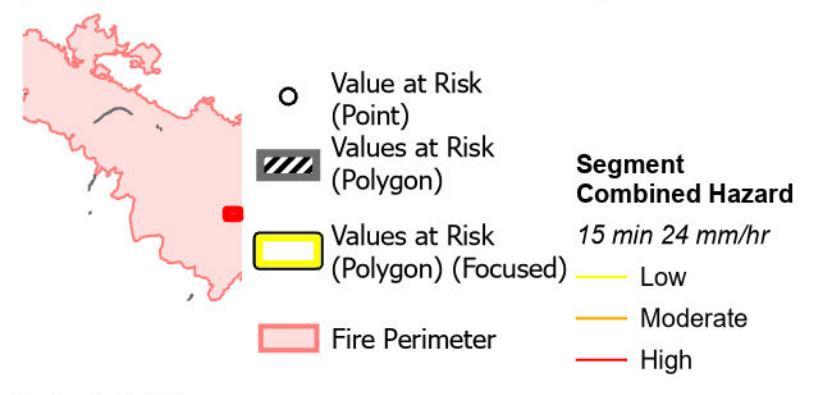
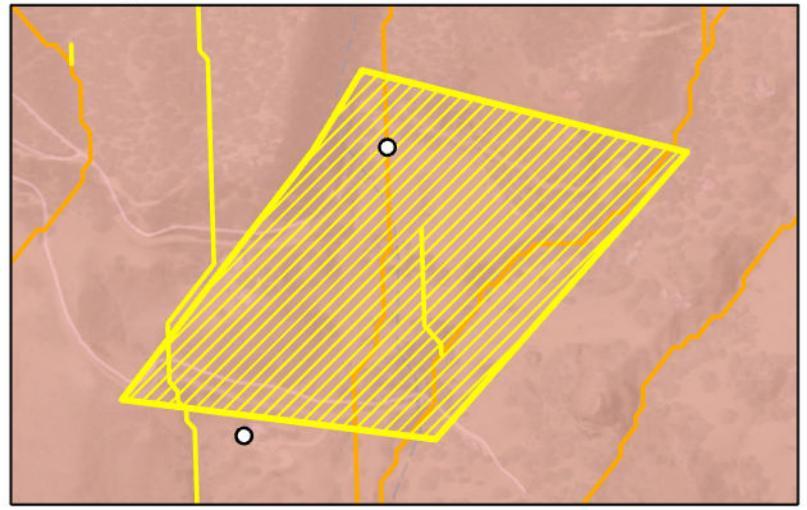
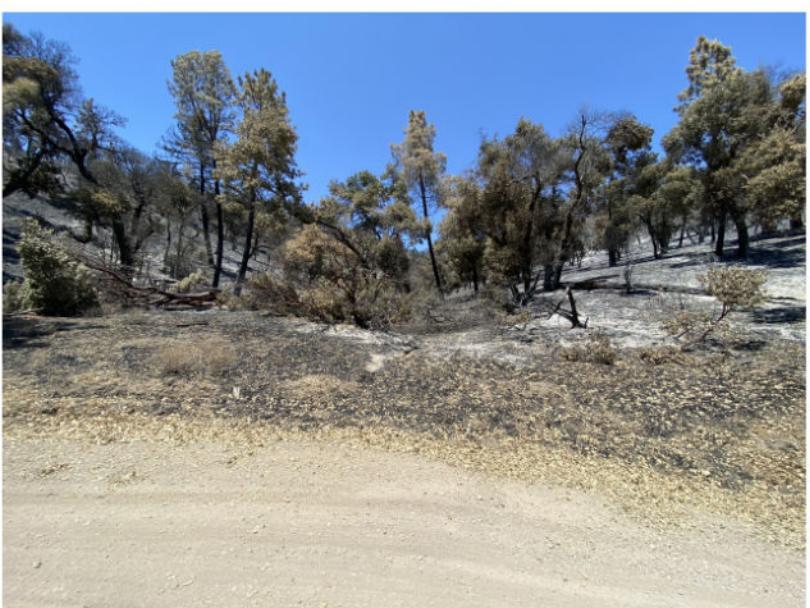
Description: Near FM-01, there is a large unchannelized swale that may be impacted by floods or flood flows. The same drainage is incised near Figueroa Road upstream. The basin was burned at mostly moderate severity and sediment appears to be readily available for transport. No culvert was present along the main road near FM-01. The road is the only source or ingress and egress for multiple homes and may be damaged during a storm. There are multiple additional small crossings in the community. Some of them have culverts and some of them do not.

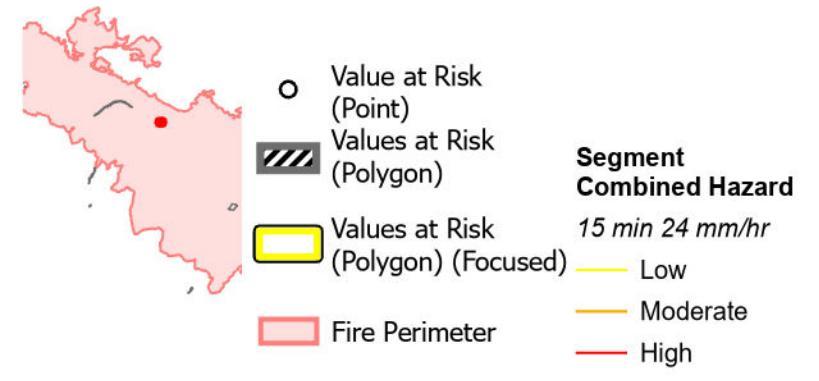
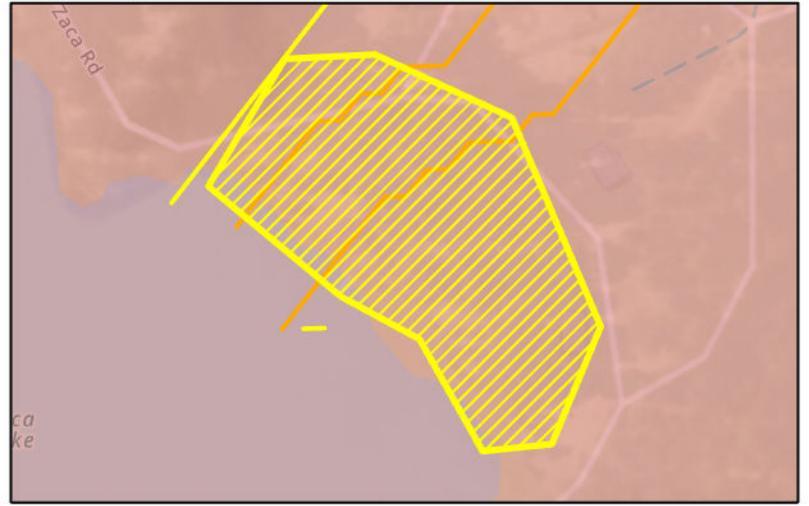
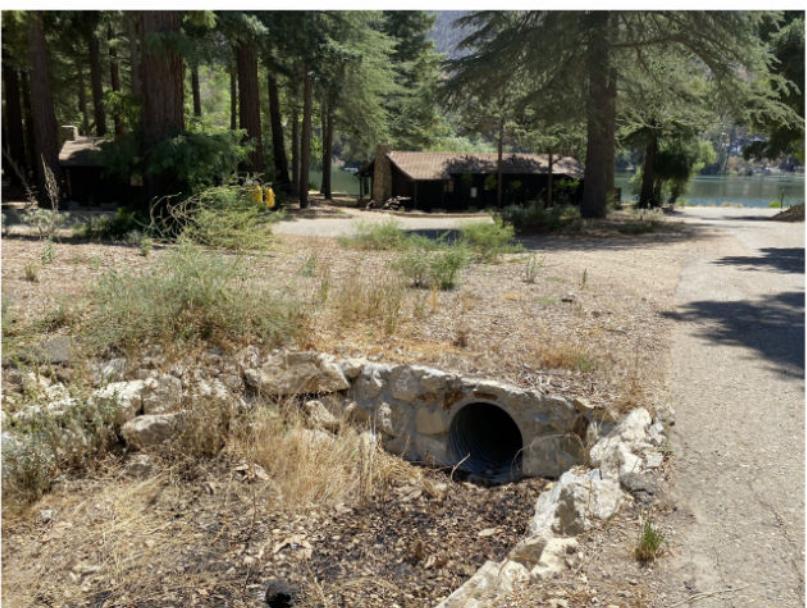
> **Description:** Land manager noted substantial flooding to cabins during large storm in January 2023. Floodplain was graded after January 2023 storm.

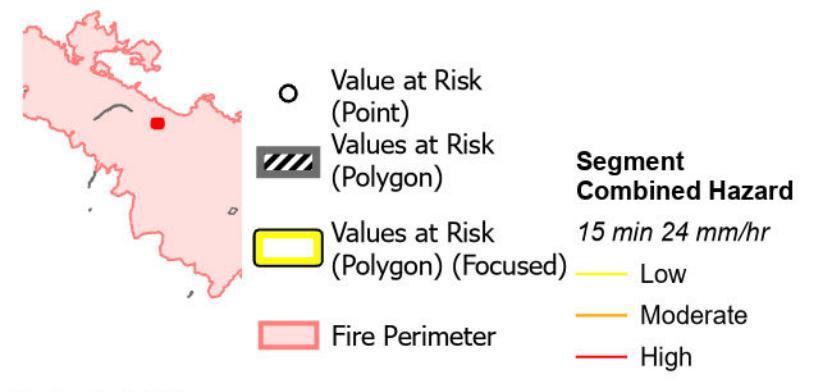
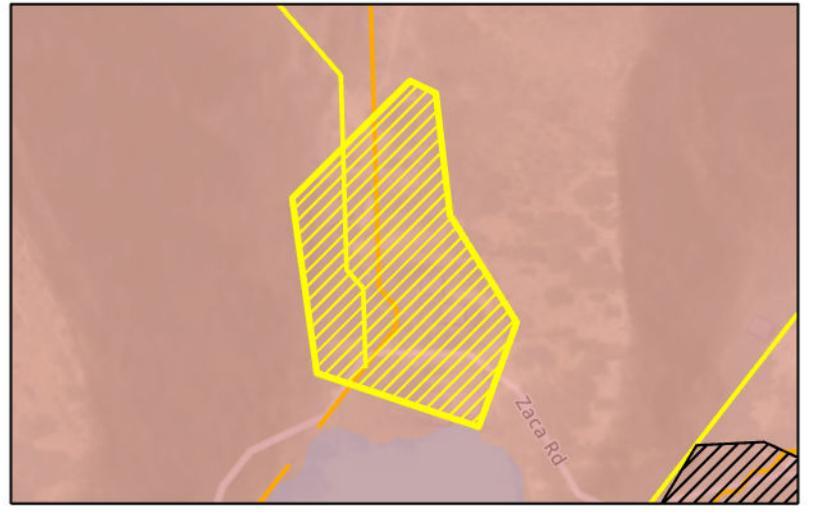
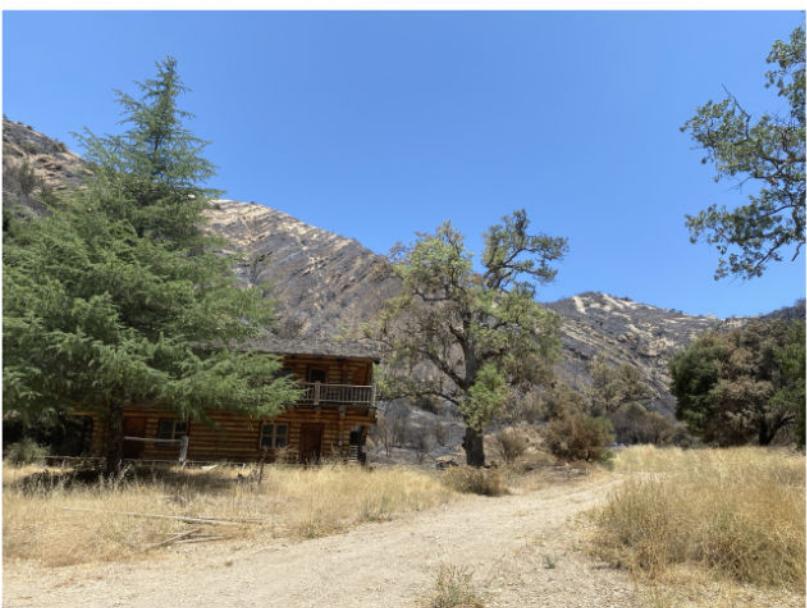
Description: Flow from primary drainage could cause potential flooding to two-story house (northern-most structure). Small swale to the west was unchannelized. Electrical infrastructure present near channel.
