Implications of Ground Motion Data Recorded in the M7.6 Chi-Chi, Taiwan Earthquake of September 21, 1999

Yi-Ben Tsai.

Institute of Geophysics, National Central University, Chung-Li, Taiwan

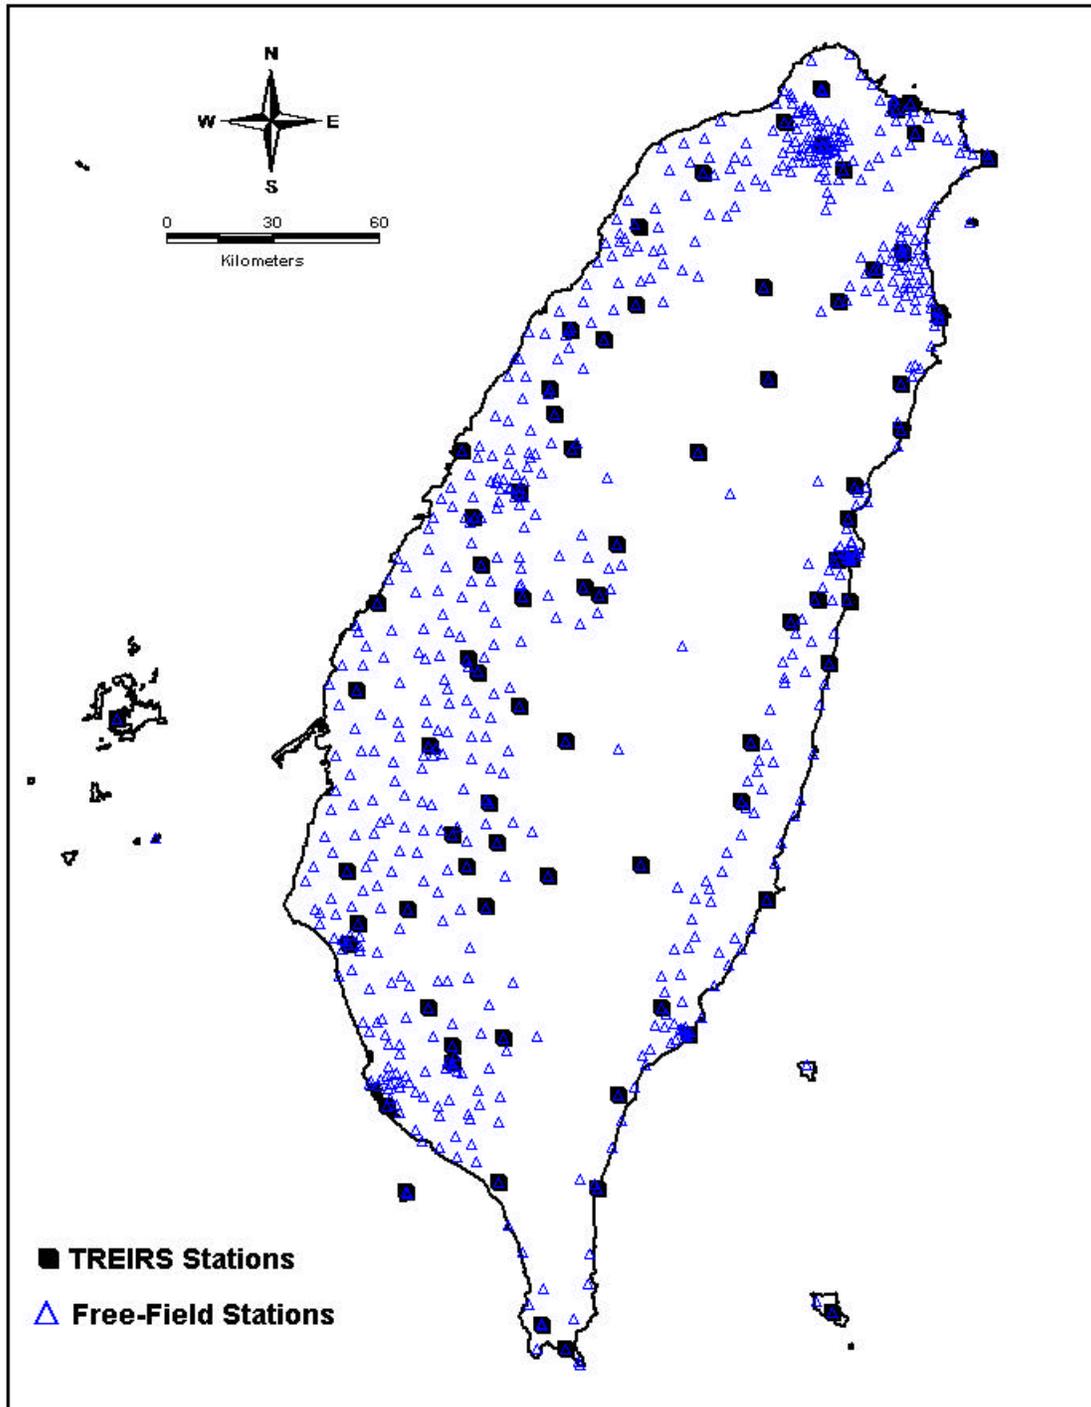
Figure 1. Locations of seismic stations for the Taiwan Rapid Earthquake Information System and the free-field strong motion network.

Figure 1 shows the locations of seismic stations in the Taiwan Rapid Earthquake Information Release System. Figure 2 shows the target times, modes, and intended recipients of rapid

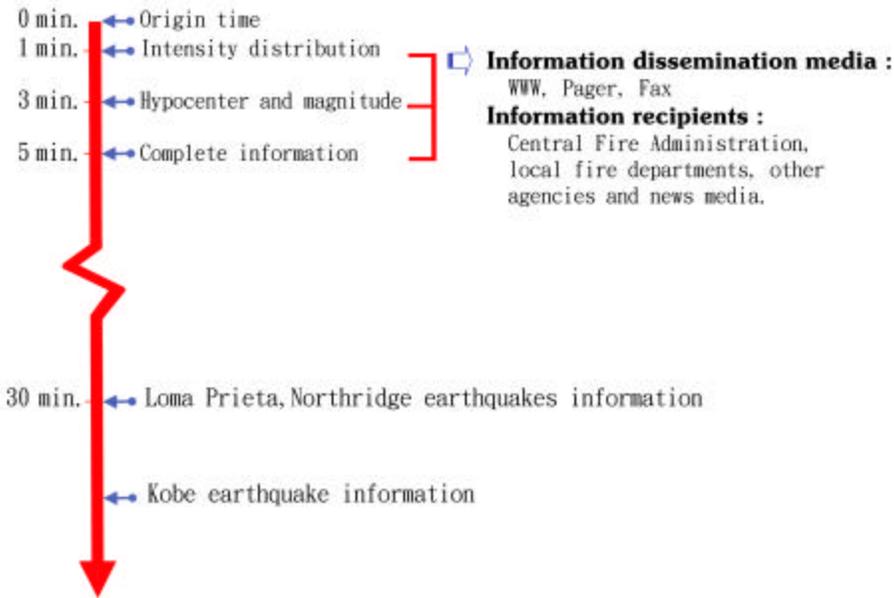
Figure 2. Target time schedule of Taiwan rapid Earthquake Information System

earthquake information. It aimed to have intensity information available in one minute, location and magnitude information available in three minutes. The information is disseminated by Pager, e-mail, fax, internet and ftp. The information is sent to the Central Fire Administration, City and County Fire departments, other government agencies and officials, and news media. Figure 3 shows the actual CWB earthquake report for the Chi-Chi earthquake. The system was also extremely valuable in providing rapid and reliable information about strong aftershocks and earthquakes in other areas in the days following the Chi-Chi earthquake. The people, both inside and outside the disaster areas, were very frightened by then. Timely and reliable earthquake information greatly helped to calm people and to prevent rumors.

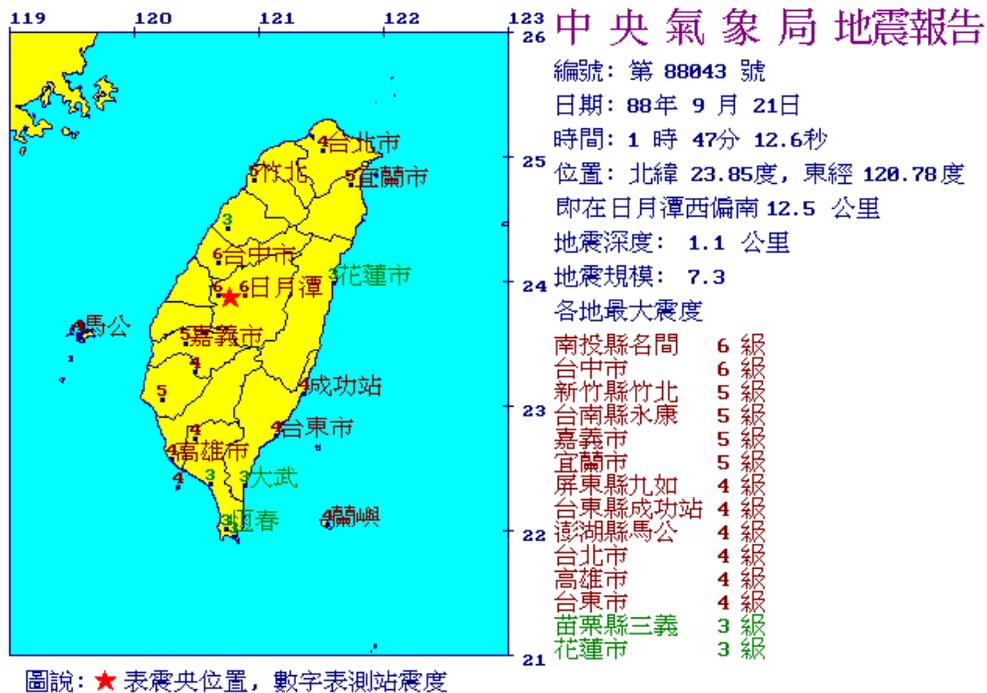
Figure 3. The Central Weather Bureau's Earthquake No.88043 on the Chi-Chi earthquake of September 21, 1999.

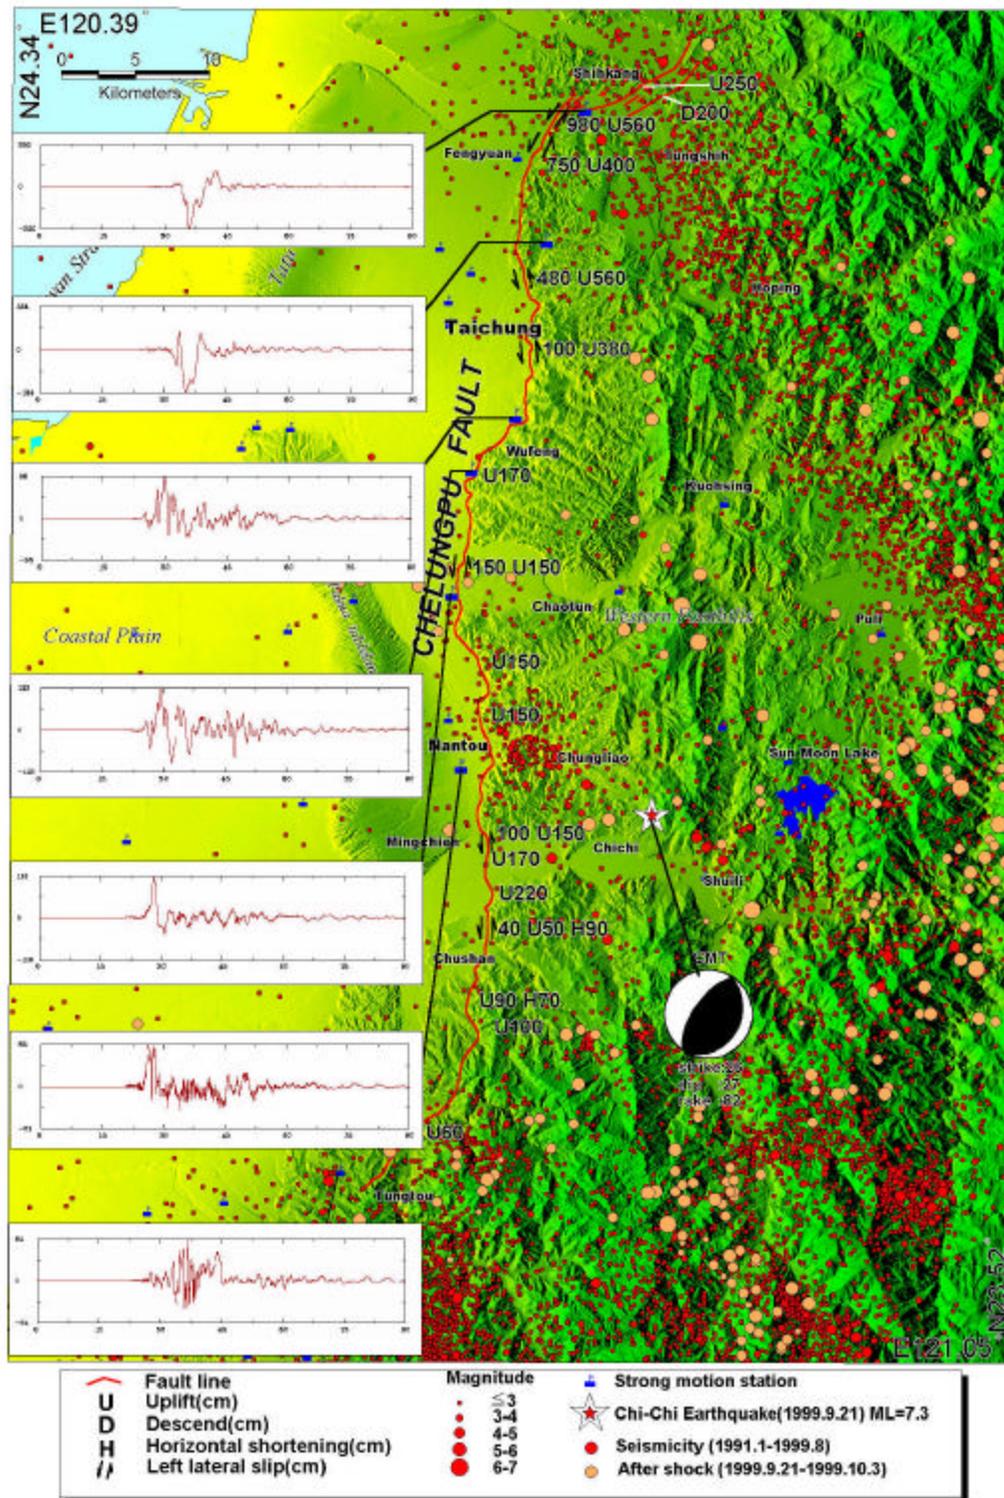
Figure 4. The Chelungpu fault, and the epicenter of the Chi-Chi earthquake. Also shown are background seismicity (in red dots), strong aftershocks (orange dots), E-W component velocity waveforms along the fault line.

Both uplift and left-lateral strike-slip displacements were observed at most outcrop locations. It is clear that the Chehlungpu fault was an oblique thrust fault. This was consistent with the fault-plane solution obtained by the first motion polarities and moment tensor inversions as shown in Figure 4. It is remarkable that the amount of slips increased persistently from a little over one meter in the southern end and to almost ten meters observed near the northern end of the fault. Figure 5 shows the regional geology of the surrounding areas (Lee et al., 1999). The Chehlungpu fault clearly marks the boundary between the Pliocene and Quaternary formations. An E-W section across the fault at the bottom of the figure shows a series of imbricated thrust faults dipping to the east. The Chehlungpu fault is just one of them. Figure 4 also shows the locations of background seismicity and strong aftershocks of the Chi-Chi earthquake. It is seen that most aftershocks took place far away from the Chehlungpu fault in the zones of active background seismicity east of the Chehlungpu fault. The zones of active background seismicity appeared to define the boundaries of the displaced crustal block. Figure 4 additionally shows the velocity waveforms of the E-W component integrated from original acceleration records at seven stations happened to align along the fault trace. It is seen from the differential timings among the big pulses that the fault rupture started from the hypocenter first and then propagated toward the north and south. The rupture velocity can be estimated at about 2 km/sec. The big pulse near the northern end was significantly enhanced due to rupture directivity.

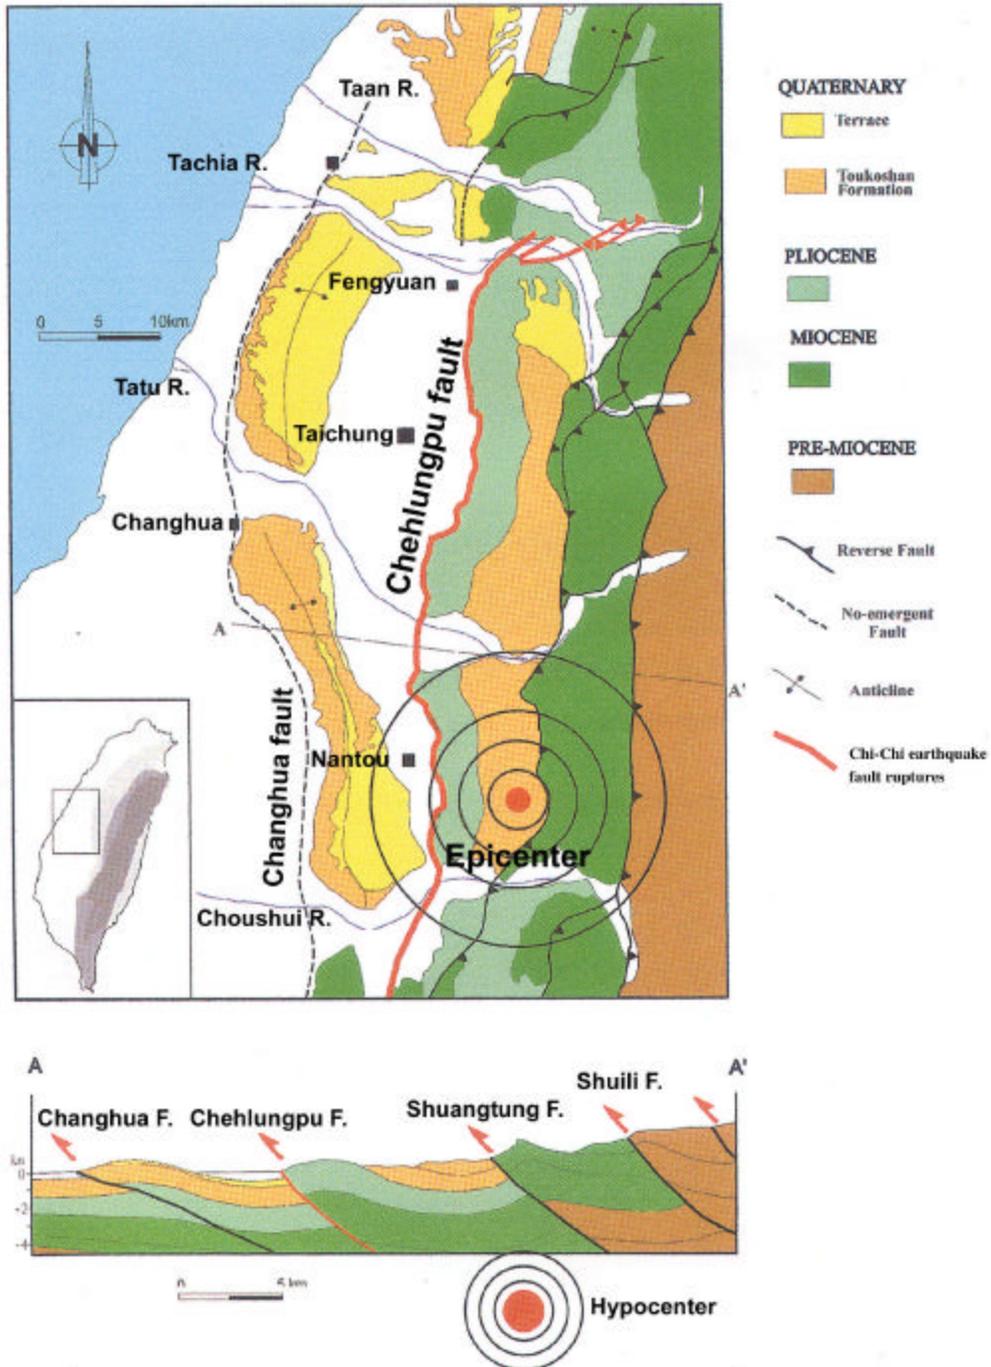
Geologic map and cross-section of central Taiwan and location of the Chi-Chi earthquake

Figure 5. Regional geology surrounding the Chehlungpu fault and an E-W cross section.(After Lee et al, 1999)

Figure 7 shows the GPS measurement results on the velocity of crustal movement in Taiwan (Yu et al., 1997). The Philippine Sea plate is seen to move northwestward toward Taiwan at a velocity of more than 8 cm/year. It is noted that the crustal velocity decreases progressively westward, causing compression across most of the island of Taiwan and resulted in series of imbricated faults, as shown previously in Figure 5.

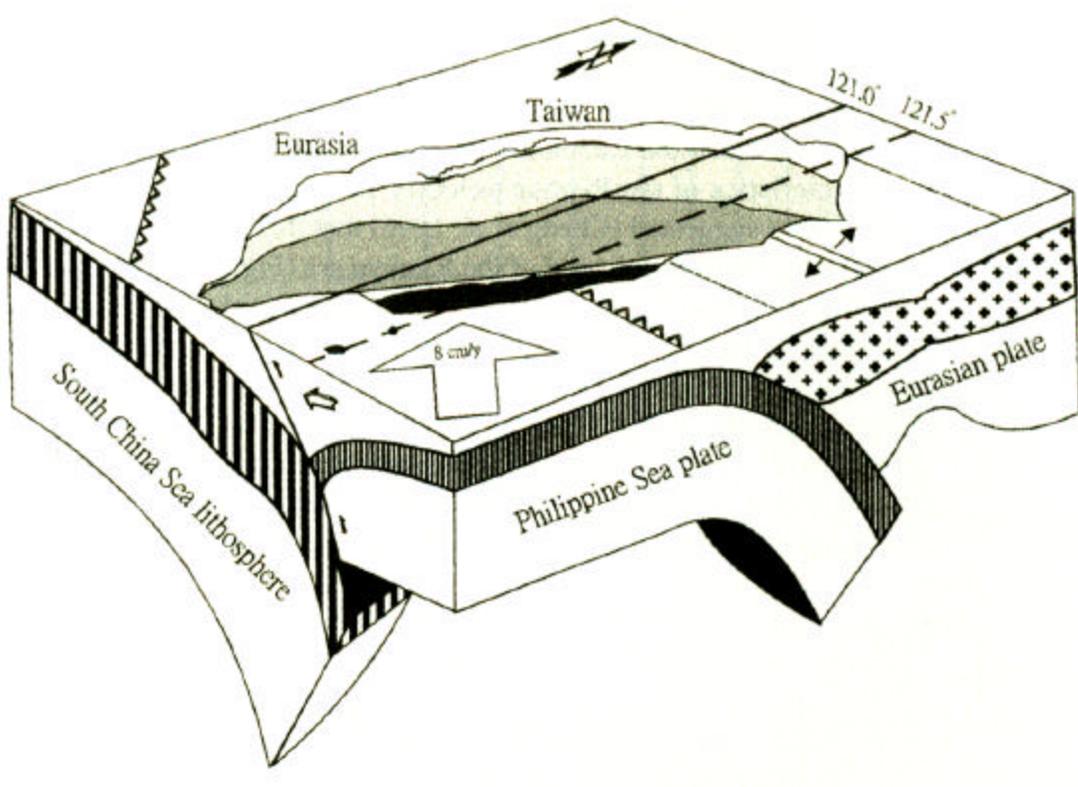
Figure 6. Plate configurations in Taiwan area (after Angelier, 1986).

The Chehlungpu fault was a product of plate collision in Taiwan area. Figure 6 shows the configurations of the Philippine Sea plate and the Eurasian plate in Taiwan area. It is seen from the figure that the two plates collide with each other along the Taitung Longitudinal Valley. The Philippine Sea plate subducts northward under the Eurasian plate in northeastern Taiwan. In the

meantime, The Eurasian plate is subducting eastward under the Philippine Sea plate in southeastern Taiwan.

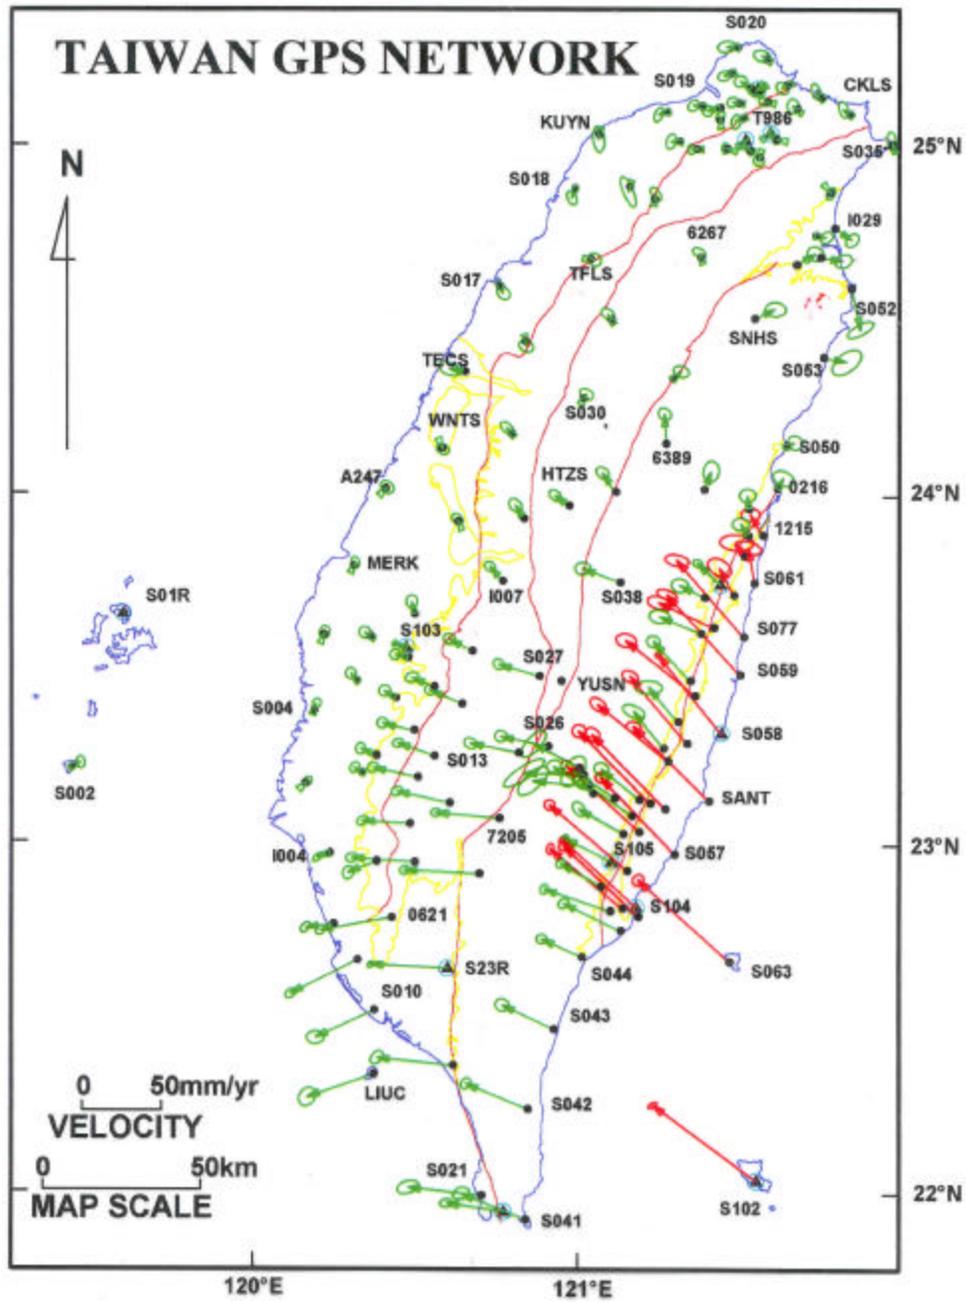
Figure 7. The velocity field of crustal movement measured by GPS (after Yu et al., 1997).

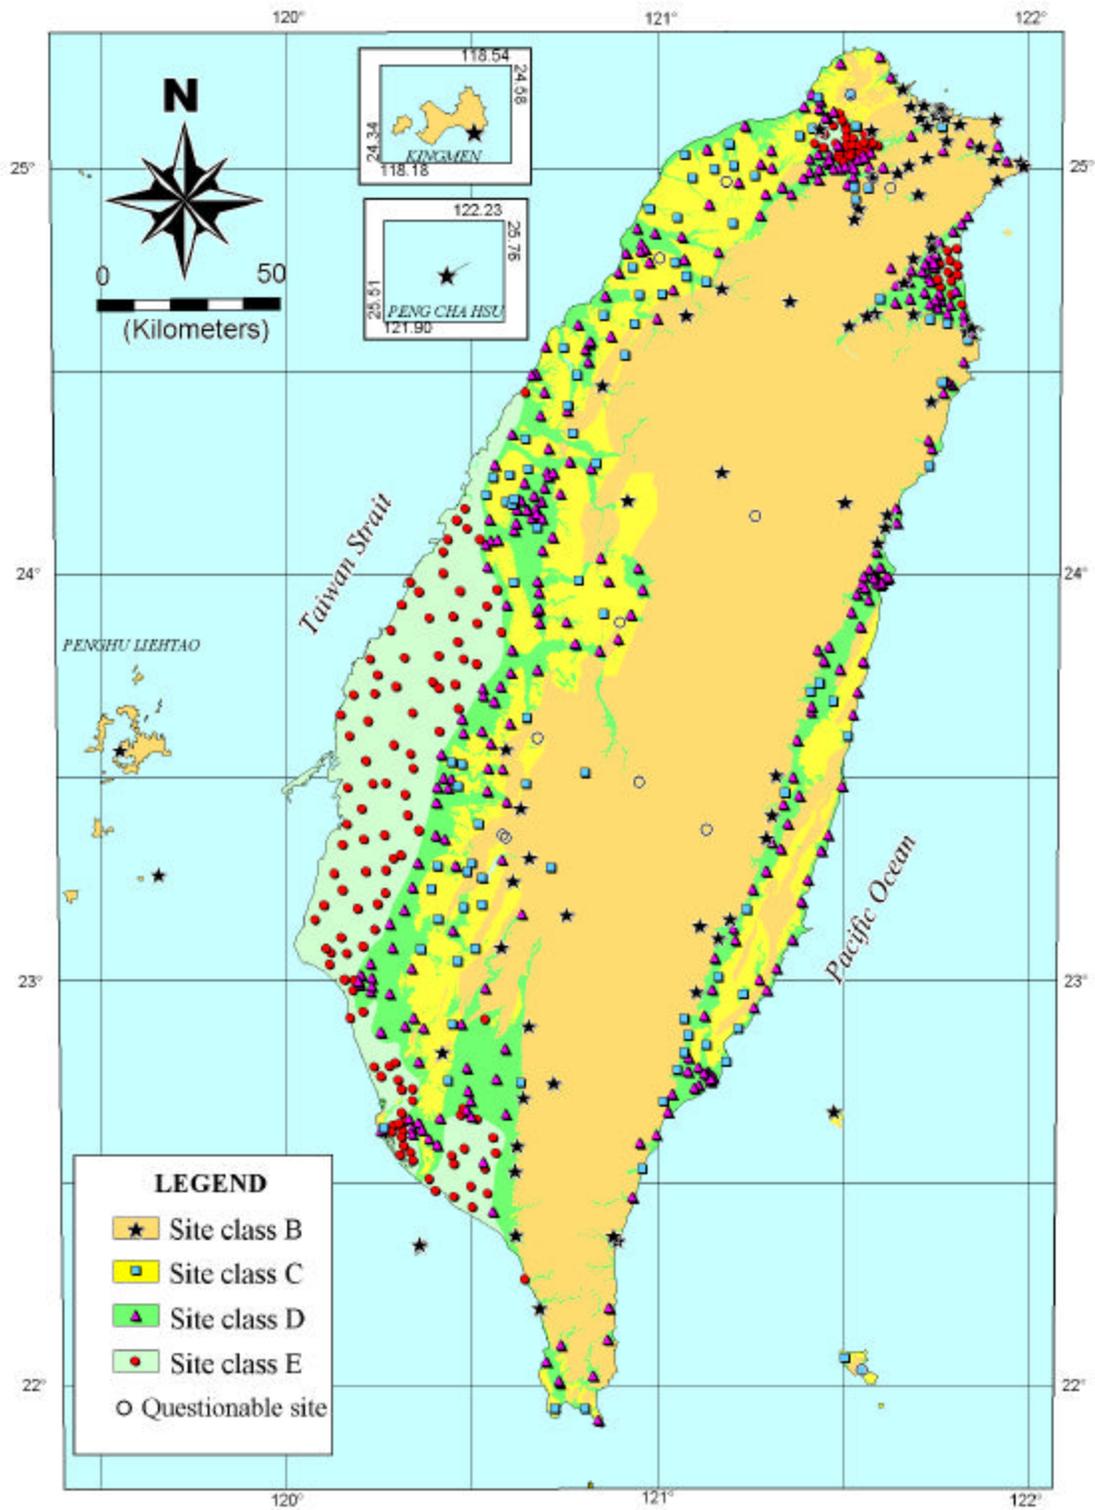
Figure 8. Free-field strong motion accelerograph sites and geologic conditions of Taiwan (Lee et al., 2001).

The Chi-Chi earthquake was well recorded by 441 high-quality free-field strong-motion accelerographs. Figure 8 shows the locations of these recording instruments at different geologic site conditions. The recording sites were classified into four classes, namely B, C, D, and E, according to geologic age (Lee, et al., 2001). Figure 9 shows distributions of the recorded horizontal peak ground acceleration (PGA) values along with the total fatalities of each county or city. It can be seen that the PGA values are significantly higher at sites along the Cheilungpu fault and in the areas to the east of the fault than other areas. This was due to its thrust faulting mechanism that often caused stronger ground motions on the hanging wall block (Abrahamson and Somerville, 1996). This ground motion feature was closely correlated with the distribution of fatality rates in the meizoseismal area, as shown in Figure 10 below.

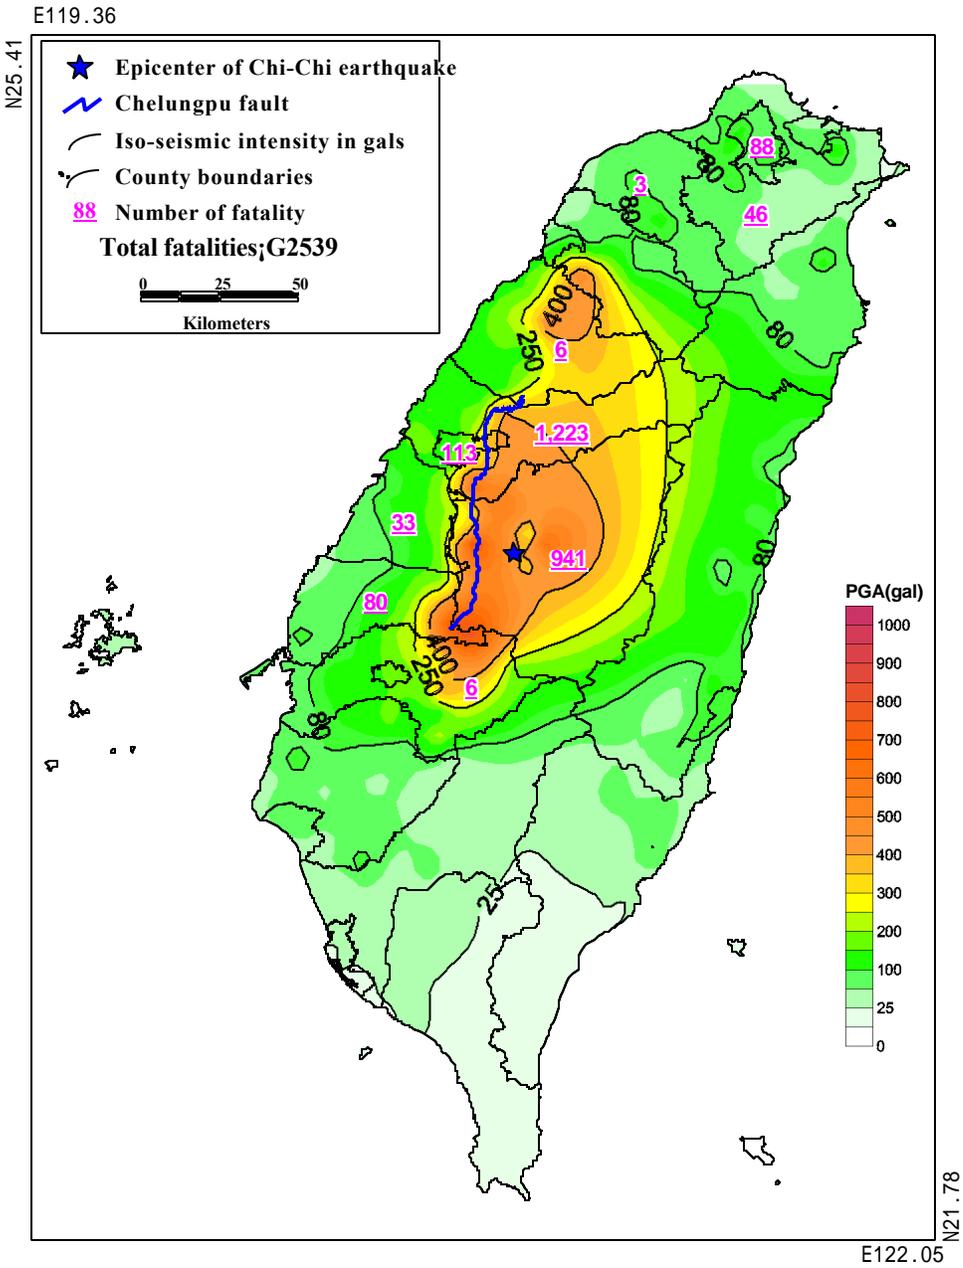
Figure 9. Contours of horizontal peak ground acceleration in gals and the total number of fatality in each county or city due to the Chi-Chi, Taiwan earthquake of September 21, 1999

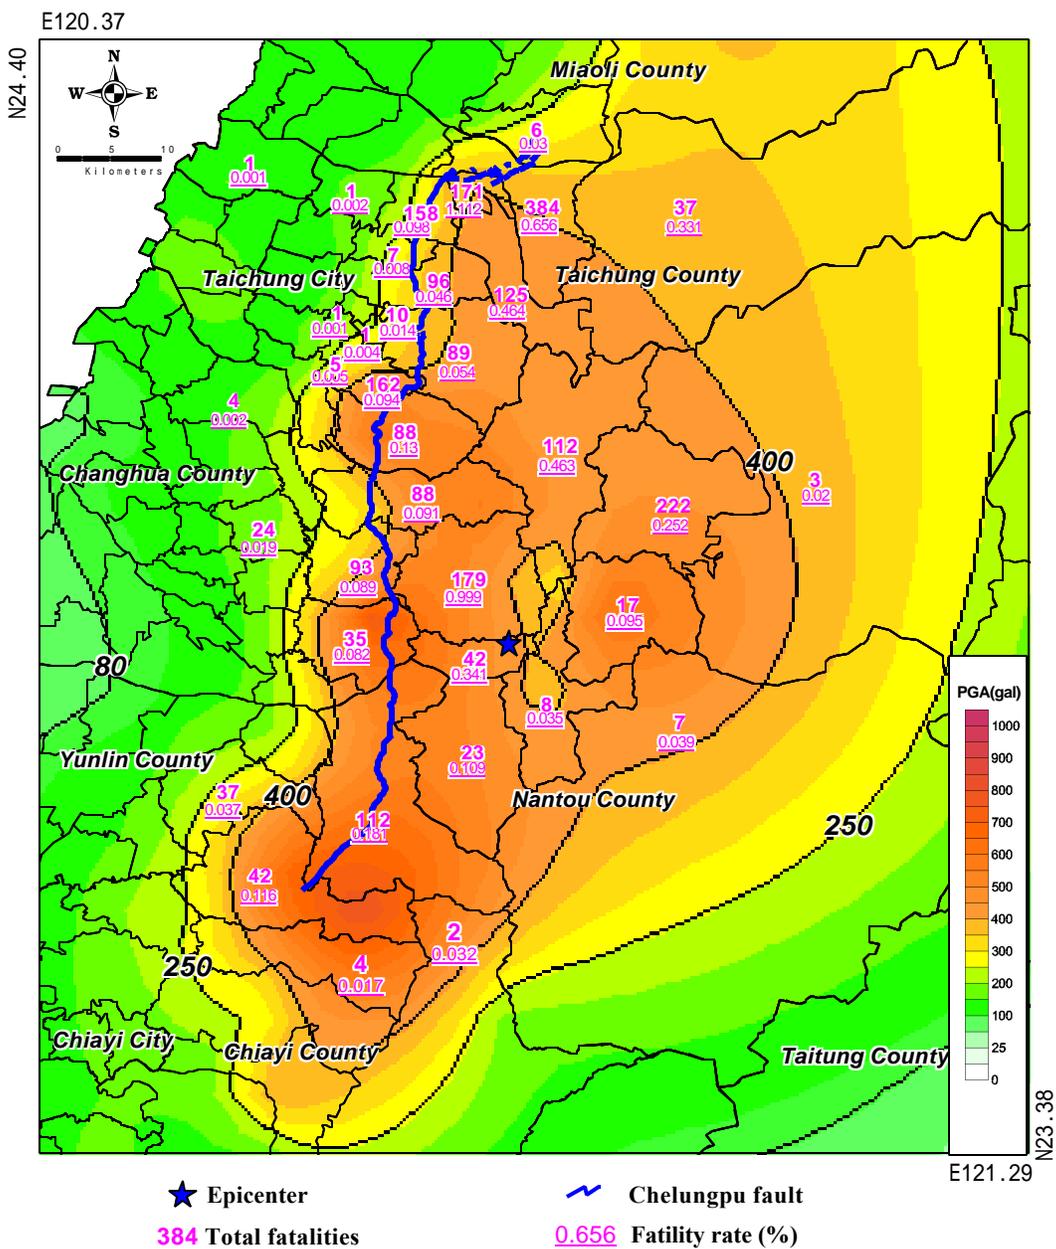
Figure.10 The total fatality and fatality rate (%) of each township. The thick dark curves are contours of horizontal peak ground acceleration in gals in central Taiwan due to the Chi-Chi, Taiwan Earthquake of September 21, 1999.

Figure 10 shows the total fatalities and fatality rates in individual townships, as well as the seismic intensity distribution in the near-fault areas in central Taiwan. It is apparent that all large fatalities took place in the towns experiencing seismic intensity greater than 250 gals. This pattern becomes even clearer when we look at the distribution of the fatality rate. We use the necessary population data from the demographic summary for 1999 (National Office of Statistics, 2000b). The fatality rates in towns experiencing more than 400 gals ranged from 0.054% to 1.112%, whereas the fatality rates were all below 0.002% in towns experiencing less than 250 gals. The only notable exception in this lower intensity zone was the town of Yuanlin in Changhua County where a fatality rate of 0.019% occurred. It was found that severe liquefaction had caused collapse of many buildings in this town (National Center for Research in Earthquake Engineering, 1999).

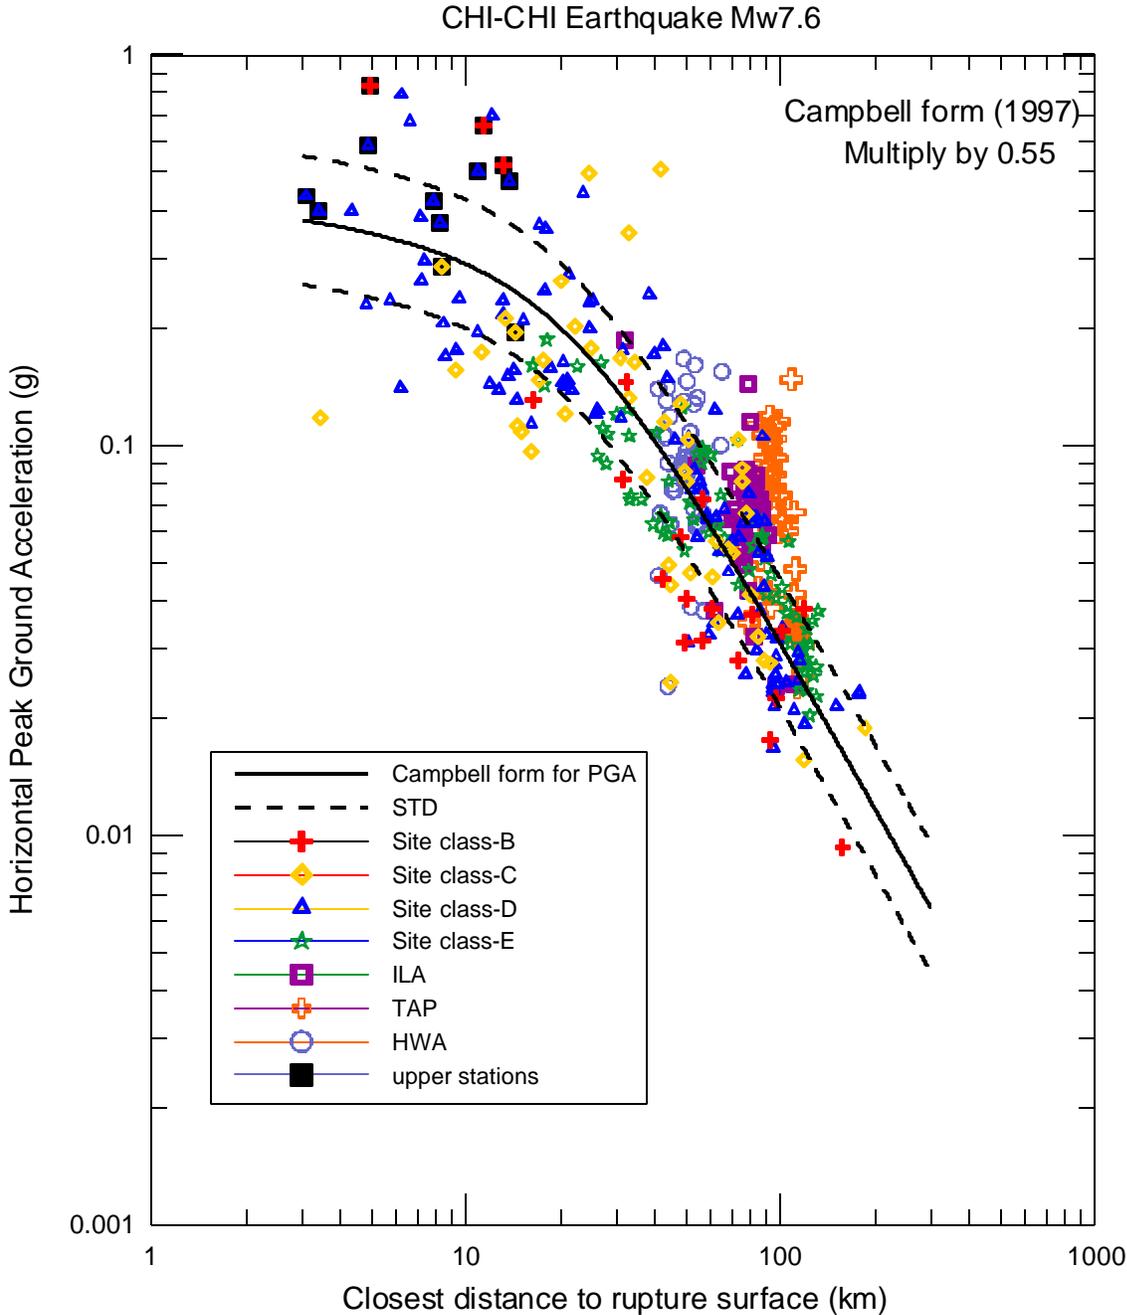
Figure 11. Attenuation of horizontal peak ground acceleration from the Chi-Chi earthquake.

Figure 11 shows the plot of horizontal PGA values as function of the closest distance to the seismogenic zone, according to Campbell's definition (Campbell, 1997). The data points are plotted according to the four site classes. In addition, the data points from the Taipei Basin, Ilan Plain, and Hwalien areas are plotted separately. In the figure we also plot the Campbell's median and median +/- one standard deviation PGA curves for M_w 7.6 that are modified by multiplying a factor of 0.55 to fit the data points. From the figure we can see the slope of Campbell's curve fit quite well with the data points from the Chi-Chi earthquake. However, the Campbell's curves would significantly overestimate relative to the actual PGA values. It is noted that the PGA values from the Taipei Basin, Ilan Plain, and Hwalien area are significantly higher than the rest of the data set. This was probably due to the basin amplification effects.

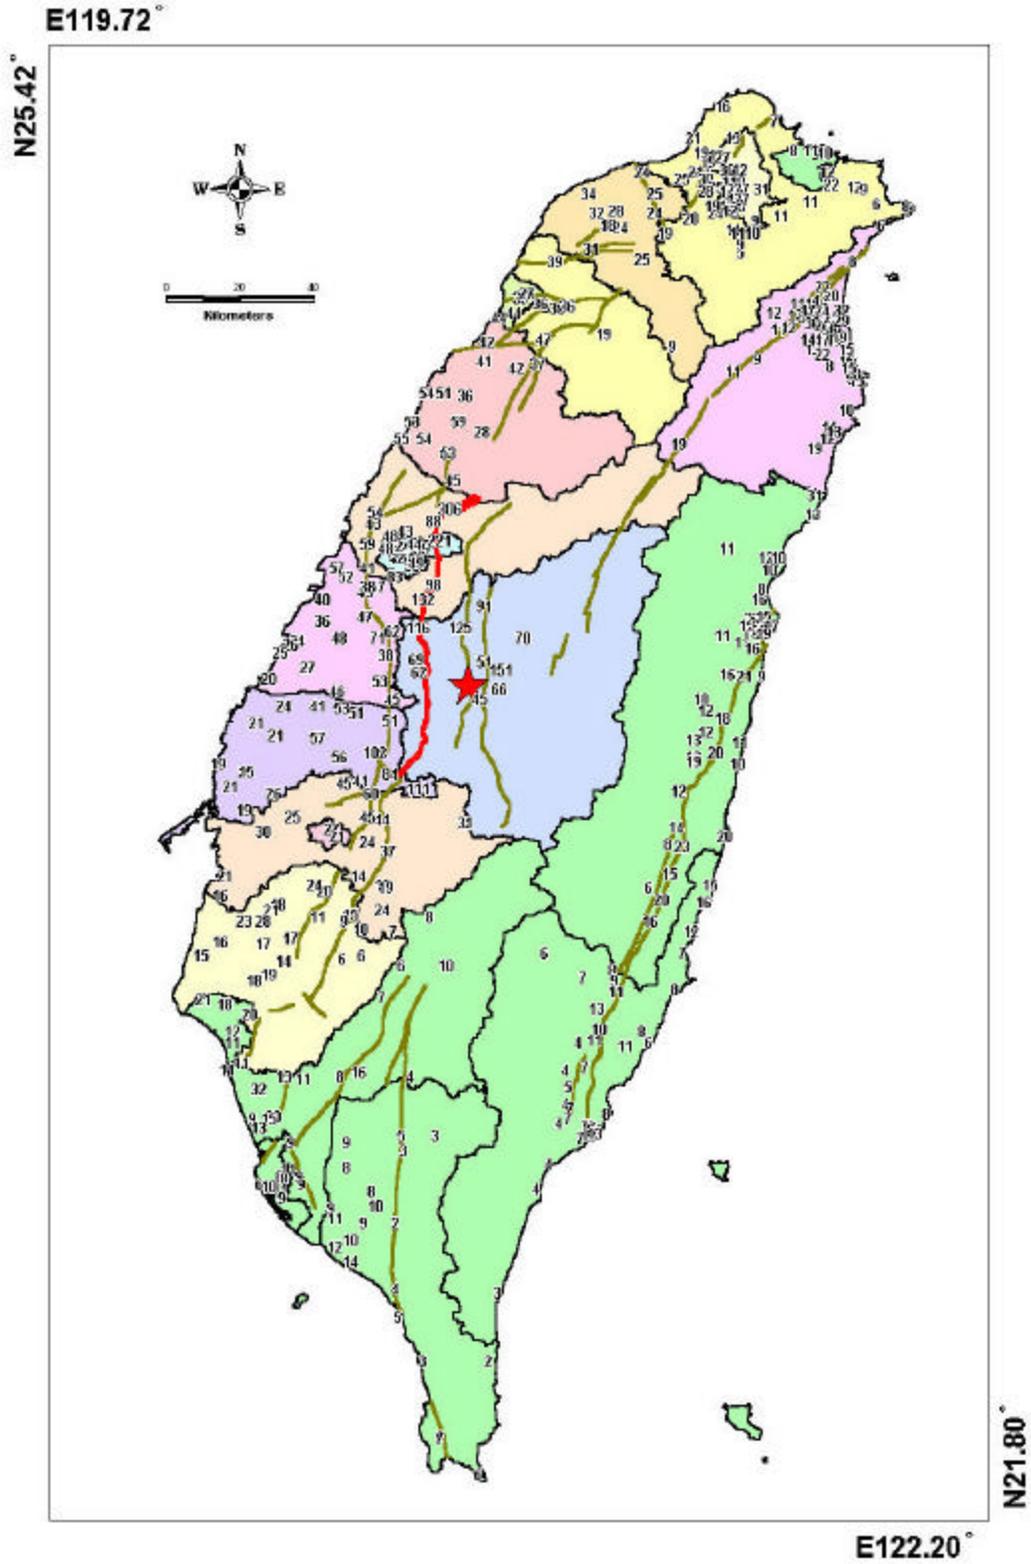
Figure 12. Distribution of integrated horizontal peak ground velocity (in cm/sec) from the Chi-Chi earthquake.

Figure 12 shows the integrated horizontal peak ground velocity (PGV) values in cm/sec. It can

be seen that the PGV values are significantly higher at sites along the Chehlungpu fault and in the areas to the east than in other areas. This was again due to its thrust faulting mechanism that often caused stronger ground motions on the hanging wall block.

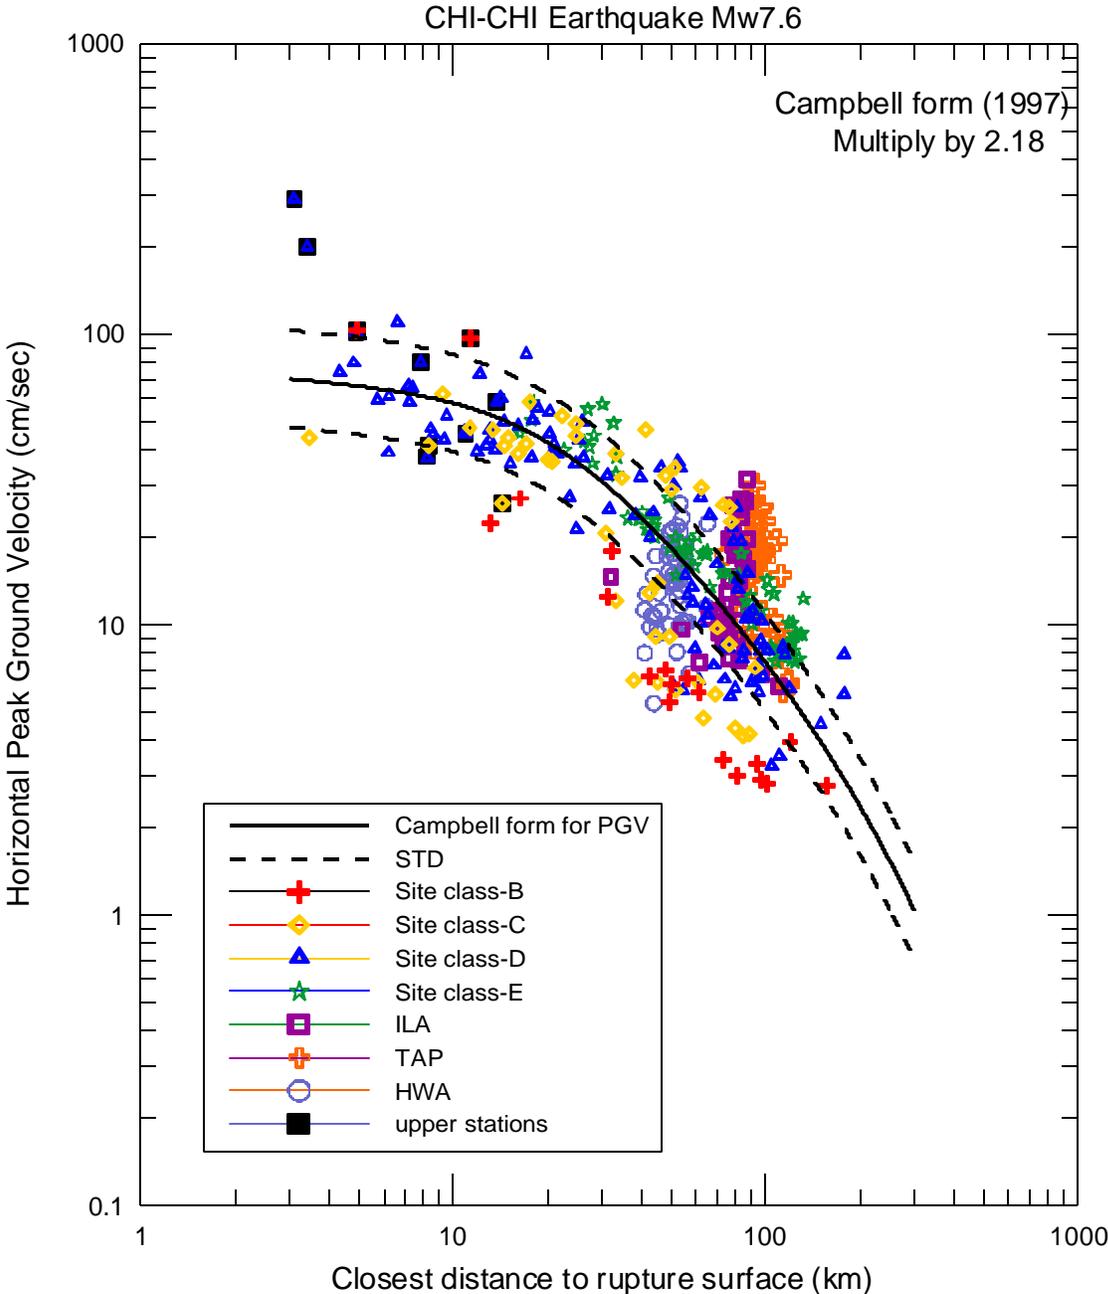
Figure 13. Attenuation of horizontal peak ground velocity from the Chi-Chi earthquake.

Figure 13 shows the plot of horizontal PGV values as function of the closest distance to the seismogenic zone, according to Campbell's definition (Campbell, 1997). The data points are plotted according to the four site classes. In addition, the data points from the Taipei Basin, Ilan Plain, and Hwalien areas are plotted separately. In the figure we also plot the Campbell's median and median +/- one standard deviation PGV curves for M_w 7.6 that are modified by multiplying a factor of 2.18 to fit the data points. From the figure we can see the slope of Campbell's curve fit quite well with the actual data points from the Chi-Chi earthquake. However, the Campbell's curves would significantly underestimate relative to the actual PGV values. It is noted that the PGV values from the Taipei Basin, Ilan Plain, and Hwalien areas are significantly higher than the rest of the data set. This was probably due to basin amplification effects.

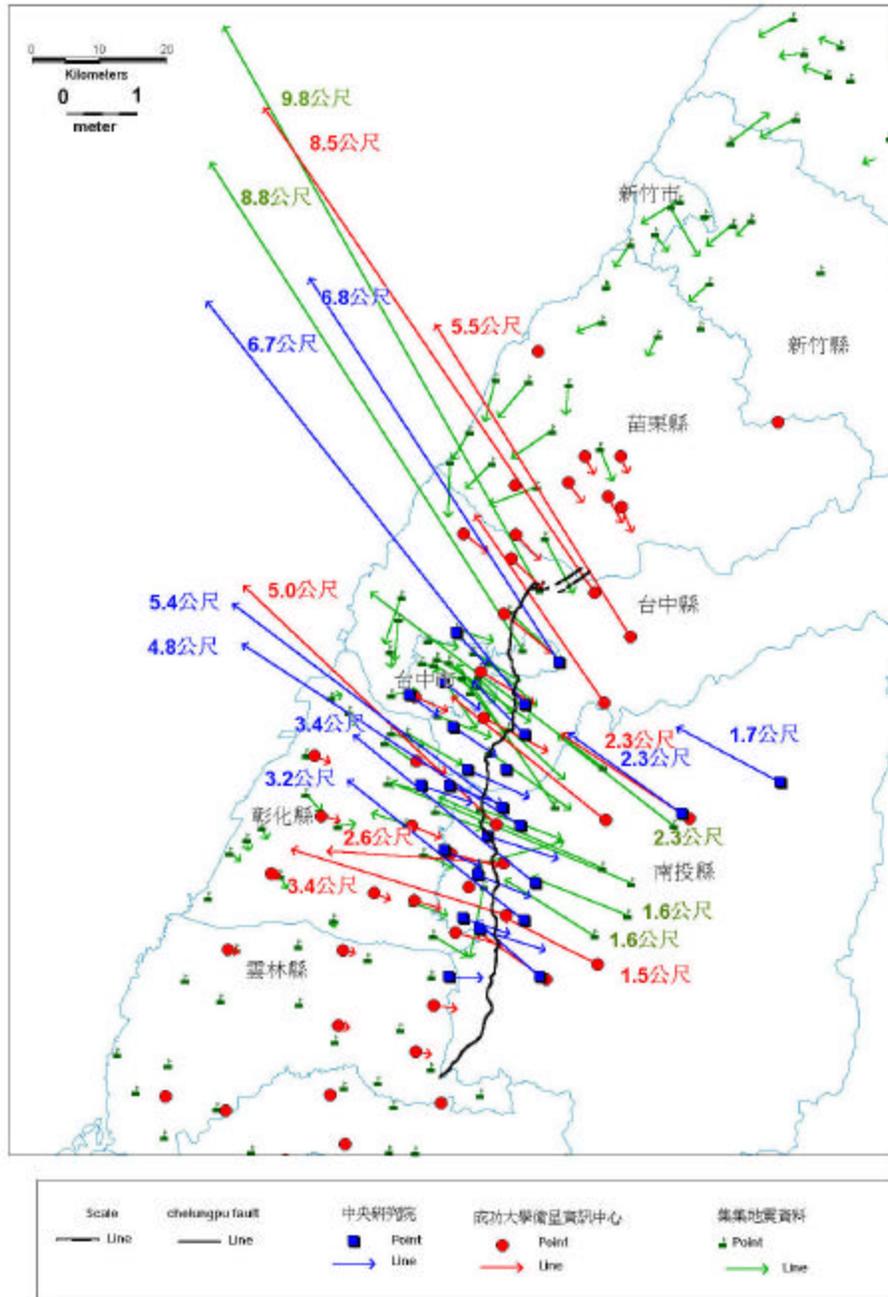
Figure 14. Distribution of integrated permanent horizontal ground displacement vectors from the Chi-Chi earthquake (in green). Also shown are the ground displacements from GPS measurements (in blue and red).

Figure 14 shows the distribution of integrated horizontal permanent displacement (PD) in meters. In the figure we also show the displacement values measured by GPS (Yu, 1999). It is found that the two sets of measurements are highly consistent with each other. This is the first time that permanent co-seismic ground displacements were observed by so many accelerographs. From the figure we can see very clearly the horizontal displacement vectors of the hanging wall block rotate clockwise in direction from south to north and increase in magnitude from about 2 meters in the south to almost 10 meters in the north. These displacement vectors are also consistent with the dislocations observed from the surface fault ruptures. Figure 15 shows the original accelerograms and the integrated velocity and displacement waveforms observed at the Shihgang station (TCU068). The records indicate the fault displaced smoothly and quickly near its northern end.

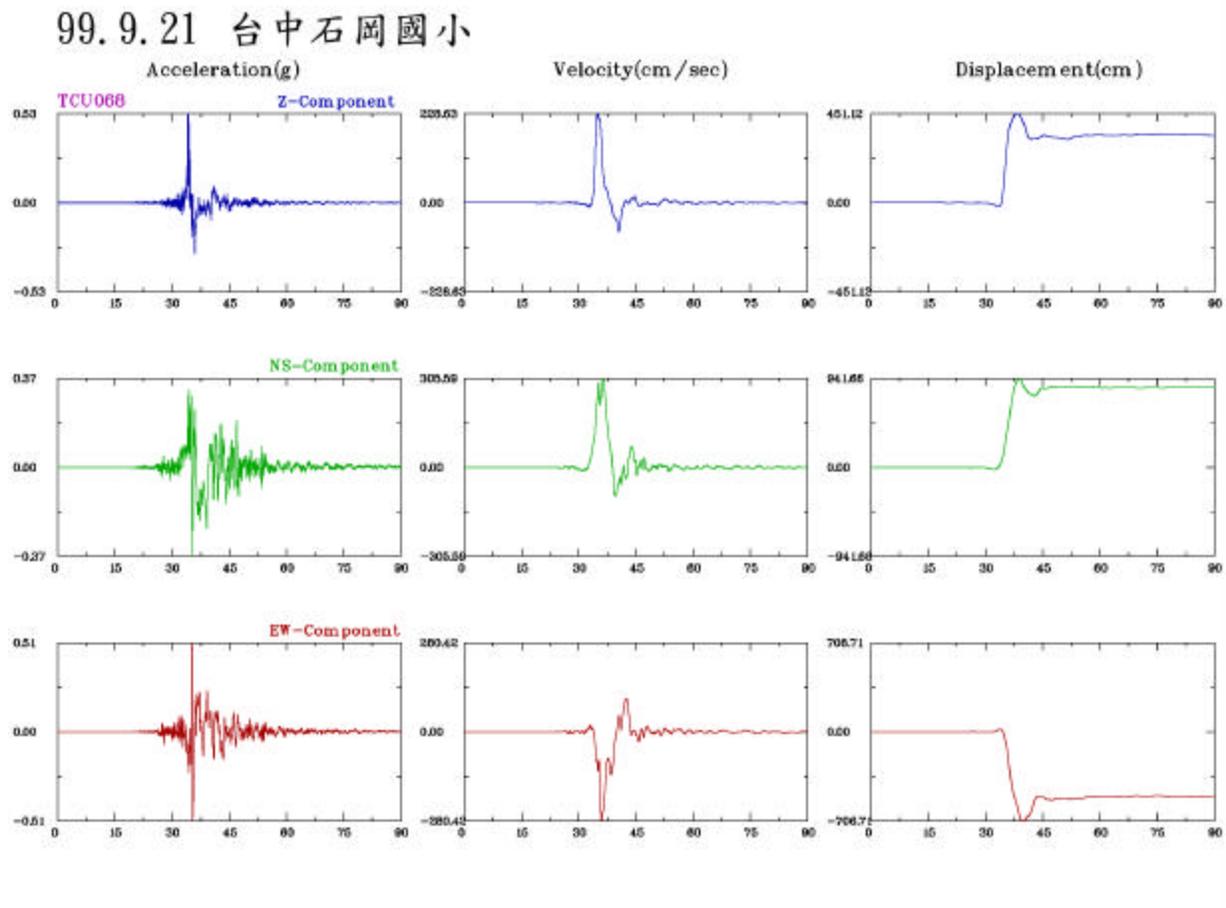
Figure 15. The recorded acceleration, integrated velocity and displacement waveforms at station TCU068 from the Chi-Chi earthquake.

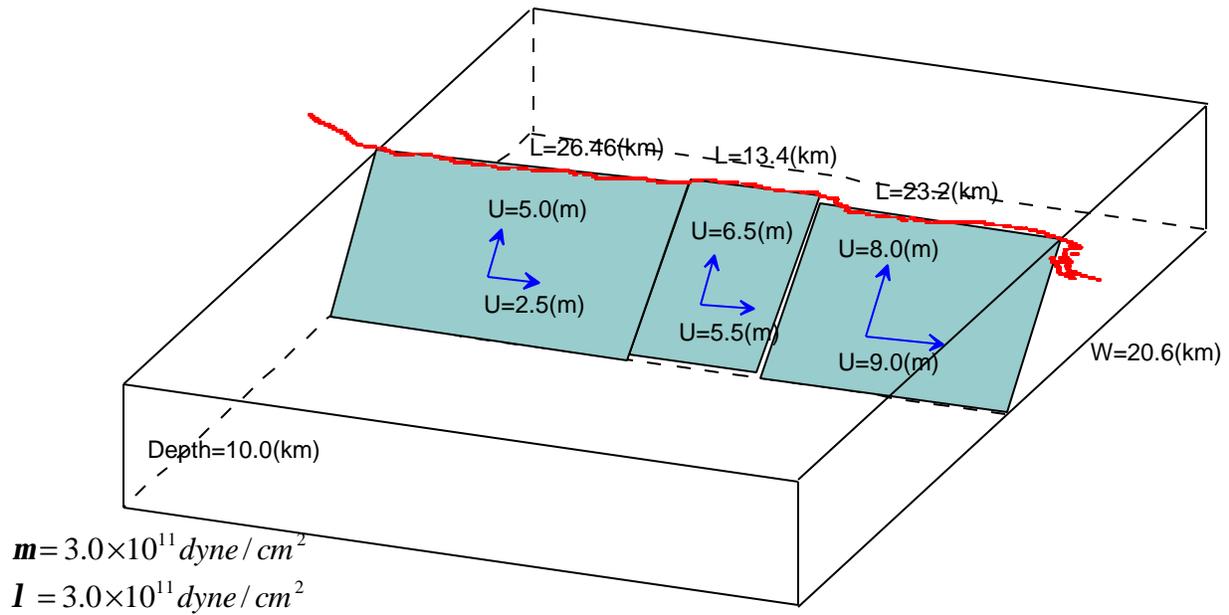
Figure 16. The first-order estimation of the dip-slip and strike-slip displacements in the southern, central and northern segments of the Chelungpu fault.

Figure 16 shows the first-order estimation of the dip-slip and strike-slip displacements in the southern, central and northern segments of the Chelungpu fault. Figure 17 compares the observed and calculated horizontal and vertical displacements across the southern, central and northern segments of the fault. The fittings are reasonably close.
