Implications of Ground Motion Data Recorded in the M7.6 Chi-Chi, Taiwan Earthquake of September 21, 1999

Yi-Ben Tsai.

Institute of Geophysics, National Central University, Chung-Li, Taiwan

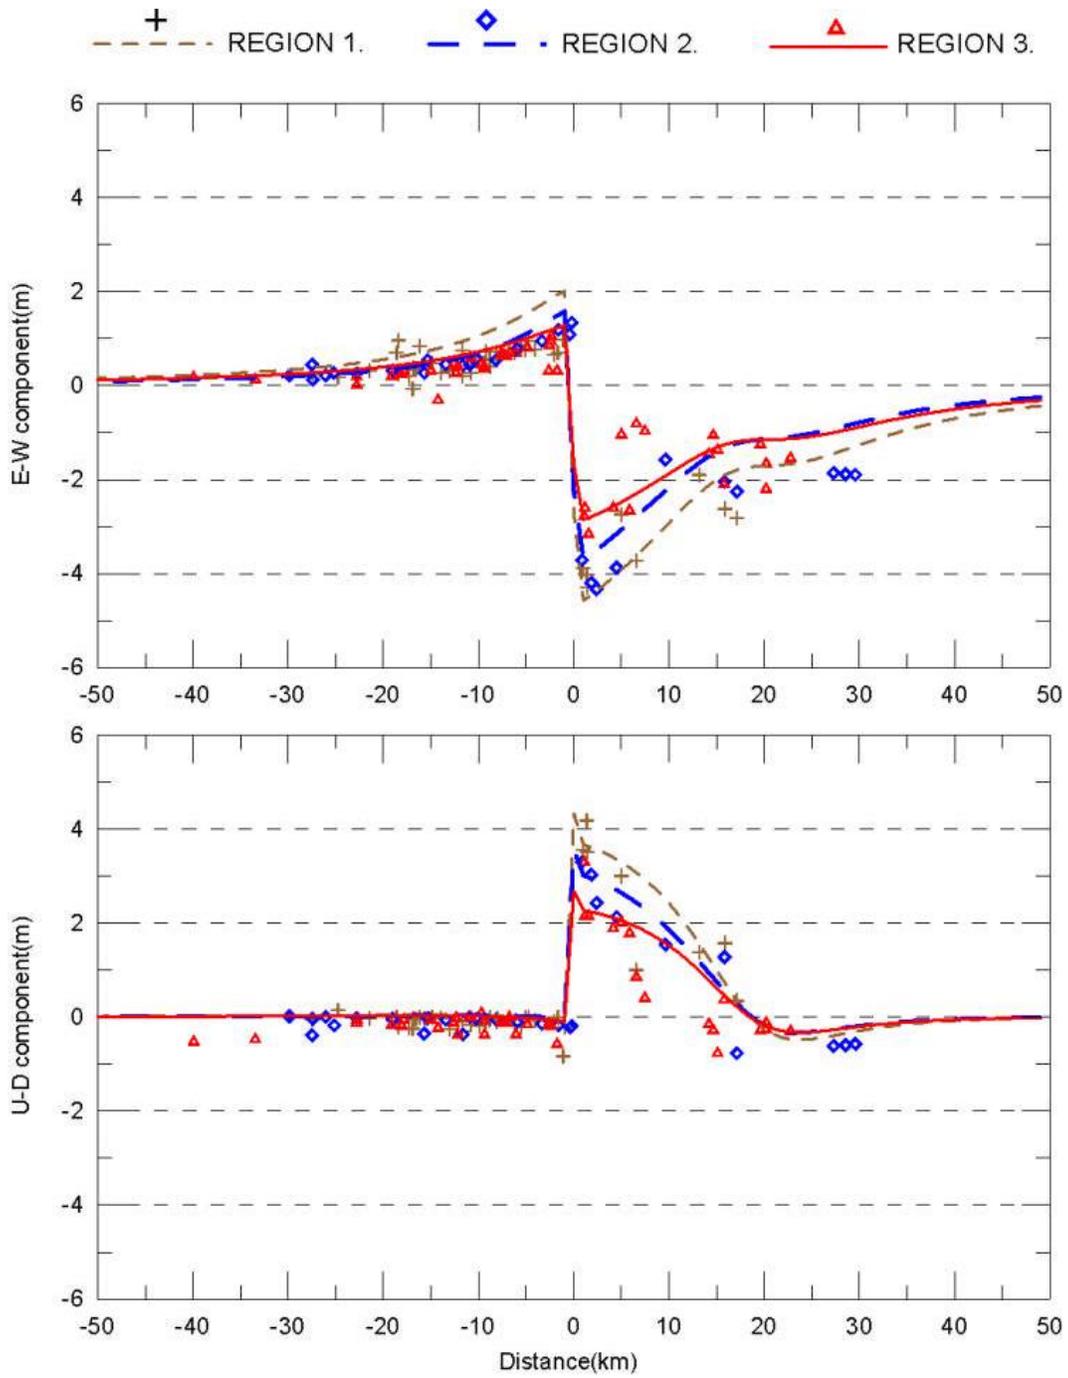
Figure 17. The observed and calculated vertical displacements across the southern, central and northern segments of the fault.

Figure 16 shows the first-order estimation of the dip-slip and strike-slip displacements in the southern, central and northern segments of the Chelungpu fault. Figure 17 compares the observed and calculated horizontal and vertical displacements across the southern, central and northern segments of the fault. The fittings are reasonably close.

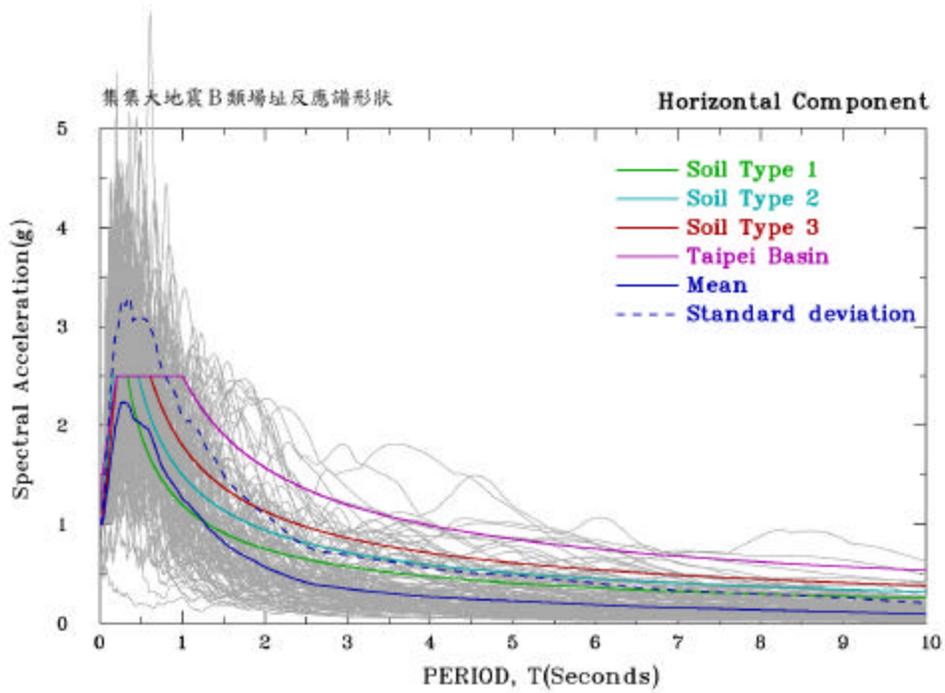
Figure 18. Comparison of the normalized 5% damped acceleration response spectra from Class B sites with the modified Type 1, 2, 3 and Taipei Basin seismic design spectra.

Figure 18 shows the normalized response spectrum shape for Class B sites on rocks of Miocene age or older, as well as the four modified seismic design spectrum shapes. The observed median curve has spectral amplification over periods up to about 1.5 seconds. It is similar to the

modified seismic design spectrum for Type 2 sites in the current Taiwan Building Code (TBC). For periods greater than 1 second the observed median curve is clearly below the modified TBC spectrum level. The peak spectral amplification factor is about 2.3.

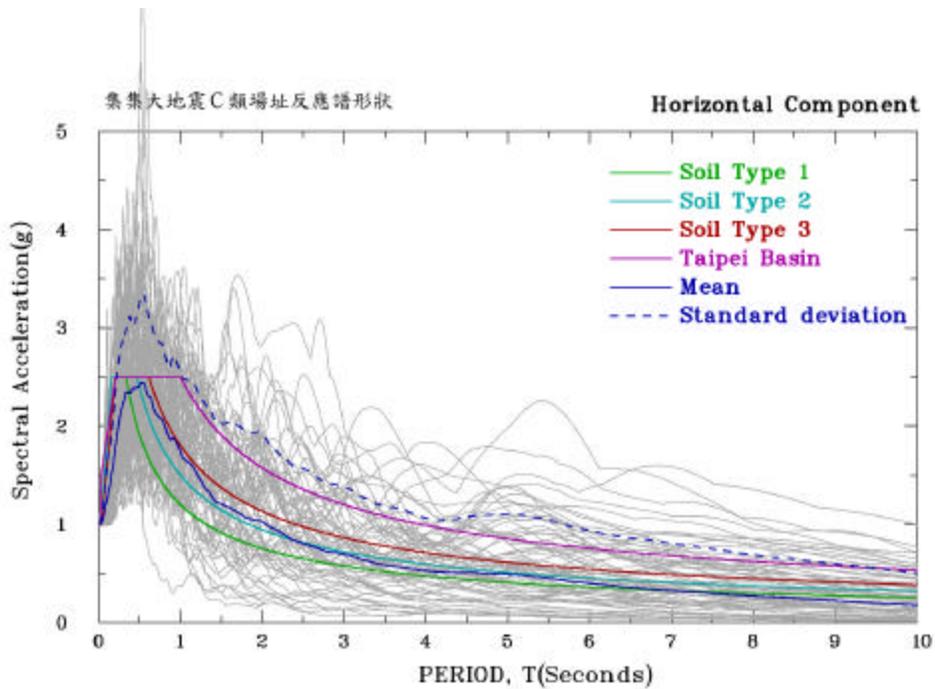
Figure 19. Comparison of the normalized 5% damped acceleration response spectra from Class C sites with the modified Type 1, 2, 3 and Taipei Basin seismic design spectra.

Figure 19 shows the normalized response spectrum shape for Class C sites on soft rocks of Pliocene or early Pleistocene ages, as well as the four modified seismic design spectrum shapes. The observed median curve has spectral amplification over periods up to about 2.0 seconds. It is similar to the modified seismic design spectrum for Type 3 sites in the current Taiwan Building Code (TBC). For periods shorter than 5 seconds the observed median curve follows closely with the modified Type 3 spectrum. The peak spectral amplification factor is about 2.4.

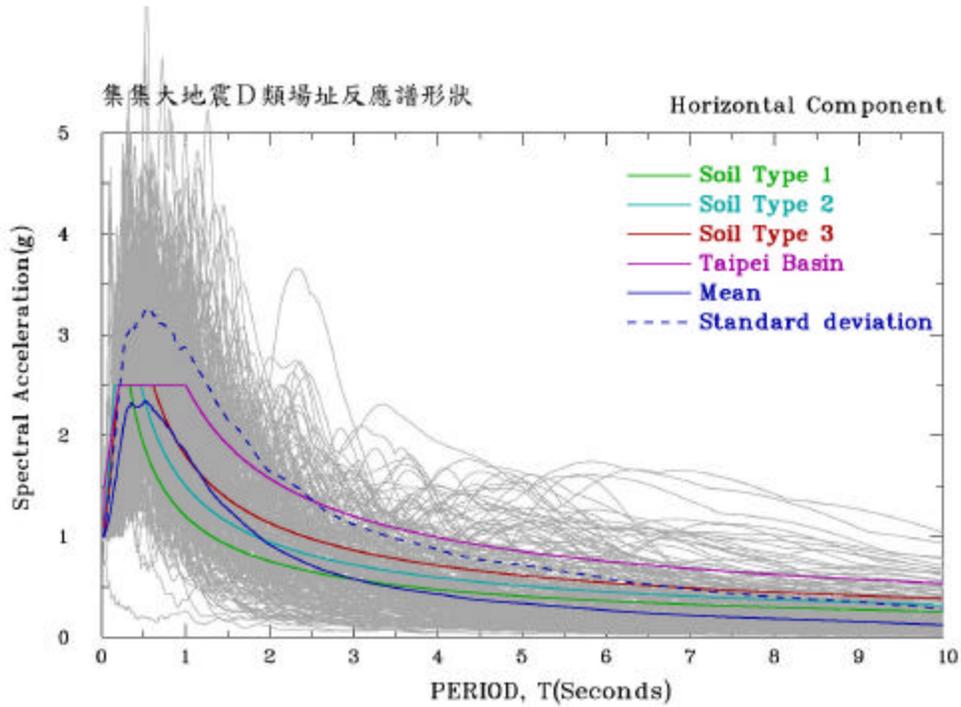
Figure 20. Comparison of the normalized 5% damped acceleration response spectra from Class D sites with the modified Type 1, 2, 3 and Taipei Basin seismic design spectra.

Figure 20 shows the normalized response spectrum shape for Class D sites on stiff soils of late Pleistocene age or younger, as well as the four modified seismic design spectrum shapes. The observed median curve has spectral amplification over periods up to about 1.7 seconds. It is similar to the modified seismic design spectrum for Type 3 sites in the current Taiwan Building Code (TBC). For periods greater than 1.5 seconds the observed median curve is clearly below the modified TBC Type 3 spectrum level. The peak spectral amplification factor is about 2.3.

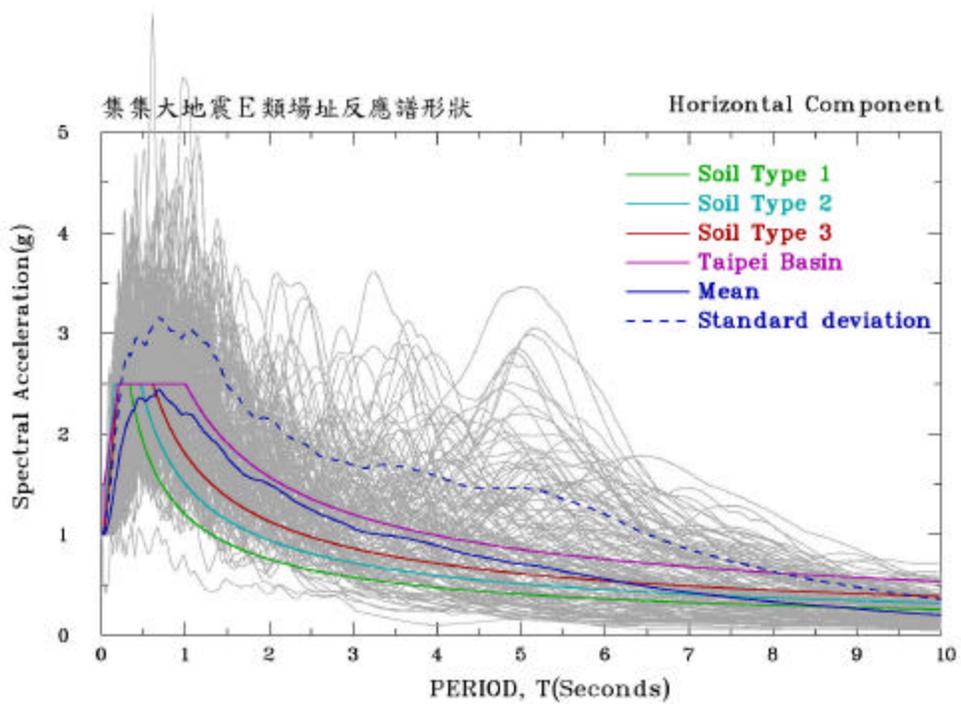
Figure 21. Comparison of the normalized 5% damped acceleration response spectra from Class E sites with the modified Type 1, 2, 3 and Taipei Basin seismic design spectra.

Figure 21 shows the normalized response spectrum shape for Class E sites on soft soils of Holocene age or younger, as well as the four modified seismic design spectrum shapes. The observed median curve has spectral amplification over periods up to about 3.0 seconds. It follows closely but falls slightly below the modified seismic design spectrum for Taipei Basin sites in the current Taiwan Building Code (TBC). For periods greater than 4.0 seconds the observed median curve deviates more below the modified TBC Taipei Basin spectrum level. The peak spectral amplification factor is about 2.4.

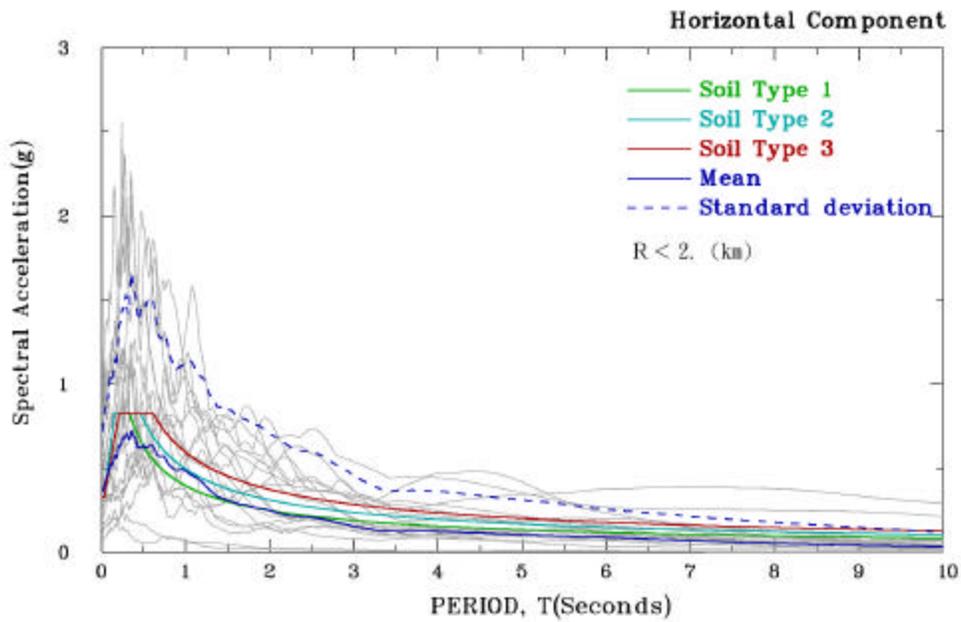
Figure 22. Comparison of 5% damped response acceleration spectra from the recording sites within 2 km of the Chehlungpu fault with the modified seismic design spectra anchored at 0.33g.

Finally, we analyzed the observed acceleration response spectra from 64 near-fault sites to study their characteristics. Figure 22 shows the response spectra for the 9 sites within 2 km from the surface fault ruptures. The observed median response spectrum has a horizontal PGA value of about 0.5 g and a corresponding spectral peak of about 1.0 g. The median-plus-one-standard-deviation horizontal PGA value is about 0.7 g and the corresponding spectral peak is about 1.8 g. In the figure are shown the three modified TBC seismic design spectra anchored at a PGA of 0.33 g. It is found that the observed median curve for sites located within 2 km of the surface fault ruptures matches well with the Type 3 design spectrum, except at very short periods. After multiplied by a scaling factor of 1.5, the modified Type 3 seismic design spectrum anchored at a PGA value of 0.33 g for Zone 1A will almost match the median-plus-one-standard-deviation curve, as shown in Figure 23.

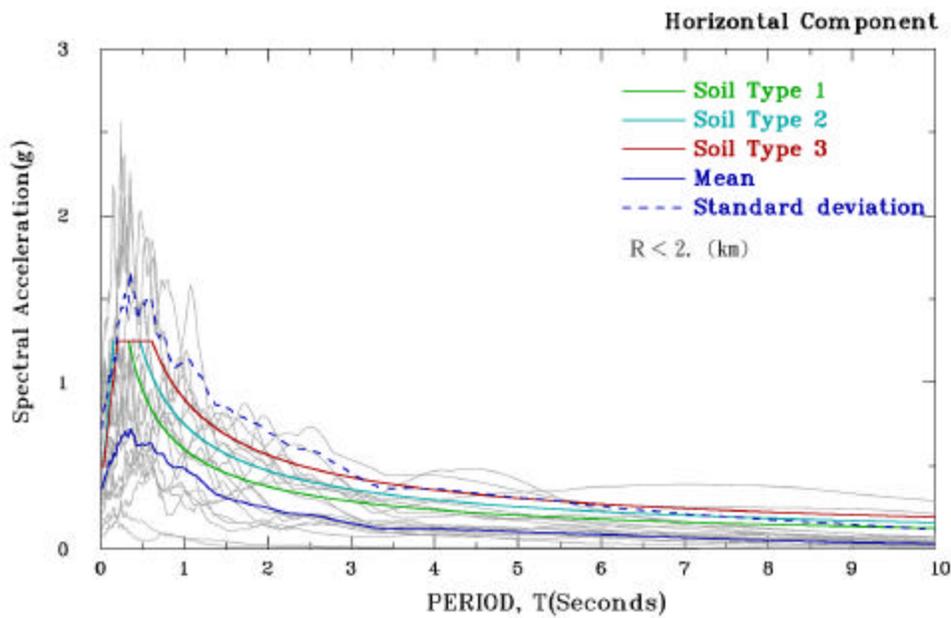
Figure 23. Comparison of 5% damped response acceleration spectra from the recording sites within 2 km of the Chehlungpu fault with the modified seismic design spectra anchored at 0.50g.

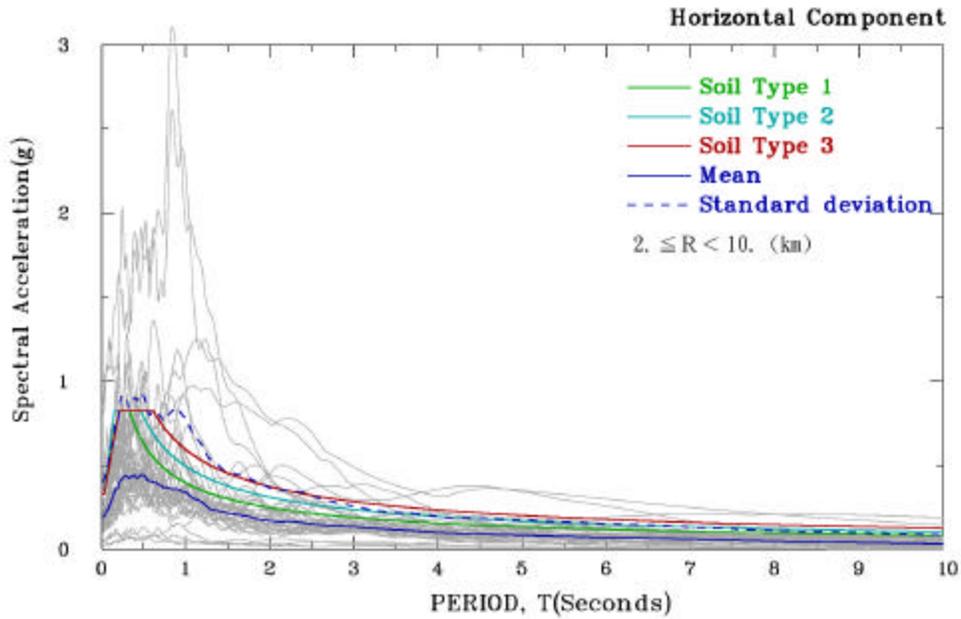
Figure 24. Comparison of 5% damped response acceleration spectra from the recording sites at 2-10 km of the Chehlungpu fault with the modified seismic design spectra anchored at 0.33g .

Figure 24 shows the response spectra for the 21 sites located at 2 to 10 km from the surface fault ruptures. The median horizontal PGA value is about 0.25 g. The corresponding peak spectral value is about 0.6 g. The median-plus-one-standard-deviation horizontal PGA value is about 0.4 g and the corresponding peak spectral value is about 0.8 g. Thus, for sites located between 2 and 10 km from the surface fault ruptures the current seismic design spectrum anchored at a PGA value of 0.33 g for Zone 1A would be more than adequate.

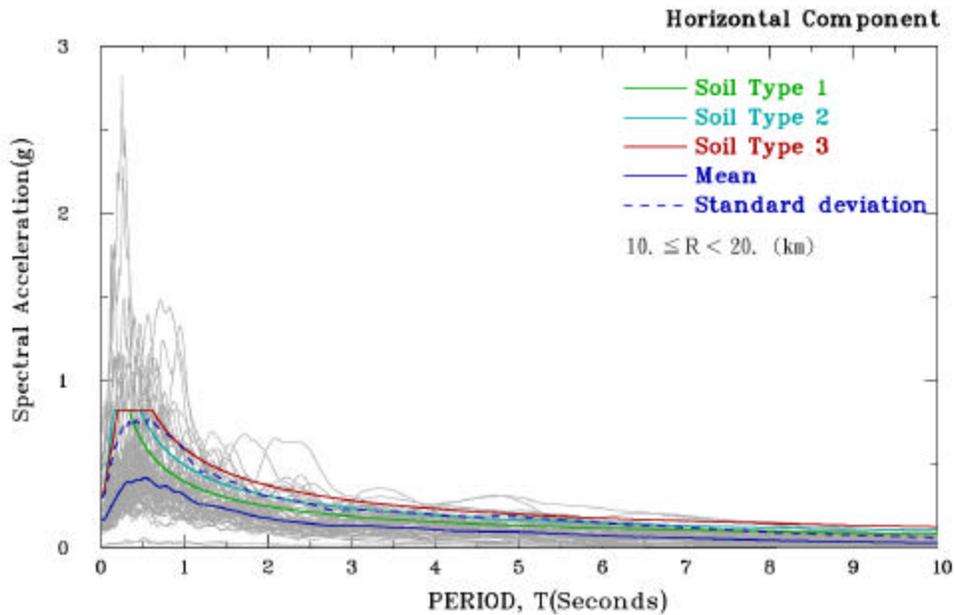
Figure 25. Comparison of 5% damped response acceleration spectra from the recording sites at 10-20 km of the Chehlungpu fault with the modified seismic design spectra anchored at 0.33g

Figure 25 shows the response spectra for the 34 sites located at 10 to 20 km from the surface fault ruptures. The median horizontal PGA value is about 0.18 g with a corresponding peak spectral value of about 0.45 g. The median-plus-one-standard-deviation horizontal PGA value is about 0.3 g with a corresponding peak spectral value of about 0.7 g. Thus, for sites located between 10 and 20 km from the surface fault ruptures the current seismic design spectrum anchored at a PGA value of 0.33 g for Zone 1A would be much more than adequate.

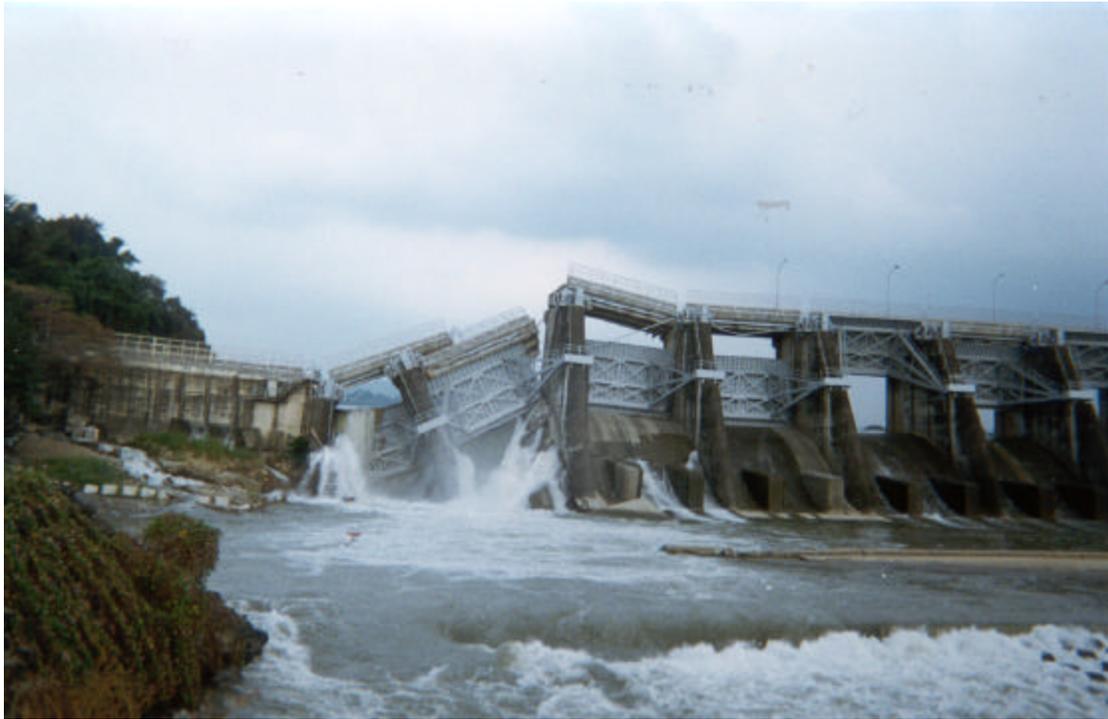
Photo 1.

By dawn in the morning immediately following the earthquake, many geologists rushed to the epicenter areas to make reconnaissance surveys of possible surface fault ruptures. It was soon discovered that the Chehlungpu fault was the culprit of the earthquake. It slipped almost continuously, although sinuously, along its whole length extending southward from Fengyuan in the northern end to Tongtuo in the southern end. Soon later, splays of NE-trending surface fault ruptures were found extending northeastward from Fengyuan toward Shihkang. Total length of the surface fault ruptures was estimated at about 100 km (Central Geological Survey, 1999). Figure 4 shows the location of the Chehlungpu fault and the amount of slips along the fault. Photos 1 to 4 show destruction of some structures caused by the fault ruptures. The structures destroyed included a dam (photo 1), bridges (photo 2), schools (photo 3), houses (photo 4), etc.
