Chorro Flats Enhancement Project
Final Report
to the
California State Coastal Conservancy

Prepared by the
Coastal San Luis Resource Conservation District
October 2002

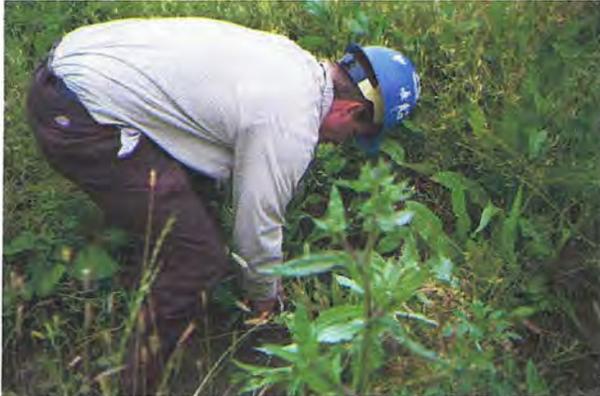
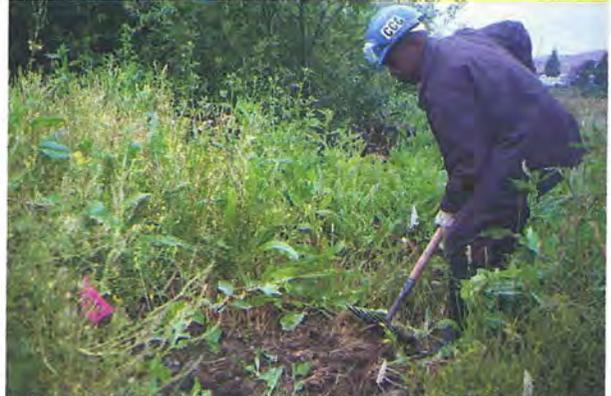
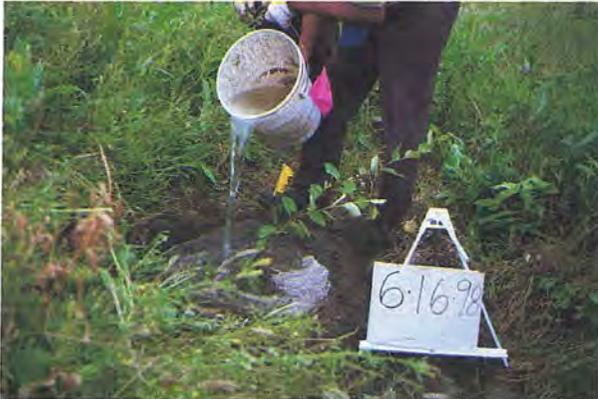
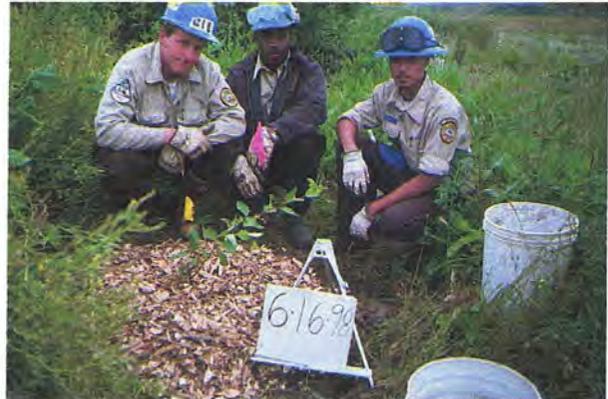
Figure 6. Typical Plant Maintenance Procedure

First you must find the plant. In this case a cottonwood.

Then clear away competing plants using hand tools.

After the irrigation basin is formed, approximately 2 gallons of water are applied.

The finished site includes 3 inches of mulch and a flag to aid future identification.

The native trees and shrubs were regularly maintained with hand weeding, mowing, building irrigation basins, irrigation, and placing mulch. These actions began in May 1998 and were repeated as needed through the summer of 2002. Typical procedures are illustrated below.

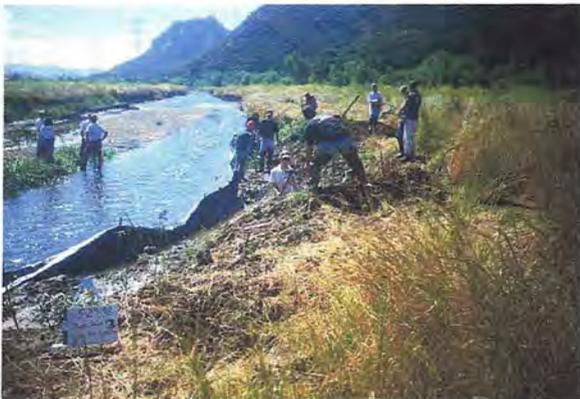
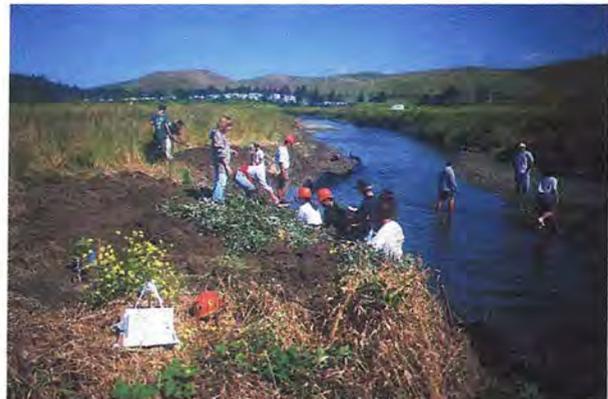
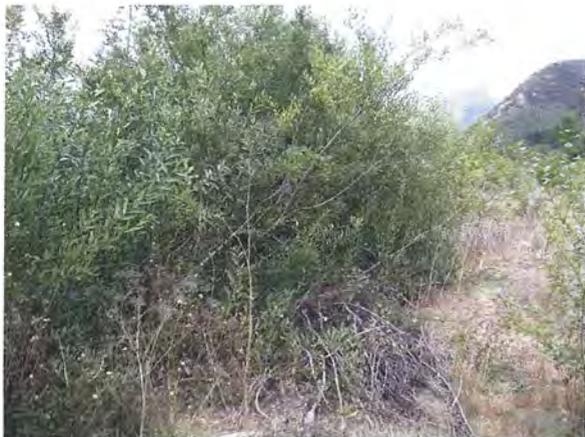
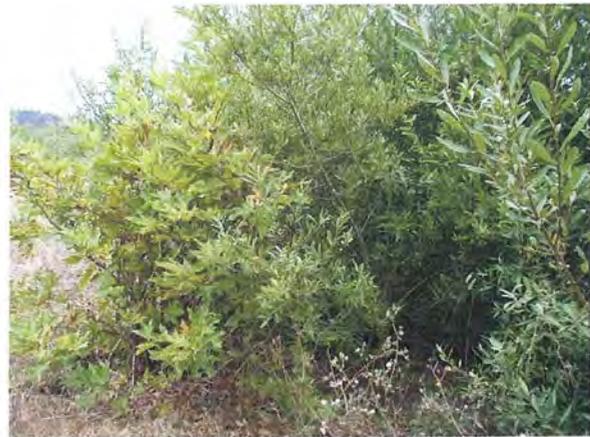
Figure 7. Willow Mattress Installation May 1998, and after 4 years.

Installation of the willow mattress 5-29-98.

View from upstream side 5-29-98

View from same location October 2002.

In June 1998, Dr. Brian Dietterick and his resource management students from Cal Poly installed a "willow mattresses" along a portion of the new channel. This work has continued during subsequent years. By October 2002, mattresses had been installed at 6 separate locations.

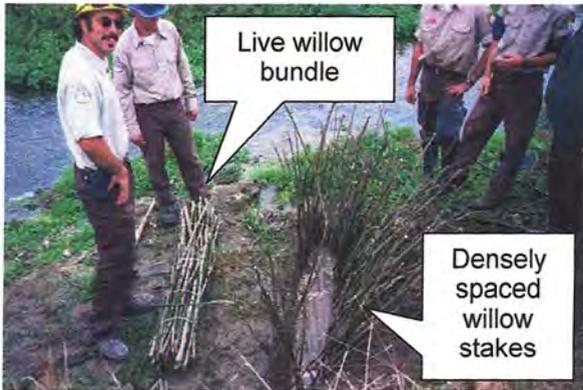
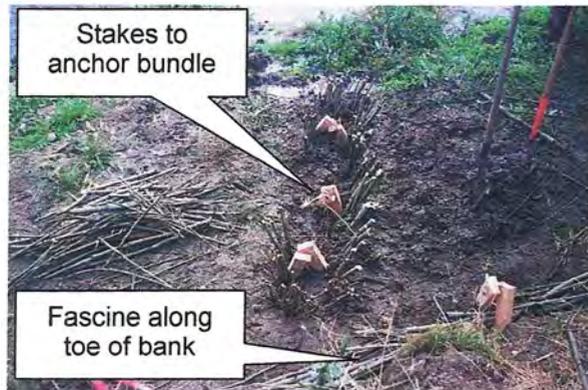
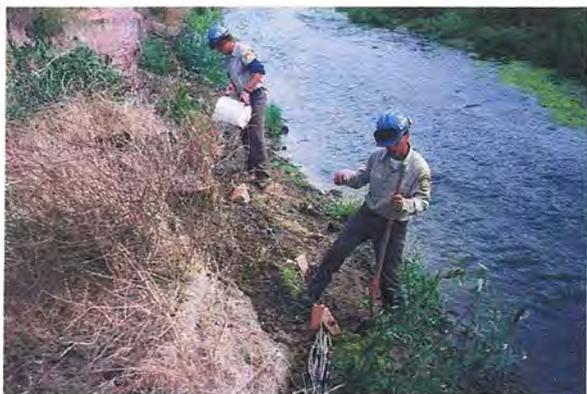
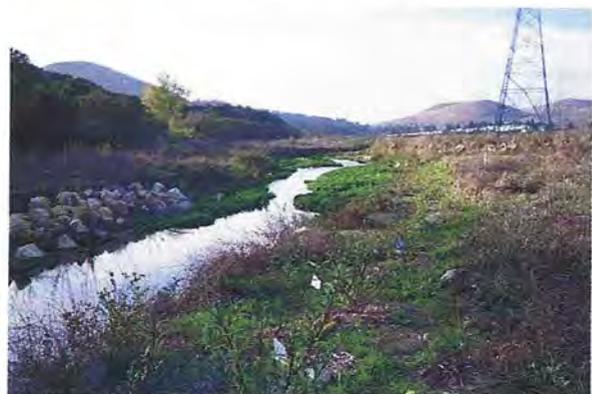
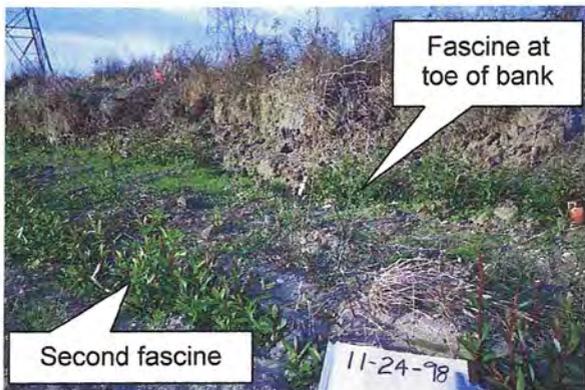
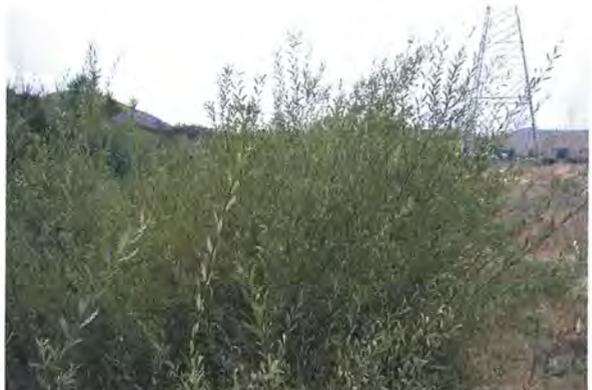
**Figure 8. Willow baffles and fascines
Installation September 1998, after 2 months, and after 4 years.**

Willow baffle installation September 1998

Completed installation September 1998

Willow fascine near mid-project well November 1998.

Willow fascines at upstream end of project November 1998

Willow fascines at upstream end of project November 1998.

Willow fascines at upstream end of project (same location as above) October 2002.

Bank erosion at the upstream end of the project and near the mid-project well was addressed by the installation of willow wattles, or fascines, during September 1998, and during July 1999, as shown below.

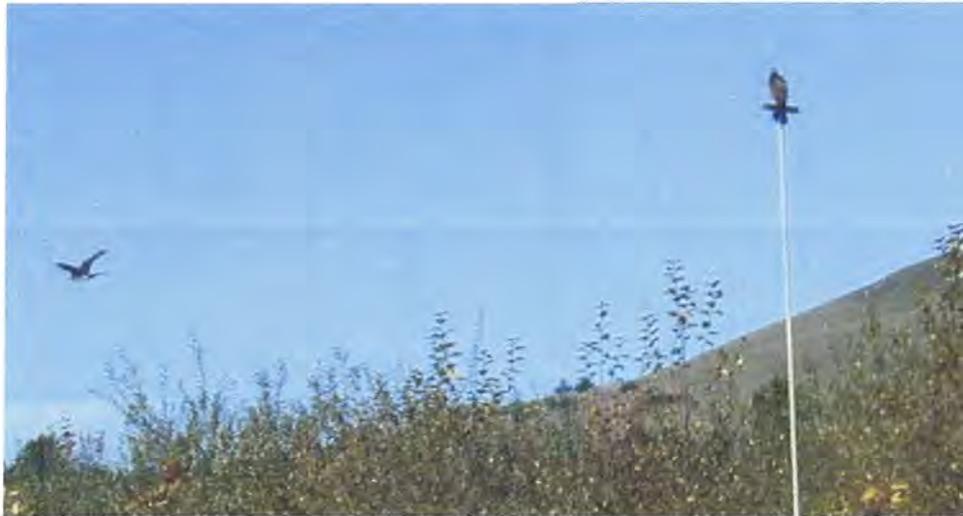
Figure 9. Raptor perch on Chorro Flats.

During June 1999, eleven raptor perches have been installed within the riparian zone along Chorro Creek, to enhance rodent control.

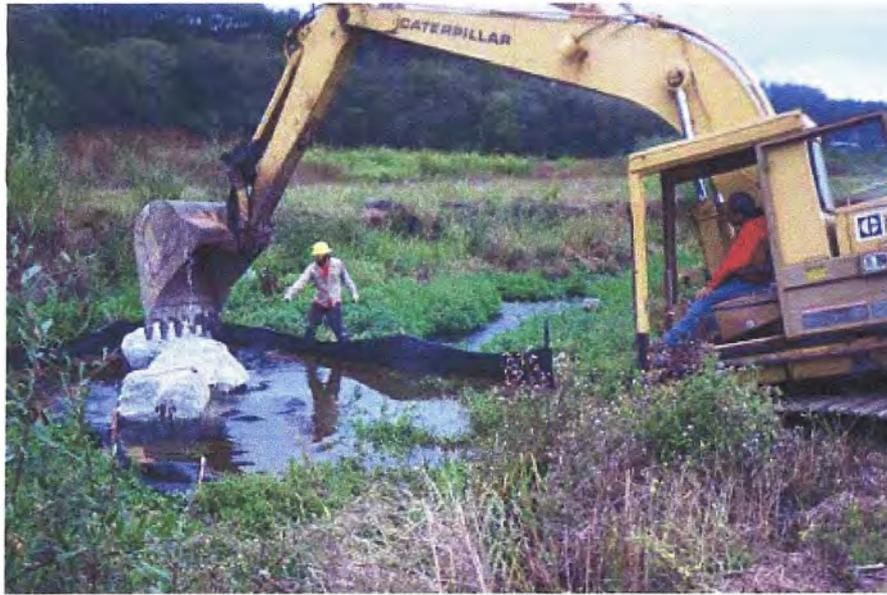
Figure 10. Instream habitat structure installation, 1999.

During 1999, 12 log and boulder structures were installed in the upstream portion of the project to improve steelhead trout summer rearing habitat. During 2001 an additional 22 structures were installed in the middle and downstream portions of the project and one previously installed structure was modified. This \$145,384 effort was funded largely by CDFG fisheries restoration grants, with some funding coming from the National Fish and Wildlife Foundation. All work followed procedures in the DFG *California Salmonid Stream Habitat Restoration Manual*. Rock for the project was imported from local quarries to the project site. Some root wads which were installed into the banks in 1997, and which were too high to function properly, were removed and used for this project. Additional root wads and logs were supplied by Morro Bay State Park and from a private contractor from Nipomo.

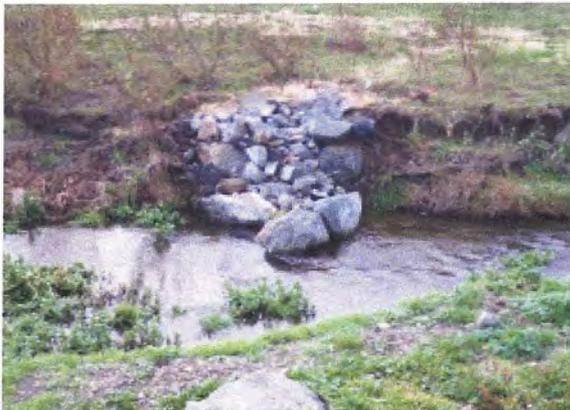
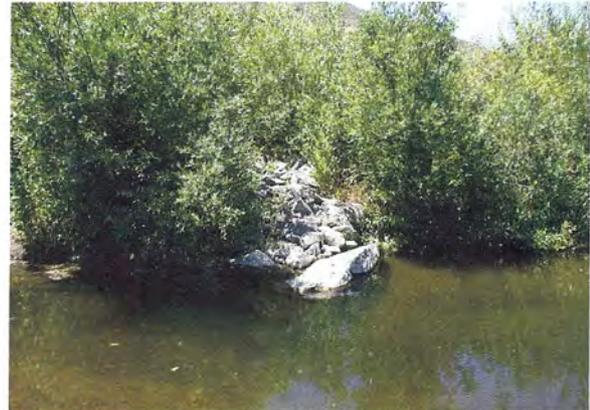
Figure 11. Instream habitat structure and pool development.

Opposing wing deflector after installation, 1999.

Opposing wing deflector, June 2001.

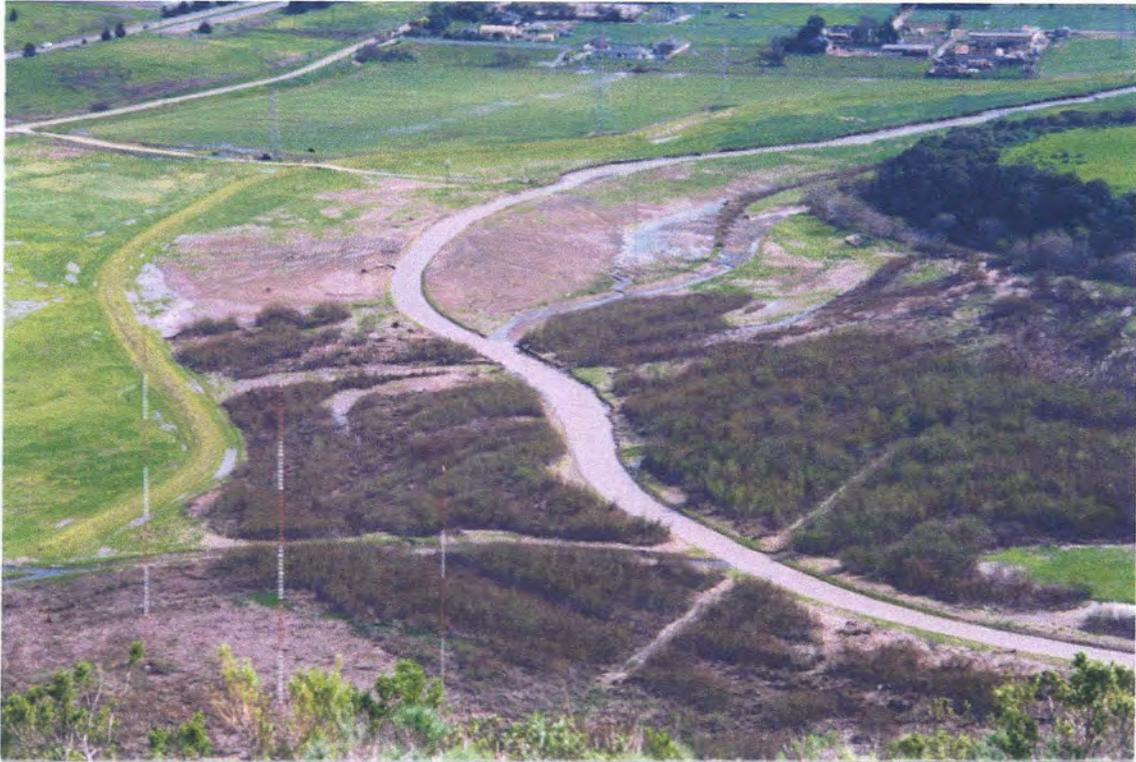
**Figure 14. Chorro Flats from Black Hill, winter 1997-98.
Note lack of riparian vegetation along new channel.**

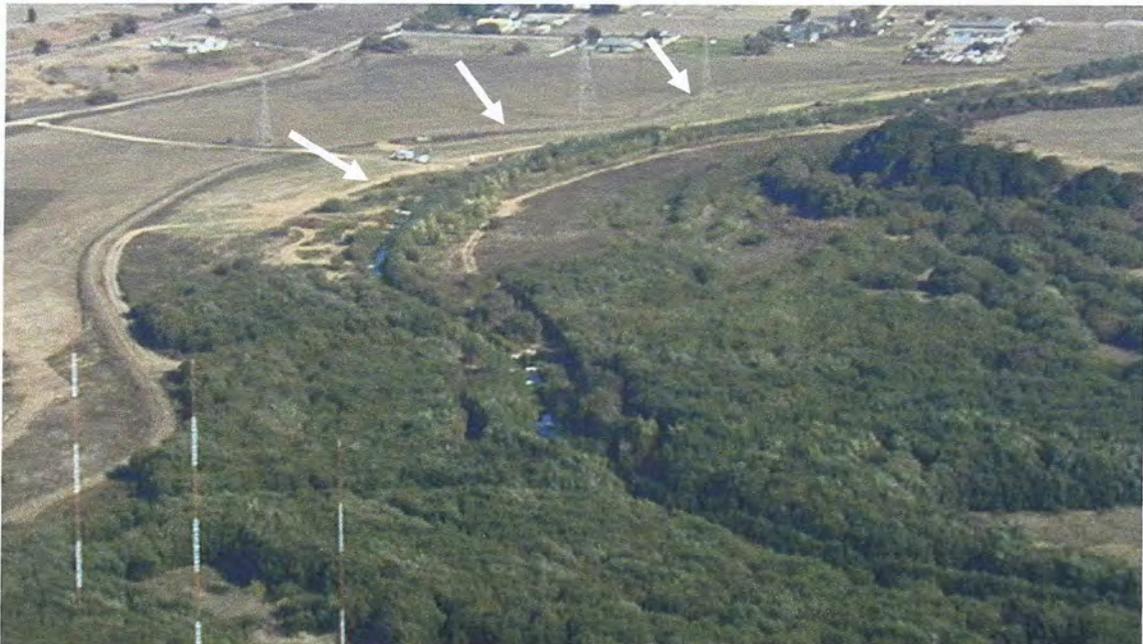
**Figure 15. Chorro Flats from Black Hill, November 2001.
Compare to previous photo. Note extensive riparian vegetation development.
The channel is largely obscured.**

Numeric “plant count” results indicate that the plant maintenance, annual revegetation activities, and native vegetation recruitment has produced the desired result: a vibrant riparian plant community has developed within the revegetation area.

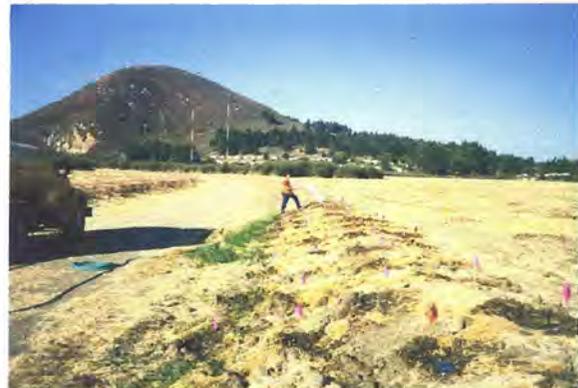
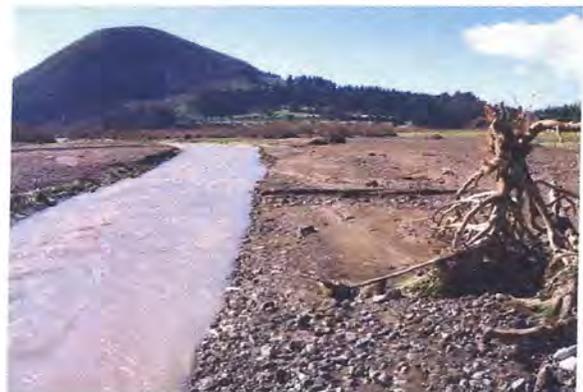
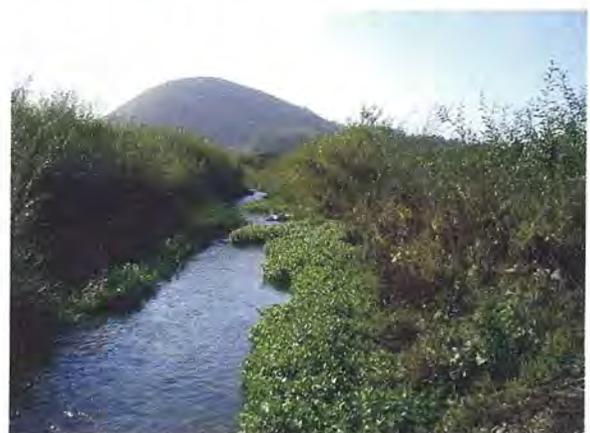
Figure 16.
Middle portion of project, August 1997

Figure 17.
Middle portion of project, early 1998.

Figure 18.
Middle portion of project, August 2001

Note that the plan for the project assumed that the revegetated channels would act as “overflow” channels, carrying water intermittently during winter – but not at all during summer. However, because the main channel “migrated” to the overflow channel, the new channel is now “wetter” during the peak growth season than initially planned.

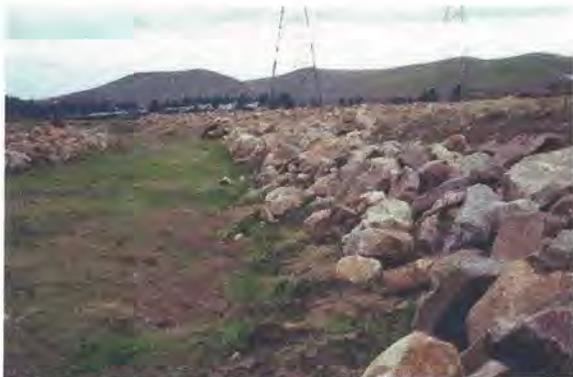
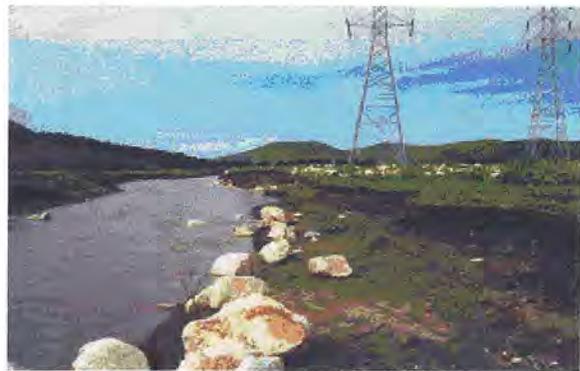
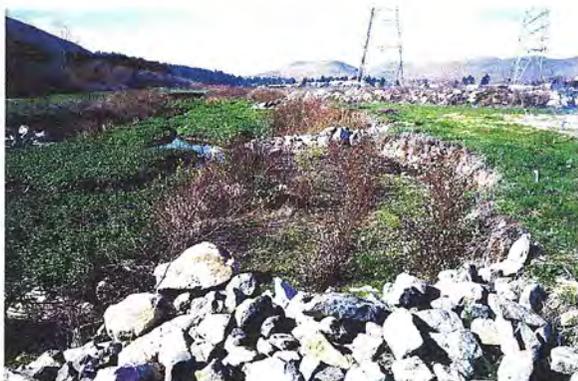
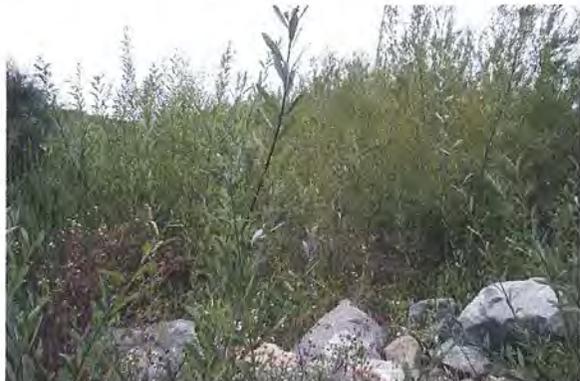
Figure 19. Upstream end of "overflow" channel. November 1997.

Figure 20. "Overflow" channel at upstream end of project. February 1998.

Figure 21. Chorro Creek at upstream end of project. January 2000. Note habitat improvement structures and willow wattle growth.

Figure 22. Chorro Creek at upstream end of project. July 2002. Note willow growth.

The following photos show the upstream end of the site, where significant erosion occurred during early 1998, where willow fascines were planted in 1998 to protect the bank, and where habitat improvement structures were installed in 1999.

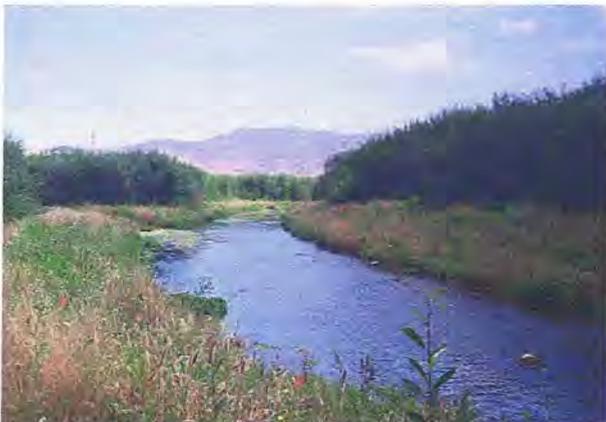
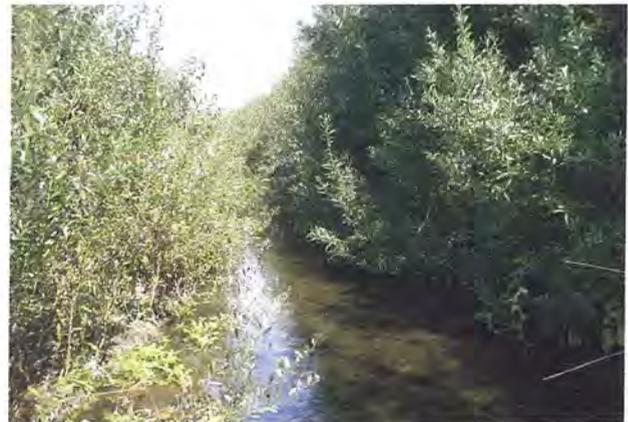
The riparian plantings are now shading Chorro Creek.

Figure 28.
Downstream portion of project, June 1998.

Figure 29.
Same downstream location, August 2001.

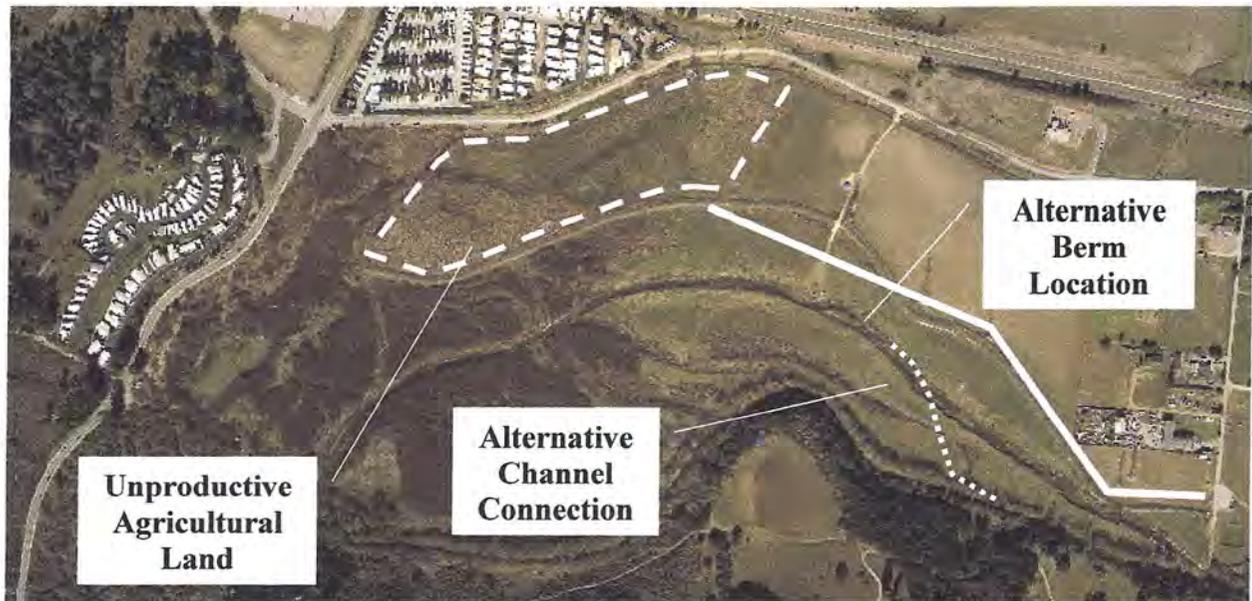
Figure 35. Alternative Location for Channel Connection and Berm

Additionally, the connection between the overflow channel and Chorro Creek was made at the extreme upstream end of the site. Connecting to Chorro Creek at this location, in conjunction with the erosion noted above, has resulted in significant erosion very close to the berm and somewhat close to the high voltage power transmission towers that cross the site. A preferable location for the connection may have been somewhat further downstream, to avoid potential impacts to the berm and towers. See below.

Conversely, the easterly end of the floodplain portion of the project is higher and drier than the rest of the site, and receives floodwaters (and sediment) less frequently. These observations lead to the suggestion that a better location for the berm may have been closer to the creek in the central portion of the site, and further from the creek in the westerly portion of the site. However, it should also be noted that prior to project implementation the western areas of the site were usually left fallow during very wet years. This leads to the idea that perhaps the berm could have been abbreviated (as shown above) so that the unproductive agricultural land could have been

more directly connected to the floodplain, thereby enhancing sediment capture. The CSLRCD is currently considering removing or relocating the western portion of the berm for the reasons noted above.
