Inventory and Assessment of Abandoned Mines on California Agency-Owned Lands

August 2009

INVENTORY AND PRELIMINARY ASSESSMENT OF ABANDONED MINES ON CALIFORNIA AGENCY-OWNED LANDS (August 2009)

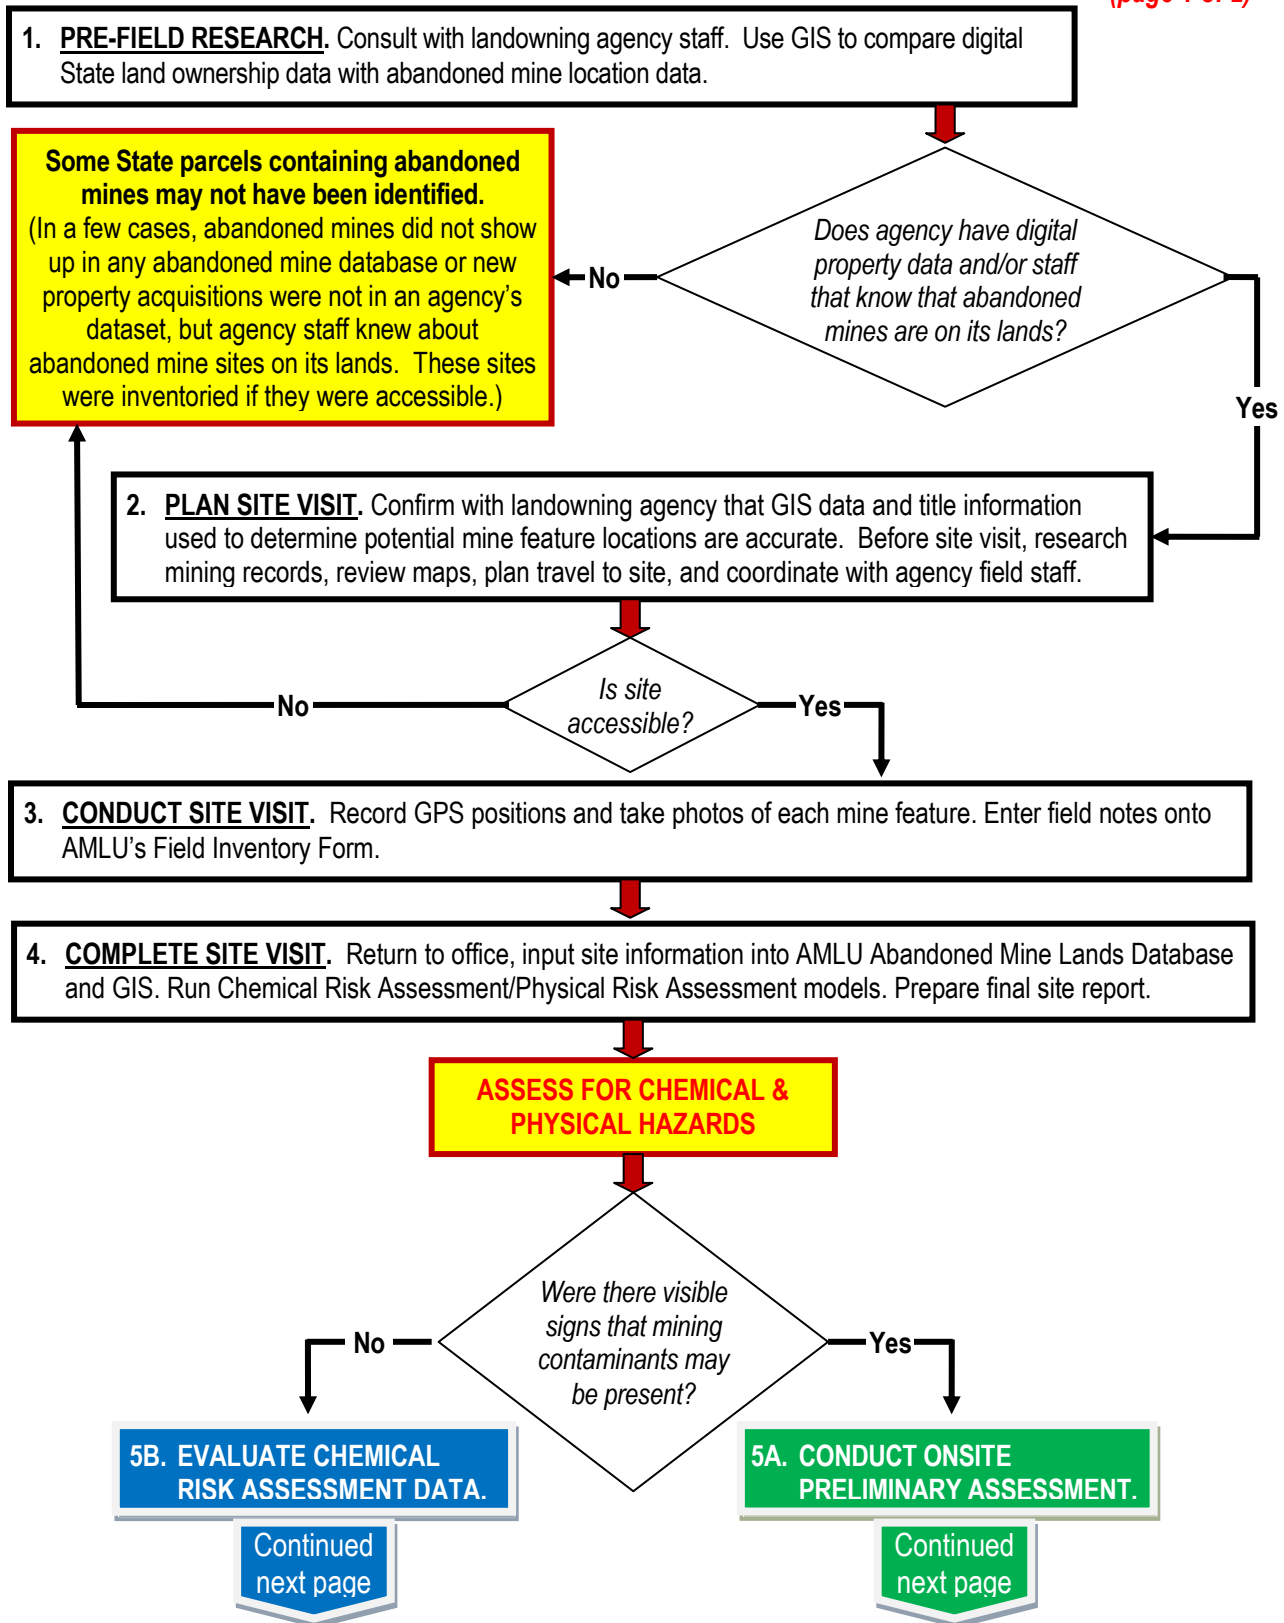
Figure A-1. Project Methodology Summary Flowchart.

The AMLU uses a standard methodology to inventory abandoned mines in California. For this project, the AMLU selected sites based on State ownership or management, which is usually only one criterion the AMLU uses to prioritize sites to inventory. Other considerations typically include expected hazard levels, proximity to population centers or recreational areas (e.g., campgrounds or off-highway vehicle [OHV] areas), and amount of public visitation. The AMLU's methodology for this project included the following steps (see flowchart in Figure A-1).

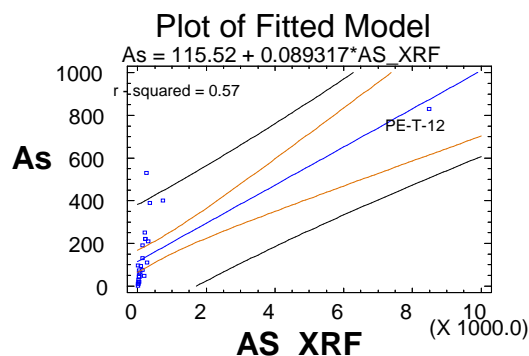
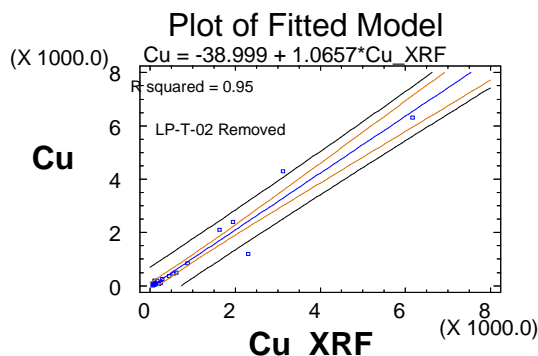
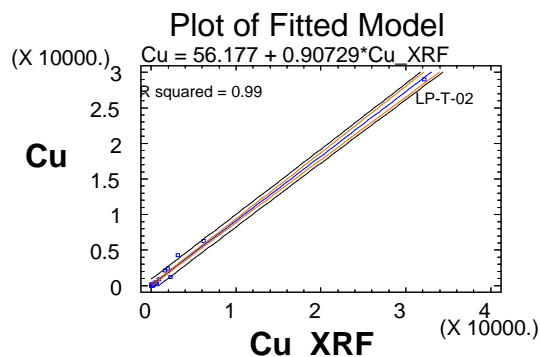
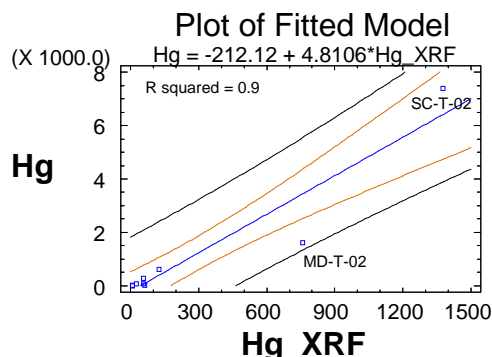
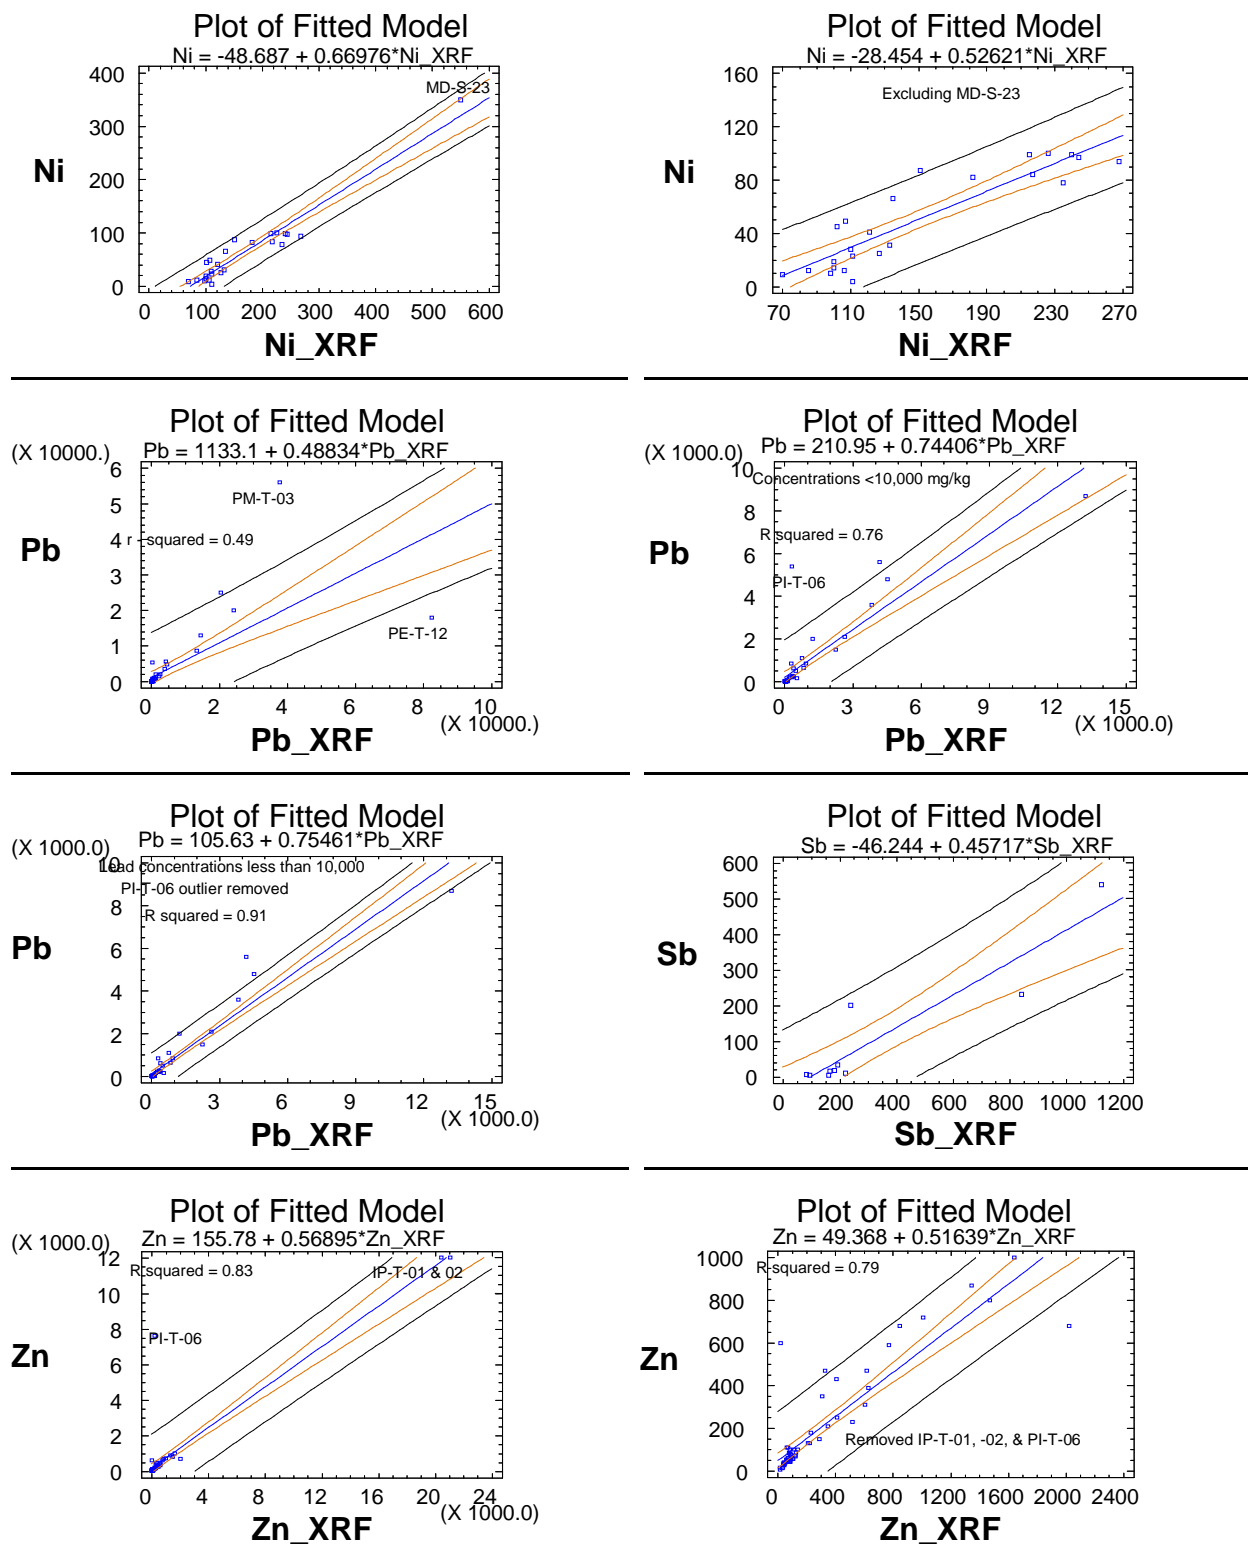
Table A-6 / Figure A-4. XRF/Laboratory Result Regressions.

Constituent (element)	Analysis (all data)		Reanalysis (remove outliers)		Comments
	# samples	R ²	# samples	R ²	
Arsenic (As)	27	0.59			
Chromium (Cr)	22	0.31			
Copper (Cu)	28	0.99	27	0.95	Reanalysis: excluding LP-T-02
Mercury (Hg)	9	0.90			Insufficient pairs of samples
Nickel (Ni)	25	0.93	24	.081	Reanalysis: excluding MD-S-23
Lead (Pb)	58	0.49	53	0.91	Reanalysis: <10,000 ppm, PI-T-0-06 removed
Antimony (Sb)	10	0.86			Insufficient pairs of samples
Zinc (Zn)	64	0.83	61	0.79	Reanalysis: outliers removed
Cadmium (Cd)	5	0.55			Insufficient pairs of samples; (no graph)
Cobalt (Co)	13	0.06			(no graph)

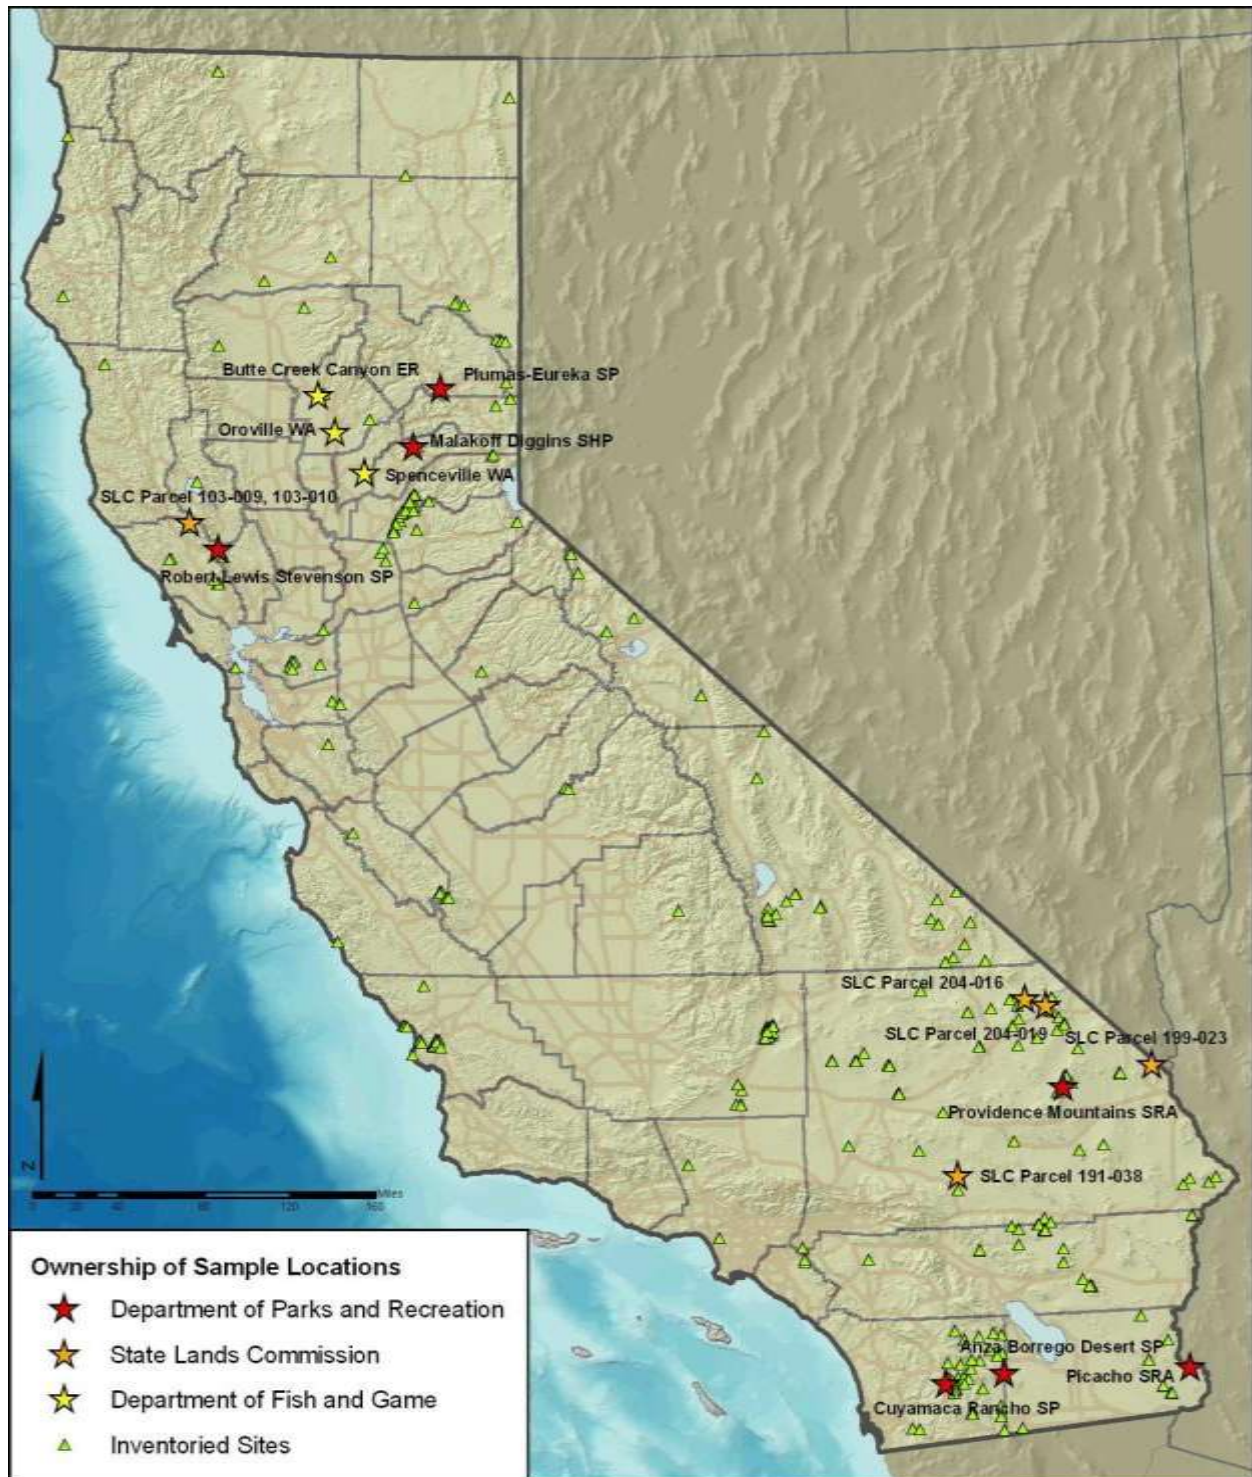
Figure B-1. Sampling locations.

Maps and summaries of individual sampling sites for three state agencies—State Parks, SLC, and DFG—are provided in Part 2 of this Appendix.

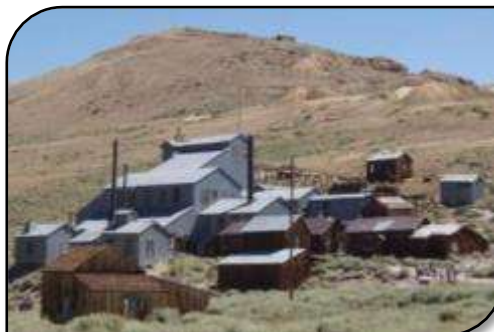
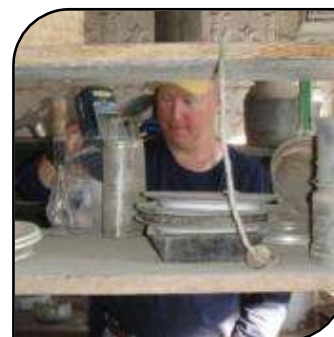
In the late 1800s to early 1900s, Bodie was part of a major gold mining district. In 1962, the town and adjacent area became Bodie SHP, which is owned and managed by State Parks. The park is preserved in a state of “arrested decay,” and a critical priority for State Parks is to maintain the appearance and historical setting of mining, including structures, artifacts, and other cultural resources, and protect public health and safety.

Above: Bodie SHP’s Standard Mill.
Below: An XRF is used to analyze dust in the Wheaton-Hollis Hotel.

From 2007 to 2009, with funds from OMR’s Surface Mining and Reclamation Account, the AMLU, State Parks, and USEPA coordinated to investigate and remediate chemical hazards at Bodie SHP left over from historic mining and gold processing, including lead (used in the assay process to measure the amount of gold in an ore sample); mercury (used as amalgamate with gold to enhance recovery); and arsenic (commonly associated with gold deposits and occurring naturally in the area). The USEPA conducted sampling and remediation work (locations and procedures were designed to fully characterize and remediate contaminants and protect cultural resources and artifacts), which was monitored by Park archaeologists and OMR staff. The project included the following tasks.

- Installation of a modified radon extraction system to reduce mercury vapor concentrations inside the Standard Mill and remediated lead-contaminated soil on slope below the Mill (placed filter fabric and clean fill, revegetated slope, and installed fences to reduce disturbance).
- Remediation of lead-contaminated soil from Bell and Rose Klyps Assay buildings (removed top foot of soil in and around buildings; replaced soil with clean fill).
- Removal of lead contaminated dust in Wheaton-Hollis Hotel using a HEPA vacuum.
- Controlling of erosion of mine tailings adjacent to Bodie Creek by building a diversion channel lined with rocks collected onsite to carry runoff away from the tailings, by constructing weirs in the creek to slow stream flows, and by composting and revegetating the tailings to promote growth of native plants

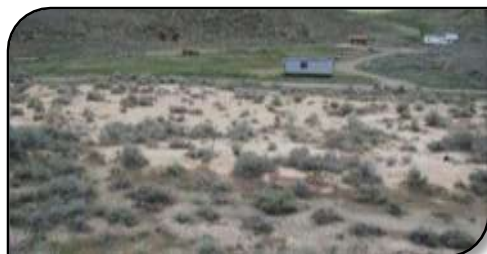
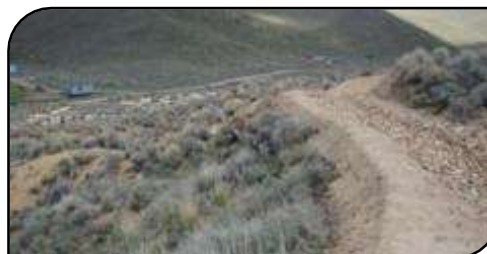
A lined diversion ditch (right) prevents runoff from eroding mine tailings (light colored soil on left).
