Selected AMLU Abandoned Mine Remediation Projects (2008)

Shafts Plugged with Polyurethane Foam and Culverts Gate Installed, Eldorado National Forest, El Dorado County, August 2008

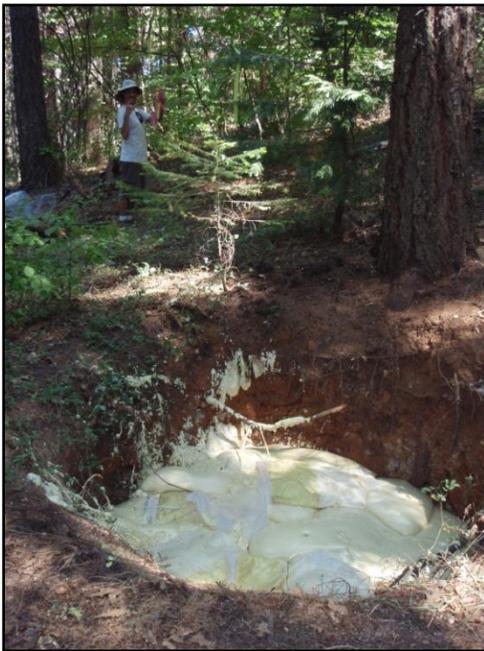
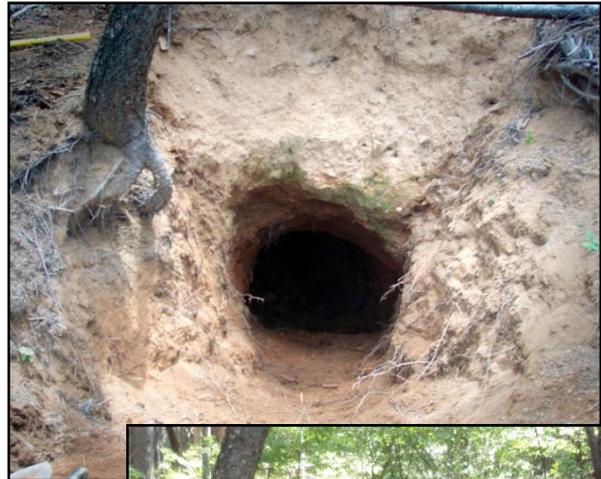
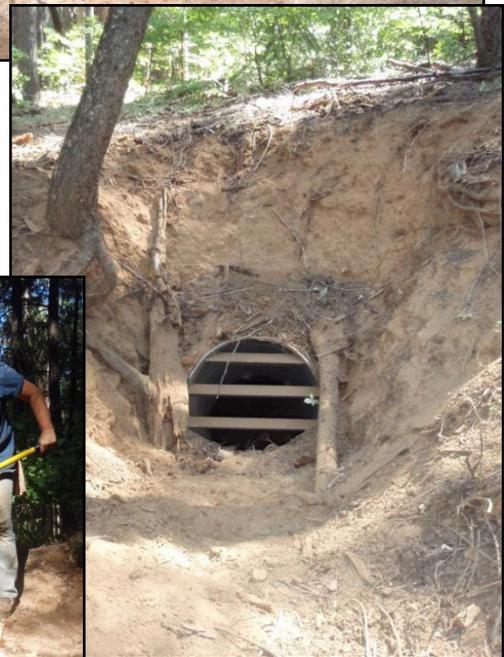
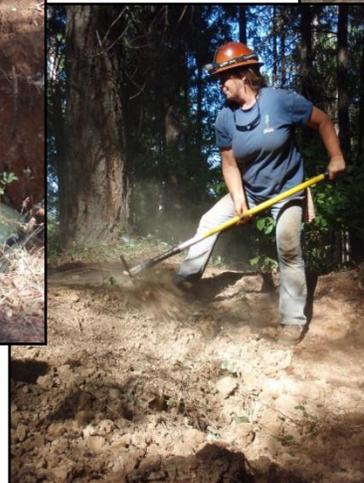
In August 2008, the AMLU partnered with the Eldorado National Forest to plug four shafts and install one culvert gate near the town of Volcanoville, CA. Polyurethane foam was used to seal the shafts located adjacent to a local horse trail after wildlife exclusions had been performed. It was also used to secure the culvert gate in place before being covered by several feet of dirt.

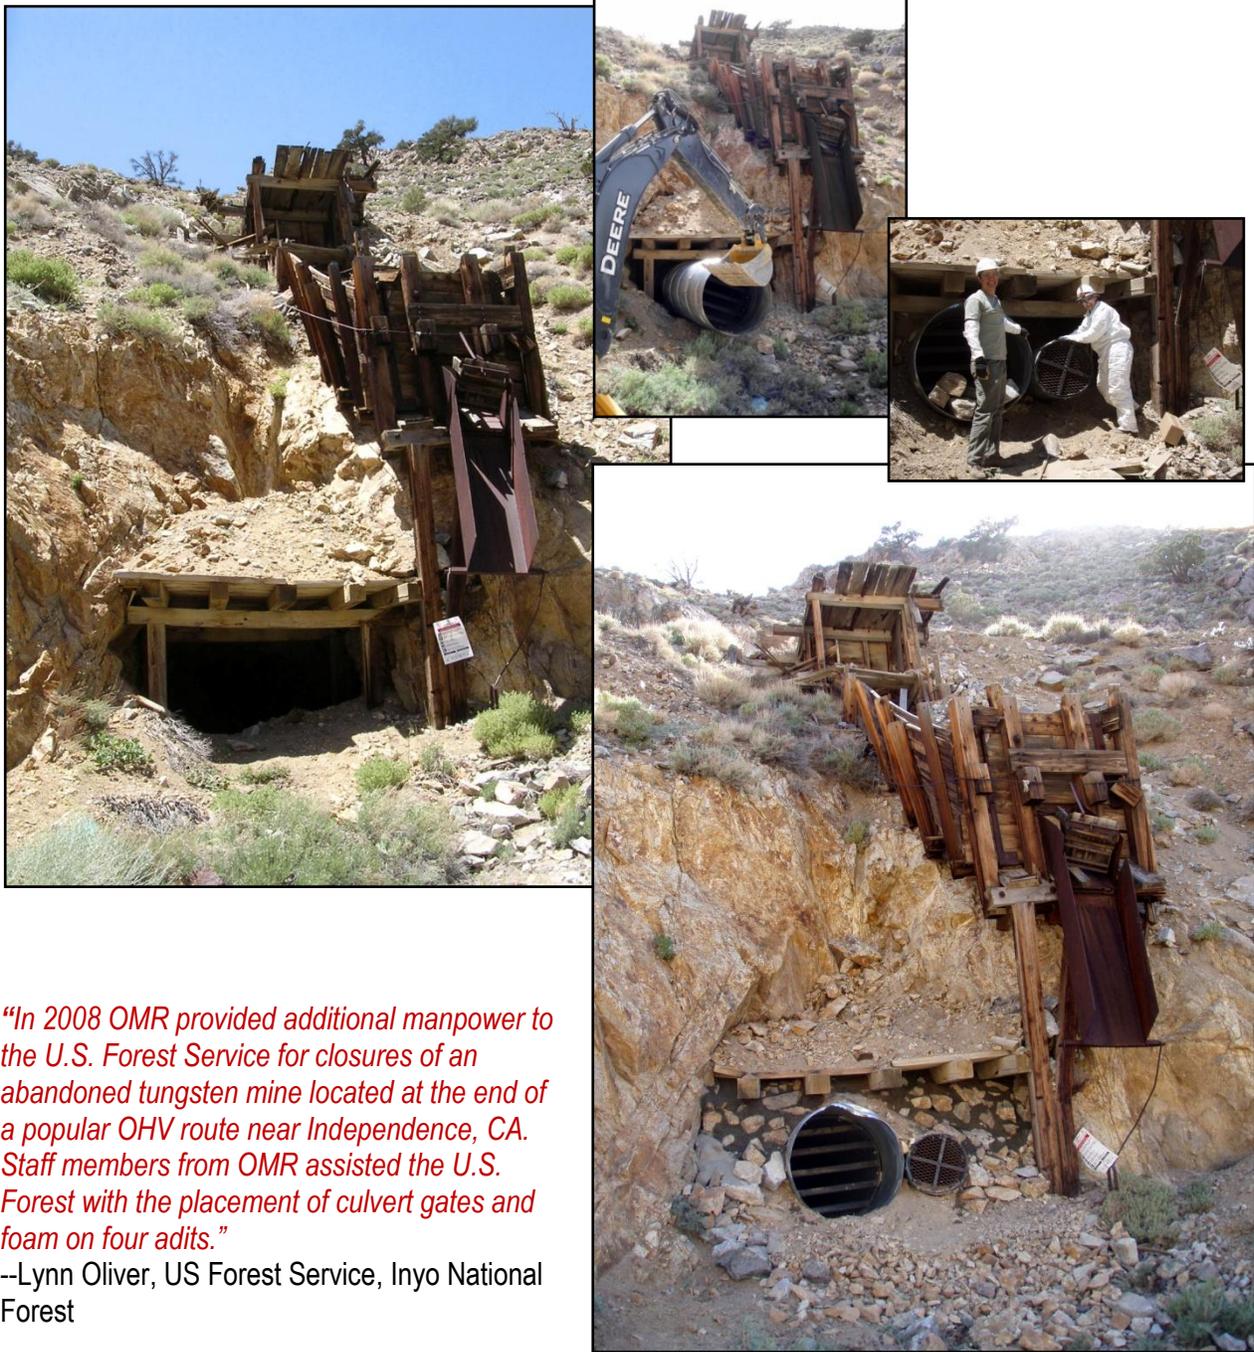
Culvert Gates and Fence Installed, Inyo National Forest, Inyo County, May 2008

In May 2008, the AMLU assisted the Inyo National Forest in the closure of four dangerous adits and fenced a shaft near Independence, CA. Working together, they were able to stabilize and help secure the future of some of the unique historical mining structures at the site. At same time, physical hazards associated with these openings were abated and wildlife habitat improved.

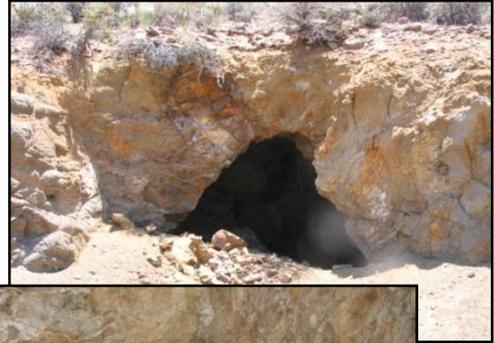
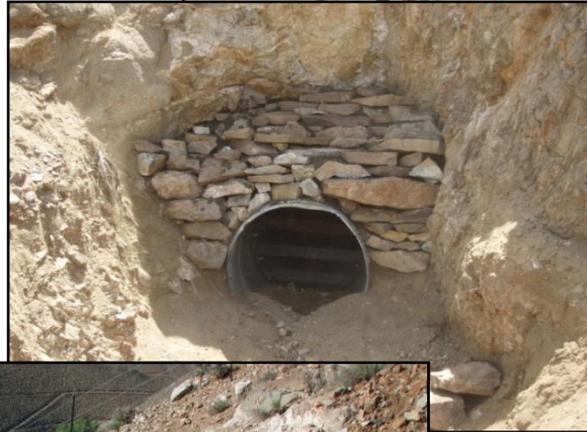
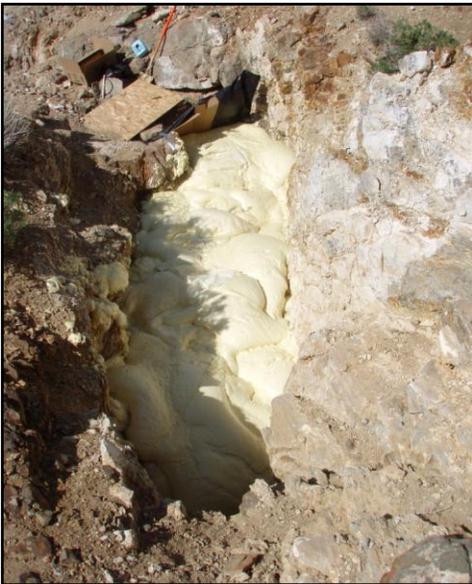
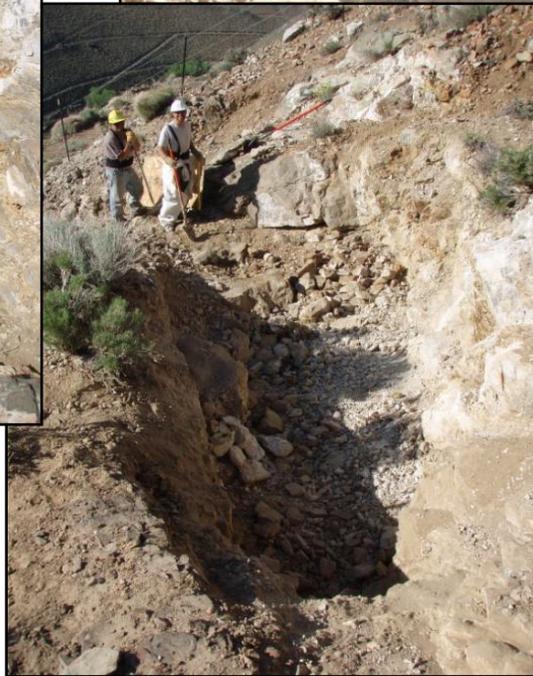
Culvert Gates, Polyurethane Foam Plug, and Backfills, Inyo National Forest, Inyo County, May 2008

In May 2008, the AMLU assisted in the closure of four adits and one vertical opening near Bishop, CA. Inyo National Forest's Road Crew came out with a backhoe to help with the heavy lifting and backfill work, while the AMLU staff aided in the securing of the two culvert gates and the placement of a polyurethane foam plug. These were the last of several dangerous features to be dealt with at this abandoned mine. In 2005 and 2006 the AMLU partnered with the Inyo National Forest to close eight other features at the mine site.

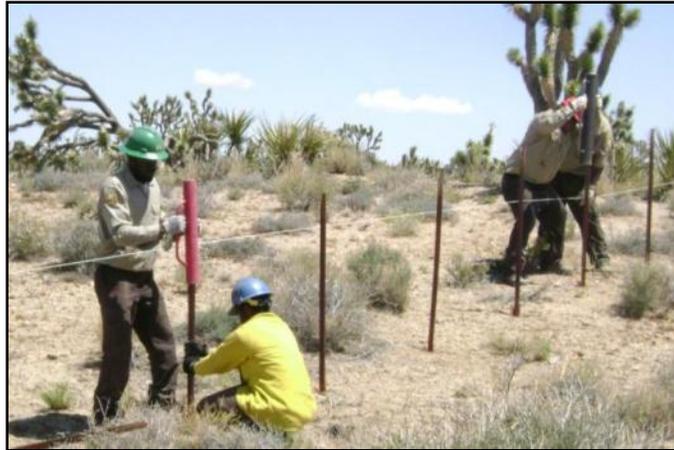
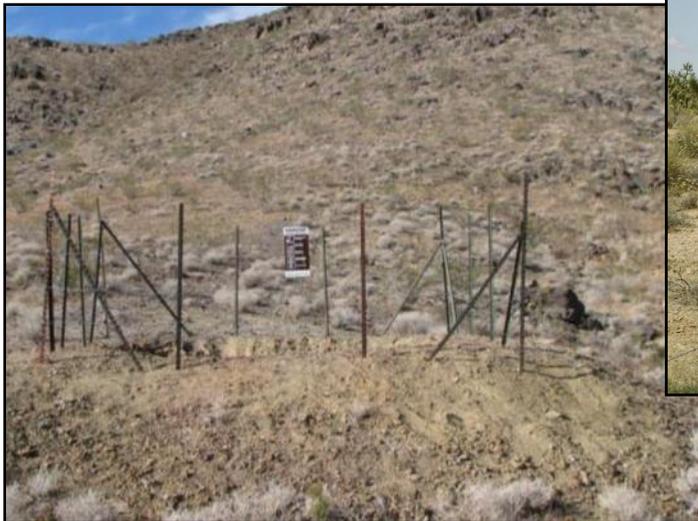
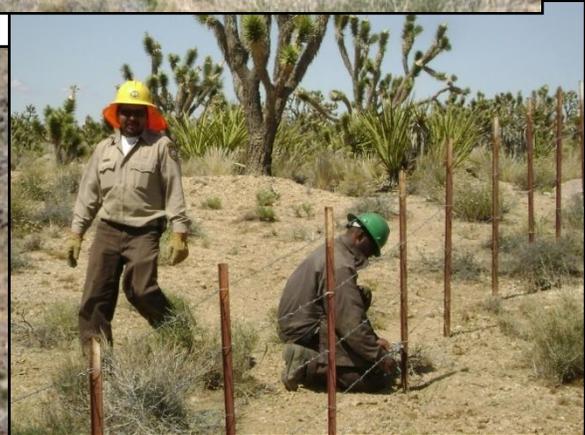
Fences Installed, Mojave National Park, San Bernardino County, May 2008

In May 2008, National Park Service staff assisted by a California Conservation Corps crew and with funding from the AMLU installed fences around 17 hazardous abandoned mine features within the Mojave National Park. The sites were located along frequently used trails, and tire tracks could be observed on the waste dumps and trails leading to several shafts.

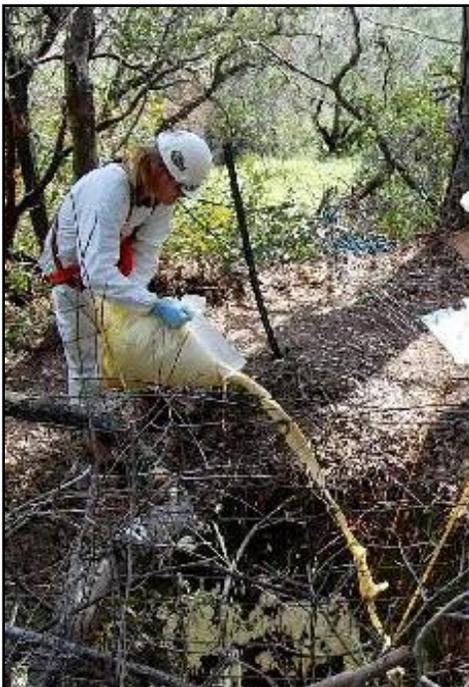
INSERTING "FALSE BOTTOM" AND POURING FOAM INTO SHAFT

In March 2008, the AMLU, California State Parks, and the U.S. Bureau of Reclamation teamed up to seal an abandoned mine exposed as a hazard after a dog fell in. On January 21, Dewie, a golden retriever, was with his owners on a trail along the Shirland Canal near the foothill community of Auburn. He was chasing a rock down an embankment in a wooded area when he suddenly vanished down a 35-foot-deep shaft, likely part of Gold Rush-era workings. Hours later, Auburn firefighters pulled Dewie to safety. Rangers quickly put up fencing around the shaft, and the AMLU contacted State Parks with the offer to help install a more permanent fix. Six weeks later, Dewie returned to stand atop the shaft after it was plugged with expandable polyurethane foam more than strong enough to support the weight of Dewie and his owners.

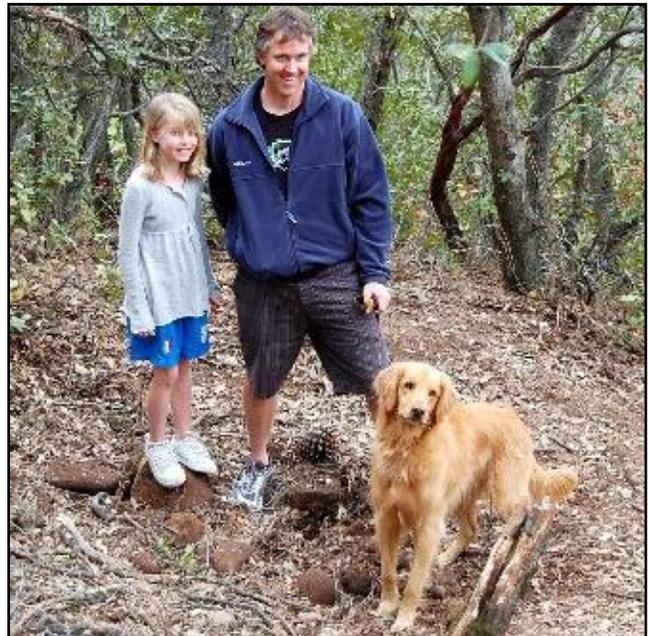
SHAFT SITE (AFTER CLOSURE)

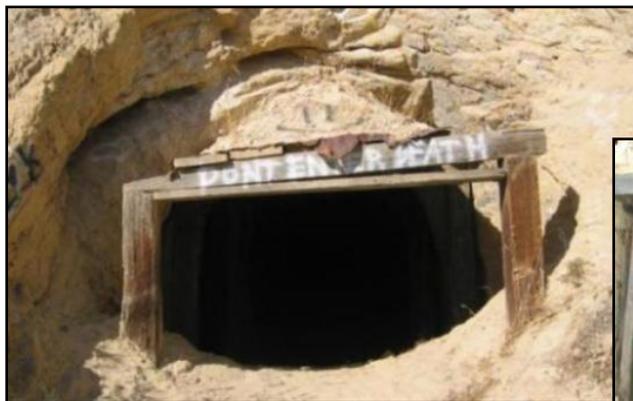
While the site is currently off-limits to the public, there is ample evidence in the form of graffiti and litter that it is visited frequently. Vandals had recently entered the site illegally and burned some of the 100-year-old wooden beams inside the entrance to one of the adits, potentially weakening the mine's supports. One mine had been used as a methamphetamine lab for a few days, until Park rangers discovered and stopped the operation. The bat gate also protects bats, including pallid and Townsend's big-eared bats, which have been found inside the abandoned mine and can hibernate or set up maternity colonies now that the human disturbance has been removed.

ADIT (BEFORE)

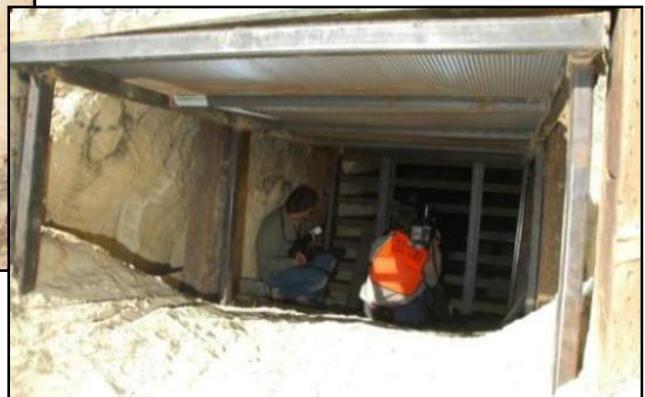
ADIT (AFTER BAT GATE INSTALLED)

In January 2008, the AMLU and California Department of Parks and Recreation (State
