CHEMICAL REMEDIATION COORDINATION AT BODIE STATE HISTORIC PARK (SHP): U.S. EPA, State Parks, CA Dept. of Conservation

AML Forum Meeting
Sacramento, California
June 3, 2009

Greg Marquis, Engineering Geologist
Cy R. Oggins, AMLU Manager
Office of Mine Reclamation
California Dept. of Conservation

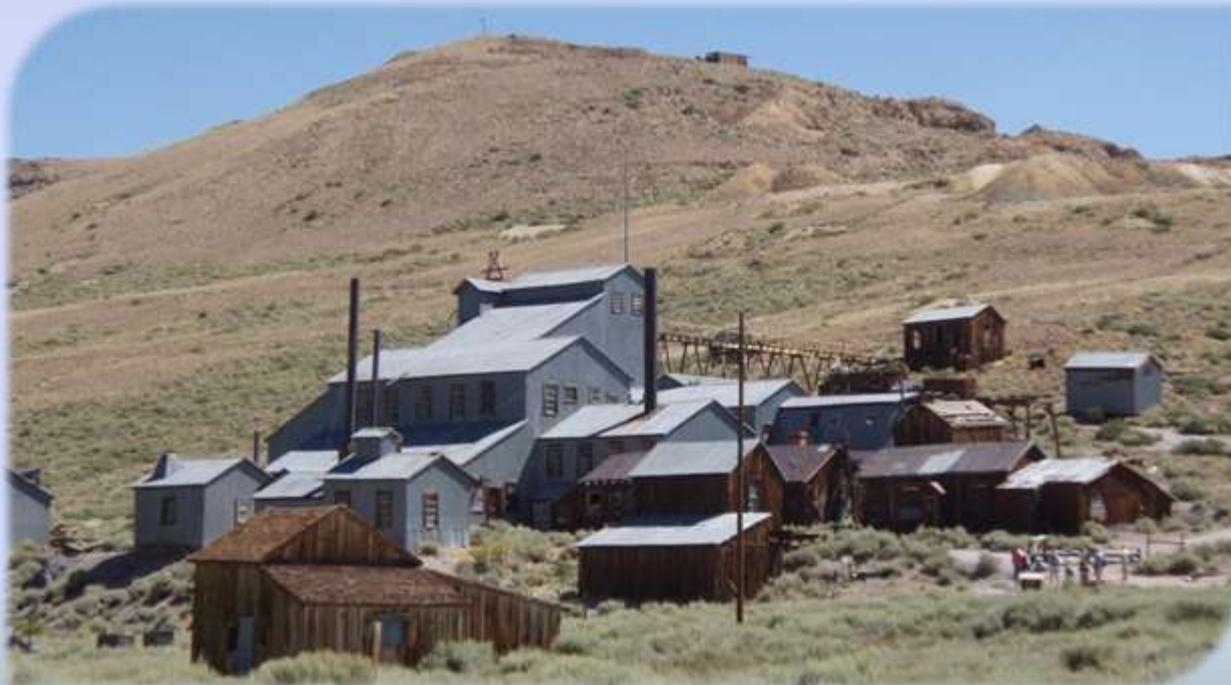
The Standard Mill (top left) is the most prominent building in the park.

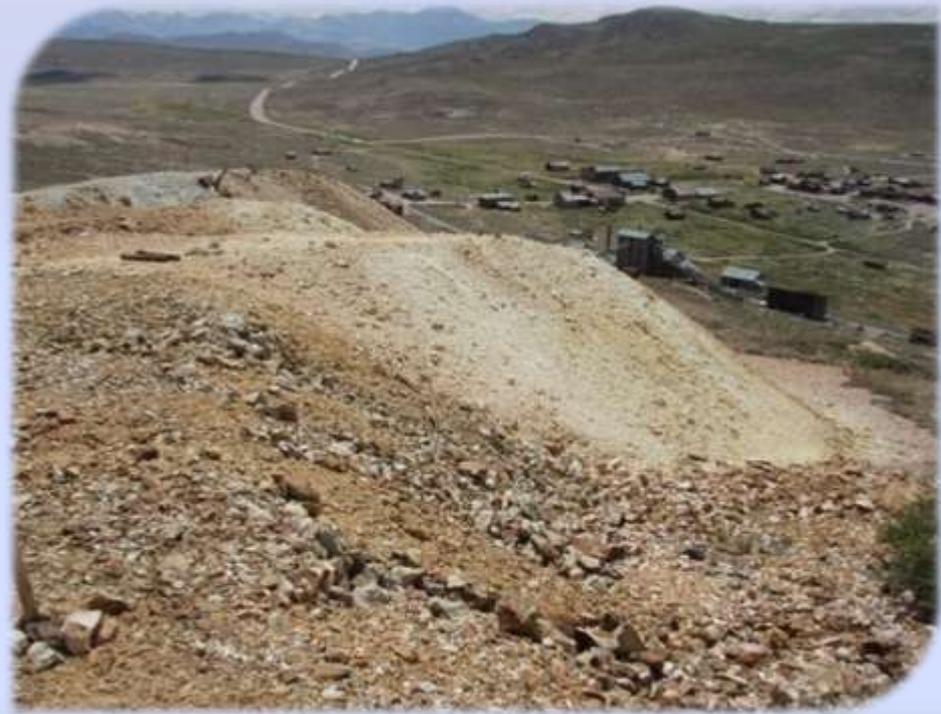
Waste pile at Bodie (town in background)

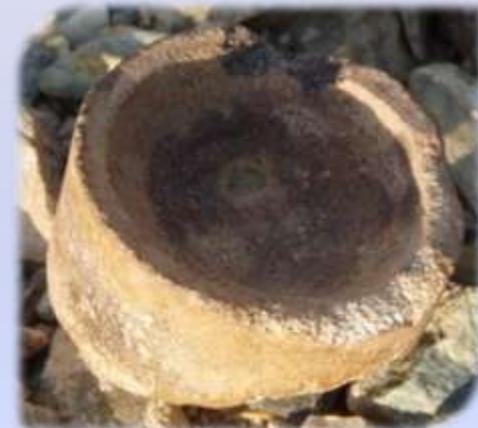
Cupel

- Mercury (**Hg**) from ore processing
 - Elemental form in tailings piles
 - Vapor form within the Standard Mill building
- Lead (**Pb**) from the assay process
 - In sediment and dust near assay areas
 - In cupels (absorbed lead oxide)
- Arsenic (**As**) associated with gold-rich mineral deposits
- PCBs in transformers in Wheaton-Hollis Hotel

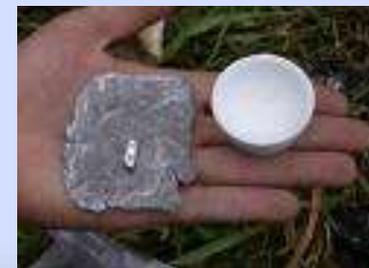
Relative size of a cupel

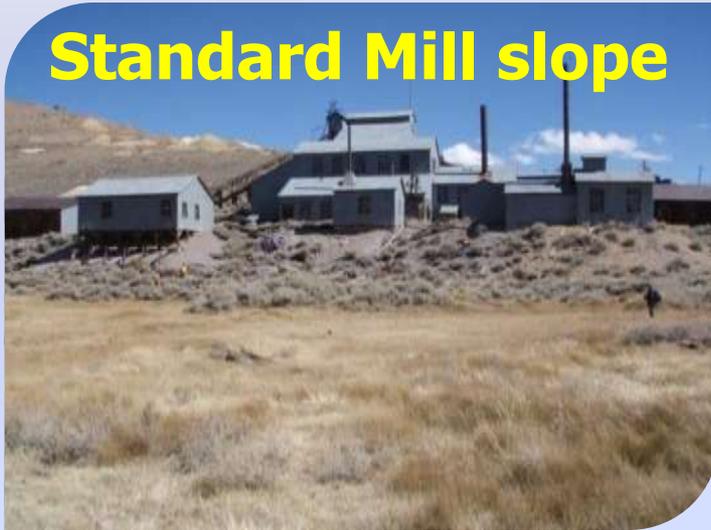
Standard Mill slope

- Placement of filter fabric
- Placement of minimum of one foot of clean fill
- Revegetation
- Fencing

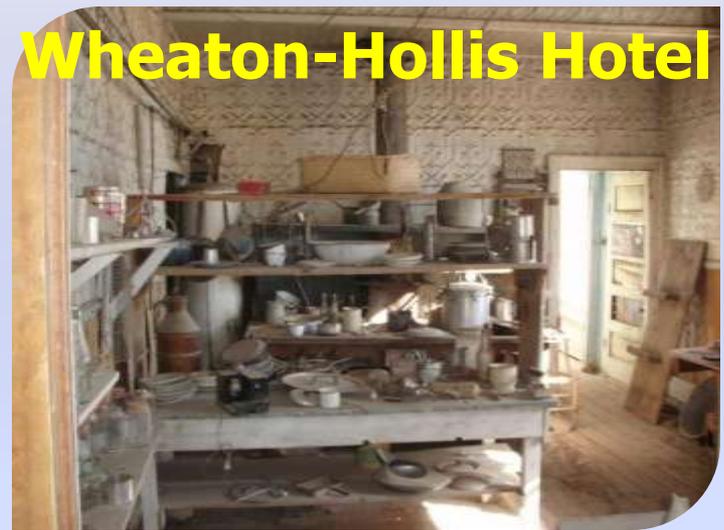
Wheaton-Hollis Hotel

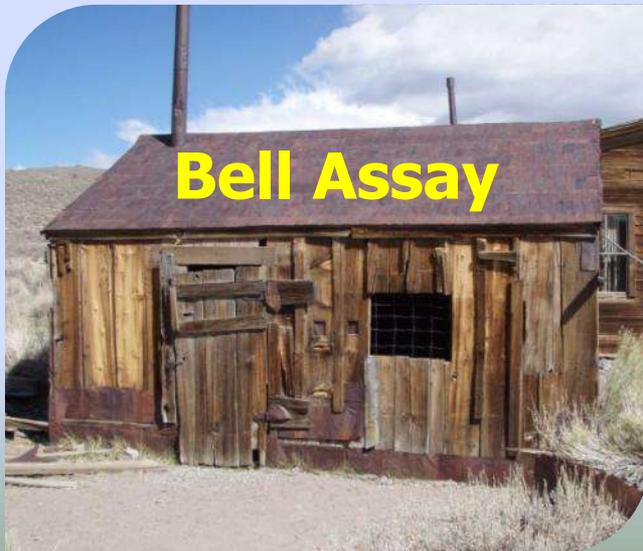
Bell Assay

- Removal of top one foot of soil
- Placement of filter fabric
- Placement of clean fill
- Replacement of artifacts (where required)

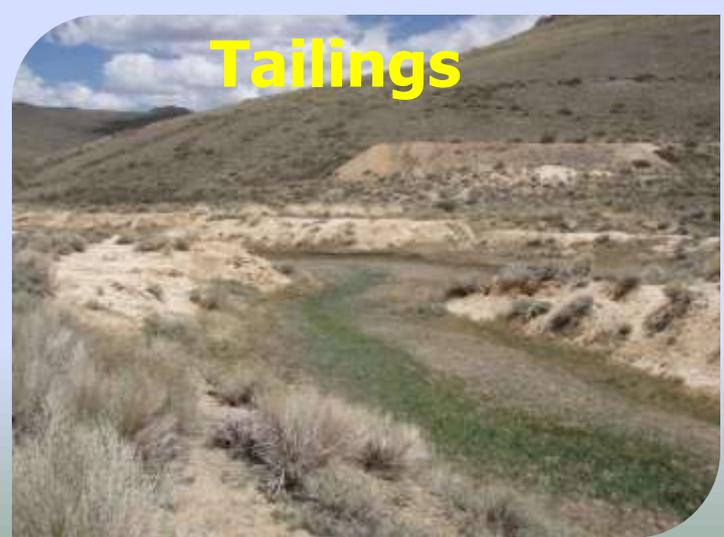
Tailings

- Stream diversion ditch (away from tailings)
 - Built for 100-year event (60 cubic feet/second)
 - Lined with 18 oz/ft² plastic liner and rip-rap
- Weir construction to slow flows
- Erosion control:
 - Organic material (compost)
 - Seeding of native grass

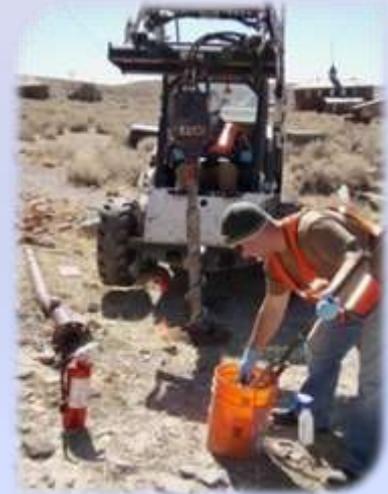
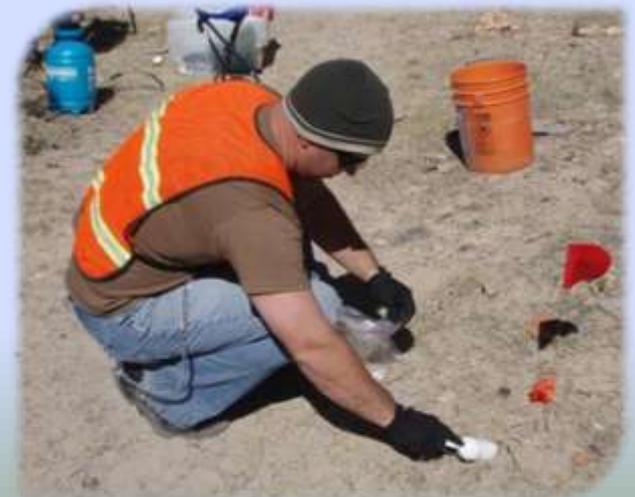
Grid Sample Locations

- Soil samples
 - X-ray fluorescence (XRF) unit used in the field; subset of samples sent to a laboratory for QA/QC
 - Two sampling grids established:
 - Smaller grid within the town
 - Larger grid encompassing an 88-acre section of the Park
 - Multiple sampling depths (up to 5 feet) in some areas

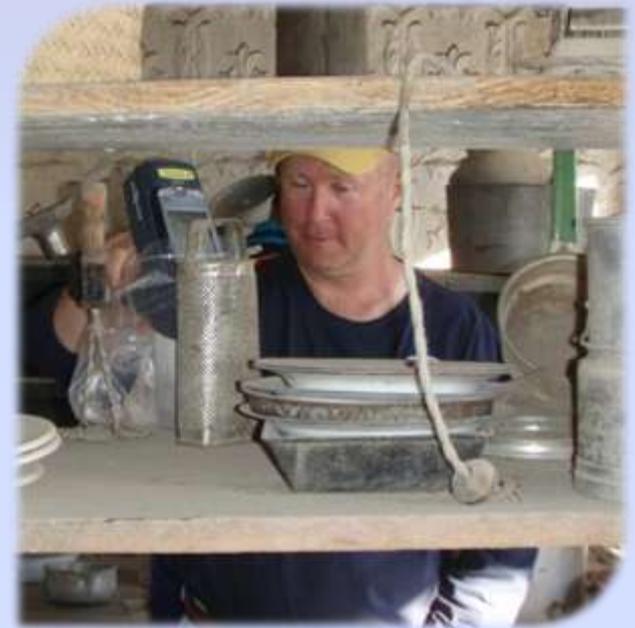
Bret Moxley (USEPA) uses an XRF on dust in the Wheaton-Hollis Hotel's kitchen.

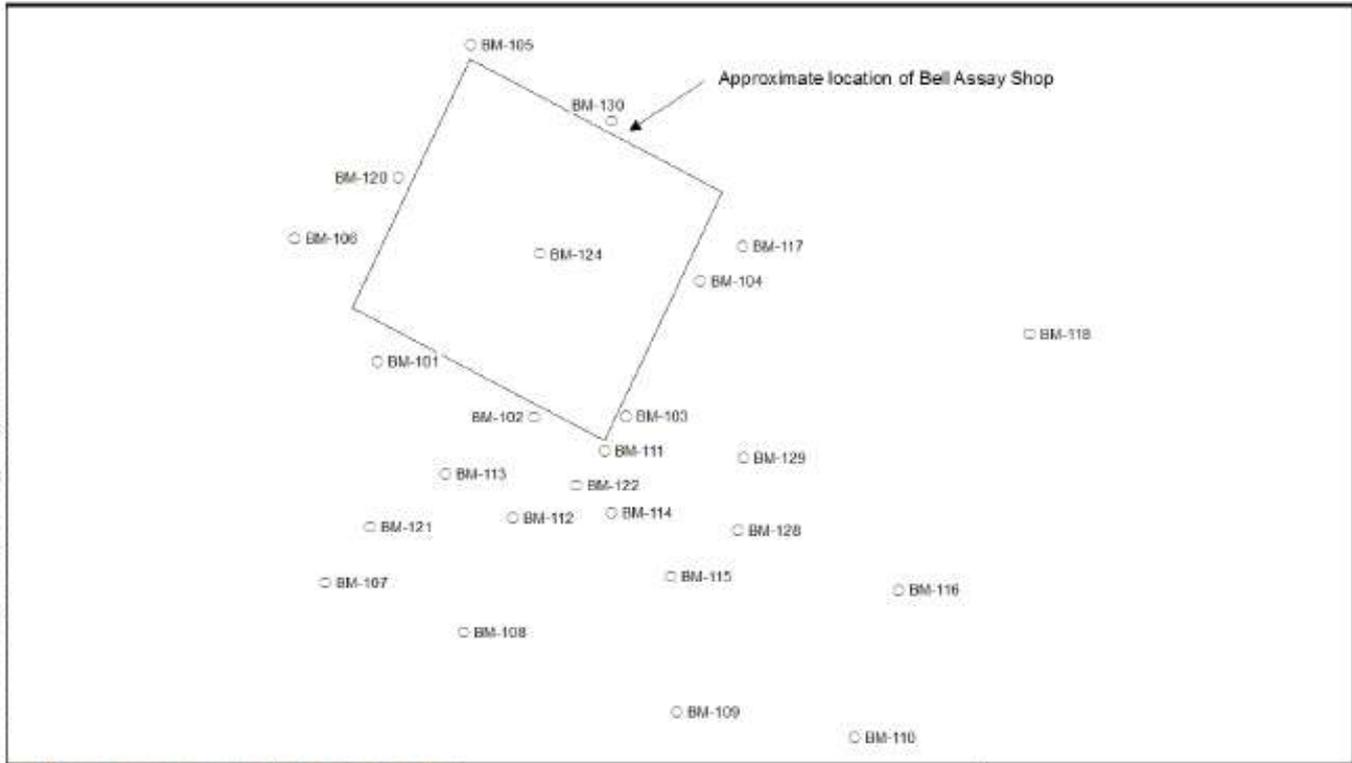
**FIGURE 4
BELL ASSAY SHOP
SAMPLE LOCATIONS**

Bell Assay Shop Sample Locations

- Elevated **Pb**
 - In Wheaton Hollis Hotel dust (up to 17,800 micrograms/wipe)
 - In and around Bell & Rose Assay buildings (>550 ppm lead action level, up to 4,560 ppm at Bell Assay)
 - On slope below Standard Mill (> 550 ppm action level)
- Elevated **Hg** vapor concentration inside Standard Mill (>1,000 nanograms/meter³ action level)
 - Major source of mercury vapor is from the basement
- Elevated **Hg** and **As** in tailings adjacent to Bodie Creek (up to 168 ppm As and 77.8 ppm Hg)
- Small amount of **PCBs** found in one transformer (transformers were previously drained)

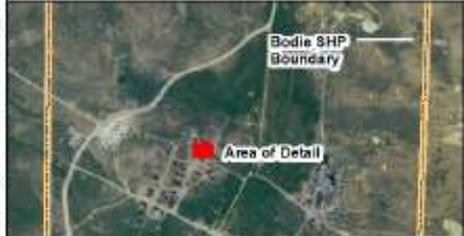
- Bell Assay sample location

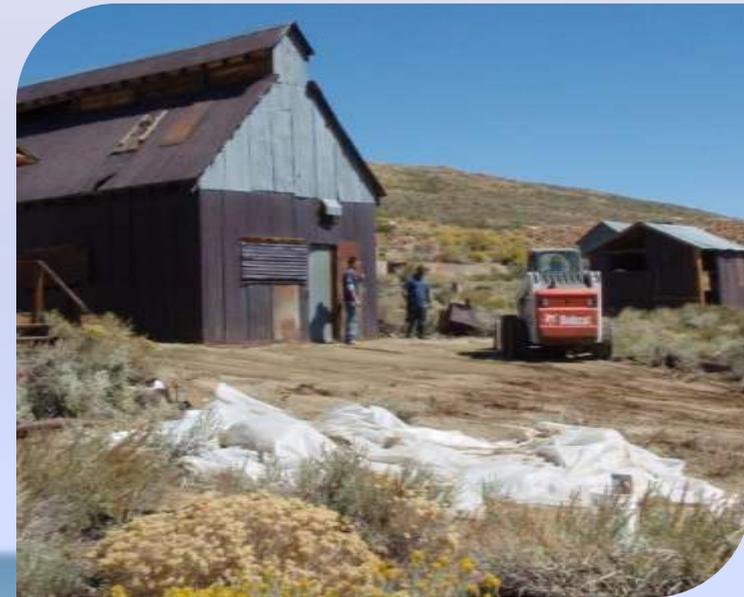
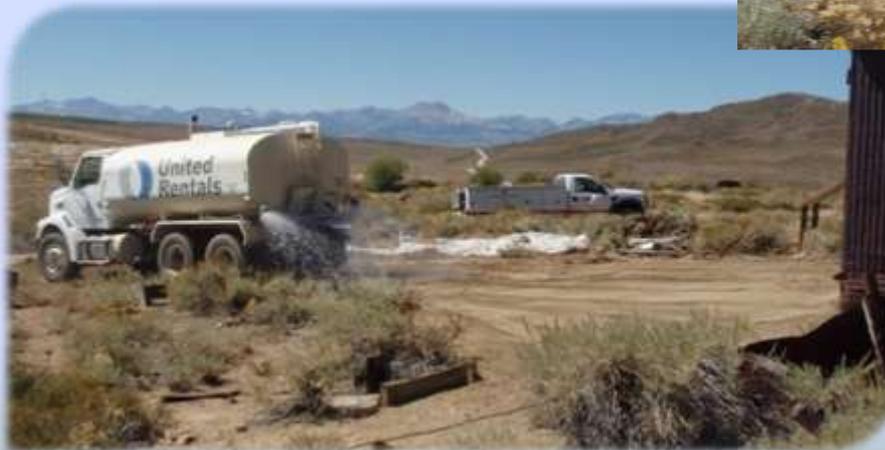
Placement of clean fill in vicinity of assay buildings

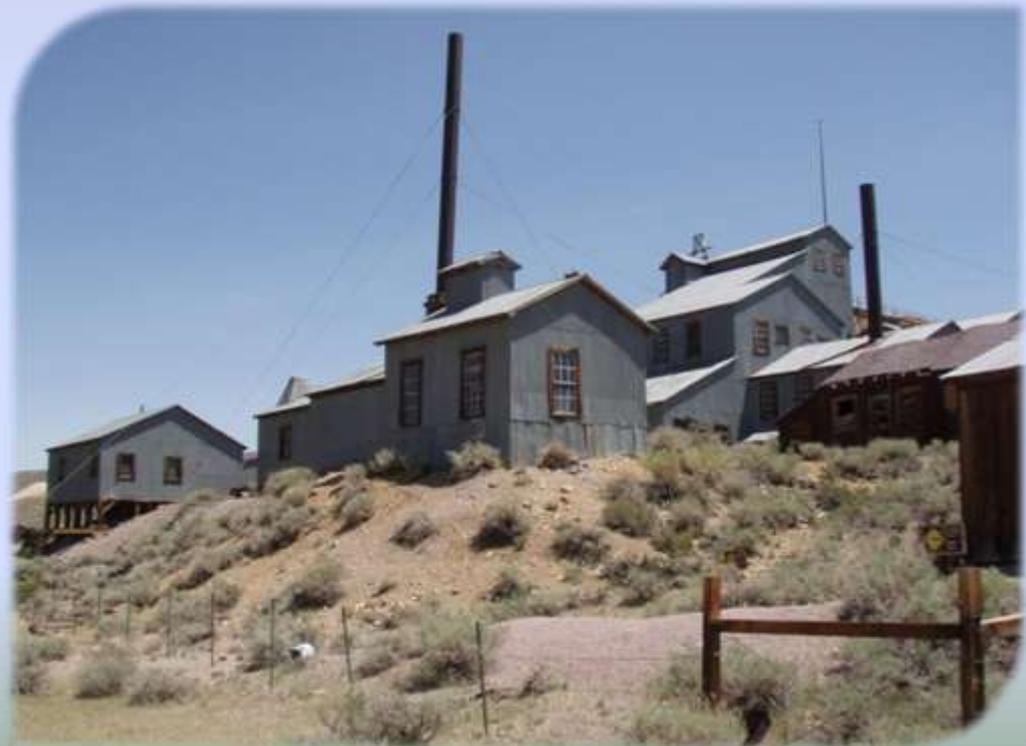
Inside Standard Mill:

- Modified Radon Extraction System
 - Mill basement vapor barrier liner
 - Fans for removal of vapors from basement
 - Expulsion of vapors through existing smokestacks

Below Standard Mill:

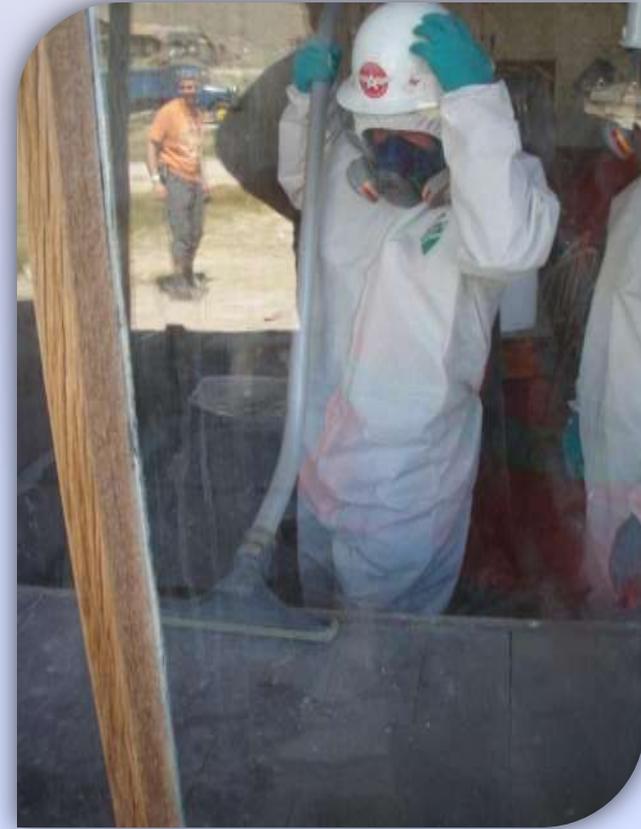
HEPA vacuuming inside
Wheaton-Hollis Hotel

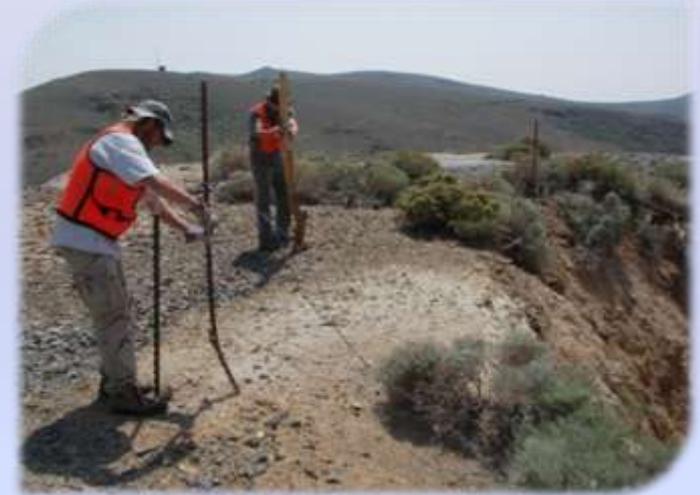
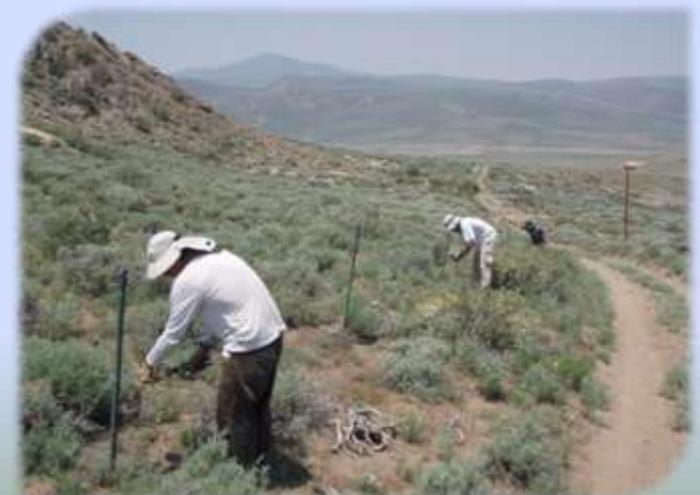
- The AMLU built fences at Bodie SHP in June, 2008
 - Repaired nine fences around physical hazards
 - Repaired two sections of perimeter fencing
 - Built one new fence around a mine shaft
- The AMLU supplied labor for the project and State Parks purchased materials.
