USING CSMIP DATA TO TEST FEMA P58 METHODOLOGY AND THE POTENTIAL FOR AUTOMATED LOSS ESTIMATION

P. Martuscelli, J. P. Moehle

Department of Civil and Environmental Engineering
University of California, Berkeley

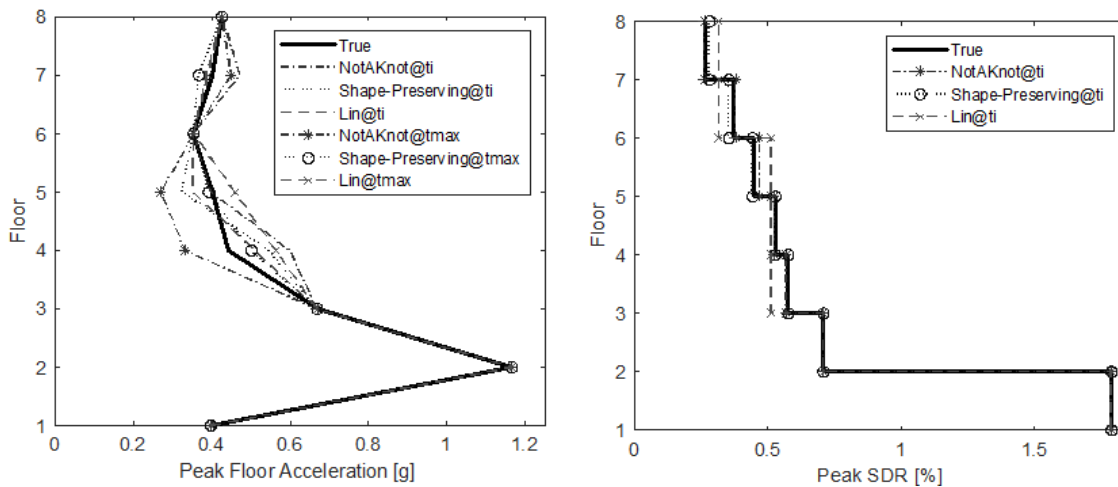
Fig.5: Different interpolation techniques for one NLRHA – Configuration C1

where x_p represents the interpolation prediction of story drift ratio (SDR) and peak floor acceleration (PFA), and \tilde{x} is the actual value from the nonlinear dynamic structural analysis. It is to be underlined that regardless of how interpolation is done (at each time step or at maximum recorded response), the error is calculated only in terms of absolute maximum SDR and PFA, since these are the only quantities of interest for loss assessment. For each instrumentation configuration, the error is calculated at each “non-instrumented” floor, as shown in the next figure:

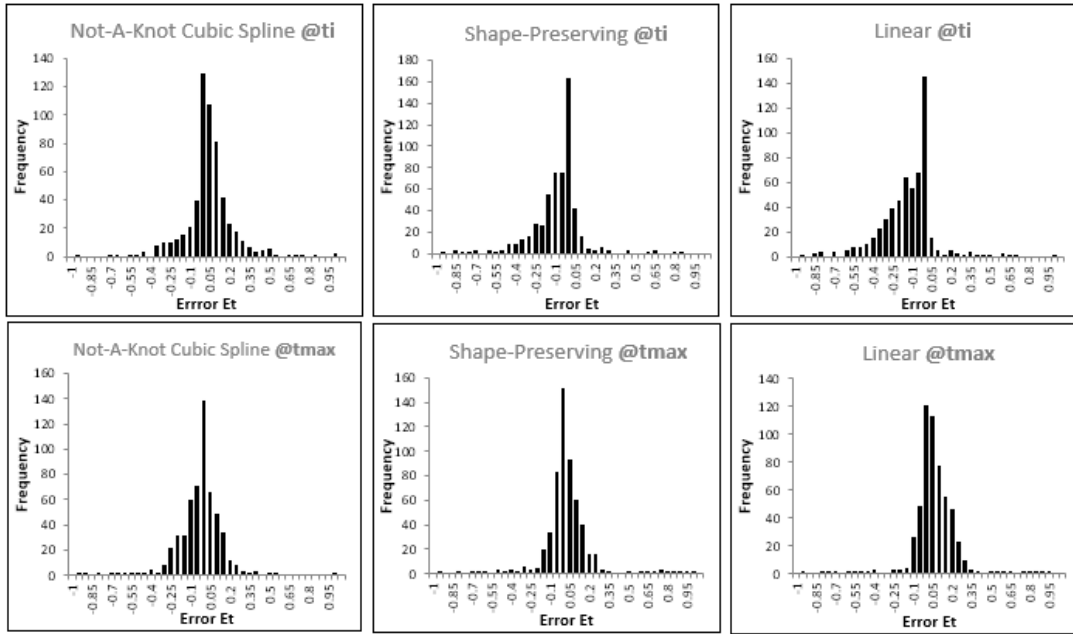
Fig.8: Et frequency distribution for PFA – Configuration C1

The aggregated data of prediction error for PFA and peak SDR, in their preliminary form, allows to define prediction error statistics for the different interpolation techniques:

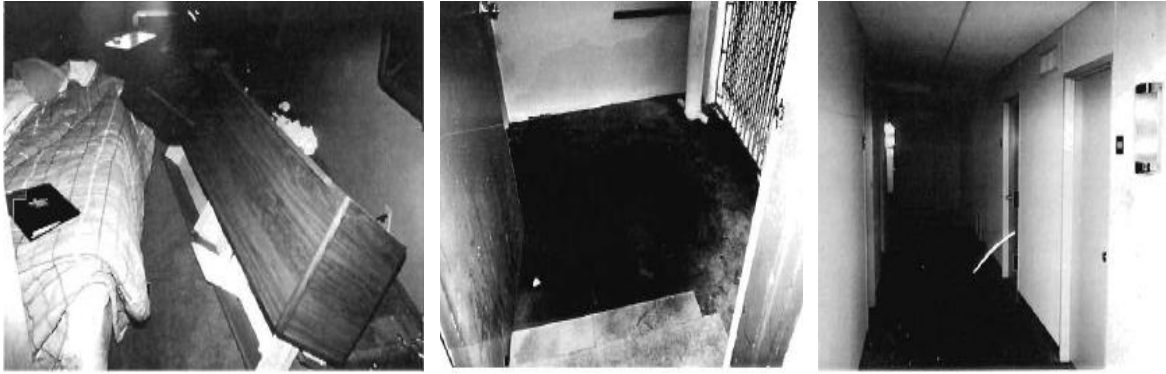
Fig.14: Non-structural damage during Northridge earthquake

During the Northridge earthquake the building suffered also some light non-structural damage, shown in the next figure:

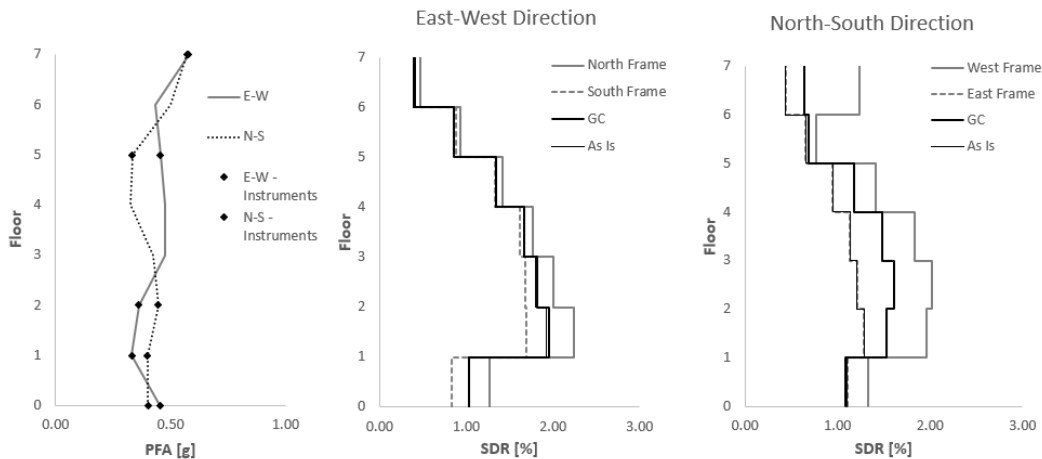
Fig.16: Calculated Engineering Demand Parameters for the building

Figure 16 presents EDPs calculated for the three analyses. It can be appreciated that transposing the displacement to the building geometric center has no effect on East-West direction response. This is because instruments used to infer EDPs are located at mid-span of the North-South building framing, as shown in Figure 12. Also, the EW direction is slightly affected by torsional building response, as it can be seen from north and south frame story drift.

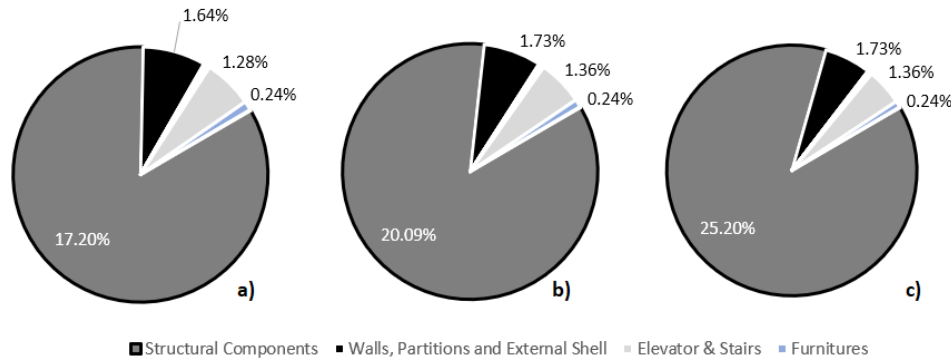
Fig.18: Direct loss analyses results, a) As Is analysis; b) GC analysis; and c) SF analysis

Figure 18 and 19 present the results of the three type of analysis in terms of capital repair costs, normalized with respect to building construction cost, and also an overview of the direct loss analyses results for three earthquakes (Landers, Big Bear, and Northridge) of the 1990s. Figure 18 shows the four largest contributors to loss (structural components; walls, partitions, and external shell; elevators and stairs; and furniture). The next largest loss items were: 1) Ceiling; 2) Piping; 3) Heating, HVAV and VAV; 4) Electrical & fire protection; and 5) Concrete tile roof. Loss for these non-structural components were too small to be identified in Figure 18

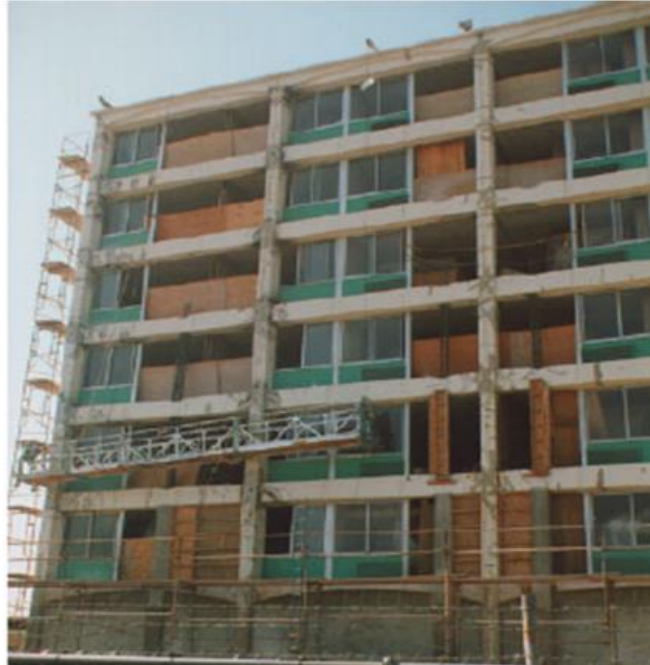
Fig.20: Building site survey during repair works - July 1995, after Lynn et al. [11]

Figure 20 shows a site survey of the building during post-Northridge repair works, where significant use of epoxy injection is apparent [11]. Evidence from this photograph is used to update an existing sketch of observed damage for the north frame [17], which does not sufficiently identify the spread of damage in the reinforced concrete beams, columns and joints.

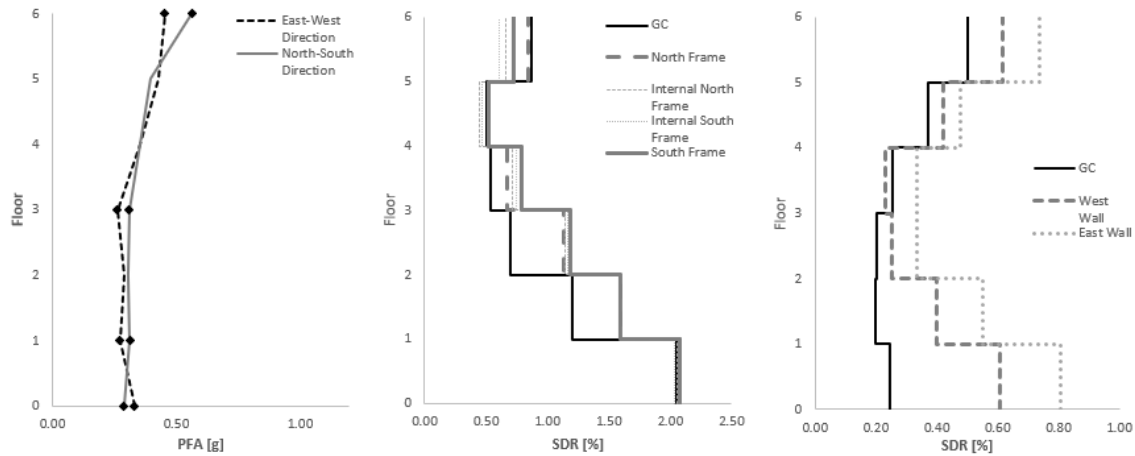
Fig.26: Calculated Engineering Demand Parameters for the building

The building response to the Imperial Valley earthquake is studied considering as input for the direct loss analysis both the peak floor accelerations and the peak story drift ratios at the geometric center of the building (GC analysis) and at the location of each moment frame and shear wall (SF analysis). Evaluation of EDPs (Figure 26) at instrumented and non-instrumented floors and loss analysis were performed under the same assumptions adopted for the 7-story hotel.

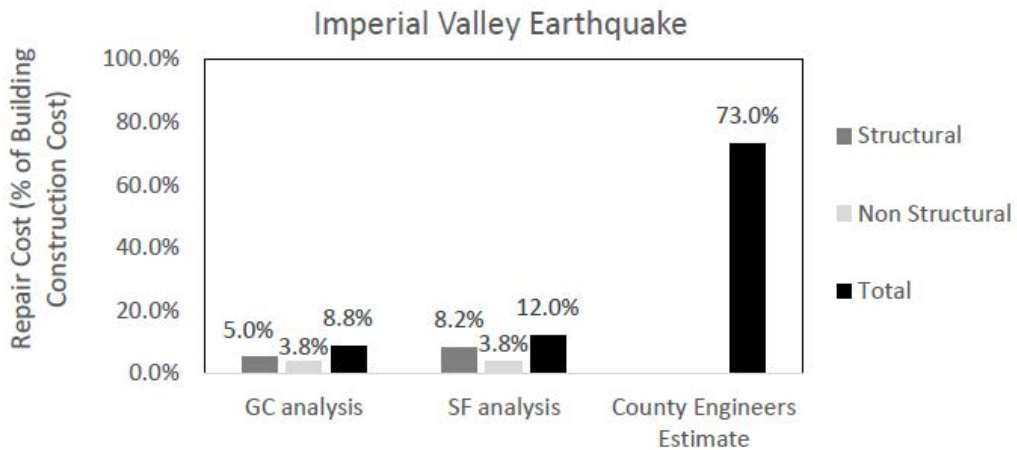
Fig.28: Predicted repair costs vs. repair cost estimate

Figure 28 compares calculated losses with a post-earthquake repair cost estimate prepared by county engineers in the aftermath of Imperial Valley Earthquake, as reported by *Whitaker et al.* [1]. The significant discrepancy is consistent with the discrepancy in results shown in Figure 27.
