## SMIP89 Seminar Proceedings

### RESPONSE EVALUATION OF THREE CONCRETE FRAME BUILDINGS TO THE JANUARY 17, 1994 NORTHRIDGE EARTHQUAKE

Farzad Naeim and Roy Lobo

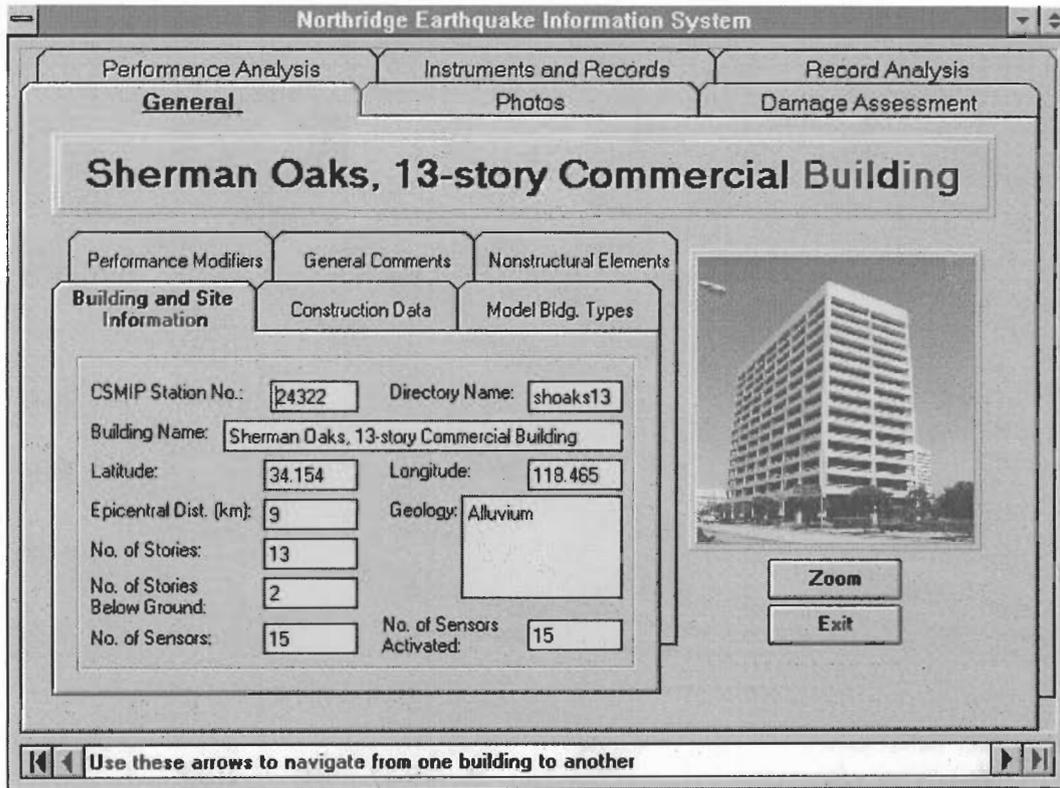
Figure 1. Three Dimensional View of the Building (from Naeim, 1997)

A photo of the building retrieved from the SMIP Information System (Naeim,1997) is shown in Figure 1. This office building has 13 stories above and two floors below the ground. It was designed in 1964. The vertical load carrying system consists of 4.5 inches thick one-way concrete slabs supported by concrete beams, girders and columns. The lateral load resisting system consists of moment resisting concrete frames in the upper stories and concrete shear walls in the basements. The foundation system consists of concrete piles. The first floor spandrel girders were modified by post-tensioning after the 1971 San Fernando earthquake. Sketches of plan and elevation of the building showing the location of sensors are presented in Figure 2.

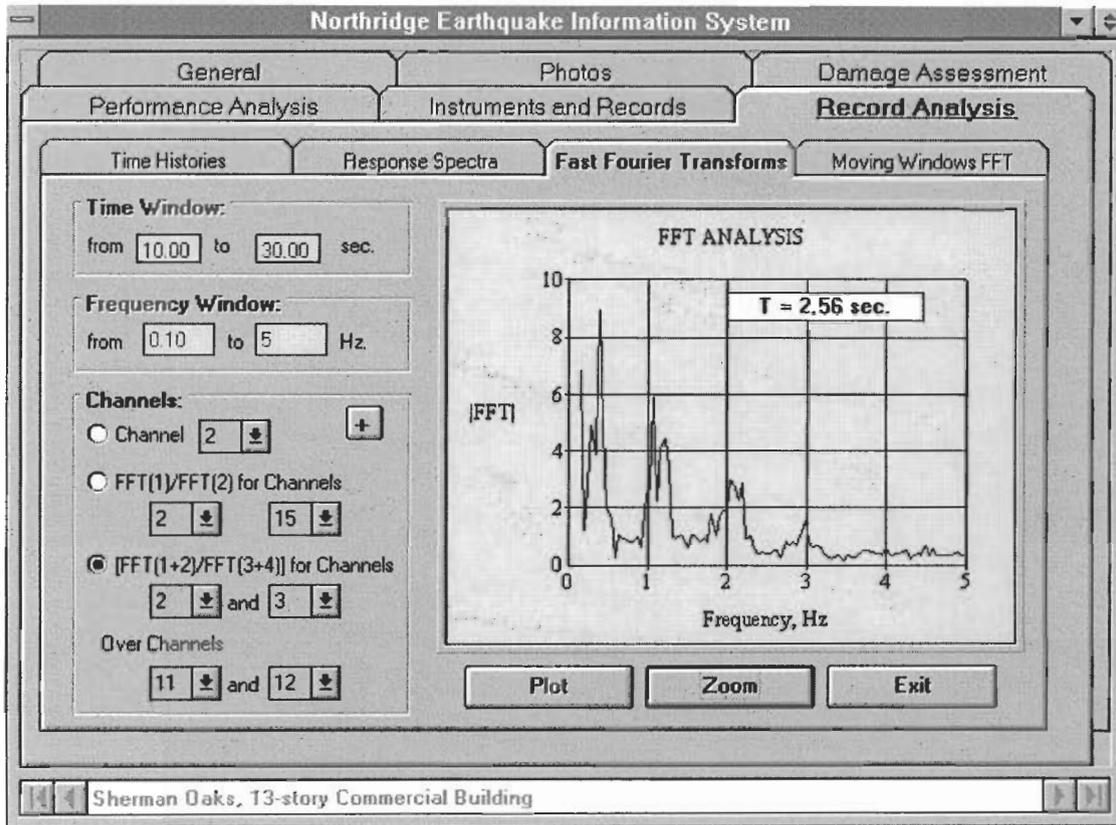
Figure 3. An FFT analysis for the N-S response (from Naeim, 1997).

As can be seen in Figure 3, participation of higher modes were particularly significant in the response of this building to Northridge earthquake. The N-S period of about 2.6 seconds is significantly larger than code estimated periods of 1.27 per UBC-67 and 1.60 seconds per UBC-94. In the E-W direction, a fundamental period of about 2.9 seconds is implied by FFT analysis (Figure 4). Our moving windows FFT analysis points to a softening of the structure which may be attributed to the concrete cracking (Figure 5).

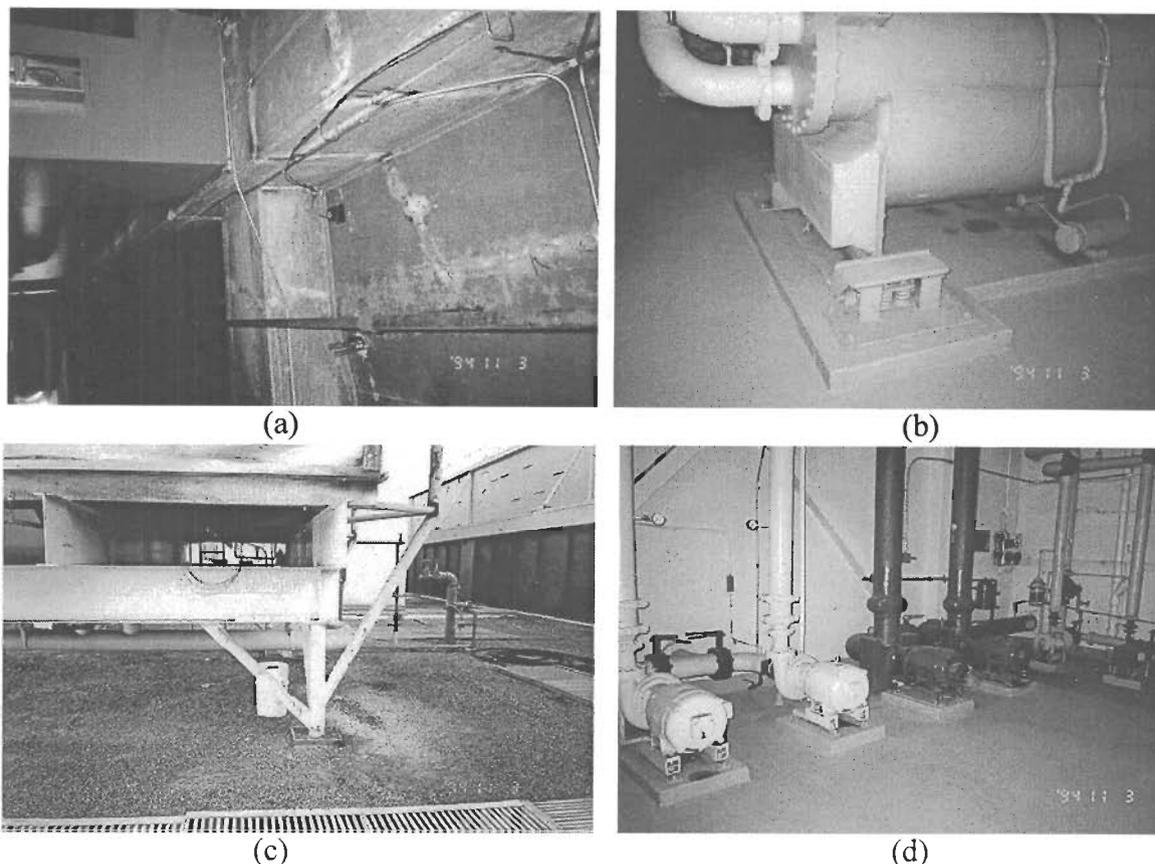
Figure 6. Contrasting Structural and nonstructural performance (13 Story Sherman Oaks Bldg).

The damage to non structural components and equipment for the building have been documented in the SMIP Interactive Information System (Naeim,1997). This building experienced noticeable but repairable structural damage in the form of cracks in the beams, slabs, girders, and walls (Figure 6a). In contrast, no mechanical equipment damage was observed either at the roof or the basement (Figures 6b, 6c, and 6d). This was due to proper mounting and anchorage details.

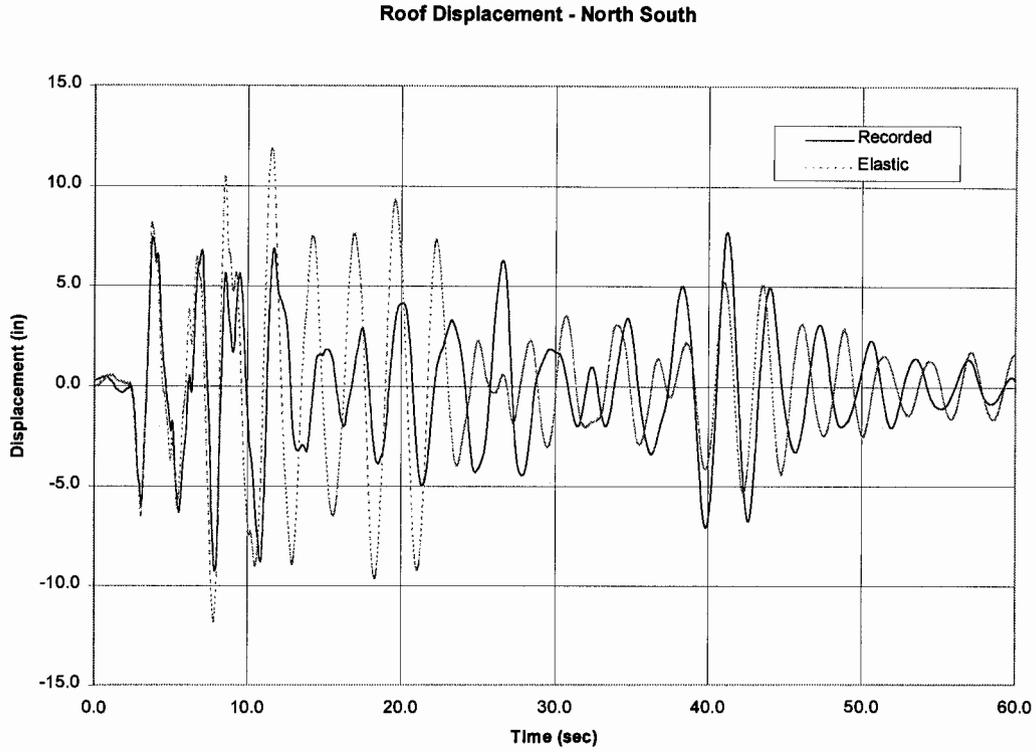
Figure 7. Comparison of Recorded Vs Elastic in North-South direction at Roof.

Time history analyses were performed on the three models using the actual recorded response at the ground floor. Figures 7 through 14 show the comparison of the responses for the various models, at the levels at which the instruments were located. The comparison of displacements at the second floor for both the Inelastic models causes a bit of concern. Probably indicating that the assumption that the boundary conditions are fully restrained is not entirely valid. In addition, there is an additional low roof structure at this level which is not modeled. The forces from this structure could be responsible for the differences between analysis and recorded responses. If the differences at this floor are reconciled, the comparison of responses for other floors become much better. We need to re-evaluate further our modeling assumptions with respect to the first floor low-rise area and boundary conditions.

The *Elastic* model does not produce very different results in terms of peak displacements, but provides a very different time history response than the one actually observed. The lengthening of the period as the earthquake progressed is fairly well captured, however, with the inelastic models. An important point to note is that the initial gravity loading plays a significant role in the response of the inelastic models. A comparison was performed where the gravity loads were not included and the response was very different from the recorded. This is because the bottom reinforcement at the supports is much less than the top reinforcement and causes early cracking in positive bending, significantly altering the response.

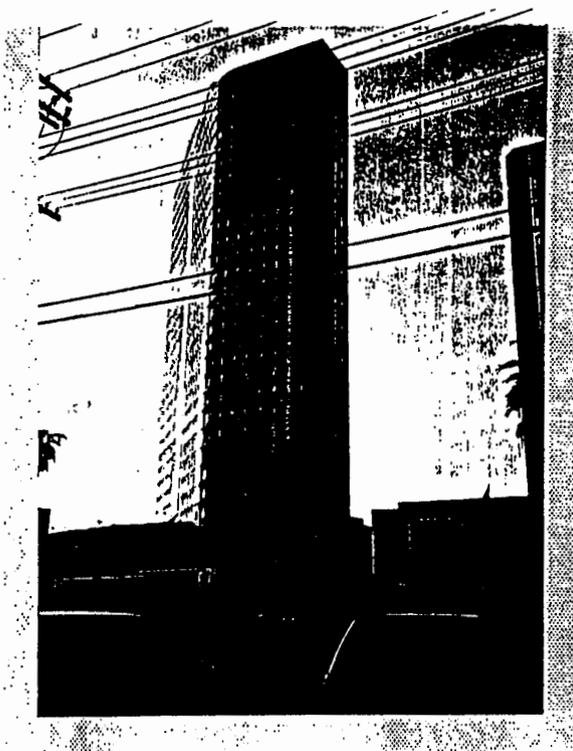
Figure 15. Southeast elevation

This building consists of a thirty-two story office building (referred to here as the “Tower Building”), and an eight-story parking structure (referred to here as the “Low-Rise Building”). Figure 15 shows a southeast elevation of the building. It was constructed in 1987 with a completed cost of \$42 million dollars.

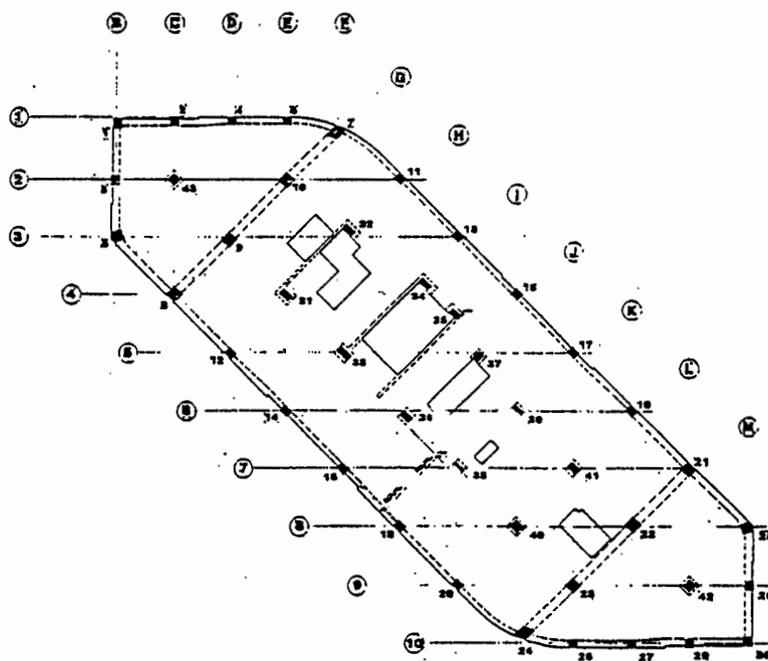
Figure 16. Typical framing plan of Tower Building

The Tower Building has typical plan dimensions of approximately 269 feet in the northwest-southeast (longitudinal) direction and 81 feet in the southwest-northeast (transverse) direction. As shown in Figure 16, columns are typically placed at 26.87 feet on center in both longitudinal and transverse directions. The typical story height for the Tower Building is 12 feet. The Low-Rise parking structure has an eight story parking garage with four levels below grade and four levels above grade. The story height for the parking structure is typically 10 feet with an exception of 14 feet for the eighth level. According to the structural drawings, the reinforced concrete column strength varies from 4 ksi to 6 ksi. The reinforced concrete beam strength is 5 ksi. The floor system consists of 7 inch post-tensioned concrete flat plate slabs with a strength of 5 ksi. Reinforcement in frame ductile members complies with then UBC Standard No. 26-4 for low alloy A706.

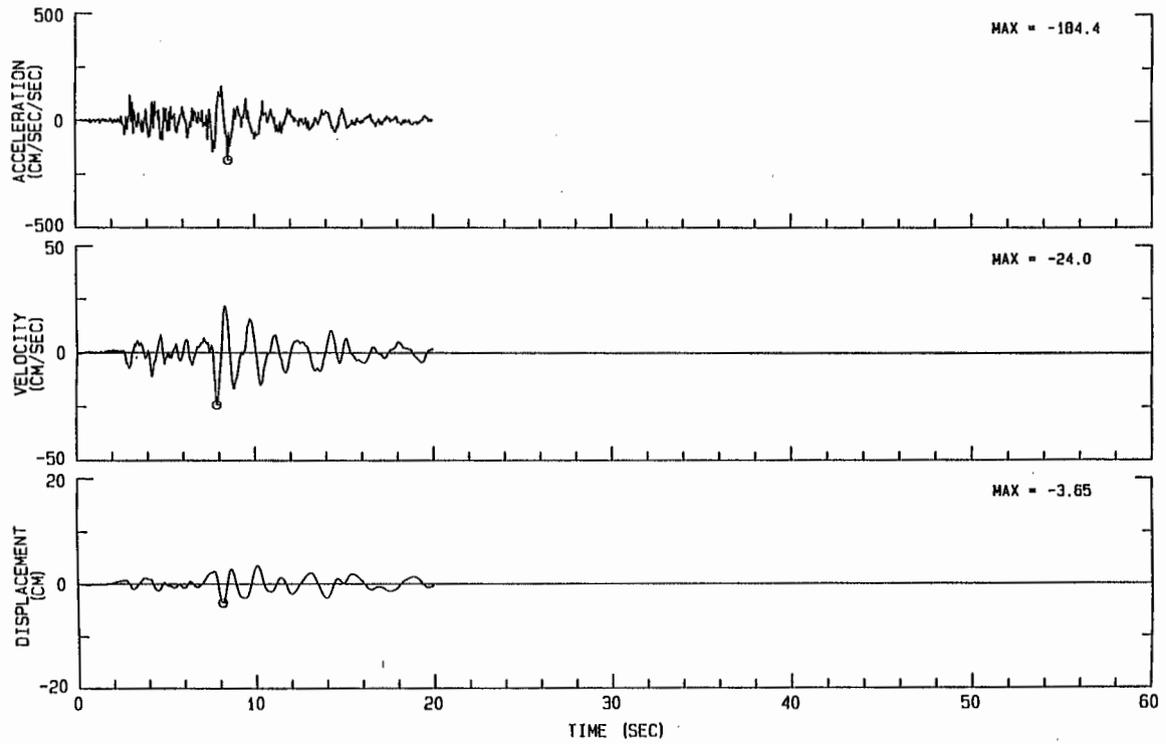
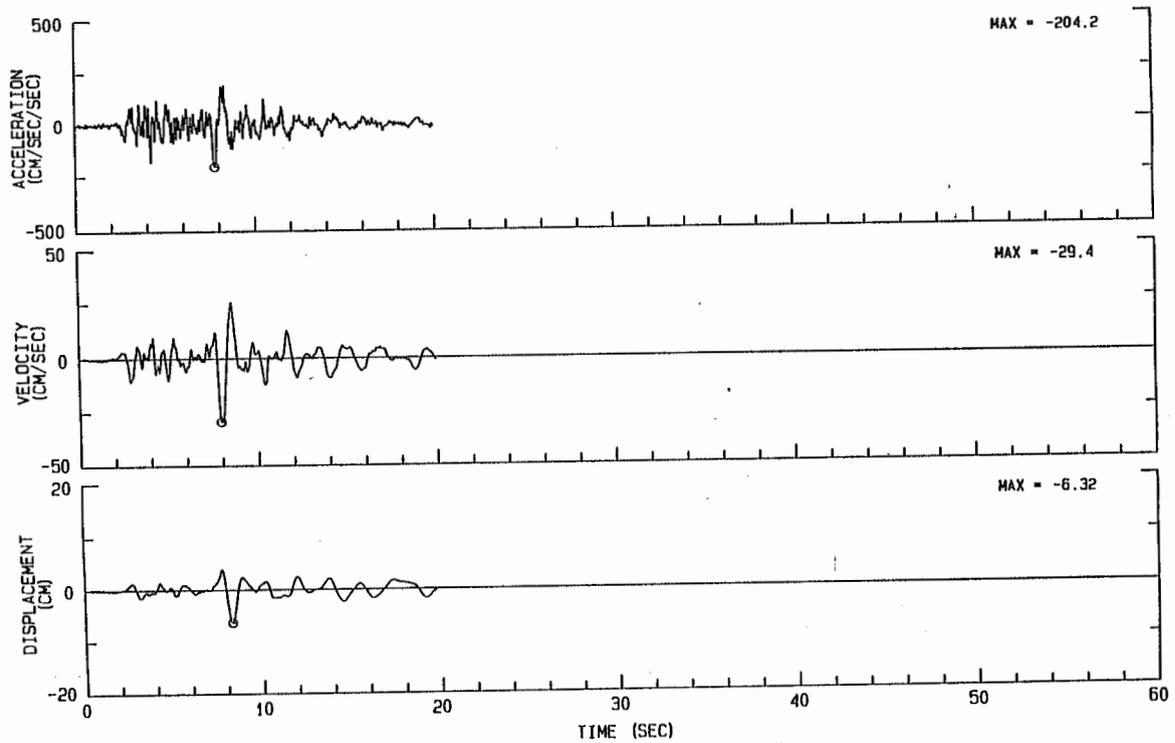
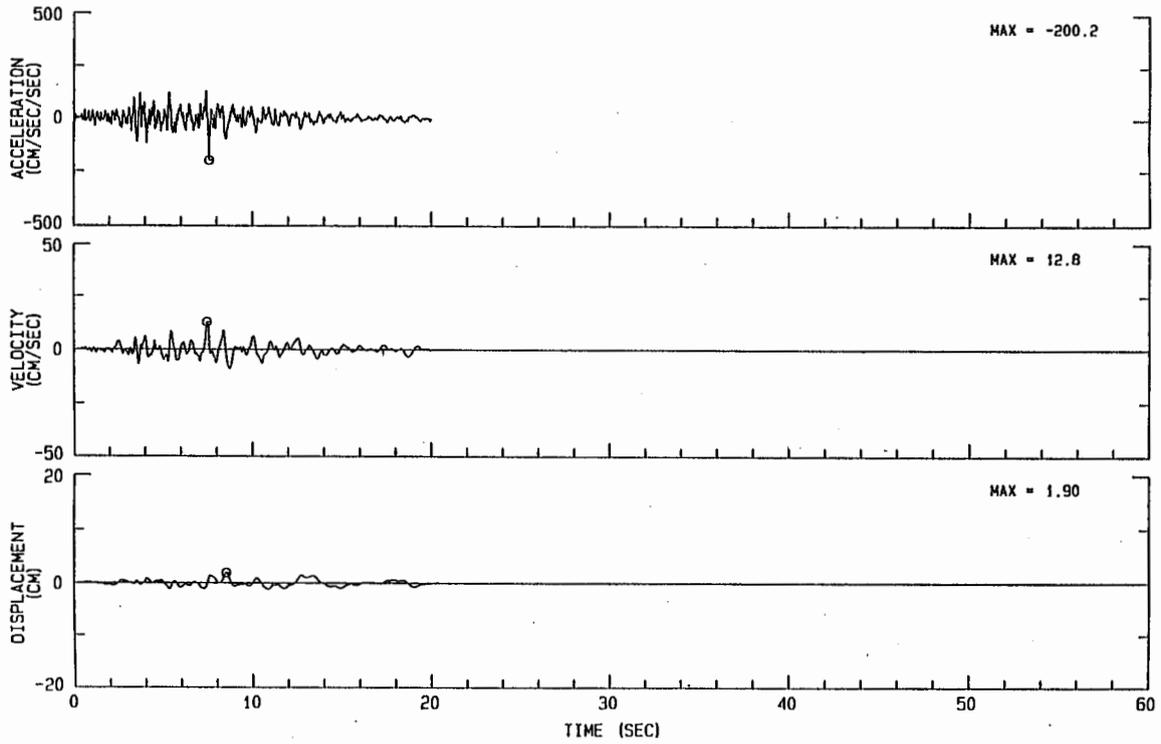
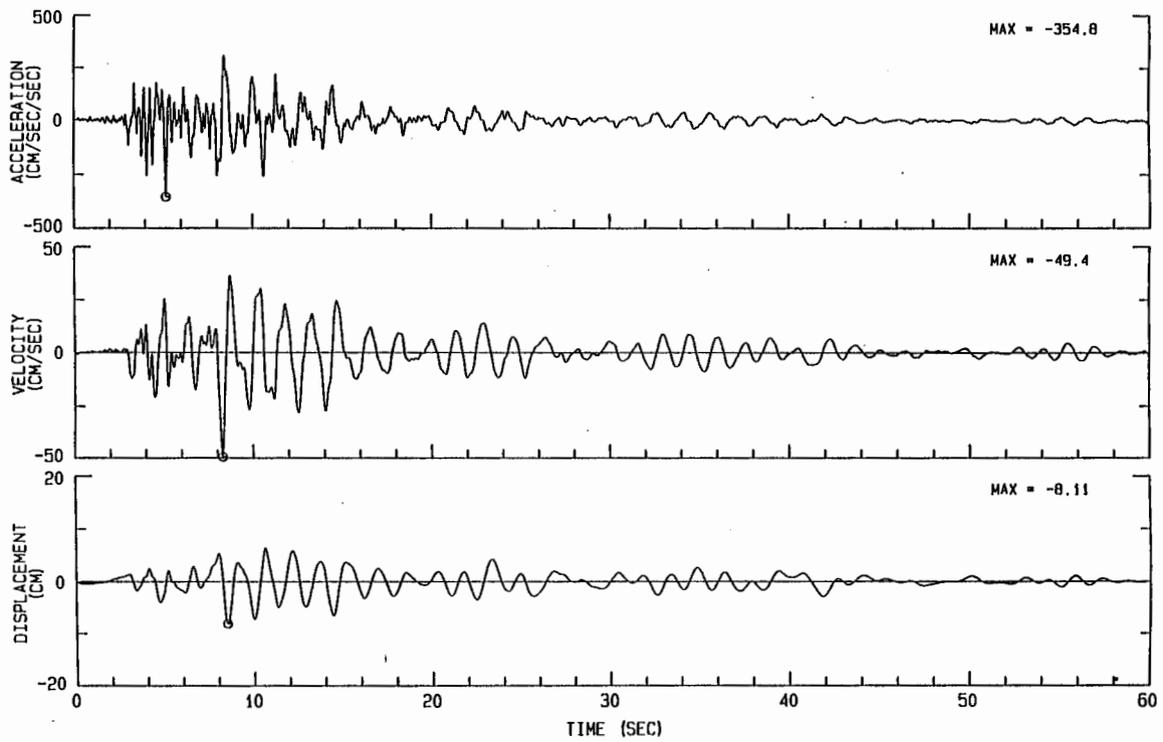
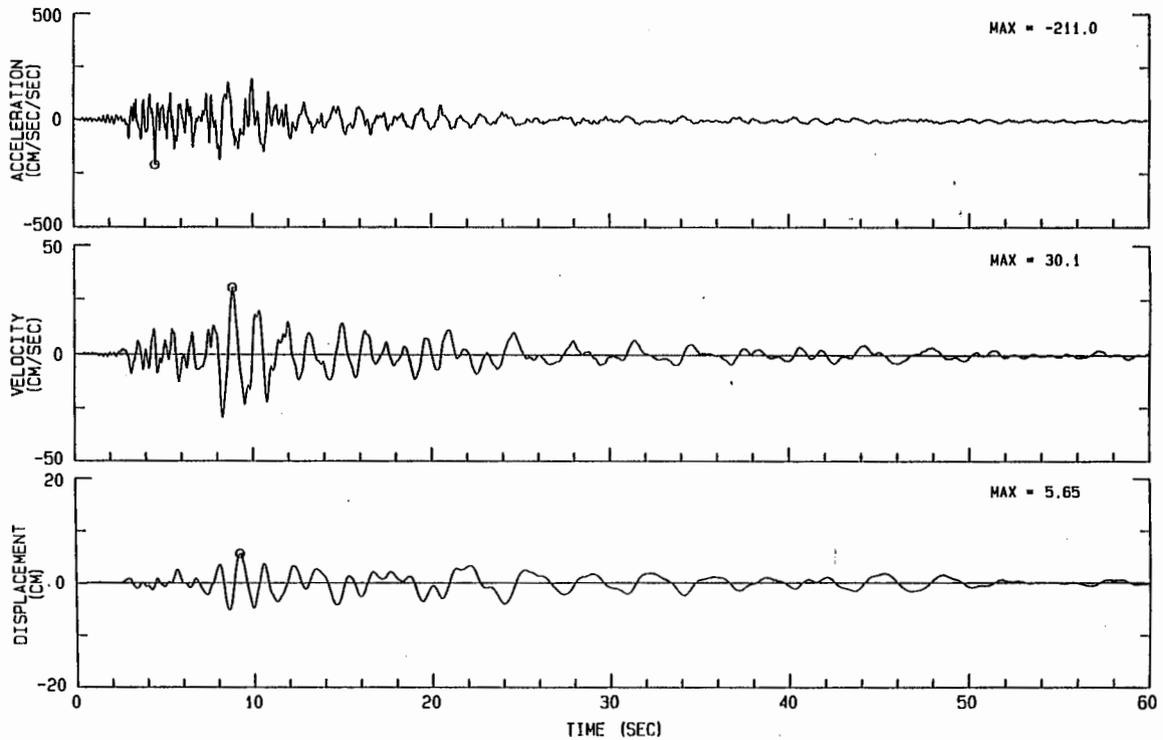
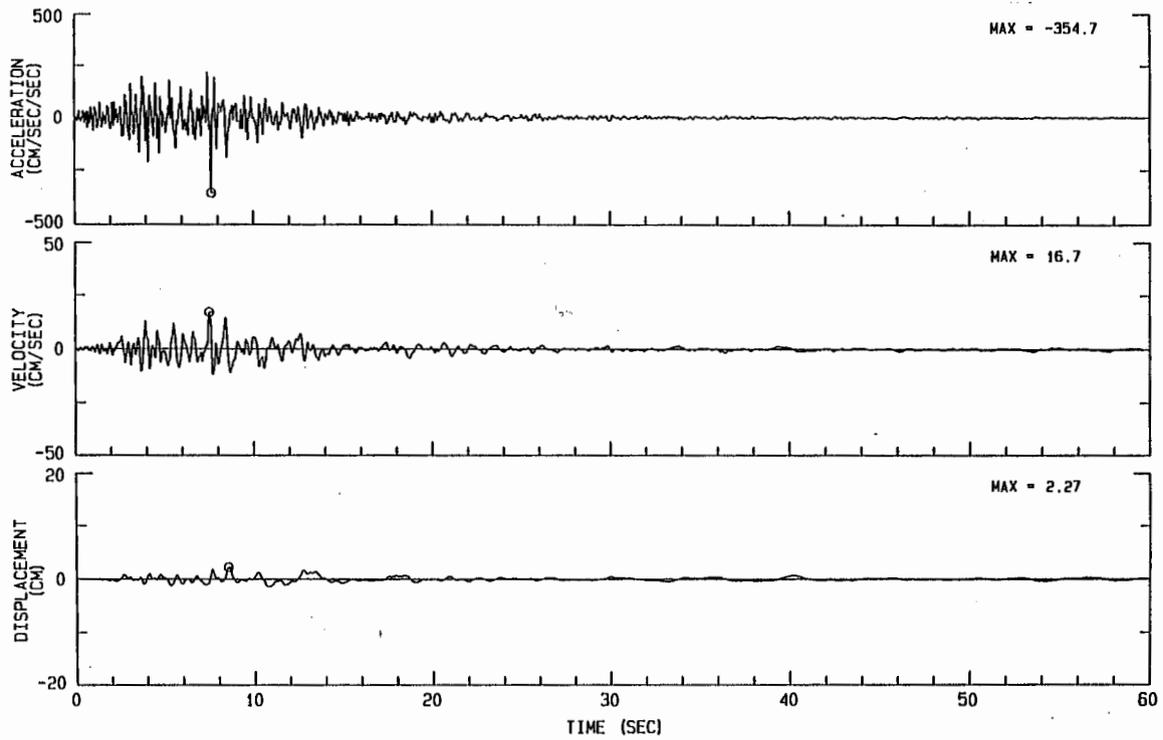
The Tower Building is instrumented at the roof, 16<sup>th</sup>, and basement levels. Instrumentation data were retrieved and processed after the 1994 Northridge earthquake. Figures 17 through 25 illustrate the acceleration, velocity and displacement time histories at the roof, 16<sup>th</sup>, and basement levels in the longitudinal, transverse, and vertical directions. The epicenter of the Northridge earthquake is located about 12 miles northwest of the building. No damage to the building was reported after the earthquake. The ground shaking lasted about 20 seconds. The peak ground accelerations are estimated as 72.6 in/s/s (0.188g) in the longitudinal direction, 80.4 in/s/s (0.208g) in the transverse direction, and 78.8 in/s/s (0.204g) in the vertical direction. Estimated fundamental building periods from these time histories are 1.48 seconds for the longitudinal direction and 3.43 seconds for the transverse direction.

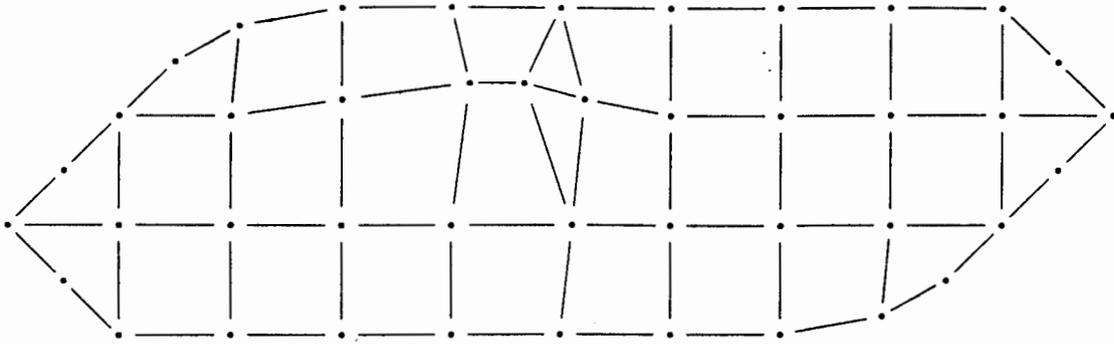
Figure 26. Frame grid line in the ETABS model

An elastic analysis was conducted using ETABS to obtain the building's mode shapes and natural periods and compare the natural periods with the estimated periods from the recorded building response data during the 1994 Northridge earthquake. A three-dimensional modal was established. The grid line of the ETABS model is shown in Figure 12 and a three-dimensional view of the model is shown in Figure 13. Only the Tower Building is included in the model. The shear walls in the Low-Rise Building are modeled as external spring restraints to the Tower Building. The model of the building is based on the existing structural plan. The post-tensioned concrete slabs are converted to equivalent concrete beams. The assumptions used in the model primarily follow the recommendations from ACI 318-95 (ACI, 1995) and ATC 40 (ATC, 1996). The following summarizes the most significant modeling assumptions used for the analysis.

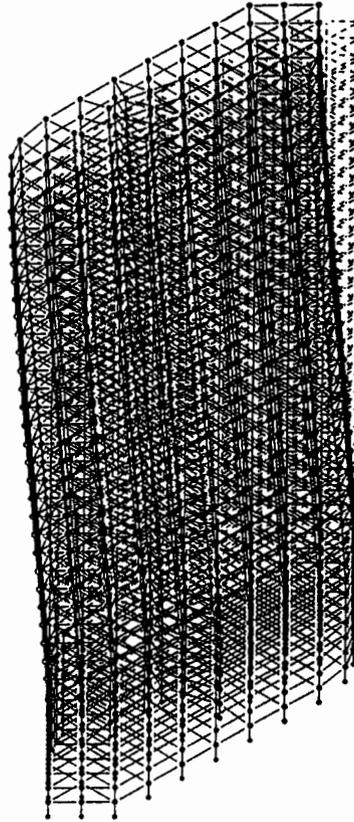
Figure 28. First mode shape from the ETABS analysis

The first three mode shapes from the ETABS analysis are shown in Figures 26 through 29. The first, second, and third modes are in the transverse, longitudinal, and rotational directions, respectively. The corresponding natural periods are 3.27 seconds, 2.23 seconds and 1.71 seconds, respectively.

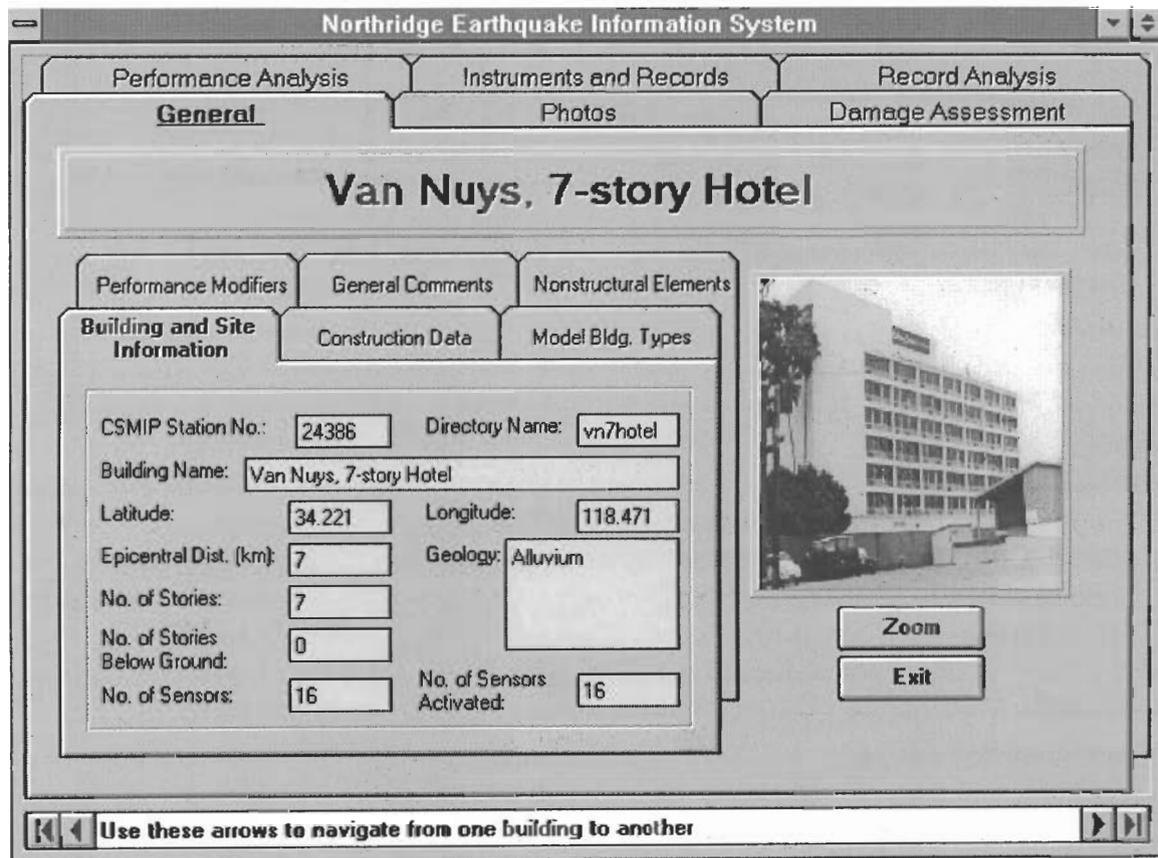
Figure 30. A view of the Van Nuys 7 Story Building (from Naeim, 1997)

This 7 story reinforced concrete structure with no basements was designed in 1965 and constructed in 1966. Its vertical load carrying system consists of 8 in. and 10 in. concrete slabs supported by concrete columns, and spandrel beams at the perimeter. The lateral load resisting system consists of interior column-slab frames and exterior column-spandrel beam frames. The foundations consist of 38 inch deep pile caps, supported by groups of two to four poured-in-place 24 inch diameter reinforced concrete friction piles. Sketches of plan and elevation of the building showing the location of sensors are presented in Figure 31.

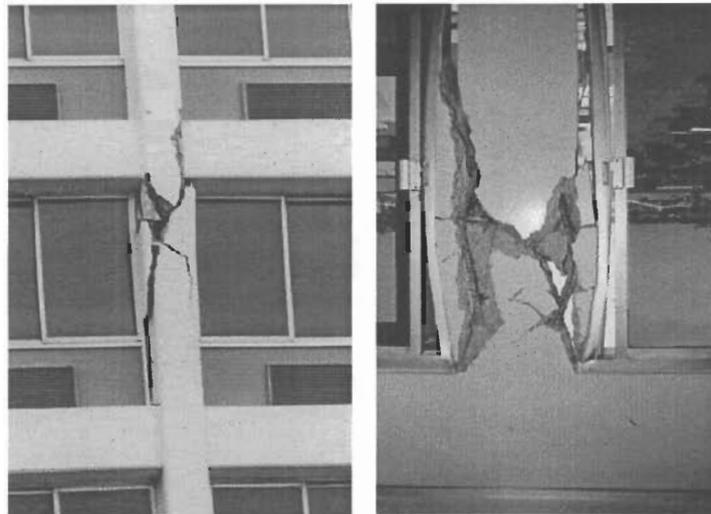
Figure 32. Shear failure of column at the fourth floor (Naeim, 1997).

The building had suffered minor structural damage and extensive nonstructural damage during the 1971 San Fernando earthquake and was subsequently repaired. The building experienced heavy damage during the Northridge earthquake where the South side exterior columns at fourth floor failed in shear (Figure 32). The building was repaired following the Northridge earthquake and the structural system in the E-W direction was changed to a shear-wall frame interaction system. The content damage was also heavy as documented in the information system. Surprisingly however, the mechanical equipment installed at the roof did not suffer any noticeable damage. The racking of the fourth floor was so significant that some of the hotel room doors needed to be opened using sledge hammers to get the occupants out (Figure 33).

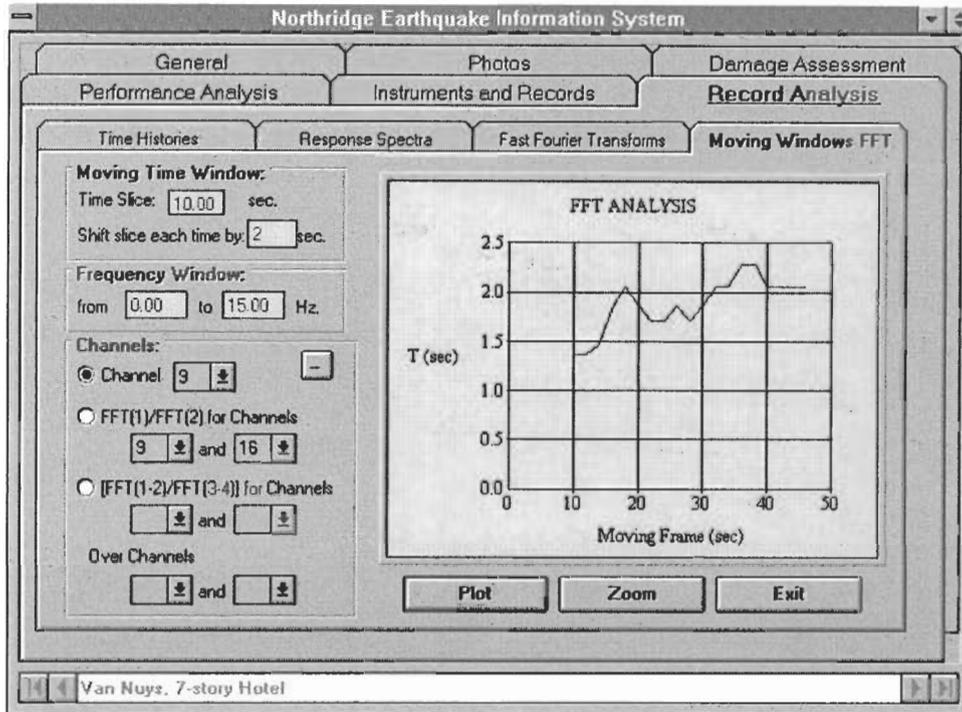
Figure 34. Moving windows FFT analysis for E-W response (Naeim, 1997).

A series of moving windows FFT analysis by Naeim, 1997 indicated an initial E-W fundamental period of about 1.4 seconds which elongates to about 2.2 seconds towards the end of the strong motion (Figure 34). Similar analysis shows a more moderate period elongation in the N-S direction from about 1.3 to 1.8 seconds, except when the kick from the E-W failure is captured (Figure 35). These periods are more than twice the code estimated periods of about 0.7 seconds.
