SEISMIC RETROFIT AND INSTRUMENTATION OF LOS ANGELES CITY HALL

Nabih Youssef and Owen Hata

Nabih Youssef & Associates, *Structural Engineers*
Los Angeles

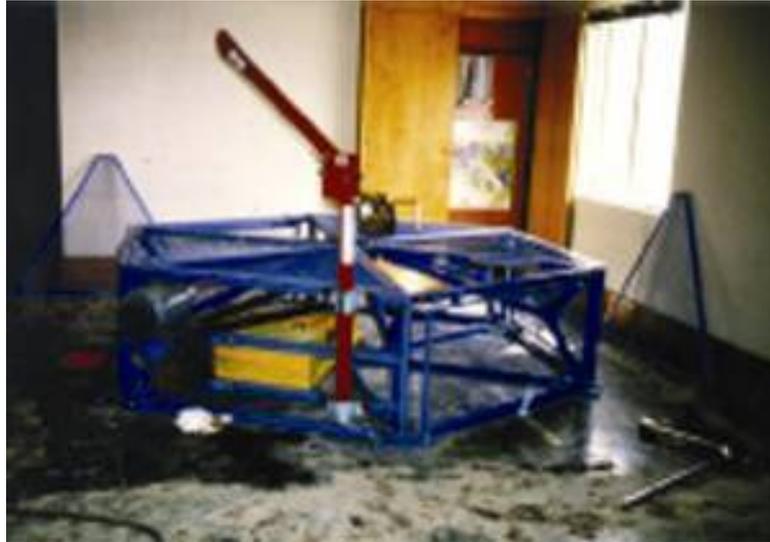
Figure 5: Forced vibration oscillator setup

Ambient and forced vibration tests were performed to determine the dynamic properties of the original building. The ambient vibration test measured the response of the building to vibrations which occur at the building site, such as vehicle traffic, wind, occupants, etc. Forced vibration tests were performed using a forced vibration oscillator to vibrate the building. The forced vibration test was used to determine the response of the building to high level excitations (*See Figure 5*). The results of these tests were used to verify the modeling assumptions made in the development of the computer model of the original building.

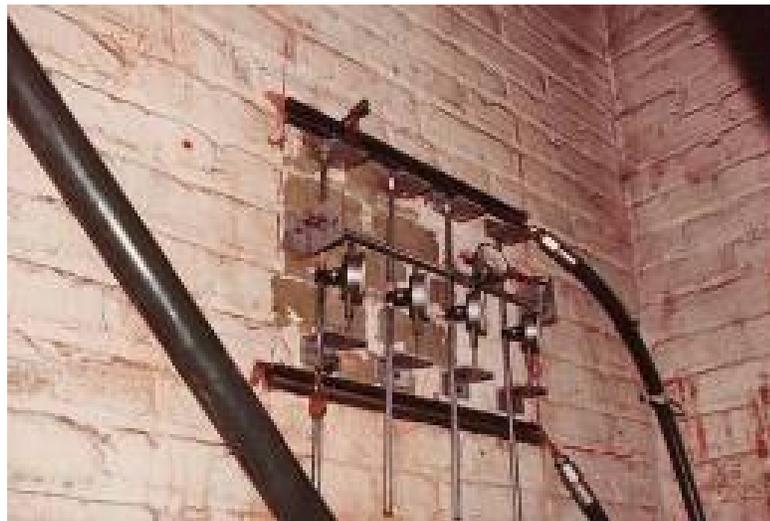
Figure 6: URM in-stu test setup

A variety of in-situ tests were performed on the unreinforced masonry. In-plane shear tests were performed on the masonry walls to determine the ability of the existing brick and mortar to resist shear stresses. Several flatjack tests were performed to determine the compressive strength and deformability properties of masonry (*See Figure 6*). The results of these tests were used in the development of computer models and in the determination of the strength capacity of the original building.

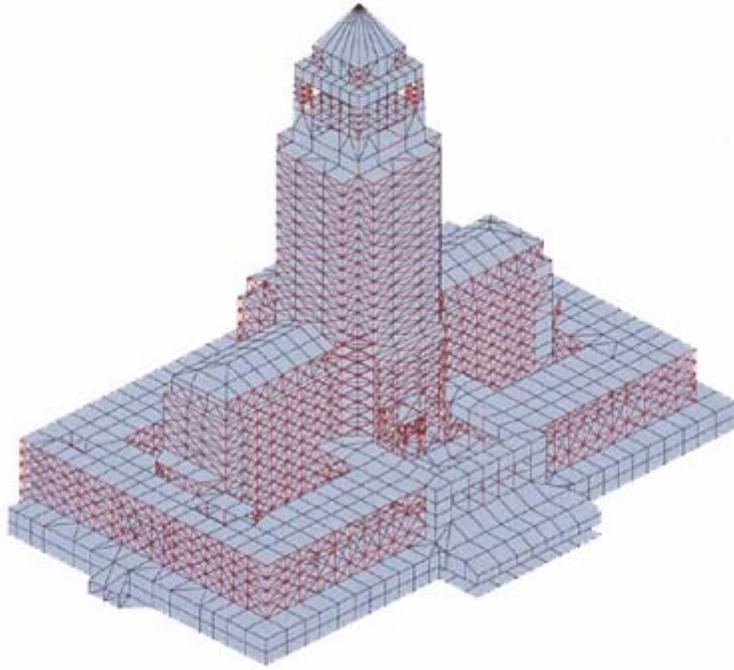
Figure 7: Plot of 3D computer model

The primary steel frame skeleton, steel bracing, reinforced concrete walls, unreinforced masonry infill walls, and concrete diaphragms were included in the linear elastic computer models to accurately simulate the behavior of the original building (*See Figure 7*). In order to assess the dynamic behavior of the building, it was crucial to understand the behavior of the existing unreinforced masonry walls. These walls represent a significant portion of the overall

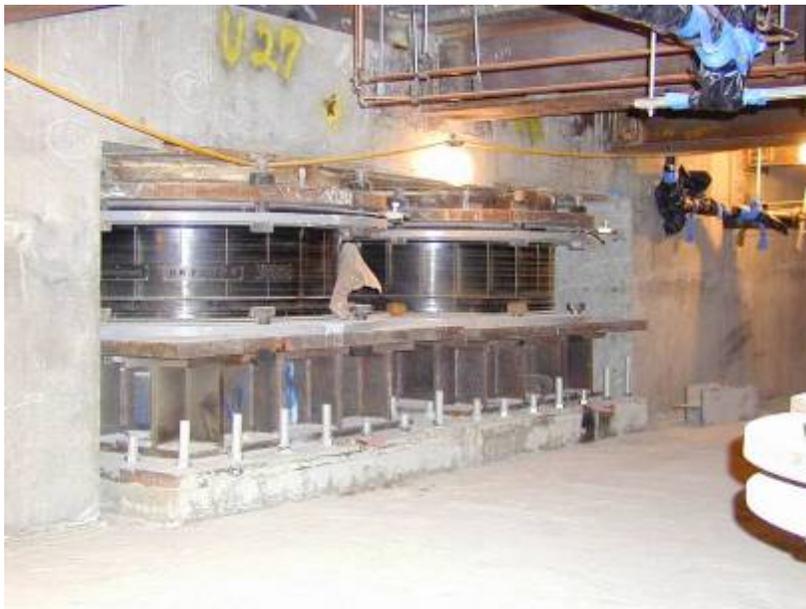
Figure 8: High damping rubber bearings installed under tower wall

The plane of isolation is located below the basement level and above the foundation. The isolation system consists of 416 high damping rubber (HDR) bearings, varying in size from 29.5 in. to 51.2 in. diameter, and 90 flat sliding bearings. The HDR bearings vary in height from 9.6 inches to 16.6 inches. (*See Figure 8*) The sliding bearings are comprised of a teflon pad mounted on a natural rubber bearing, and a stainless steel sliding plate. The sliding bearings support less than 10% of the total building weight.

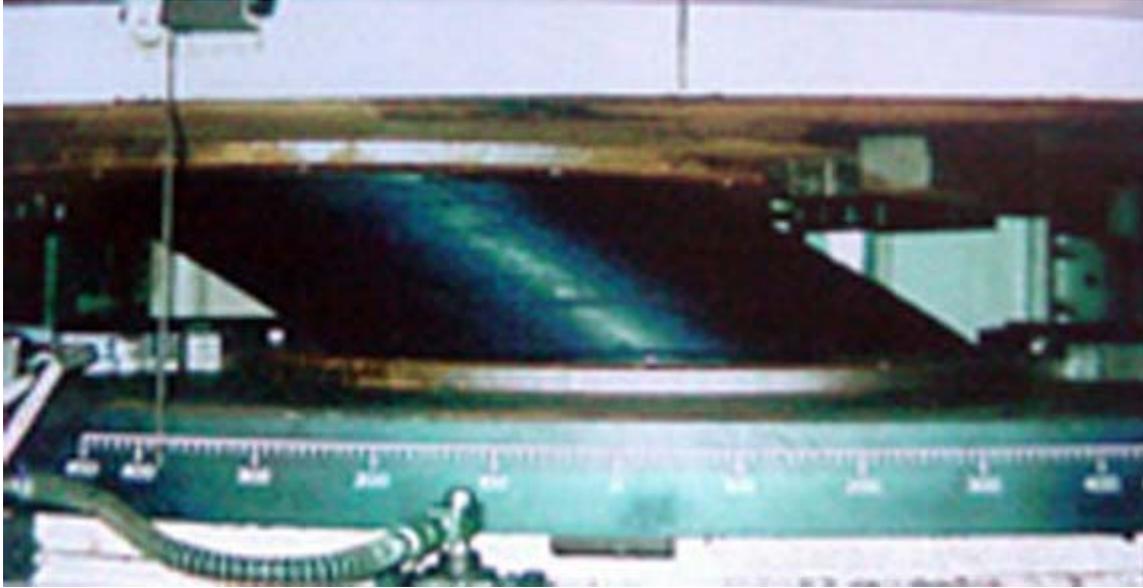
Figure 9: Shear displacement test of bearing

The bearings were rigorously tested to verify their properties used in the analysis and design. Bearing stability at a maximum lateral displacement of 21 inches was also verified (*See Figure 9*).

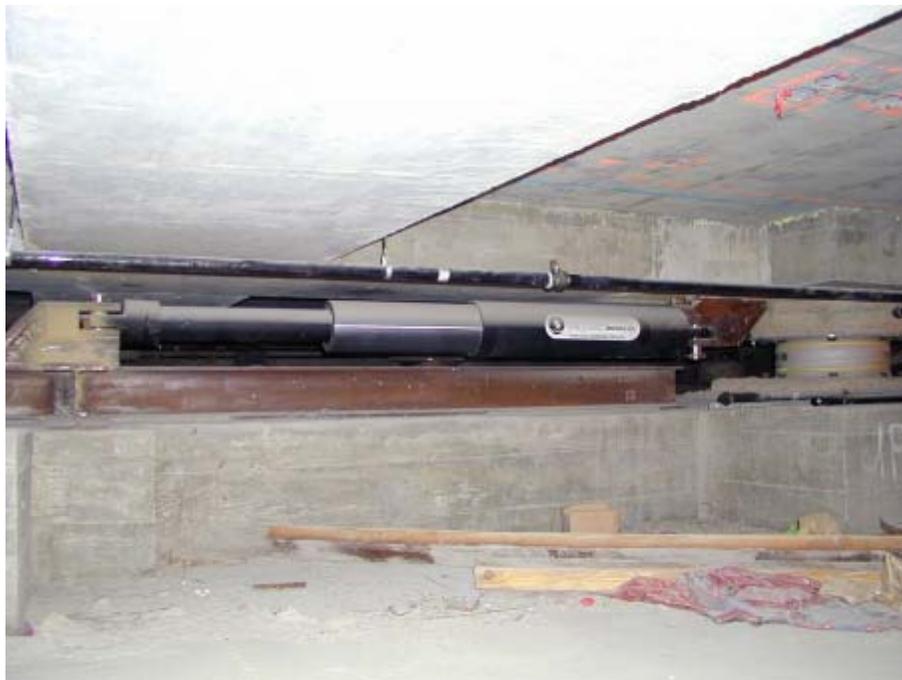
Figure 10: 300 kip damper installed at plane of isolation

The isolation system is supplemented with 52 viscous dampers, 26 in each direction, at the plane of isolation. These dampers bridge the plane of isolation, i.e. one end is connected to the foundation and the other to the underside of the basement slab. The dampers have a mid-stroke length of 143 inches, a force rated capacity of 300 kips at 50 in/sec, and a stroke of ± 21 inches (*See Figure 10*).

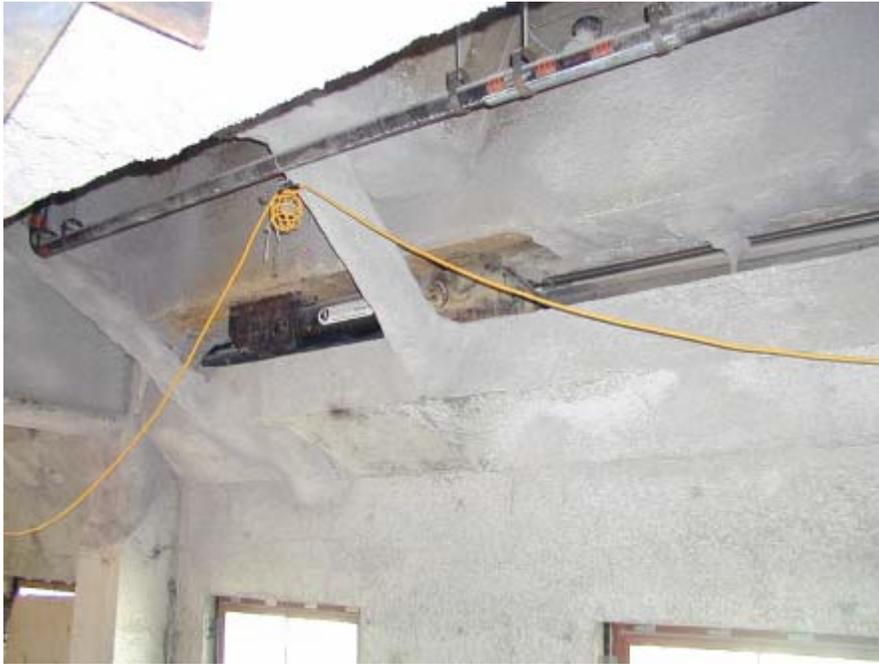
Figure 11: 225 kip damper installed at 26th floor

Twelve viscous dampers, six in each direction, have been installed between the 26th and 27th floor. These dampers have a force rated capacity of 225 kips at 10 in/sec, a stroke of ± 4 inches, and a mid-stroke length of 46 inches (*See Figure 11*).

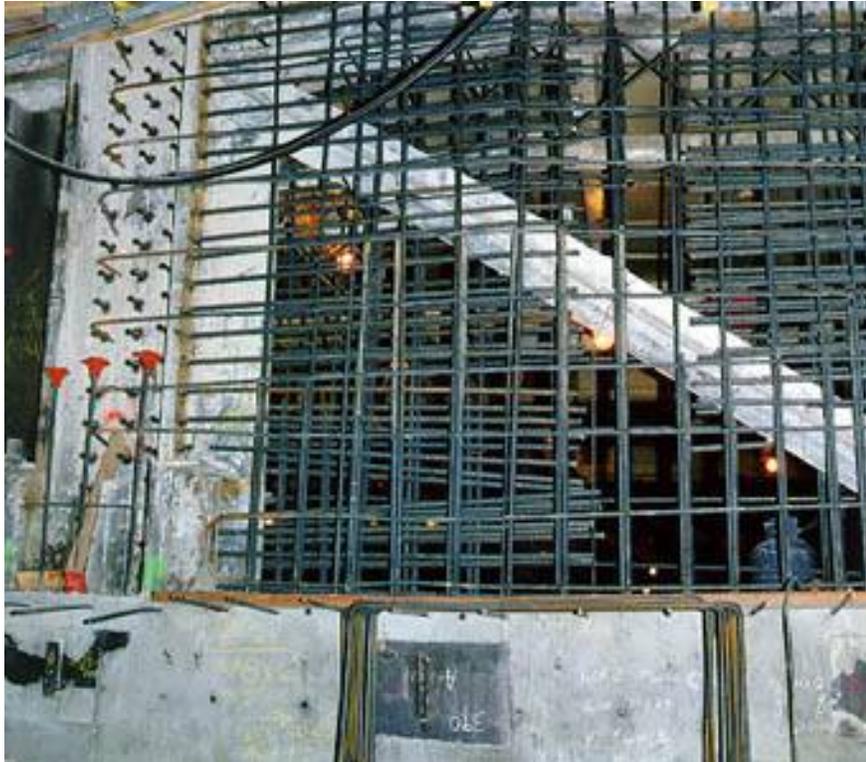
Figure 12: Rebar for new concrete shear wall at basement level

The new walls are located along the perimeter walls of the tower extending to the basement and along the walls at the north and south ends of the mid-rise extending to the basement. The walls under the tower re-distribute the seismic over-turning forces and reduce the net uplift experienced by the isolators under the walls (*See Figures 12 and 13*).

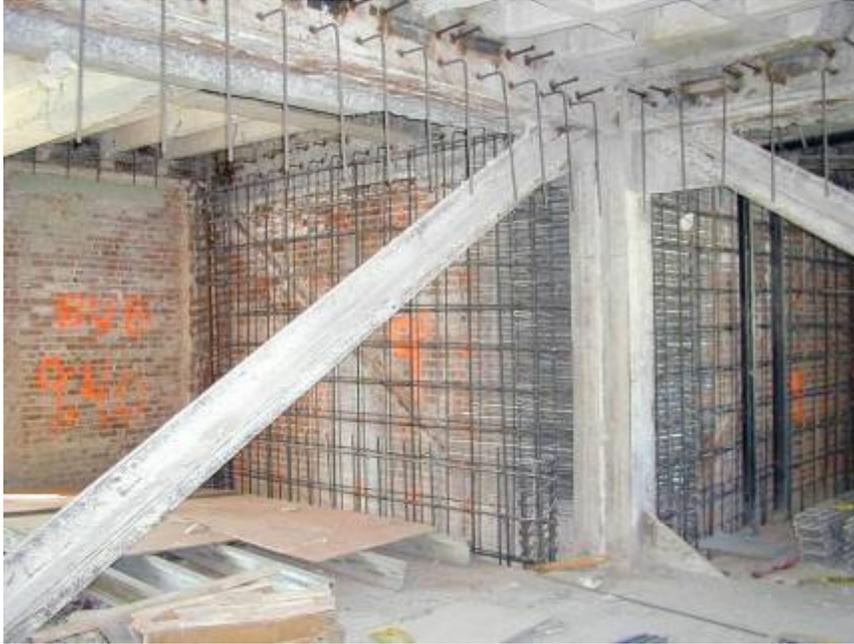
Figure 13: Rebar for new concrete shear wall in tower

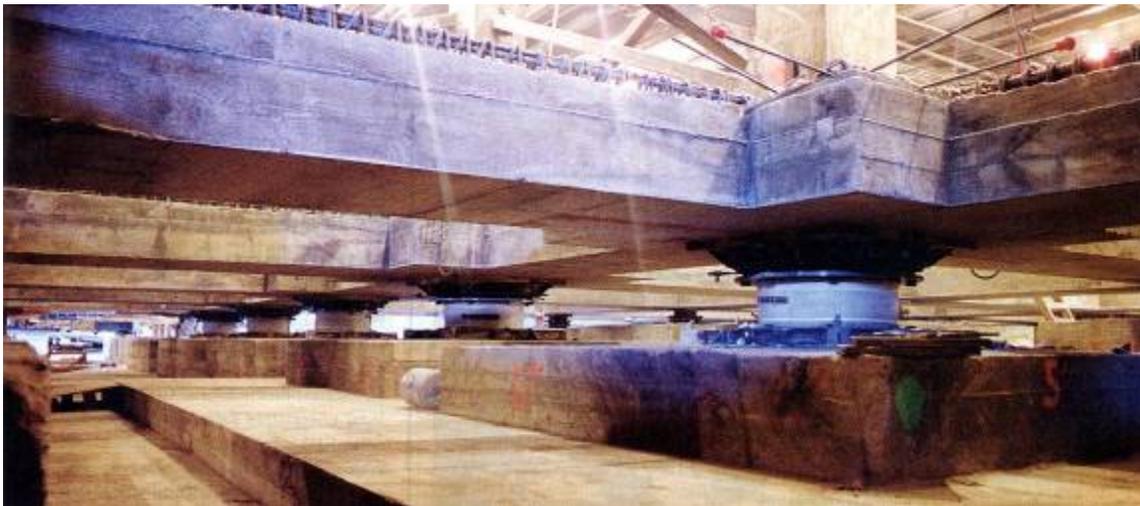
Figure 14: New basement diaphragm in construction

The original basement diaphragm was demolished and a new 8 inch thick concrete diaphragm constructed. Demolition of the original diaphragm provided access to the foundation

and simplified the installation of the isolators. The new diaphragm system ties all of the isolators together and ensures proper force transfer between the super-structure and isolation system (*See Figure 14*).

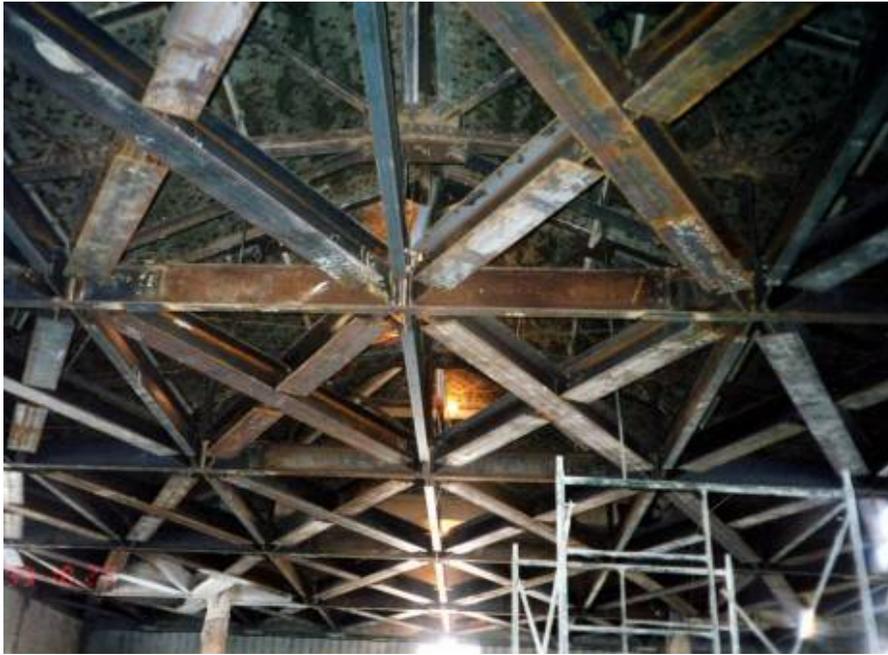
Figure 15: New horizontal steel truss diaphragm at 11th floor

A new horizontal steel truss diaphragm was added at the roof of the mid-rise to facilitate the transfer of seismic forces from the tower to the new RC walls at the north and south ends of the mid-rise. This diaphragm couples the new tower walls to end walls of the mid-rise providing an additional load path for seismic forces and reduces the over-turning demand at the base of the tower (*See Figure 15*).

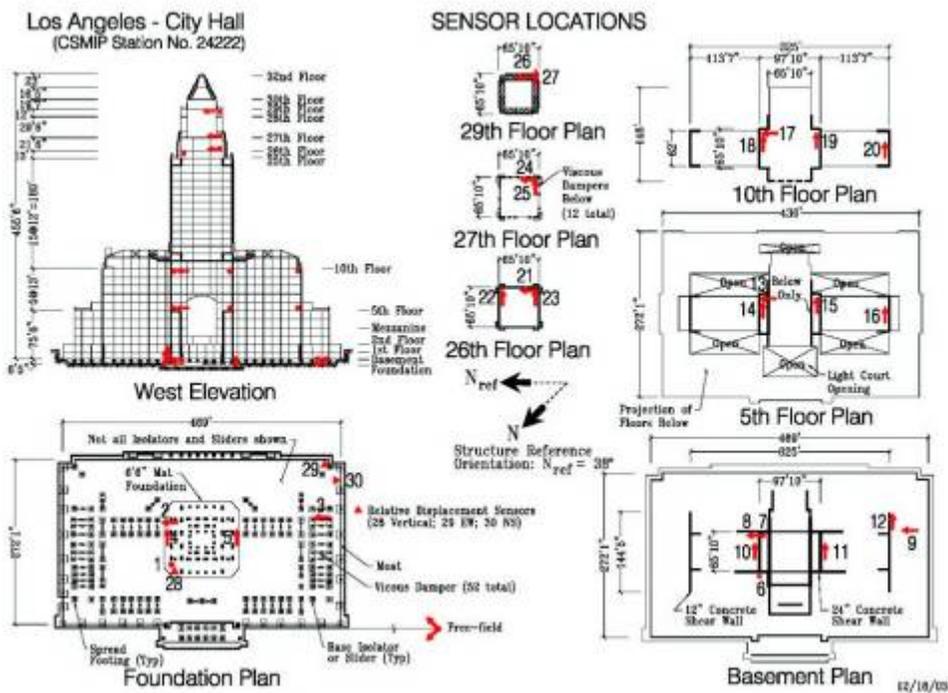
Figure 16: Sensor layout (from CGS/CSMIP)

There are a total of 27 accelerometers and 3 displacement sensors. The accelerometers are distributed throughout the building with 5 sensors at the foundation (below the plane of isolation), 7 at the basement diaphragm (immediately above the plane of isolation), 4 at the 5th and 10th floors, 3 at the 26th floor, and 2 at the 27th and 29th floors (*See Figure 16*). These locations were selected to optimize the value of the recorded data using the least sensors. The sensors at the foundation and basement levels provide response information above and below the plane of isolation. The sensors at the 5th and 10th floors are located at levels where major transitions (setbacks) in the building configuration occur. The sensors at the upper levels of the tower will provide data on the whiplash effect of the tower and the effectiveness of the viscous dampers at the 26th floor. All of the displacement sensors are located at the plane of isolation. The accelerometers and displacement sensors are also distributed in plan to capture any torsional response at each instrumented floor.

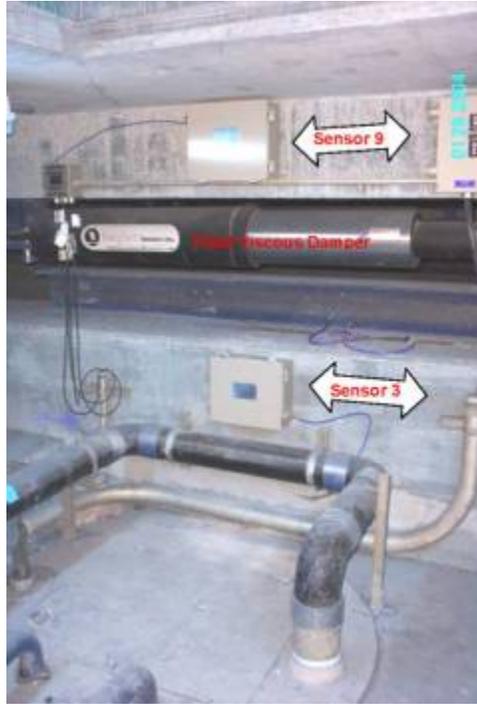
Figure 17: Sensors installed above and below damper at plane of isolation (from CGS/CSMIP)

The sensors at the foundation and basement levels were judiciously located near isolators and dampers. Recorded data from these sensors will allow the study of the building response and the behavior of the isolators and dampers (*See Figure 17*). Sensors that measure vertical motion are located above and below an isolator near the center of the building (*See Figure 18*). Data from these sensors will provide information on the vertical response of the building and overturning/uplift.

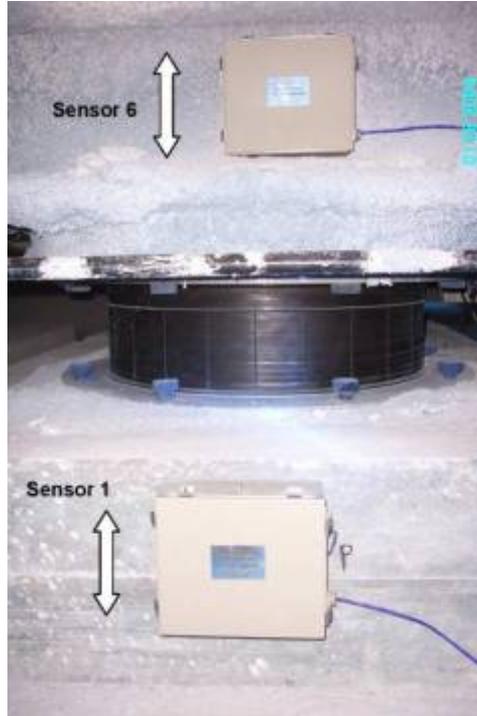
Figure 18: Sensors installed above and below isolator at plane of isolation (from CGS/CSMIP)
