OBSERVATIONS OF STRUCTURAL PERFORMANCE NEAR STRONG-MOTION STATIONS DURING THE ITALY L'AQUILA EARTHQUAKE

Chris D. Poland
Degenkolb Engineers, San Francisco

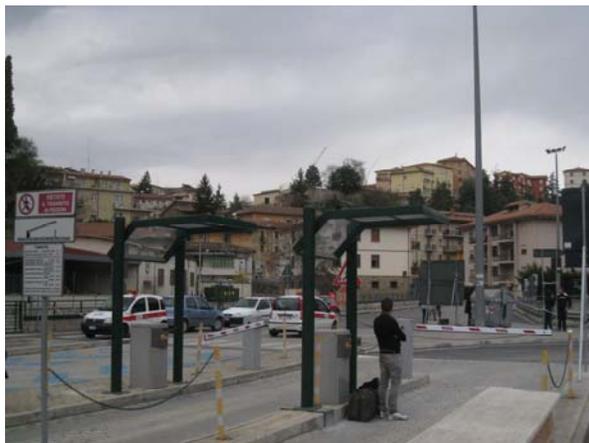
Figure 1. Strong Motion record near the Ancient City, .36g PGA

Figure 1 includes a single, sample response spectrum for the record taken nearest the ancient city and a cluster of buildings located nearby. None were seriously damaged. Figure 2 includes three of the five instruments in the valley array along with buildings located in the

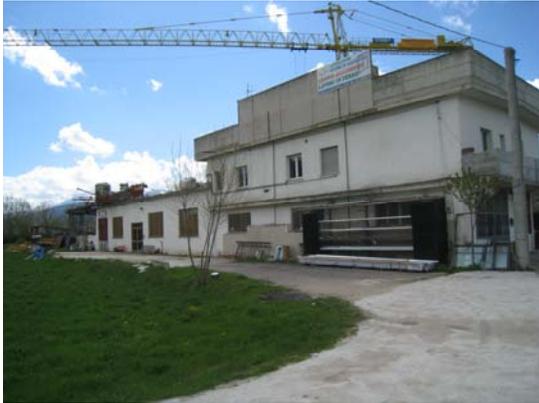
Station AQV, Valley location, .67g PGA

immediate vicinity. In all cases, damage to the adjacent buildings was light to not visible, even for those in the area of the instrument that went off-scale. The buildings observed included many of the styles of construction in the region and ranged in height from one to six stories. The strength of these records and the lack of damage suggest that acceleration alone is not a good indicator of damage potential.

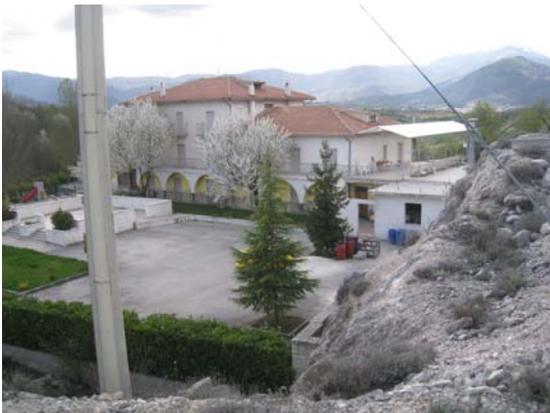
Station AQG, Rock location beyond valley edge, .51g PGA

Figure 2. Response Spectra and nearby Sample Building Performance

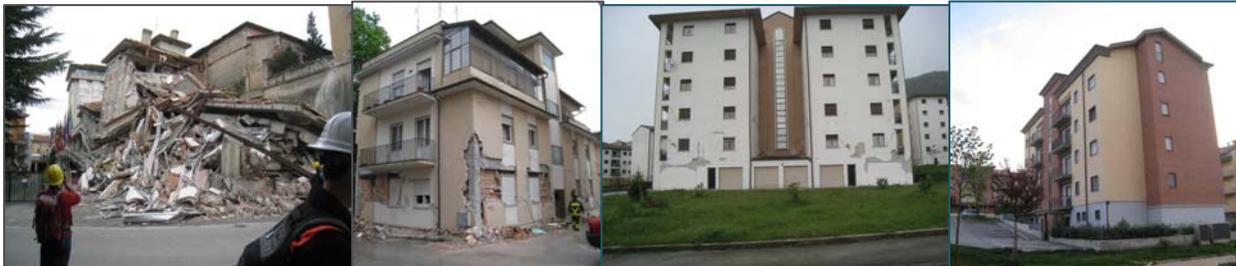
Figure 3. Inferred Intensity from Damage Observations

In an effort to catalogue the variations in the intensity of shaking throughout the region, the extent of damage to reinforced concrete frame/infill buildings was catalogued throughout the region. Four damage states from “Extreme” to “Mild” were defined and assigned based on visual inspection from the street. The GPS coordinates of each building were determined and plotted with an indicator of damage level on a Google Map image of the region as shown in Figure 3. The location of the strong motion instruments is also shown on the figure along with the zones of intensity inferred from the individual building observations. These zones represent the general damage patterns observed within each zone and not the worst-case occurrences.
