## California Geological Survey

# THE EARTHQUAKE

# **1933 LONG BEACH EARTHQUAKE** THE FIELD ACT, IMPROVING THE DESIGN AND BUILDING STANDARDS FOR CALIFORNIA SCHOOLS

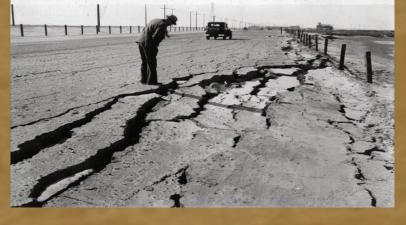
Liquefaction lateral spread lamaged road near Seal Beach.

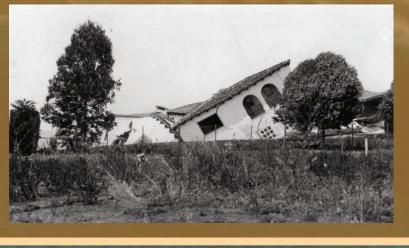
Landslide along coastal bluff damaged home in San Clemente.

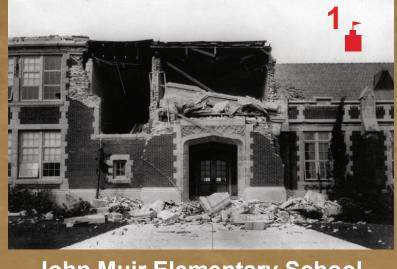
John Muir Elementary School Long Beach

Damage was most significant to poorly designed and unreinforced brick structures.
