# Montecito 2023 Storm Response

## Mission Task #2023-SOC-94072

## MEMORANDUM

**SUBJECT:** Montecito 2023 Storm Response – Cal OES Mission Task #2023-SOC-94072

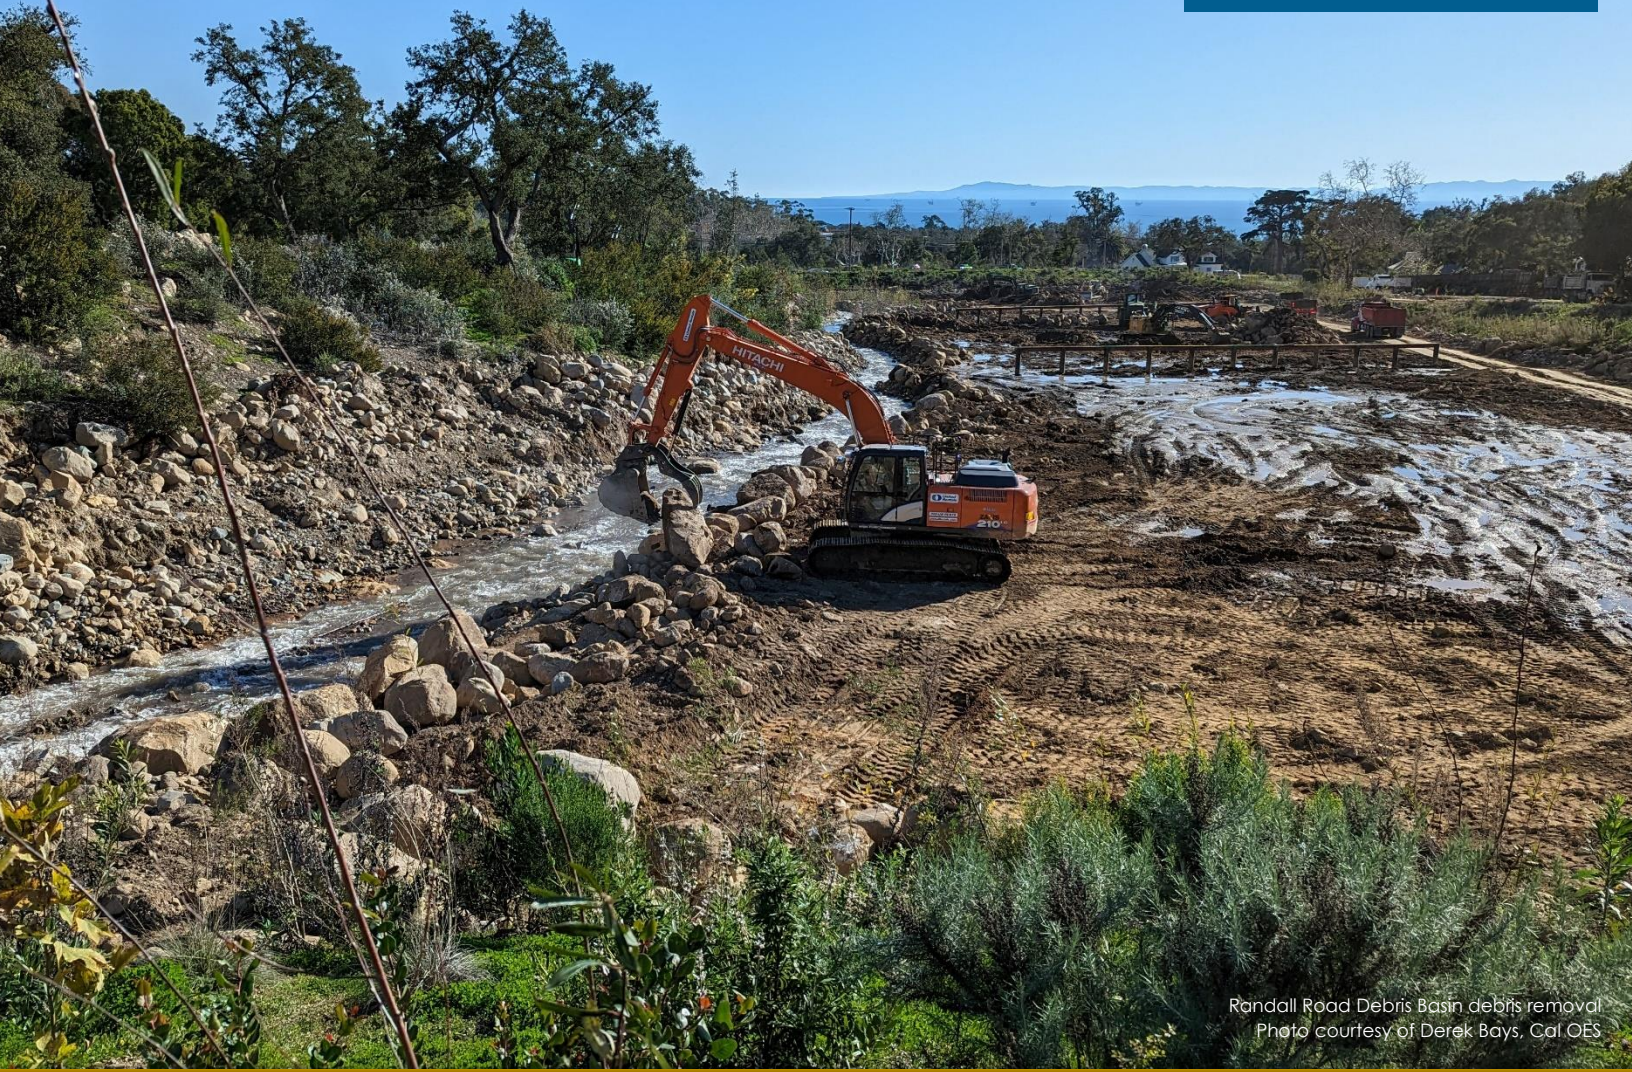
Randall Road Debris Basin debris removal  
Photo courtesy of Derek Bays, Cal OES

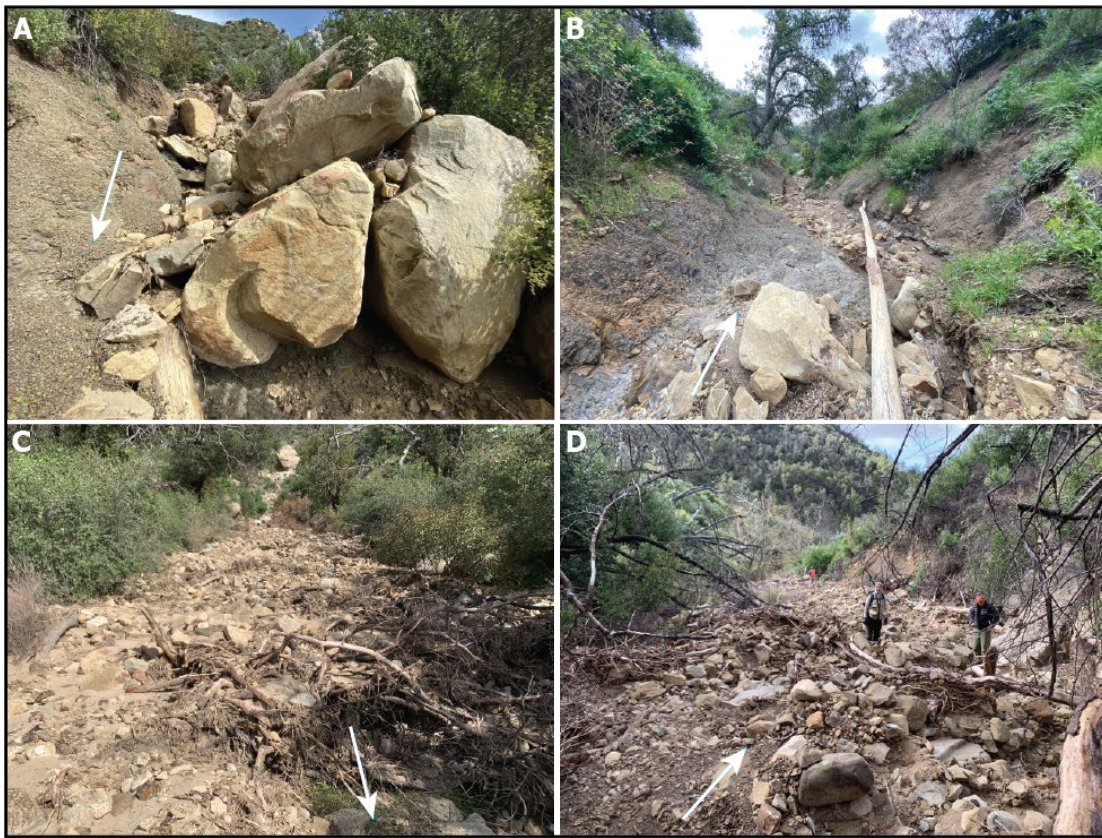
The distribution of recently deposited and reworked colluvial sediment following the January 2023 AR varied throughout tributary channels across the study area. Observations made along San Ysidro Creek and Cold Spring Creek appeared representative of conditions over the broader study area. Tributaries to San Ysidro Creek showed the presence of recently deposited and reworked colluvial sediment trapped directly upstream of channel blockages, such as keystone boulders (Figure 8A) positioned high within first-order channels. In lower elevations, channels showed evidence of reworked alluvium and scoured sediment indicating more scour than deposition (Figure 8B). And downgradient of depleted landslide scars, a few channel reaches contained extensive volumes of recently reworked, colluvial sediment deposits that were observed within tributaries of San Ysidro Creek (estimated volume of 5,000 cubic feet; Figure 8C) and Cold Spring Creek (estimated volume of 19,000 cubic feet; Figure 8D).

Figure 8. Amount and distribution of available sediment throughout low-order channels. A. Recently deposited and reworked, colluvial sediment within a tributary of San Ysidro Creek following the January 2023 AR event. B. Reworked channel-bed sediment within a tributary of San Ysidro Creek. C. Recently deposited and reworked, colluvial sediment within a tributary of San Ysidro Creek and (D.) Cold Spring Creek. Arrows in the photos indicate flow direction; channel widths are approximately 7 ft (A), 15 ft (B), 17 ft (C), and 30 ft (D).

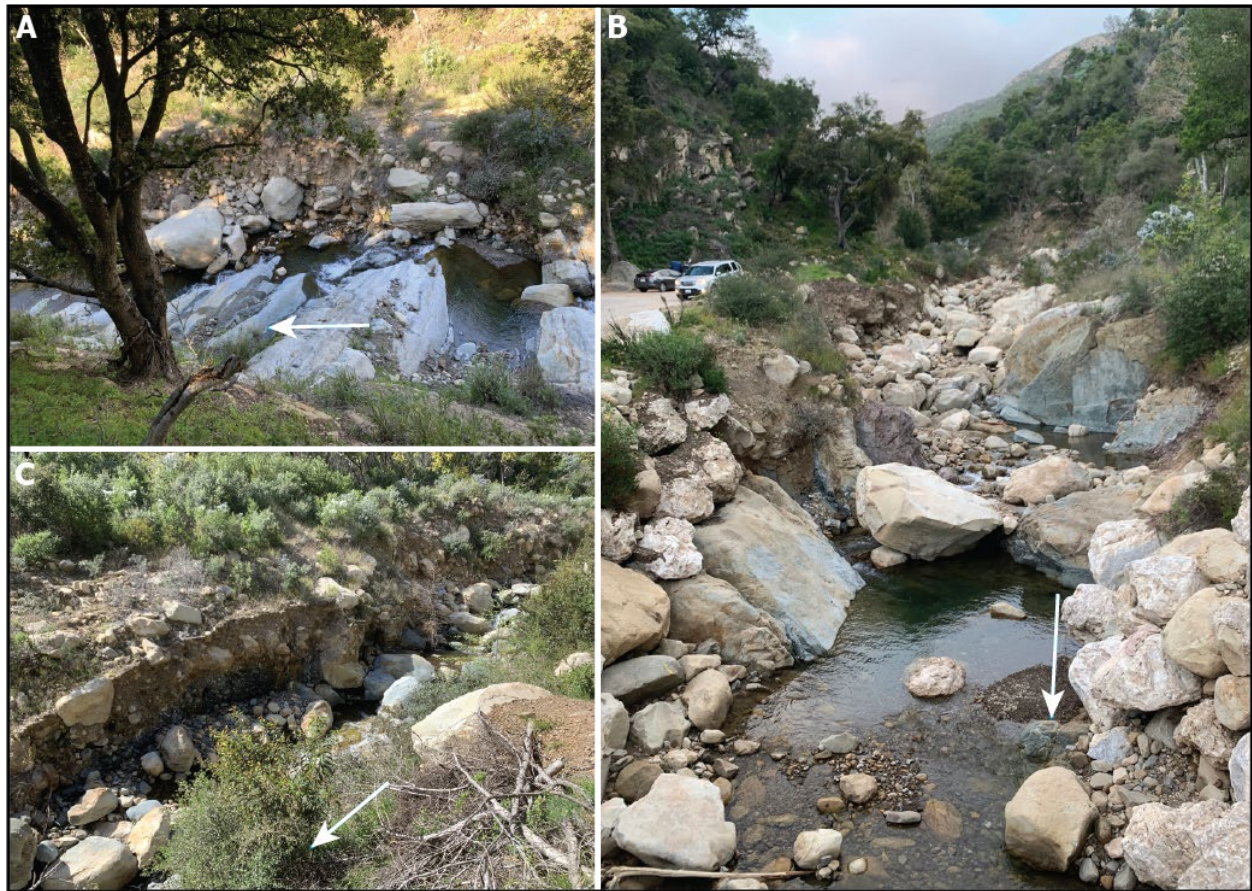
The mainstem channels showed more evidence of recent bed and bank scour than deposition. Both Cold Spring and San Ysidro Creeks have recently scoured down to bedrock in many locations (Figure 9A). However, there is evidence of erodible sediment remaining within the channel and along oversteepened banks that could be entrained and transported downgradient during future runoff events. Examples of sediment currently stored within the channel bed and banks are shown in San Ysidro Creek (Figure 9B and Figure 9C) and Romero Creek (Figure 10A and Figure 10B).

Figure 9. Amount and distribution of available sediment throughout the mainstem channels. A. More evidence of scour within mainstem channels than deposition in San Ysidro and (B) Cold Spring Creeks. C. Easily erodible sediment currently located in mainstem channels is available to transport in San Ysidro Creek. Channel widths are approximately 50 ft (A and B), and 30 ft (C).
