# Five Years Later: Looking Back at the 2019 Ridgecrest Earthquake Sequence

by Carla Rosa, PG, Tim Dawson, PG, CEG, Kate Thomas, and Alex Morelan, Ph.D., PG  
*CGS Seismic Hazards Program*

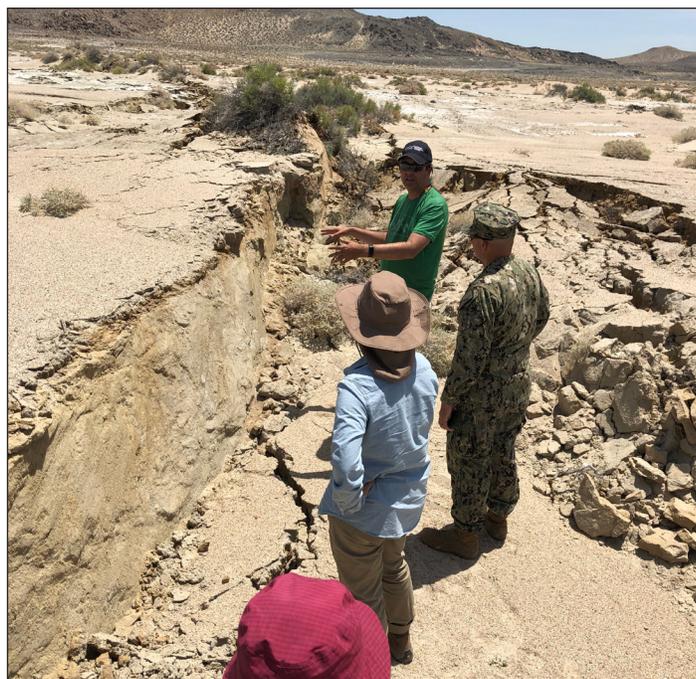
CGS geologist Tim Dawson (in green shirt at top of image) shows U.S. Navy staff surface fault rupture related to the July 5, 2019, M7.1 earthquake on the Paxton Ranch fault. Photo: Ken Hudnut, USGS

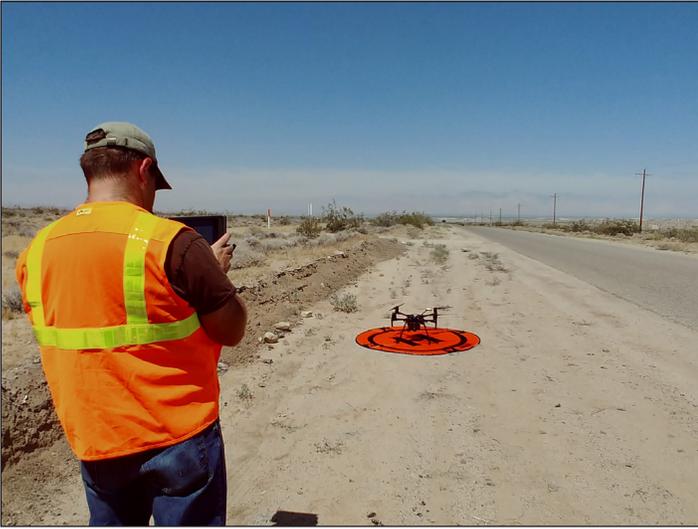
Left image shows Nathaniel Roth preparing to pilot the DJI Matrice 210 for post-earthquake field reconnaissance. Photo by Kate Thomas, CGS. Right image depicts aerial imagery acquired during post-earthquake field reconnaissance. Black arrows point to trace of surface rupture.

The Ridgecrest Earthquake Sequence provided the CGS with the opportunity to make advances in post-earthquake reconnaissance and fault mapping, such as implementing a digital data acquisition application (Collector for ArcGIS) which facilitated the collection of over 6,000 on-the-ground site observations. This allowed for faster data acquisition, ensured data quality, and provided seamless compilation of those data into a single database. This event also was the first post-earthquake reconnaissance where CGS flew the Da-Jiang Innovations (DJI) Matrice 210 drone to acquire video and images of the surface rupture.
