Selected AMLU Abandoned Mine Remediation Projects (2005 and earlier)

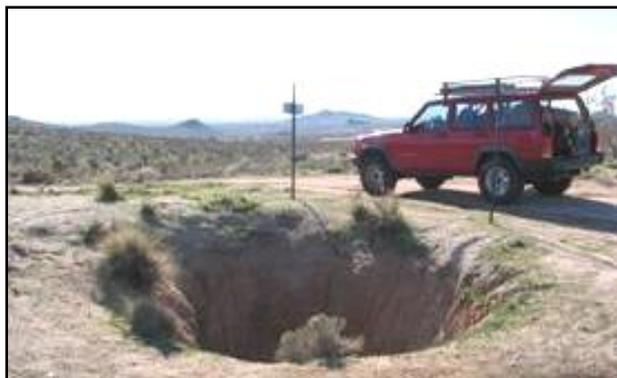
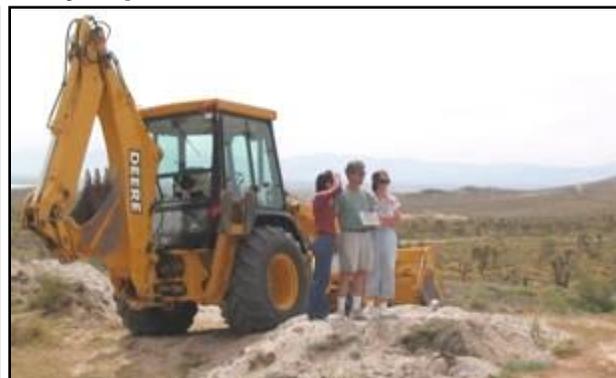
Shaft near Rosamond Backfilled, Kern County, April 2005

BEFORE

AFTER

In December 2004, Paul Etner and his family discovered an unmarked mine shaft the hard way: they nearly backed their SUV into it. After gingerly pulling all four wheels back onto solid ground, Mr. Etner contacted the AMLU. The AMLU determined that the 53-foot mine shaft was located on property owned by the California State Lands Commission (CSLC). In April 2005, a backhoe pushed rock and soil from the mine dump back into the shaft. The project was accomplished pursuant to a Memorandum of Understanding established between the Department of Conservation and CSLC in April 2004 to assess and remediate health and safety hazards associated with abandoned mines on State School Lands.

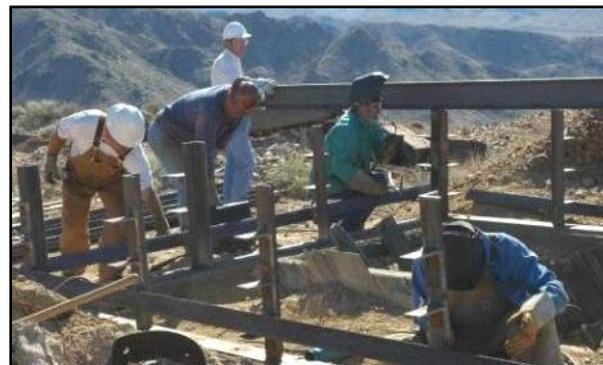
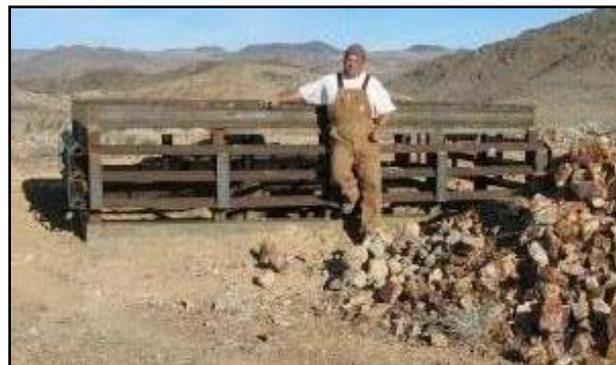
Bat Gate Building Workshop, San Bernardino County, November 2004

DURING (students and instructors building a bat cupola) AND AFTER

The AMLU, National Park Service, Army Corps of Engineers, and Bat Conservation International, Inc. collaborated in a bat gate building workshop with a classroom session held in Baker, CA, and hands-on training at the Paymaster Mine in the Mojave National Preserve. Students helped to construct one bat gate in a horizontal adit and two bat cupolas above hazardous vertical shafts, one of which was over 200 feet deep.

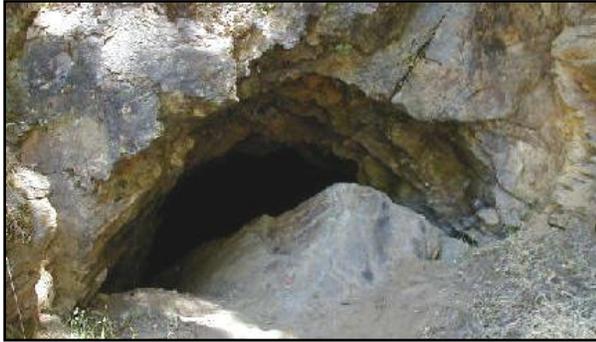
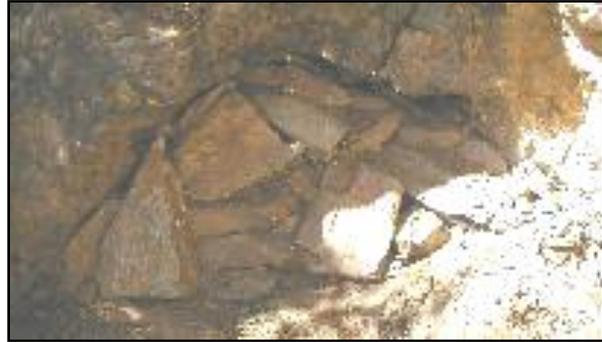
Mokelumne River Adit Sealed, Amador County, September 2004

BEFORE

AFTER

The AMLU partnered with the Folsom Field Office of the Bureau of Land Management (BLM) to install a polyurethane foam plug to close a hazardous mine opening adjacent to the Mokelumne River. This adit was near a popular river access point and showed signs of regular visitation. Rocks were embedded in the foam to give it a natural look.

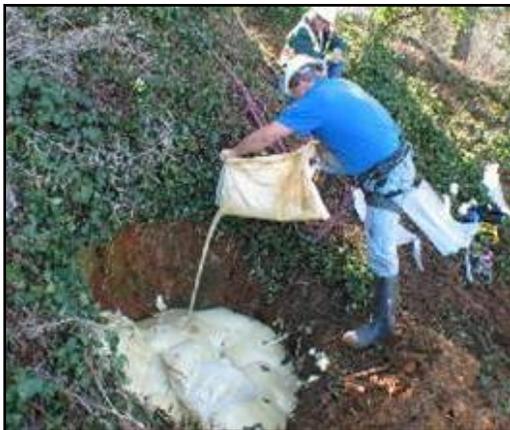
AMLU Closes Shaft along Highway, Nevada County, February 2004

California Department of Transportation (Caltrans) workers discovered a collapsed mine shaft on the embankment of Highway 49 in Grass Valley. The shaft was a potential fall hazard for Caltrans workers as well as highway cleanup crews. Because it was located below a group of trees and high up from the highway, backfilling the shaft would have been difficult and expensive. Caltrans instead enlisted the assistance of the Abandoned Mine Lands Unit. On the morning of February 5, 2004, the AMLU sealed the shaft using polyurethane foam mixed onsite. It then covered

the hardened foam plug with adjacent soil. Total project costs were less than one quarter of the amount previously estimated to backfill the shaft.

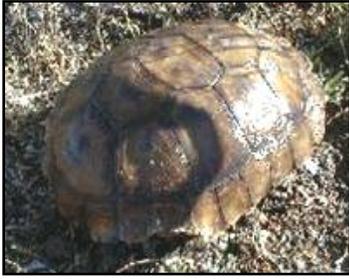
AMLU Assists in Tortoise Rescue, Kern County, January 2004

While preparing for an abandoned mine remediation project in the Western Rand Mountains Area of Critical Environmental Concern, the AMLU's Sarah Reeves and Jonathan Mistchenko found two desert tortoises (*Gopherus agassizi*) trapped in a shallow excavation. Unfortunately, one of the tortoises had already perished. With the assistance of staff from the Ridgecrest Field Office of the Bureau of Land Management (BLM), the live tortoise was removed to a safe location. The AMLU and Ridgecrest Field Office subsequently backfilled the excavation and two similar, nearby excavations. This incident points out that even small, shallow abandoned mine features can be deadly to native vertebrates.

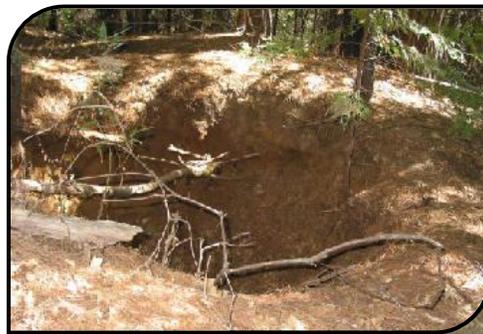
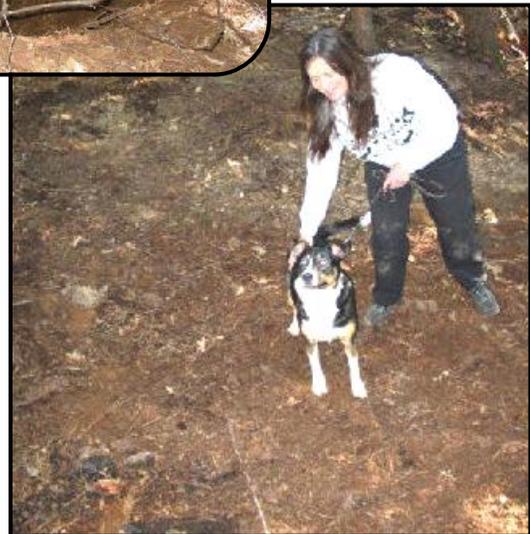
Magalia Mine Shaft Sealed, Butte County, November 2003

In April, 2003, an Australian Shepherd mix named Molly fell down this 55-foot abandoned mine shaft in Magalia. Luckily, she survived for eight weeks before being rescued. The dog owner's home was only a few hundred feet from the shaft, and many nearby residents were unaware of the hazard. The Paradise Irrigation District, which owns the property, teamed up with the AMLU to close the shaft with polyurethane foam. The Lassen County Search and Rescue Team cleared the shaft prior to the closure.

BEFORE

AFTER

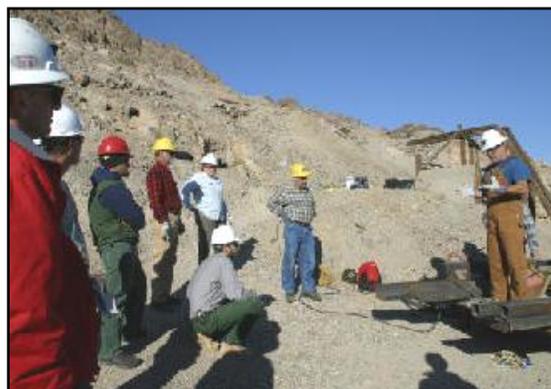
AMLU Sponsors Bat Gating Workshop, San Bernardino County, November 2003

The AMLU, Bureau of Land Management, and Bat Conservation International, Inc. teamed up to hold a workshop on bat gate design and construction. Participants built bat-friendly gates at two abandoned mine adits at the Salt Creek Hills Area of Critical Environmental Concern. The gates safeguard curious visitors from abandoned mine hazards while protecting habitat for four bat species. State Parks Off-Highway Motor Vehicle Recreation Division "Green Sticker" fees helped to fund the bat surveys for this project.

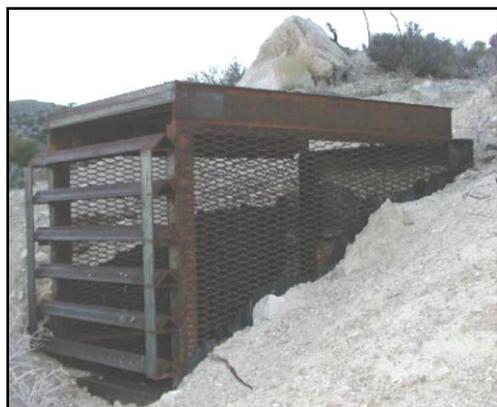
Pacific Fluorite Mine Bat Cupola, San Bernardino County, April 2003

The California State Lands Commission (CSLC) and the AMLU partnered on two significant physical hazard remediations, including this one in the Clark Mountains of San Bernardino County. In order to preserve sensitive wildlife habitat, a custom "bat cupola" was installed to allow passage by bats but not by humans.

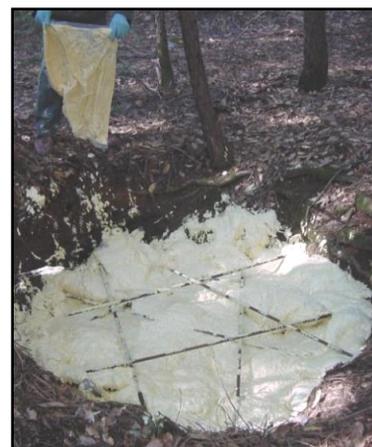
Ten Hazardous Features Remediated in the Tahoe National Forest, Sierra and Nevada Counties, February 2003

The AMLU worked closely with the U.S. Forest Service's Tahoe National Forest to remediate ten hazardous features at six abandoned mine sites. Five features were closed using polyurethane foam (PUF), one was blasted shut with dynamite, and the remaining four were cleared of unstable structures and hazardous debris. At right, PUF is used to seal off a dangerous shaft that was within several hundred feet of a school bus stop.
