Selected AMLU Abandoned Mine Remediation Projects (2008)

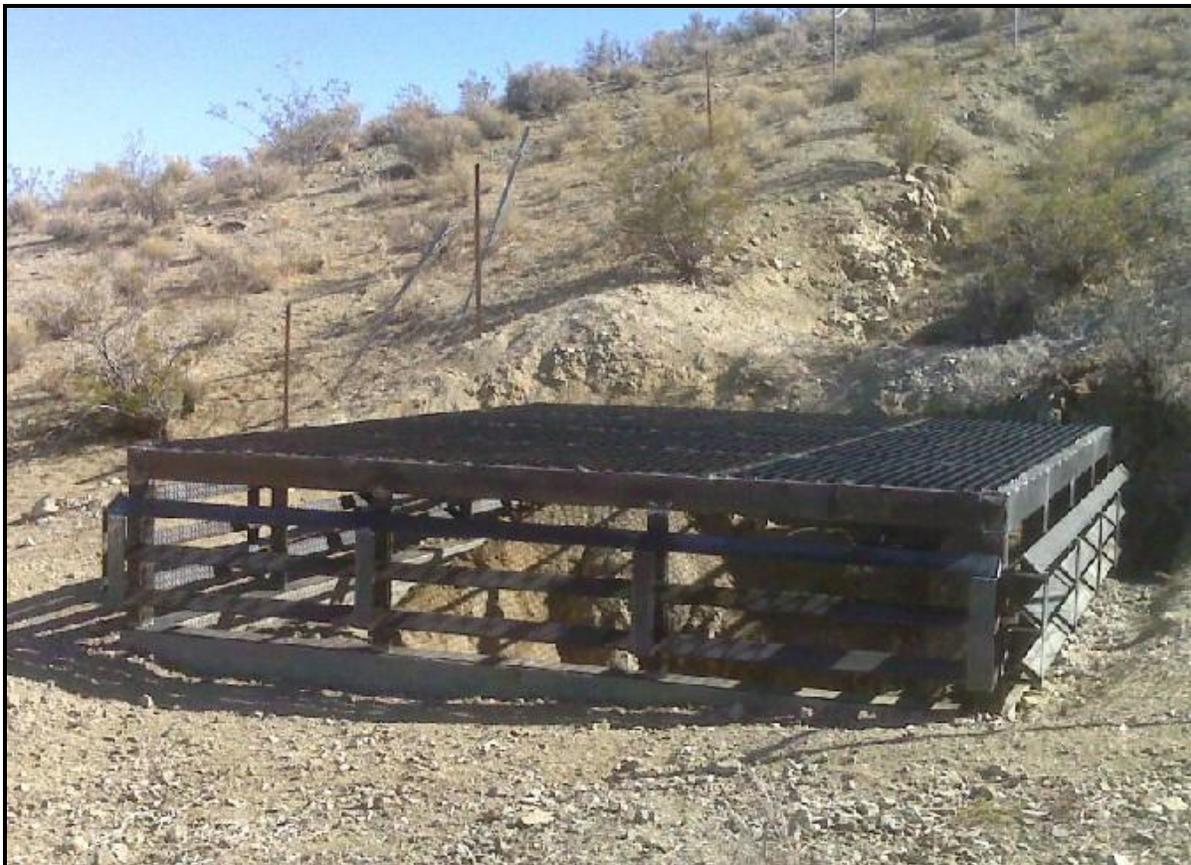
AMLU's 500th Remediation Project: Cupola Installed on BLM Shaft, Kern County, October 2008

In late October 2008, the Abandoned Mine Lands Unit (AMLU) completed its 500th physical hazard remediation project since it began funding such projects in 2002: the installation of a dome-like cupola to keep people safe while allowing bats to enter and leave at the Gold Bug Mine complex in Kern County. The project involved closing a 40-foot-deep shaft on U.S. Bureau of Land Management (BLM) property near Ridgecrest, less than a mile from Cerro Coso Community College. There's high traffic in this area, with people 4-wheeling, running, and walking their dogs in the Rademacher hills.

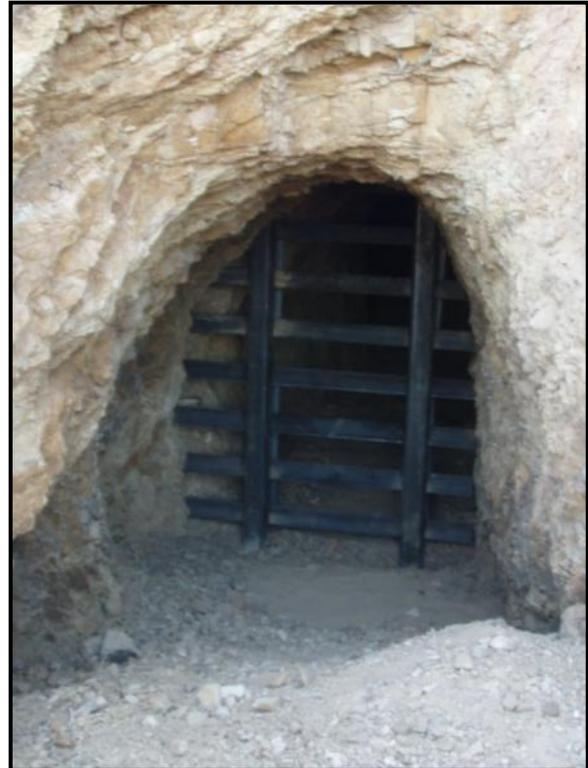
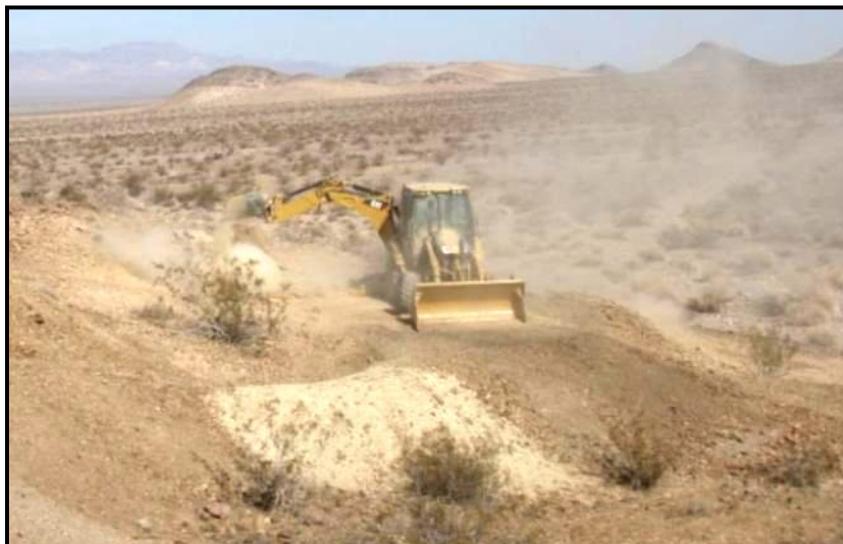
Closure of Hazardous Features by Backfill and Bat Gate, San Bernardino County, October 2008

In October 2008, California State Lands Commission and AMLU staffs partnered to close five abandoned mine features on a state-owned parcel in the Ship Mountains area of San Bernardino County. An adit at the site has continuously provided habitat for bats, while the other features, including a 66-foot-deep shaft and a prospect pit, represented a hazard to the public and wildlife. The features were secured with a bat compatible closure and backfills.

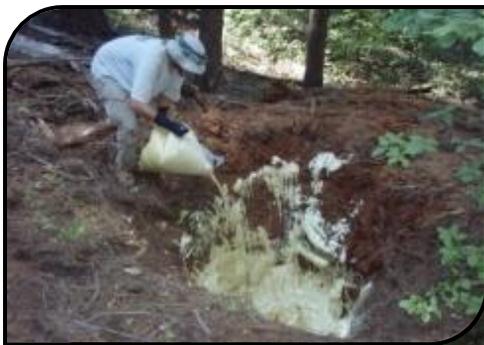
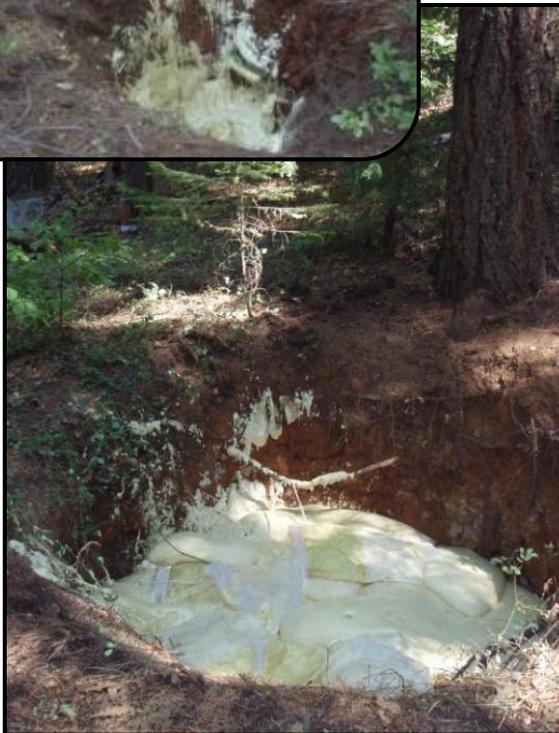
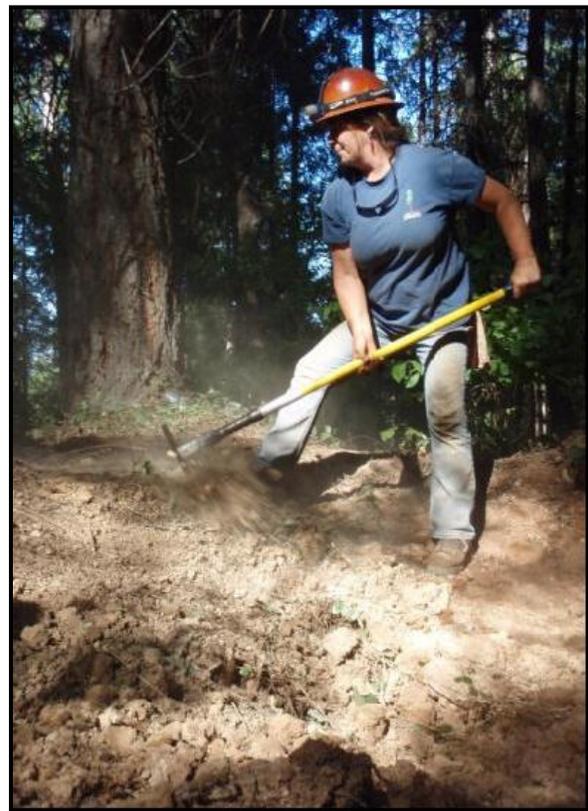
Shafts Plugged with Polyurethane Foam and Culverts Gate Installed, Eldorado National Forest, El Dorado County, August 2008

In August 2008, the AMLU partnered with the Eldorado National Forest to plug four shafts and install one culvert gate near the town of Volcanoville, CA. Polyurethane foam was used to seal the shafts located adjacent to a local horse trail after wildlife exclusions had been performed. It was also used to secure the culvert gate in place before being covered by several feet of dirt.

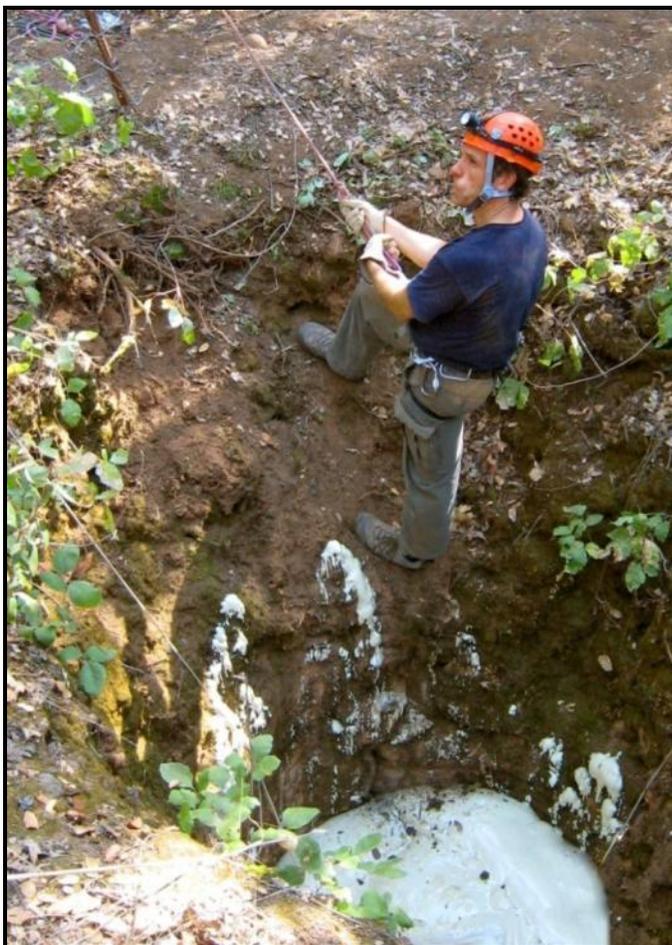
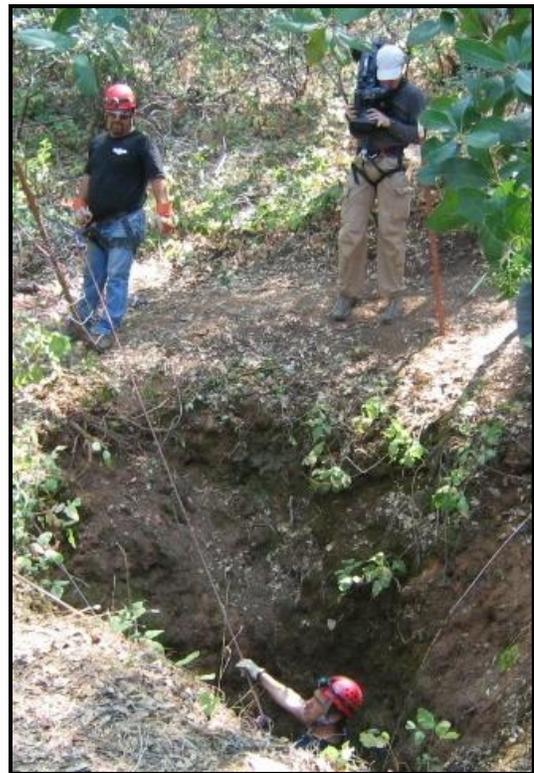
The 50-foot deep shaft was located across the shallow and narrow Shirland canal from a well-used trail within the Auburn city limits and near to some relatively new housing developments. It was discovered only after a dog survived a fall down a slightly shallower shaft nearby, prompting a site survey. Staffs from the AMLU, U.S. Bureau of Reclamation, and California State Parks coordinated on site selection, environmental review, and project completion.

In July 2008, the host of *Dirty Jobs*, Mike Rowe, joined Ed Winchester, a Mine Safety and Health Administration-certified contractor who has worked with the AMLU on numerous abandoned mine remediation projects throughout California, to seal a dangerous abandoned mine shaft in the Auburn State Recreation Area in Placer County and to highlight the hazards associated with abandoned mines. Polyurethane foam used to close the shaft was donated by Dennis Dunham, president of Foam Concepts, a company based in Minnesota.

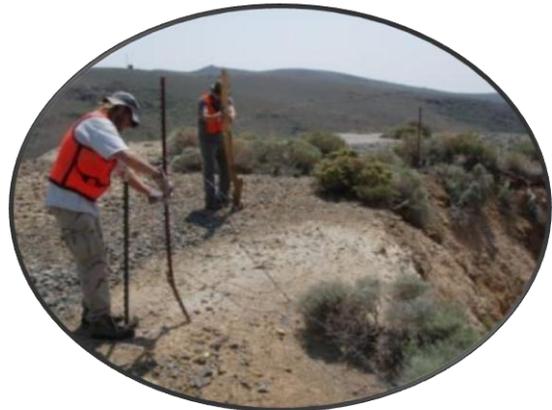
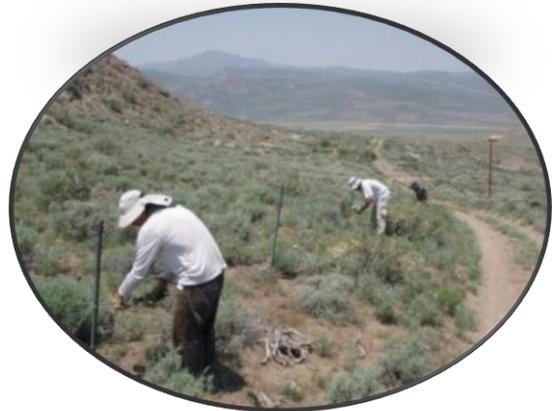
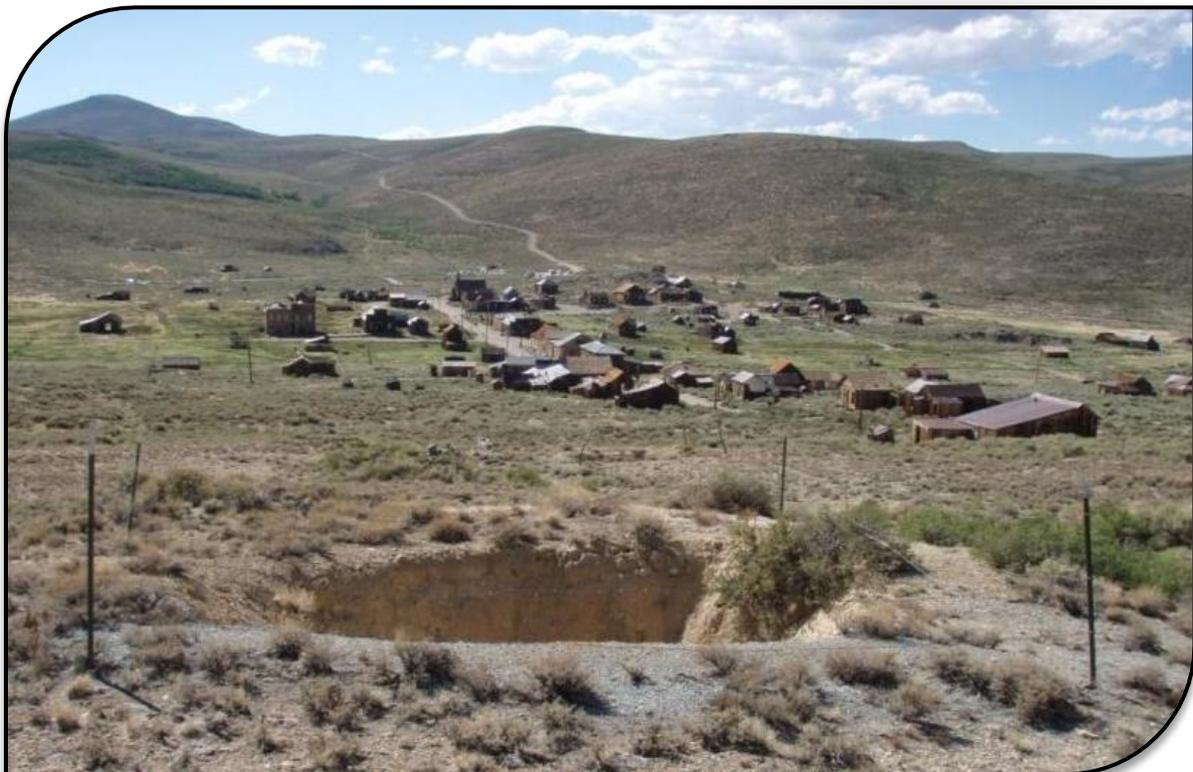
Fencing, Bodie State Historic Park (SHP), Mono County, June 2008

In June 2008, an AMLU field team built several fences at Bodie SHP to help protect the public and the historical resources for which the Park is noted. The AMLU completed the following.

- Repaired nine fences around physical hazards.
- Repaired two sections of perimeter fencing.
- Built one new fence around a mine shaft.

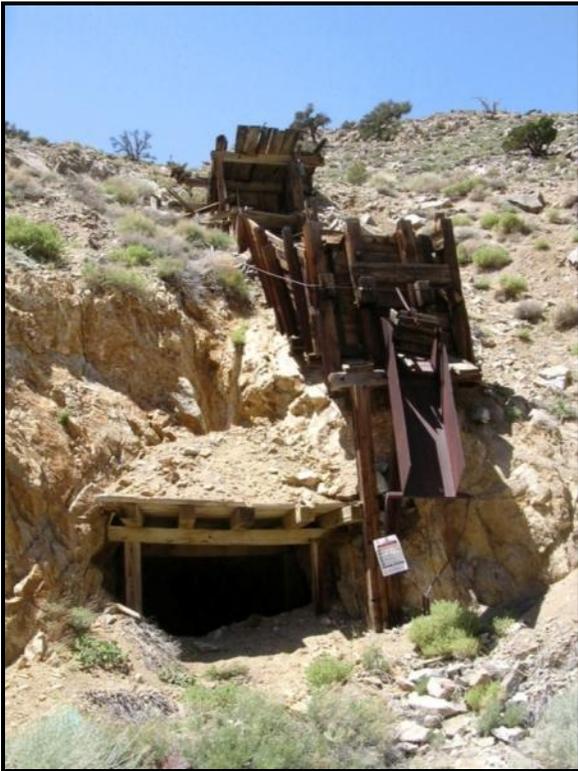
Culvert Gates and Fence Installed, Inyo National Forest, Inyo County, May 2008

In May 2008, the AMLU partnered with the Inyo National Forest (NF) to close four dangerous adits and fence a shaft near Independence, CA. Working together, they stabilized and secured the future of some of the unique historical mining structures at the site, abated physical hazards associated with these openings, and improved wildlife habitat. Inyo NF's road crew came out with a backhoe to help with the heavy lifting and backfill work, while the AMLU staff aided in the securing of two culvert gates and the placement of a polyurethane foam (PUF) plug. These were the last of several dangerous features to be remediated at this abandoned mine. In 2005 and 2006 the AMLU and Inyo NF partnered to close eight other features at the mine site.

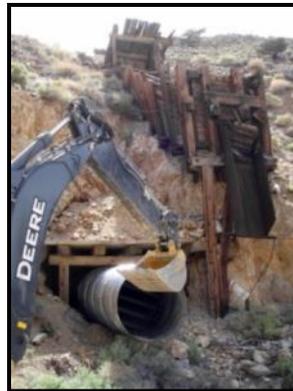
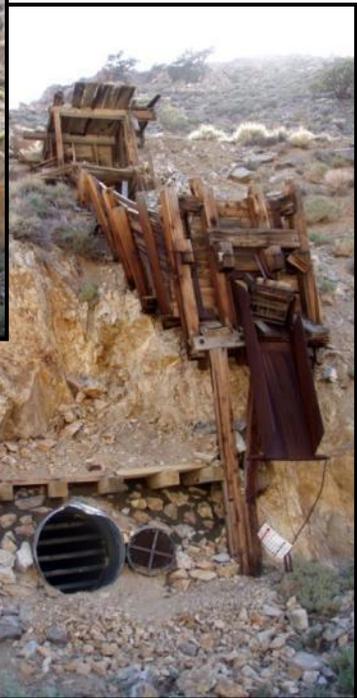
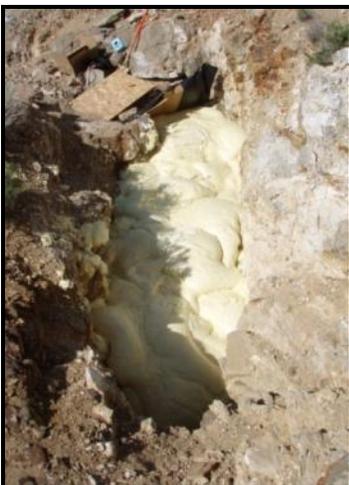
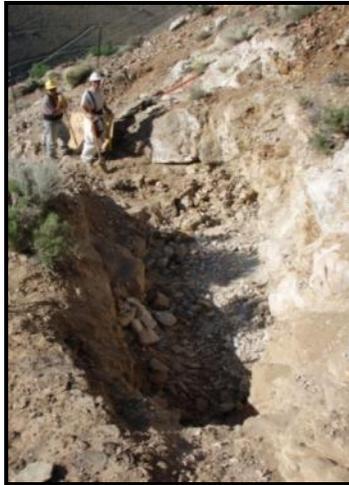
"In 2008 OMR provided additional manpower to the U.S. Forest Service for closures of an abandoned tungsten mine located at the end of a popular OHV route near Independence, CA. Staff members from OMR assisted the U.S. Forest with the placement of culvert gates and foam on four adits."

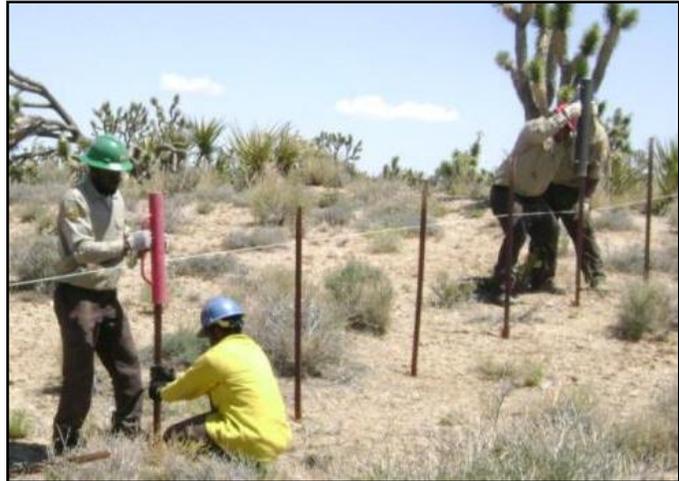
Fences Installed with Assistance from the California Conservation Corps, Mojave National Preserve, San Bernardino County, May 2008

In May 2008, National Park Service staff assisted by a California Conservation Corps crew and with funding from the AMLU installed fences around 17 hazardous abandoned mine features within the Mojave National Preserve.

The sites are located along frequently used trails, and tire tracks can be observed on the waste dumps and trails leading to several shafts.

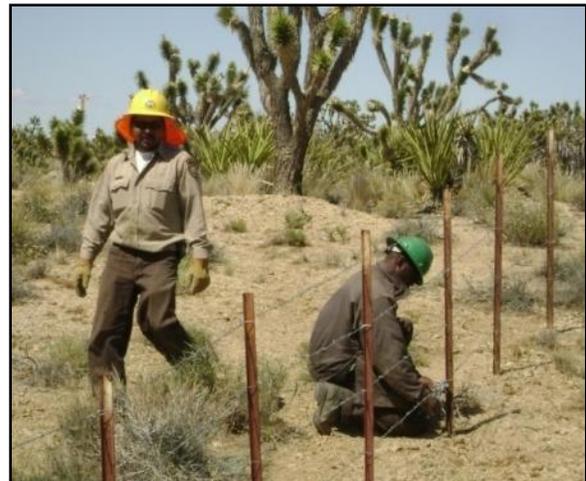
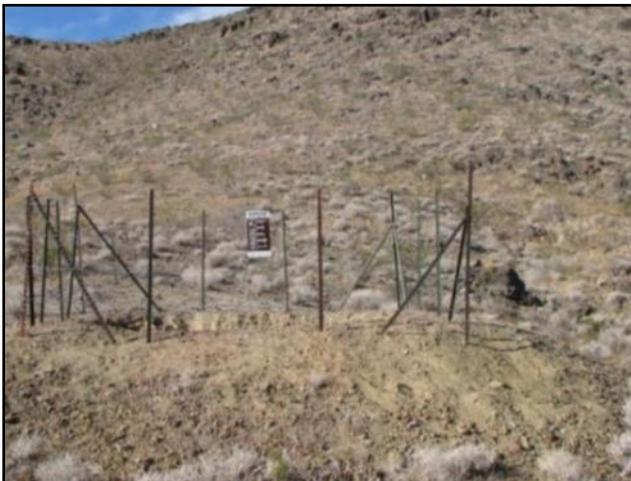
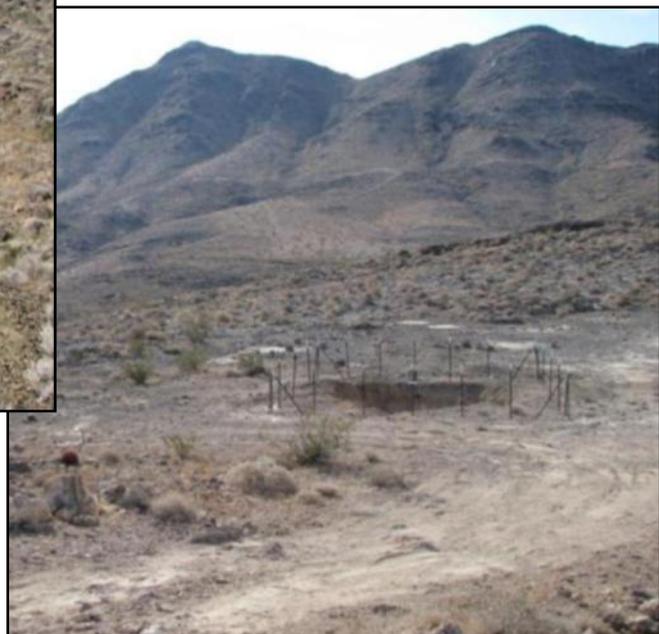
“Thanks for funding our projects. To this point, we have completed the chain link fence around the trench and eight associated features. We also installed the footing for a bat cupola on the main shaft. At [another site], we installed six barbed wire fences and rebuilt an additional one. We also installed a fence around one shaft that is being used by barn owls and fenced a decline. More work to follow as this saved other project funds. Again, many thanks for the help.”

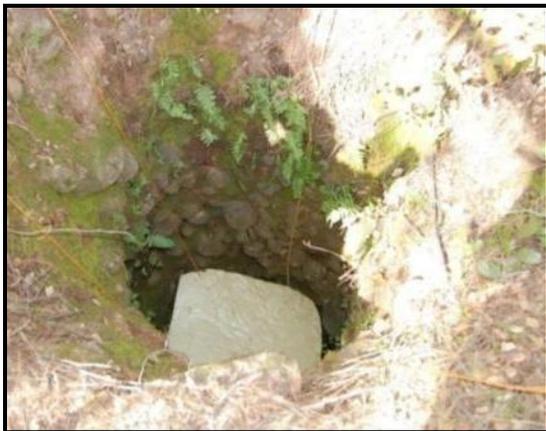
**INSERTING A
“FALSE BOTTOM”**

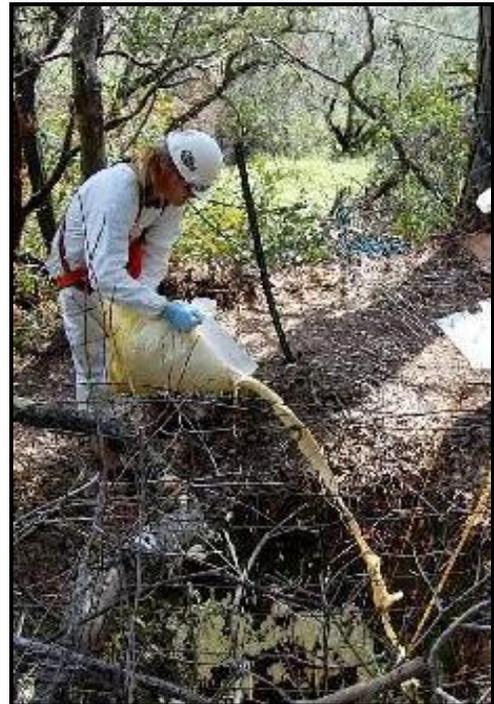
**POURING PUF INTO
THE SHAFT**

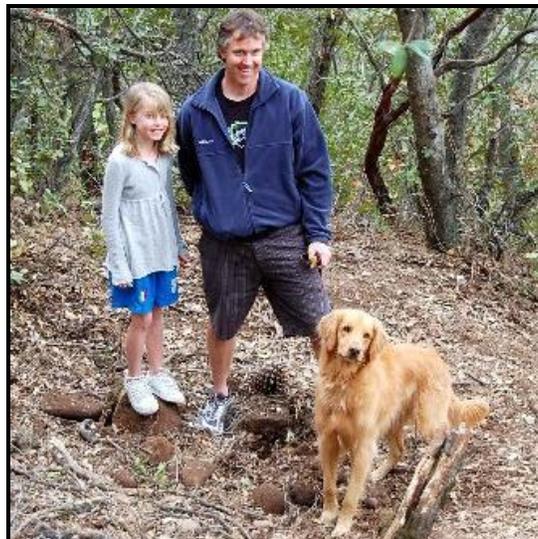
**SHAFT SITE (AFTER
THE CLOSURE)**

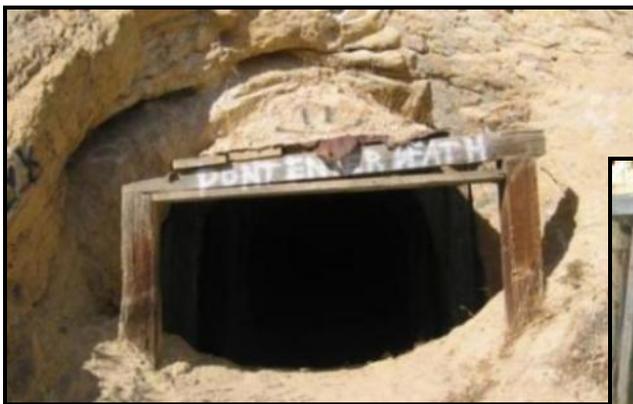
ADIT (BEFORE BAT GATE)

While the site is currently off-limits to the public, there is ample evidence in the form of graffiti and litter that it is visited frequently. Vandals had recently entered the site illegally and burned some of the 100-year-old wooden beams inside the entrance to one of the adits, potentially weakening the mine's supports. One mine had been used as a methamphetamine lab for a few days, until Park rangers discovered and stopped the operation. The bat gate also protects bats, including pallid and Townsend's big-eared bats, which have been found inside the abandoned mine and can hibernate or set up maternity colonies now that the human disturbance has been removed.

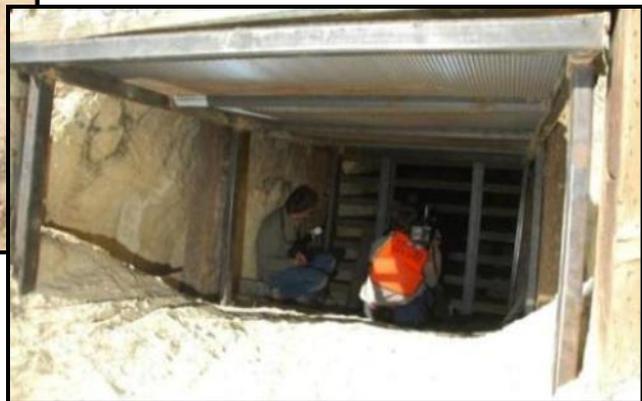
ADIT (AFTER GATE INSTALLED)

In January 2008, the AMLU and California State Parks teamed up to protect public safety by installing several bat gates on hazardous abandoned mine openings at a historically significant site that was once California's largest coal mining center. The agencies invited the media to view the closure and to highlight the site's historical value and the AMLU's "**Stay Out – Stay Alive**" message.
