Remediation

Public Safety Remediation Projects

Examples of Public Safety Remediation Projects

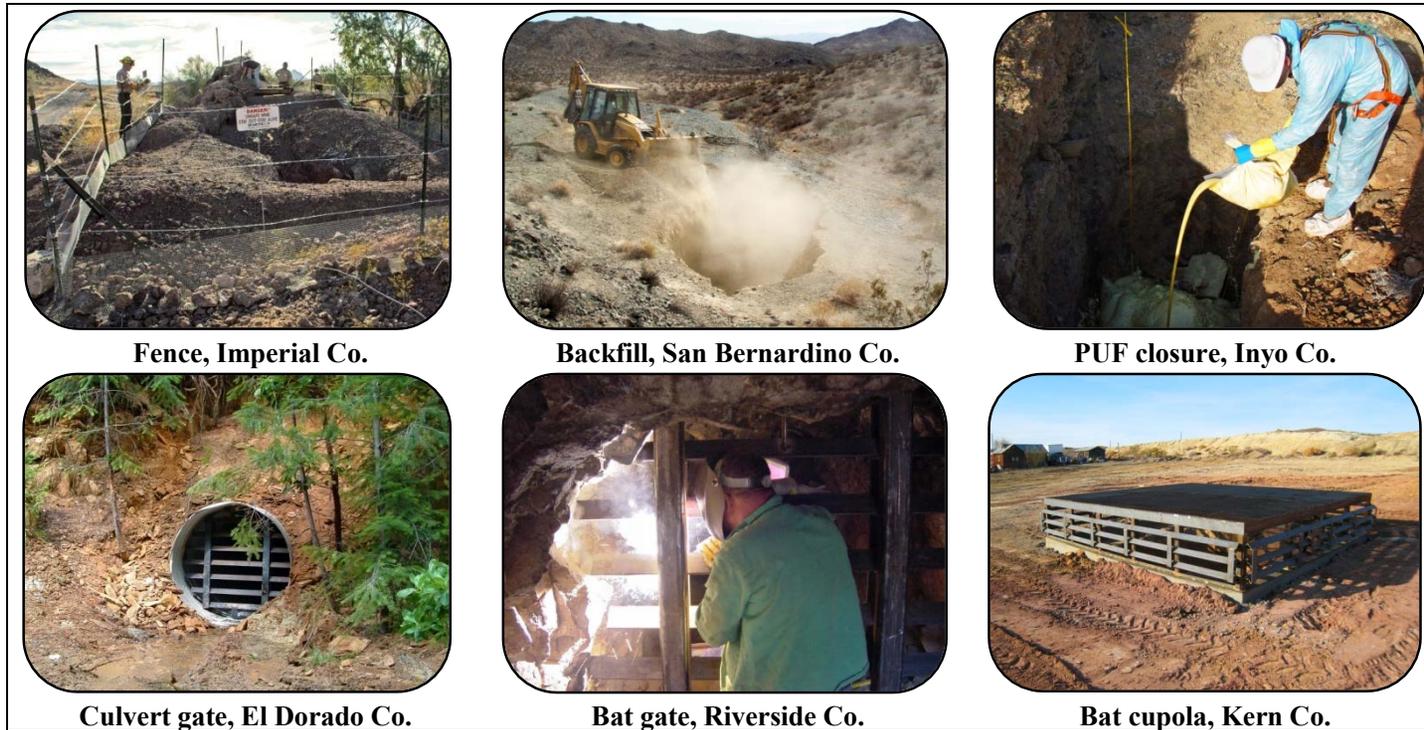
Figure 6. Examples of closure techniques for remediating hazardous mine openings.

Additional examples of safety closures from around the state include backfills, cupolas, bat gates, culverts and polyurethane foam (PUF).

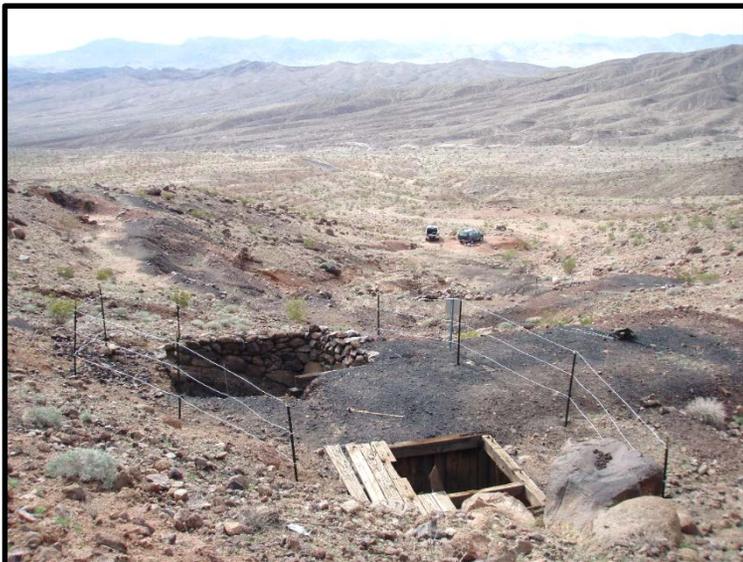
The California State Lands Commission and the Department have partnered to inventory and remediate dozens of hazardous mine openings. Photo: Jon Mistchenko, DOC (2015)

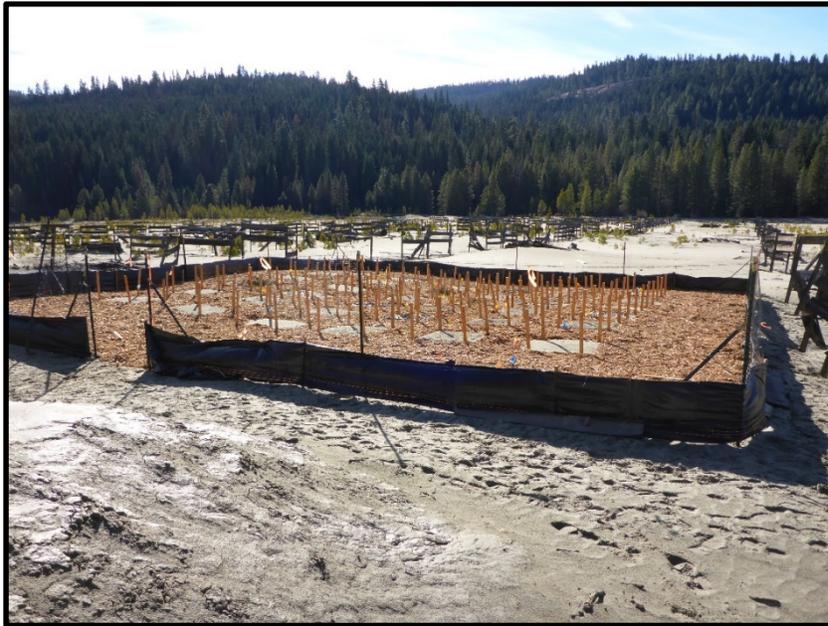
Vegetation test plot on 100-acre tailings pond at Walker Mine in Plumas National Forest in Plumas County. Photo: Sarah Reeves, DOC (2015).

Walker Mine Tailings Revegetation Study and Dust Mitigation Project - The Walker Mine Tailings, part of the 2007 priorities list, is a 100 acre mine tailings located on the Plumas National Forest, east of Quincy in Plumas County. The Walker Mine produced significant quantities of copper during its operation between 1915 and 1941. The tailings from a mill located at the mine were deposited in a drainage, filling the drainage with fine-grained, sandy, silty, and clayey tailings. Under its Comprehensive Environmental Response, Compensation, and Liability Act (CERCLA)

program, the USFS must minimize release of contaminants from the tailings adjacent Dolly Creek and Little Grizzly Creek and eliminate exposure of the public and on-site workers to fugitive silica-laden dust blown by wind from the tailings surface. OMR is performing a study of soil and vegetation conditions on the tailings in order to prepare a revegetation and mulching plan under a \$449,789 agreement with the USFS.

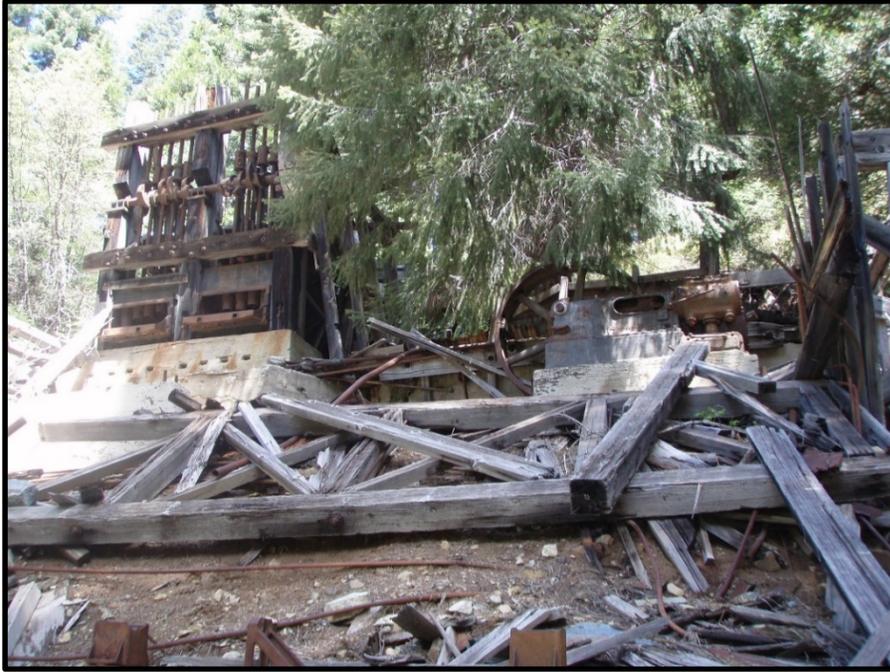
Robinson mine and stamp mill in Plumas National Forest in Plumas County. Photo: David Tibor, DOC (2014).

Robinson Mine Preliminary Assessment and Site Investigation - The Department has partnered with the USFS and obtained a \$75,000 grant from the Sierra Nevada Conservancy's Proposition 84 grant program to develop a Preliminary Assessment and Site Inspection (PA/SI) for the historic abandoned Robinson Mine and stamp mill, a mine on the 2007 priorities list. The Robinson Mine is located in the Plumas National Forest, southwest of Quincy in Plumas County,

California. The mine site is immediately adjacent to Frazier Creek, which is located in the Middle Fork Feather River watershed. The Robinson Mine site is being remediated by USFS under its CERCLA program due to contamination from mercury used at the mill to extract gold. If contamination levels indicate the need, an Engineering Evaluation / Cost Assessment will also be completed, with additional funding from USFS and Office of Mine Reclamation. Environmental sampling of the site was completed in fall 2015.

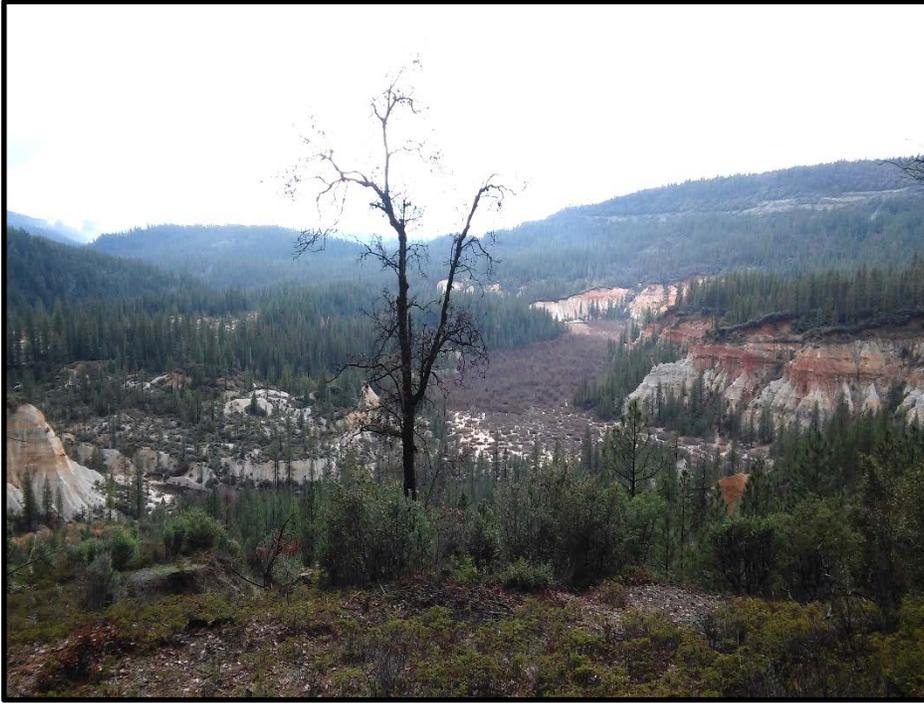
Mercury-laden sediment discharges from massive hydraulic gold mine in Malakoff Diggins State Historic Park. Photo: Jon Mistchenko, DOC, (2014).

Malakoff Diggins State Park and Humbug Creek Watershed - The AMLP is assisting Malakoff Diggins State historic Park, located in Nevada County, with the Malakoff Diggins Hydraulic Mine Feasibility Study¹, led by The Sierra Fund and a multi-agency project team. AMLP is directly assisting the Park with evaluating visitor protection at several deep shafts along a heavily used park trail and contributed data to the sediment erosion study for the park's primary hydraulic mine pit. AMLP used \$28,000 from the AMRMF to provide the aerial LiDAR map of the main hydraulic pit

and Humbug Creek watershed, which will be used along with ground-based LiDAR (performed by the U.S. Geological Survey) to measure erosion rates and sediment sources in and around the main hydraulic pit. AMLP staff are evaluating ways to improve visitor safety around the shafts along the major drain tunnel that can discharge mercury-laden sediment directly into Humbug Creek, a tributary to the South Yuba River. Most of the shafts are located directly adjacent to the visitor trail. Some are flooded or have failing fencing, and one shaft drains water across and down a segment of the trail, which makes the trail muddy and unsafe for park visitors. The park is making a new trail design to relocate this trail segment with funding assistance from AMLP and reviewing a remediation proposal from an AMLP contractor to address the shafts and discharge opening of the drain tunnel.

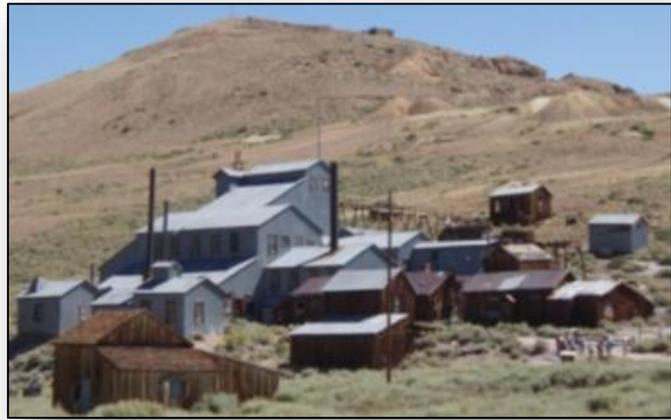
Bodie State Historic Park (SHP) - In the late 1800s to early 1900s, the town of Bodie in Mono County was part of a major gold mining district. In 1962, the town and adjacent area became Bodie SHP, which is owned and managed by the Department of Parks and Recreation (State Parks). The park is preserved in a state of “arrested decay,” and a critical priority for State Parks is to maintain the appearance and historical setting of mining, including structures, artifacts, tailings, and other cultural resources. As a consequence of mining and gold processing, however, Bodie was contaminated by lead (used in the assay process, which allows for measuring the amount of gold in an ore sample), mercury (used as amalgamate with gold to enhance recovery), and arsenic (commonly associated with gold deposits and occurring naturally in the area).

In 2007, the Department, using funds appropriated by the State Legislature to “remediate specified chemical hazards” (Assembly Bill 1801, Item 3480-001-0035, 2006), partnered with State Parks and a U.S. Environmental Protection Agency Region 9 Emergency Response Section (USEPA) team to investigate, characterize, and remediate chemical hazards at Bodie SHP generated by historic mining activities. The USEPA’s sampling and remediation procedures were designed to fully characterize and remediate contaminants and protect human health, while project activities were reviewed and monitored by park archaeologists to preserve cultural resources and artifacts. The project, completed in 2009, included the following tasks.

- Installed a modified radon extraction system to reduce mercury vapor concentrations inside the Standard Mill and remediated lead-contaminated soil on slope below the Mill (placed filter fabric and clean fill, revegetated slope, and installed fences to reduce disturbance).
- Remediated lead-contaminated soil from Assay building areas (removed top foot of soil in and around buildings; replaced soil with clean fill).
- Removed lead contaminated dust in Wheaton-Hollis Hotel using a HEPA vacuum.
- Controlled erosion of mine tailings adjacent to Bodie Creek by building a diversion channel lined with rocks collected onsite to carry runoff away from the tailings, by constructing weirs to slow stream flows, and by composting and revegetating the tailings to promote native plant growth.

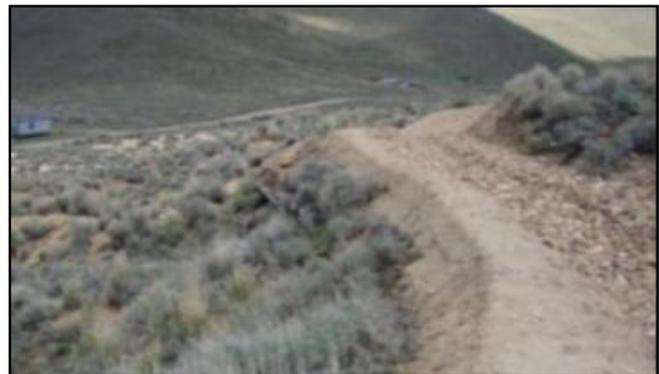
A lined diversion ditch (right side of photo) prevents runoff from eroding mine tailings. Photo: Greg Marquis, DOC, (2009).

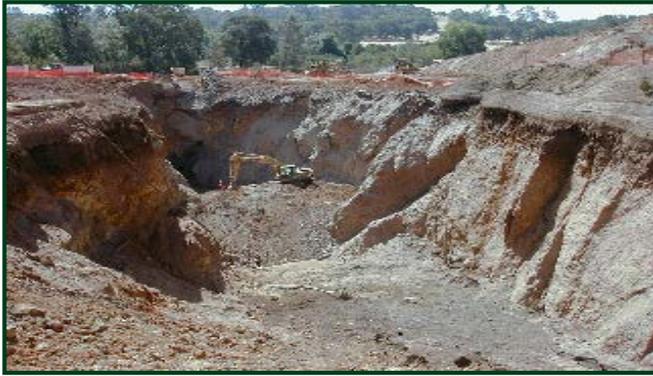
Open mine pit drained acidic water into Little Dry Creek. Photo: DOC (2001).

Spenceville Mine Acid Mine Drainage and Pit Reclamation Project - Spenceville Mine was a copper mine that operated from 1875 through 1918 in Nevada County. Problems with the abandoned open-pit mine included acid mine drainage (AMD) and the forming of an open pit lake in the abandoned mine workings. The mine water had a pH of about 2.5 with elevated levels of iron, copper, and zinc. During high precipitation, water from the pit overflowed into Little Dry Creek, which is under the jurisdiction of the Department of Fish and Wildlife (CDFW). Under contract with CDFW, the Department developed a strategy to mitigate the AMD and reclaim the mine site to a safe and stable condition. The Department's objective was to identify and select a low-cost, low-maintenance treatment strategy that would: (1) prevent future discharges to state waters by cleaning up and containing AMD and associated heavy metal problems onsite; (2) provide a stabilizing vegetative cover; and (3) meet Central Valley Regional Water Quality Control Board (RWQCB) requirements. The Department's

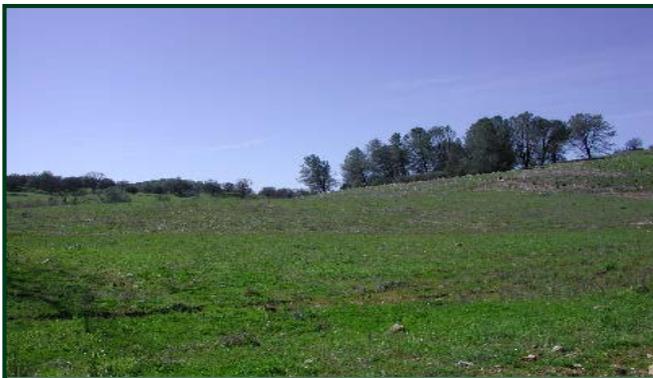
Treated mine waste was used to backfill the pit, and then the site was recontoured, covered with topsoil and revegetated. Photo: DOC (2004).

- **Phase 1.** Evaluate existing site conditions and the adequacy of existing information on the site contained in previous studies. Gather additional site data, as needed.
- **Phase 2.** Multiple tasks, including: evaluate alternative control strategies; conduct a feasibility study; develop conceptual design criteria for alternative strategies; estimate capital, operating, and maintenance costs for the proposed alternatives; select an abatement and remedial strategy based on the feasibility study and testing; and prepare a preliminary design report for the recommended source control and cleanup alternative.
- **Phase 3.** Develop biddable plans and specifications for the selected strategy.

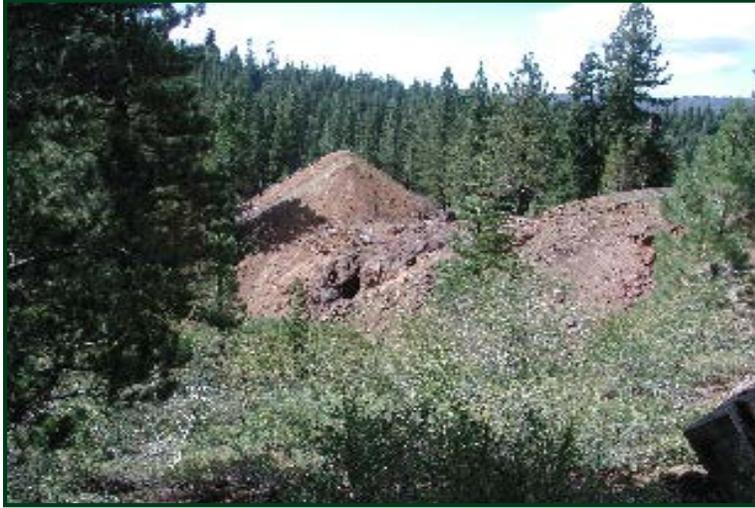
Ore and waste rock piled adjacent to mine pit. Walker mine. Photo: Jon Mistchenko, DOC (2003).

Walker Mine Pit Backfill Project - The Walker Mine pit backfill project was part of an effort by the Central Valley RWQCB to mitigate water quality impacts of this abandoned Plumas County copper mine. Previous RWQCB efforts included construction in the 1980s of a concrete seal near the mill site to stop discharges of acidic waters into an adjacent creek and the construction in the 1990s of drainage channels to capture and redirect runoff away from pits connected to underground workings. In 2003, the RWQCB

contracted with the Department to conduct site-specific studies to evaluate the potential impacts of backfilling the pits and modifying channels where adjacent springs were not fully captured. The Department conducted field and office studies throughout 2003 and 2004, prepared plans and contract documents to implement a pit backfilling and channel modifications project, and prepared a final report that presented the findings and recommendations from its investigations.

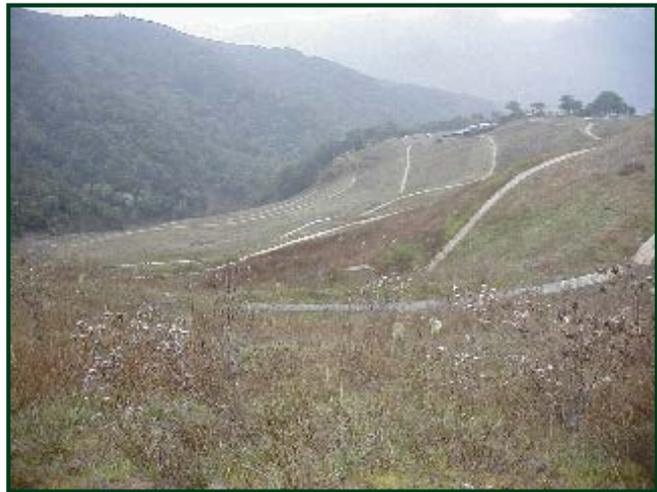
Final grade with drainage ditches and native vegetation. Gambonini Mine. Photo: DOC (2005).

Gambonini Mercury Mine - During historic mining at the Gambonini Mercury Mine, located in Marin County, mine wastes were placed in a steep canyon covering an area of about 11 acres. Consequently, large quantities of mercury-laden sediment would discharge each year into Salmon Creek—a tributary to Walker Creek and Tomales Bay. Threats to the beneficial uses of these waters included degradation of fish spawning areas in Walker Creek and bioaccumulation of mercury by wildlife and fish in Tomales Bay. Under contract with the San Francisco Bay RWQCB, the Department provided revegetation, erosion, and construction monitoring, and consulted on creek remediation options.

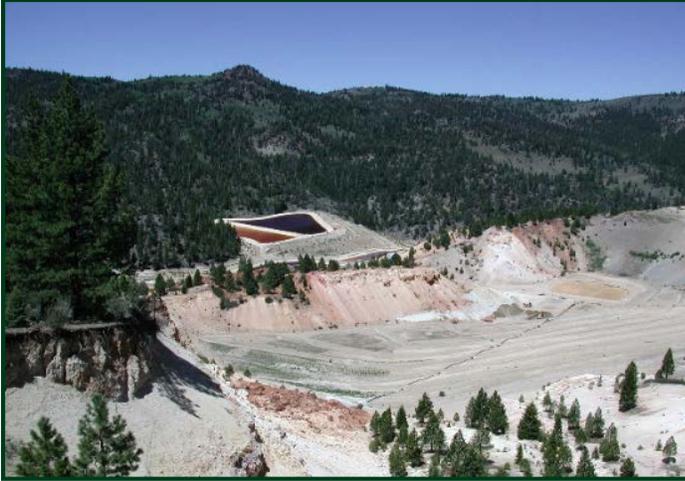
Settling ponds and pit showing test plots and drainage ditches. Leviathan Mine. Photo: DOC (2002).

Leviathan Mine - Leviathan Mine is an abandoned open-pit mine in Alpine County, high on the eastern slope of the Sierra Nevada southeast of Lake Tahoe that was placed on the USEPA National Priority List (Superfund) in May 2000. The Toiyabe National Forest surrounds the site. Although some mining for copper minerals took place onsite since the 1860s, major environmental problems originated during the open-pit sulfur mining that occurred from 1951 through 1962. Several hundred acres of eroding disturbance remain at the mine as a consequence of the historic mining operations. This disturbance consists of

the open pit, overburden, and mining waste piles. Barren conditions of the site have increased AMD generation, pollutant transport, and slope instability resulting in discharges to Leviathan and Aspen Creeks of low pH AMD containing high concentrations of dissolved sulfate, arsenic, nickel, aluminum and iron. Under contract with the Lahontan RWQCB, the Department performed geophysical surveys, revegetation monitoring, and provided botanical expertise for revegetation and weed control strategies. C

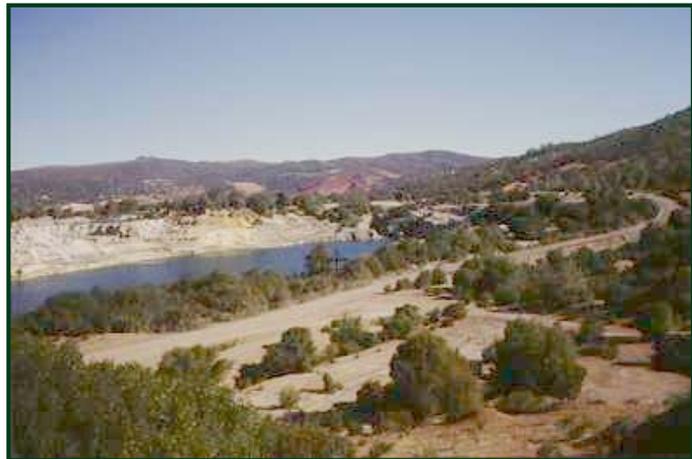
Harmon Impoundment and mine waste at Sulphur Bank Mine. Photo: DOC (1999).

Sulphur Bank Mercury Mine - Sulphur Bank Mercury Mine, once one of the largest producers of mercury in California, was initially mined for sulfur from 1865 to 1871. Mercury ore was mined intermittently by underground methods from 1873 to 1905. The site periodically was opened for pit mining from 1915 to 1957, when it became inactive. Approximately 120 acres of mine tailings and waste rock and an open, unlined mine pit (called the Herman Impoundment) were located on the property. After mercury was found in the tailings and bottom sediments in

Clear Lake, and high levels of mercury were detected in fish from the lake, the State issued an advisory against eating fish from the lake. Under contract with the USEPA, the Department performed statistical analyses of data, revegetation monitoring, and provided botanical expertise for revegetation and weed control strategies.
