## ANALYSIS OF RECORDS FROM FOUR BASE-ISOLATED BUILDINGS DURING THE 1992 LANDERS EARTHQUAKE

M. J. Huang<sup>1</sup>, P. K. Malhotra<sup>1</sup> and A. F. Shakal<sup>1</sup>

FIFTH U.S. NATIONAL  
CONFERENCE  
ON  
EARTHQUAKE  
ENGINEERING

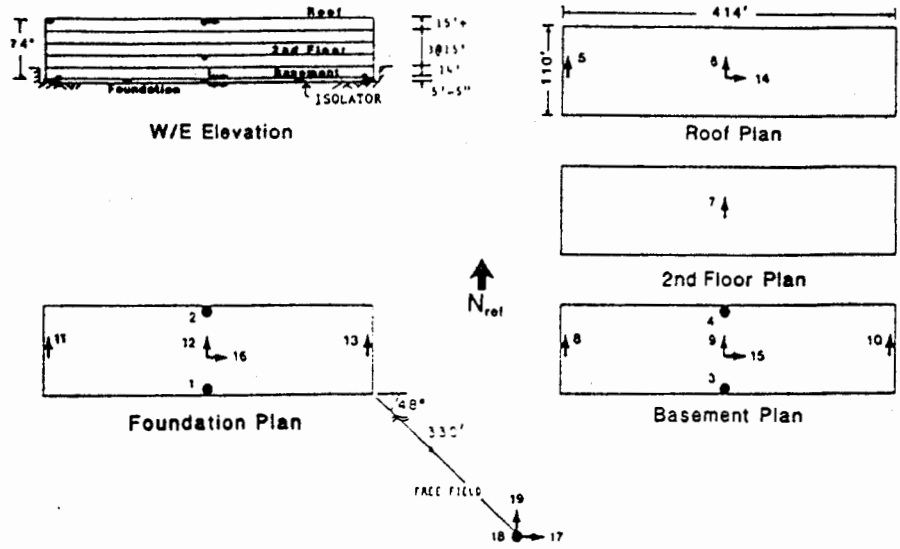
Fig. 1. Locations of accelerometers in San Bernardino County's Rancho Cucamonga Law and Justice Building.

The San Bernardino County Law and Justice building in Rancho Cucamonga is a 5-story structure and is the first building constructed using a base-isolation system in the United States. The building is 414 by 110 feet in plan and 74 feet. The lateral force-resisting system of the superstructure consists of 4-story braced steel frames in the upper four stories and concrete shear walls in the basement. The structure is isolated by high-damping rubber bearings placed on the foundation under each of the 98 columns. More detailed information on the base isolation system used in this building is given in Tarics et al.(1984). The building was instrumented by CSMIP in 1985 with 16 accelerometers in the building and three at a reference free-field site. The locations of the accelerometers are shown schematically in Figure 1.

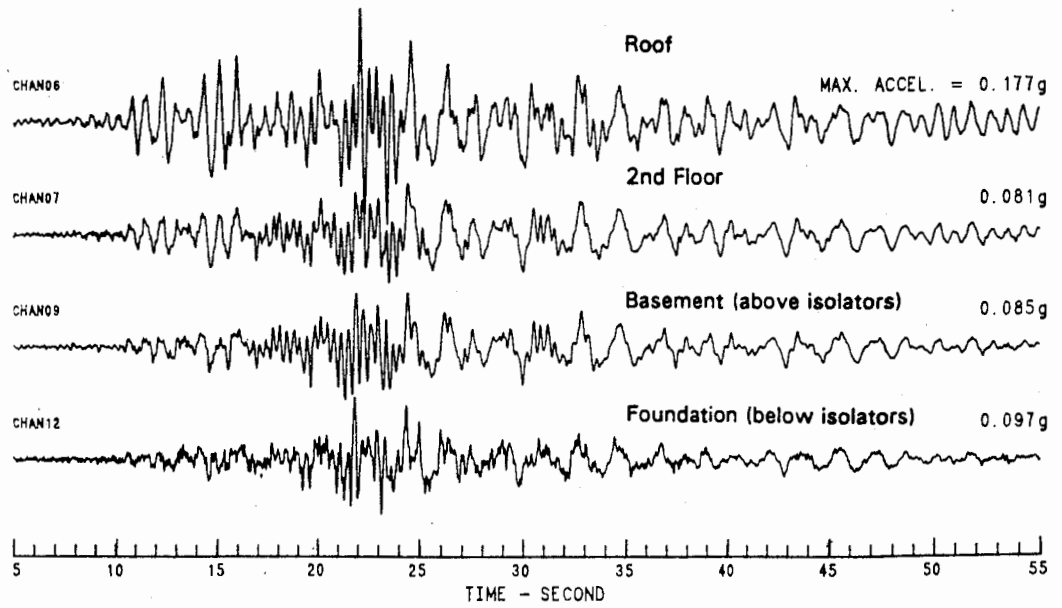
Fig. 2. Acceleration records in the transverse direction obtained at the Rancho Cucamonga Law & Justice Bldg. during the 1992 Landers earthquake.

The acceleration records obtained from four base-isolated buildings during the 1992 Landers earthquake are included in the CSMIP data report by Shakal et al.(1992). Portions of the acceleration records from selected sensors in the transverse direction are shown in Figure 2 for the Rancho Cucamonga Building and Figure 4 for the Fire Command Building. Similarly, Figure 6 shows records for the University Hospital and Figure 8 for the Seal Beach Office Building.

Comparison of the acceleration across the isolators for each building shows that relatively high frequency horizontal motions were filtered out by the isolators. Significant amplifications of the motions from the base of the superstructure to the roof can be seen in all except in the Fire Command Building. As shown in Figure 4, the motions at the roof, the 2nd floor level and the base of the Fire Command Building are almost identical, which indicates that the building superstructure responded like a rigid body above the isolators.

Differencing the records from a pair of parallel horizontal sensors on the same floor allows estimation of the torsional motion at the floor. The results show that significant torsional motions occurred at the Rancho Cucamonga Building. On the other hand, rigid body rotation of the entire superstructure above the isolators, which does not cause torsional deformation of the superstructure, is significant for the Fire Command Building.

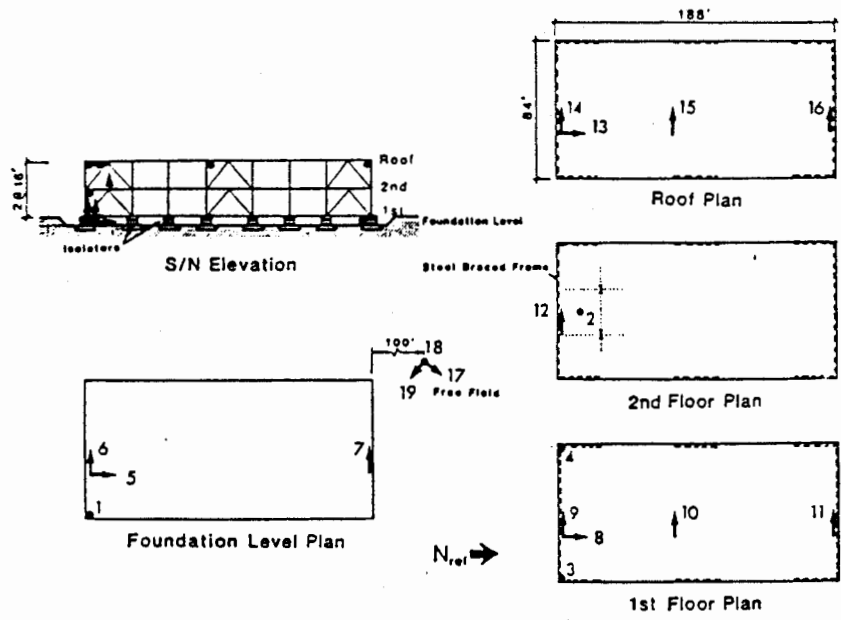
Fig. 3. Locations of accelerometers in the Los Angeles County Fire Control and Command Building.

The Los Angeles County Fire Department's Fire Command and Control Building is a base-isolated 2-story structure which has a plan dimension of 188 by 84 feet. The lateral force-resisting system consists of perimeter braced steel frames supported by high-damping rubber bearings under all 32 columns. The isolators have a restraint system to control the uplift and the horizontal displacement across the bearings. Detailed information on the building is given in Bachman et al.(1990) and Anderson(1990). The building was instrumented by CSMIP in 1990 with 16 sensors in the building and three at a reference free-field site. The locations of the sensors are shown schematically in Figure 3.

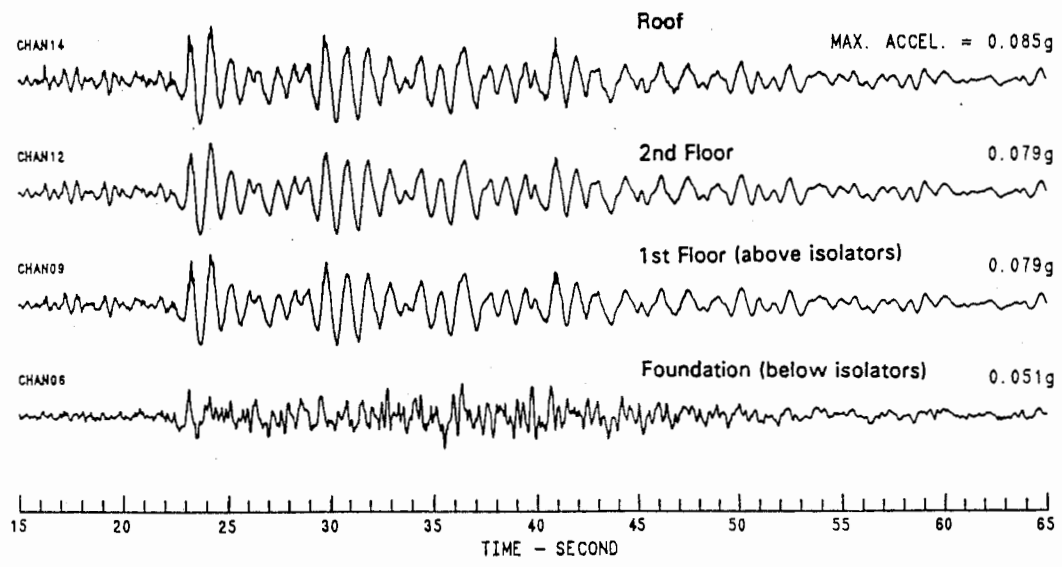
Fig. 4. Acceleration records in the transverse direction obtained at the Los Angeles County Fire Command Bldg. during the 1992 Landers earthquake.

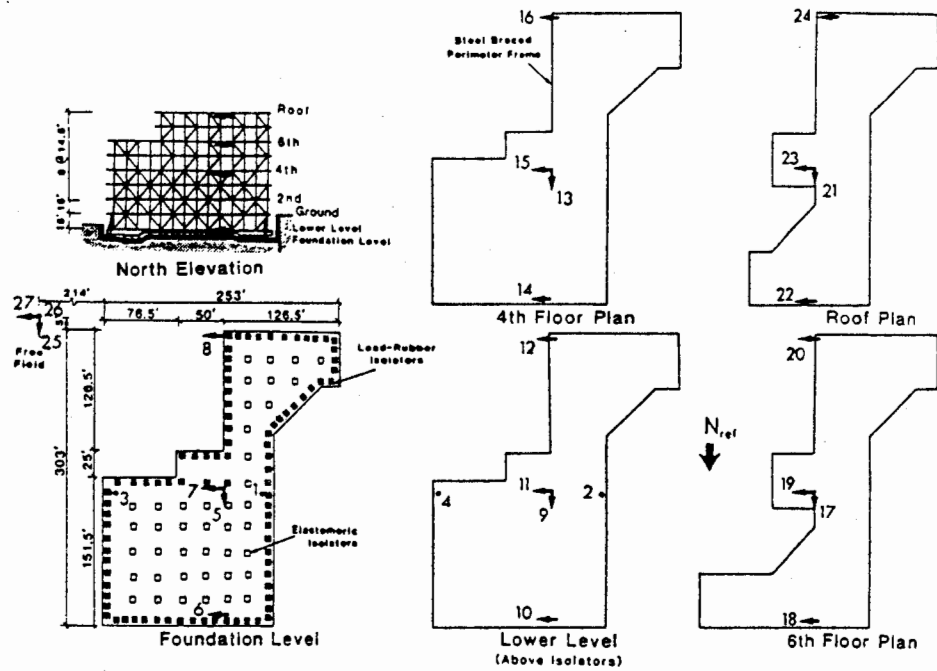
Fig. 5. Locations of accelerometers in the Los Angeles University Hospital Building.

The USC University Hospital is a 7-story steel braced frame building with a 1-story basement. The floor plan is quite irregular and has two wings connected by a narrow section. The seismic isolation system consists of 68 lead rubber bearings and 81 high-damping rubber bearings. Most of the lead rubber isolators are located under the perimeter frame. Detailed information on the building is given in Asher et al.(1990). The building was instrumented with assistance from CSMIP in 1991. The locations of the 24 accelerometers in the building and three at a reference free-field site are shown in Figure 5.

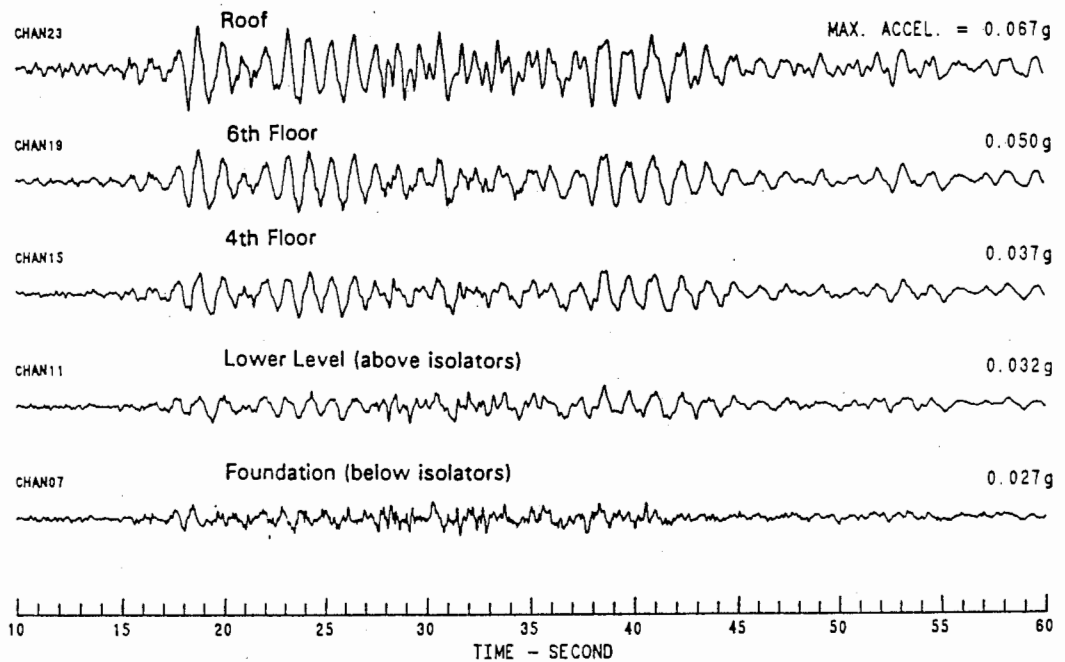
Fig. 6. Acceleration records in the transverse direction obtained at the Los Angeles University Hospital Bldg. during the 1992 Landers earthquake.

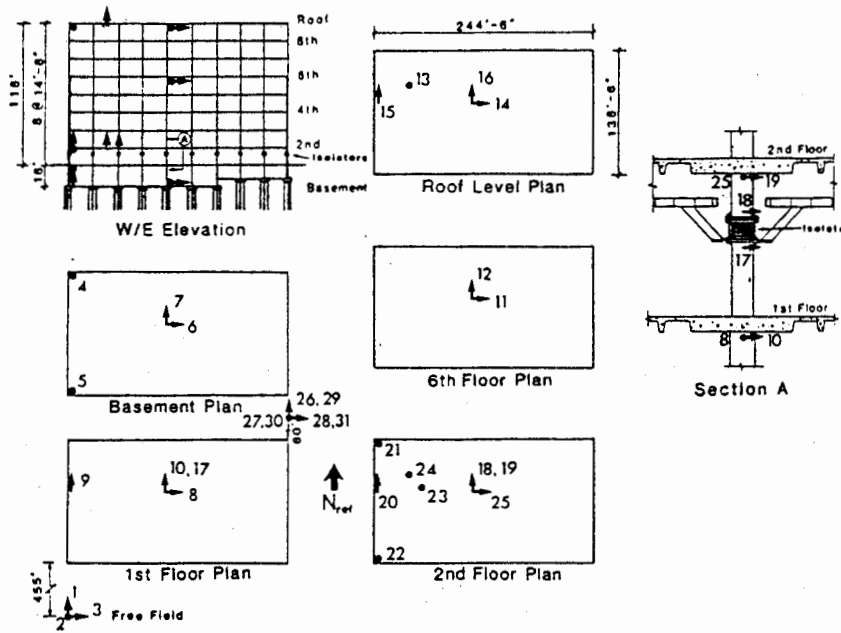
Fig. 7. Locations of accelerometers in the Seal Beach Office Building.

instrumented by CSMIP before and after the seismic strengthening was completed in 1991. The locations of the 22 accelerometers in the building and 9 outside the building are shown in Figure 7.

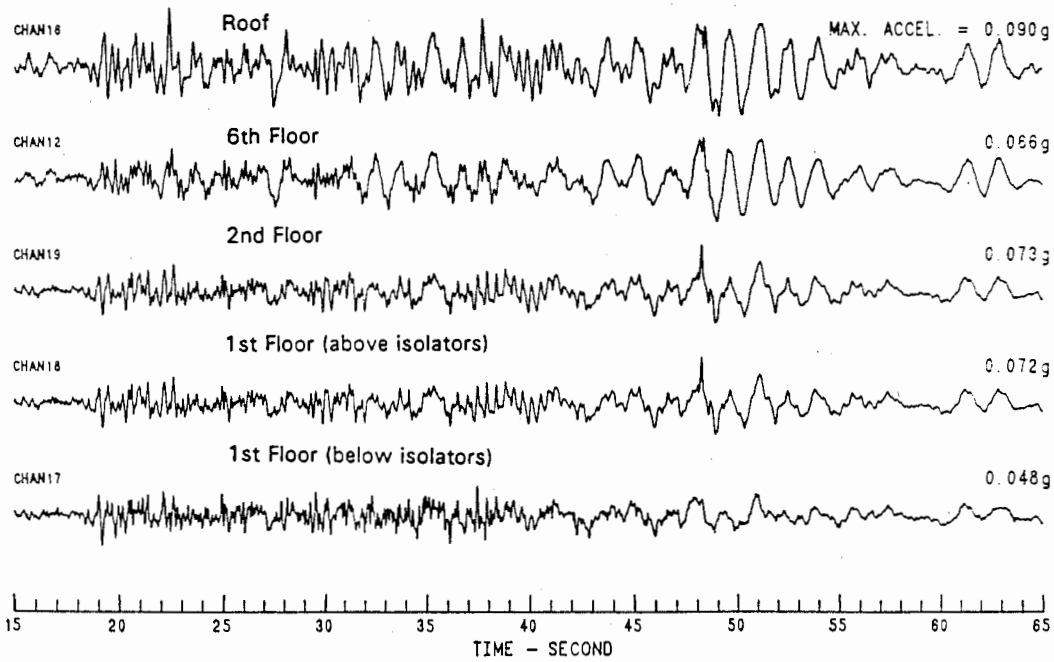
Fig. 8. Acceleration records in the transverse direction obtained at the Seal Beach Office Bldg. during the 1992 Landers earthquake.

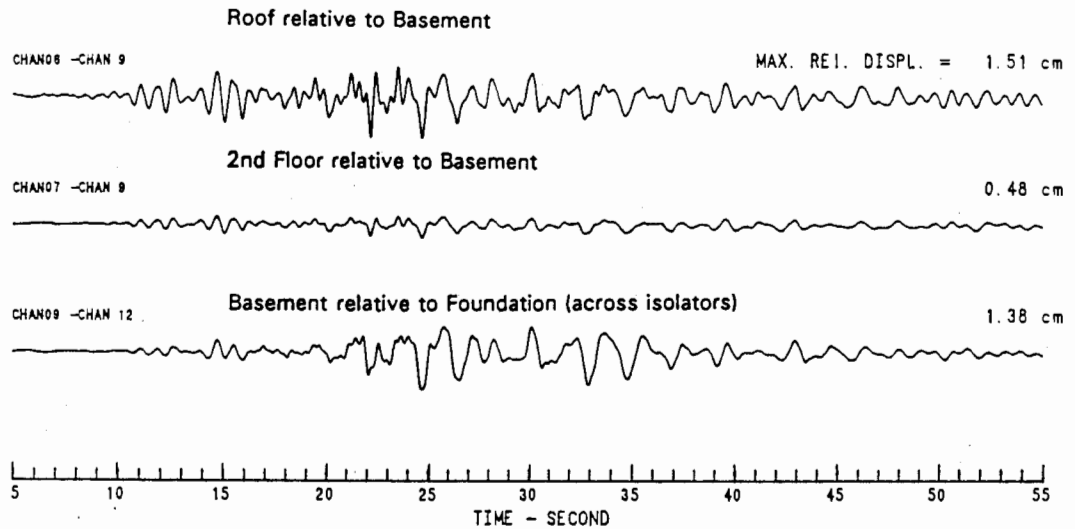
Fig. 9. Relative displacements in the transverse direction at the Rancho Cucamonga Law & Justice Bldg. during the 1992 Landers earthquake.

To show the drift of the superstructure, the computed displacements of the upper floors relative to the base (above the isolators) are plotted in Figures 9 through 12. The deformation of the isolators for each building is shown by the displacement of the base relative to the foundation, also plotted in these figures. The deformation of the isolators ranges from 0.8 to 1.6 cm, which is much smaller than the design value that ranges from 25 to 40 cm. As shown in Figure 10, the superstructure of the Fire Command Building had negligible drift and most deformation occurred at the isolators. In other words, the superstructure of the Fire Command Building responded as a rigid body although the isolator deformations were much smaller than the design values.

Periods of the fundamental mode are estimated from the relative displacements in Figures 9 through 12 and are compared with the periods for the fixed-base structure (without isolators). The periods of all four buildings during the Landers earthquake are only slightly larger than the fixed-base periods. This is expected since the deformations of the isolators were much smaller than the design values.

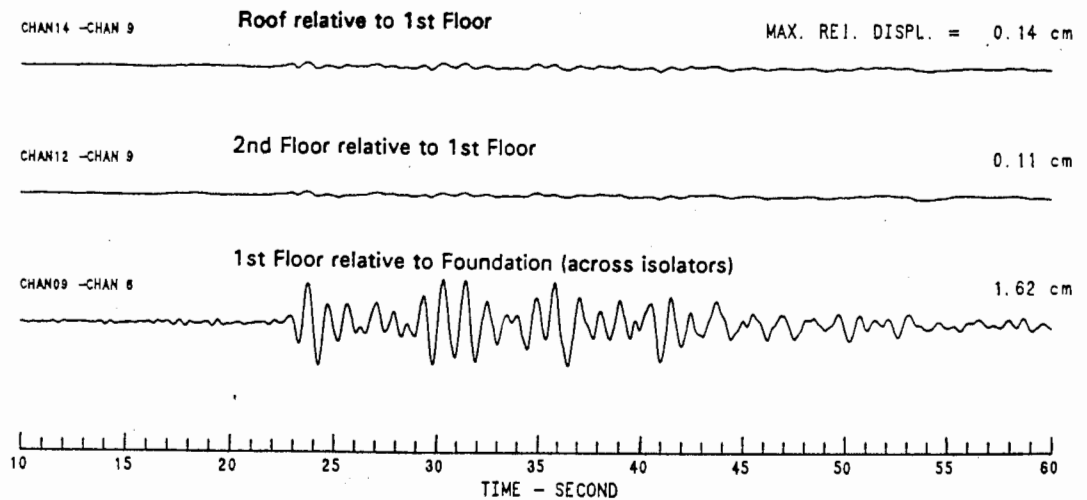
Fig. 10. Relative displacements in the transverse direction at the Los Angeles County Fire Command Bldg. during the 1992 Landers earthquake.

The hysteretic response of the isolators at the Fire Command Building can be investigated from the lateral force versus relative displacement diagram. Since the building responded as a rigid body, the lateral force (or the base shear) experienced by the isolator is proportional to the acceleration recorded by Sensor 9, directly above the isolator. The equivalent viscous damping ratio estimated from the hysteresis loop corresponding to large motion in the record is about 10%.

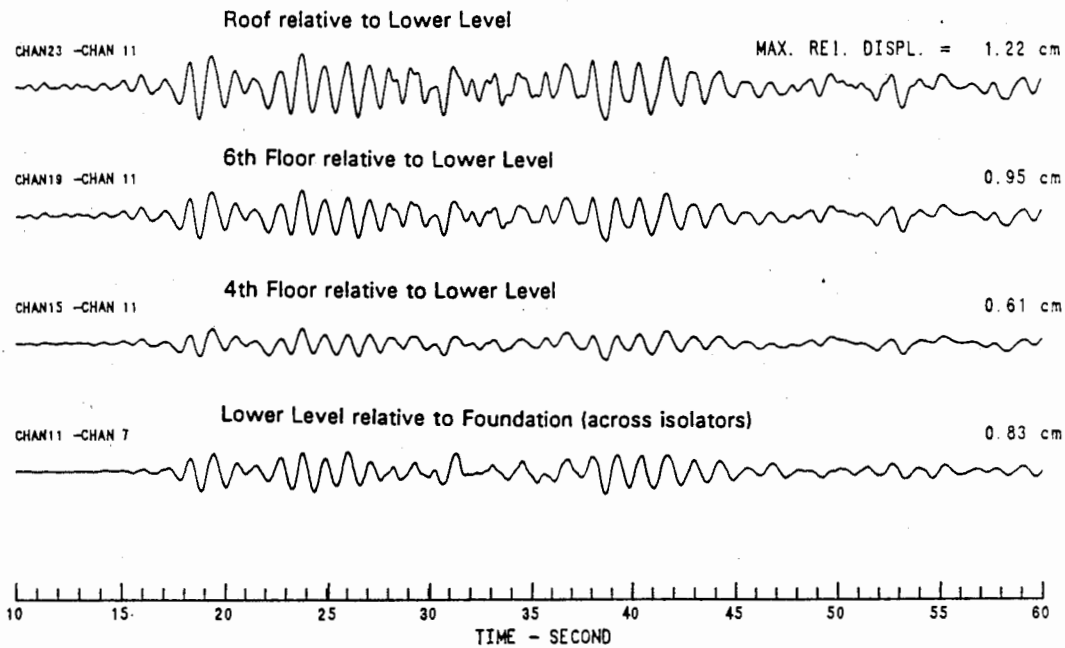
Fig. 11. Relative displacements in the transverse direction at the Los Angeles University Hospital Bldg. during the 1992 Landers earthquake.

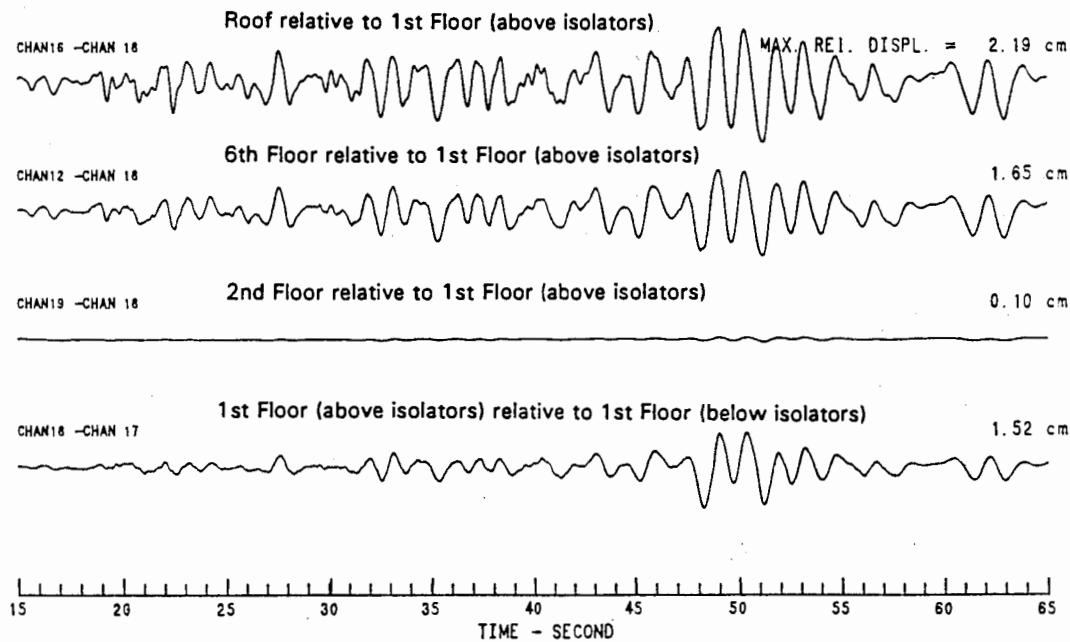
Fig. 12. Relative displacements in the transverse direction at the Seal Beach Office Bldg. during the 1992 Landers earthquake.
