A Model For Re-“Mediation”: Balancing Historic Preservation And Environmental Remediation At Bodie State Historic Park

AML Forum Meeting
Sacramento, California
June 3, 2009 (UPDATED)

Greg Marquis & Cy Oggins
California Department of Conservation
Abandoned Mine Lands Unit (AMLU)

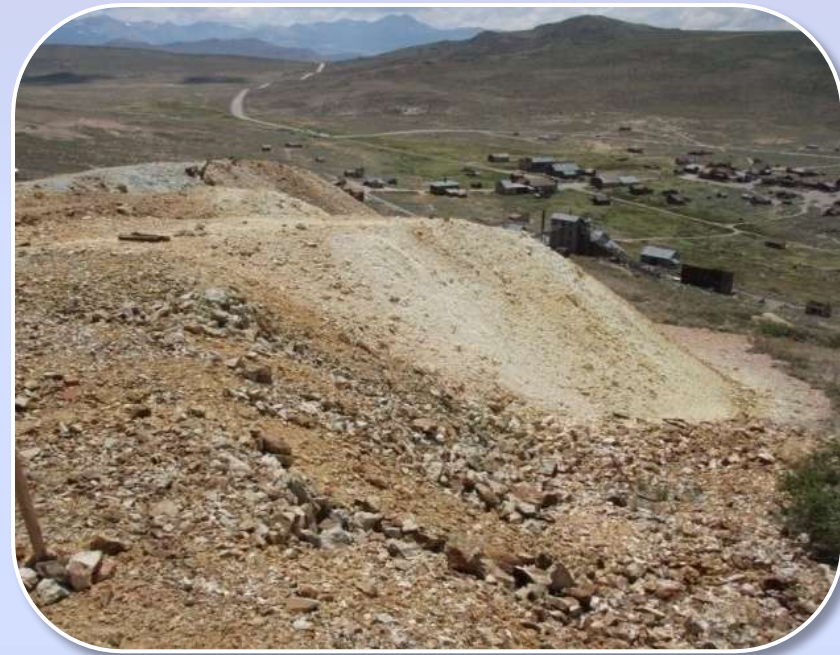
Waste pile at Bodie
(town in background)

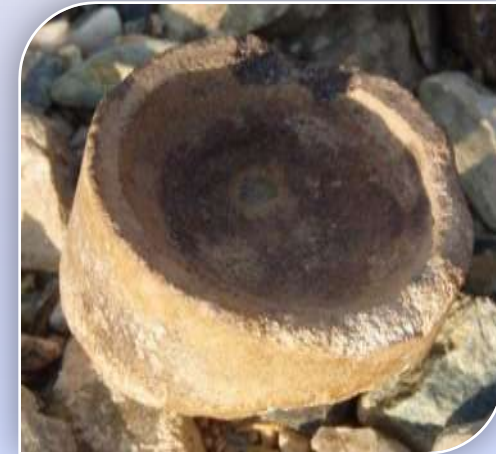
Cupel

- **Mercury (Hg)** from ore processing.
 - Elemental form in tailings piles.
 - Vapor form within the Standard Mill building.
- **Lead (Pb)** from the assay process (used to determine the amount of gold and silver in ore).
 - In sediment and dust near assay areas.
 - In cupels (absorbed lead oxide).
- **Arsenic (As)** associated with gold-rich mineral deposits.
- **PCBs** in transformers in Wheaton-Hollis Hotel.

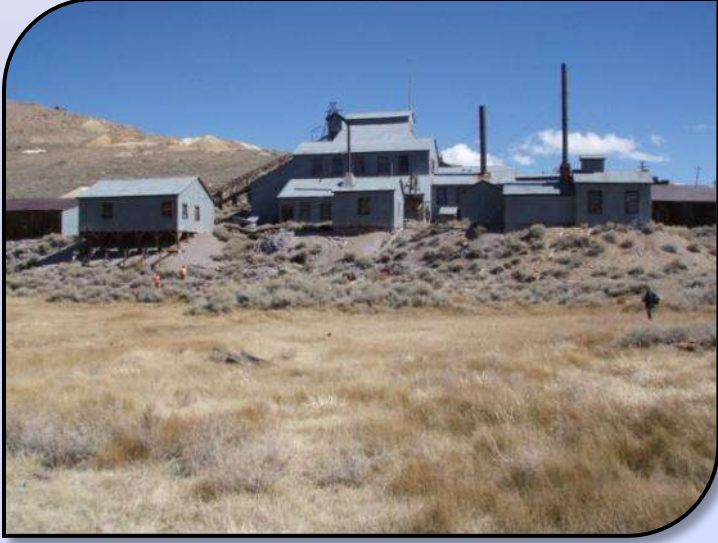
Standard Mill
(inside & slope)

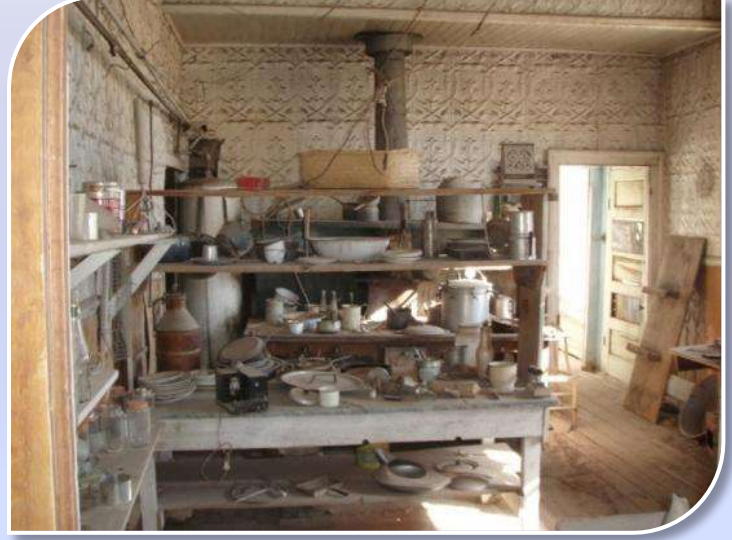
Wheaton-Hollis Hotel

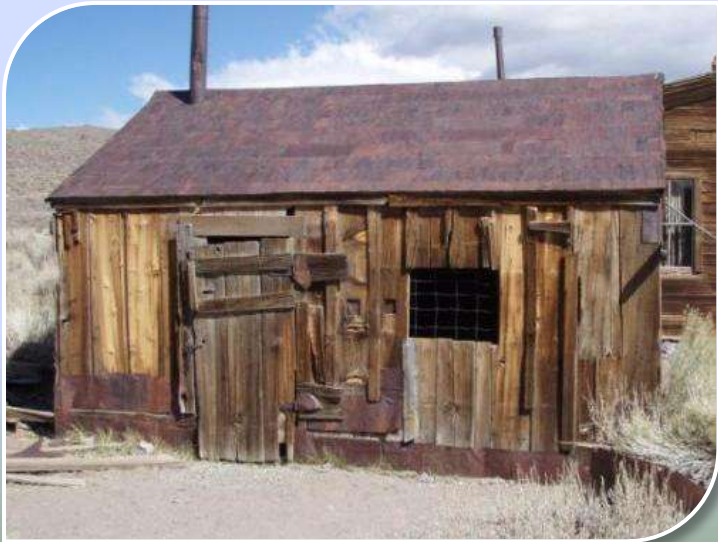
Assay Buildings

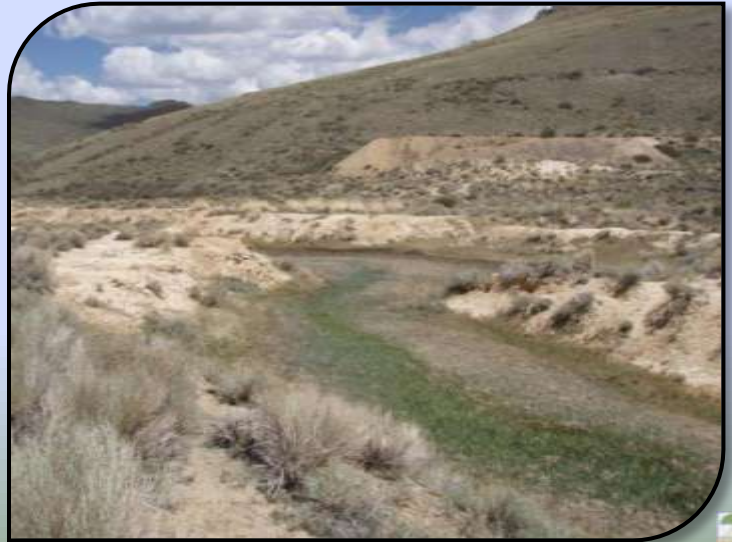
Tailings

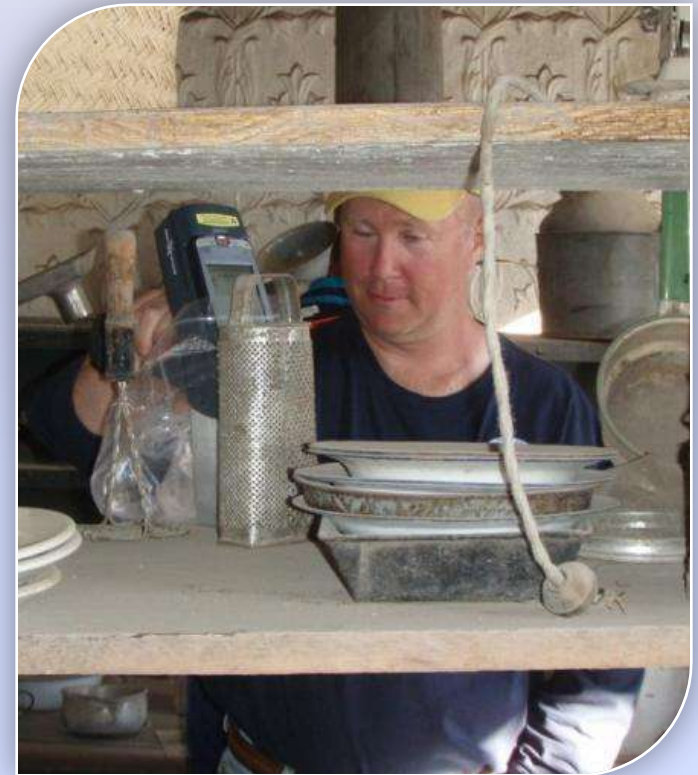
Using an XRF on dust in the Wheaton-Hollis Hotel kitchen

- Elevated **Pb**.
 - In dust in Wheaton-Hollis Hotel (up to 17,800 micrograms/wipe).
 - In and around Bell & Rose Klyps Assay buildings (>550 ppm lead action level, up to 4,560 ppm at Bell Assay).
 - On slope below Standard Mill (> 550 ppm action level).
- Elevated **Hg** vapor concentration inside Standard Mill (>1,000 nanograms/meter³ action level).
 - Major source of mercury vapor from the basement.
- Elevated **Hg** and **As** in tailings adjacent to Bodie Creek (up to 168 ppm As and 77.8 ppm Hg).
- Small amount of **PCBs** found in one transformer (transformers were previously drained).

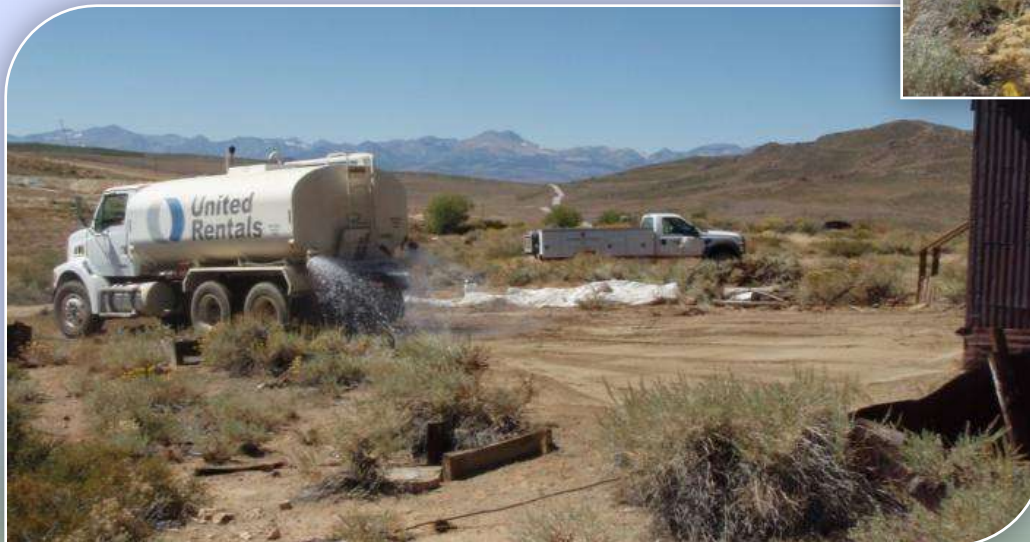
Placement of clean fill
surrounding Rose Klyps
Assay building

- Removal of top one foot of soil.
- Placement of filter fabric.
- Placement of clean fill.
- Replacement of artifacts (where required).

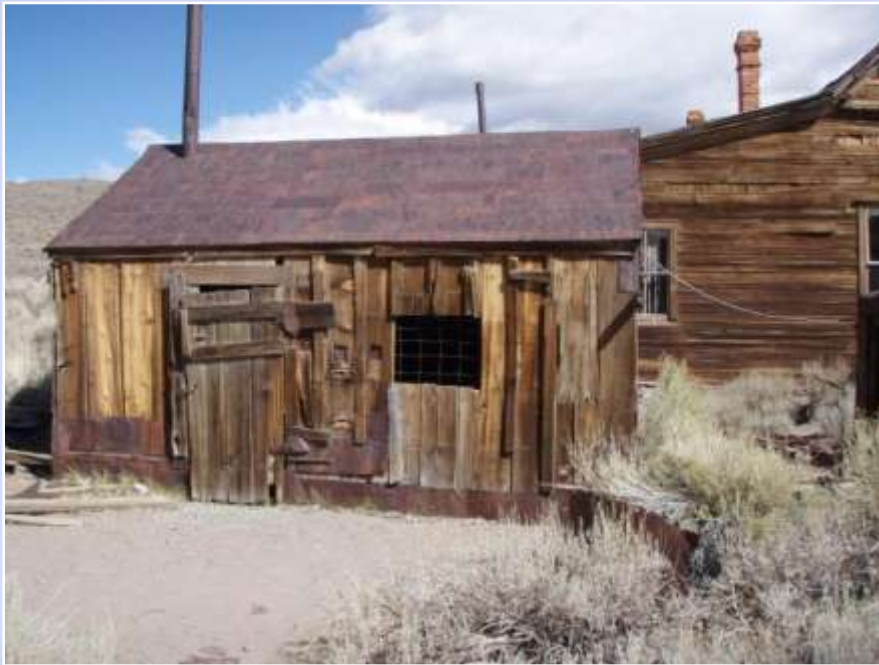
Before: Bell Assay in October 2007

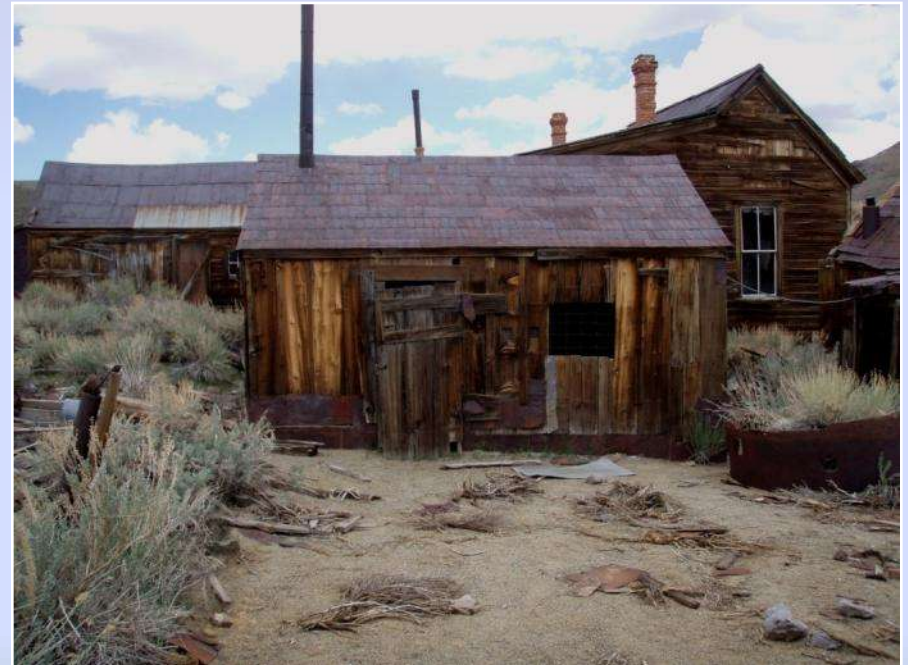
After: Bell Assay in May 2009

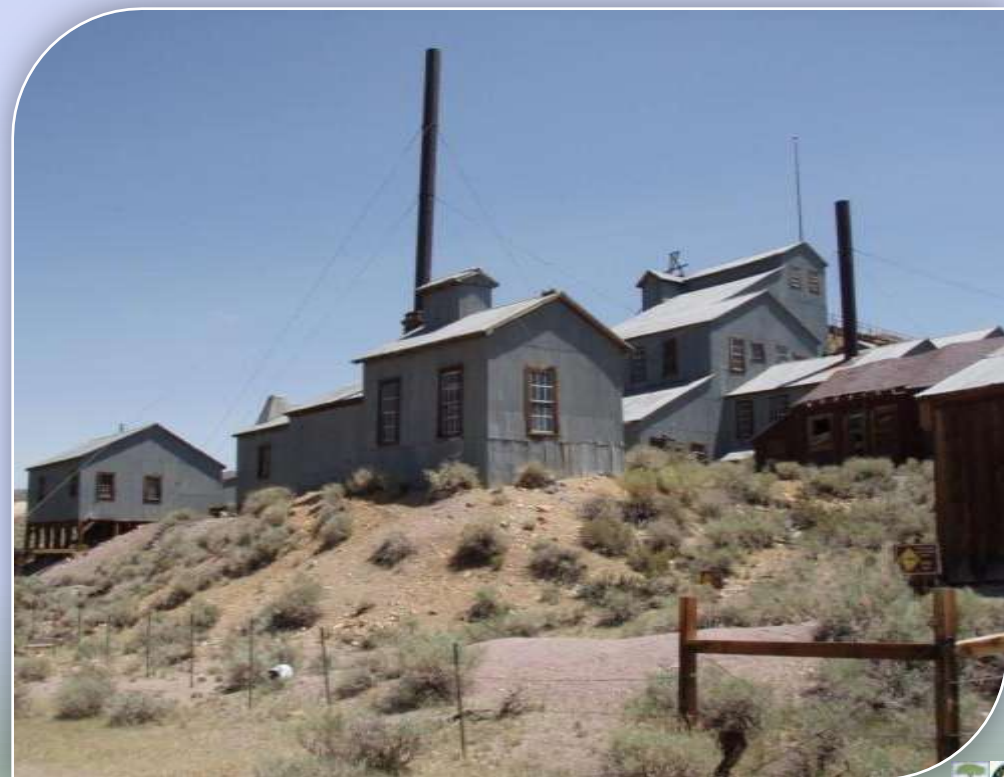
- Modified Radon Extraction System.
 - Mill basement vapor barrier liner
 - Fans to remove vapors from basement
 - Expulsion of vapors through existing smokestacks

- Placement of filter fabric.
- Placement of minimum of one foot of clean fill.
- Revegetation.
- Fencing.

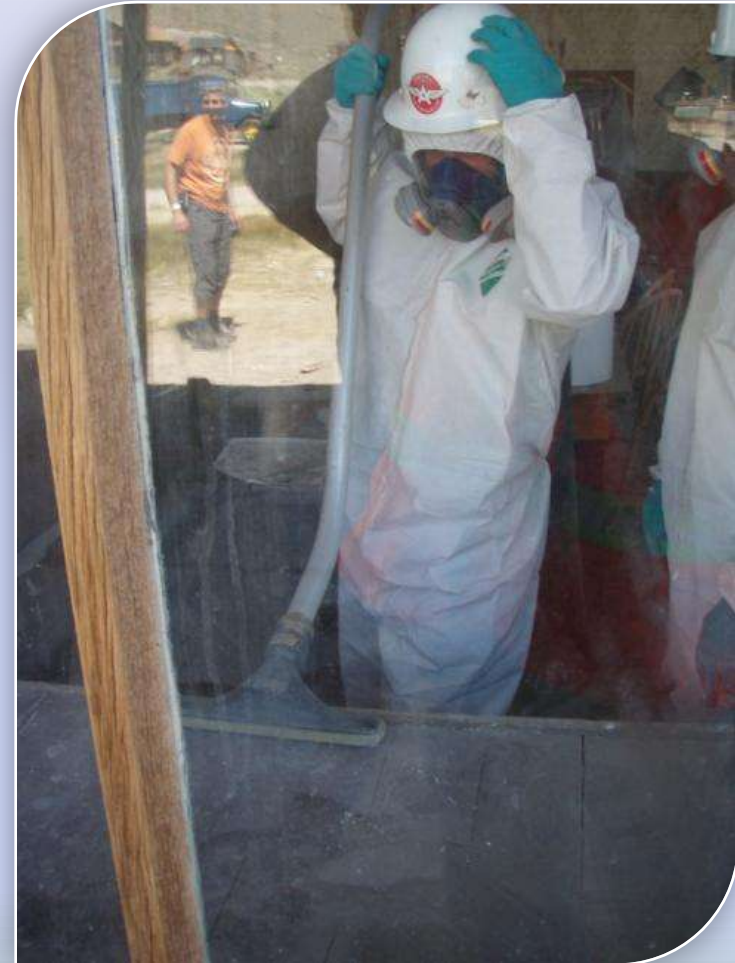
HEPA vacuuming inside
Wheaton-Hollis Hotel

- HEPA vacuum dust removal.
- Institutional controls.

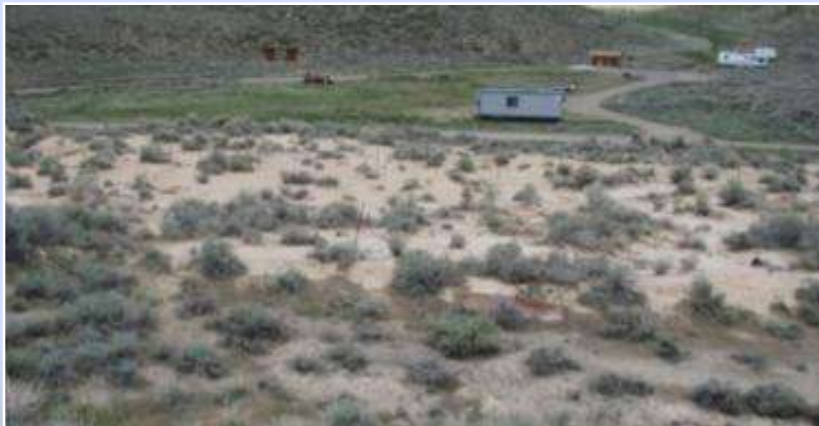
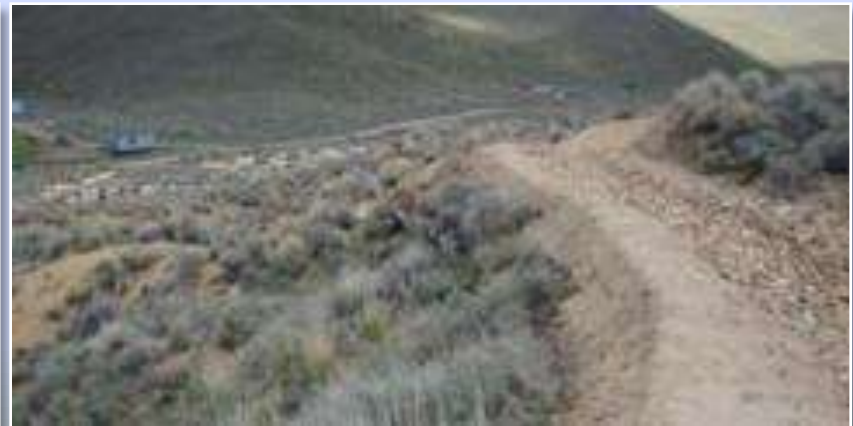
The rocky, lined diversion ditch (right) intercepts runoff from the hills above so that it doesn't erode the mine tailings (light colored soil on left and above) and takes it downstream.

- Stream diversion ditch (away from tailings).
 - Built for 100-year event (60 cubic feet/sec.).
 - Lined with 18 oz/ft² plastic liner and rip-rap.
- Weir construction to slow flows.
- Erosion control.
 - Composting with organic material.
 - Sand seeding with native grass.

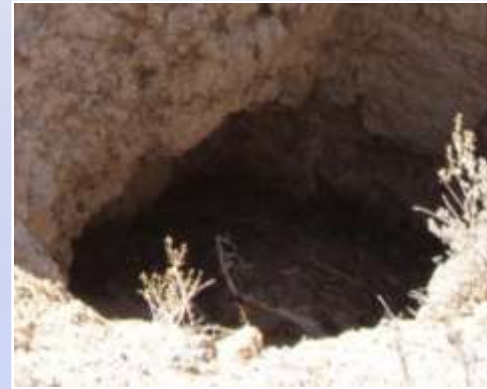
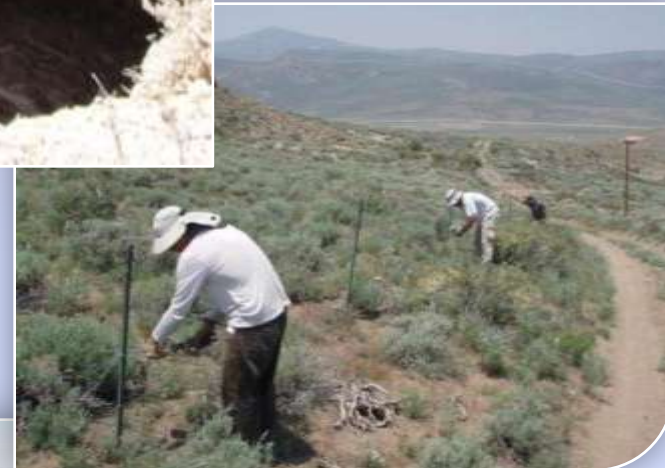
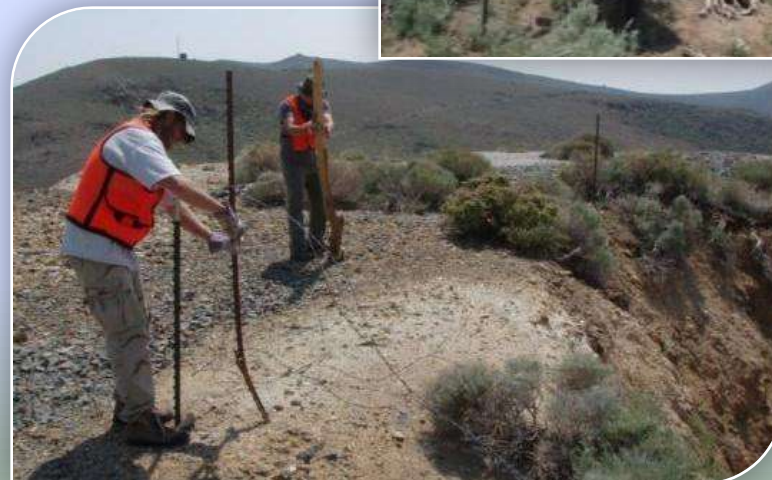
- The AMLU built fences at Bodie SHP in June, 2008.
 - Repaired nine fences around physical hazards.
 - Repaired two sections of perimeter fencing.
 - Built one new fence around a mine shaft.
- The AMLU supplied labor for the project and State Parks purchased materials.
