### **Hazard Management: Remediating Physical Hazards at Abandoned Mine Sites**

### **AMLU Physical Hazard Remediation Projects**

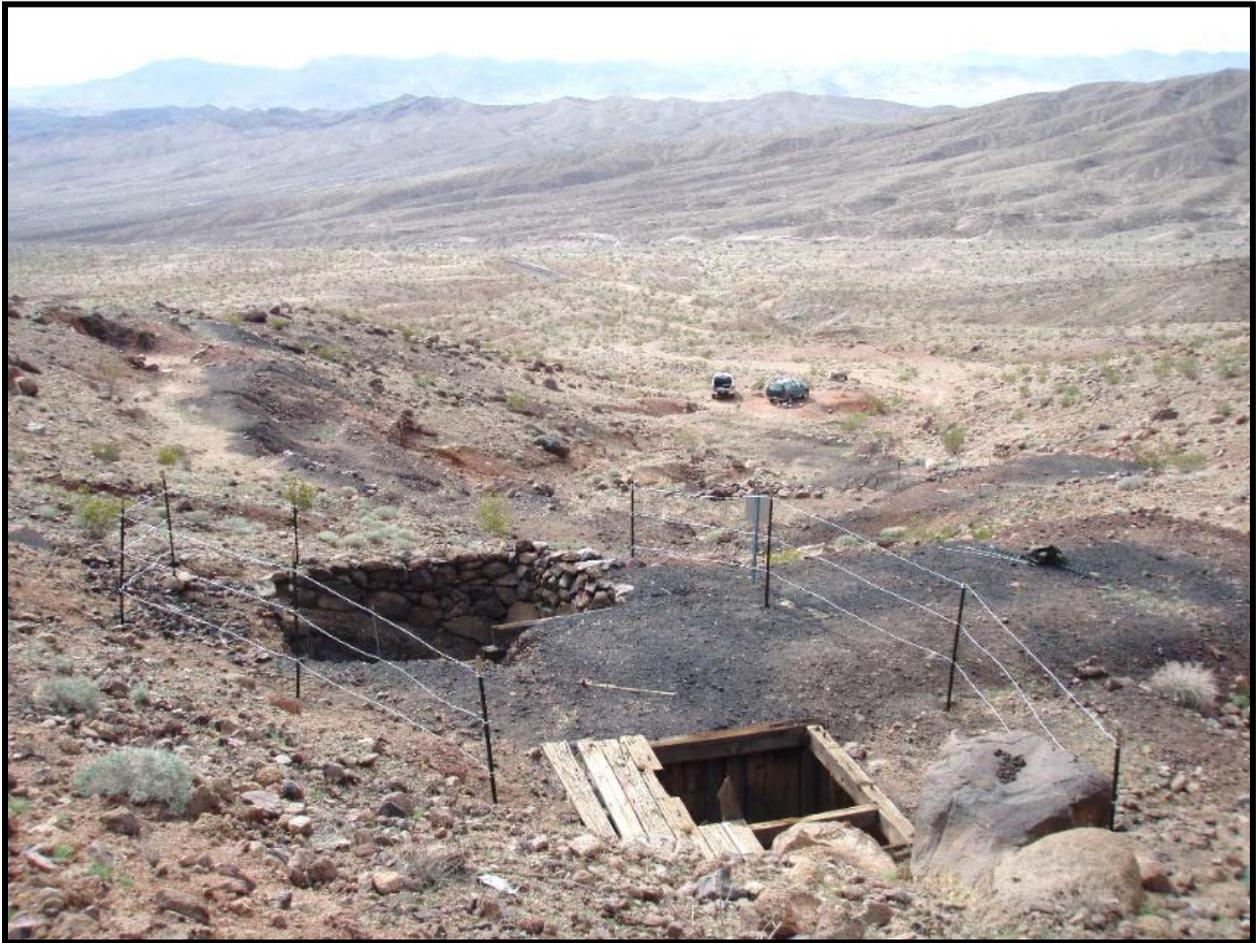
Fencing installed around hazardous mine shafts on State land in San Bernardino County. Photo: DOC (2015)

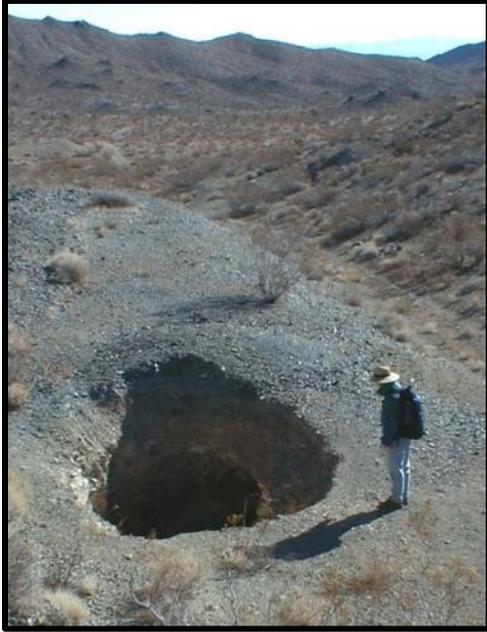
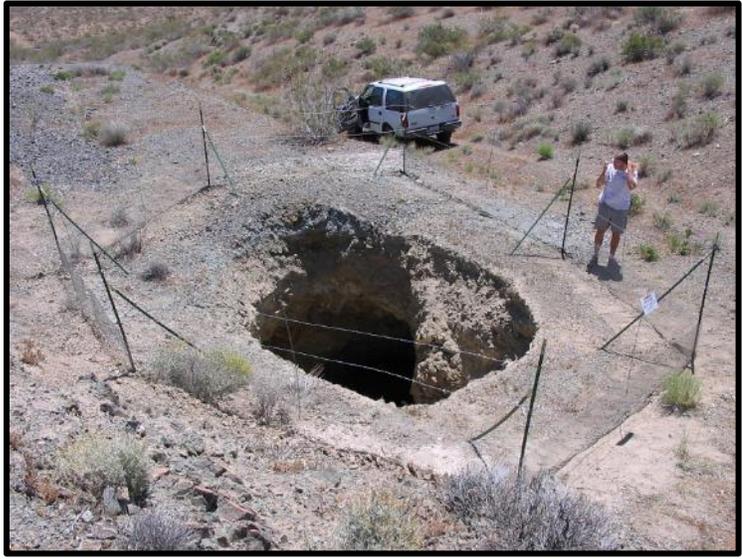
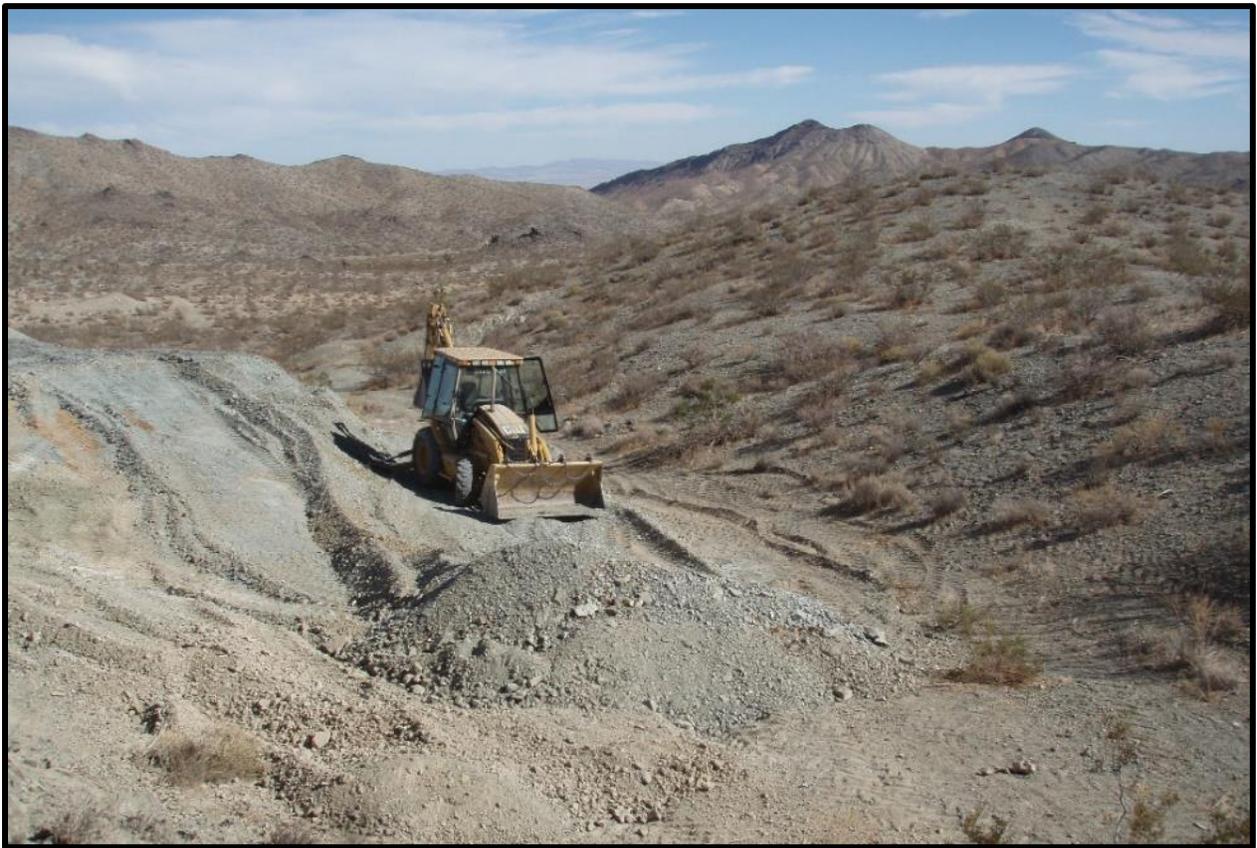
Fencing installed around a hazardous mine shaft adjacent to a dirt road on State land in San Bernardino County. An AMLU contractor later permanently backfilled the opening, which was increasing in size, with a backhoe using onsite material. Photos, DOC (2002-2007)

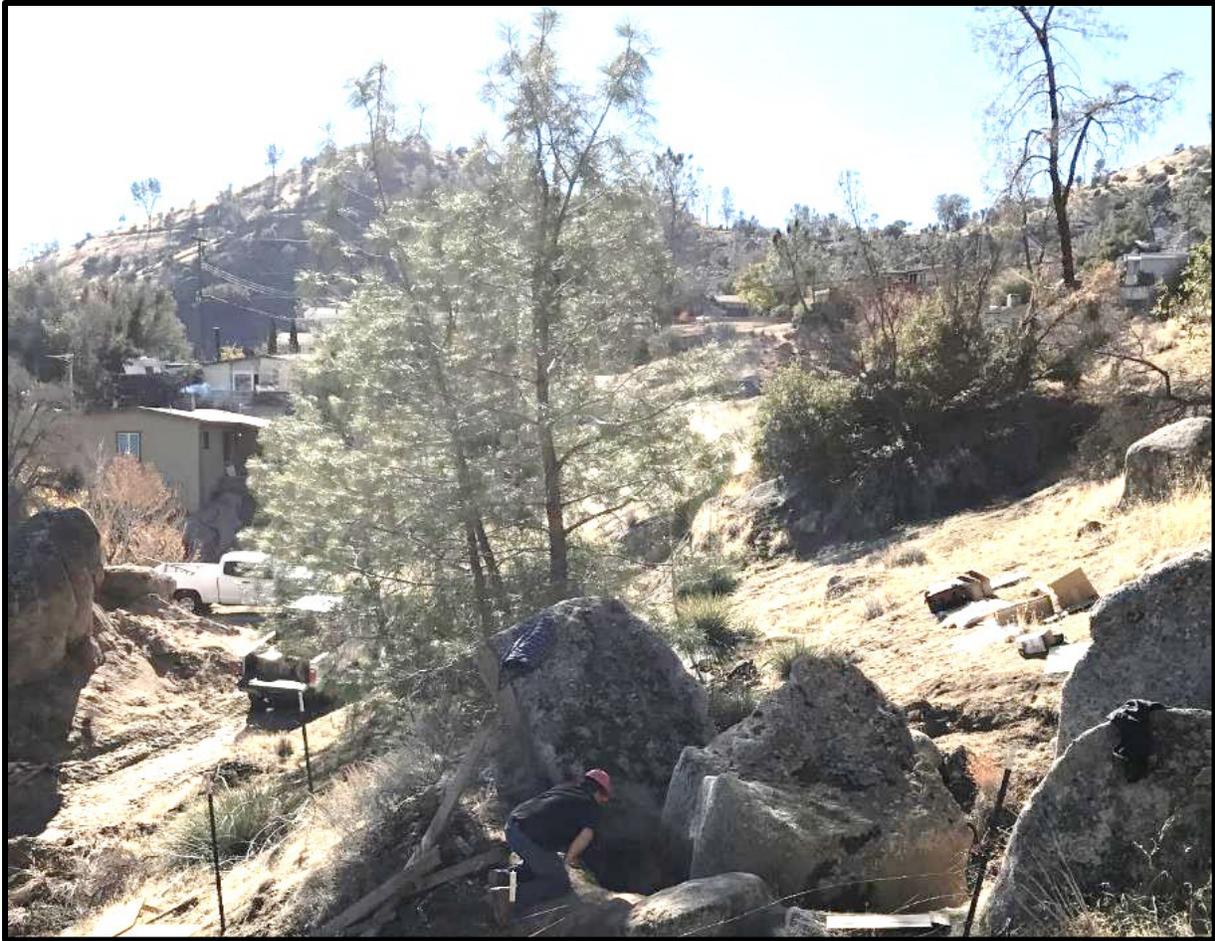
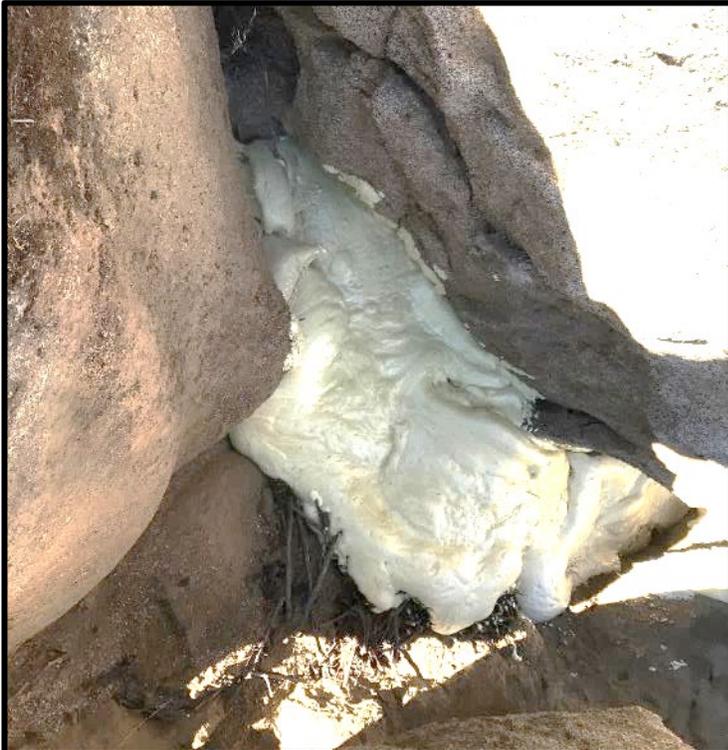
An AMLU contractor (bottom center of photograph above) examines a hazardous shaft on U.S. Bureau of Land Management (BLM) land in Kern County that was discovered near multiple residences by a homeowner's young son. The mine shaft was subsequently sealed with expanding polyurethane foam (PUF) (left). The PUF plugs were then covered with soil, leaving no sign of the shaft. Photos: DOC (2018)

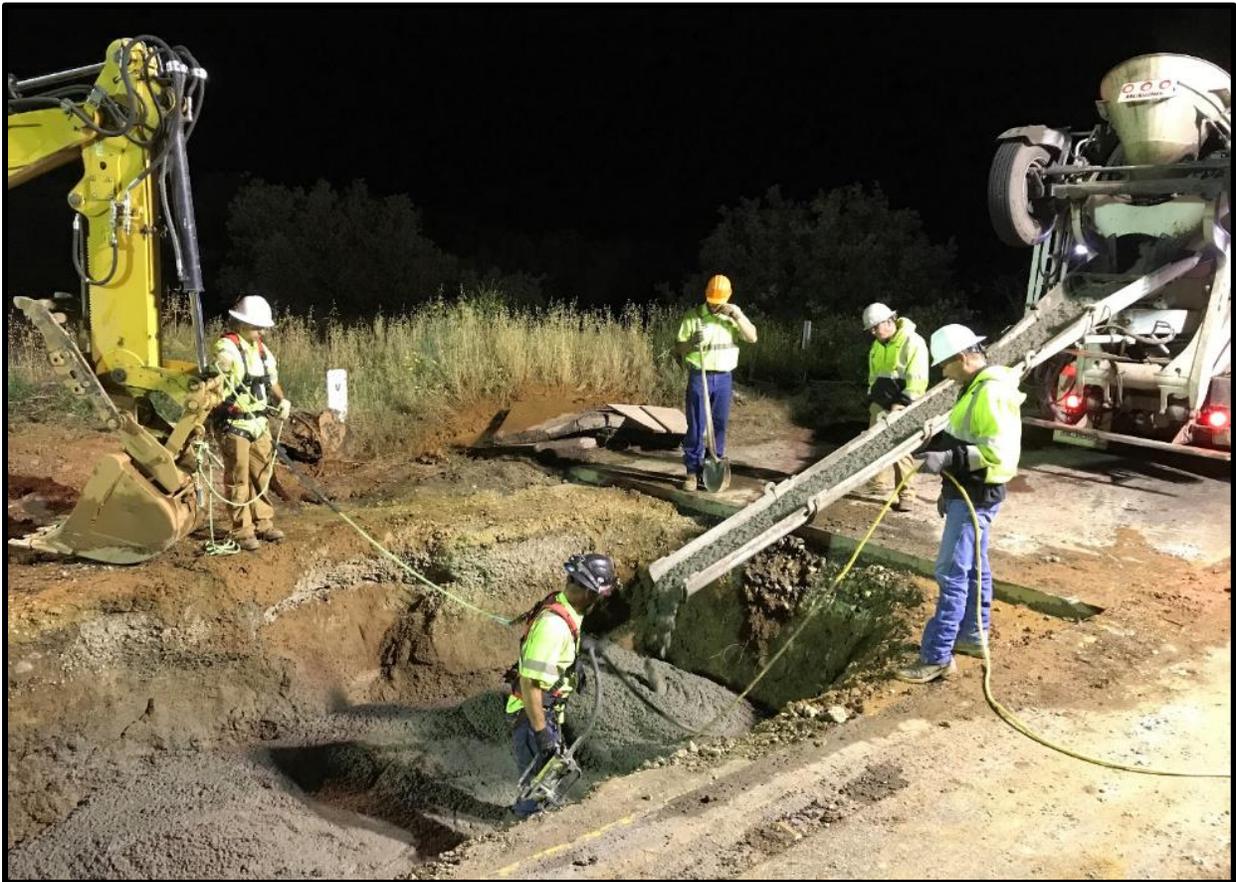
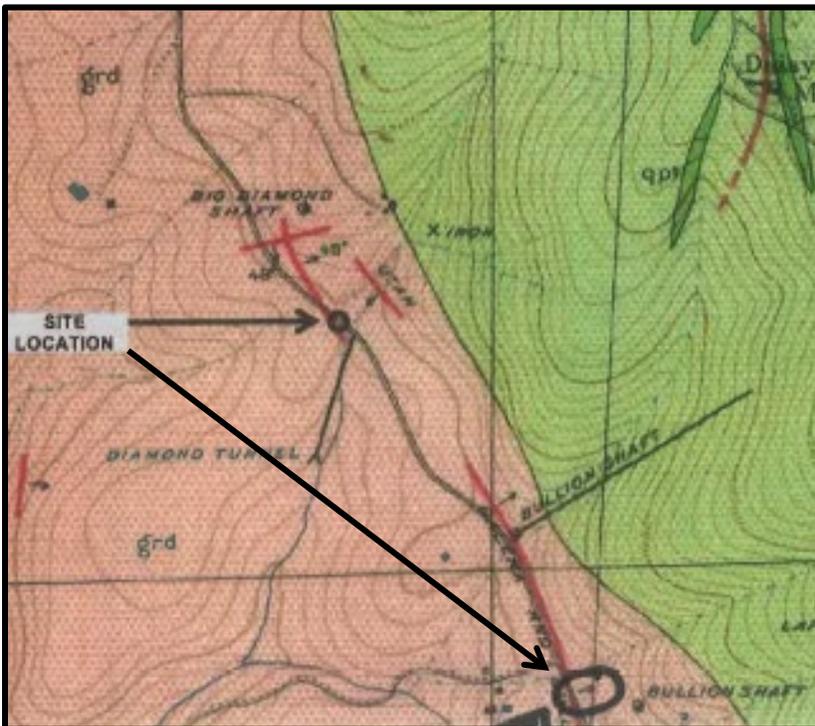
When two abandoned mine shafts opened on the shoulder of a public road, the AMLU provided funding to the Nevada County Department of Public Works to help close the mine openings. An engineering firm hired by the County cut away asphalt around the openings, excavated loose material to define the size and shape of each subsidence, and cast in place tapered concrete plugs from high-strength, quick-curing concrete. Photos and map: DOC (2019)

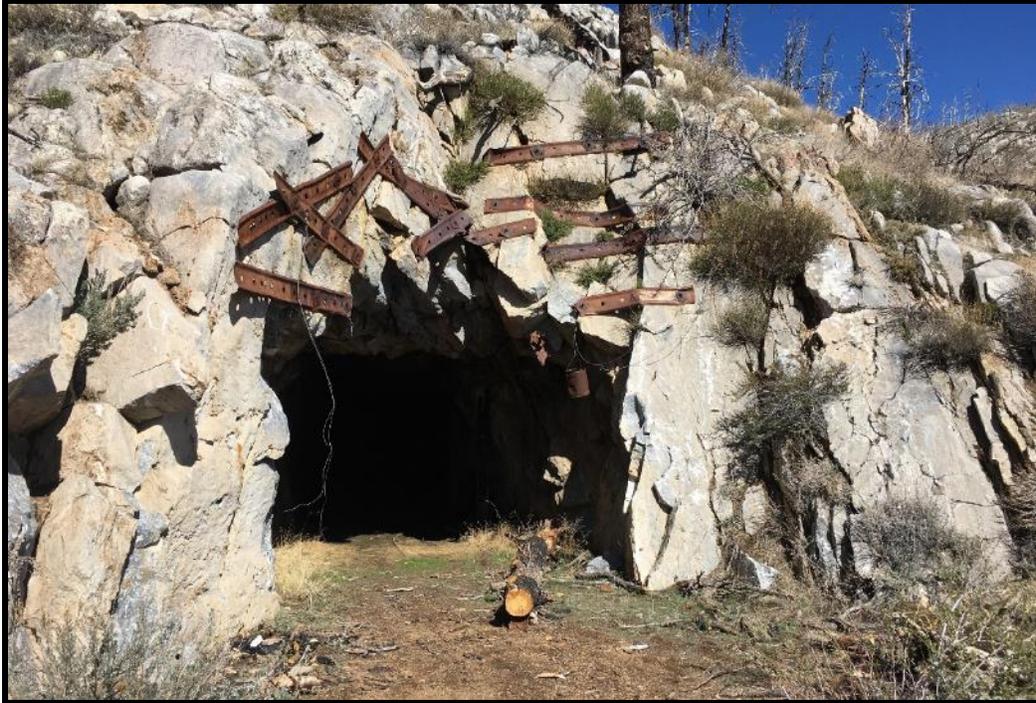
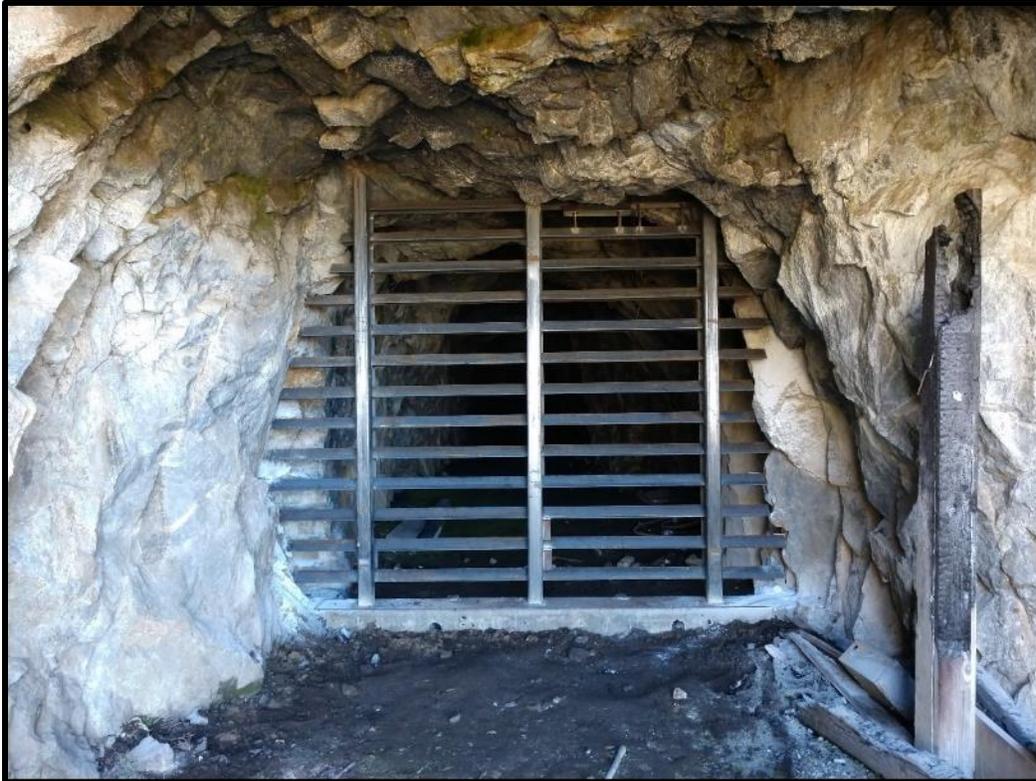
Bat gate installed on adit in the U.S. Forest Service (USFS) Sequoia National Forest in Kern County. The gate allows access for bats and other wildlife that use abandoned mines for habitat or shelter while keeping humans safely out. Photos, DOC (2019)

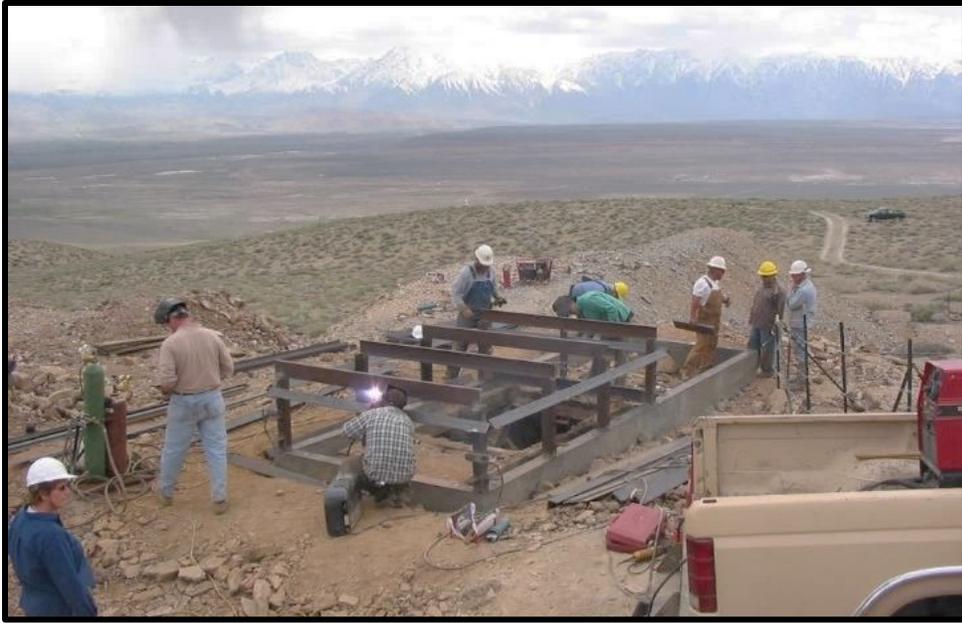
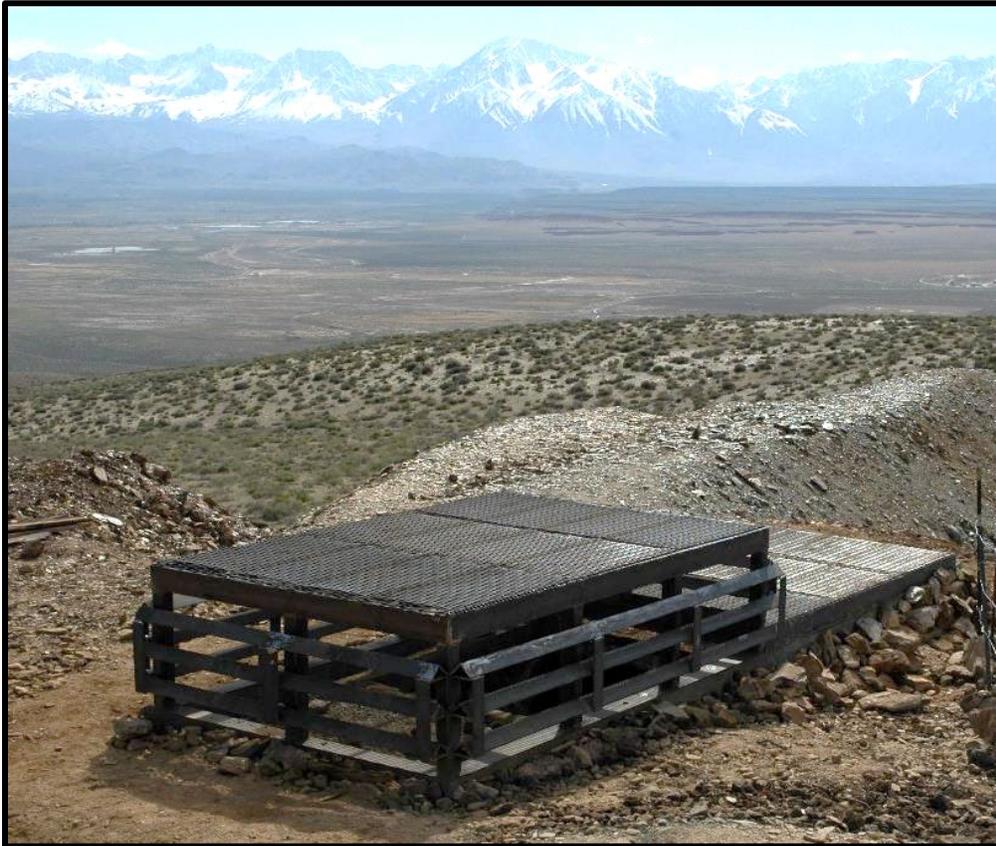
One of many cupolas installed on shafts on federal abandoned mine lands in Inyo County. Like bat gates, cupolas allow access for bats and other wildlife that use abandoned mines for habitat or shelter while keeping humans safely out. For this project, the AMLU tasked its primary contractor to also train other small businesses to build abandoned mine safety structures. Photos, DOC (2006)

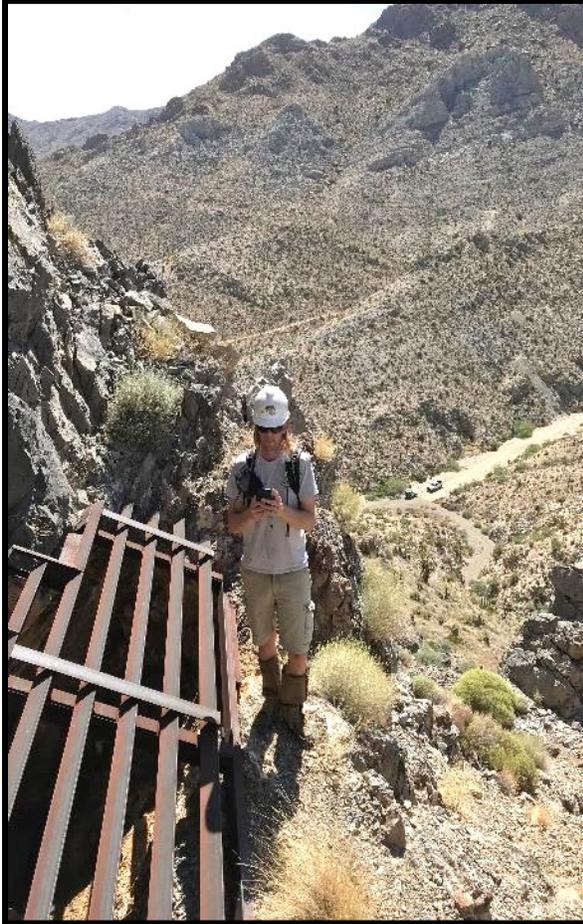
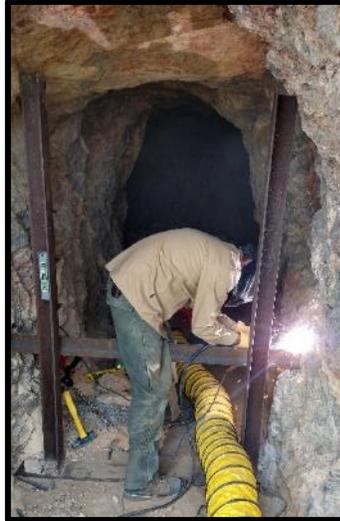
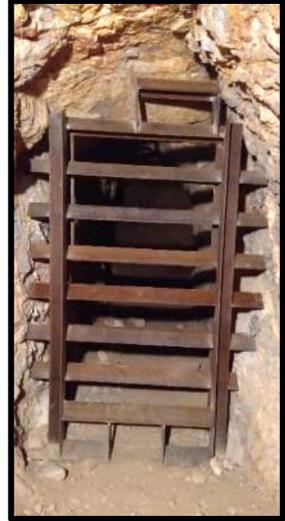
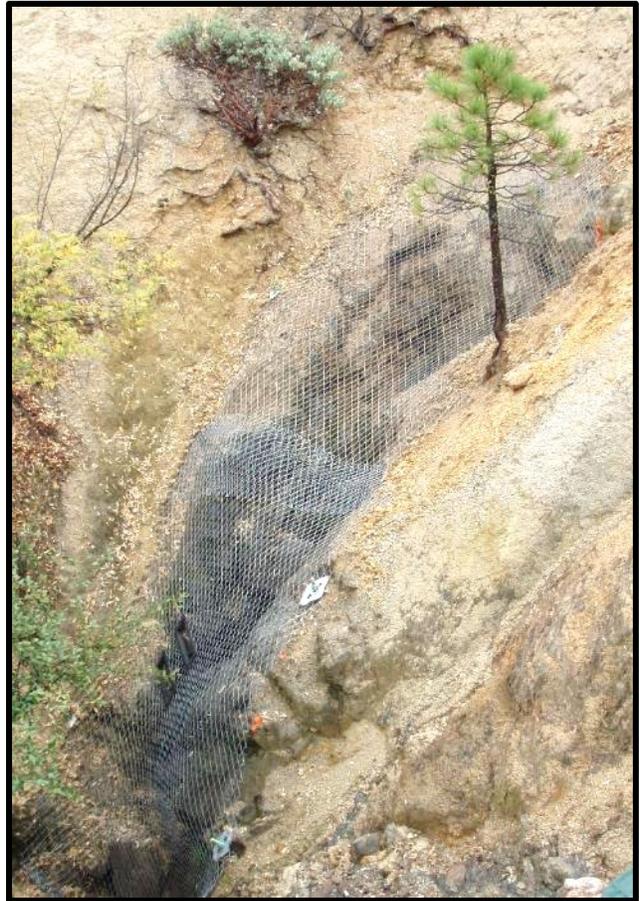
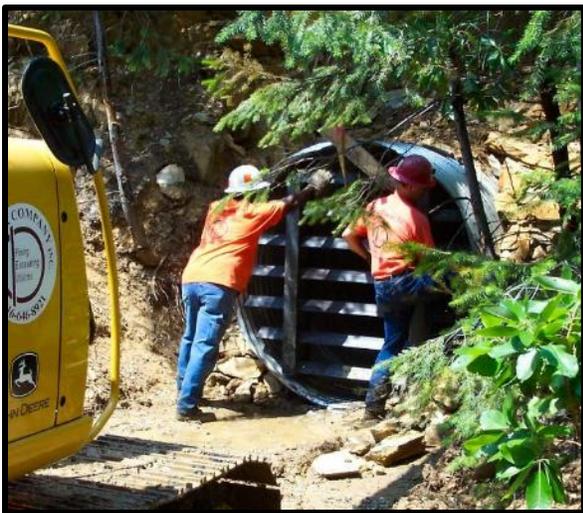
Clockwise from top left corner: (1) Staff inspecting a cupola on National Park Service land in the Mojave National Preserve, San Bernardino County; (2-3) Contractor building a bat gate on State Parks land in the Providence Mountains State Recreation Area, San Bernardino County; (4) Geo-mesh cable net installed over a feeder shaft on BLM land, Nevada County; (5) Contractors building a culvert gate below a public school, El Dorado County. Photos, DOC (2020, 2021, 2007, 2006)
