Hazard Management: Managing Chemical Hazards at Abandoned Mine Sites

DMR Mine Environmental Hazard Reclamation or Remediation Projects

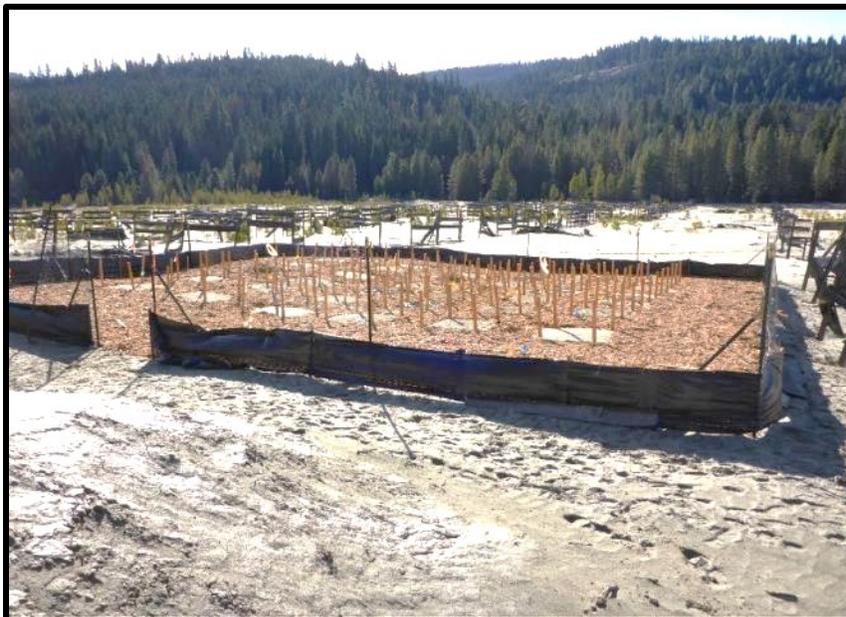
Vegetation test plot at Walker Mine Tailings site, Plumas National Forest, Plumas County. Photo: DOC (2015)

The 100-acre Walker Mine Tailings site is on the Plumas National Forest, Plumas County. During its operation (1915 - 1941), the Walker Mine produced large quantities of copper, and the Mine's mill deposited fine-grained, sandy, silty, and clayey tailings that filled the drainage below. Under the Comprehensive Environmental Response, Compensation, and Liability Act (CERCLA), the U.S. Forest Service (USFS) needed to eliminate both exposure of the public to fugitive silica-laden dust blown by wind from the tailings surface and contaminant releases from the tailings to Dolly and Little Grizzly Creeks. Pursuant to a USFS agreement, DMR implemented a study of soil and vegetation conditions on the tailings and prepared a revegetation and mulching plan.

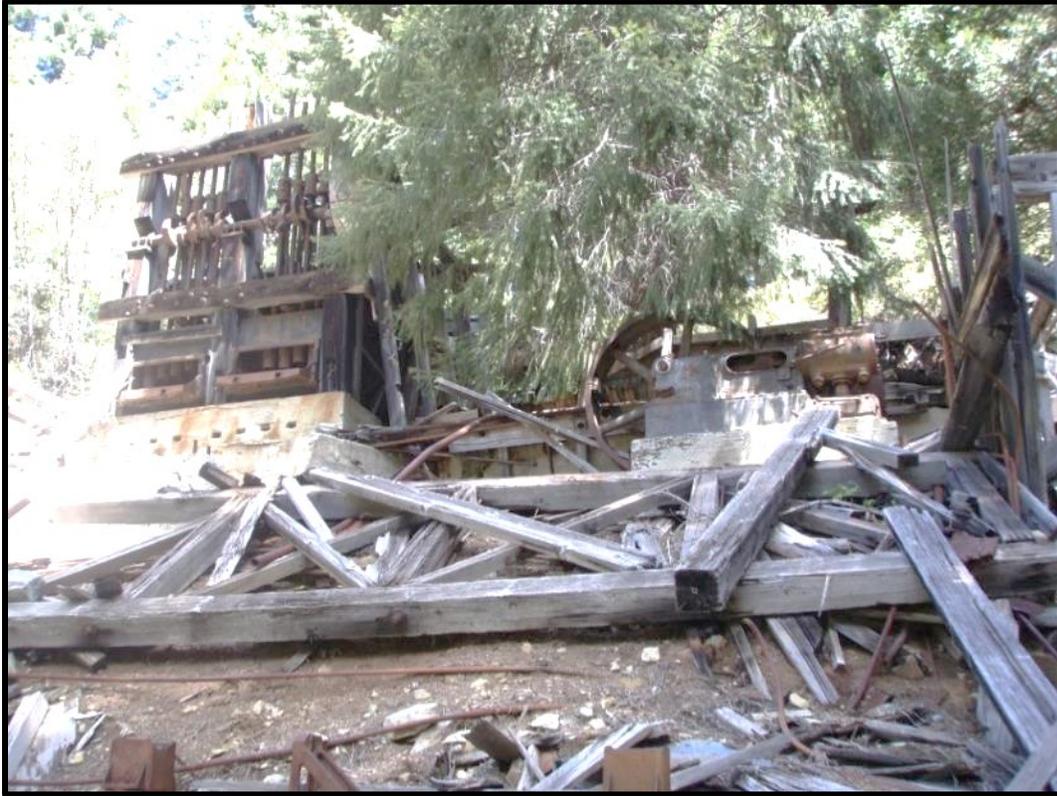
Robinson mine and stamp mill in Plumas National Forest in Plumas County. Photo: DOC (2014)

DMR partnered with the USFS and obtained a grant from the Sierra Nevada Conservancy's Proposition 84 grant program to develop a Preliminary Assessment and Site Inspection (PA/SI) for the historic abandoned Robinson Mine and stamp mill. The Robinson Mine is located in the Plumas National Forest, southwest of Quincy in Plumas County. The mine site is immediately adjacent to Frazier Creek, which is located in the Middle Fork Feather River watershed. The USFS is remediating the Robinson Mine site under its CERCLA program due to contamination from mercury used at the mill to extract gold. Environmental sampling of the site was completed in fall 2015.

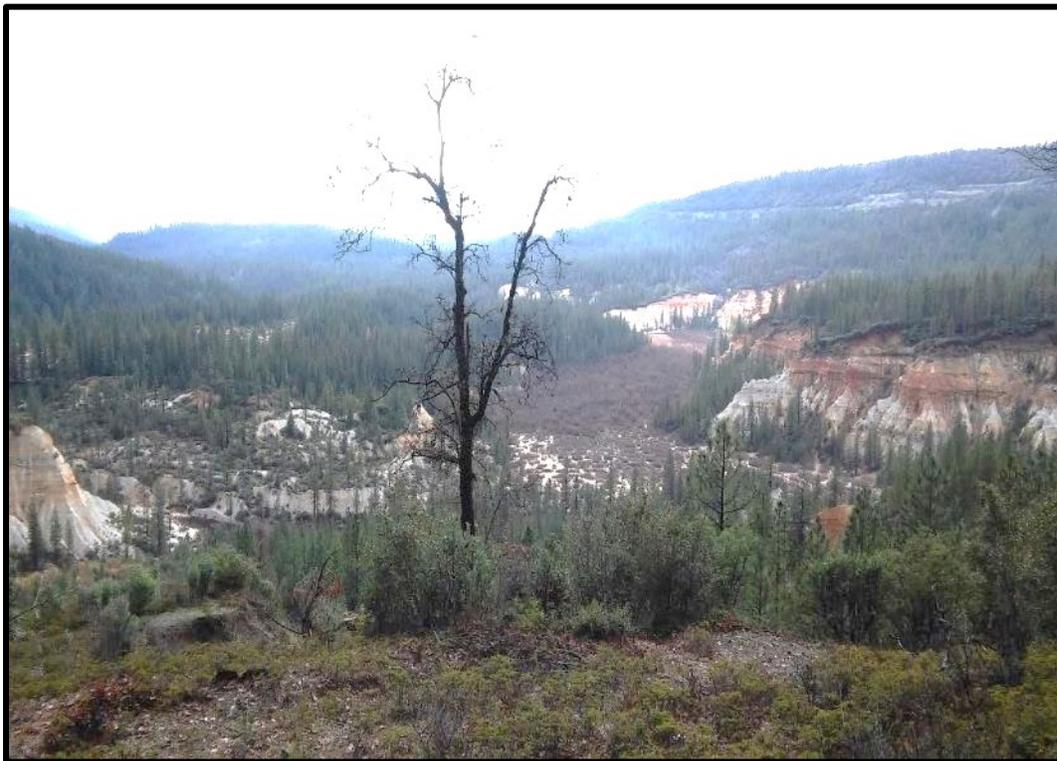
Mercury-laden sediment discharges from massive hydraulic gold mine in Malakoff Diggins State Historic Park. Photo: DOC (2014)

At what is now Malakoff Diggins State Historic Park (SHP) in Nevada County, the historic technique of hydraulic mining to find gold carved huge cliffs and washed away entire mountains with mighty jets of water. The resulting sedimentation along with the mercury used in gold mining contaminated downstream watersheds. The site is part of the Malakoff Diggins Hydraulic Mine Feasibility Study, led by The Sierra Fund and a multi-agency project team funded by a Department of Water Resources Integrated Regional Water Management Plan Proposition 84, grant (the Cosumnes, American, Bear, Yuba Headwaters Resilience and Adaptability Program). DMR helped fund the preparation of an aerial LiDAR map of the main hydraulic pit and Humbug Creek watershed that was used, with ground-based LiDAR performed by the U.S. Geological Survey, to measure erosion rates and sediment sources in and around the main hydraulic pit. DMR is also assisting the Department of Parks and Recreation (State Parks) with evaluating visitor protection at several deep shafts along a heavily used park trail. The trail parallels the major drain tunnel that can discharge mercury-laden sediment directly into Humbug Creek, a tributary to the South Yuba River. Some of the shafts are flooded or have inadequate fencing, and one shaft drains water across and down a segment of the trail, which makes the trail muddy and unsafe for Park visitors. The Park is developing a new trail design and with funding assistance from DMR may relocate this trail segment.

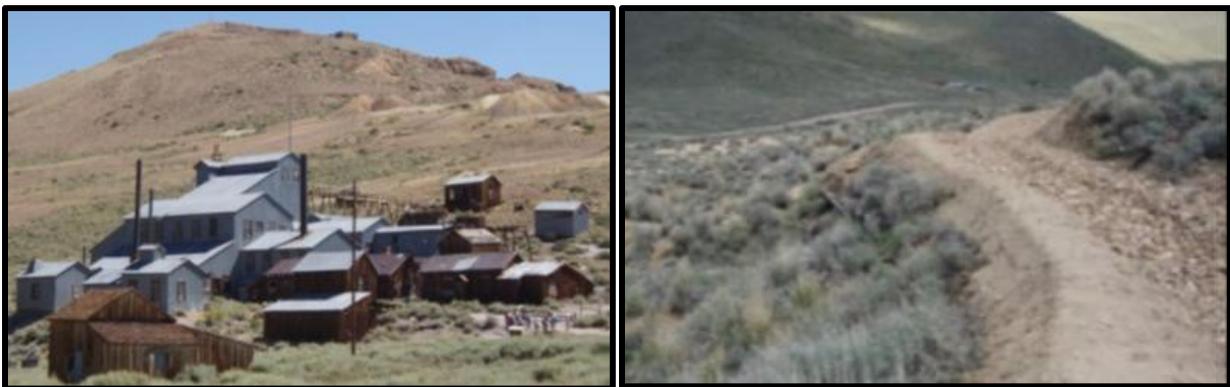
Left: Standard Mill at Bodie State Historic Park. Right: A lined diversion ditch prevents runoff from reaching and eroding mine tailings. Photo: DOC (2009)

- Installed a modified radon extraction system to reduce mercury vapor concentrations inside Bodie's Standard Mill and remediated lead-contaminated soil on the slope below the Mill (placed filter fabric and clean fill, revegetated slope, and installed fences to reduce disturbance).
- Remediated lead-contaminated soil from Assay building areas (removed top foot of soil in and around buildings; replaced soil with clean fill).
- Removed lead-contaminated dust in Wheaton-Hollis Hotel using a HEPA vacuum.
- Controlled erosion of mine tailings adjacent to Bodie Creek by building a diversion channel lined with rocks collected onsite to carry runoff away from the tailings, by constructing weirs to slow stream flows, and by composting and revegetating the tailings to promote native plant growth.

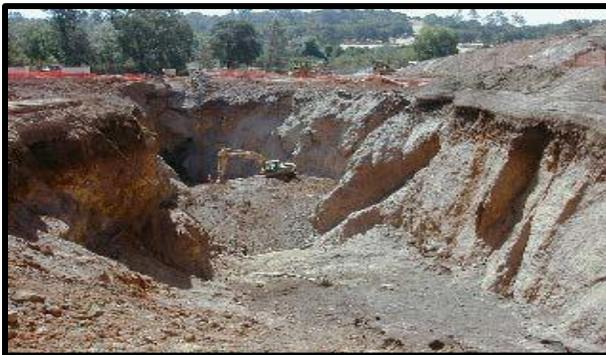
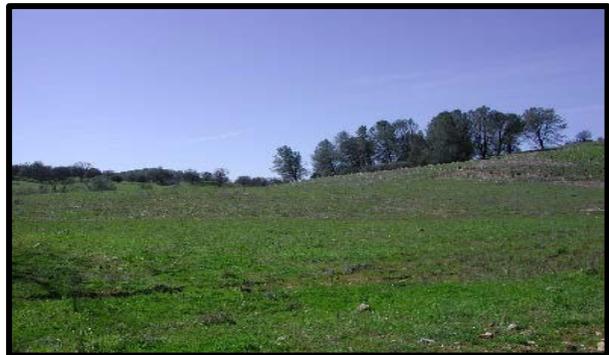
Left: Open mine pit drained acidic water into Little Dry Creek. Right: Treated mine waste was used to backfill the pit, and then the site was recontoured, covered with topsoil and revegetated. Photos: DOC (2001, 2009)

Spenceville Mine was a copper mine that operated from 1875 through 1918 in Nevada County. Problems with the abandoned open-pit mine included AMD and the forming of an open pit lake in the abandoned mine workings. The mine water had a pH of about 2.5 with elevated levels of iron, copper, and zinc. During high precipitation, water from the pit overflowed into Little Dry Creek, which is under the jurisdiction of the California Department of Fish and Wildlife (CDFW). Under contract with CDFW, DMR developed a strategy to mitigate AMD and reclaim the mine site to a safe and stable condition. DMR's objective was to identify and select a low-cost, low-maintenance treatment strategy that would: (1) prevent future discharges to state waters by cleaning up and containing AMD and associated heavy metal problems onsite; (2) provide a stabilizing vegetative cover; and (3) meet Central Valley Regional Water Quality Control Board (RWQCB) requirements. DMR's contract work included three phases:

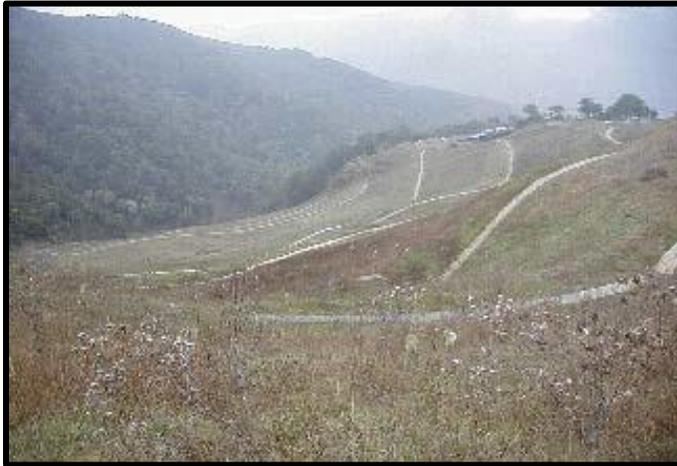
Gambonini Mine final grade with drainage ditches and native vegetation. Photo: DOC (2005)

During historic mining at the Gambonini Mercury Mine, in Marin County, mine wastes were placed in a steep canyon covering an area of about 11 acres. Consequently, large quantities of mercury-laden sediment would discharge each year into Salmon Creek—a tributary to Walker Creek and Tomales Bay. Threats to the beneficial uses of these waters included degradation of fish spawning areas in Walker Creek and bioaccumulation of mercury by wildlife and fish in Tomales Bay. Under contract with the San Francisco Bay RWQCB, DMR provided revegetation, erosion and construction monitoring, and consulted on creek remediation options.

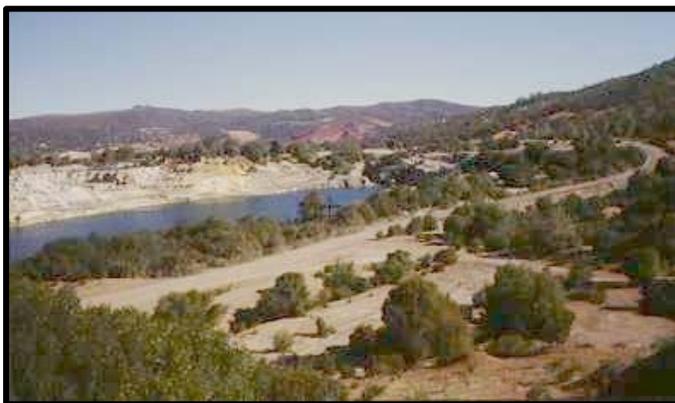
Harmon impoundment and mine waste at Sulphur Bank Mine. Photo: DOC (1999)

Sulphur Bank Mercury Mine in Lake County was once one of the largest producers of mercury in California. It was initially mined for sulfur (1865 – 1871), then intermittently for mercury ore by underground methods (1873 – 1905). Pit mining occurred periodically from 1915 to 1957, when it became inactive. About 120 acres of mine tailings and waste rock and an open, unlined mine pit (the Herman Impoundment) were located on the property. After mercury was found in the tailings and bottom sediments in Clear Lake, and high levels of mercury were detected in fish from the lake, the State issued an advisory against eating fish from the lake. Under contract with the USEPA, DMR performed statistical analyses of data, revegetation monitoring, and provided botanical expertise for revegetation and weed control strategies.
