**IMPRESSIONS FROM A FIELD INVESTIGATION OF  
THE WENCHUAN, SICHUAN PROVINCE, EARTHQUAKE  
OF MAY 12, 2008**

Marshall Lew, David A. Friedman and Laurie A. Johnson

Members of the Earthquake Engineering Research Institute (EERI)  
Field Investigation Team

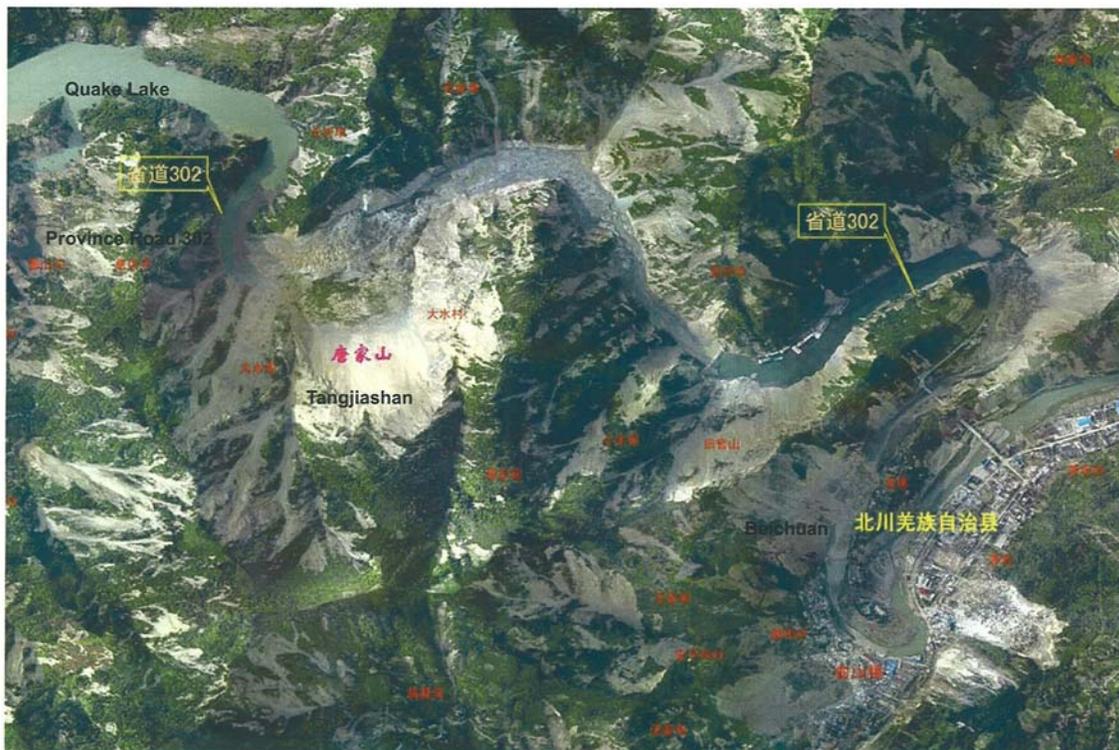
The Longmenshan Mountains are prone to numerous landslides just due to the topography and steepness of the mountains under normal conditions. The earthquake is reported to have caused almost 10,000 landslides. Some 26 landslides are believed to have volumes exceeding 10 million cubic meters of material. Landslides and rockslides buried villages and towns resulted in numerous fatalities, with two landslides killing about 2,500 persons in the Beichuan area. Landslides near Beichuan also dammed the river and created the Tangjiashan Quake Lake, which was a threat to downstream towns and villages should the landslide mass be breached or overtopped; see Figure 8. The China People's Liberation Army deployed troops to cut channels through the slide to stop the rising water and reduce the risk of a catastrophic failure of the landslide dam and resulting flooding downstream.

Fig. 8 Tangjiashan Quake Lake near Beichuan (source: National Survey Bureau)

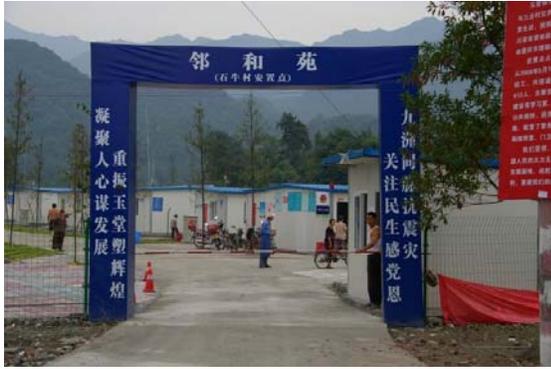
Figure 27 Temporary housing in Dujiangyan

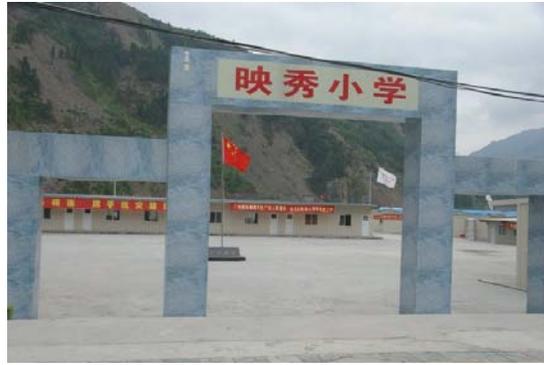
Sponsoring localities have been major suppliers of the temporary housing, and planning institutes from sponsoring localities have volunteered to plan the temporary housing encampments, following the design principles laid out by the central government in the Wenchuan Earthquake Disaster Recovery and Reconstruction Act. Figure 27 shows one temporary shelter in northeastern Dujiangyan. The processes for determining the number of units needed and the site selections are unclear. Local officials described site selections being determined based upon the availability of water, electricity, and access, but less certain about environmental and hazard considerations. Some very large encampments were observed in river floodplains and at the base of steep slopes. Many of the temporary housing encampments include temporary school facilities, such as the elementary school in Yingxiu shown in Figure 28.

Figure 28 Temporary elementary school in Yingxiu
