MINERAL INFORMATION SERVICE

MARCH 1970

SANTA ROSA EARTHQUAKES

THE SANTA ROSA EARTHQUAKES OF OCTOBER, 1969

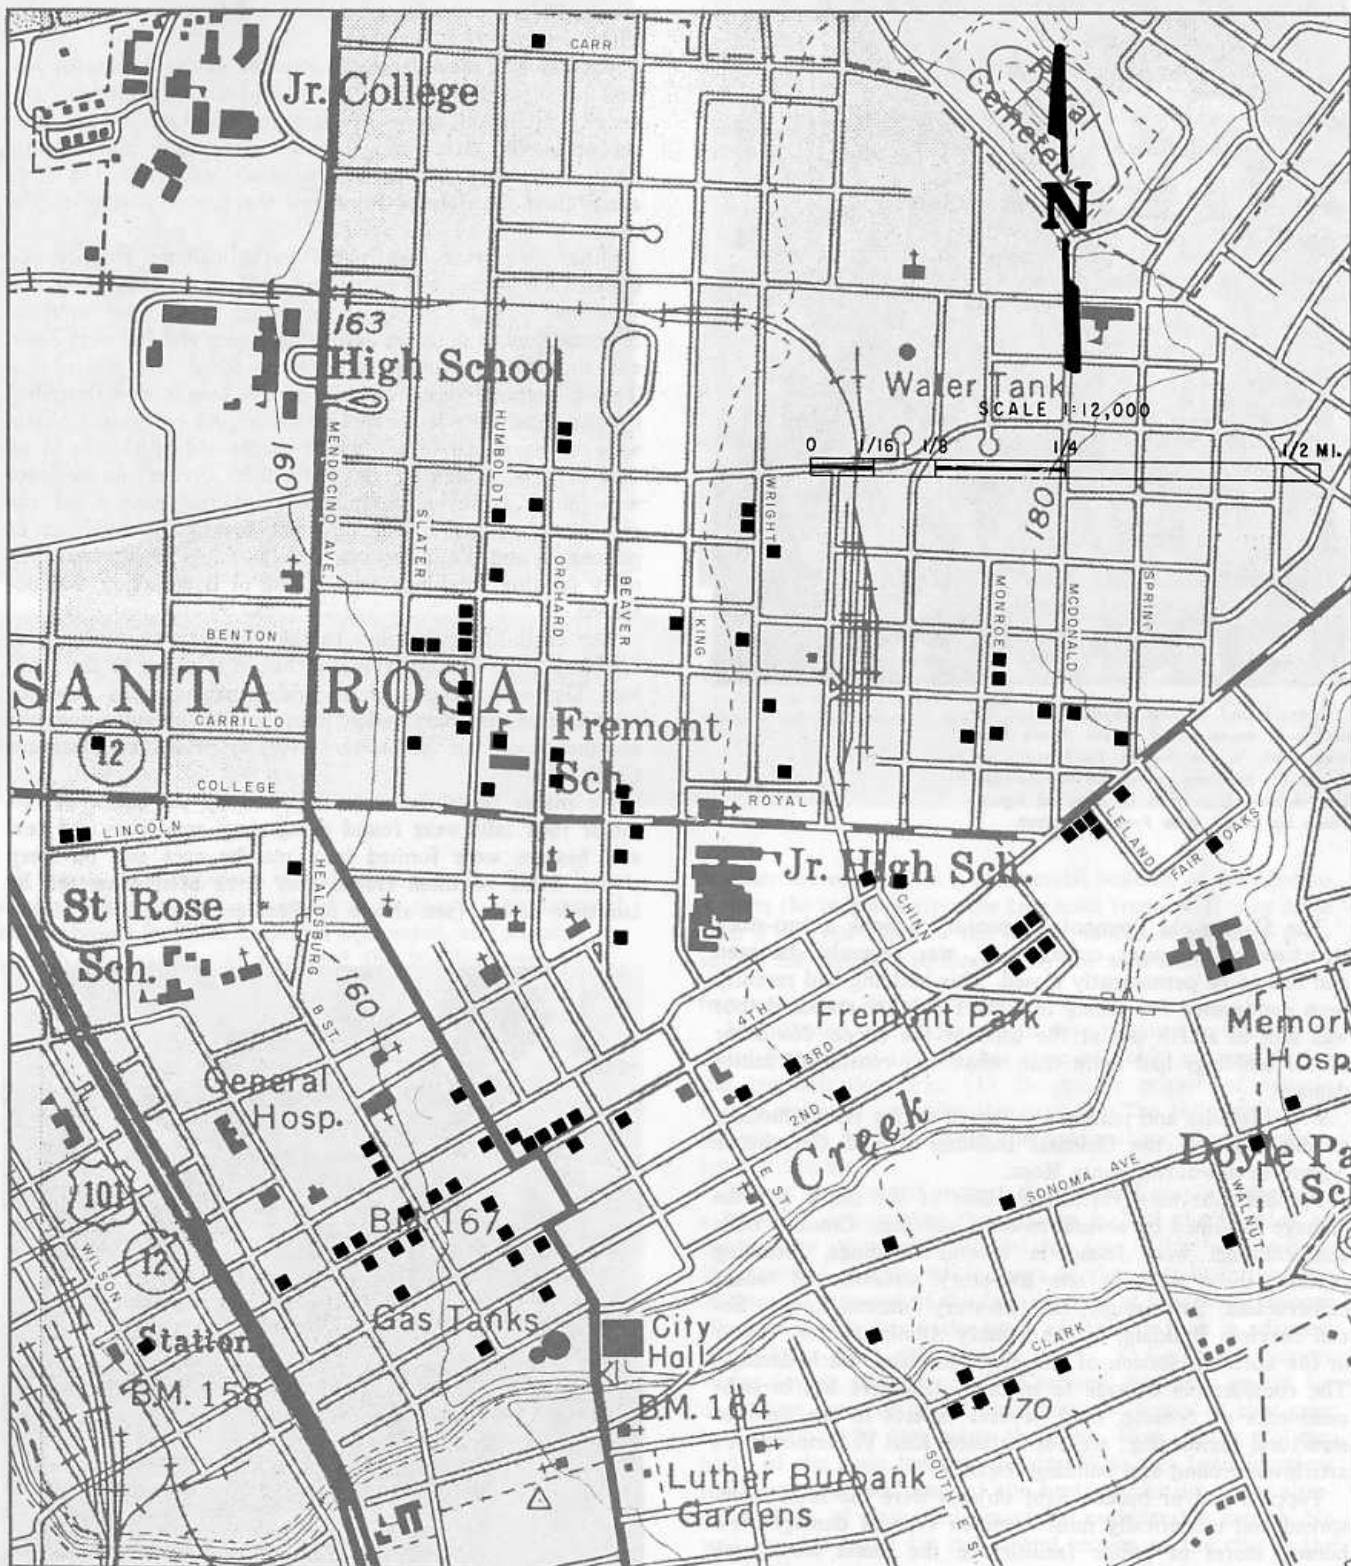
Structural damage was confined almost exclusively to the city of Santa Rosa. A systematic inspection by city building inspectors revealed (as of the beginning of November) that 99 structures were seriously damaged (see map)—49 in the central business district and 50 in residential areas. Of the central district buildings, 17 were scheduled for abatement; in the residential areas, 28 were so listed.

The locations of severely damaged buildings in central Santa Rosa are shown by the square black symbols, from information compiled by the city building inspector's office. Many of these buildings have been demolished or have required extensive repairs.
