# **Liquefaction and Other Ground Failures in Imperial County, California, from the April 4, 2010, El Mayor-Cucapah Earthquake**

By Timothy P. McCrink, Cynthia L. Pridmore, John C. Tinsley, Robert R. Sickler,  
Scott J. Brandenburg, and Jonathan P. Stewart

**CGS Special Report 220**  
**USGS Open File Report 2011-1071**  
**Version 1.0**

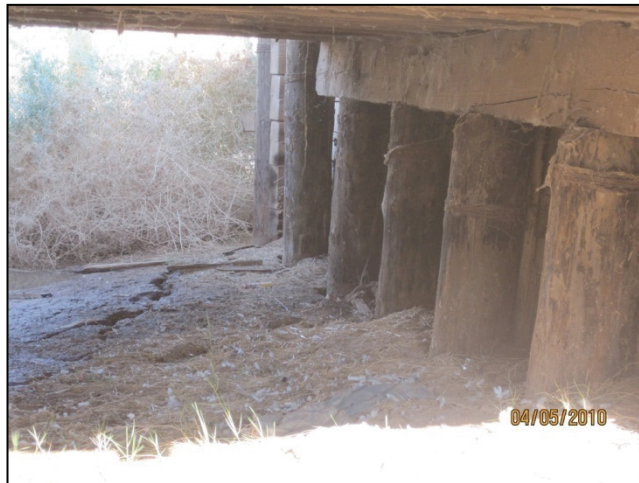
The Brockman Road crossing of Greeson Drain consists of a timber bridge supported on timber piles. The plan dimensions of the bridge are approximately 7 m × 8 m. No vented sand was observed at this bridge or the surrounding area. However, lateral spreading of the south bank of the drain (fig. 4), settlement of fill at both approaches, and lateral spreading of the northeast fill shoulder (fig. 5A) suggest that liquefaction occurred either below or within the fill. Strong shaking of the bridge structure appears to have split one of the guardrail support posts (fig. 5A). The fill settlement was pronounced enough for the authorities to close the bridge to traffic, though it could still be safely crossed at slow speed.

**Figure 4.** Lateral spread ground cracking on the north bank of Greeson Drain beneath the Brockman Road Bridge (R02). Photo by E. Seyhan, 4/5/10.

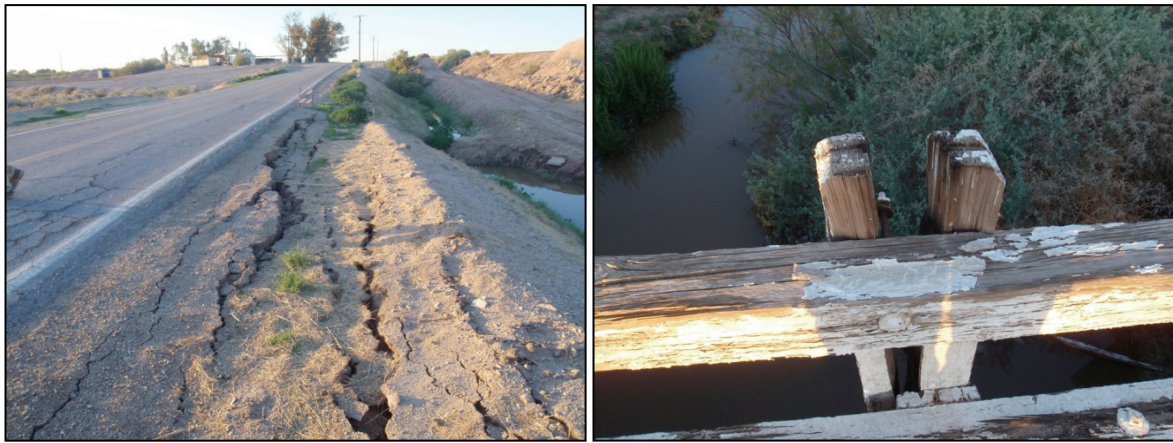
**Figure 5.** A, View along east margin of Brockman Road near Greeson Drain (R02) showing fractures and slumping of road fill. Tape in middle ground is 1 m long. Extensional cracking also affected pavement of Brockman Road. B, Strong ground shaking and ground deformation in fill drove the wood guardrail from south to north, causing posts supporting the guardrail to split. Photos by J. Tinsley, 4/7/10.

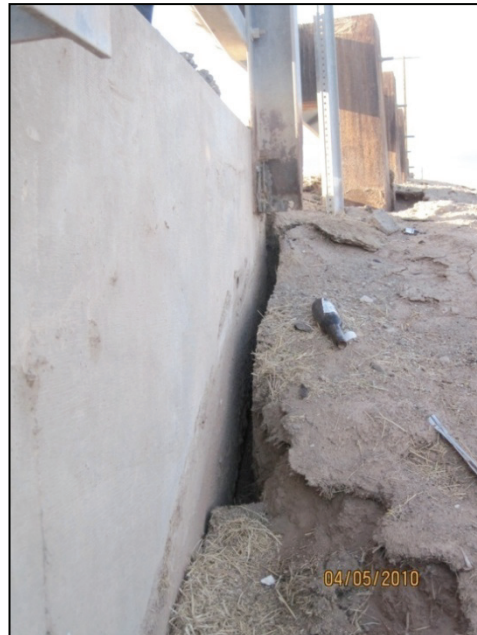
The Brockman Road overcrossing of the New River exhibited ground deformation consisting of embankment fill separating from the abutment in the transverse (fig. 6) and longitudinal directions, and longitudinal cracking of the pavement at both approaches (fig. 7). The single-span bridge had plan dimensions of approximately 10 m × 25 m and is supported on concrete piles. On the north side of the bridge, separation between the soil and pile of approximately 8 cm was observed. Along both sides of the road, modest ground cracking, settlements and lateral deformation of 8 cm width and 5 cm height were observed. Surface evidence of liquefaction in the form of vented sand was not found at this site, though the patterns of ground deformation are consistent with the effects of liquefaction documented at other bridge sites.

**Figure 6.** Approximately 5 cm separation of embankment soil from the concrete abutment at the Brockman Road Bridge over the New River (R05). Photo by E. Seyhan, 4/5/10.

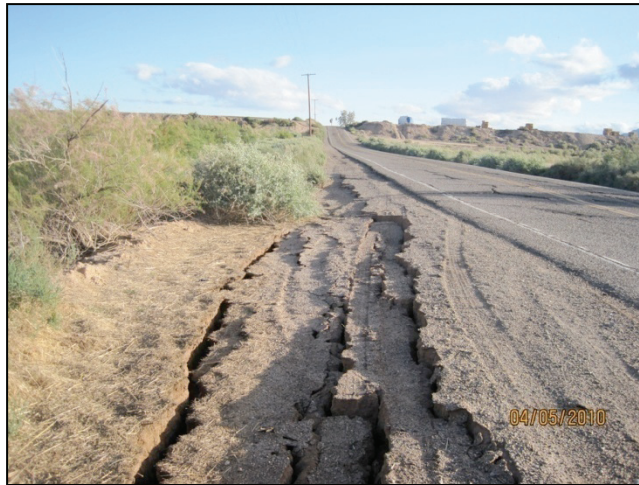
**Figure 7.** Ground cracking, settlement, and lateral deformation along the south approach to the Brockman Road Bridge crossing the New River (R05). Photo by E. Seyhan on 4/5/10.

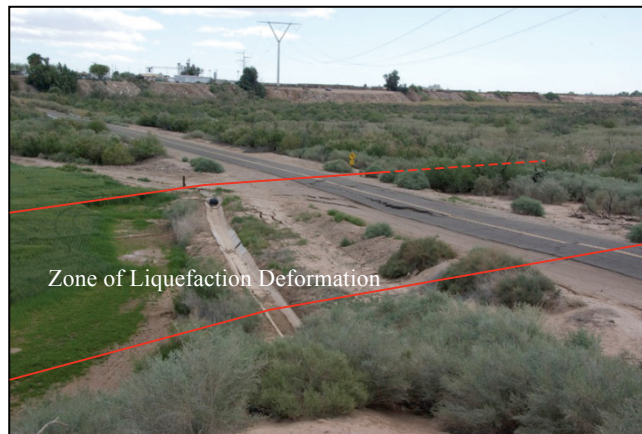
Liquefaction-induced lateral spreading occurred in the New River floodplain at Lyons Road at a distance of roughly 200 m west of the New River bridge crossing and again about 100 m east of the bridge, where the road name changes to Nichols Road. Southwest of the bridge, lateral spreading occurred primarily toward the field on the north side of Lyons Road (fig. 8), though deformation to the east-northeast toward the river was also apparent south of Lyons Road for a distance of at least 100 m. Ground deformation caused horizontal and vertical offsets in road pavement (fig. 9); the road was closed following the earthquake. An irrigation canal adjacent to the north side of Lyons

**Figure 8.** View of damage to Lyons Road and adjacent irrigation canal owing to lateral spreading toward field on left side of image (R06). The approximate area that experienced liquefaction deformation is indicated. The bridge structure over the New River is roughly 200 m farther to the northeast (upper left background in the photo) and suffered no apparent damage. Photo by S. Brandenburg, 4/5/10.

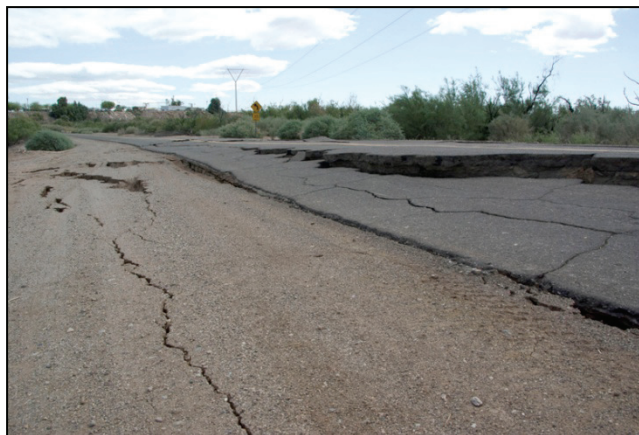
**Figure 9.** Settlement of Lyons Road pavement and north shoulder owing to lateral spreading within the zone of liquefaction deformation shown in the preceding photo (R06). Photo by S. Brandenburg, 4/5/10.

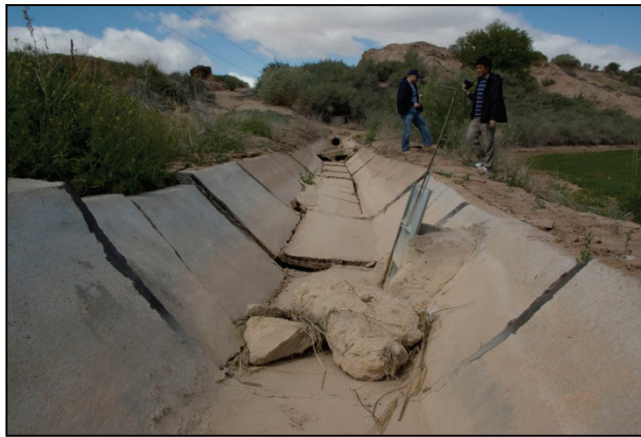
**Figure 10.** Effects of lateral spreading on the small irrigation canal adjacent to Lyons Road (R06). Photo by S. Brandenburg, 4/5/10.

Road was also substantially damaged by liquefaction-related deformation (fig. 10). Vented clean fine sand was observed in several places in the southwest corner of an agricultural field north of Lyons Road (fig. 11).

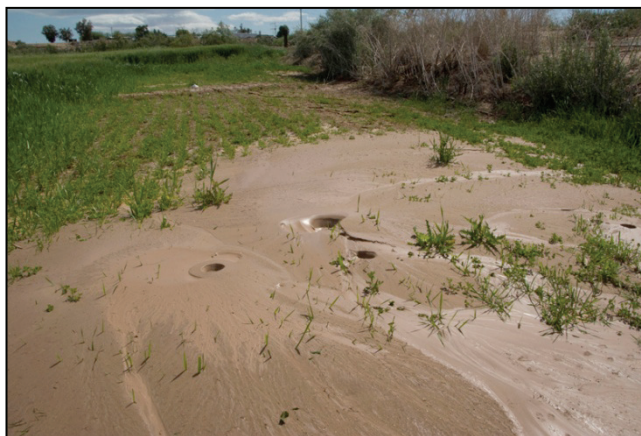
**Figure 11.** Vented sand in the agricultural field immediately north of Lyons Road (R06). Photo by S. Brandenburg, 4/5/10.

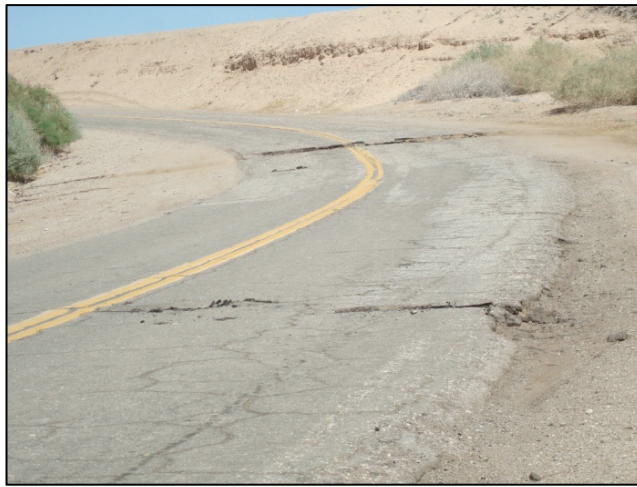
Roughly 100 m northeast of the bridge, on Nichols Road, less severe settlement was observed, and no vented sand was apparent. A pair of fissures 20 to 30 m apart cross the paved road (fig. 12) and extend into and through the fill embankment on both sides. The upper fissure had about 5 cm vertical separation, down on the downslope side. The lower fissure showed minor compression of the asphalt. Road-parallel fissures formed in the southeast embankment suggesting some insipient lateral spreading on this side. Dense vegetation precluded observations of the surrounding flood plain deposits.

**Figure 12.** Possible liquefaction-related settlement in fill underlying Nichols Road, northeast of the New River (R06). Upper fissure had about 5 cm vertical displacement with extension in the asphalt, whereas the lower fissure had little vertical displacement but showed compression in the asphalt. Road-parallel fissures were observed in the fill embankment to the right of this photo. Photo by T. McCrink, 4/9/10.

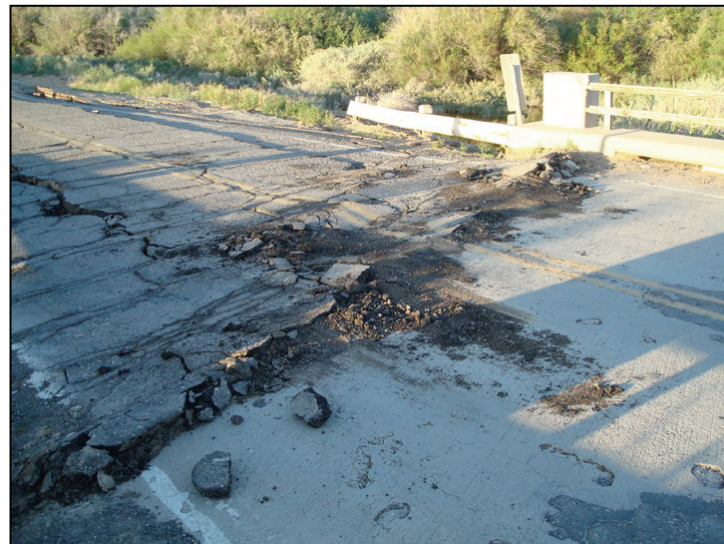
**Figure 15.** Battered asphalt on the north side of the concrete Drew Road Bridge structure (R07). Similar deformation was found on the south side as well. View to the northeast. Photo by T. McCrink, 4/8/10.

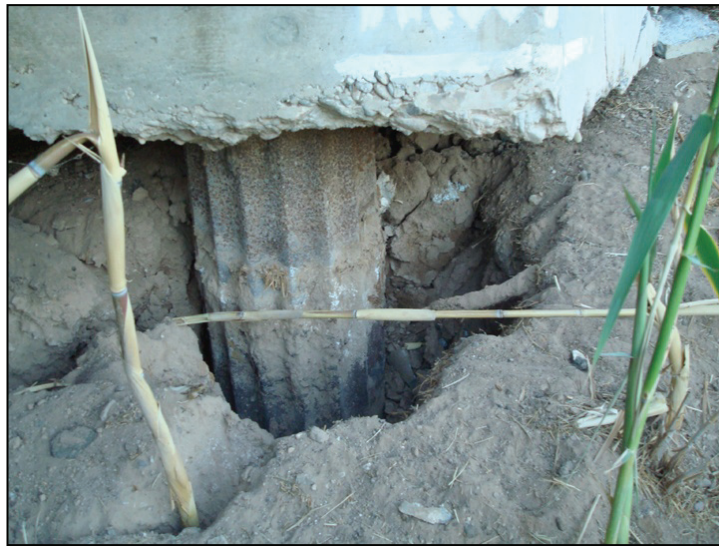
disturbance around the piers suggests significant north-south movement of the bridge structure during the earthquake due to shaking.

**Figure 16.** View of the concrete pier under the northeast corner of the Drew Road Bridge abutment (R07). Soil pushed away from the pier coupled with the battered asphalt on the road above (fig. 15) suggests that the bridge structure experienced large shaking displacements. Note spalled and cracked concrete in the abutment in the upper right corner of photograph. Photo by T. McCrink, 4/8/10.

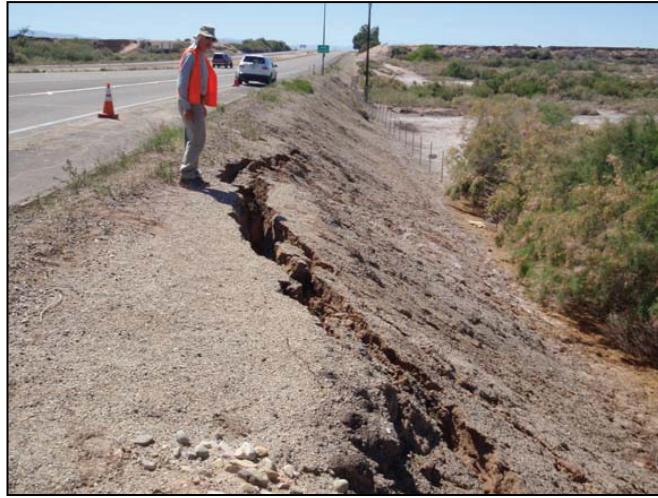
**Figure 18.** Extensional fractures and fill failure on the north side of Interstate Highway 8 and east bank floodplain of the New River, just north of the extensional fractures shown in figure 17 (R08). All deformation here inferred to be due to liquefaction on the basis of the presence of lateral spread fissures and vented sand on the New River flood plain 50 m or less to the west. Photo by J. Tinsley, 4/7/10.

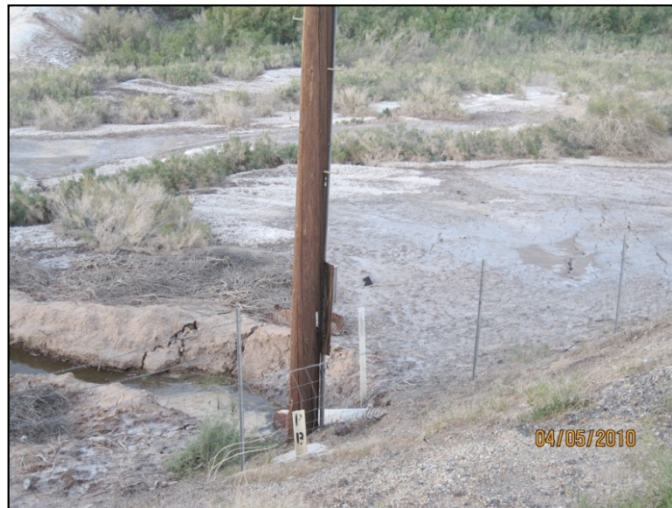
**Figure 19.** Lateral spread fissures and vented sand north of Interstate Highway 8 on the east bank of the New River (R08). These liquefaction features were only 50 m or less from the fill failure and pavement fractures shown in the previous figures, and they strongly suggest that liquefaction is responsible for the deformation of the highway. Photo by E. Seyhan, 4/5/10.

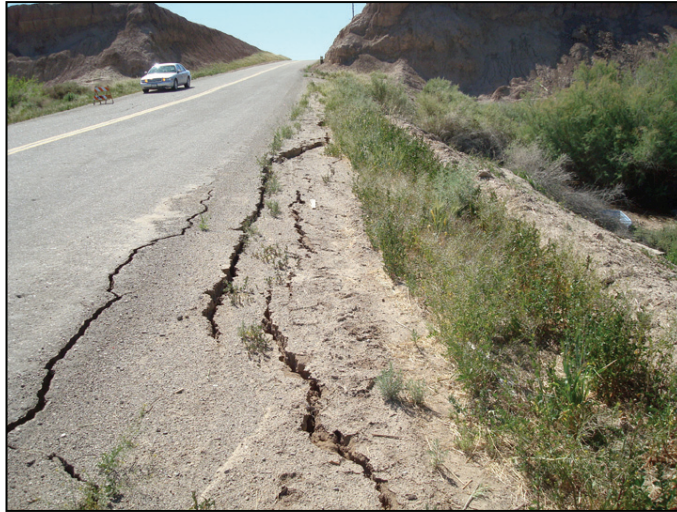
Cracks from lateral spreading were observed on both sides of the west approach fill (fig. 23) but no vented sand was found. The bridge structure recorded movement in response to strong shaking in the form of soil pushed away at the base and sides of the bridge abutments (fig. 24). Additional liquefaction-related features include a series of cracks along and parallel to the river’s bank northeast and southwest of the bridge. On the northeast side, the cracks extend as much as 100 m north of the bridge and a part of the river’s bank slumped into the river with a vertical displacement of as much as 1 m. On the southwest side, river-parallel cracks were found to extend

**Figure 23.** Lateral spreading fissures in approach fill on the northwest side of the Worthington Road Bridge over the New River (R18). Similar fissures were observed on the south side, but no vented sand was found. View is to the west. Photo by T. McCrink, 4/8/10.

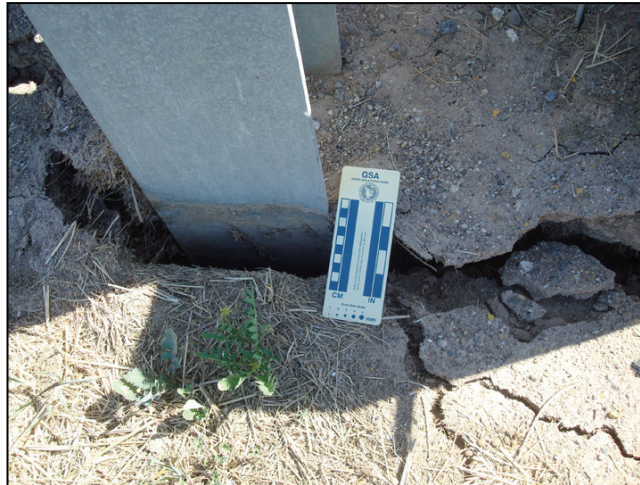
**Figure 24.** Bridge fill pushed away by the Worthington Road Bridge abutment due to strong shaking (R18). Photo by T. McCrink, 4/8/10.

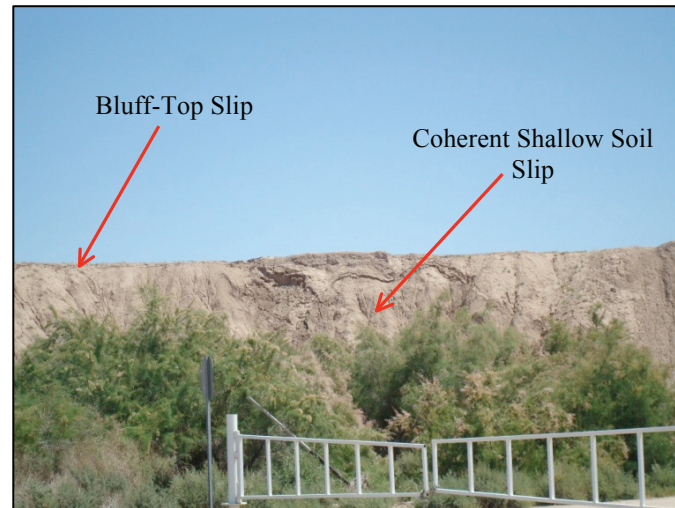
Observations were made at the Forrester Road crossing of the New River, just north of the intersection with Larsen Road. Cracks in road fill and adjacent alluvium along Larsen Road next to the river indicate some minor movement (2 millimeters (mm)) toward the river free face. No vented sands were found. The driven pile foundation of the Forrester Road Bridge appeared undamaged. Shallow soil slips of loose colluvial material were observed on the steep bluffs south and southeast of the bridge. These soil slides occurred as 5- to 20-m-wide coherent crusts of colluvial material with 10 to 30 cm of displacement at their heads, or linear slip cracks at the interface of the colluvial material and well-cemented soil near bluff tops with 5 to 10 cm of displacement (figure 25).

**Figure 25.** Shallow colluvial soil slips on steep slopes southeast of the Forrester Road Bridge over the New River (R22). Photo by T. McCrink, 4/8/10.

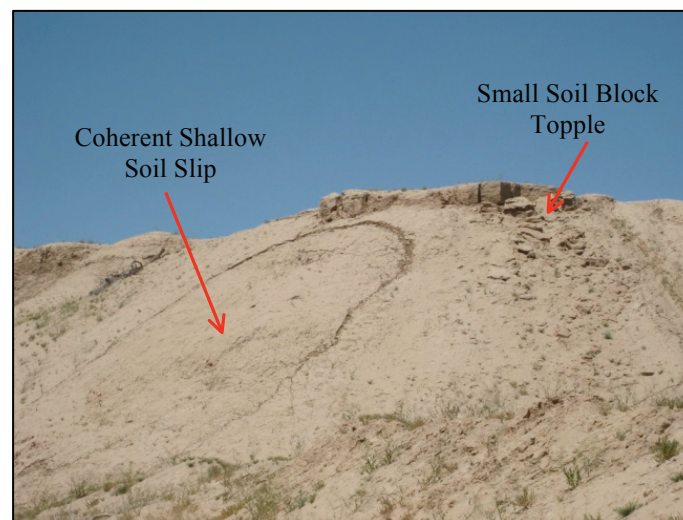
**Figure 26.** View of the roadcut northwest of the Keystone Road Bridge (R23). A shallow soil slip with 10 to 15 cm displacement is evident on the left side of the photo, and a soil block topple is visible on the upper right. Photo by C. Pridmore, 4/8/10.

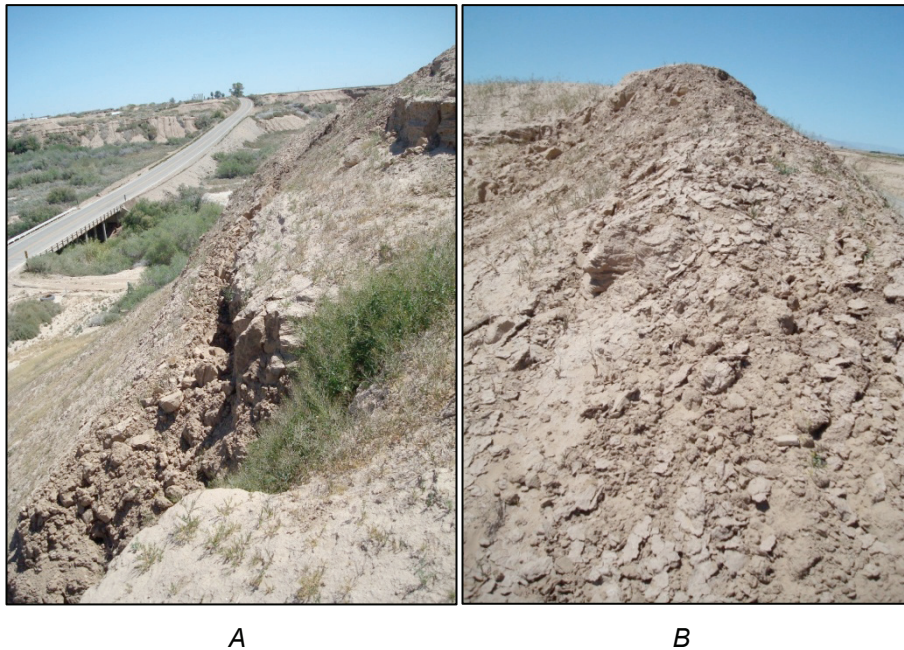
**Figure 27.** Slope effects near the top of the New River bluff at the Keystone Road Bridge (R23). *A*, View of Keystone Road Bridge at the New River with detached mass of colluvial soil in foreground. View to the northeast. *B*, Shattered soil crust on small east-west ridge southwest of the Keystone Road Bridge. Photos by T. McCrink, 4/8/10.

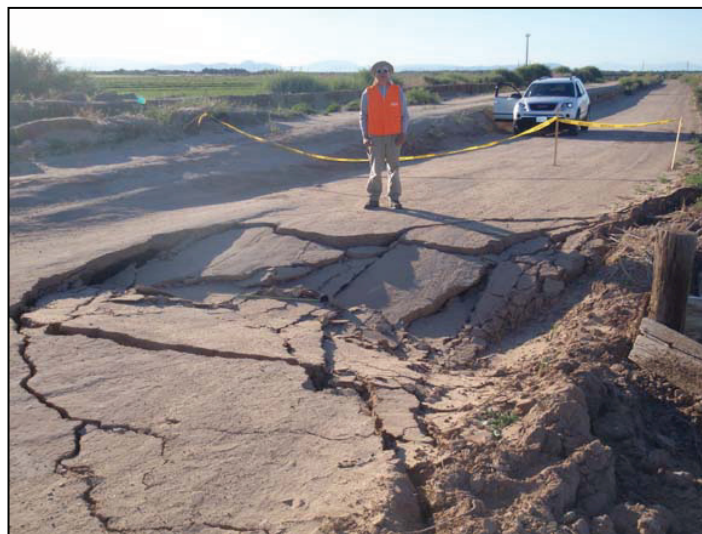
Approximately 450 m south of Highway 98, a part of the Westside Main Canal's western levee collapsed into a void of uncertain origin (fig. 38). An absence of vented sand suggests that the observed ground failure may be ascribed to pre-earthquake piping that caused voids to form beneath the road surface within the levee materials. A nearby well and pump installation also showed evidence of ground settlement.

**Figure 38.** Collapse of the Westside Main Canal's western access road (C05). Undermining of the road surface probably reflects pre-earthquake piping along transverse subgrade structures or other zone of seepage from the canal. No vented liquefied materials were noted in the area. Photo by J. Tinsley, 4/6/10.

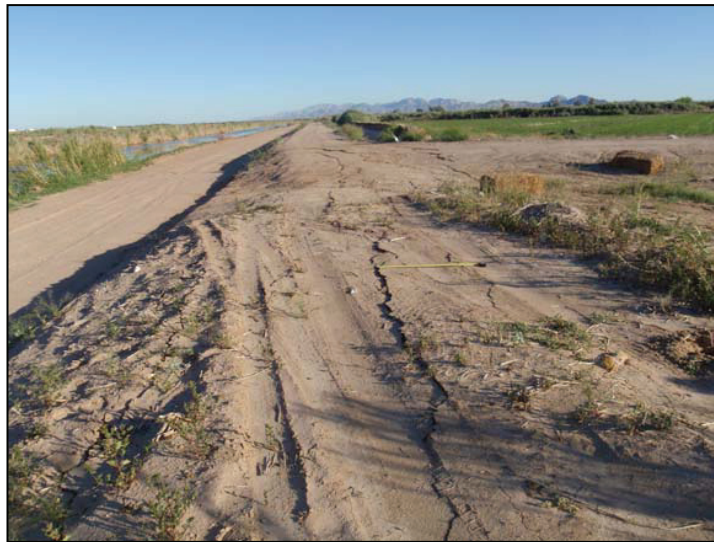
A substantial lateral spread spanned the 19 m width of the west bank levee of the Westside Main Canal and extended into an area of higher ground farther west (fig. 39). These arcuate fractures continue for about 100 m along the channel, and cumulative extensional displacements amounted to about 10 cm at the head of the failure. No vented sand was observed, but liquefaction is a likely cause of the deformation.

**Figure 39.** View of extensional fractures at head scarp of lateral spread crossing the embankment in the foreground and including Westside Main Canal's service road to the left (C06). Riparian vegetation is tilted towards the canal owing to lateral spreading. Photo by J. Tinsley, 4/6/10.

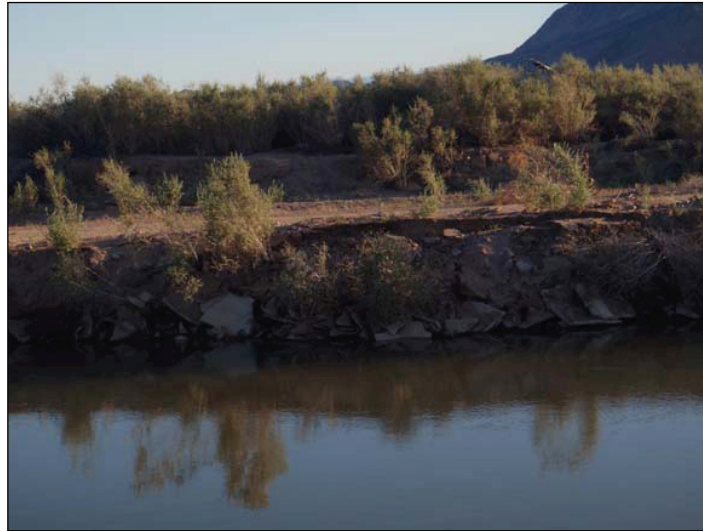
**Figure 41.** Bank failure probably unrelated to liquefaction in the west bank of Westside Main Canal (C08). This style of failure was observed on both sides of the Westside Main Canal for nearly a kilometer north of State Highway 98. Failures seldom extended more than a meter or two into the levee materials and the bulk of the levees remained undamaged. Photo by J. Tinsley, 4/7/10.

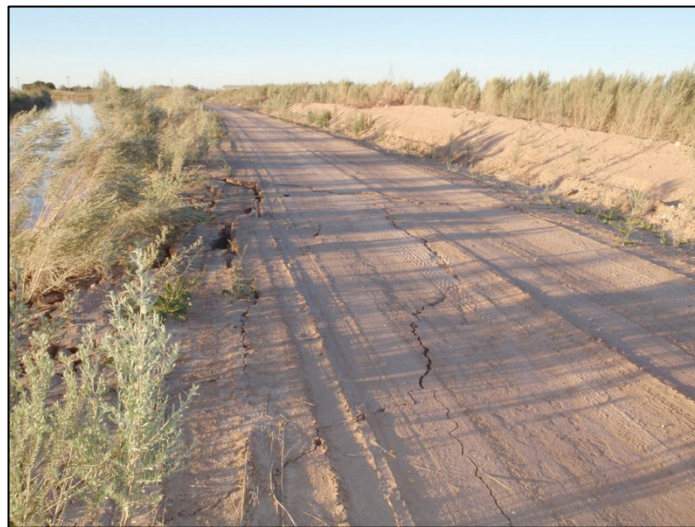
A small ground failure, possibly a lateral spread, was observed (fig. 42). Extensional fractures were open to a depth of 94 cm and one single block shows a maximum differential

**Figure 42.** View to north across inferred liquefaction lateral spread in the east bank of the Westside Main Canal (C14). Extensional fractures are open to 95 cm depth and extend across entire width of Westside Main Canal east service road for tens of m. Photo by J. Tinsley, 4/6/10.

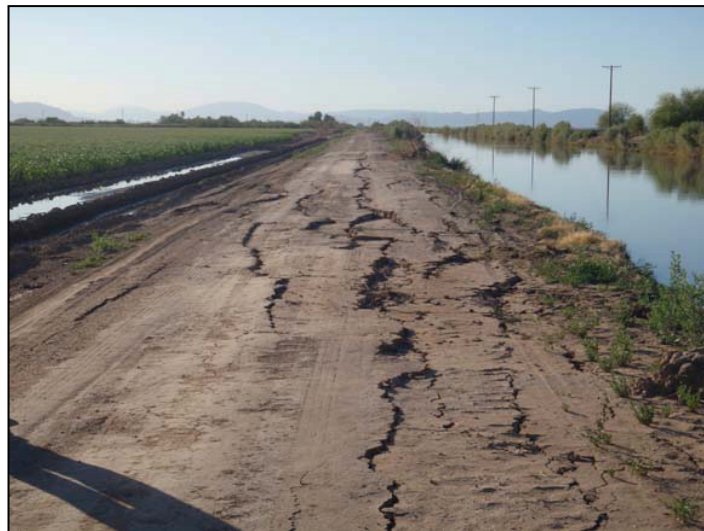
**Figure 45.** View to the northwest along the western levee of the Westside Main Canal showing large lateral spread ground failure that spanned the entire width of the levee (C25). The ground failure extended about 200 m along the levee, and the small in-facing scarplets indicate that the levee mass sank differentially into a liquefied substrate. Photo by J. Tinsley, 4/7/10.

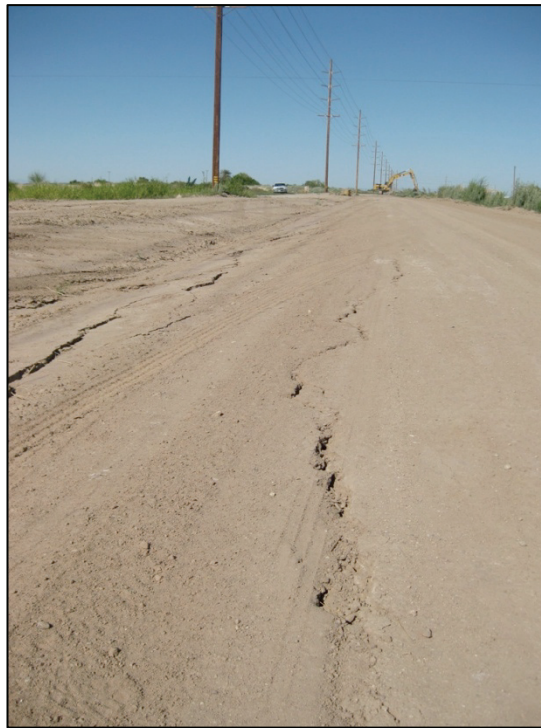
offsets extended through the entire levee road, which is approximately 10 to 12 m wide in this area (fig. 56). Vented sand was not observed, but liquefaction is inferred from the nature of the failures. On April 8, 2010, a track-mounted excavator was just beginning to make repairs to the shallow bank failure along this section of levee.

**Figure 56.** View to the northeast of fractures running through the outer edge of the Westside Main Canal levee road (C51). Extensional and vertical displacements are one to several centimeters with displacement downward and toward the canal. Photo by C. Pridmore, 4/8/10.

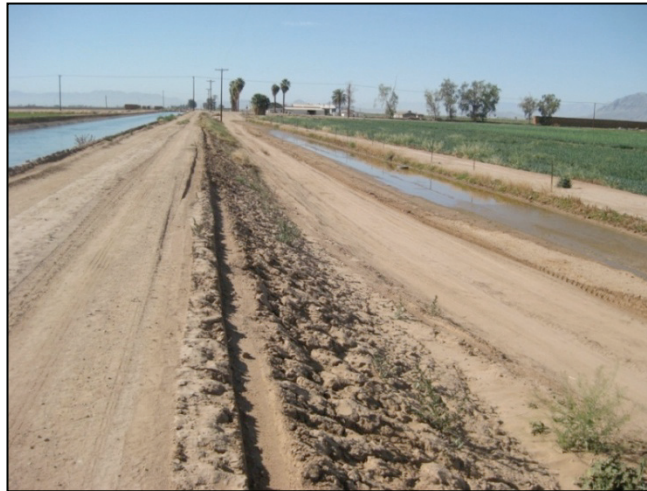
The Eucalyptus Canal was the only irrigation canal that exhibited clear evidence of water seicheing over the canal levee. This evidence was observed in two places, the first along a 150 m length north of McCabe Road (fig. 67). Surface soils on the west levee clearly showed the effects of water flow, and a large puddle of water was still on the adjacent Nichols Road one week after the earthquake.

**Figure 67.** View to the southwest along Nichols Road showing ponded water in a low lying area along Nichols Road (C40). This area is located approximately 150 m north of McCabe Road, which is marked by the trees in the background. Soils on the outer levee side that have not been disturbed by postearthquake traffic show erosion caused by water flow. Photo by C. Pridmore, 4/11/10.

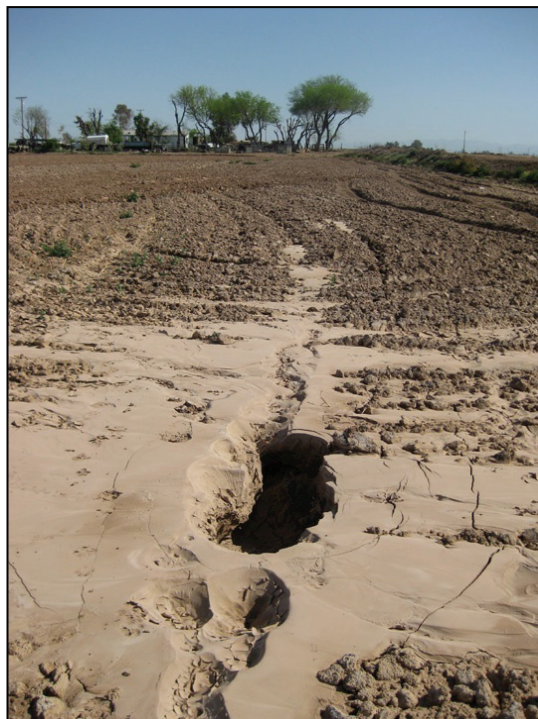
**Figure 75.** Large sand boil that formed along a fissure on the east side of the Rosita Canal (C56). The sand boil has an unusually large crater and the concentric cracks suggest subsequent caving. View to the south; the Rosita Canal is to the right of the picture. Photo by C. Pridmore, 4/11/10.

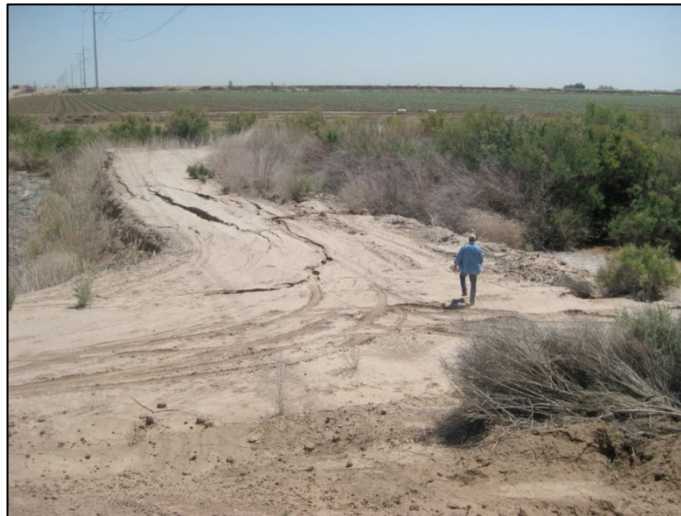
**Figure 78.** View to the east across Greeson Drain at liquefaction lateral spread fissures in the access road fill prism (D03). The full width of the road fill settled and the northern two-thirds spread to the north. Photo by C. Pridmore, 4/9/10.

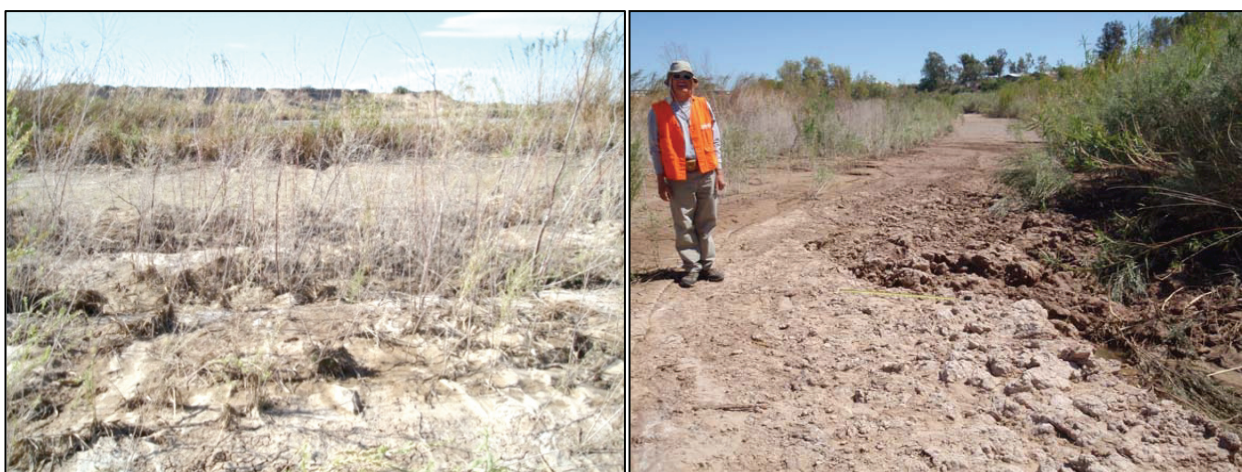
**Figure 82.** Depositional and erosional features resulting from seiche wave overtopping of Fig Lagoon levee (D10). A, Sand deposition and flow features on the Fig Lagoon levee as a result of overtopping by seiche waves. Water flow came toward the photographer. Lateral spread slump is in the middle background; Fig Lagoon is beyond riparian vegetation on the outer edge of the slump. Photo by T. McCrink, 4/10/10. B, Outwash channel eroded into the Fig Lagoon levee adjacent to the New River. Lateral spread slump shown in figure 80 is immediately left of this photo, and the New River is immediately to the right. Photo by J. Tinsley, 4/7/10.

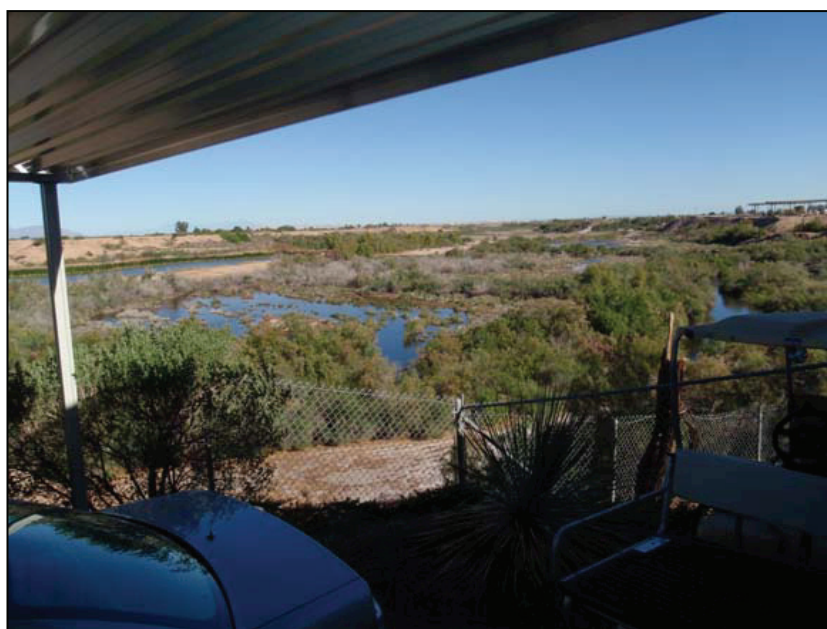
**Figure 83.** View to north and west from the upland east of the New River channel, showing flooding of the New River floodplain between Fig Lagoon, upper left, and the New River, middle right (D10). Photo by J. Tinsley, 4/7/10.

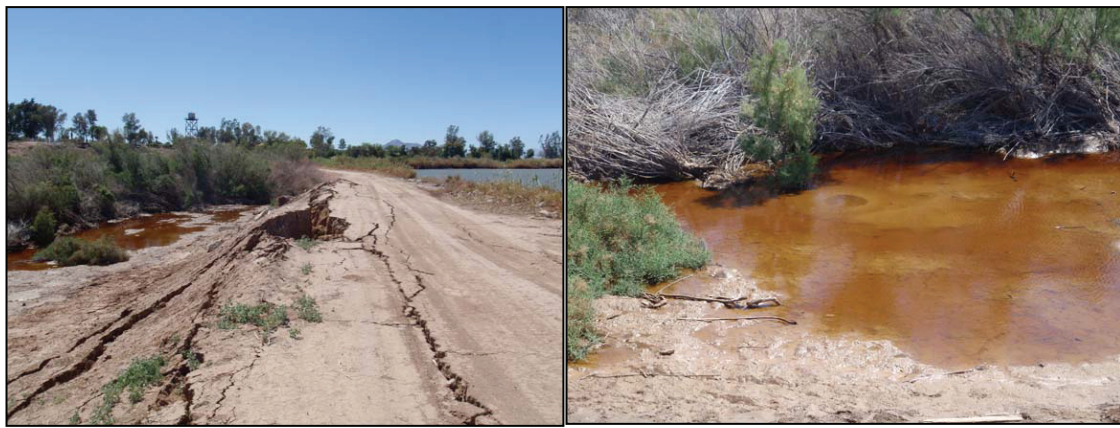
**Figure 84.** Zone of liquefaction-triggered ground failure in Fig Lagoon levee 175 m north of the slump and overflow channel depicted in preceding photos (D10). A, Scarps in the levee indicate that differential subsidence into a liquefied substrate probably occurred. B, Sand boil deposits presently underwater atop late Holocene floodplain deposits of New River at Fig Lagoon. Preservation of vented materials is morphologically excellent, indicating that a subaqueous eruption is probable. Photos by J. Tinsley, 4/7/10.

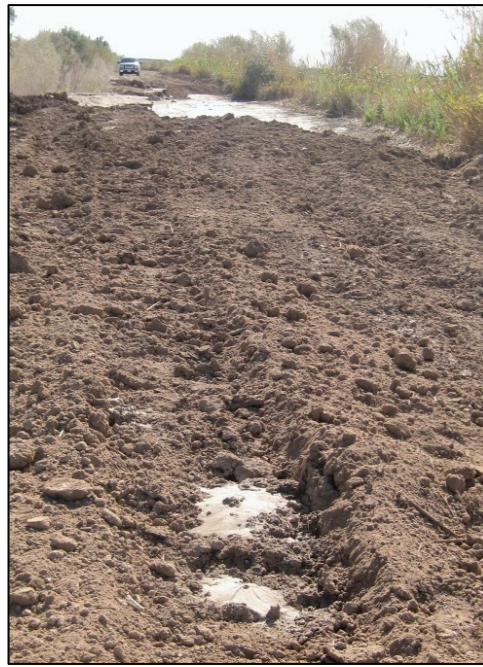
exception was the large slump that caused the levee breach. Aftershock-driven liquefaction on the levee had already produced vented sand on some portions of the regraded levee (fig. 86).

**Figure 86.** Vented sand (bottom center) on a recently regraded levee next to Fig Lagoon, indicating that liquefaction of saturated soils continued to occur during aftershocks (D10). Fig Lagoon lies to the right of the vegetation in the upper right. Wet area between graded material in the foreground and vehicle in the background is where lateral spreading and overtopping of lake water occurred (figs. 80 and 81). Photo by C. Pridmore, 4/10/10.

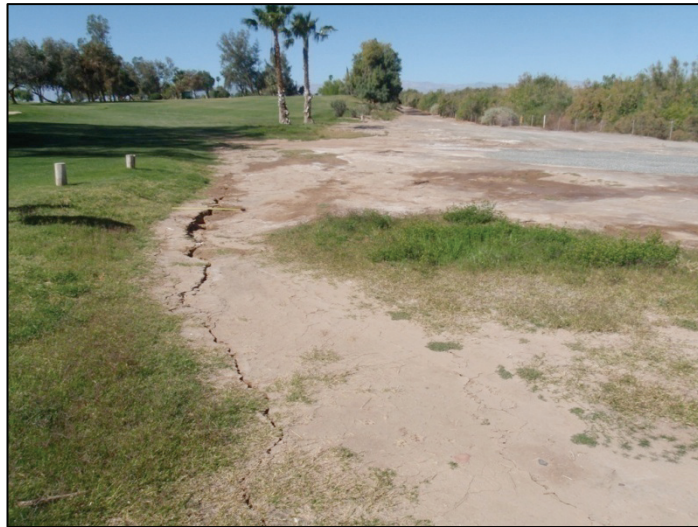
Liquefaction lateral spreading was found on the north side of the golf course adjacent to the New River, across the river southeast of the main levee breach between Fig Lagoon and the New River (see fig. 80). This arcuate spread displaced the ground about 15 cm horizontally to the northwest, toward the active channel of the New River, and included both fill and recent alluvium of the New River. Vented sand, still wet three days after the earthquake, was found near the upper parts of this spread (fig. 87).

**Figure 87.** Liquefaction lateral spread west of the Rio Bend RV Park (D11). Golf course on the left and New River active channel is at the right immediately beyond the line of riparian vegetation. A horizontal extension of about 15 cm was measured. Wet vented sand, dark brown in the photo, was observed here, 3 days after the mainshock. Photo by J. Tinsley, 4/7/10.

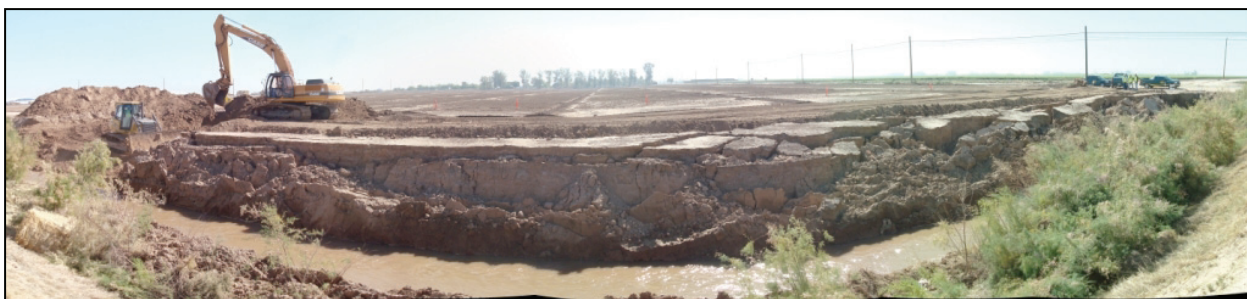
Repairs to the lateral spread were underway at the time of the visit (April 9, 2010) and were concentrated on the east bank of the Rice Drain (fig. 89). According to the owner of the field, the west-facing bank of the drain was transported across the drain, depositing salt cedar bushes on the opposite bank. The road on the east bank was severely disrupted by open fissures reported to have been as much as 1 m wide and 30 cm deep prior to the start of repairs (fig. 90). The operator of the

**Figure 89.** Panoramic view of the lateral spread at Evan Hewes Highway (on the right along the line of telephone poles) and Rice Drain No. 3 (foreground) (D12). Repairs underway on the left consist of excavation and replacement of the levee materials. Photos by T. McCrink, 4/9/10.

sheepsfoot roller working on the repair reported that when he turned on the roller's vibrator, water squirted out of the ground and his roller sank to a depth that required a bulldozer to pull it out.

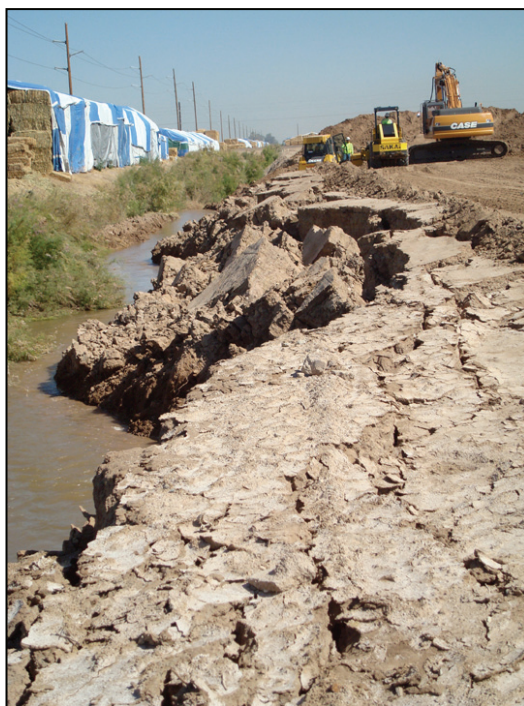
**Figure 90.** View looking north at the lateral spread into the Rice No. 3 Drain (D12). Owner of the agricultural field reported that the salt cedar bushes now on the west bank were on the east bank before the earthquake. Photo by T. McCrink, 4/9/10.

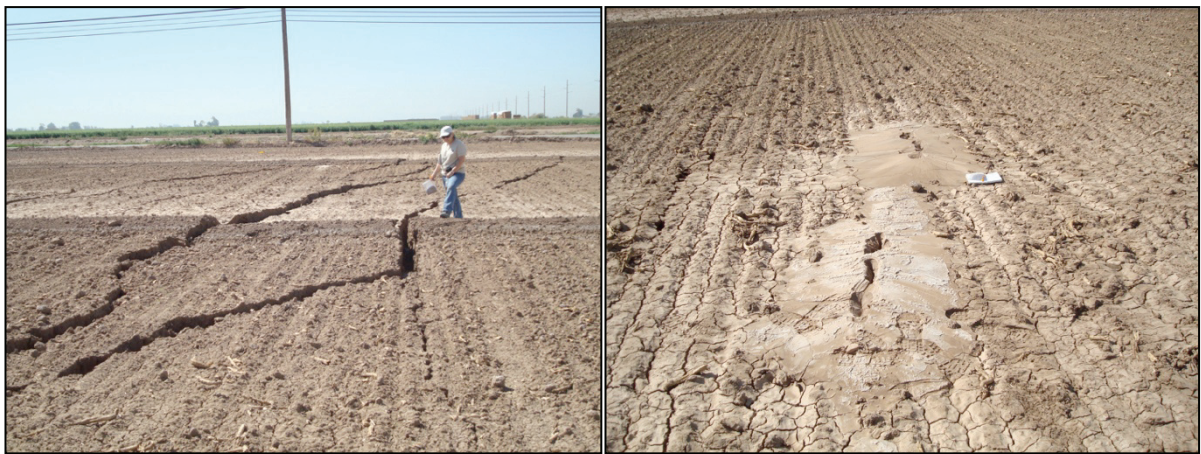
The eastern portion of the lateral spread manifested as a series of arcuate cracks and several sand boils (fig. 91). The sand boils were generally not associated with the fissures, but vented from within soil blocks between them. However, all cracks wide enough to see into were filled to various depths with liquefied silty sand. The fissures showed extensional movement from a few mm to 30 cm wide and a vertical displacement as much as 20 cm.

Discussions with the land owner revealed that clay tile drains that are typically installed in most agricultural fields in the area were not installed in the westernmost 150 m of this field. These drains are usually placed at depths of 2 to 3 m at regular intervals. It may be that the absence of these drains contributed to liquefaction at this location by enabling shallow groundwater to persist after irrigation.

**Figure 91.** A, Arcuate lateral spread fissures and B, vented sand near the eastern extent of the lateral spread at Rice Drain No. 3 (D12). Photos by T. McCrink, 4/9/10.

Samples of sand vented on the surface and material that flowed into one of the major cracks were collected, and grain size analyses are presented in appendix A (Sample IDs IMC–163 and IMC–164, respectively).

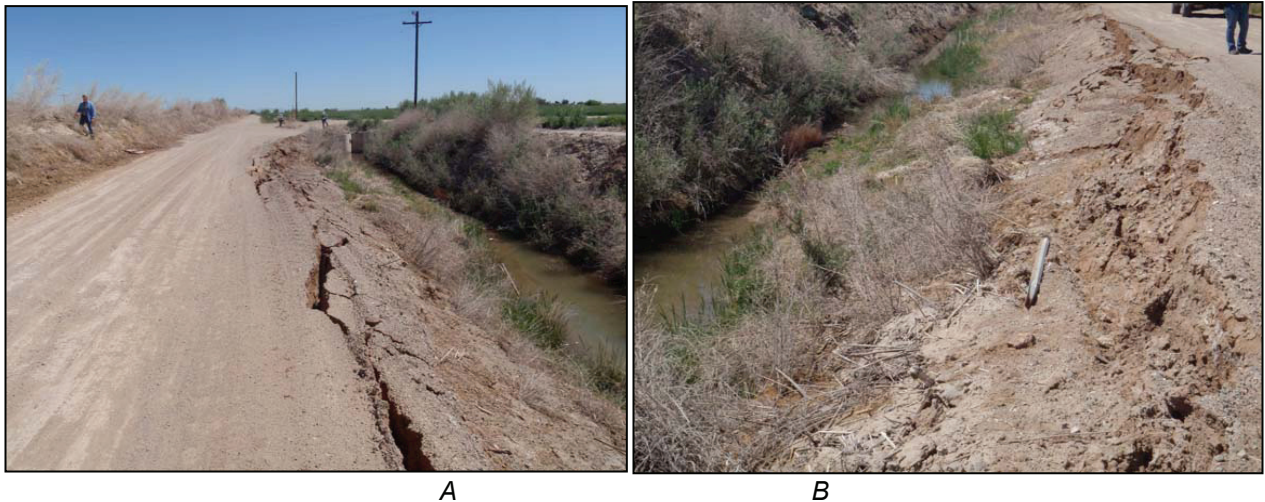
The northernmost inferred liquefaction was found as a slump into Cook Drain along Fites Road, approximately 350 m east of where Urquhart and West Carter roads intersect. This location is adjacent to the southeast levee of the Westside Main Canal, and the surface of Fites Road is approximately 2 m lower than the levee top. The slump extended along Cook Drain for 40 to 50 m, dropped the edge of Fites Roads as much as 1 m, and the toe of the slump in two places flowed across the width of the drain channel impeding water flow (fig. 92). The slump corresponded to a stretch of the Westside Main Canal levee that was wet and had enough seepage to create a puddle on Fites Road (fig. 93). A road caution sign was lying on the ground near the puddle water on Fites road and showed indications of having been there for a long time, suggesting that seepage at this location has been prevalent for a while. The correspondence of the seepage zone with the slump and the morphology of the slump itself suggest that seepage extended beneath Fites Road, creating the opportunity for liquefaction to contribute to the triggering of the slump.

**Figure 92.** A, View to northeast showing probable lateral spread ground failure into Cook Drain along Fites Road (D15). Wet sediment noted on west side of the road is believed to be seepage from Westside Main Canal, located to the left of the photo. Slump displacement is to the right; it visibly narrows the channel in the middle of the image. B, View of toe of slope failure where it partially blocks flow within the Cook Drain. Ground failure narrowed the channel at two different points along the zone. Photos by J. Tinsley, 4/8/10.

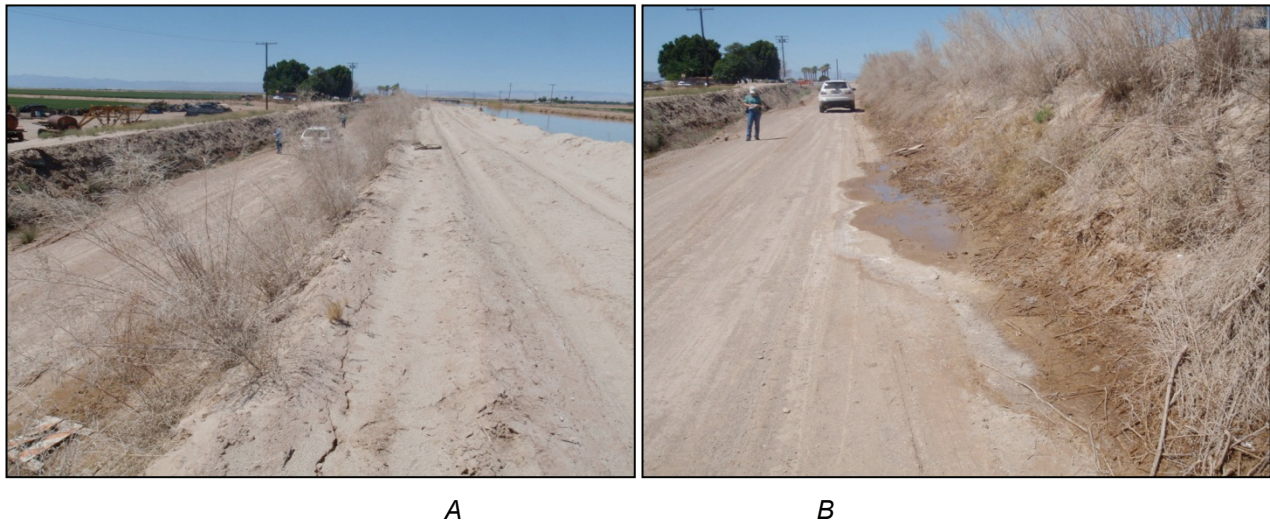
**Figure 93.** A, Overview of southeast levee confining the Westside Main Canal adjacent to Fites Road, showing minor extensional cracking at the outer edge (D15). Extensional cracking extended for a fraction of the length of the slope failure adjacent to the drainage channel at left. No vented liquefied materials were observed along the Westside Main Canal levee. B, View to southwest along Fites Road showing seepage from the Westside Main Canal, which created a puddle of standing water on Fites Road. Photos by J. Tinsley, 4/8/10.

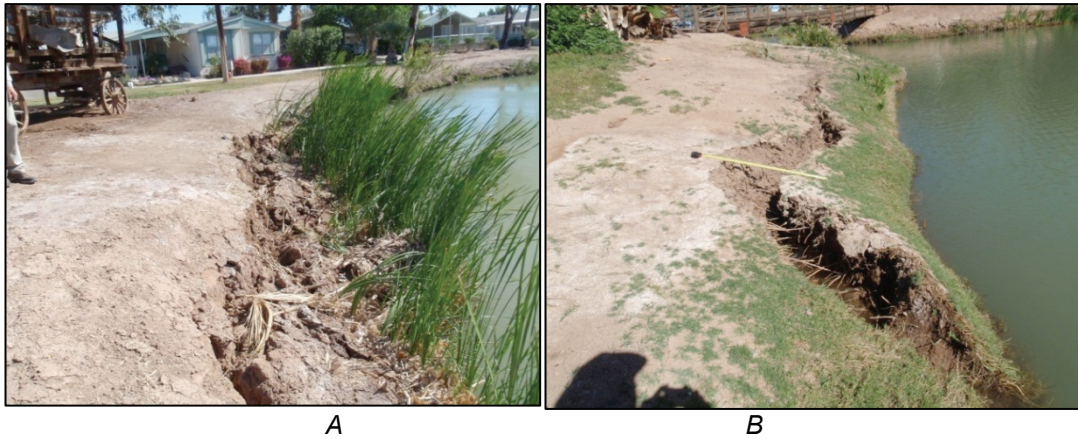
A small man-made lake at the Rio Bend recreational vehicle (RV) Park experienced two small bank failures, which may be related to liquefaction, and some clearly liquefaction-related lateral spreading on the southwest side of the lake. The small bank failures occurred on the north and south sides of the lake, and on the east side where the lake narrows and is crossed by a bridge. Both features are suggestive of having been caused by liquefaction, but no vented sand was observed (fig. 94). Maximum extensional displacement was measured at roughly 52 cm. Lateral spreading with associated vented sand was observed at the edge of pavement near the southwest side of the lake, and similarly oriented small cracks were observed in the asphalt pavement (fig. 95). Separation amounting to less than a centimeter was observed between the asphalt and a concrete verge on the south side of the deformed pavement.

**Figure 94.** Bank failures around Rio Bend RV Park Lake (F01). *A*, Bank failure on the north side of the lake. *B*, Bank failure on the south side. This failure extended underneath the footbridge seen in the distance. Photos by J. Tinsley, 4/7/10.

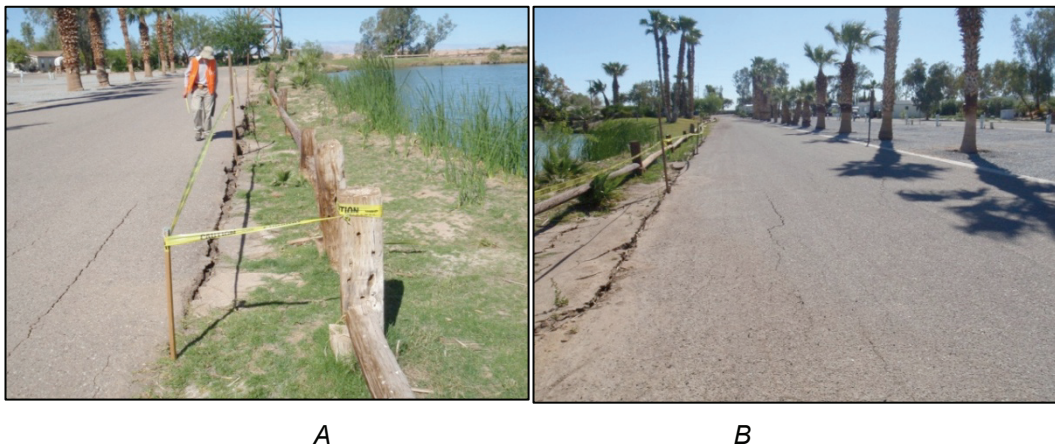
**Figure 95.** Liquefaction lateral spread at the southwest side of the Rio Bend RV Park Lake (F01). *A*, View to the west; deformed asphalt pavement and adjacent fence. Liquefied fine silty sand vented from fracture that opened along northern limit of paving. *B*, View to the east showing an echelon extensional crack in asphalt pavement and the open extensional fissures at the left of photo. Photos by J. Tinsley, 4/7/10.
