# **Liquefaction and Other Ground Failures in Imperial County, California, from the April 4, 2010, El Mayor-Cucapah Earthquake**

By Timothy P. McCrink, Cynthia L. Pridmore, John C. Tinsley, Robert R. Sickler,  
Scott J. Brandenburg, and Jonathan P. Stewart

**CGS Special Report 220**  
**USGS Open File Report 2011-1071**  
**Version 1.0**

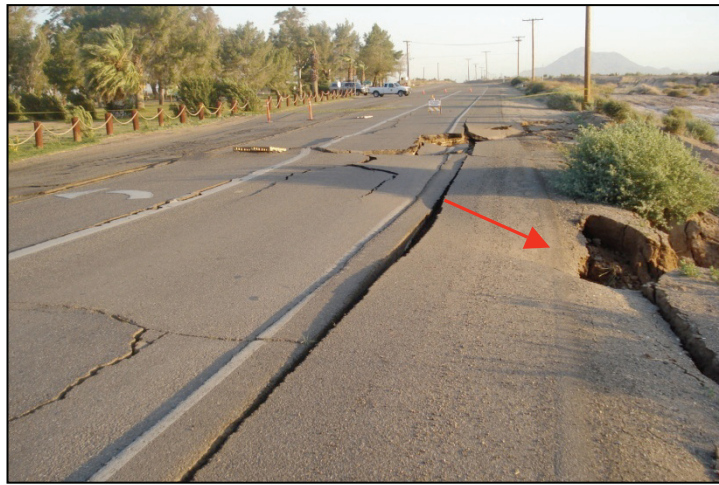
Earthquake shaking from the mainshock on April 4 caused liquefaction of the dam crest, of the gently sloping embankment between the dam crest and Drew Road, and in Drew Road fill materials (fig. 97). The Sunbeam Lake park ranger witnessed water geysering through the asphalt surface of Drew Road, and photographs taken soon after the earthquake show both settlement and lateral displacement of the road (fig. 98). Unfortunately, the road had been leveled with dirt by the time any postearthquake investigators arrived, and no displacement could be measured. The road fill above the outlet pipes was washed away by water flow through the embankment soon after the earthquake (fig. 99), exposing several types of utilities and breaking at least one of them. It was reported that a gas main was also located in the roadbed on the east side of Drew Road.

**Figure 98.** Liquefaction-related settlement and lateral spreading of Drew Road, immediately west of Sunbeam Lake Dam (R12). View is toward the south with El Centinela Peak in the distance. An eyewitness reported water geysering out of the pavement during the earthquake. Outlet pipes from Sunbeam Lake and from a large irrigation drain enter the stream to the right of the prominent slump in the center-right of the photo, indicated by the arrow. Both apparently were damaged by liquefaction. Photo taken 4/4/10; courtesy of the Imperial County Planning and Development Services Department.

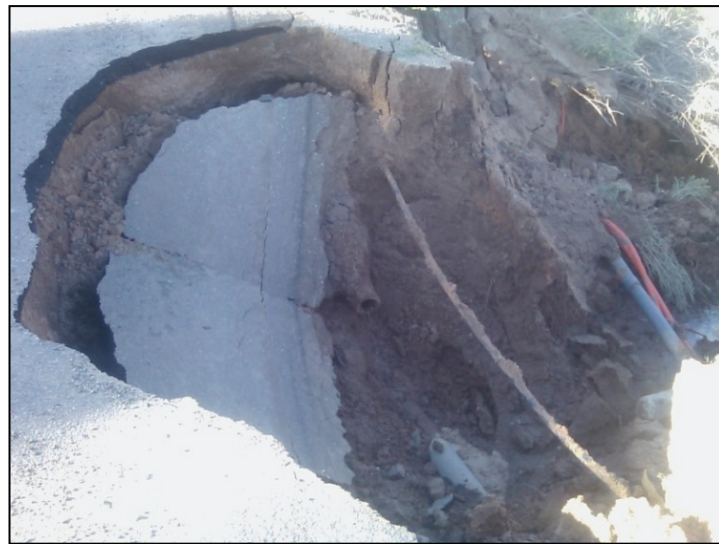
**Figure 99.** Close-up of the slump on the west side of Drew Road mentioned in the previous photo (R12). Several utility lines are exposed and some are broken. The outlet flow from Sunbeam Lake and probably the Seeley irrigation drain are just visible on the right. Photo courtesy of Imperial County Planning and Development Services Department.

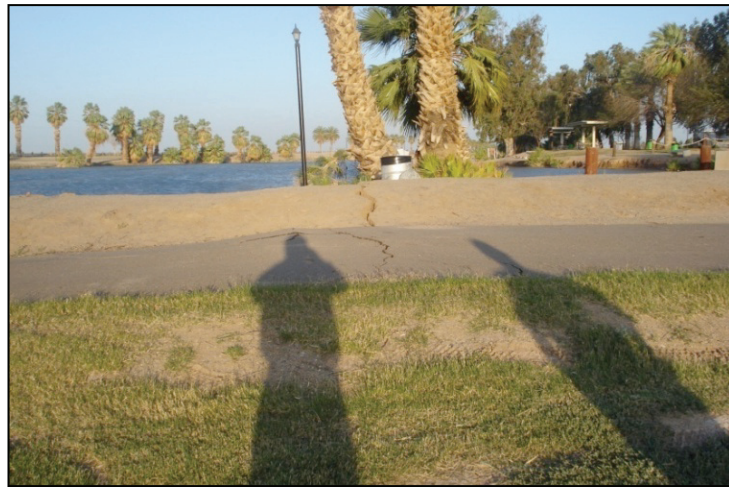
The south half of the dam crest settled vertically between 15 and 30 cm and the upstream face spread toward the lake (figs. 100, 101 and 102A). Arcuate cracks at the north end of the dam

**Figure 100.** View of the south end of the Sunbeam Lake Dam crest, looking east (F02). Photo was taken soon after the earthquake. Dam crest to the left has dropped 15 to 30 cm relative to the area to the right of the large crack in the center of the photo. Photo courtesy of Imperial County Planning and Development Services Department.

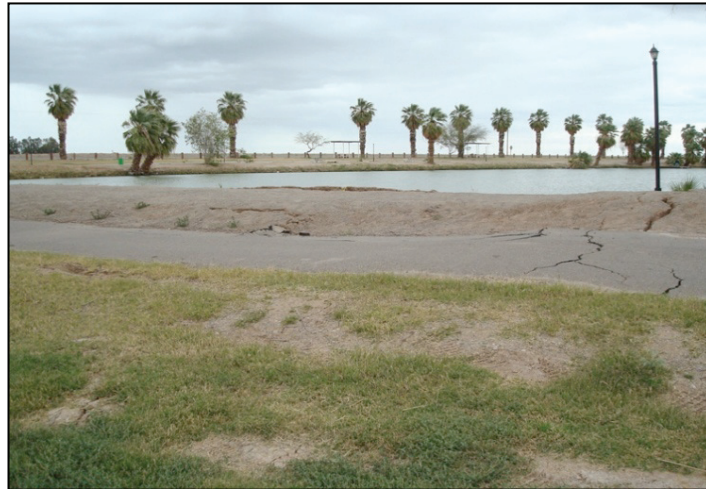
**Figure 101.** View of the south end of the Sunbeam Lake Dam crest, looking northeast (F02). Photo was taken 8 days after the earthquake. Transverse crack on the crest is larger and new cracks parallel to it are now visible. Cracks in asphalt are more pronounced and several newly visible cracks extend into the lawn area. The continued deformation may be the result of a week of strong aftershocks. Photo by T. McCrink, 4/12/10.

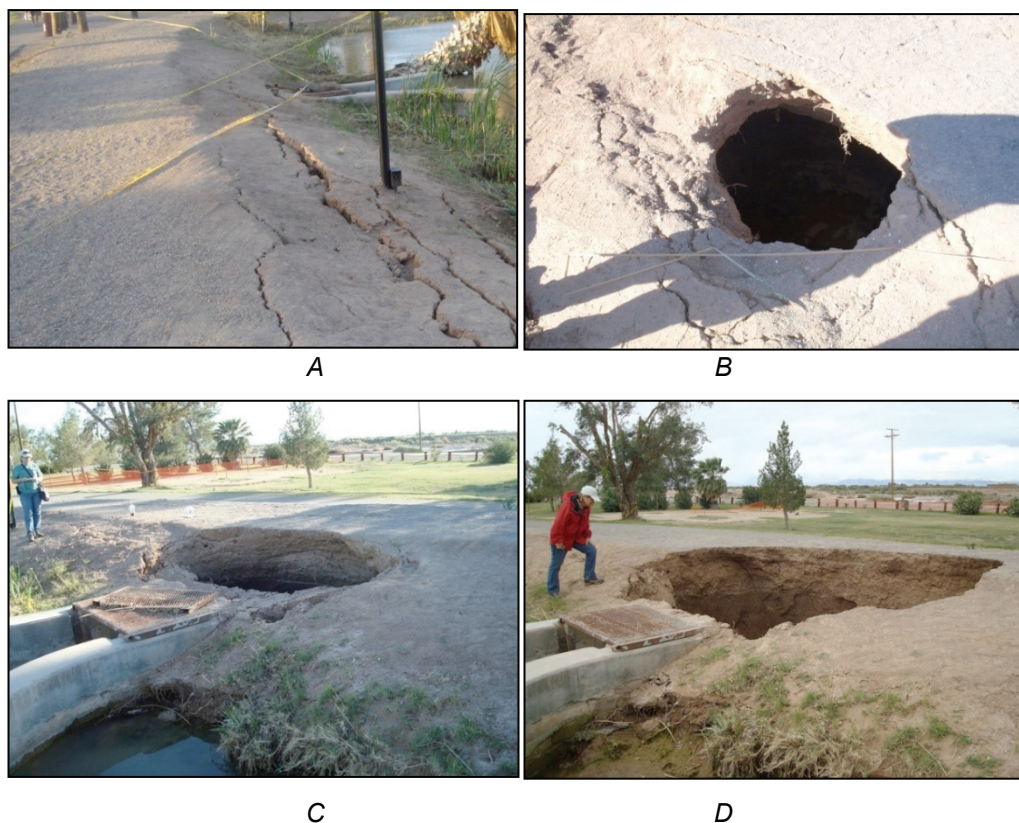
Liquefaction-related settlement and lateral spreading of the dam crest disrupted the outlet pipes near the lake outflow weir structure. Water flowing outside of the pipes and through the

embankment began piping away embankment soils leading to the development of a sinkhole on the dam crest (fig. 102). After a week, the sinkhole had grown to an estimated 15 m<sup>3</sup> depression on the top of the dam and threatened its integrity. On April 20, 2010, after field work had ceased, the assistant director for Imperial County Public Works informed one of the authors of this report (McCrink) that the dam outlet had been repaired by excavating to a depth of 6 m and replacing three sections of pipe (fig. 103). On June 8, 2010, McCrink had the opportunity to revisit the Sunbeam Lake dam and found repairs included those described by the county to the outlet, placement of concrete rubble on the upstream side of the dam, repairs to the outlet pipe on the west side of Drew Road, and regrading of the dirt access roads on both sides of the drain west of Drew Road. However, as of September 15, 2010, Drew Road was still closed and waiting for repairs.

**Figure 102.** Time sequence photographs of a sinkhole that formed on the Sunbeam Lake Dam (F02). *A*, The dam crest and outlet weir on the day of the earthquake. Photo courtesy of Imperial County Planning and Development Services Department. *B*, Early stage of sinkhole formation on the morning of 4/7/2010; the person whose shadow partly covers the sinkhole is standing on the outlet weir. Photo by J. Tinsley. *C*, Sinkhole on the evening of 4/8/2010. Photo by T. McCrink. *D*, Sinkhole on 4/12. Photo by T. McCrink.

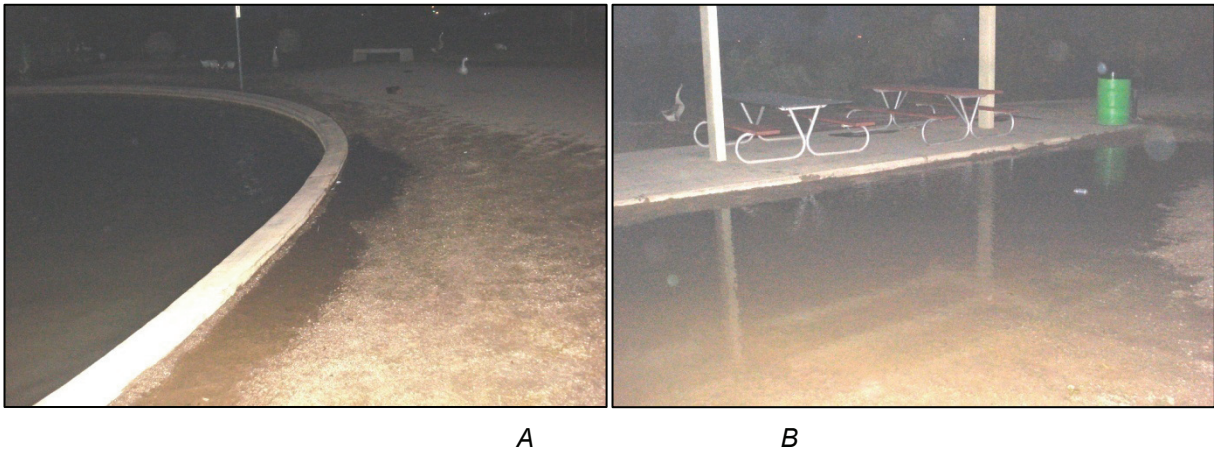
Seicheing was also observed at Sunbeam Lake Park. According to the county's park ranger, the swimming pool on the south side of the lake sloshed enough water to flood the surrounding picnic areas and nearby restrooms (fig. 104). In addition, the banks of the lake are shown to be wet in photographs taken by Imperial County personnel in the evening after the earthquake (fig. 105). In order to wet the banks of the lake, seiche waves had to be locally on the order of half a meter high.

**Figure 104.** Standing water resulting from earthquake-generated seiche waves at Sunbeam Lake Park (F02). *A*, Photograph of the swimming pool south of Sunbeam Lake. Wet area shows the extent of the water that sloshed out of the pool. *B*, Picnic area adjacent to the pool flooded by water sloshed out of the pool. Photos courtesy of Imperial County Parks and Recreation; taken 4/4/10.

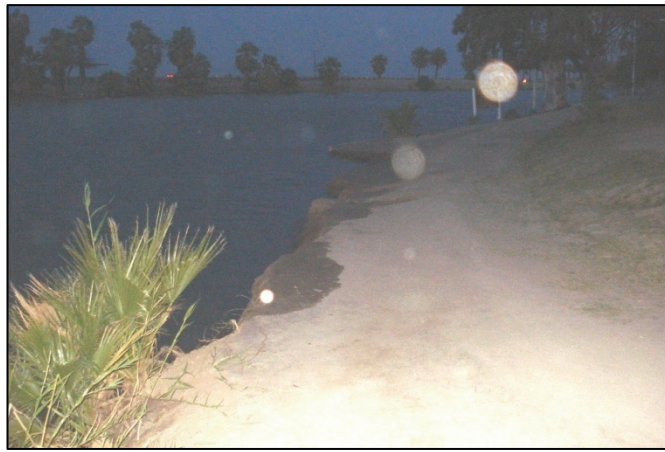
**Figure 105.** Photograph of the south bank of Sunbeam Lake (F02). Wet areas, shown as dark soil at the edge of the dirt path, indicates where water splashed out of the lake. The steep sides of the bank are on the order of 0.5 m high. Photo courtesy of Imperial County Parks and Recreation; taken 4/4/10.

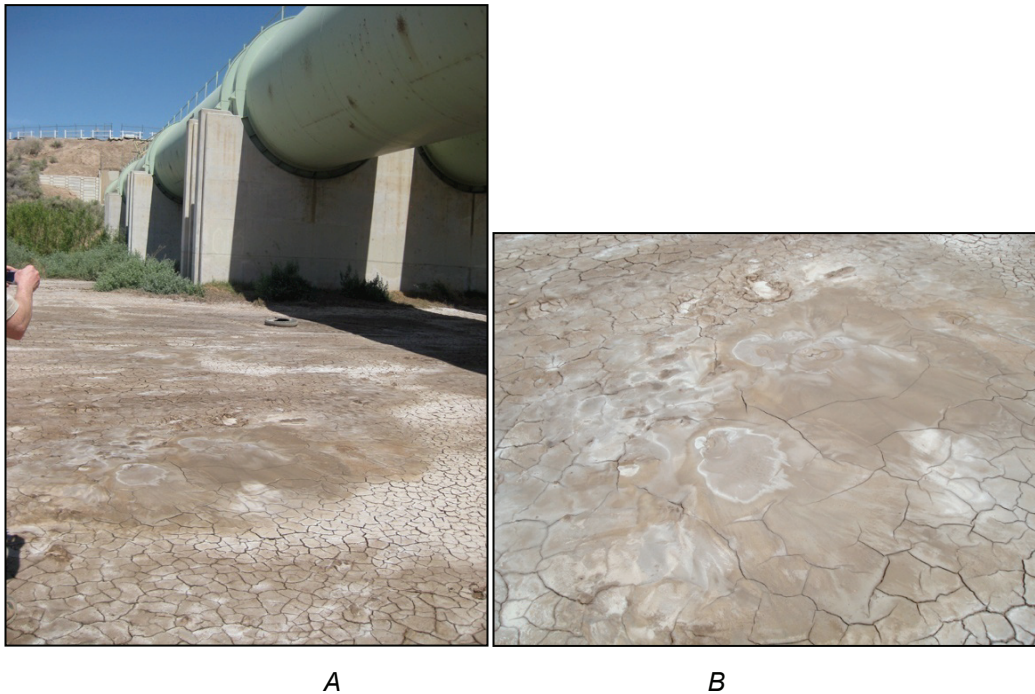
The All American Canal crosses the New River through a closed aqueduct system composed of two approximately 4-m-diameter pipes, which are elevated above the riverbed by four massive, rectangular concrete supports (fig. 106). By April 10, 2010, when the site was visited, much of the flat floodplain area of the New River had been graded. However, considerable evidence of liquefaction in this area was still observed. A 30-m-wide lateral spread slump were seen on the south bank of the New River 150 m upstream from the aqueduct. Sand boils were found in nearly all flood plain areas left ungraded around the aqueduct, particularly underneath and west of the structure. Vented sand was characterized by very fine grained ejected material, often displaying shrinkage cracks, in relatively small volumes (fig. 106). At the base of one concrete support, a linear string of these fine-grained sand boils paralleled the support structure, suggesting

**Figure 106.** Liquefaction vented sand near the All American Canal aqueduct over the New River (F03). Relatively low volumes of fine-grained ejected material characterize the sand boils in this area. *A*, View of vented sand on the New River flood plain, looking northeast toward the aqueduct. Photo by C. Pridmore, 4/10/10. *B*, Close-up of vented sand. Photo by T. McCrink, 4/10/10.

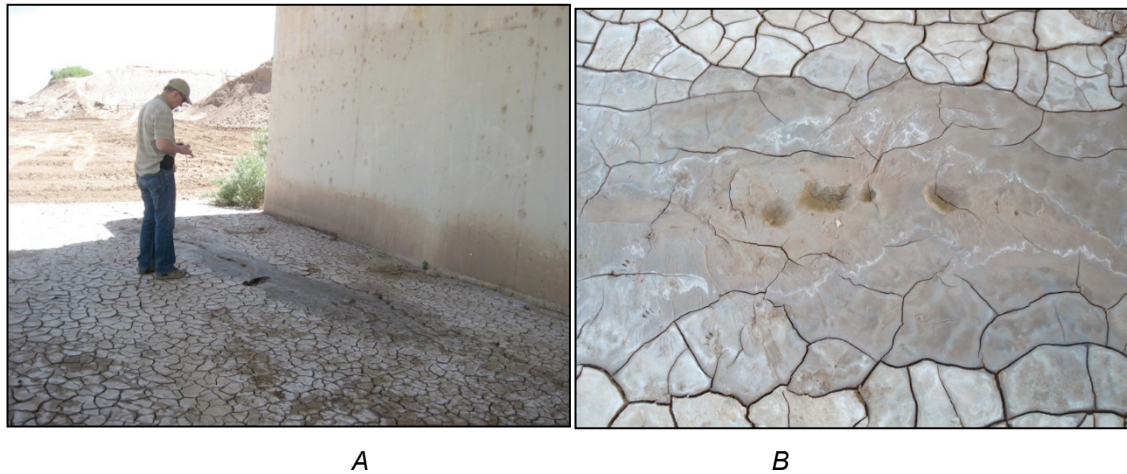
some influence of the structure on liquefaction at this location (fig. 107). A timber bridge crossing the New River east of the aqueduct (R15) was closed on April 10, 2010, but the damage that caused the closure was not readily discernible.

**Figure 107.** Liquefaction sand boils near the base of one All American Canal aqueduct support structure (F03). A, Line of sand boils parallel to the support structure. Photo by C. Pridmore, 4/10/10. B, Close-up of the vented fine sand. Note desiccation cracks forming in ejected material. Photo by T. McCrink, 4/10/10.

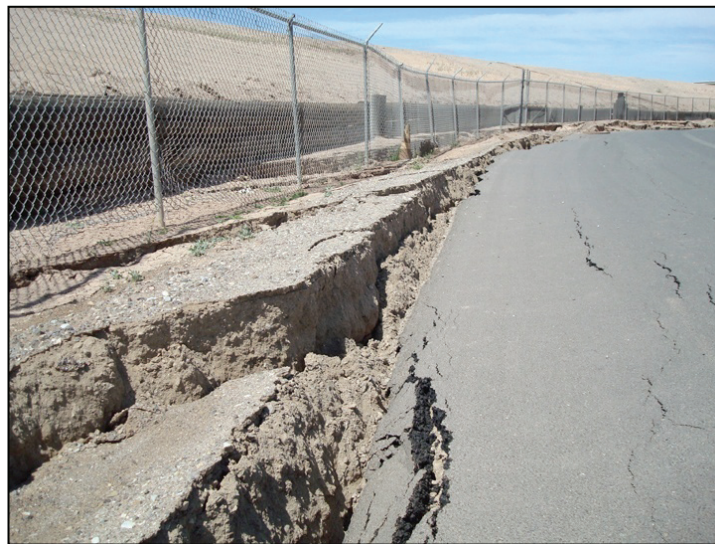
Liquefaction damage to the access road extends for a distance of about 350 m with the greatest damage in the central portion where the road curves. Cumulative vertical displacement on the inboard (southwest) side of the road may be as much as 1 m maximum, and horizontal displacement is on the order of 20 to 30 cm (figs. 109 and 110). No evidence of slump and spread movement at the base of the road embankment was found along the southeast half of the damaged access road, perhaps because it was masked by rubble piles. Additionally, no evidence of cracking or sand boils was observed on the flood plain immediately northeast. Damage to the outboard (east-northeast) side of the road was not apparent except where the road adjoins a large nonengineered fill lying to the east-northeast (fig. 108). Here, uphill-facing scarps with less vertical displacement than on the inboard side indicate both settlement and rotation of the road fill prism. Geotextile was found in road base beneath asphalt in an exposed crack on the northeast side of the road, and this may explain why the pavement did not experience the same intensity of damage as the sides of the road. It was reported that this road was reconstructed and paved in the last four years.

**Figure 109.** Liquefaction lateral spread and slump of waste water treatment plant access road (F04). A matching but smaller uphill-facing scarp on the other side of the road indicates that the soil under the pavement settled and rotated. Geotextile was observed in exposed road base, which may have helped keep pavement from experiencing the intensity of fissuring observed on the sides of the road. View to the west. Photo by T. McCrink, 4/10/10.

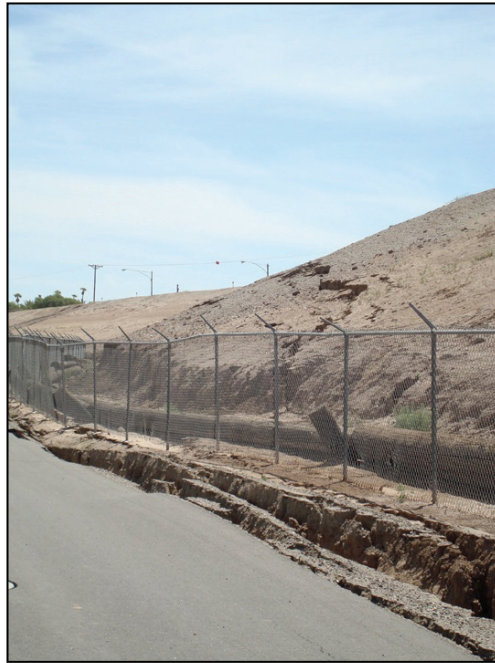
**Figure 110.** Liquefaction lateral spread and slump of waste water treatment plant access road (F04). A portion of the hill, probably fill, also experienced slumping. View to the southeast. Photo by T. McCrink, 4/10/10.

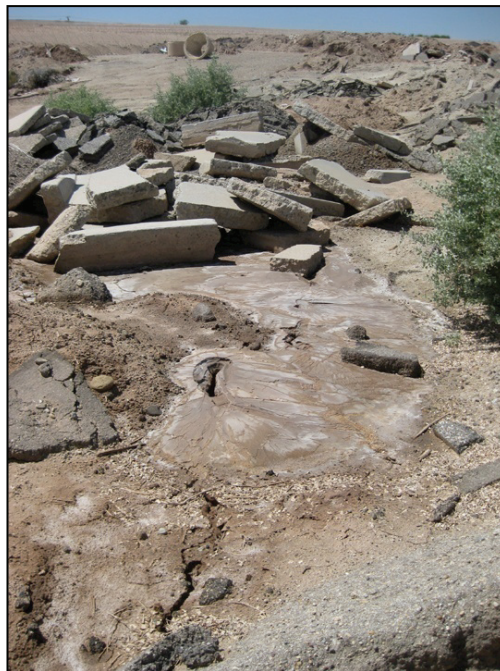
Extensional cracks were found throughout most of the fill area, and numerous sand boils were seen toward the northeast where the fill thins (fig. 111). On the flood plain north and east of the fill, numerous fissures and related sand boils were found (fig. 112).

**Figure 111.** Liquefaction vented sand and related cracking in nonengineered fill adjacent to the Treatment Plant access road (F04). Access road is at the base of the hill in the distance and the airport is just beyond. View to the southwest. Photo by C. Pridmore, 4/10/10.

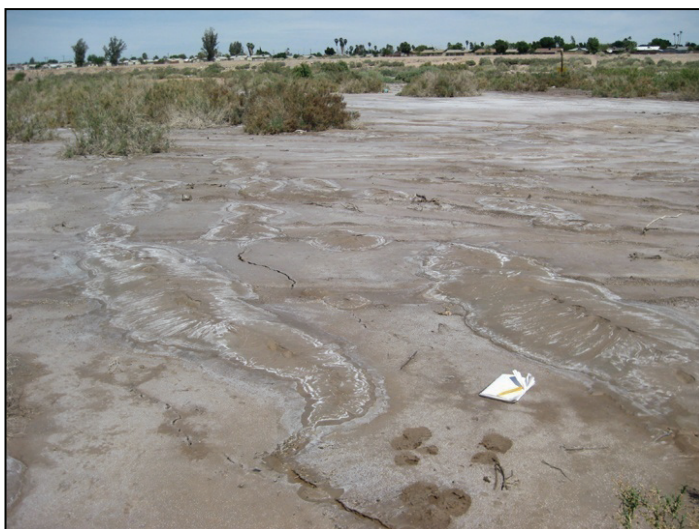
**Figure 112.** Liquefaction sand boils and fissures on the New River flood plain, just north of the nonengineered fill along the Treatment Plant access road (F04). Stains on sand boils are thought to be salts contained in the groundwater that turn white upon drying. Most sand boils were wet in this area, and are believed to have been reactivated by a M4.4 aftershock that occurred the night before. View to the north. Photo by C. Pridmore, 4/10/10.

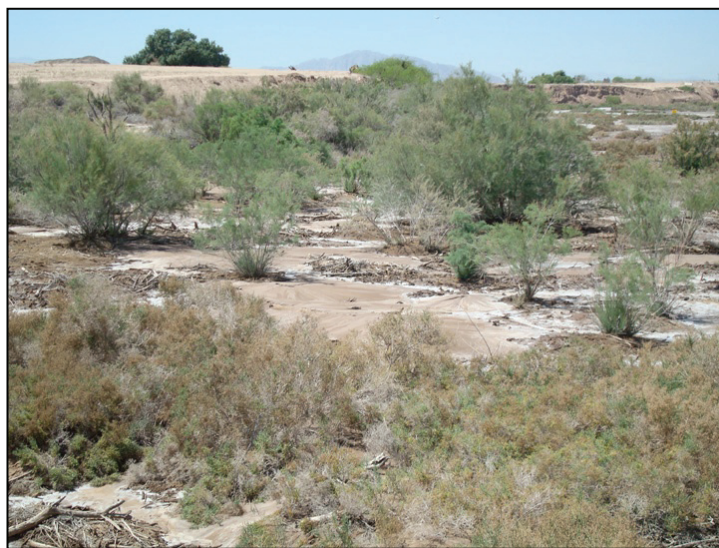
The west side of the waste water treatment plant is characterized by extensive areas of sand boils and lateral spread cracks (figs. 113 through 116). Sand boils appear confined to floodplain areas, though considerable volumes of sand were ejected. Lateral spread fissures occur on the floodplains associated with sand boils and extend into and through fill areas, including pond embankments at the plant.

**Figure 113.** Extensive vented sand flooding areas between bushes on the New River floodplain west of the waste water treatment plant (F04). View to the west. Photo by T. McCrink, 4/10/10.

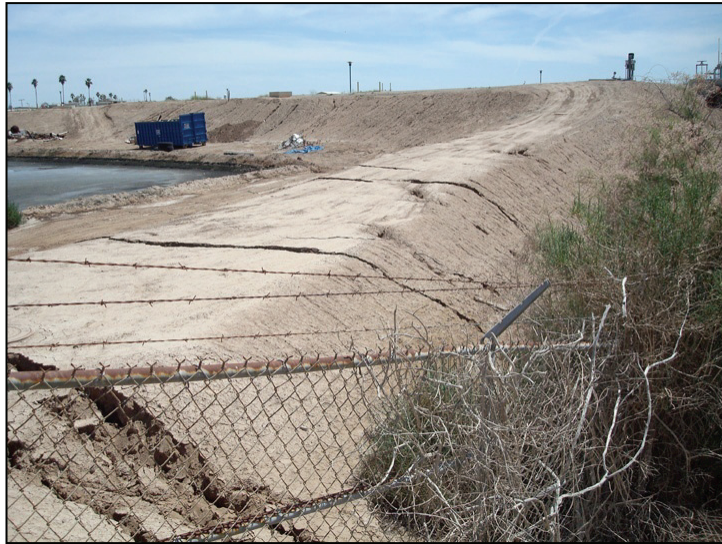
**Figure 114.** Lateral spread fissures extending through sludge drying ponds on the west side of the waste water treatment plant (F04). Fissure in the foreground is extensional and those in the middle of the picture show vertical displacement on the order of 2 to 5 cm. View to the southeast. Photo by T. McCrink, 4/10/10.

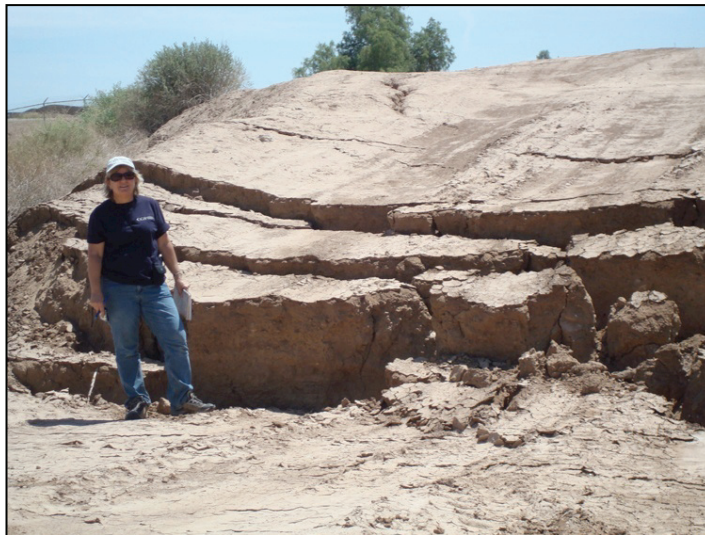
**Figure 115.** View to the southeast of a large scarp at the head of a liquefaction lateral spread on the west side of the Calxico Waste Water Treatment Plant (F04). Cumulative vertical displacement is about 1 m. Photo by T. McCrink, 4/10/10.

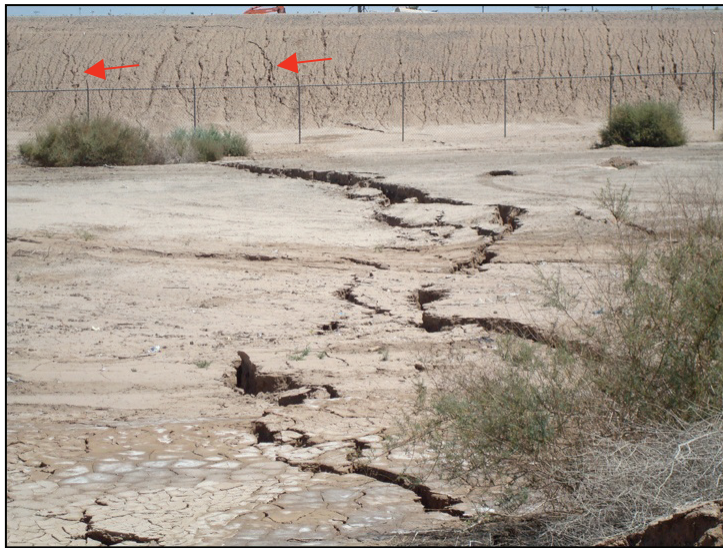
**Figure 116.** Liquefaction lateral spread fissures extending across New River flood plain into pond embankments on the west side of the Waste Water Treatment Plant (F04). Arrows point to fissures in the embankment. At the time of the California Geological Survey visit, a track-mounted excavator (orange machine arm in the top center of this photo) was making repairs in the center of the plant at a point suspiciously in line with these fissures. View to the east from the large scarp shown in figure 115. Photo by T. McCrink, 4/10/10.
