**DEGRADATION OF PLYWOOD ROOF DIAPHRAGMS
UNDER MULTIPLE EARTHQUAKE LOADING**

Data Utilization Report CSMIP/94-02

California Strong Motion Instrumentation Program

February 1994

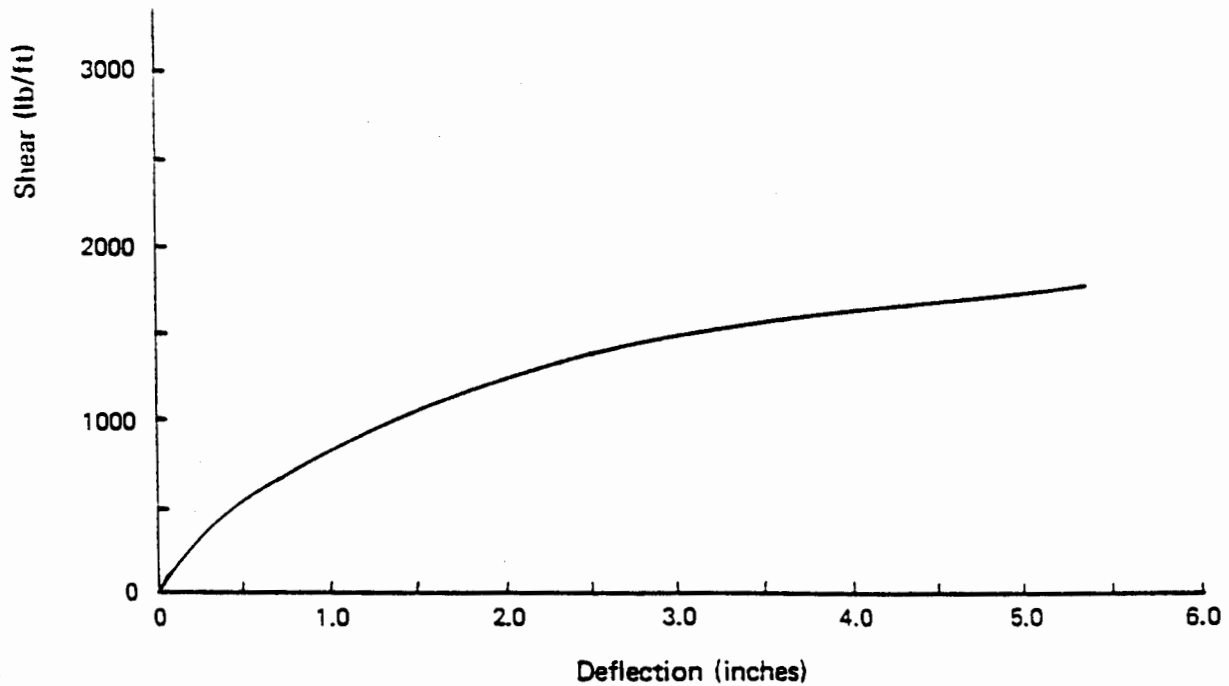
Comparing the plots of the acceleration FFT's for the Morgan Hill and Hollister earthquakes with the plot for the Loma Prieta earthquake, a shift in the predominant frequency of the roof diaphragm is noted. This indicates a softening of the diaphragm stiffness. The magnitude of change in predominant frequency and the associated changes in the relative diaphragm stiffness between the three earthquakes is presented in Table 3. This degradation or softening of plywood diaphragms under high loads has been previously noted in static tests. Non-cyclical tests of plywood diaphragms have shown them to be highly non-linear. A substantial portion of this non-linearity can be attributed to nail slip, a progressive and degenerative process. A representative load-deflection curve of tests on a full size 1/2 inch plywood diaphragm, showing degradation of diaphragm stiffness with increasing load is shown in Figure 10.

Figure 10. Shear-Deflection Plot for 1/2 inch Plywood Diaphragm. (APA)
