**STRONG-MOTION RECORDS FROM  
BUILDINGS DAMAGED IN EARTHQUAKES**

M.J. Huang, P.K. Malhotra and A.F. Shakal

California Strong Motion Instrumentation Program  
Division of Mines and Geology  
California Department of Conservation

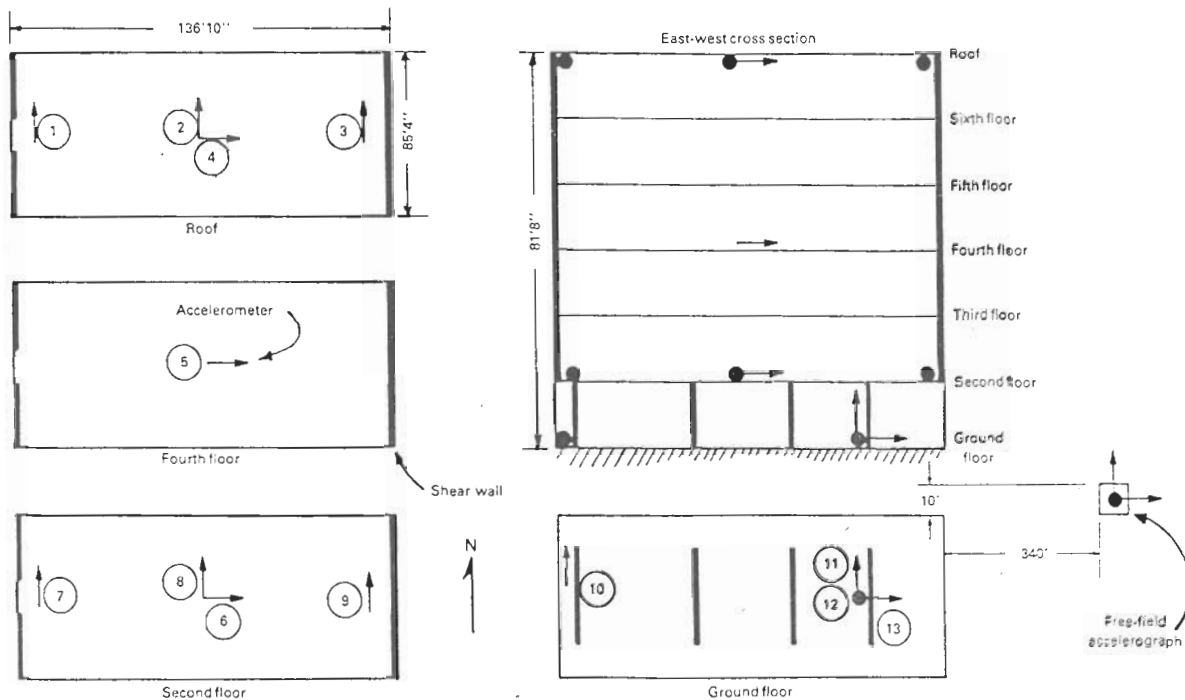
Fig. 2. Locations of accelerometers in Imperial County Services Building and reference free-field site during the 1979 Imperial Valley earthquake (Rojahn and Ragsdale, 1980).

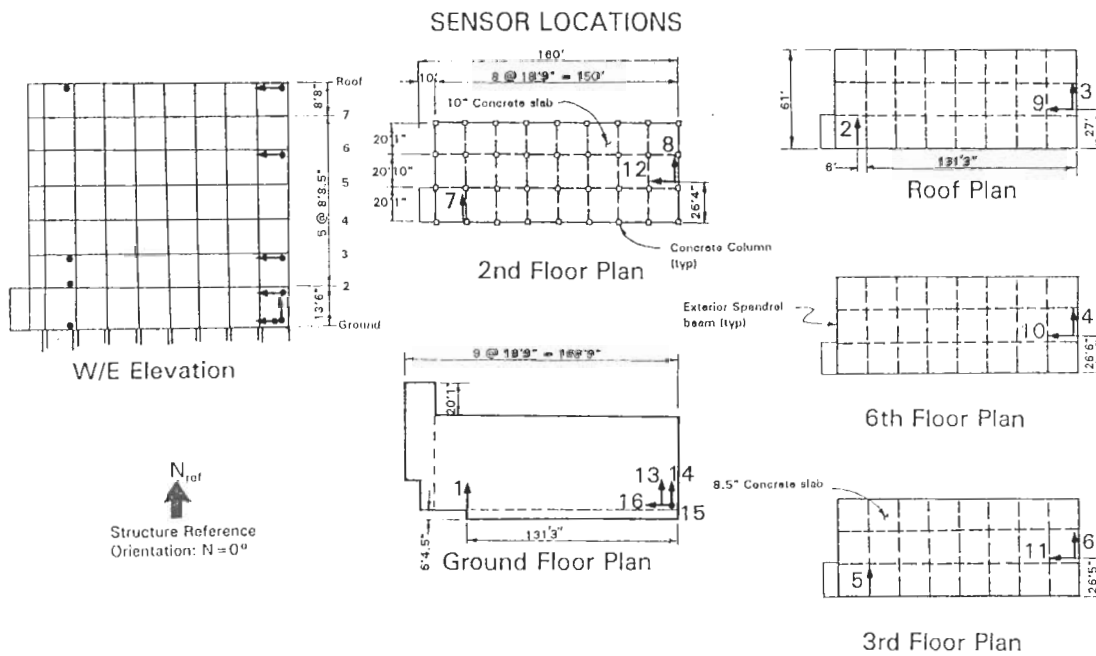
Van Nuys - 7-story Hotel  
(CSMIP Station No. 24386)

The sensor locations and the structural system for the building are shown in Figure 6. The earthquake resistance of the building in each direction was provided by perimeter column-spandrel beam frames and interior column-slab frames. The structural damage during the Northridge earthquake was mainly in the longitudinal perimeter frames. As shown in Figure 5, the most severe damage occurred in the columns just below the fifth floor spandrel beam on the south side of the building. More detailed description of the damage is given in the Earthquake Engineering Research Institute (EERI) Reconnaissance Report (EERI, 1995) and in the Seismic Safety Commission Case Studies Report (SSC, 1996).

Fig. 5. Partial south elevation of Van Nuys 7-story Hotel showing damage to columns (indicated by an arrow) below fifth floor spandrel beams during the 1994 Northridge earthquake.

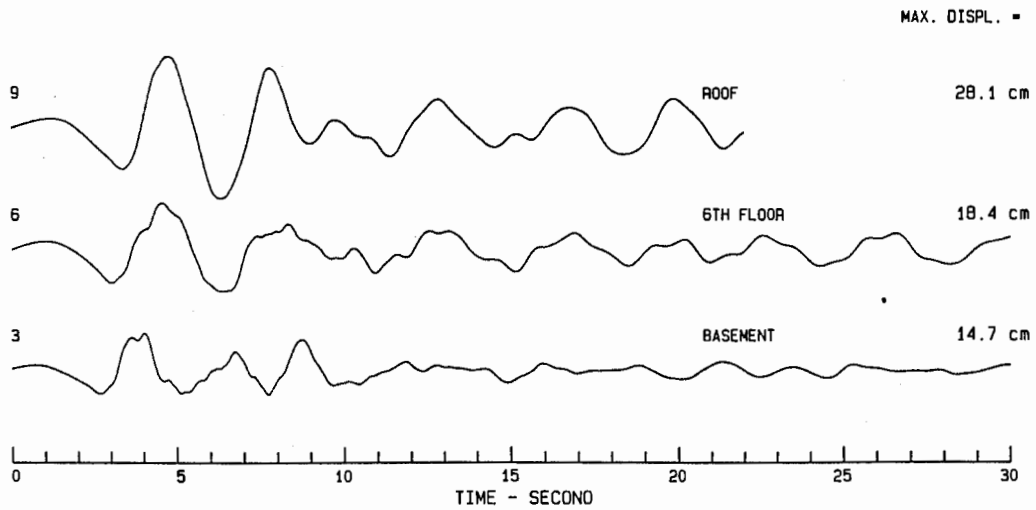
Fig. 10. Displacements corresponding to the accelerations in Fig. 9.

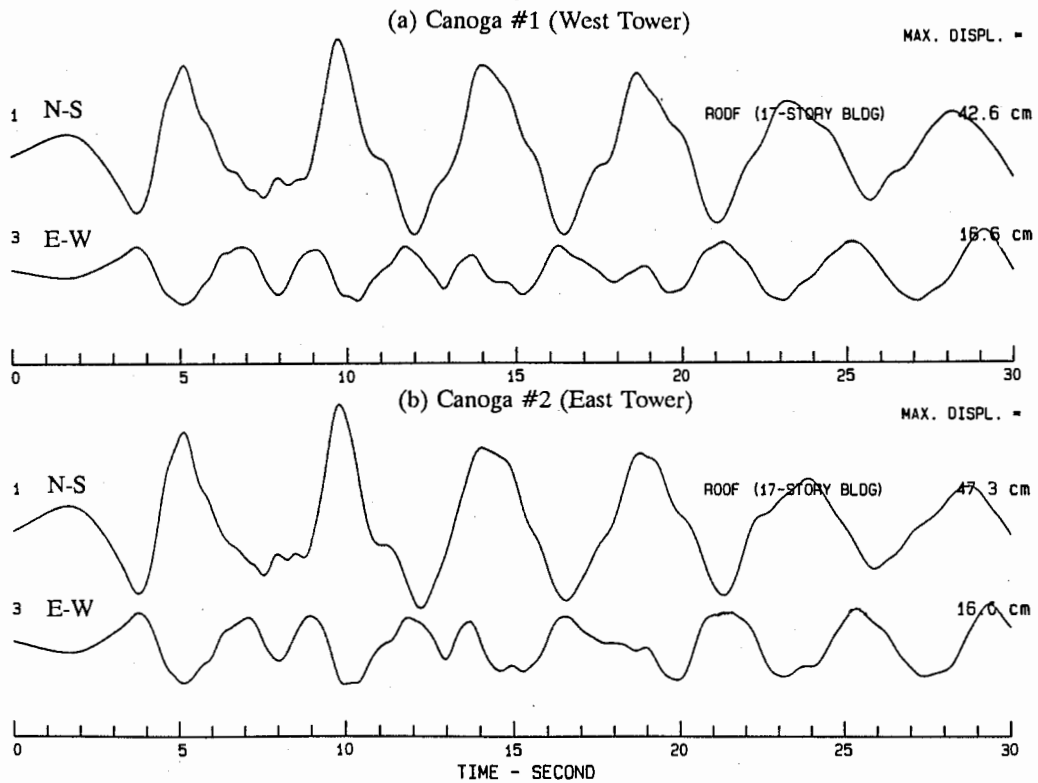
Fig. 12. Displacements corresponding to the accelerations in Fig. 11.
