# Watershed Emergency Response Team (WERT) 2024 Airport Fire

CA-ORC-127883

October 25, 2024

**REPORT TITLE:** Watershed Emergency Response Team (WERT) Evaluation – 2024 Airport Fire

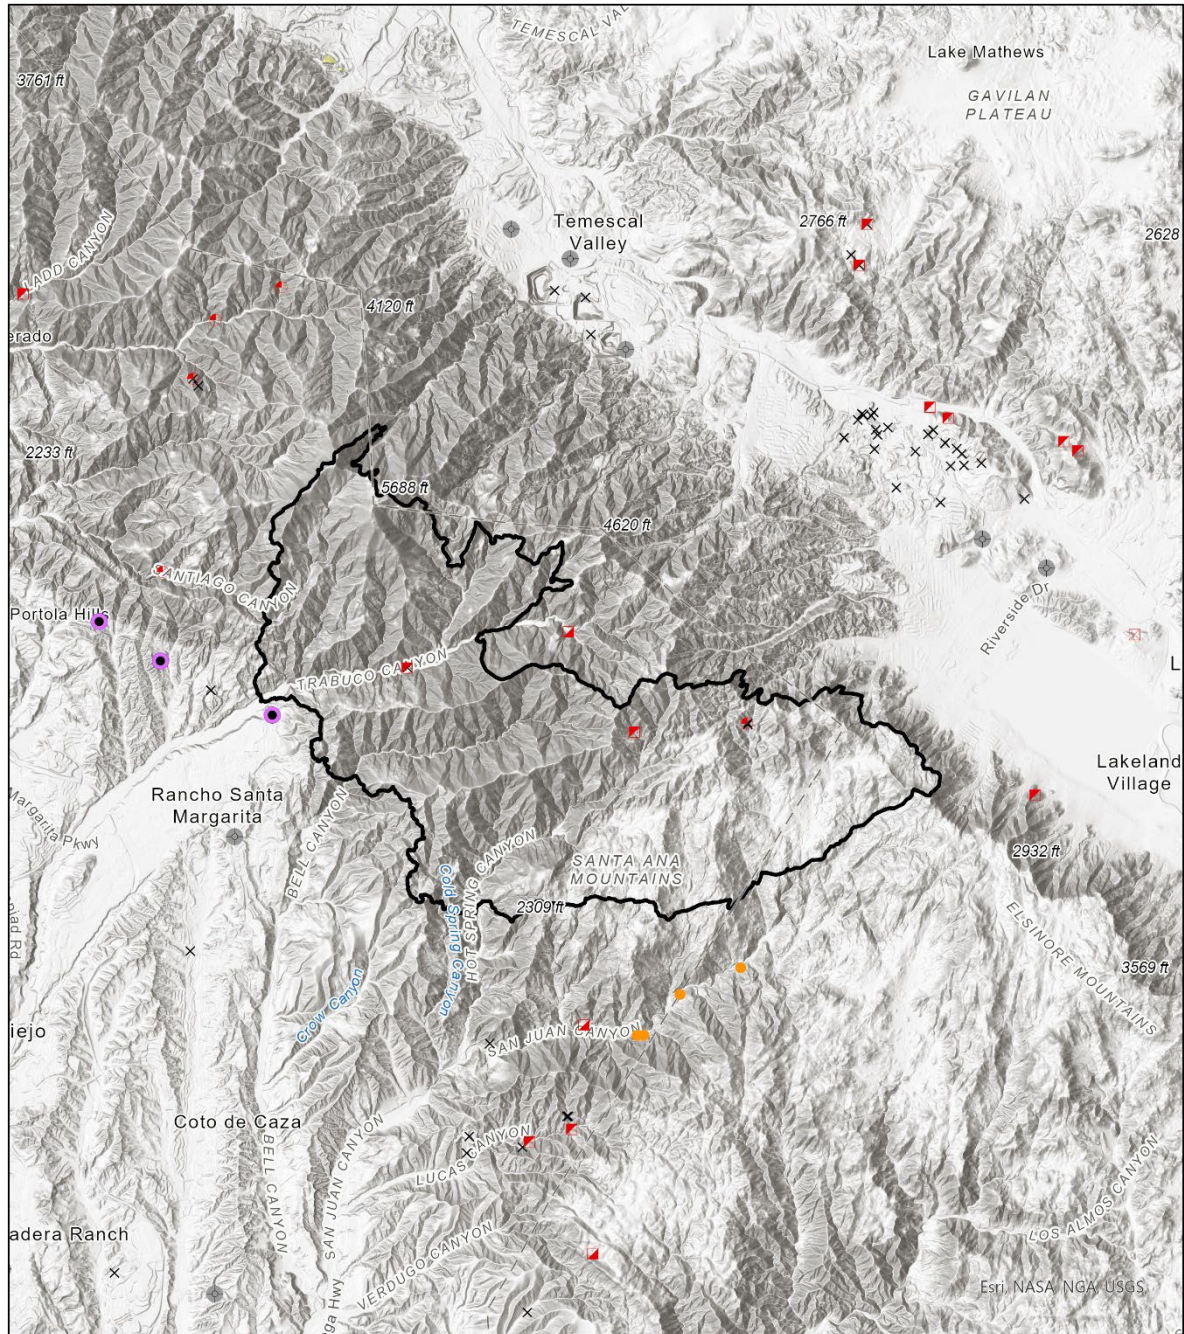
**Figure 3a. Mineral Hazards and Wells map for the Airport Fire.**

There are three old mine or prospecting sites within the burned area perimeter (Figure 3). The easternmost site was prospected for lead and other metals. The two other sites were prospected for gold. These mining operations may still contain mine tailings and mine waste that may contain potentially harmful concentrations of heavy minerals. The use of mercury was common practice to enhance gold recovery in all the various types of mining operations since 1850. Potential adverse impacts to health and safety from these three features related to postfire conditions is considered negligible given their remote nature. For information on hazardous minerals, please refer to <https://www.conservation.ca.gov/cgs/minerals/mineral->

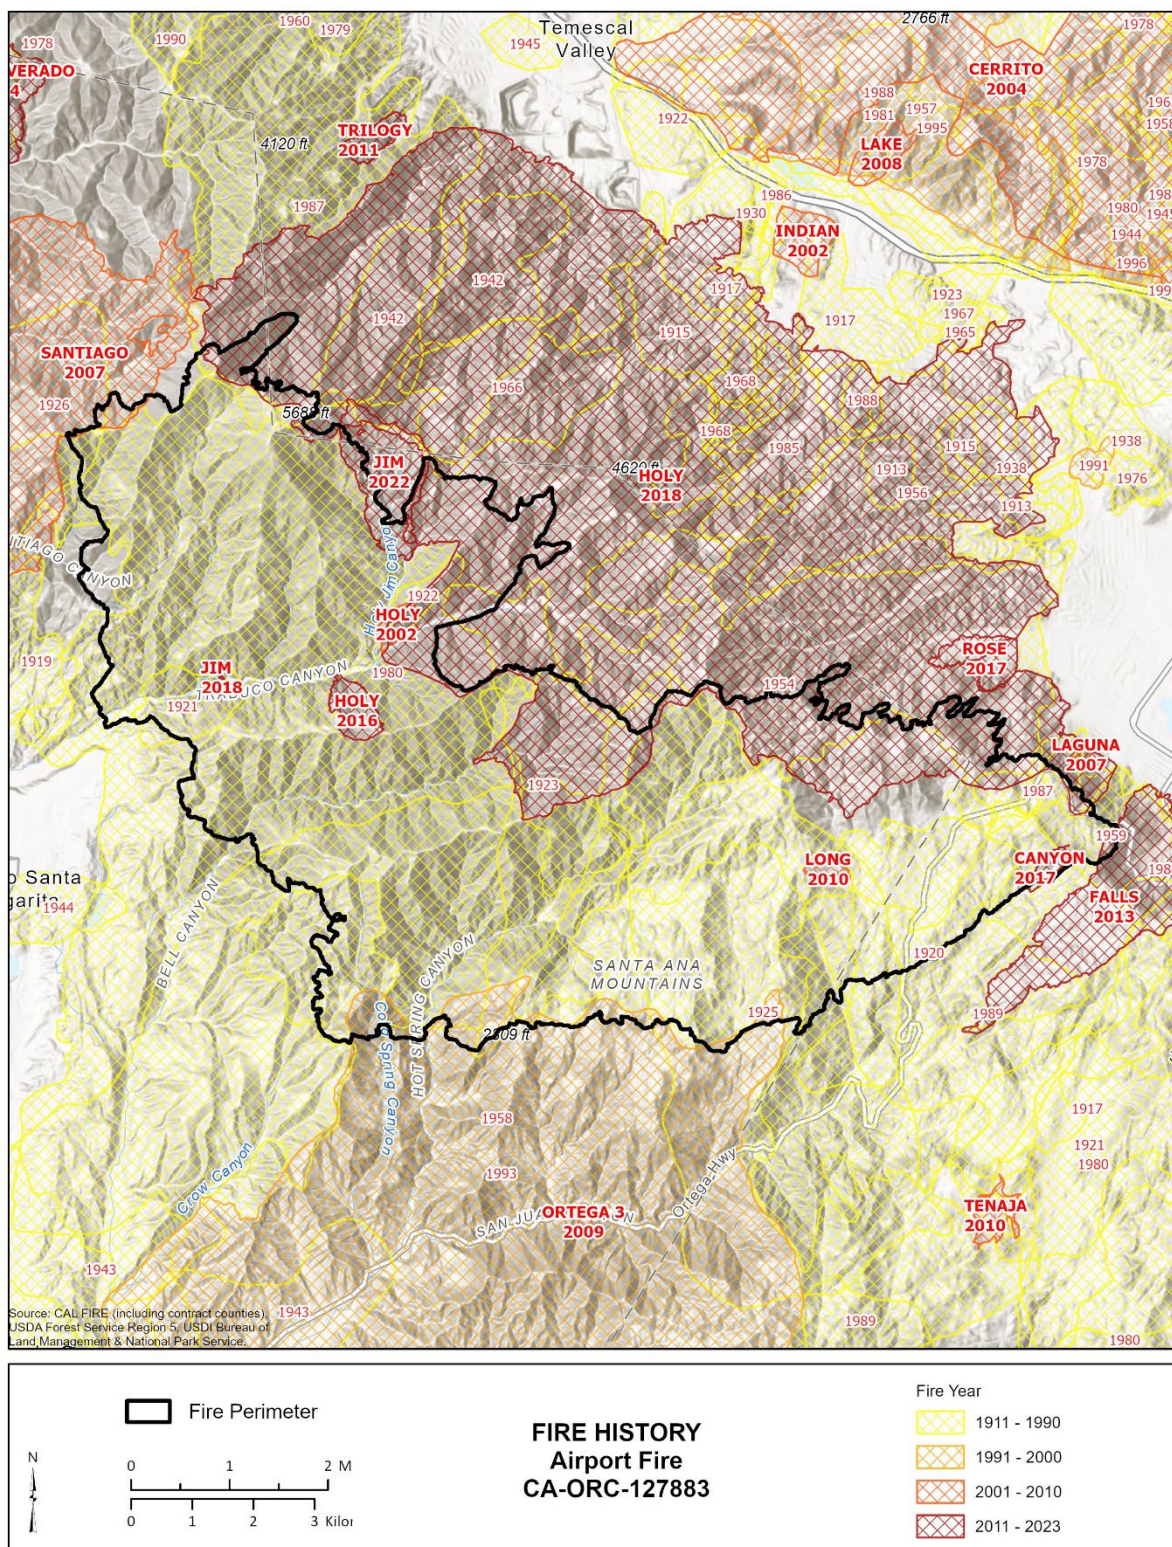
**Figure 4.** Fire history for the Airport Fire. Note: Areas that haven't burned for many decades have a potentially higher erosional response than areas that have been subject to recent fire.

Prior to Euro-American settlement, mean fire return interval ranged from 11-31 years in the vegetation types represented in the Airport Fire burn area (Van de Water and Safford, 2011). The Airport Fire footprint mostly occupies slopes that have not burned in over 40 years (Figure 4). Two older fires that overlap large areas of the Airport Fire include the 1958 Steward Fire, which burned portions of Bell, Hot Springs, and Long Canyons, and the 1980 Indian Fire, which burned portions of Santiago and Trabuco Canyons. However, more recent fires do overlap small portions of the Airport Fire area including the Holy Fire (2018, 22,838 acres) to the north and east, and the Jim Fire (2022, 563 acres) and the Santiago Fire (2007, 26,795 acres) to the

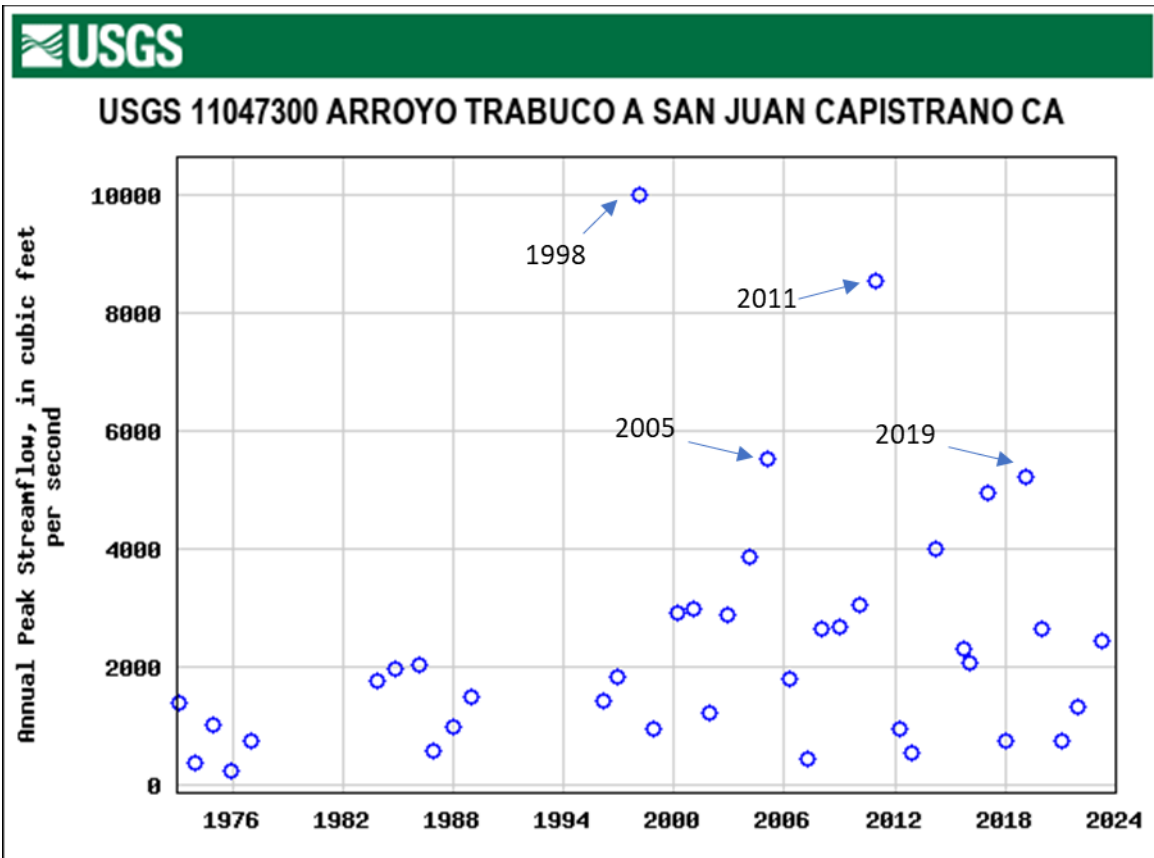
**Figure 5.** Annual peak streamflow for the USGS Arroyo Trabuco at San Juan Capistrano, CA, gage (11047300) that highlights the top three recorded flow events between 1973 to present (Source: [USGS | National Water Dashboard](https://water.usgs.gov/nwd/)).

A stream gage located on lower Trabuco Creek, in the city of San Juan Capistrano (Gage Site Number 11047300), is approximately 15 miles downstream of the fire perimeter. This gage has confirmed data from 1972 to present and lists the top four highest flows occurring in 1998, 2011, 2005, and 2019 with estimated discharges of 10,000 ft<sup>3</sup>/s, 8,530 ft<sup>3</sup>/s, 5,510 ft<sup>3</sup>/s, and 5,230 ft<sup>3</sup>/s, respectively (Figure 5). Based on the lack of fire history within the Trabuco Canyon watershed prior to 2005, the top three runoff events were all unrelated to postfire effects. However, the 2019 runoff event followed the 2018 Holy Fire, which likely influenced runoff through sediment and debris bulking.

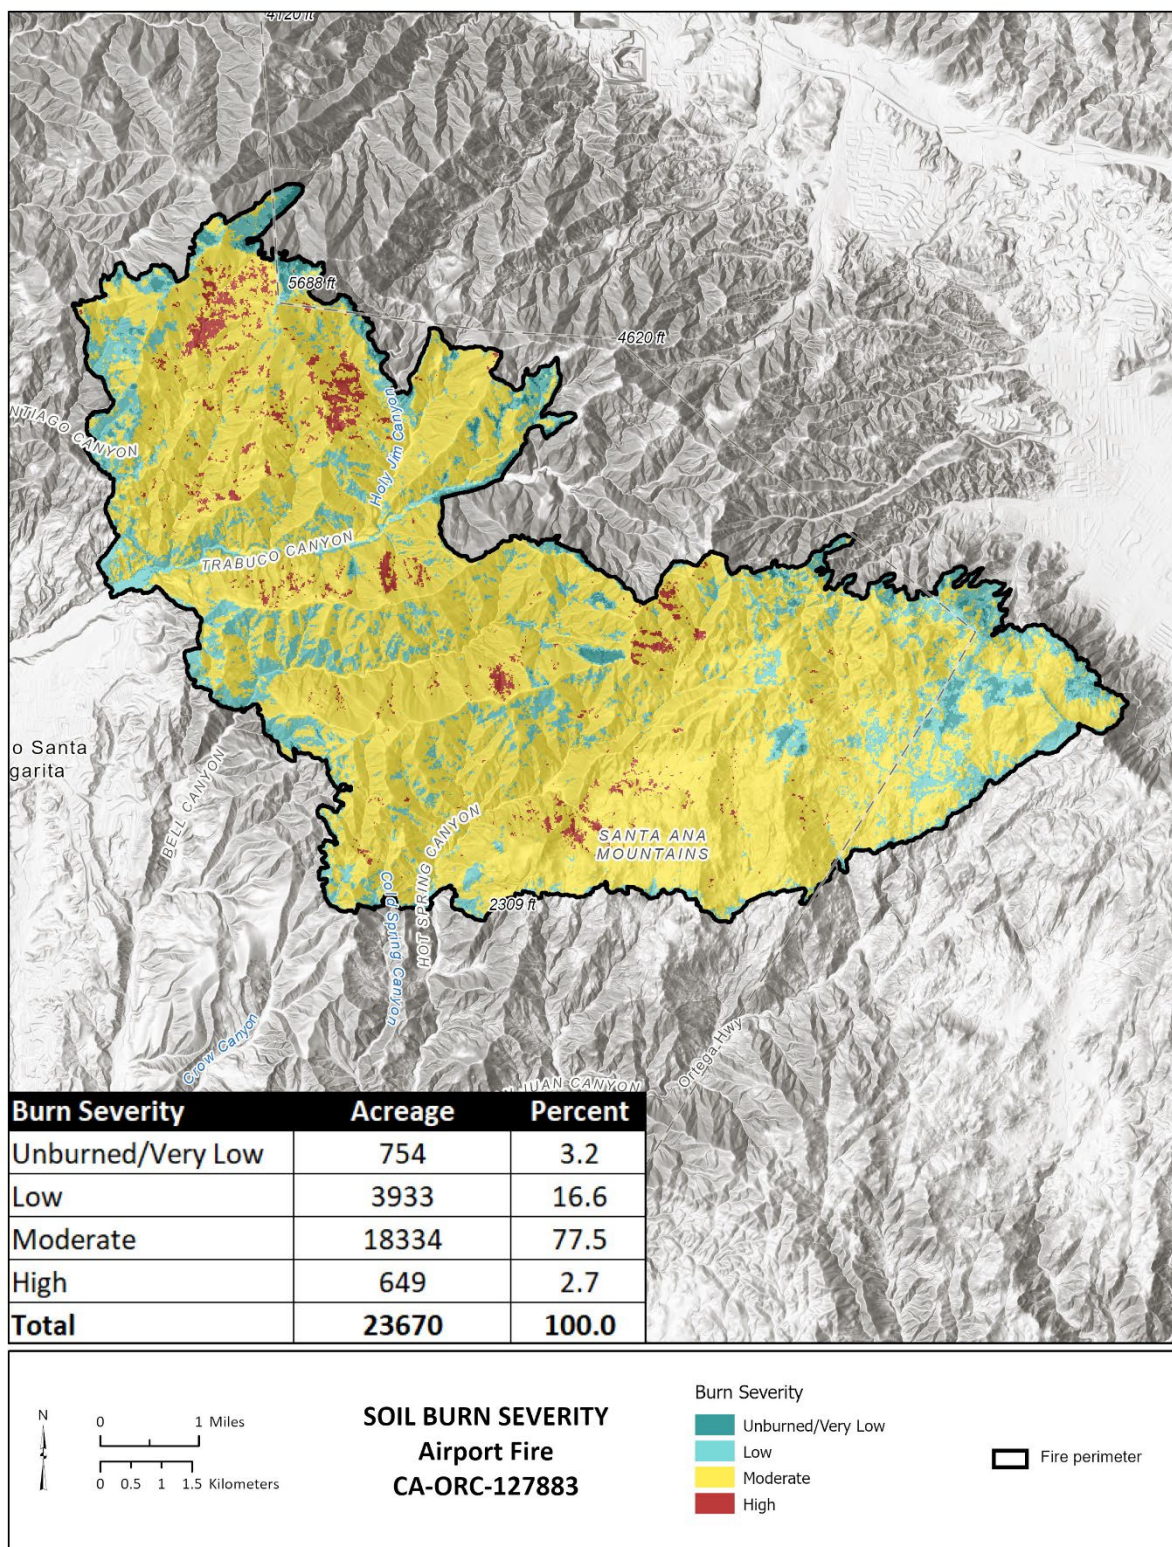
**Figure 6.** Soil Burn Severity map for the Airport Fire.

- The Airport Fire produced mostly moderate soil burn severity. Airport Fire area soil burn severity: Unburned to Very Low (3%), Low 17%, Moderate (78%), High (3%).

The initial field assessment by the WERT was conducted using a Burned Area Reflectance Classification (BARC) map that was field validated and edited in collaboration with soil scientists from the USFS Park Fire BAER team to create a Soil Burn Severity (SBS) map of the burn area (Figure 6).

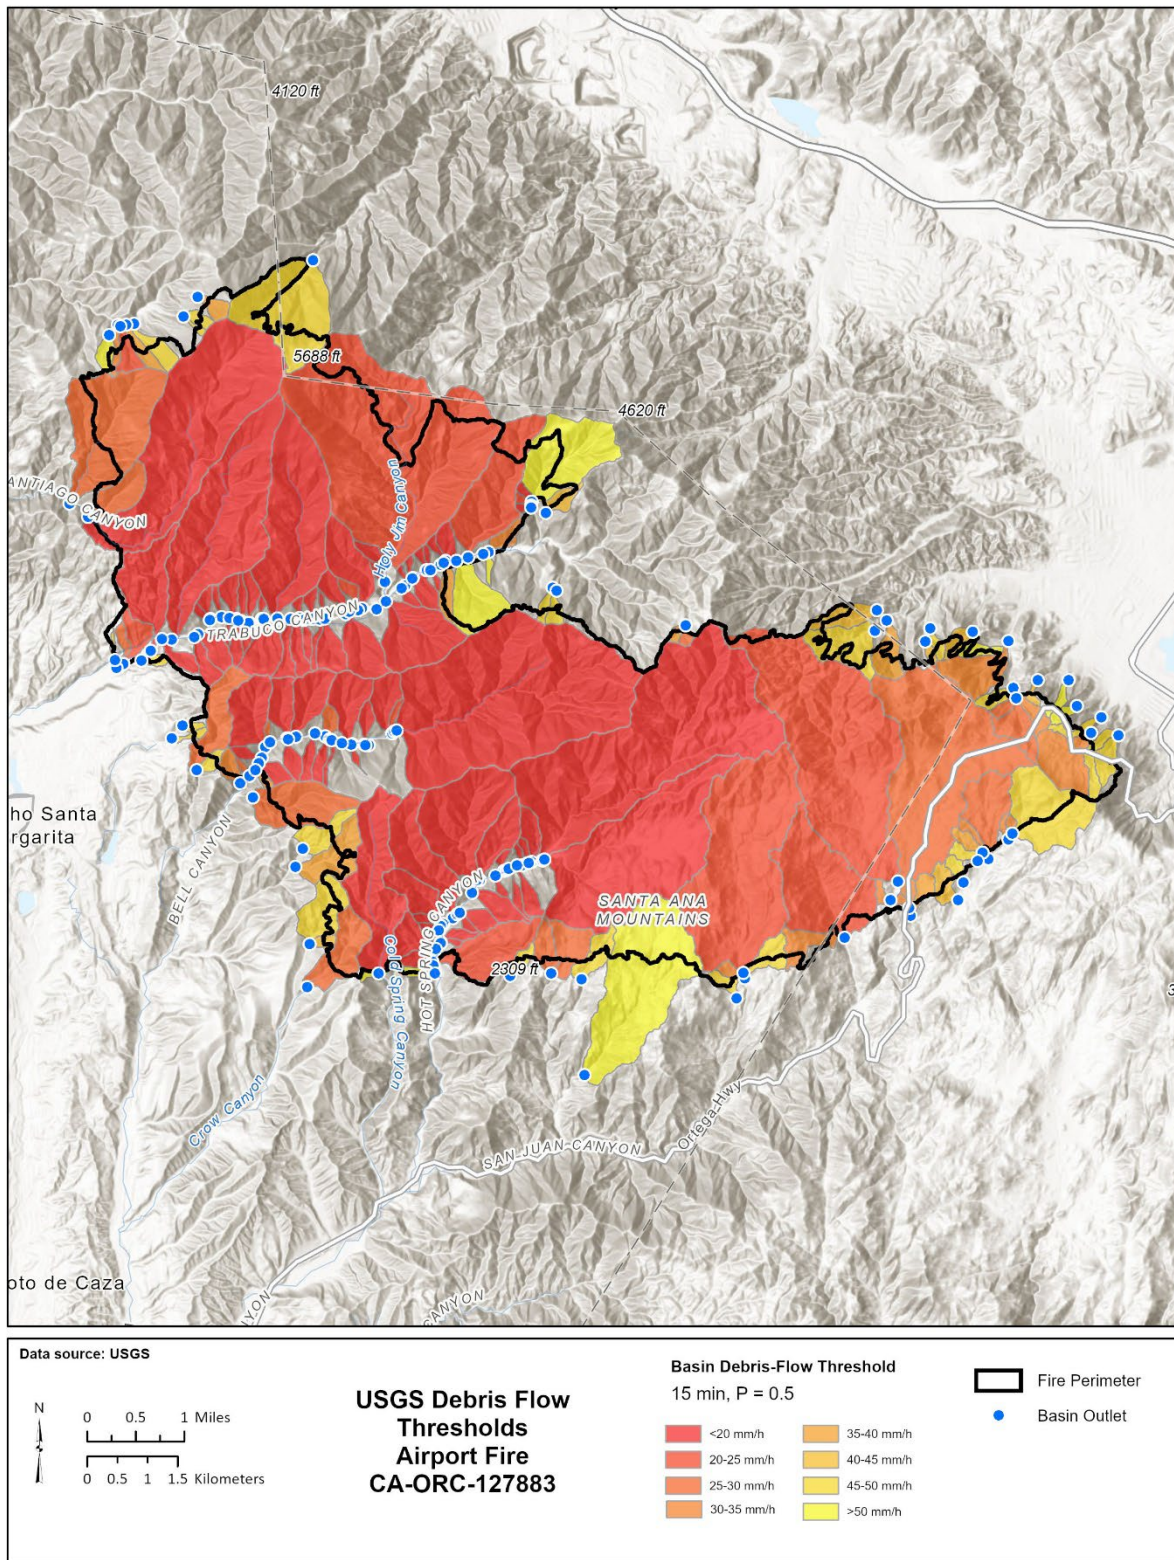
**Figure 8.** Predicted 15-minute rainfall intensity with a 50 percent likelihood of triggering a debris flow for the Airport Fire.

Figure 8 illustrates 15-minute rainfall intensities required to generate a 50 percent likelihood of debris flows for each basin across the burned area. The fire wide basin average 15-minute rainfall intensity threshold is about 21.5 mm/hr (0.85 in/hr). Basins on the west side of the mountain range, particularly those underlain by metasedimentary rock and exhibiting steep slopes, have a low triggering threshold of less than 20 mm/hr (0.79 in/hr), while the more gentle slopes in the southeast portion of the burn area underlain by granitic rock have slightly higher triggering thresholds ranging from 20 to 45 mm/hr (0.79 to 1.77 in/hr).

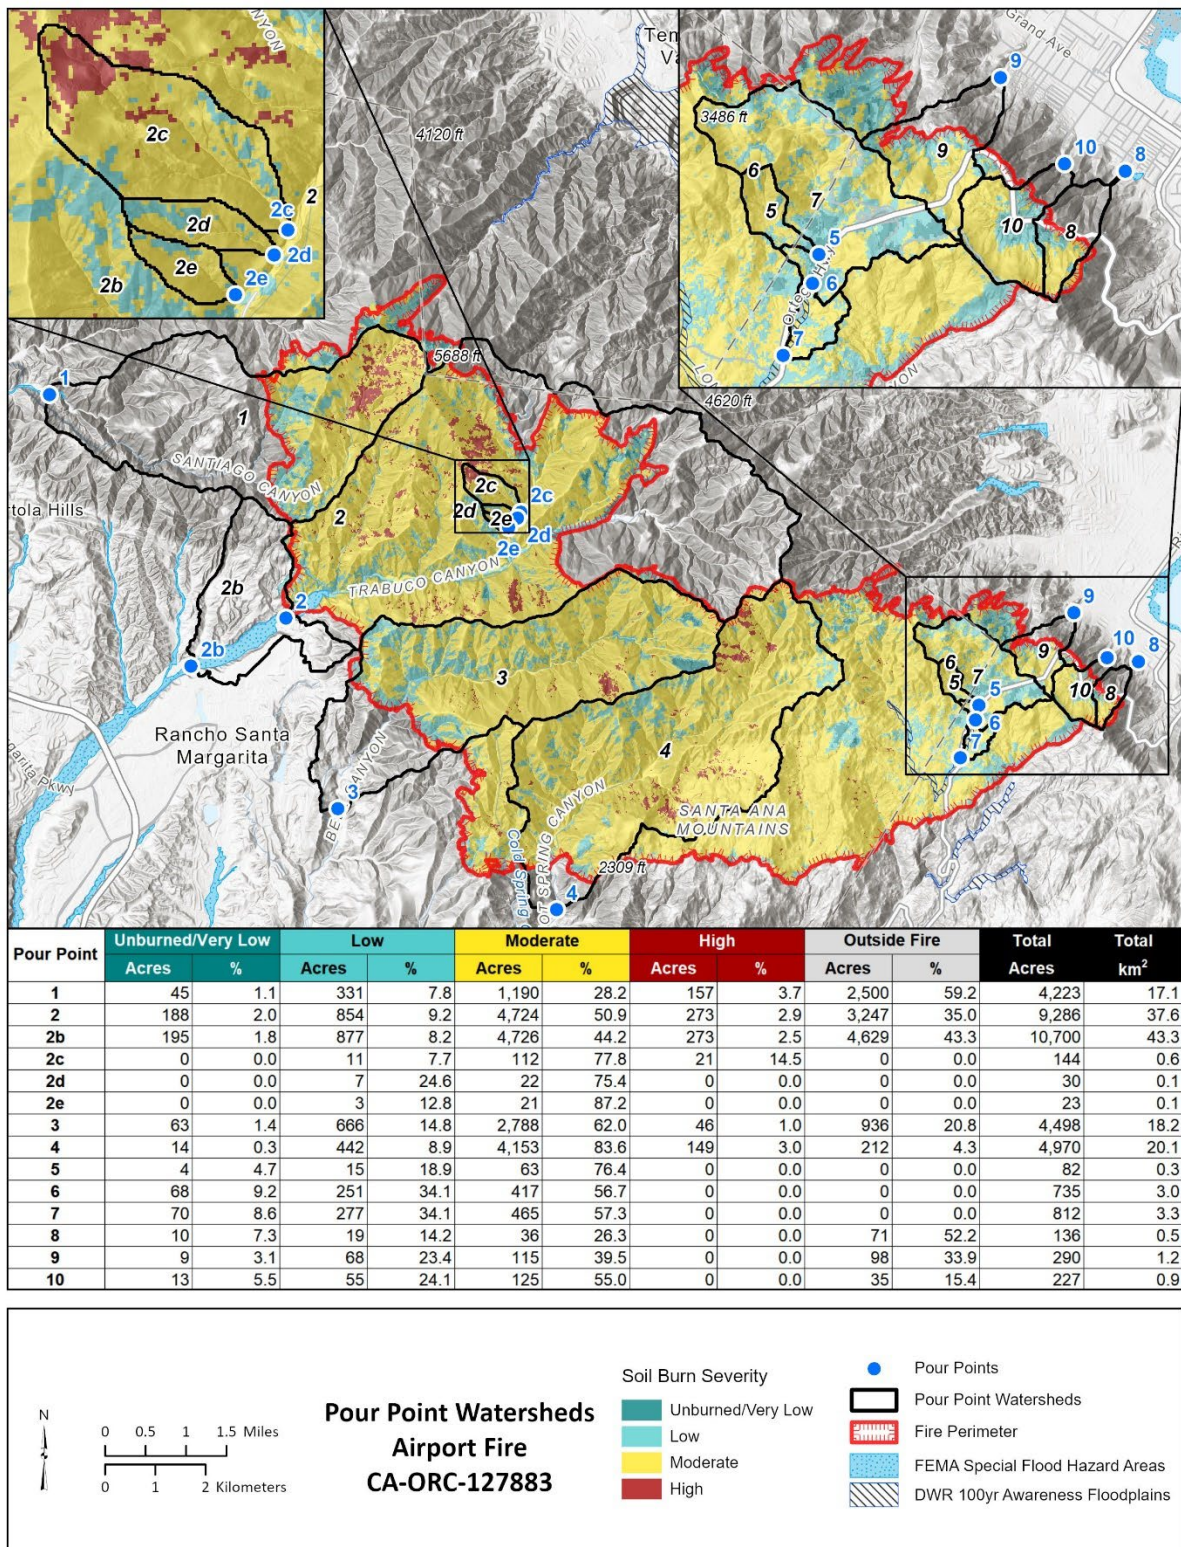
**Figure 9.** Pour Point locations within and downstream of the Airport Fire.

The WERT selected fourteen “pour points” (PP) to estimate potential postfire peak flow increases to Values-at-Risk (VAR) from flood to debris flow hazards. Figure 9 shows the fourteen pour point locations, which include all major canyons that drain west, including Santiago, Trabuco, Bell, and Hot Springs Canyons. Three pour points are located below small basins within Holy Jim Canyon that present a high debris flow hazard. Additional pour points are located within small basins that drain to more densely populated areas, such as in the El Cariso area and neighborhood areas west of Lake Elsinore. Lastly, three pour points are at the intersection of drainages that are crossed by major roads including Trabuco Canyon Road and Highway 74. These pour points represent elevated flood and debris flow hazards to private and public roads and residential structures. Pour points located close to or within basins burned at moderate and high soil burn severity (SBS) yield larger postfire flow increases than those far below the fire perimeter or burned at lower severity.

Three basins that fit the criteria necessary to apply the Kean et al. 2016 model is PP-2c, 2d, and 2e positioned upslope of cabins in Holy Jim Canyon, which is tributary to Trubuco Canyon. These basins, in addition to other basins in the vicinity, have high USGS predicted postfire debris flow probabilities (Figure 7) and exhibit geomorphic evidence indicative of high debris flow potential. Table 2 provides a summary of basin information as well as pre-fire and post-fire flow estimates based on a 2-year recurrence interval flow. Results indicate that postfire runoff events for a 2-year recurrence interval storm can produce floods and debris floods that are about 2 to 6 times larger than normal streamflow. The largest change occurs within Bell and Hot Springs canyons where postfire debris flood hazards are high due to their high percent of slopes burned at moderate soil burn severity. For the small debris-flow-prone basins in Holy Jim Canyon, the postfire flow multiplier ranges from 32 to as high as 57, well inside the expected range for true debris flows (Kean et al. 2016). This large increase in clearwater equivalent peak discharge illustrates the significance of dilated surge fronts for debris debris flows and better frames the potential hazards to life and property in debris-flow-prone basins. Additional basins believed to represent and elevate threat of mobilizing sediment and debris to form dilated surge fronts include pour points, in descending order of perceived threat, Upper and Lower Trubuco Canyon (PP-2 and 2b), El Cariso Rd area and Hwy 74 (PP-6 and PP-7), Jamieson St. (PP-10), and Santiago Canyon (PP-1).

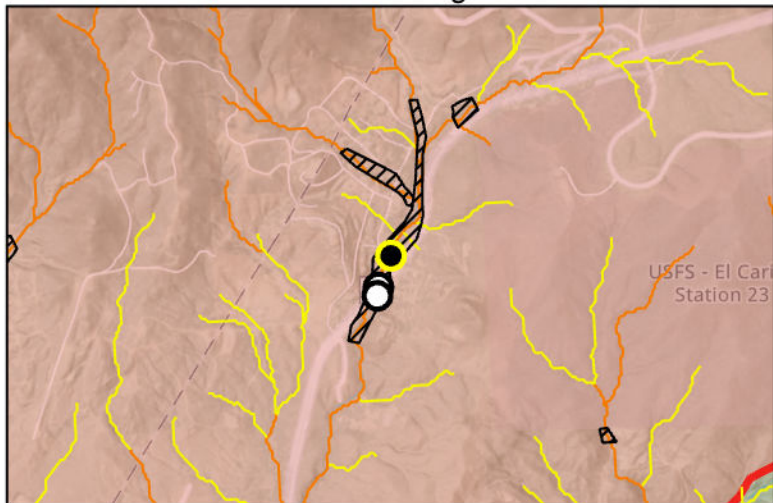
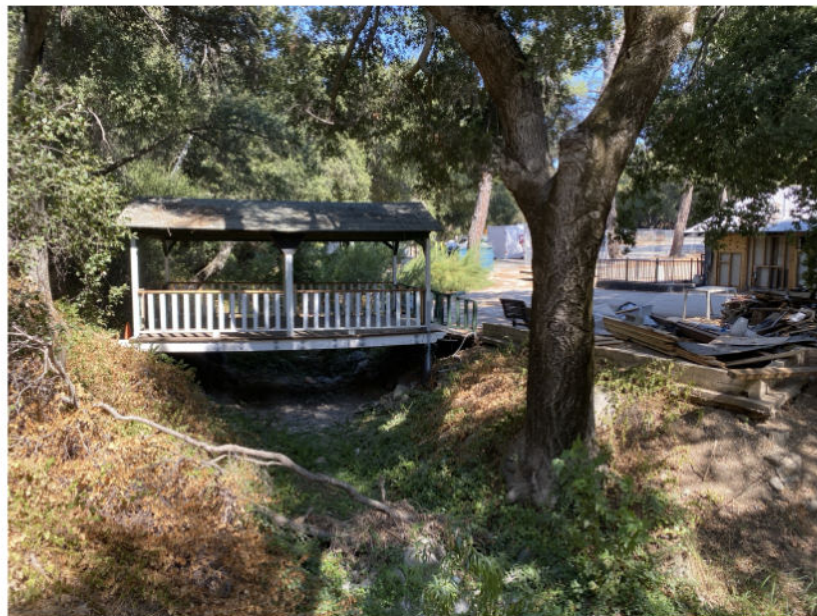
**Field Observation or Potential Hazard:** Business under renovation (Hells Kitchen restaurant) is adjacent to watercourse and gazebo that spans the channel. Flood flows and plugged culvert may cause inundation impacting restaurant, and flooding with mobilized debris impacting gazebo.

**Description:** Plugged bridge culvert may lead to backwater effects and inundation.

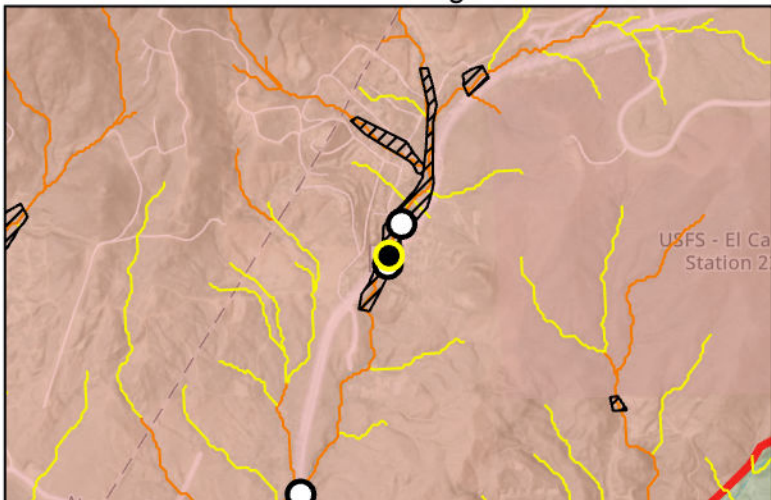
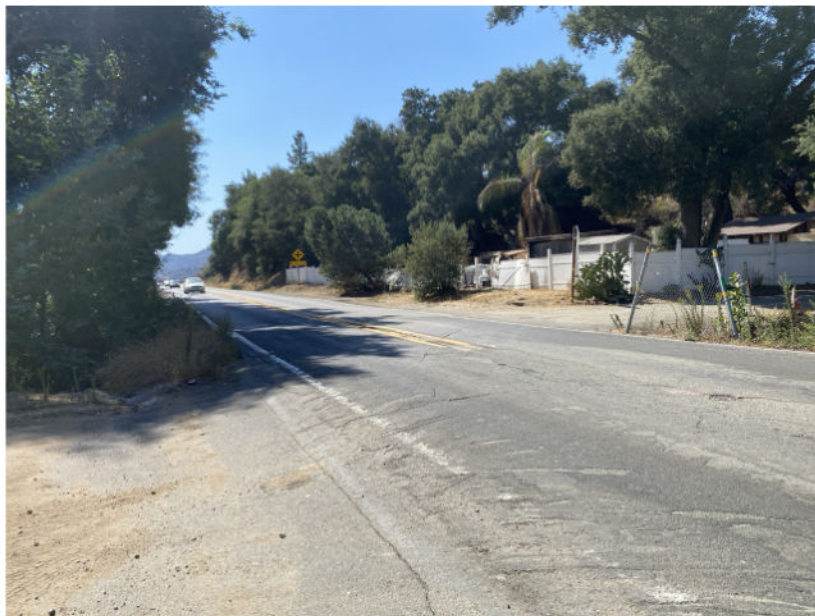
**Field Observation or** 4' by 6' concrete box culvert crossing at Highway 74. Potential hazard is flood flows mobilizing woody debris

**Potential Hazard:** plugging culvert, leading to overtopping of road, with some flows directed down the highway to the east.

**Description:** Culvert has flared wing walls with a 4 foot head wall. Dense riparian vegetation is in the drainage, including a large fallen tree across the upstream side of drainage.

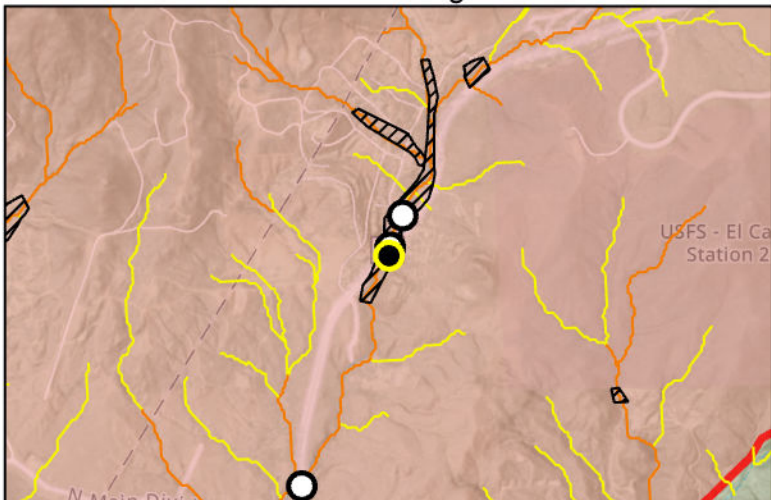
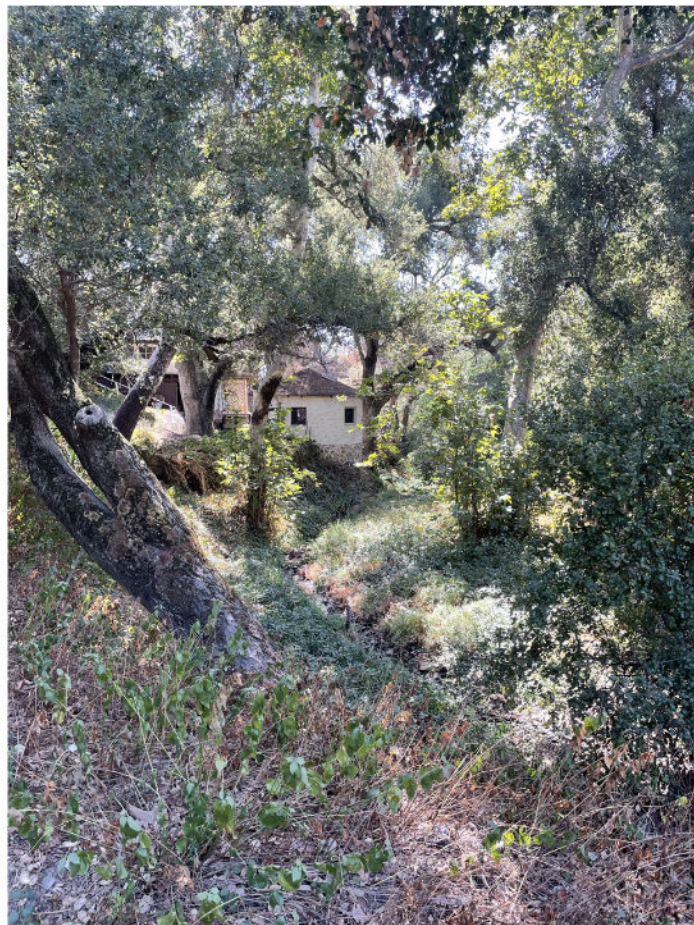
**Description:** Small round house adjacent to stream, possibly part of 32750 Ortega Highway property. Upstream drainage of 3 square km, with 90% moderate or high soil burn severity on slopes >23 degrees. It could have debris and flooding partly due to clogged culvert upstream and some flows overtopping road.

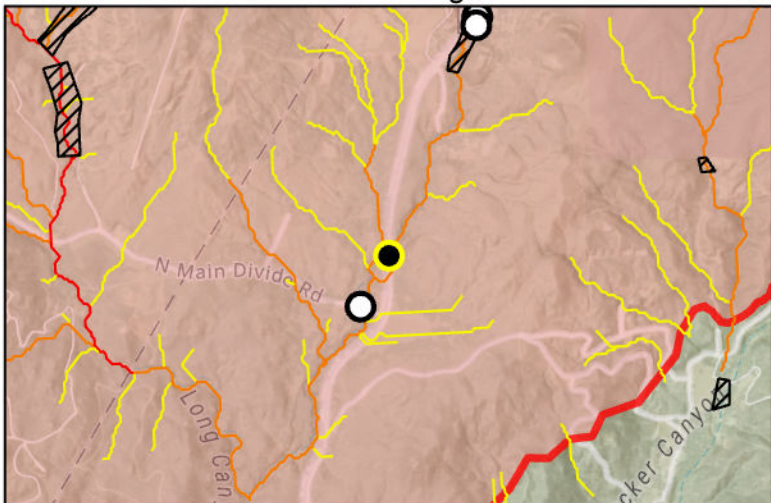
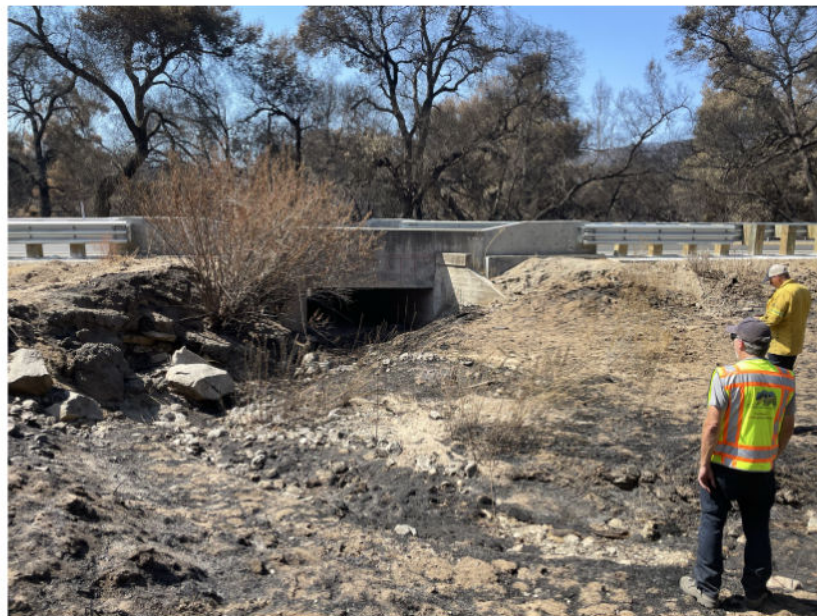
**Field Observation or** Flood and debris flows may overwhelm crossing composed of box culvert and cause flows to be diverted down  
**Potential Hazard:** Highway 74.

**Description:** Highway 74 is a high volume road, and water and debris may be a moderate hazard. Basin upslope is burned at mostly moderate soil burn severity.

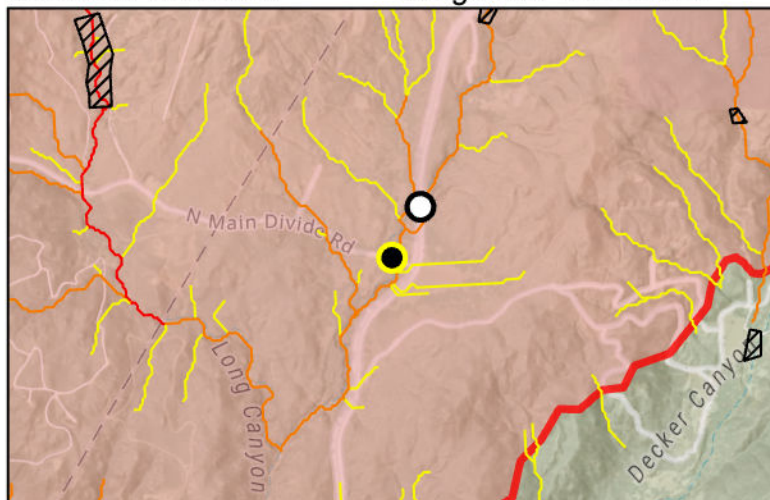
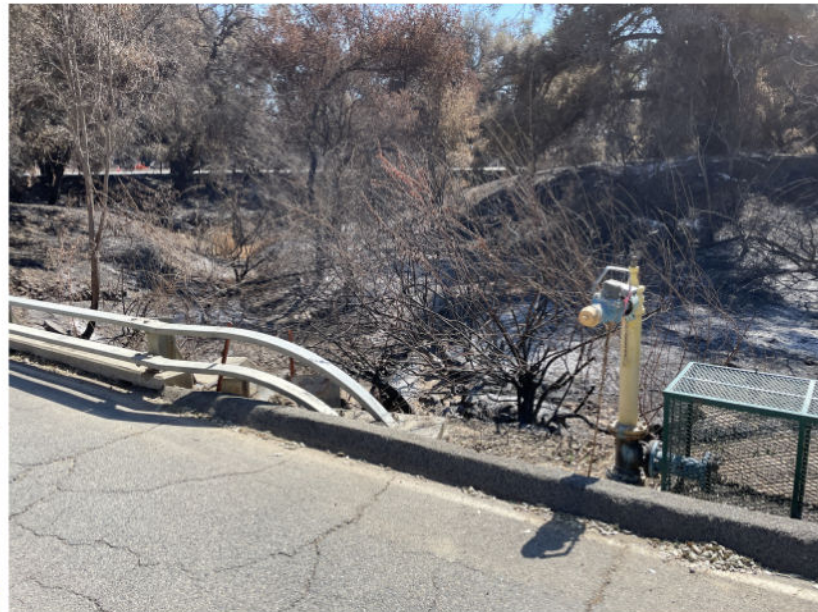
**Field Observation or Potential Hazard:** Culverted road crossing. Potential hazard is flood flows moving sediment and debris that can block culvert and overtop road. Potential impact to fire hydrant.

**Description:** Basin above is burned at mostly moderate soil burn severity. Channel has a lot of dead trees along it that can be mobilized by flood flows. Double barrel box culvert, 6' high x 8' wide, may get plugged by debris.

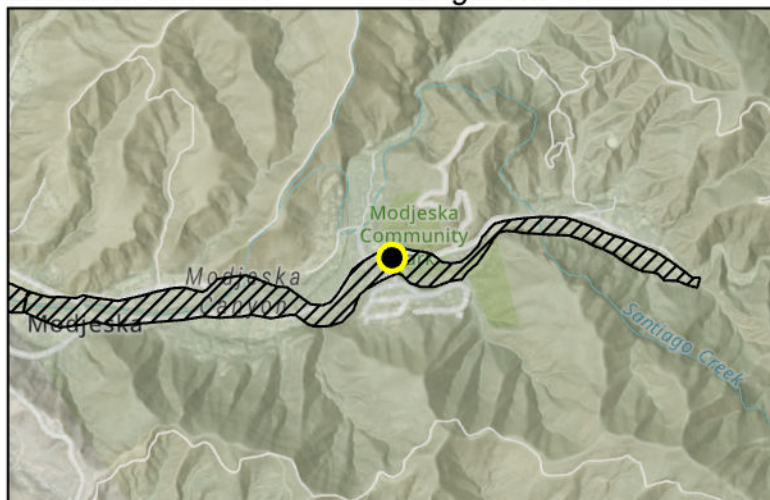
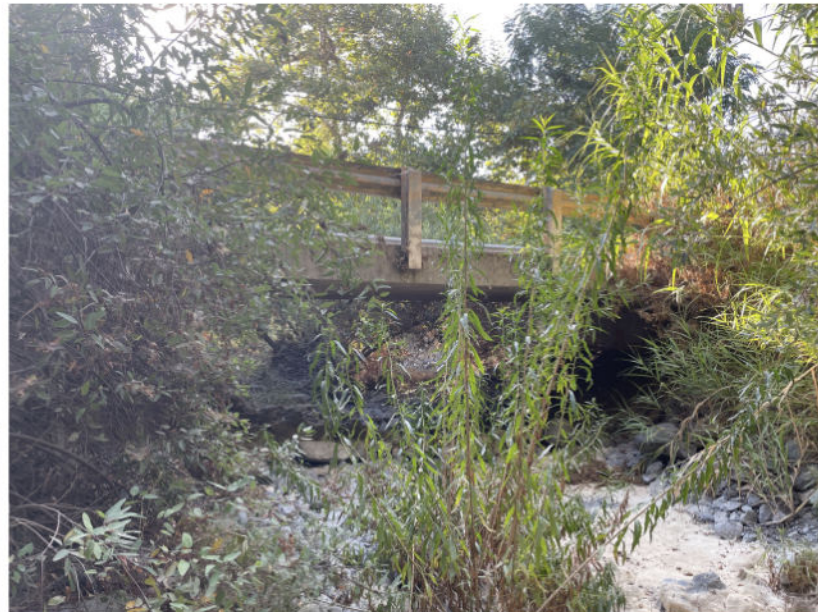
**Field Observation or** Bridge by fire station  
**Potential Hazard:**

**Description:** Limited capacity and evidence of high water in the recent past. High diversion potential putting flood water on road and flood terrace. Average height is 6', average width is 35'. Bridge provides ingress and egress to eastern residential community, and Modjeska House historical landmark, as well as additional residential area to south of Santiago Creek.

**Text:** Clear upstream debris so that bridge does not clog and cause flooding. Early warning for the neighborhood to the south, accessed via Olive Hill Road.

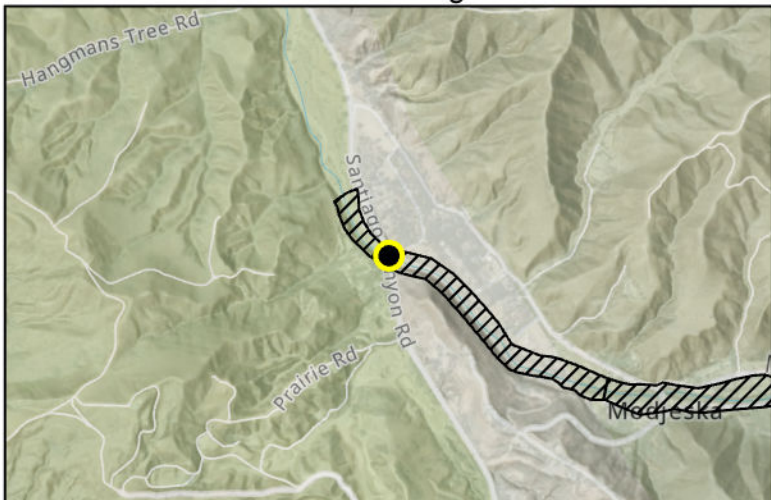
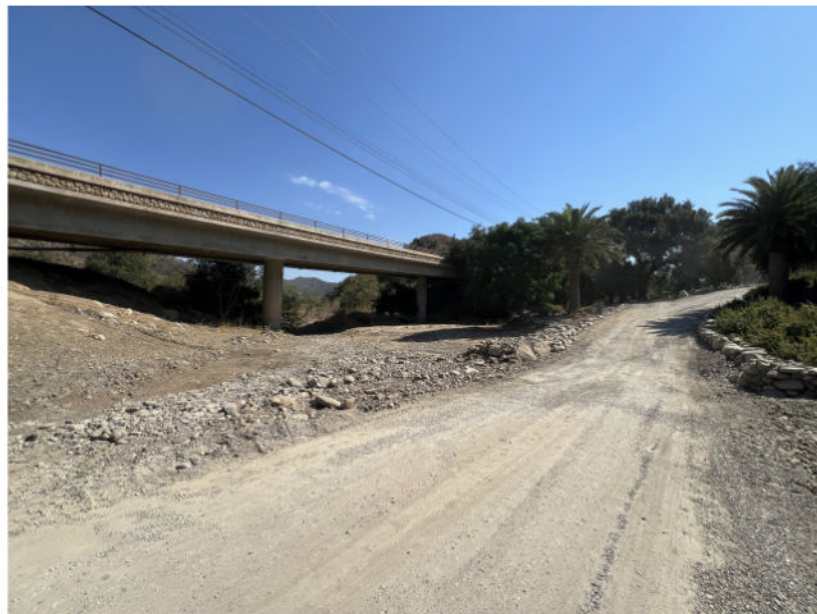
**Potential Hazard:** emanating from the burned upstream watershed.

**Description:** Local residents will be affected by flood flows interrupting access to properties on the south side of Santiago Creek.

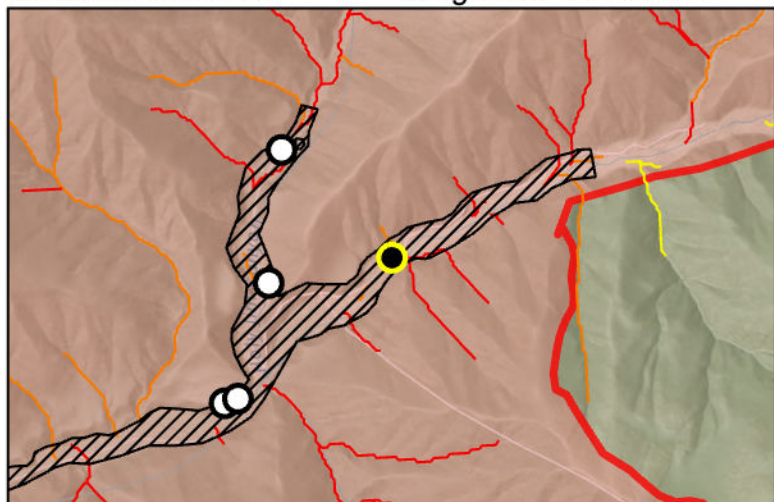
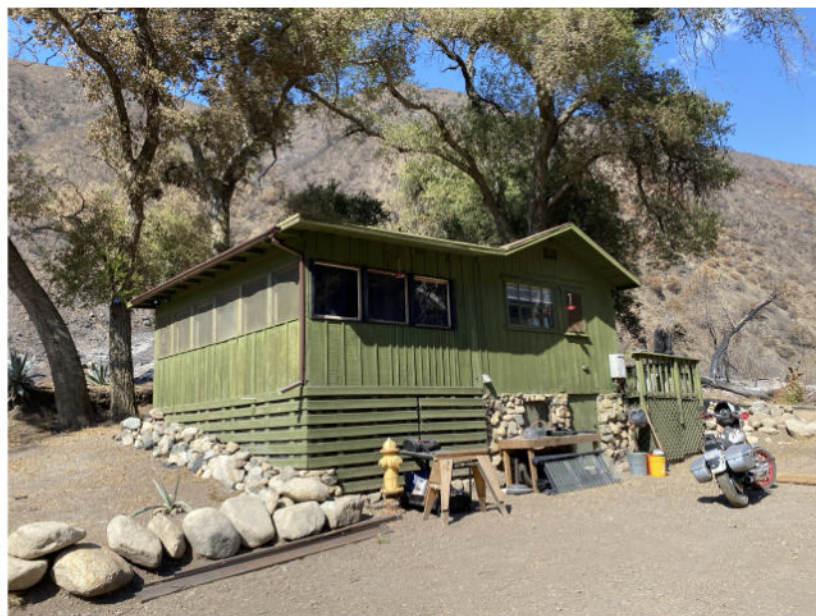
**Field Observation or Potential Hazard:** Cabin located within the main canyon drainage and at the base of a steep side canyon drainage. Potential hazard is debris flood/flow from upland swales, potentially simultaneously.

**Description:** This VAR may be impacted by south-facing ascending slope-derived inundation from debris/flood flows onto an active debris fan, as well as by inundation potential delivered by Trabuco Creek. Ingress and egress will be severely impacted from multiple watershed hazards as discussed in VAR TC-01. It is likely that following a stressing rainfall event this location will be cut off entirely by access in any direction.

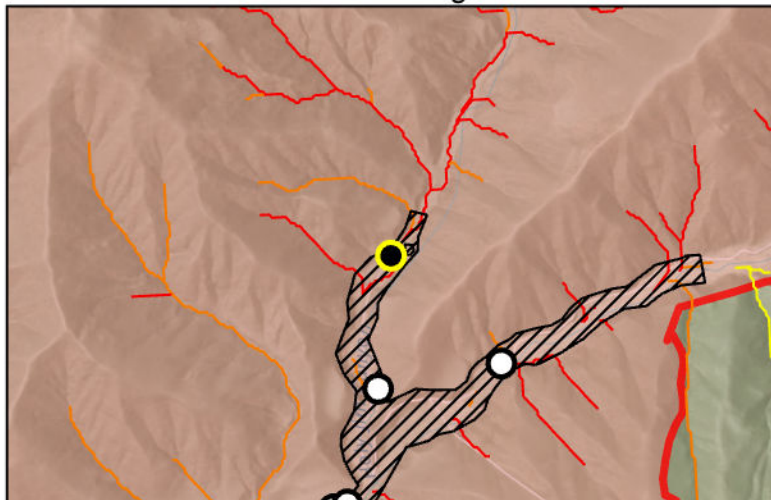
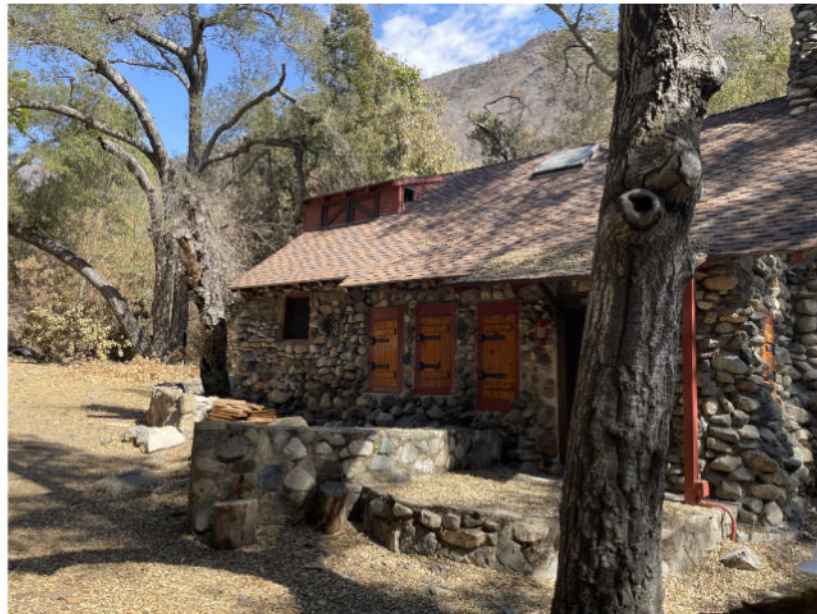
**Field Observation or Potential Hazard:** Potential flood flows may overtop channel banks and impact structure.

**Description:** Installing deflection structures, such as HESCO barriers, muscle walls, and sandbags, may help mitigate potential hazards.

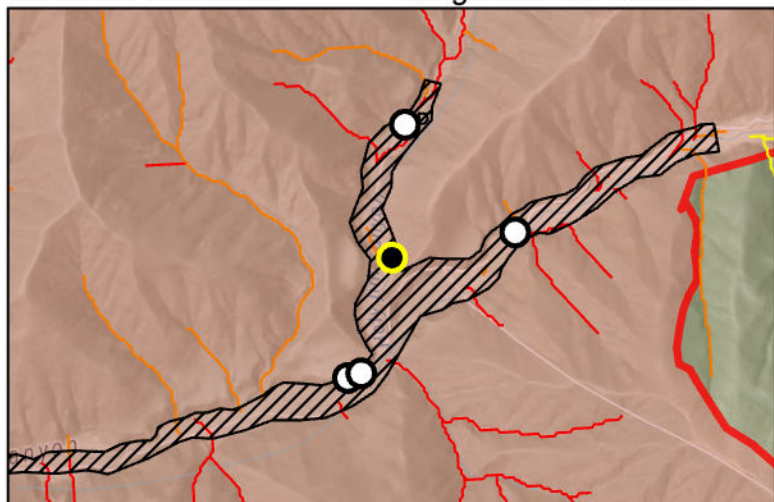
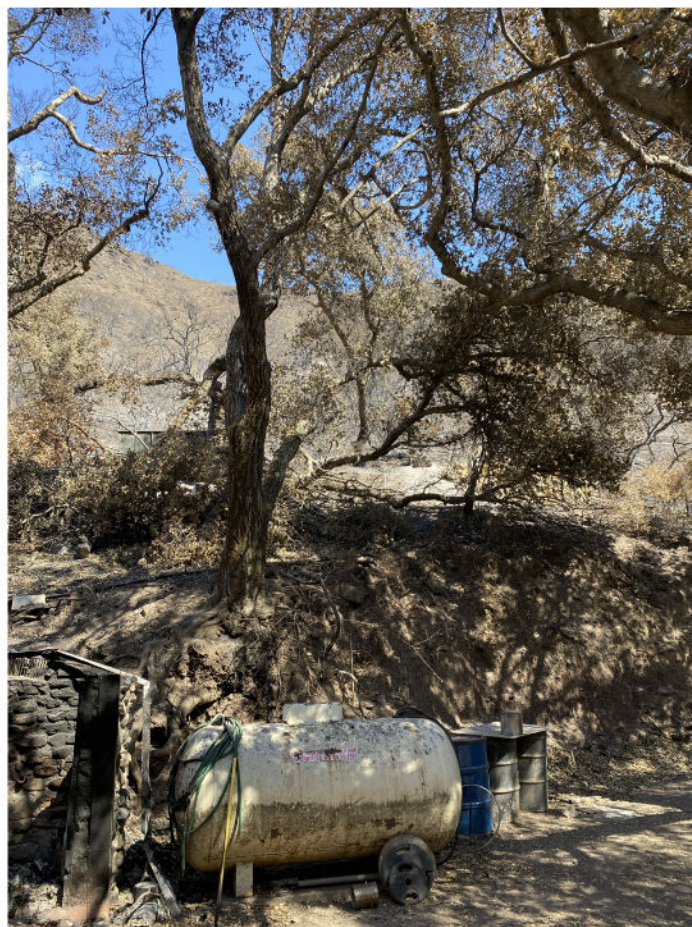
**Field Observation or** Cabin is located at base of convex drainage. Debris flood flow path could impact cabin. Oversteepened hillsides  
**Potential Hazard:** also have a potential for shallow landsliding.

**Description:** HESCO barrier installation on areas of ascending slopes behind the cabin is advised. Additional deflection structure installation on home pad behind cabin may assist with directing water/flood flow away from rear of cabin.
