# Watershed Emergency Response Team (WERT) 2024 Airport Fire

CA-ORC-127883

October 25, 2024

**REPORT TITLE:** Watershed Emergency Response Team (WERT) Evaluation – 2024 Airport Fire

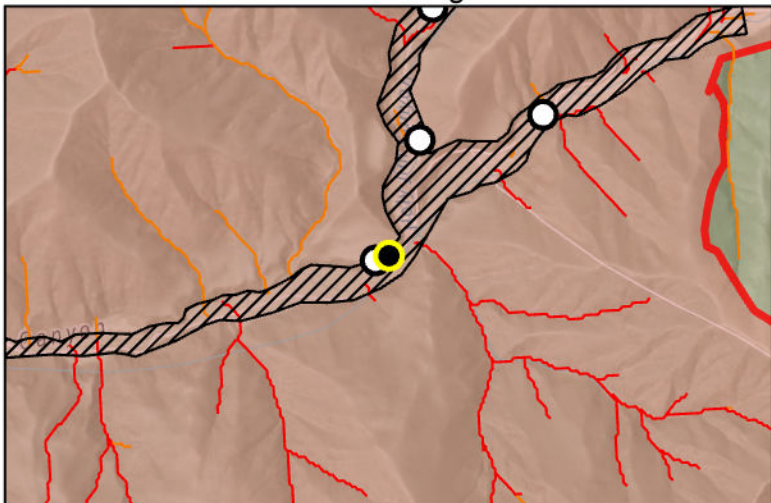
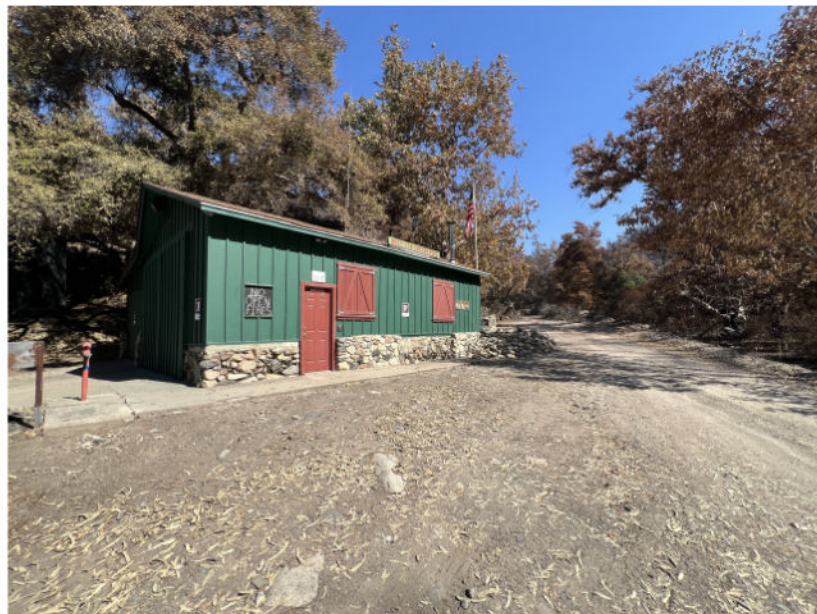
**Potential Hazard:** Existing trees growing out of the slope to the rear of the cabin are leaning against the cabin.

**Potential Hazard to Life: high**

**Potential Hazard to Property: high**

**Description:** Though the cabin is adjacent to a slope that decreases in gradient to the north, the entire slope was burned at a moderate soil burn severity. Due to the currently situated trees leaning into the rear of the home, if portions of the ascending slope become destabilized, the combination of bulked mud and debris adding to the force applied against the rear of the cabin may cause the cabin to be inundated and/or crushed during a stressing rainfall event, or after cumulative stressing rainfall events.

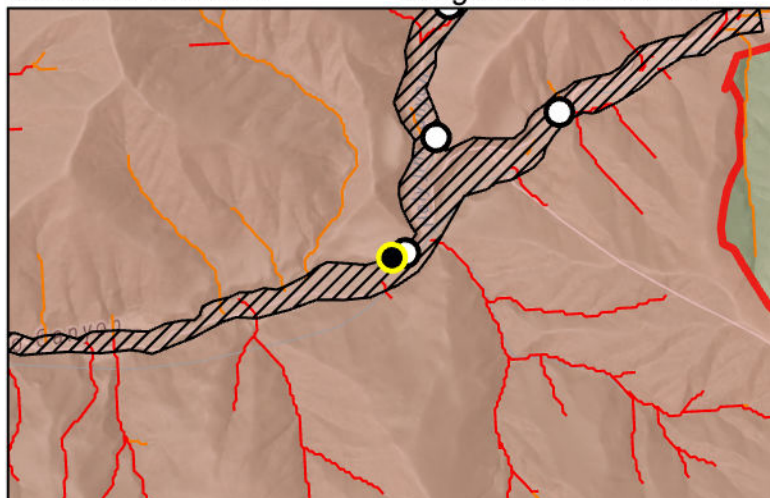
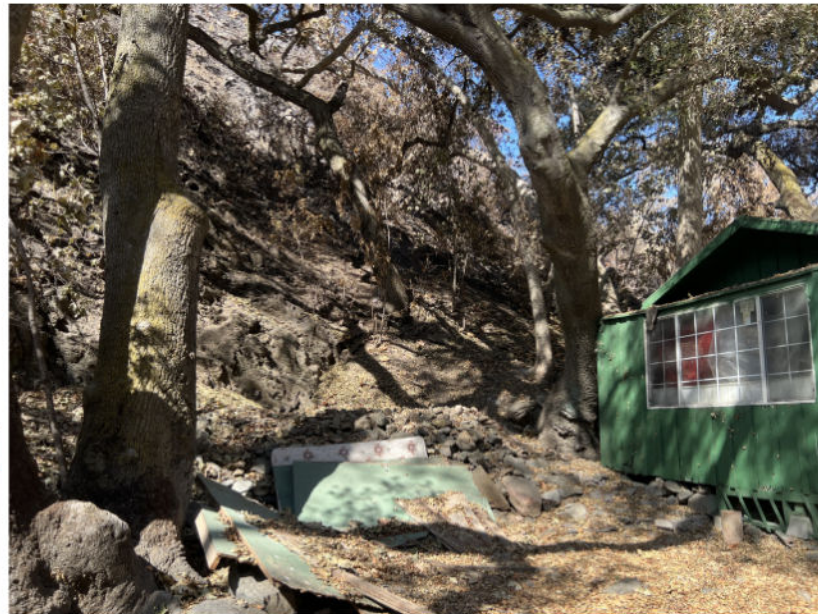
**Potential Hazard:**

**Potential Hazard to Life: low**

**Potential Hazard to Property: moderate**

**Description:** According to the Supervising Park Ranger, this structure has historically been outfitted with inflatable door seals to add precautionary protection against any potential flood flows originating within the Trabuco Creek/Canyon and/or Live Oak Canyon FEMA-mapped floodplains. Flood flows occurred during stressing rainfall events following the 2018 Holy Fire. There is a berm that extends along the north side of the active channel of Trabuco Creek that aids in confining swollen creek flow to its channel; however, anecdotal evidence indicates that the berm has been occasionally eroded during large flow events. The park staff have worked to repair the berm following every berm erosion incident, and are aware that they will have to remain vigilant during stressing rainfall events to come, originating from a larger burned watershed upstream.

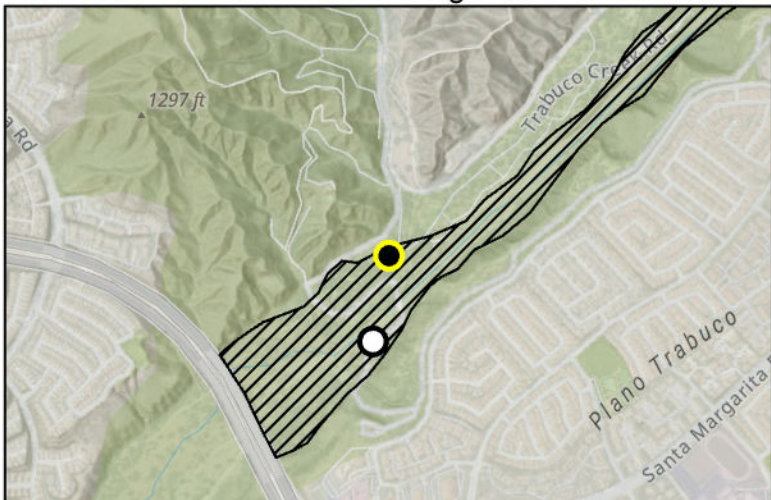
**Field Observation or Potential Hazard:** Restroom building is at risk of flood flow inundation. According to the Supervising Park Ranger, this structure has been inundated during past flood flows that overtopped the adjacent berm along the south side of Trabuco Canyon.

**Potential Hazard to Life: low**

**Potential Hazard to Property: moderate**

**Description:** Flood flows following the 2018 Holy Fire reportedly impacted the restroom building; as a result, the park installed debris barriers and deflection structures on the north/northeastern sides of the building in order to divert subsequent flood flows. Based on discussion with the Supervising Park Ranger, the park is aware of the likely increase in flood flow hazards associated with the Trabuco Canyon active floodplain during stressing rainfall events to come.

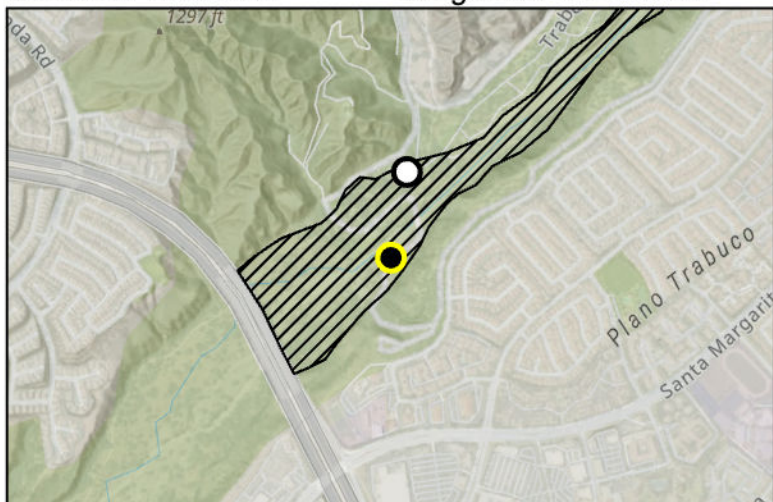
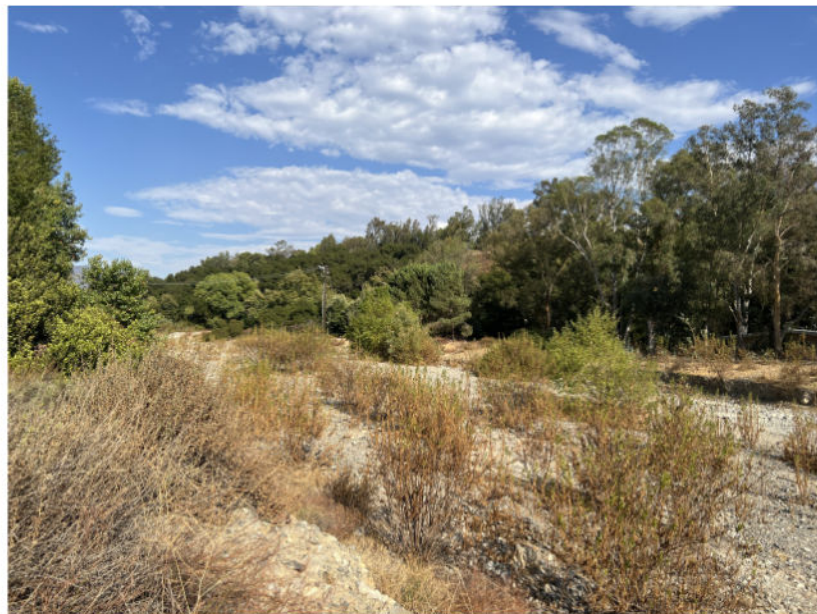
**Potential Hazard to Life: moderate**

**Potential Hazard to Property: high**

**Description:** The upslope basin burned at mostly moderate soil burn severity. The channel shows signs of high energy flow. Mobilized trees and debris could cause debris jams that force flows out of channel. Downstream bridge may be impacted by debris.

**Text:** Deflection structures such as K - rails and HESCO barriers could be effective to mitigate damage to home adjacent to channel. Bridge downstream should be maintained and kept free of debris.

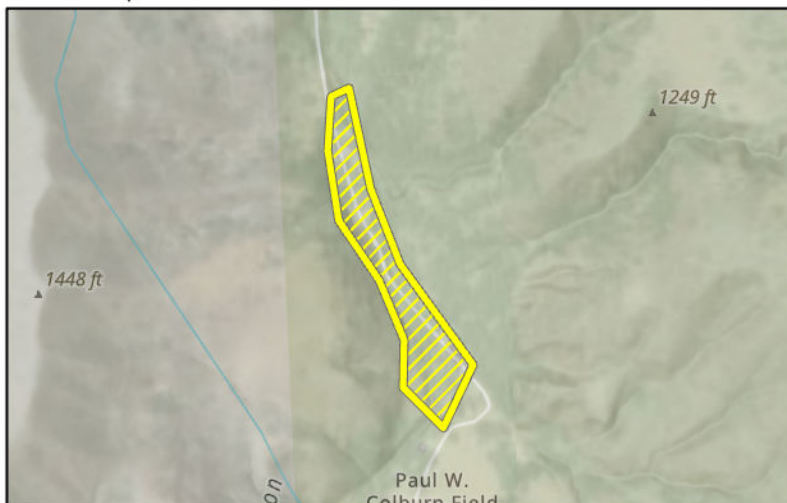
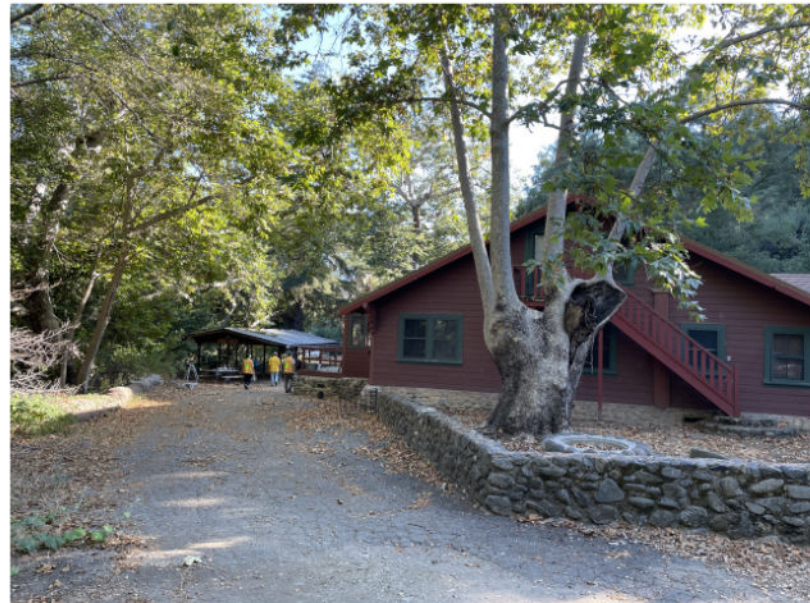
**Field Observation or** Burnt residence adjacent to watercourse and access road crossing. Potential hazard is flood that could mobilize  
**Potential Hazard:** burnt debris and sediment, overtopping crossing and impacting temporary housing and/or future structure(s).

**Potential Hazard to Life: low**

**Potential Hazard to Property: low**

**Description:** The VAR is located in the upper portion of a drainage burned at a mostly moderate soil burn severity.

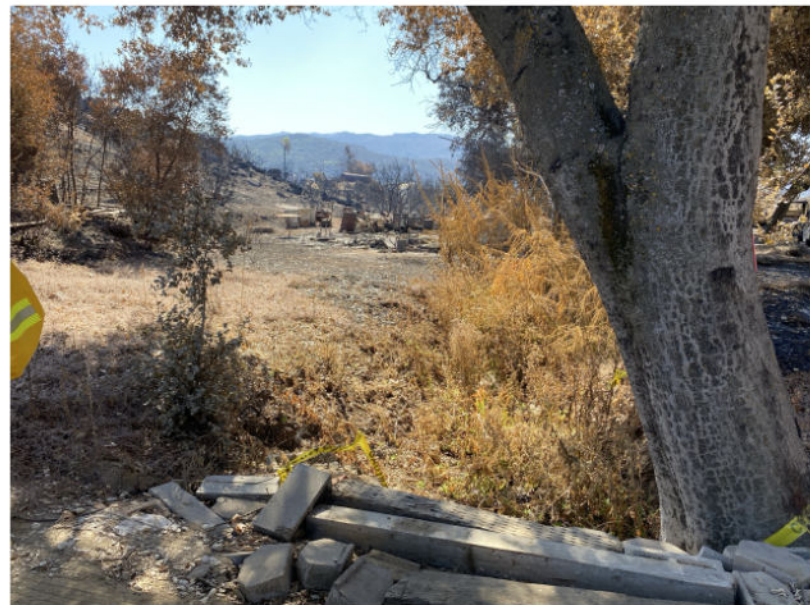
**Field Observation or Access road crossing, residence and outbuildings. Potential hazard is debris flood/flow plugging culvert, Potential Hazard:** resulting in overtopping and inundation of road. Potential avulsion and impacts to residence downstream of crossing adjacent to watercourse.

**Potential Hazard to Life: moderate**

**Potential Hazard to Property: moderate**

**Description:** Culvert includes a squashed 36" CMP, now 42" x 28", and three ~22" concrete barrels. Barrels up to 60% are plugged with sediment. Upstream channel is choked with brush and vegetation. Block wall adjacent to culvert outlet and downstream made of stacked rock provides some protection to residence. Small pond in residence yard could attenuate potential avulsion away from home. The upstream basin mostly burned at moderate soil burn severity.

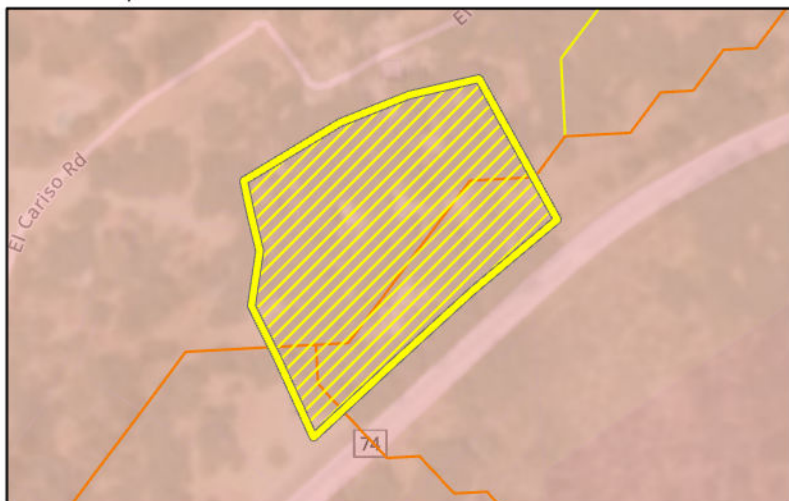
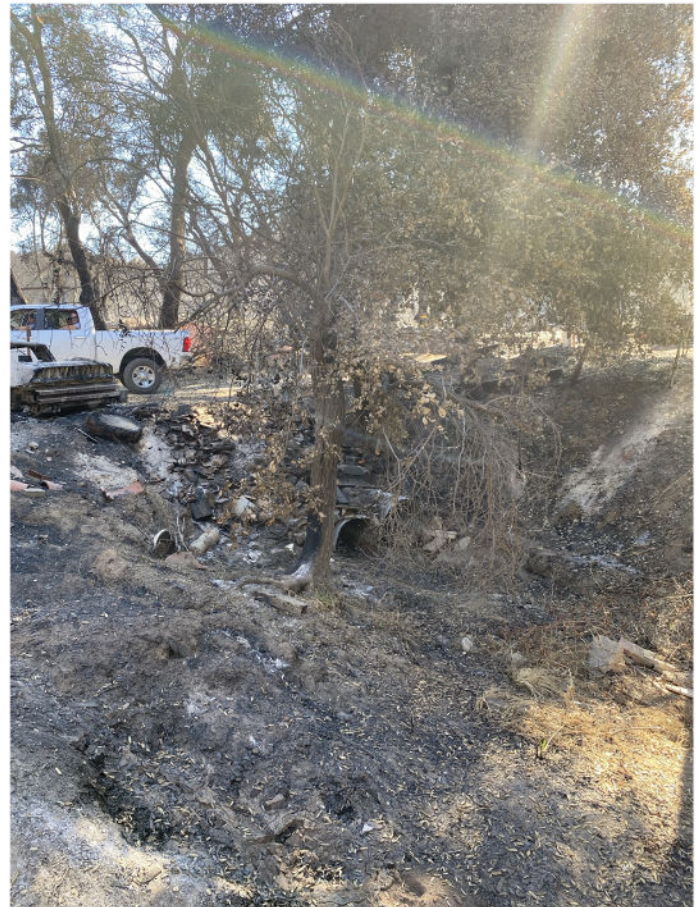
**Field Observation or** Multiple residences and structures are located adjacent to watercourse. Potential hazard is flood flows  
**Potential Hazard:** overtopping banks and inundating structures and access roads.

**Potential Hazard to Life: moderate**

**Potential Hazard to Property: moderate**

**Description:** Upstream basin burned at mostly moderate soil burn severity with some low.

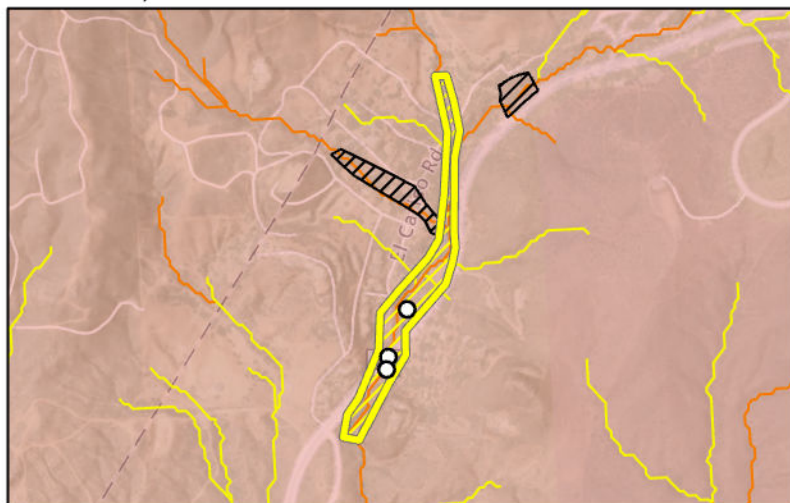
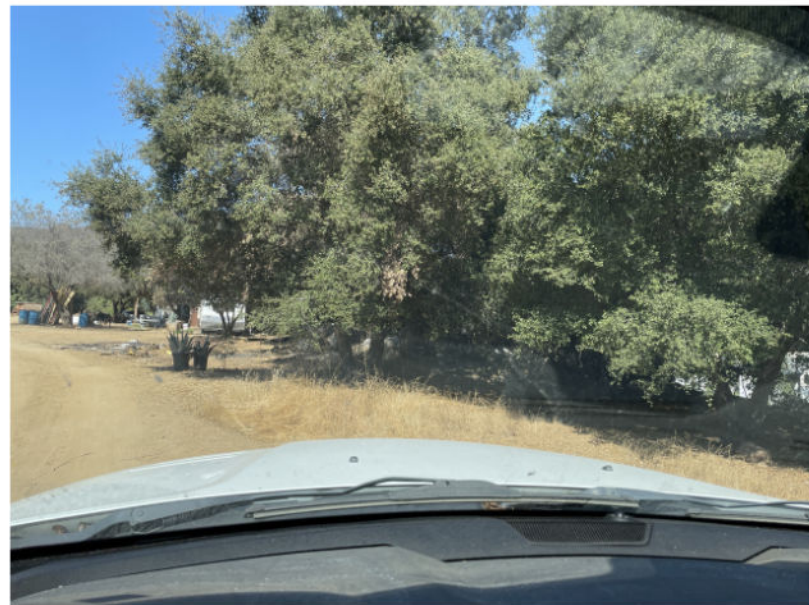
**Field Observation or** Multiple residences are located adjacent to watercourse. Potential hazard is flood and debris impacting multiple  
**Potential Hazard:** small crossings, resulting in diversions that can impact residences and associated structures.

**Potential Hazard to Life: moderate**

**Potential Hazard to Property: high**

**Description:** Upstream basin burned at moderate soil burn severity. Poor drainage exists along flow paths.

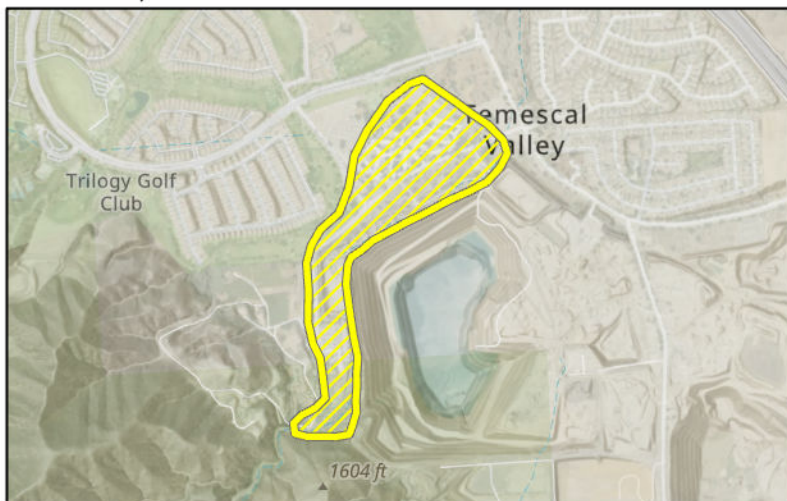
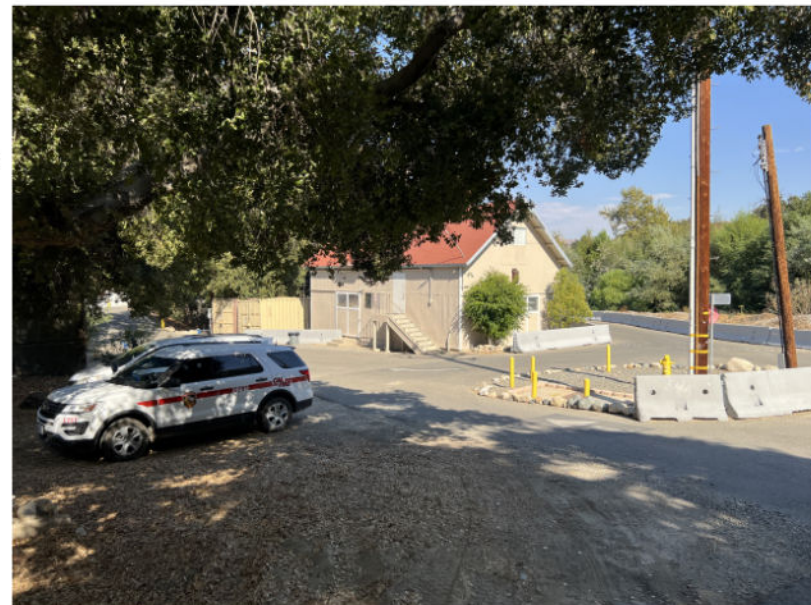
**Potential Hazard:** Potential hazard is debris flow/flood that can overtop banks and inundate structures.

**Potential Hazard to Life: high**

**Potential Hazard to Property: high**

**Description:** The basin upstream burned mostly at moderate soil burn severity with some high. Geomorphic evidence composed of braided channel network, large bedload material featuring large boulders, and steep gradient all suggest a high flow regime capable of flooding and transporting debris. Evidence of past walking bridge failure.

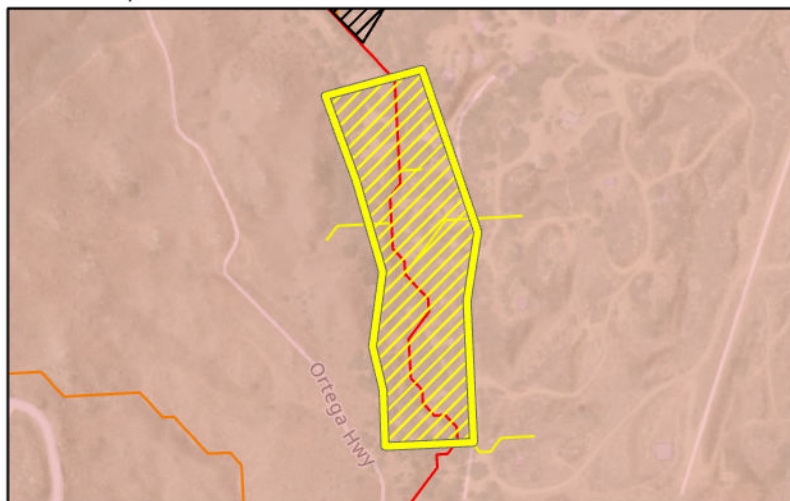
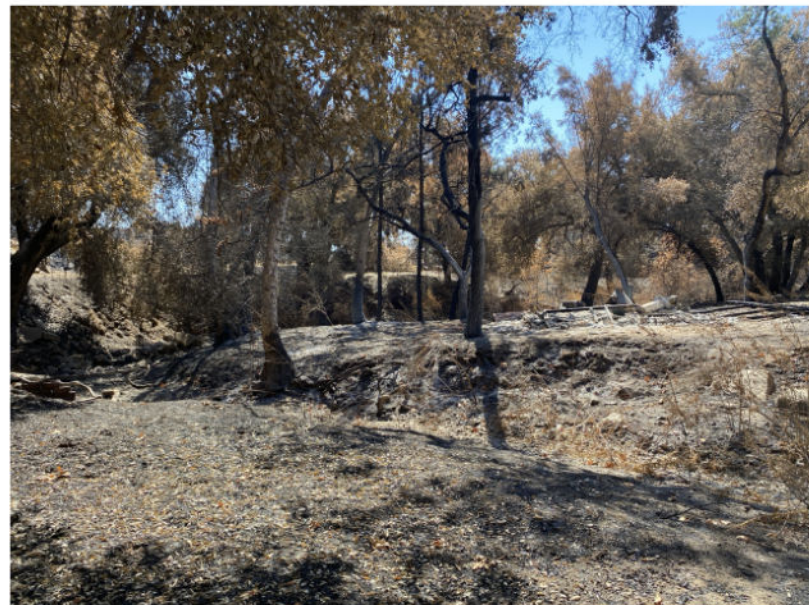
**Description:** Drainage was near capacity following the 2018 Holy Fire. Flows remained in channel but Brookstone crossing did get plugged. Diversion potential exists down Toft road.

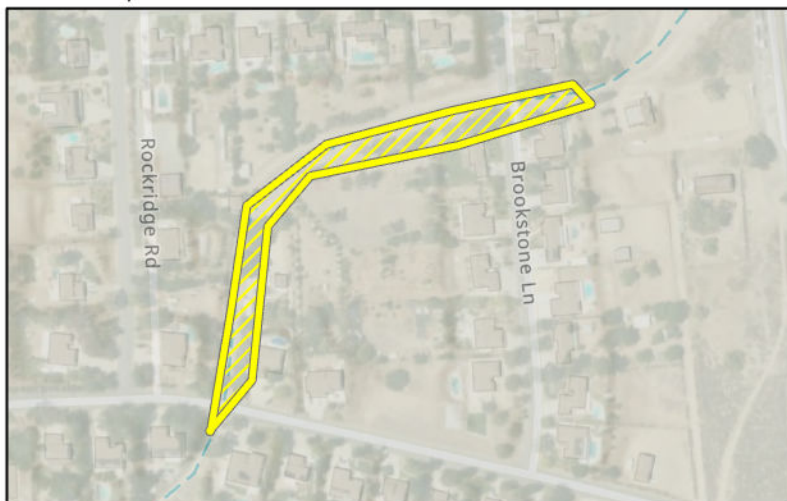
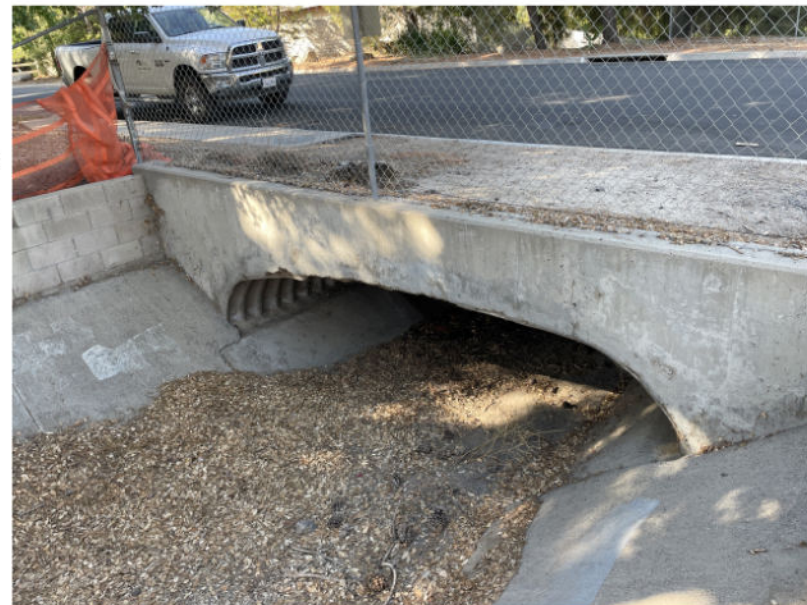
**Description:** Portion of basin in the burn scar burned mostly at moderate. 0.44 km2 at mod and high. Drainage adjacent to homes narrow and relatively steep with boulders.

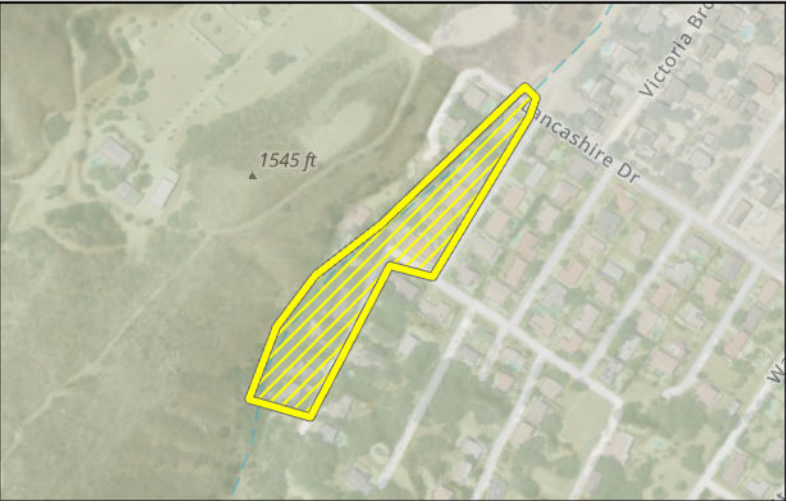
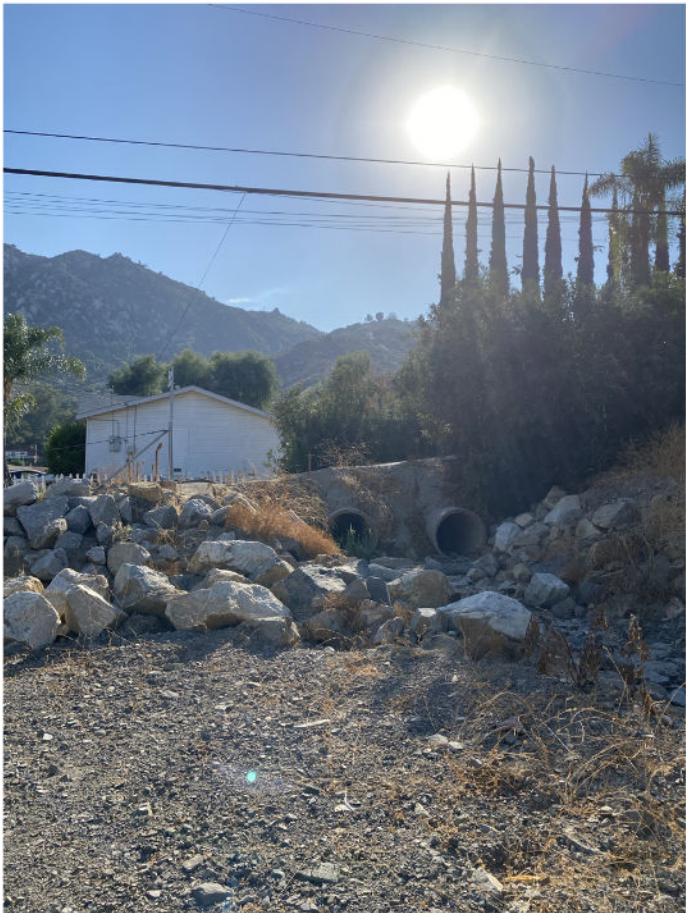
**Description:** 40% of basin burned with most of that area above Highway 74.

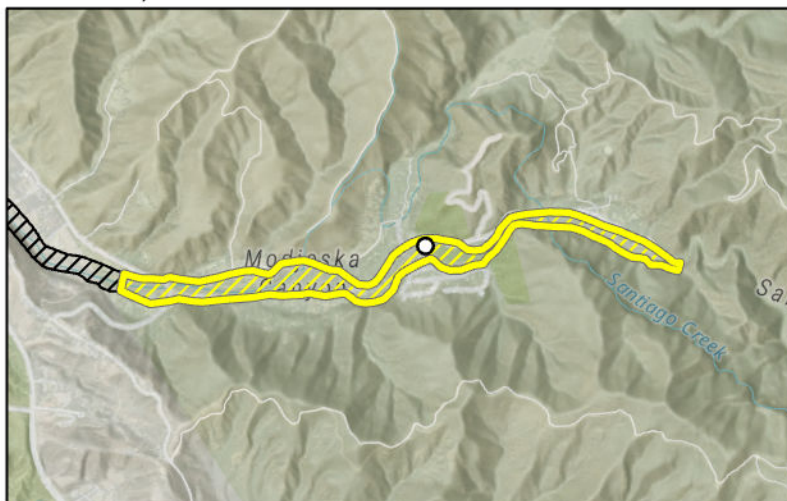
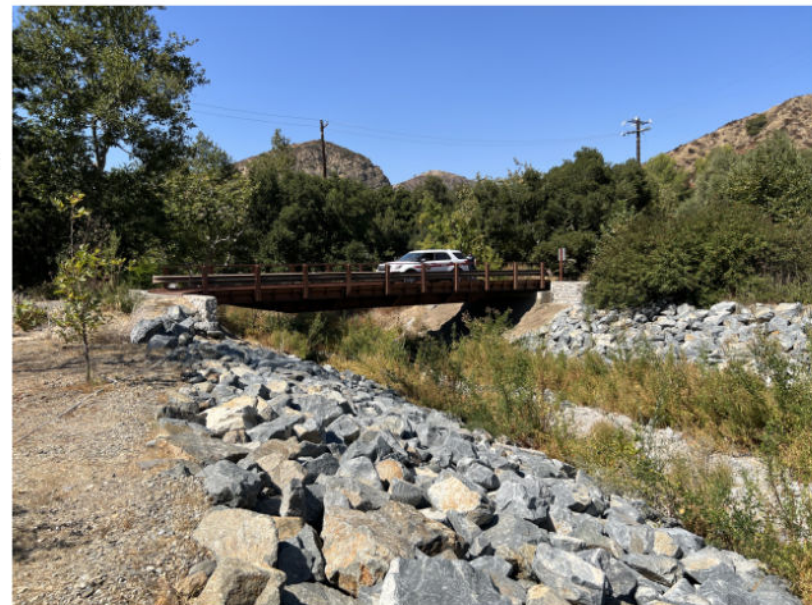
**Description:** Hazards within this VAR should be additionally characterized following a stressing rainfall event, which will more fully illuminate the map area/extent of impactful flood flows. Based on field reconnaissance/surveying, there did not appear to be many homes adjacent to or within the VAR. However, several horse pens and horse training facilities were observed adjacent to the active canyon bottom and floodplain.

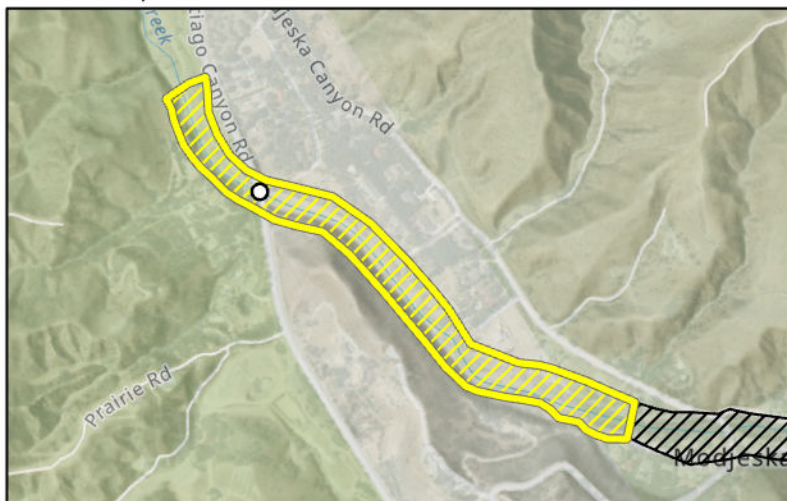
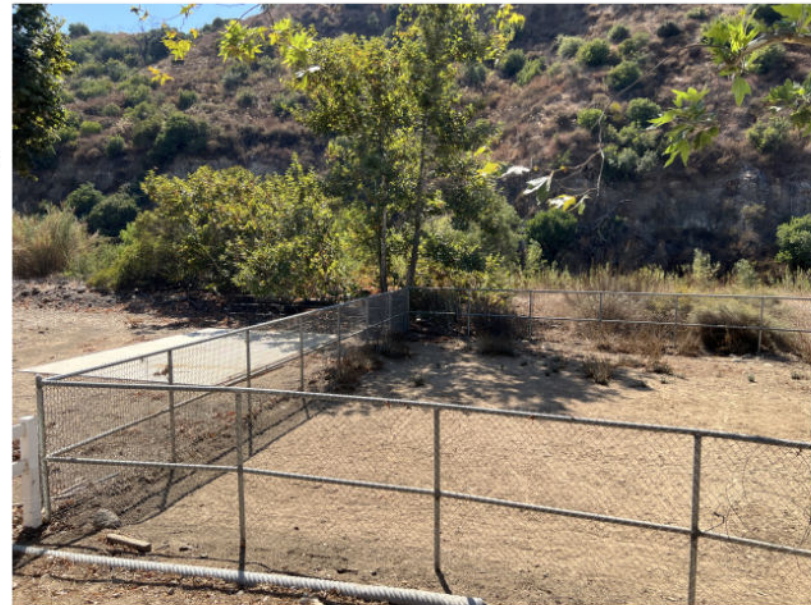
**Field Observation or** This reach of Santiago Creek is unconfined and possible distributed flood flows may impact ingress and egress  
**Potential Hazard:** for residents, structures, and road and drainage infrastructure during stressing rainfall events.

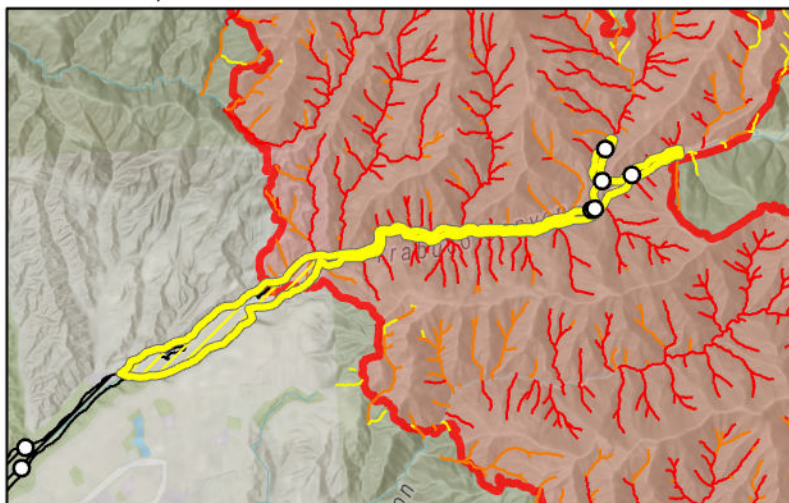
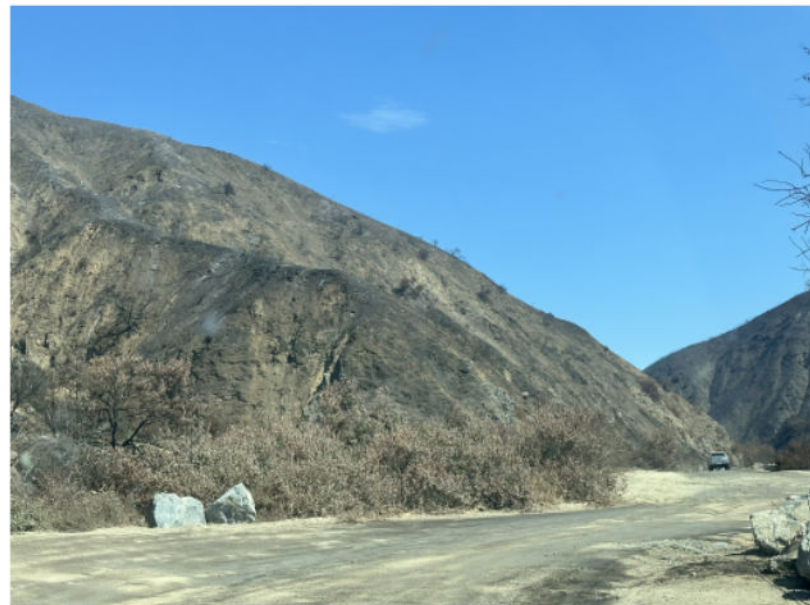
**Field Observation or** The entire floodplain and adjacent slopes contain the full spectrum of post-fire watershed hazards capable of  
**Potential Hazard:** impacting Trabuco Creek Road and residences. Landslides, rockfall, and debris and flood flows are all possible.

**Description:** The hazards within the polygon have the potential to combine and become cascading in nature.

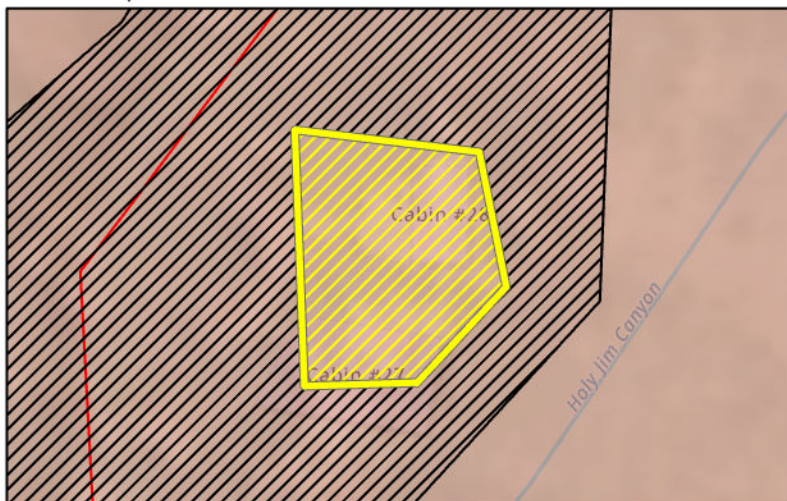
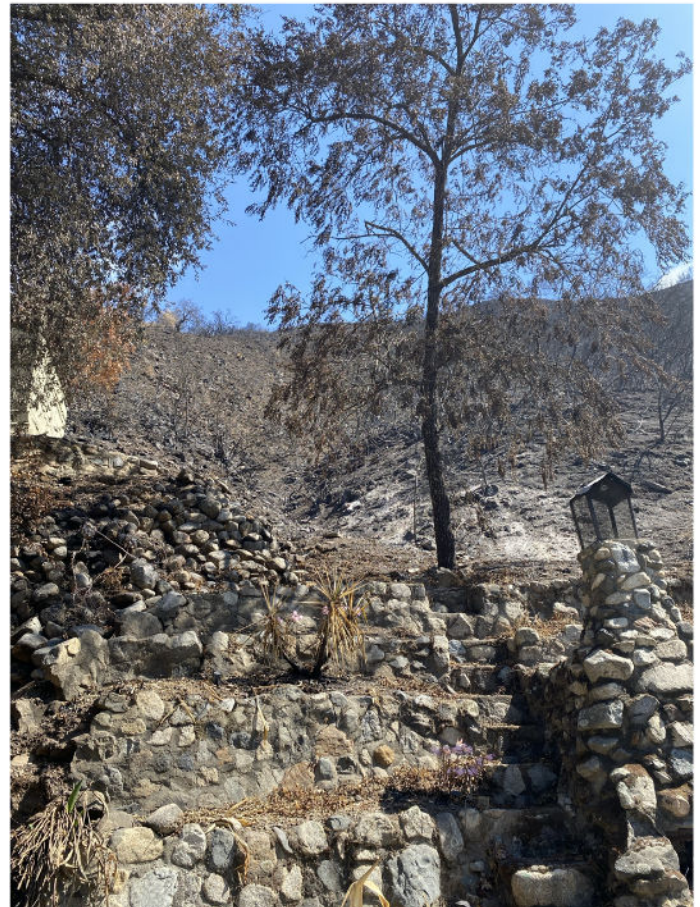
**Field Observation or** Cabins located at base of steep drainages, oversteepened hillsides. Potential hazard is rockfall and debris flood  
**Potential Hazard:** flows/flow directed directly into back of residences. No retaining walls or debris barrier structures are currently present.

**Description:** HESCO barriers may be implemented to protect cabin 27 (south of the two). The drainage pouring into the rear of Cabin 28 has no outlet other than into the back of the cabin. If HESCO barriers or any other deflection structures can be engineered into the ascending slope behind the cabin, installation is advised.

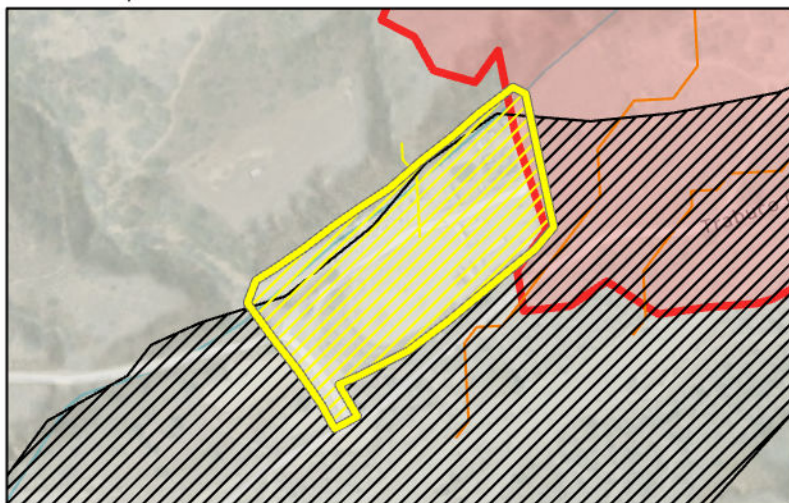
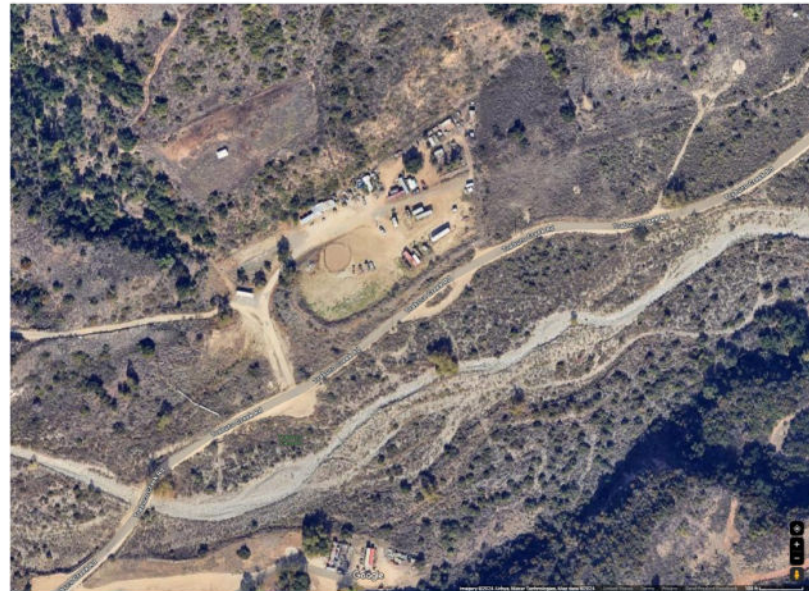
**Field Observation or** The access roadway into the VAR is within the active Trabuco Creek watercourse. Ingress and egress will be **Potential Hazard:** impacted during and following stressing rainfall events.

**Description:** The outbuildings and assorted property (cars, shipping containers) located within the VAR will potentially be impacted due to avulsions caused by flood flows in Trabuco Creek. The property will not be accessible during and after anticipated flood flows in Trabuco Creek and the associated floodplain.

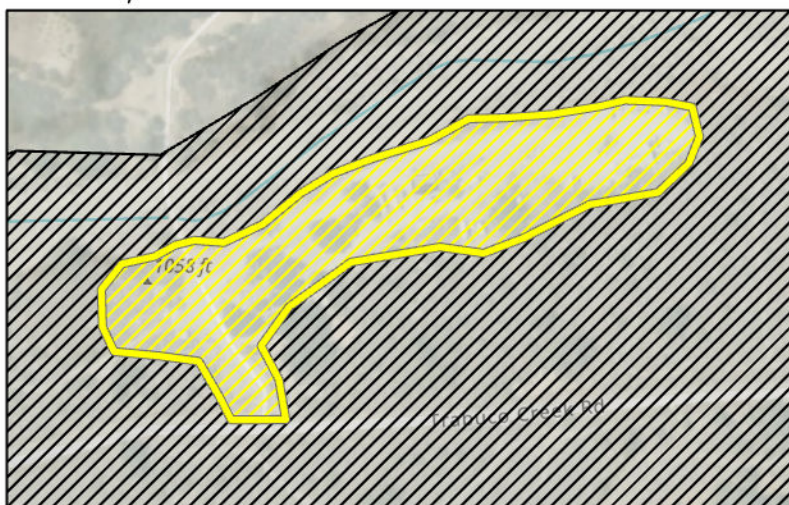
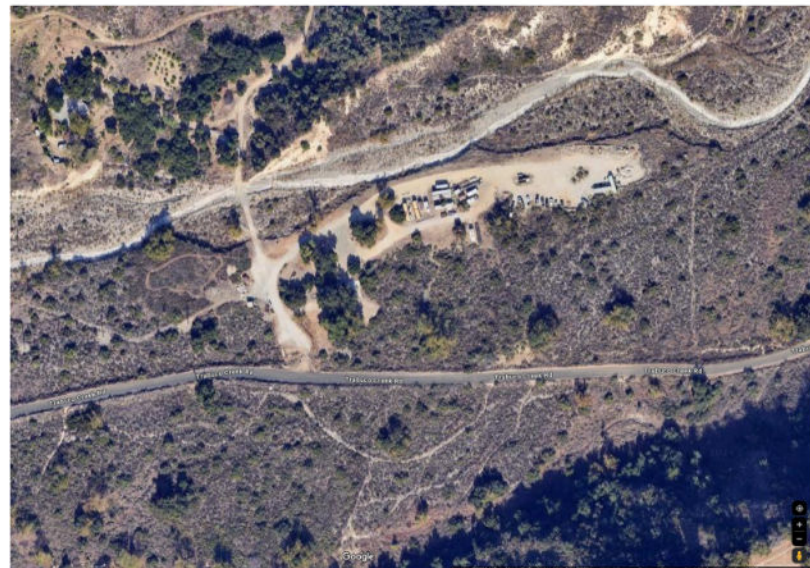
**Field Observation or Potential Hazard:** Inundation within an active floodplain due to flood/debris flows. Ingress and egress for this site as well as a neighboring property to the northwest, on the bluff above Trabuco Creek, will likely be impacted during a stressing rainfall event.

**Description:** This VAR was not directly accessed or observed during the WERT field reconnaissance. However, review of Google imagery indicates that the northern portion facing the active channel of Trabuco Creek will be at risk of highly concentrated flow emanating from Trabuco Canyon.

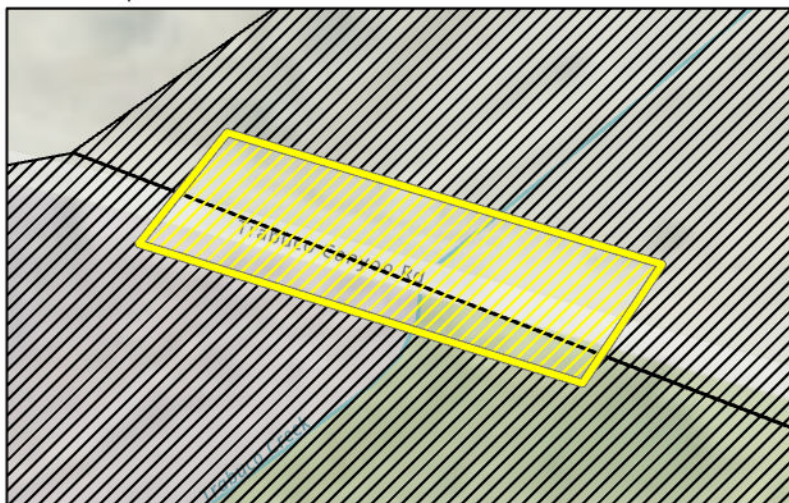
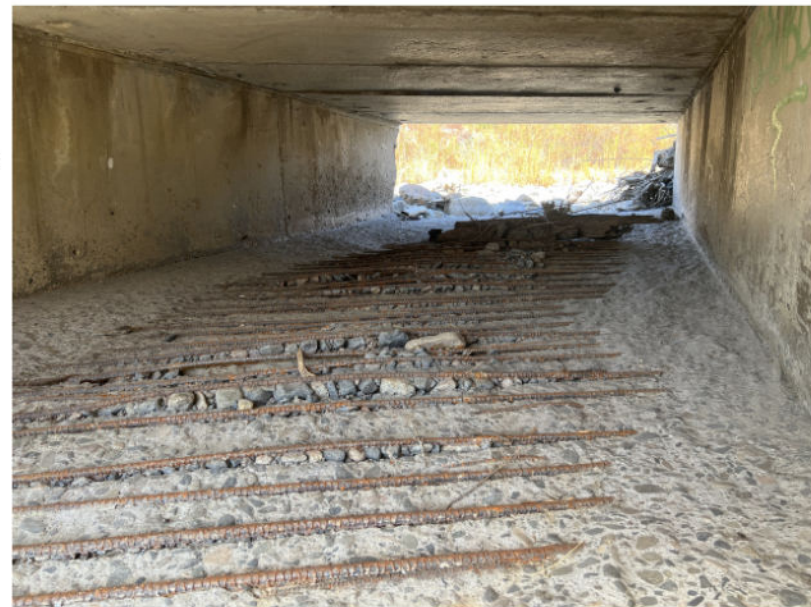
**Field Observation or** The Arizona Bridge crossing structure across Trabuco Creek has the potential to be inundated during high-  
**Potential Hazard:** volume debris-filled flood flows.

**Description:** This crossing structure formerly had guard rails which were destroyed by the 12/6/18 debris flow emanating from the uppermost portion of Trabuco Canyon burned in the Holy Fire. While the current crossing structure remains optimized for handling bulked flood flows, given the massive increase of upstream burned area, expected flood flows during stressing rainfall events will cause overtopping and present an extreme life safety hazard. Potential channel avulsions upstream of the crossing structure could cause a wider zone of inundation on roadways adjacent to the crossing structure. Existing signage on both sides of the bridge warns the community ("When Flooded Turn Around Don't Drown" & "Flooded During Rains") about this watershed hazard. This message should be amplified preceding anticipated stressing rainfall events.

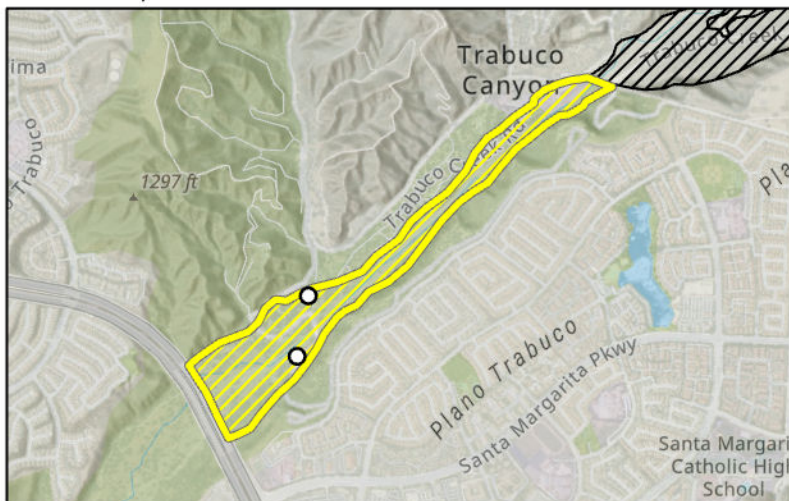
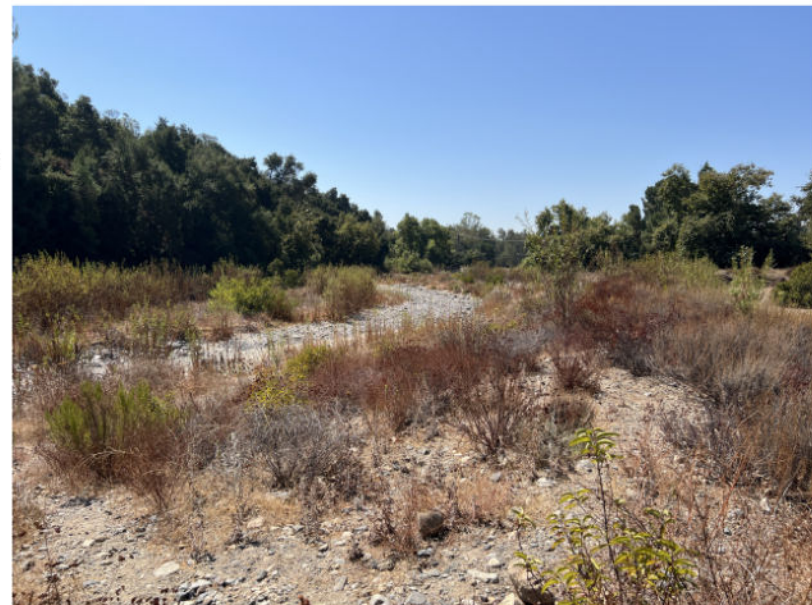
**Field Observation or Potential Hazard:** Active floodplain inundation with flood flows and possible distributed hyperconcentrated flow runout across the width of Trabuco Canyon. Historic damaging flood flows have occurred in this reach of the canyon following the 2018 Holy Fire.

**Description:** This VAR, similar to its upstream counterpart, occupies a sizeable area of the canyon floodplain. Many potentially impacted entities (OCFA, O'Neill Regional Park) will need clear communications regarding the potential hazards and exposure generated by stressing rainfall events to come. Anecdotal evidence provided by the O'Neill Regional Park Supervising Park Ranger indicates that lower areas of the park were impacted with flood flows that eroded the berm adjacent to Trabuco Creek following the 2018 Holy Fire. The park has implemented inflatable door seals to protect the Nature Center, and debris barriers/deflection structures have been placed around the bathroom on the south side of Trabuco Creek in the past as precautionary measures in the event of flooding. There are many access points to the park that will need to be closed in advance of stressing rainfall events.

**Text:** Evacuation is advised prior to stressing storm events. Flood flow hazard is historically very well-documented.
